Inspection Photos
Location Name: CAERUS PICEANCE LLC O29NE Pad
Location ID: 335085

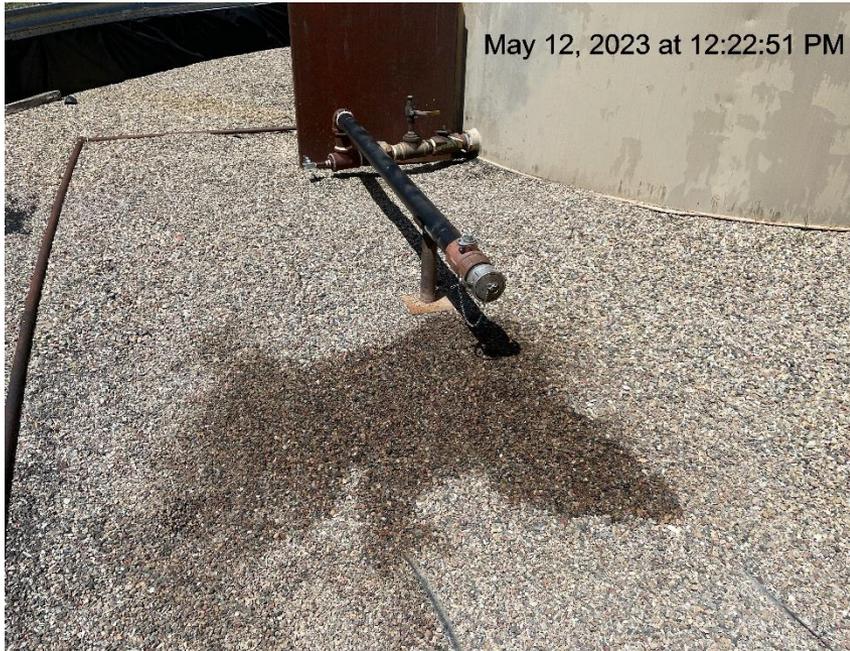
Photo # 7647 Stained gravel inside secondary containment

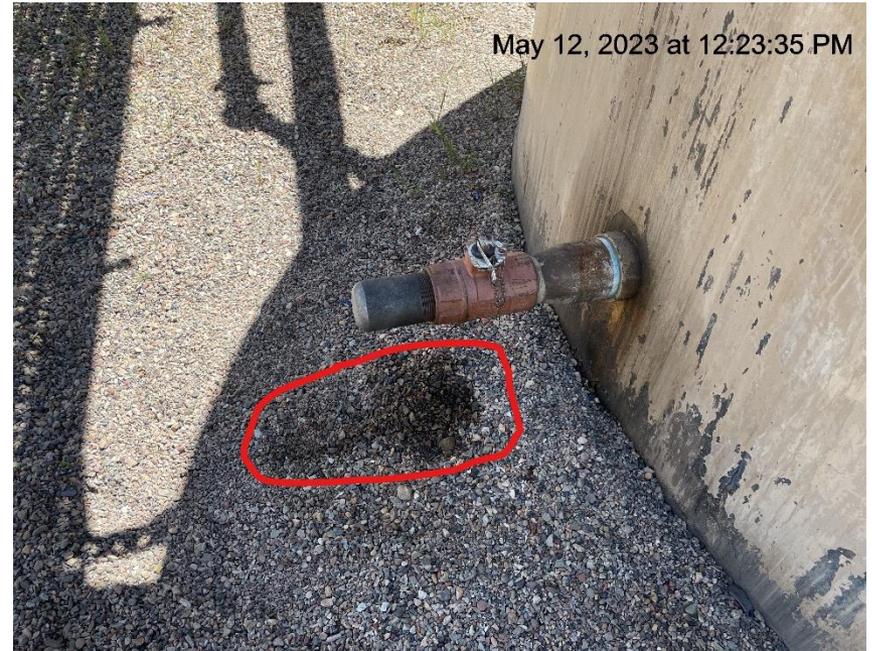
Photo # 7649 Stained gravel inside secondary containment

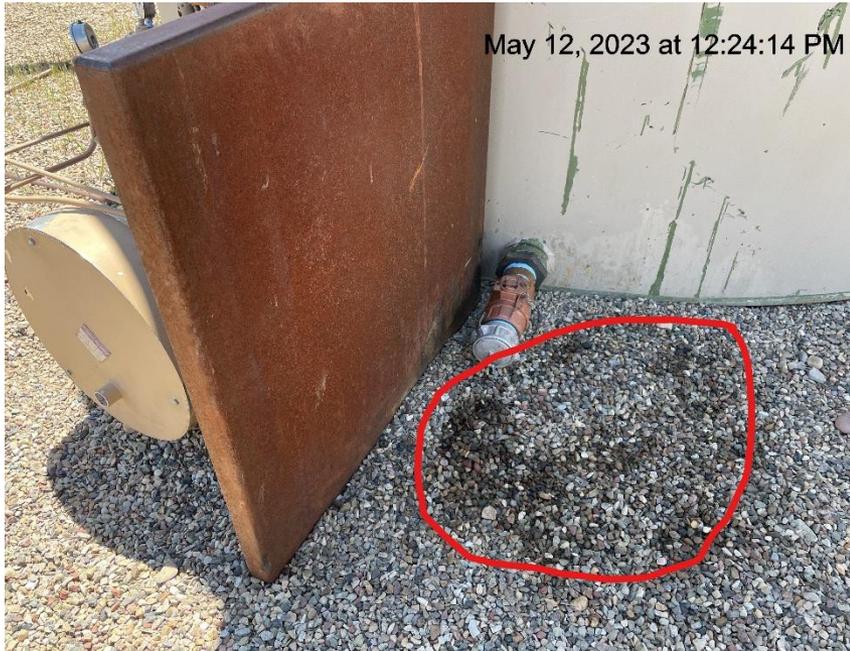
Photo # 7650 Stained gravel inside secondary containment

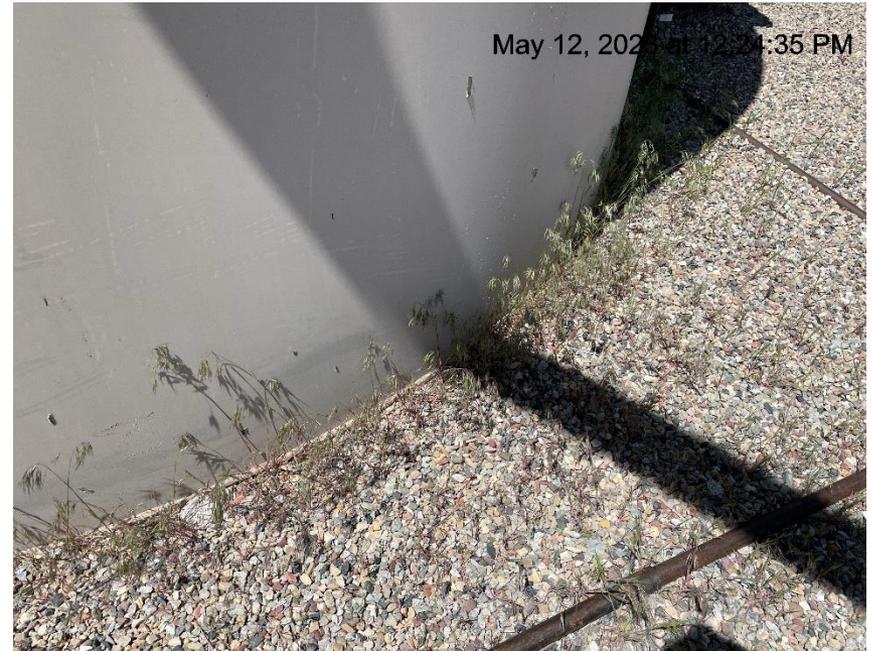
Photo # 7652 Weeds in secondary containment

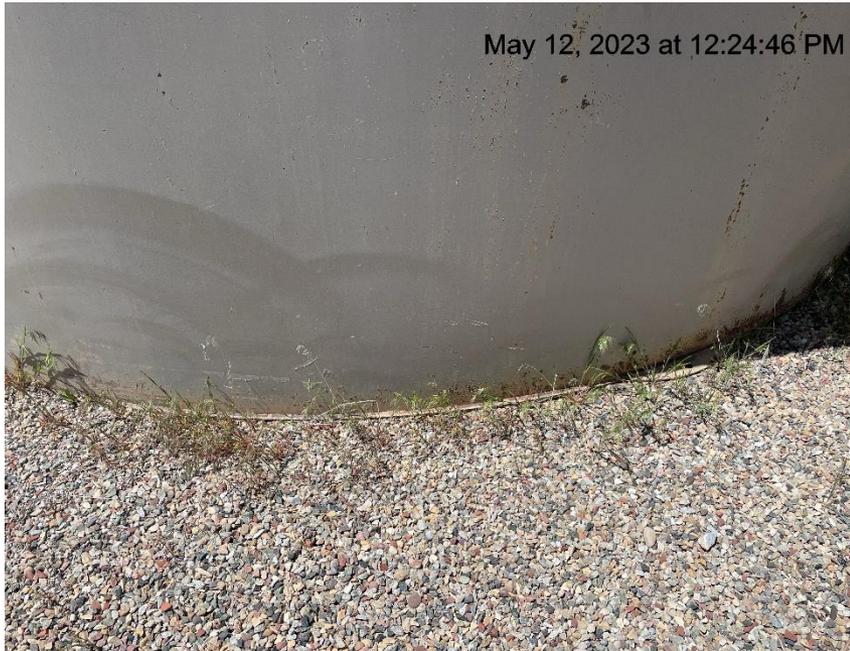
Photo # 7653 Weeds in secondary containment

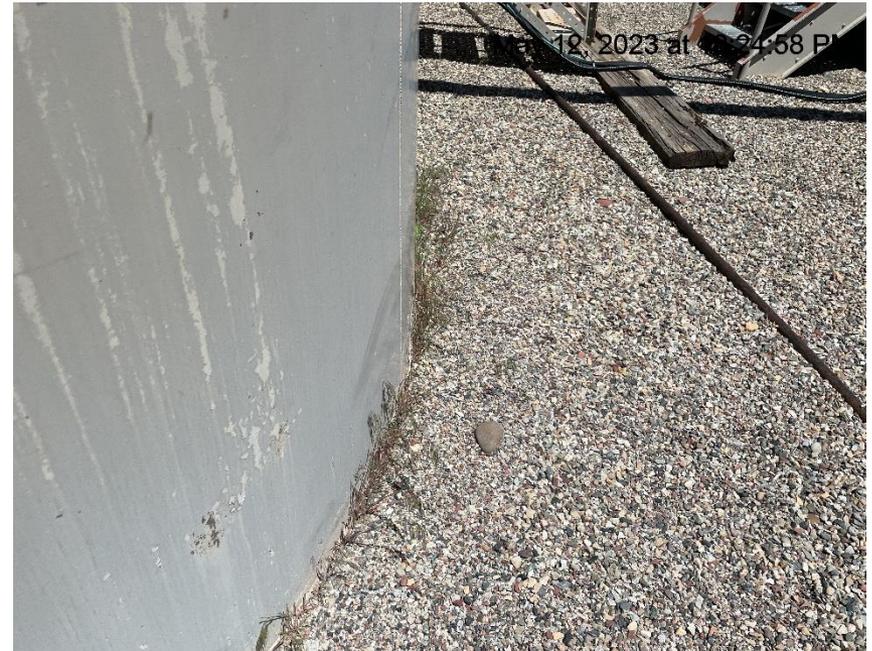
Photo # 7654 Weeds in secondary containment

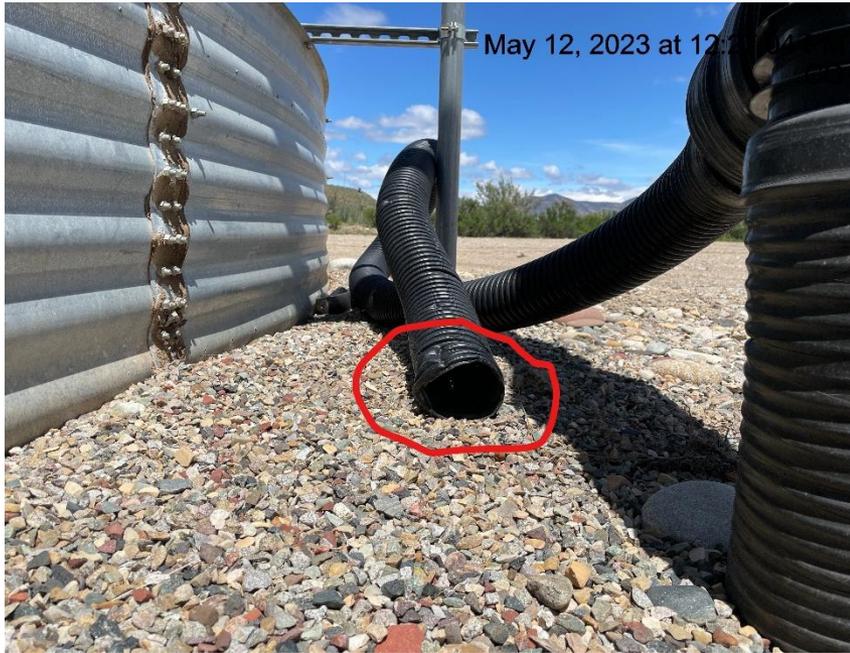
Photo # 7657 Flowline heating insulation open ended

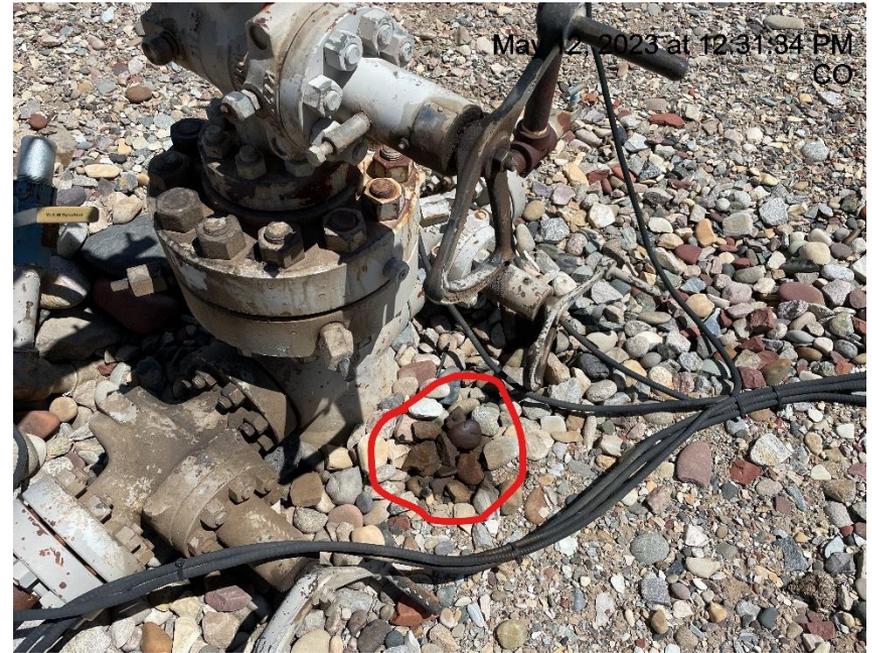
Photo # 7660 Stained soils & gravel

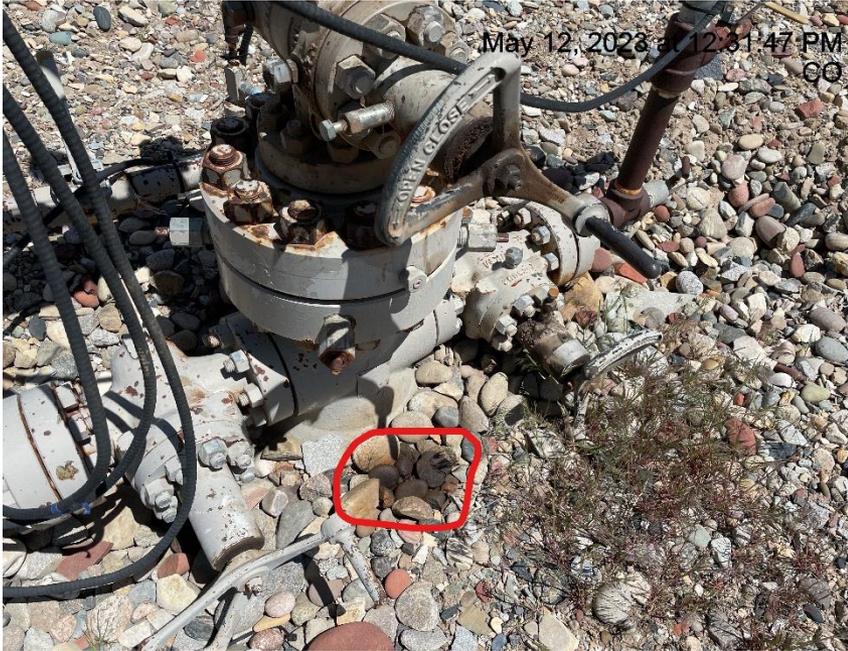
Photo # 7661 Stained soils & gravel
