Storm water Management and Erosion control
Location Name: CAERUS PICEANCE LLC G32NEC Pad
Location #: 334901

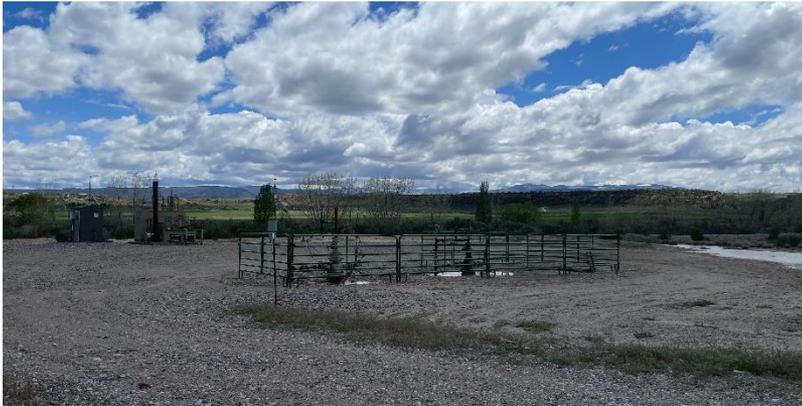
North West corner of location.

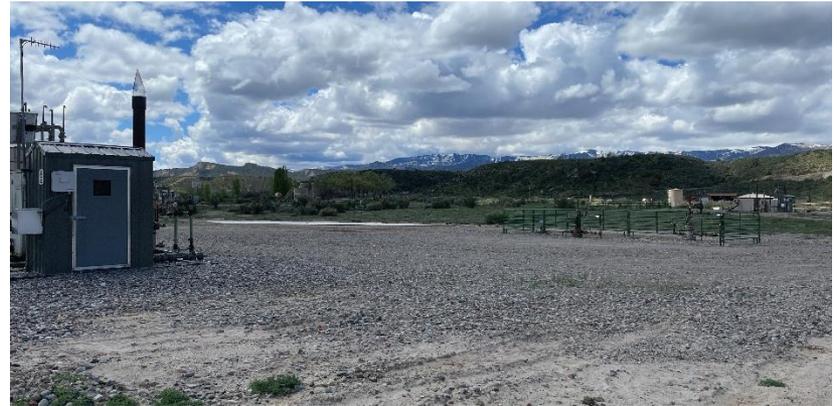
North East corner of location.

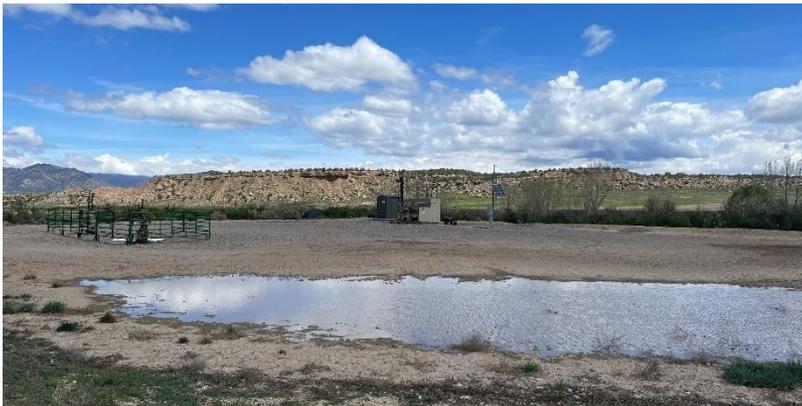
South West corner of location.

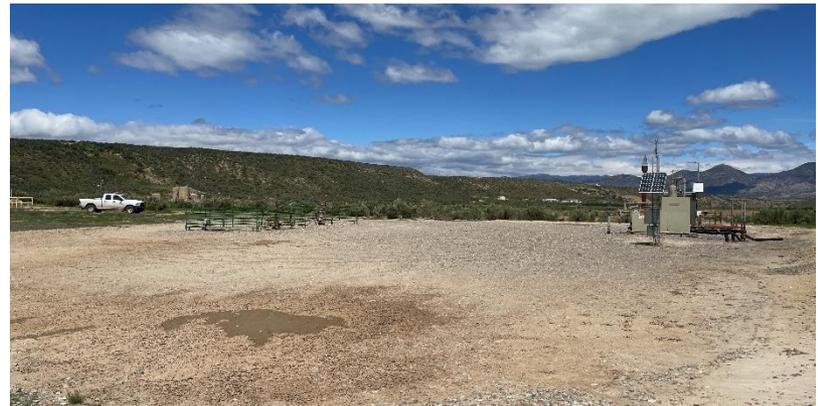
South East corner of location.

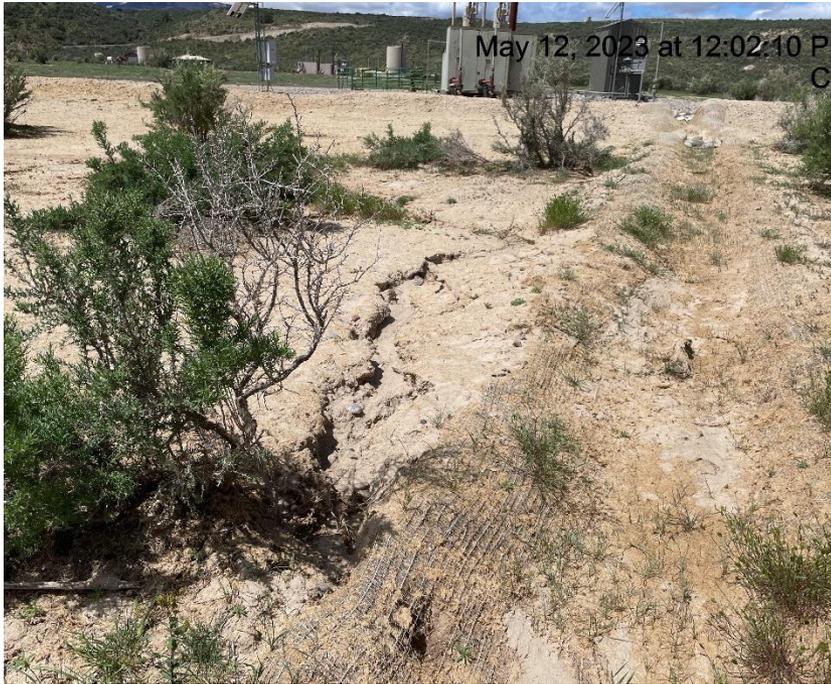
Photo # 7620 Erosion cutting into ditch

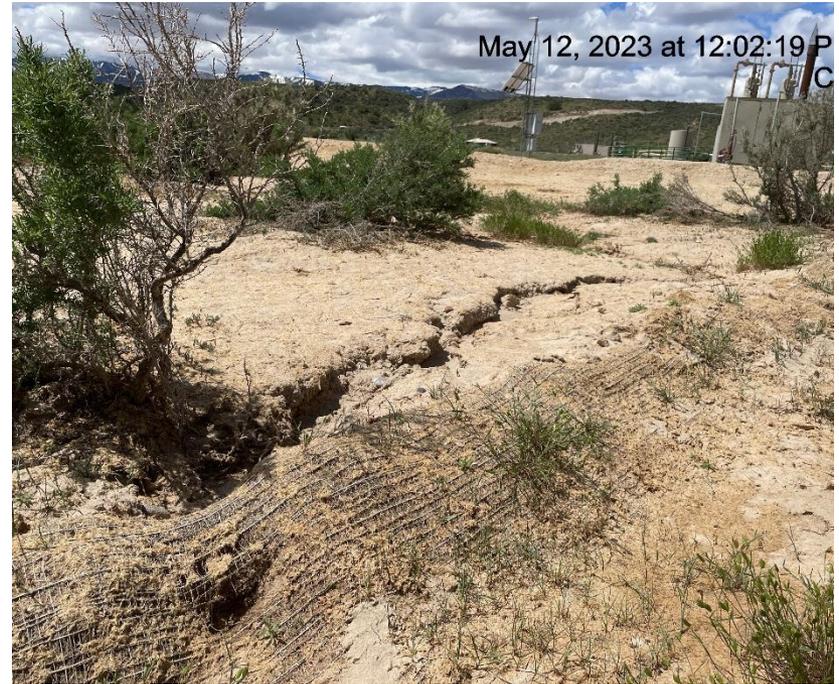
Photo # 7621 Erosion cutting into ditch

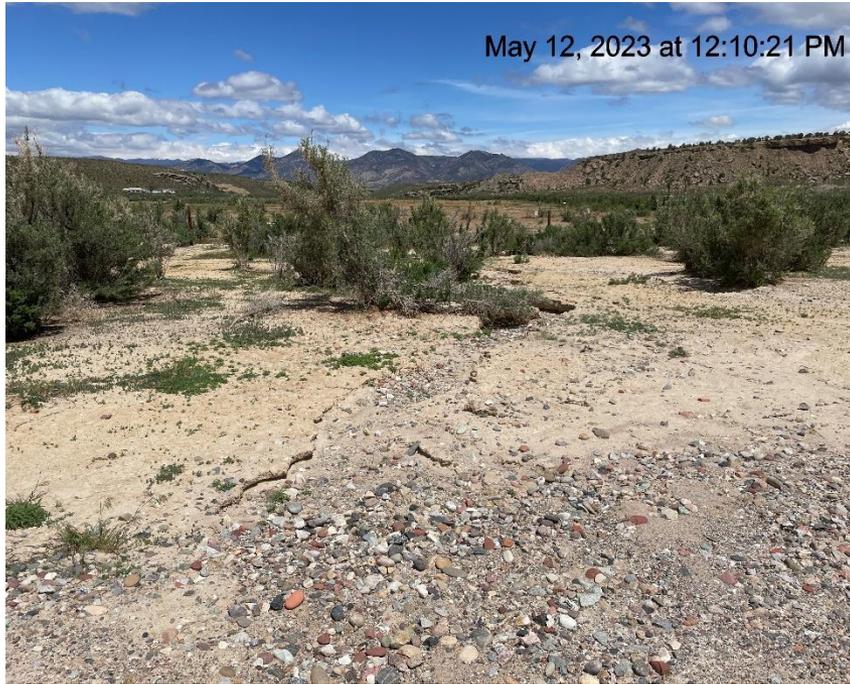
Photo # 7628 Erosion & transport of sediment/Insufficient run off controls/BMP's

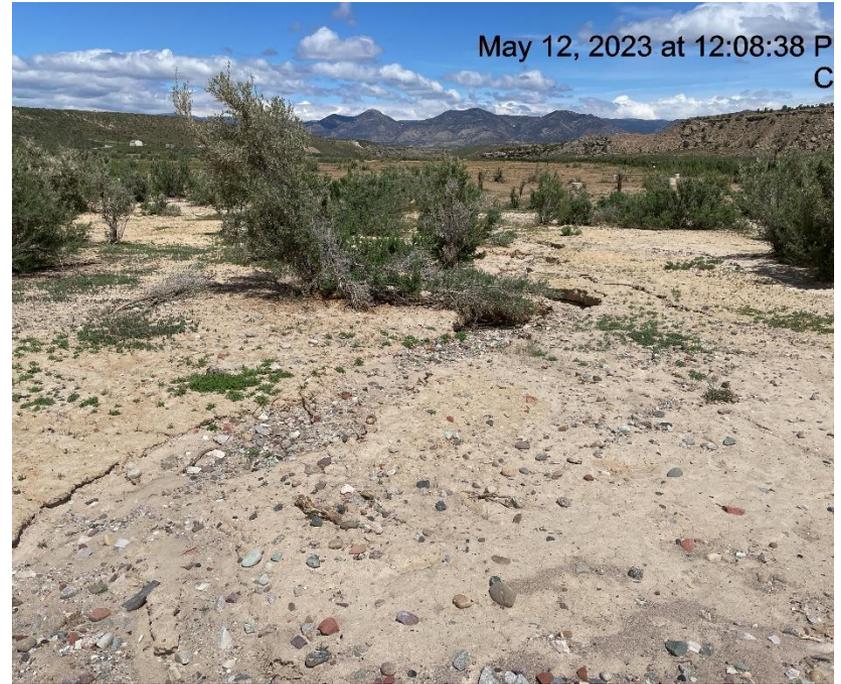
Photo # 7629 Erosion & transport of sediment/Insufficient run off controls/BMP's

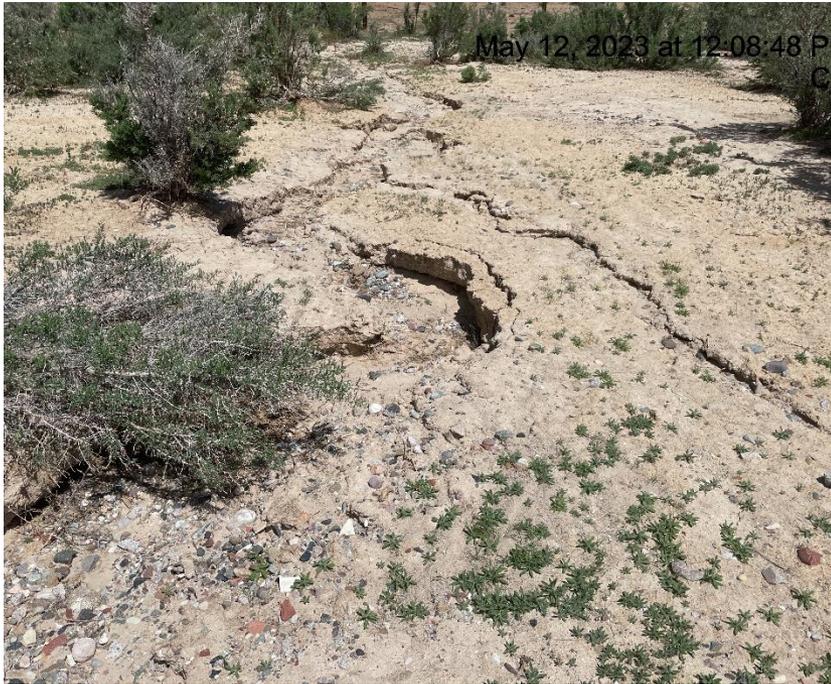
Photo # 7630 Erosion & transport of sediment/Insufficient run off controls/BMP's

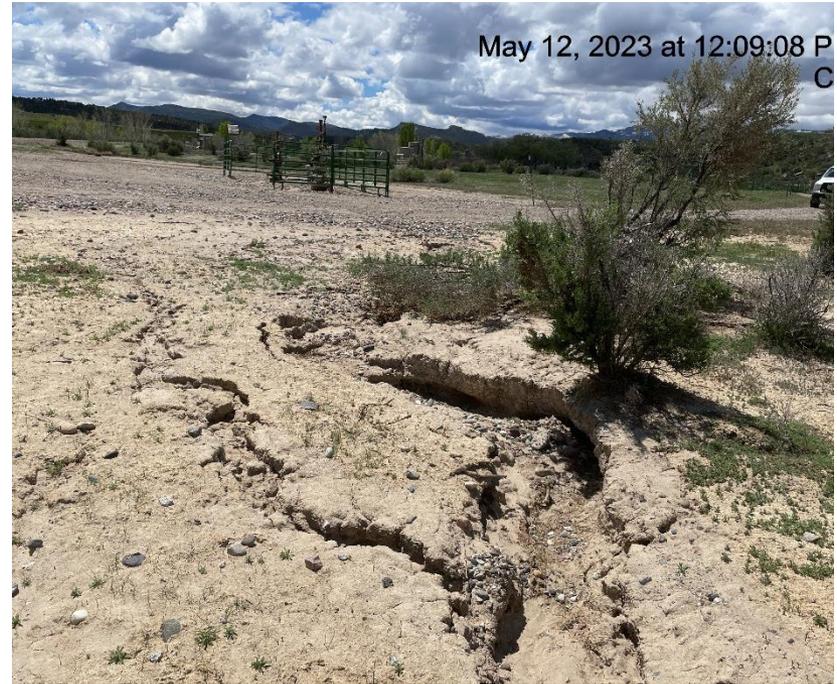
Photo # 7631 Erosion & transport of sediment/Insufficient run off controls/BMP's

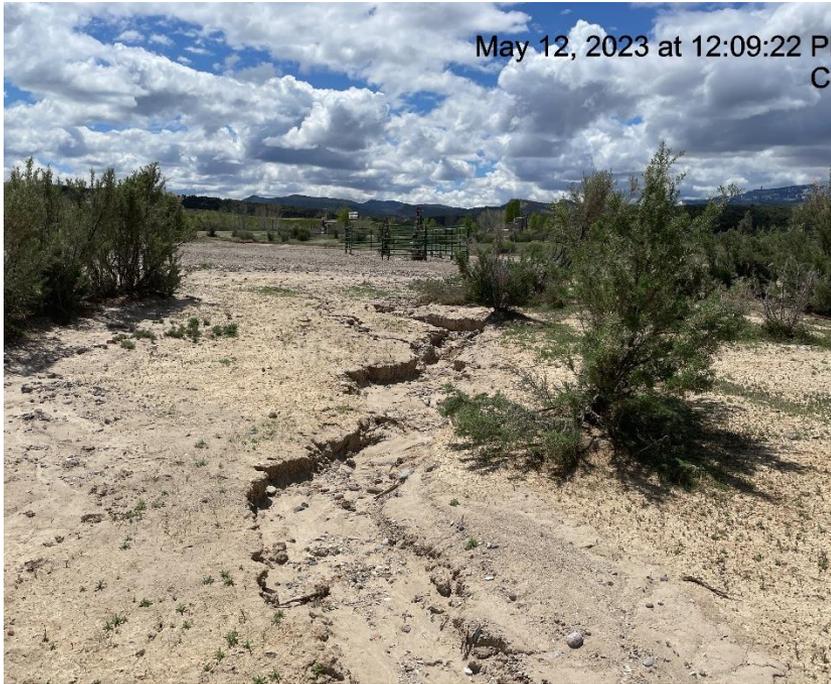
Photo # 7632 Erosion & transport of sediment/Insufficient run off controls/BMP's

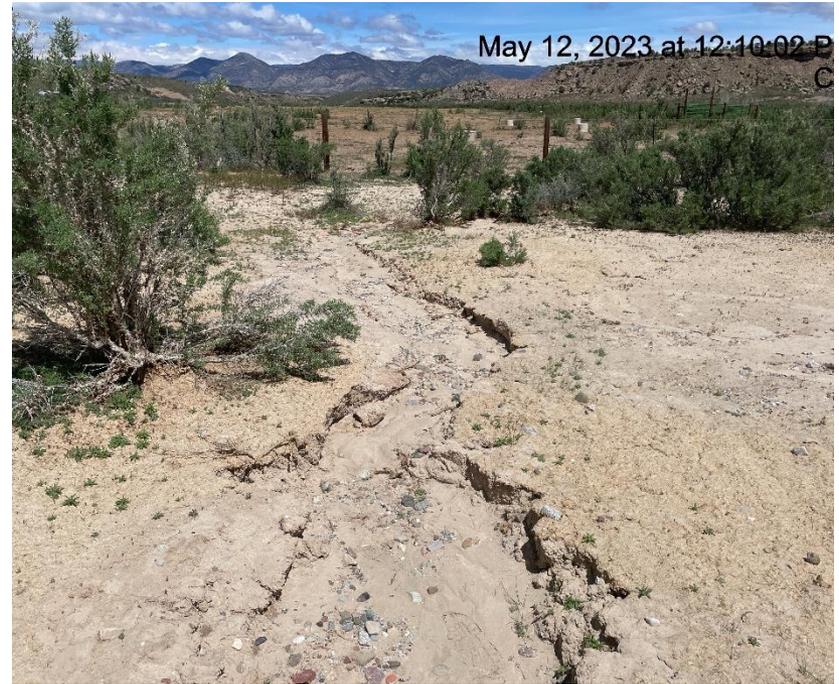
Photo # 7635 Erosion & transport of sediment/Insufficient run off controls/BMP's

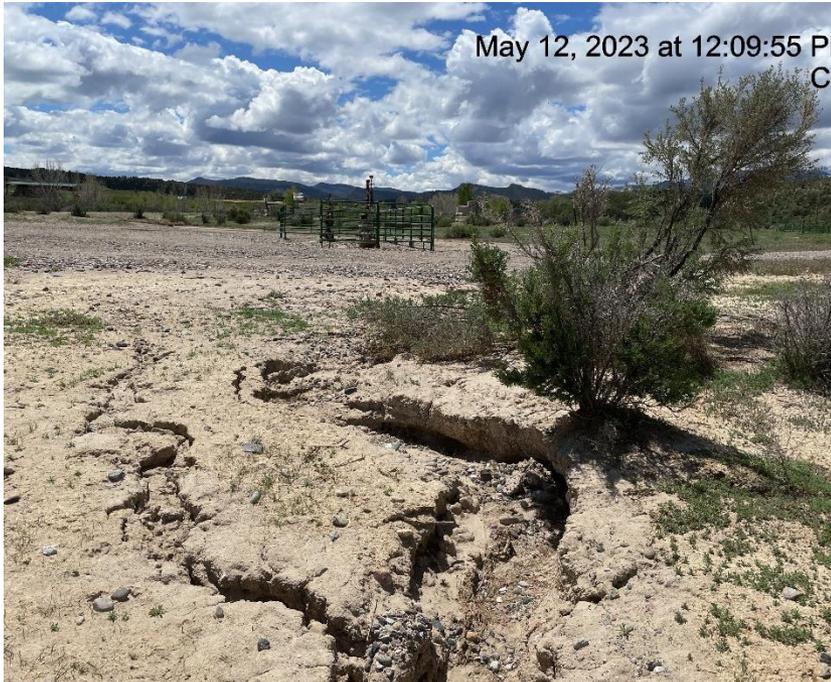
**Photo # 7634 Erosion & transport of
sediment/Insufficient run off controls/BMP's**
