Interim Reclamation and Stormwater Inspection

Operator: UPLAND EXPLORATION LLC- #10701

Location ID: 456651

Inspection Document #: 697504665

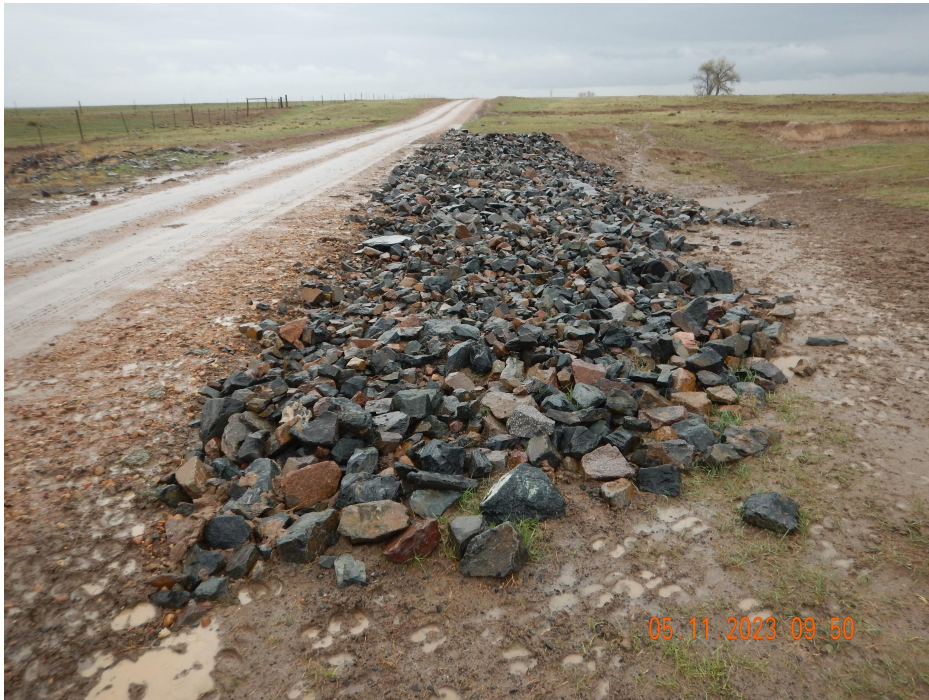
Photo 1. Photo taken from Geary Creek, facing East. Photo illustrates riprap has been imported to stabilize the fill slope into Geary Creek and control stormwater runoff into Geary Creek.

Note- this work was performed and completed by CCRP, not Upland.

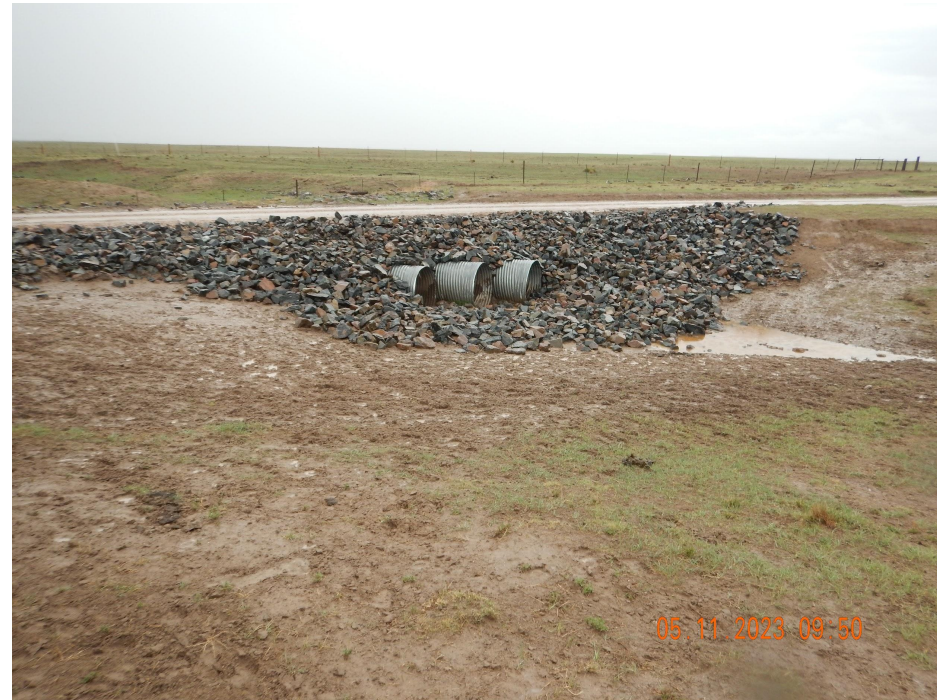
Photo 2. Photo taken from Geary Creek, facing North. See comments under Photo 1.

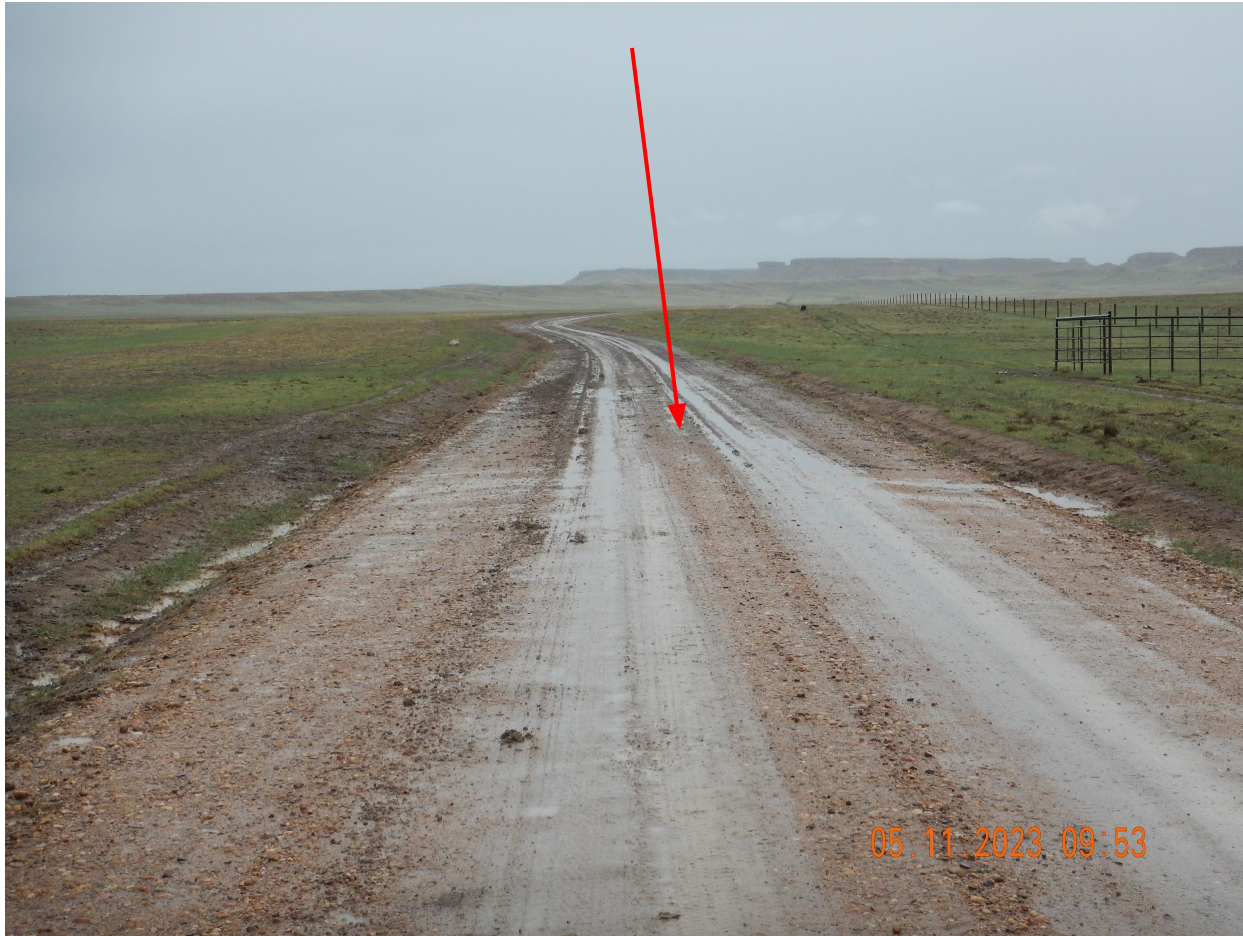
Photo 3. Photo taken from a section of the access road at the approximate 1 mile marker, facing West. Photo illustrates the approximate end point of where new gravel was imported. No new gravel import has been brought in since the previous inspection.

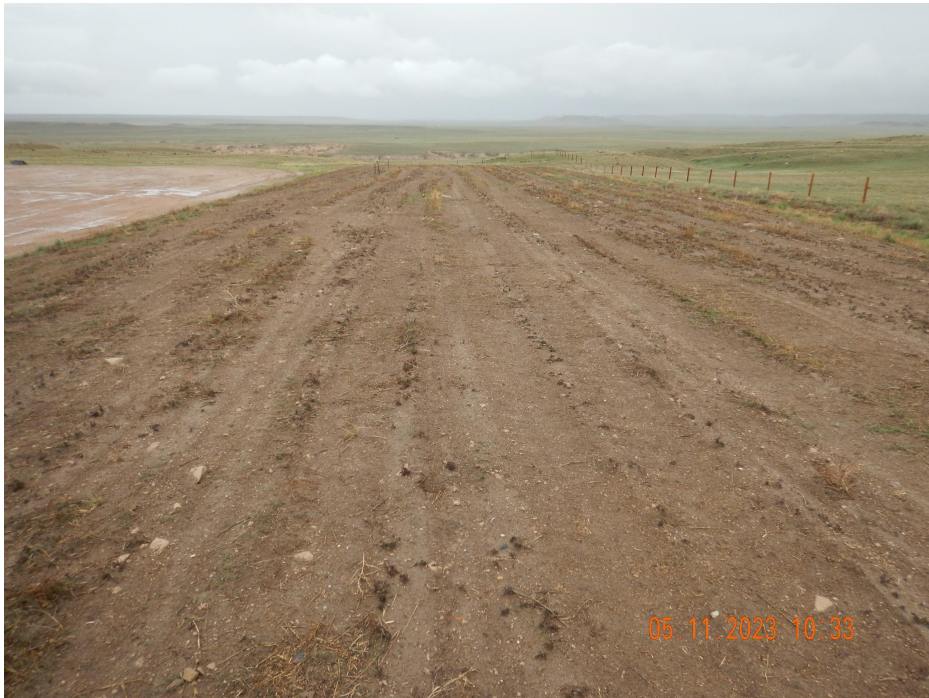
Photo 4. Photo taken from topsoil stockpile, facing West. Photo illustrates the topsoil stockpile has not been stabilized, which was communicated to the Operator back on April 7th. Operator indicated that the topsoil has been reseeded.

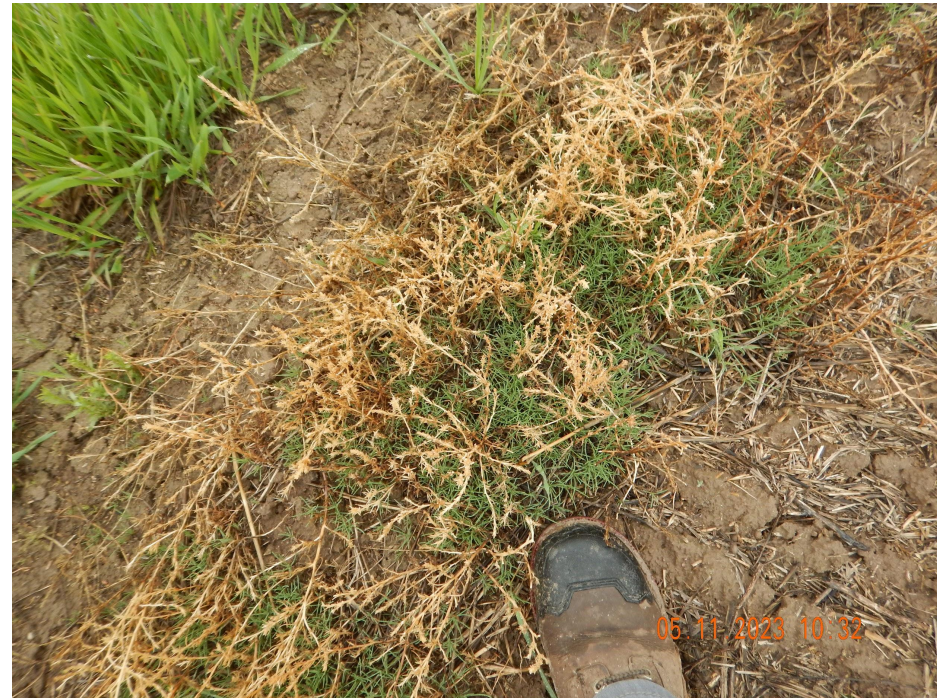
Photo 5. Photo taken from the southern slope of the topsoil stockpile. Photo illustrates Russian thistle seedling growth.

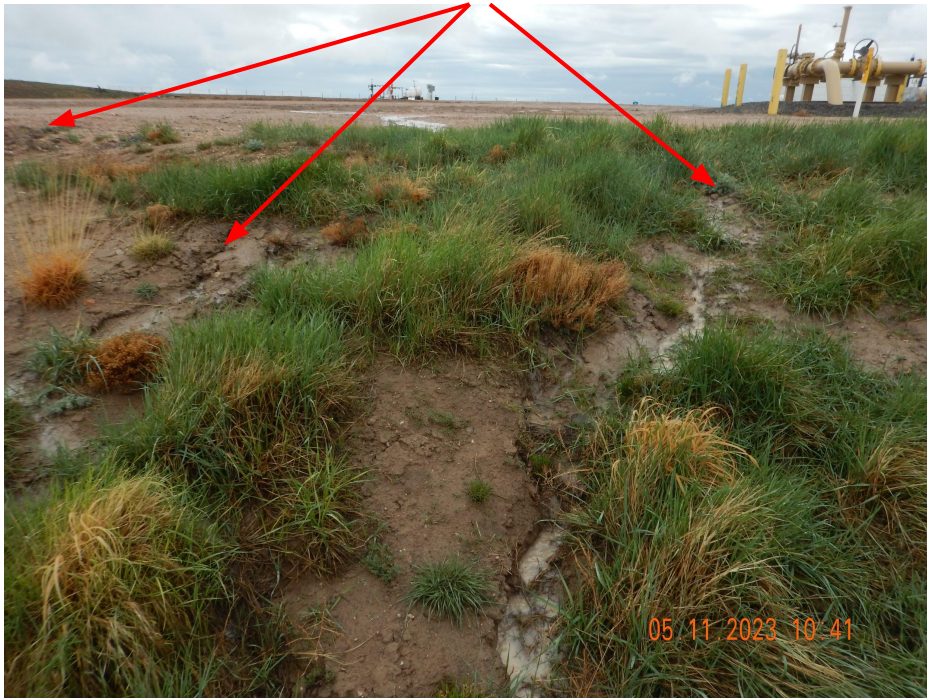
Photo 6. Photo taken from western fill slope, facing East. Photo illustrates sediment laden stormwater discharging off location (red arrows).

Note- there was no perimeter BMP at the base of the fill slope.

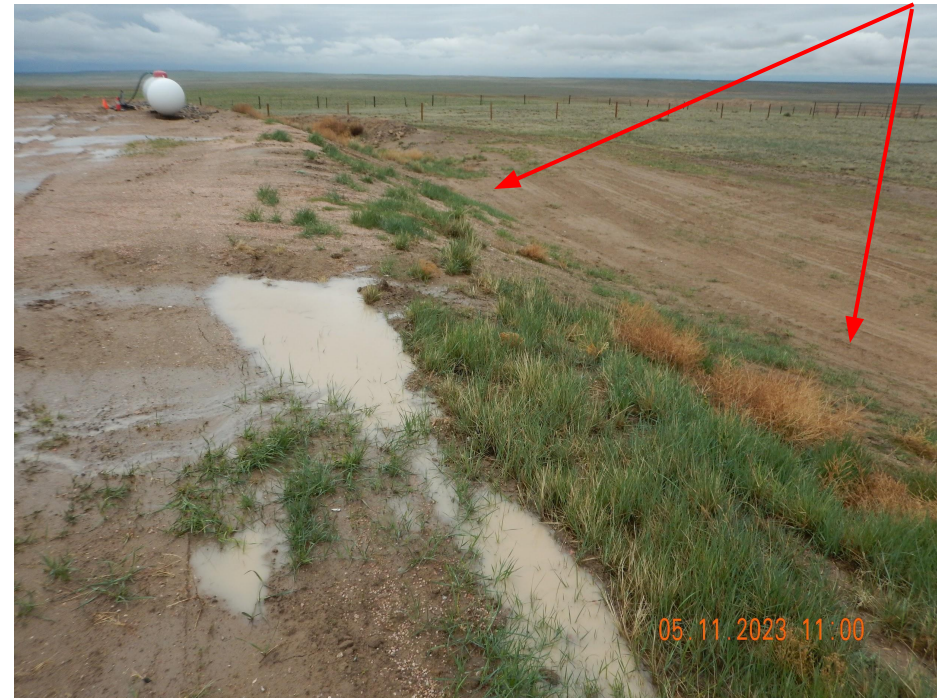
Photo 7. Photo taken from western fill slope, facing South. Photo illustrates the point of sediment laden stormwater discharging off location without a perimeter BMP (red arrows indicating no perimeter BMP).

Note- there was a ditch BMP installed during the initial construction; however, the ditch no longer exists to direct stormwater into the sediment trap and recent disturbances near the red arrows failed to re-install the ditch BMP.

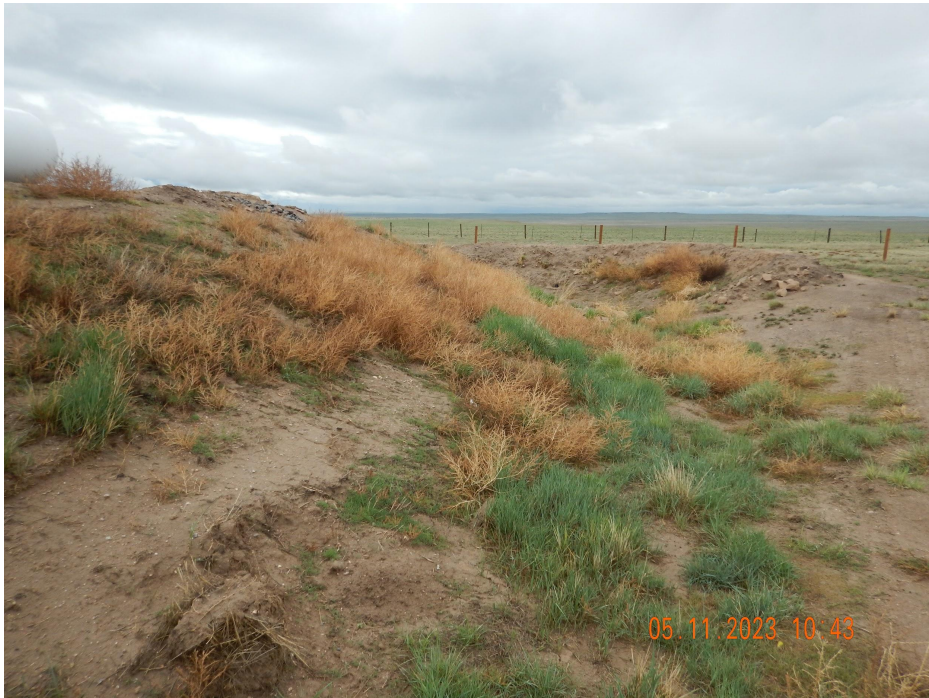
Photo 8. Photo taken from southwestern fill slope, facing South. Photo illustrates Russian thistle weed debris along the fill slope.

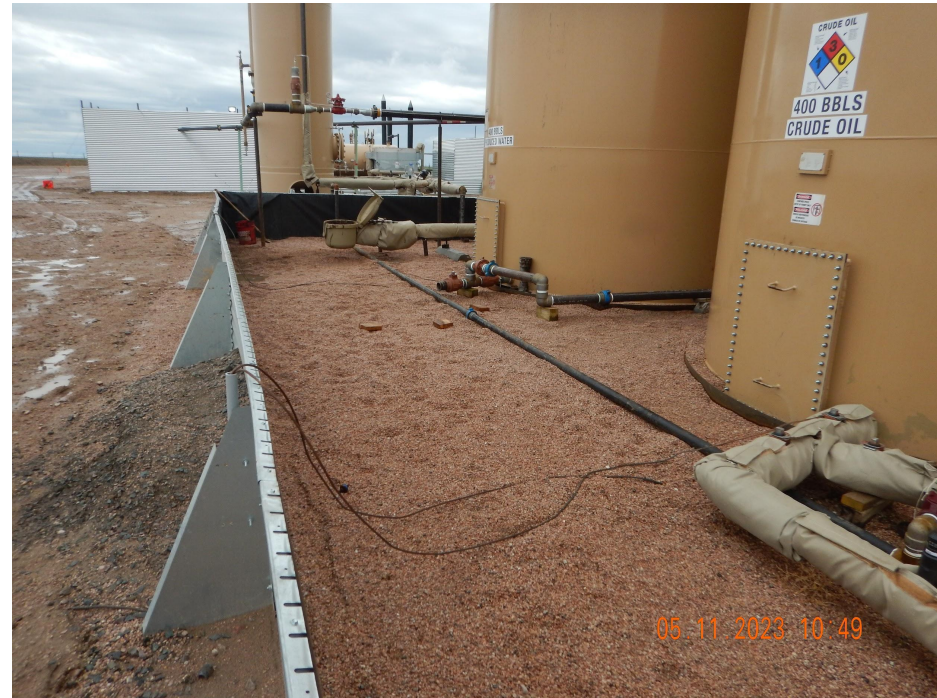
Photo 9. Photo taken from the production area, facing South. Photo illustrates it appears oily waste underneath the load out has been cleaned up.

Note- no change has occurred since the previous inspection.

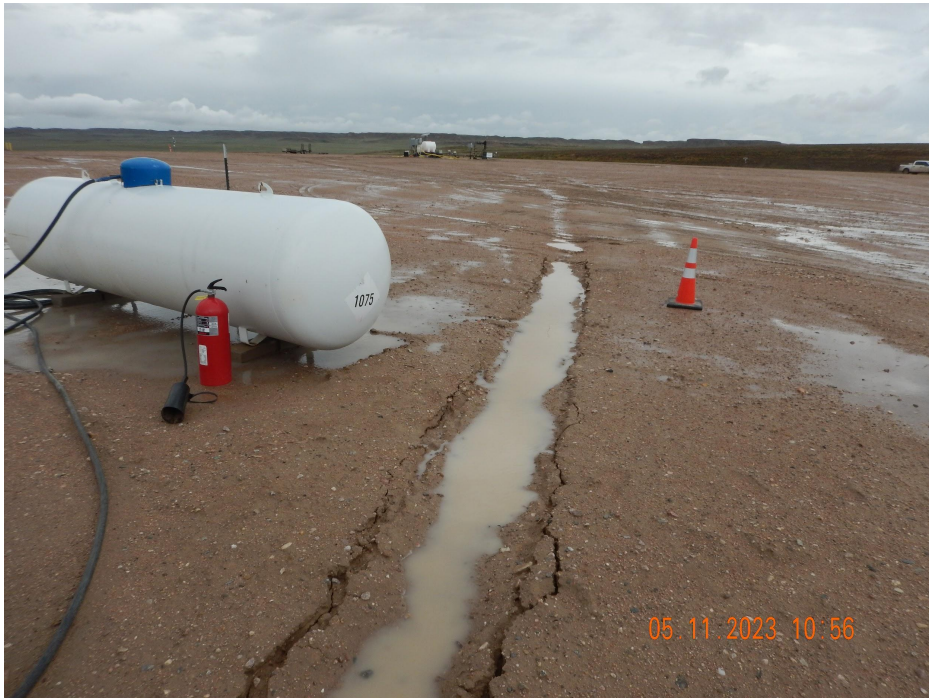
Photo 10. Photo taken from southern well location, facing North. Photo illustrates subsidence along a flowline in need of repair.

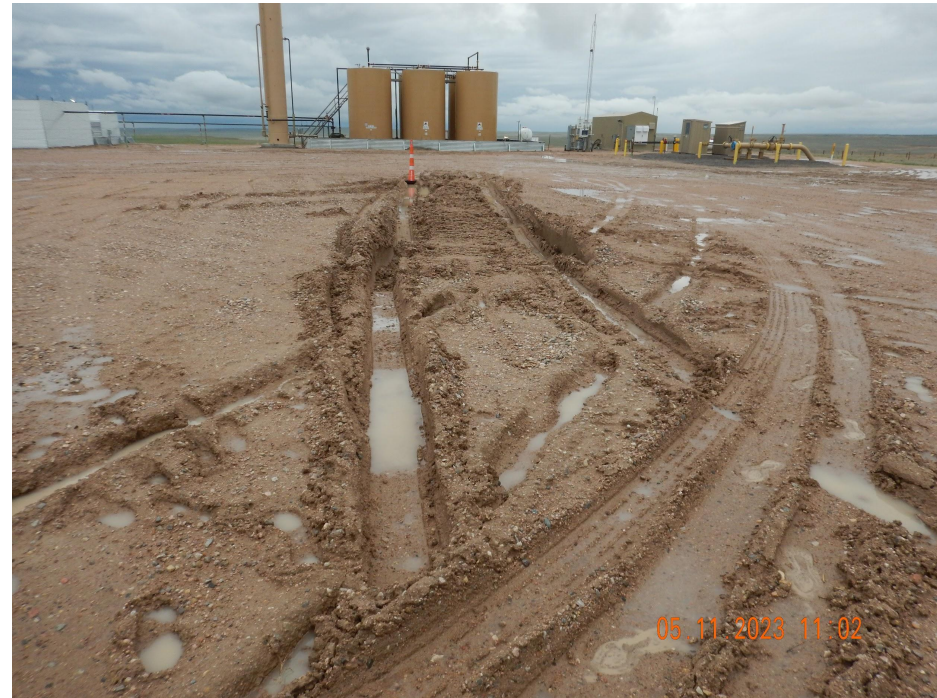
Photo 11. Photo taken from western well location, facing South. Photo illustrates vehicle rutting in need of repair.

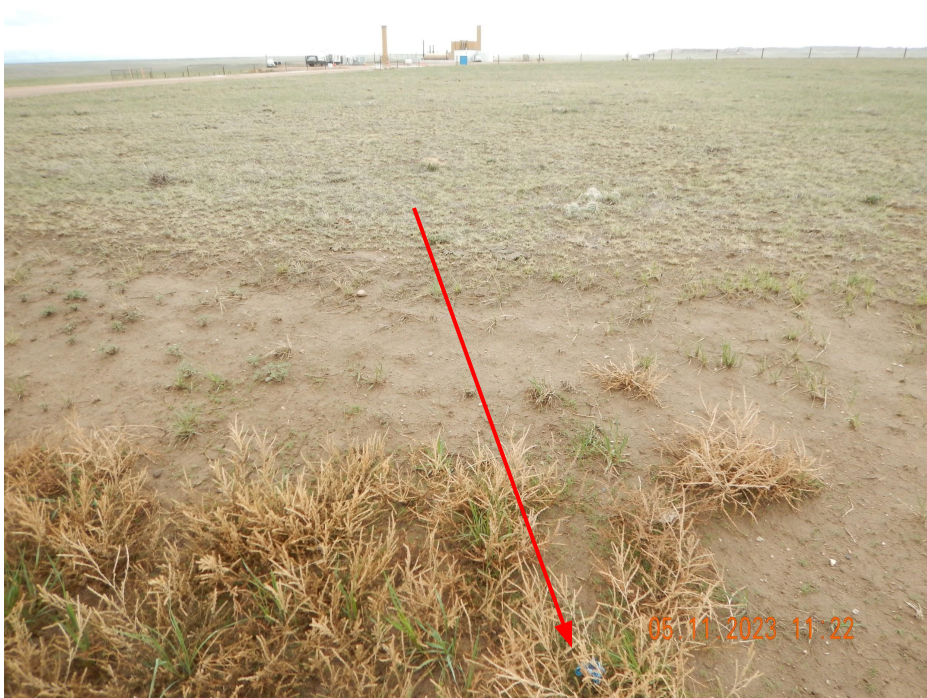
Photo 12. Photo taken from a portion of the access road approximately 250 feet from the location, facing West. Photo illustrates trash outside of containment that has blown off location.

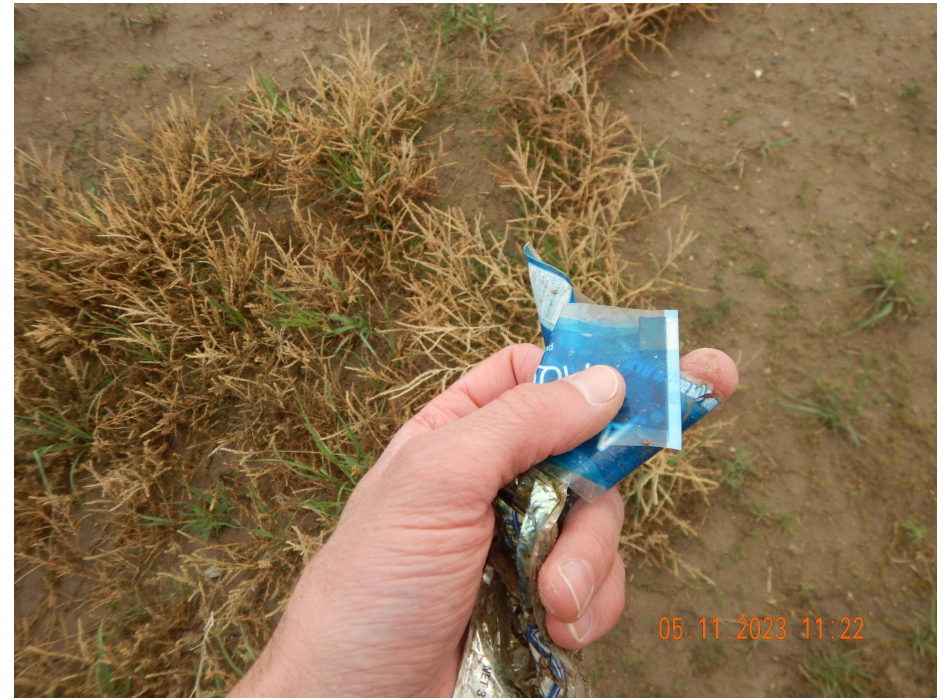
Photo 13. Close up photo of trash illustrated in Photo 12, which was picked up by COGCC staff.

Note- other trash was observed outside of containment that has blown off location.

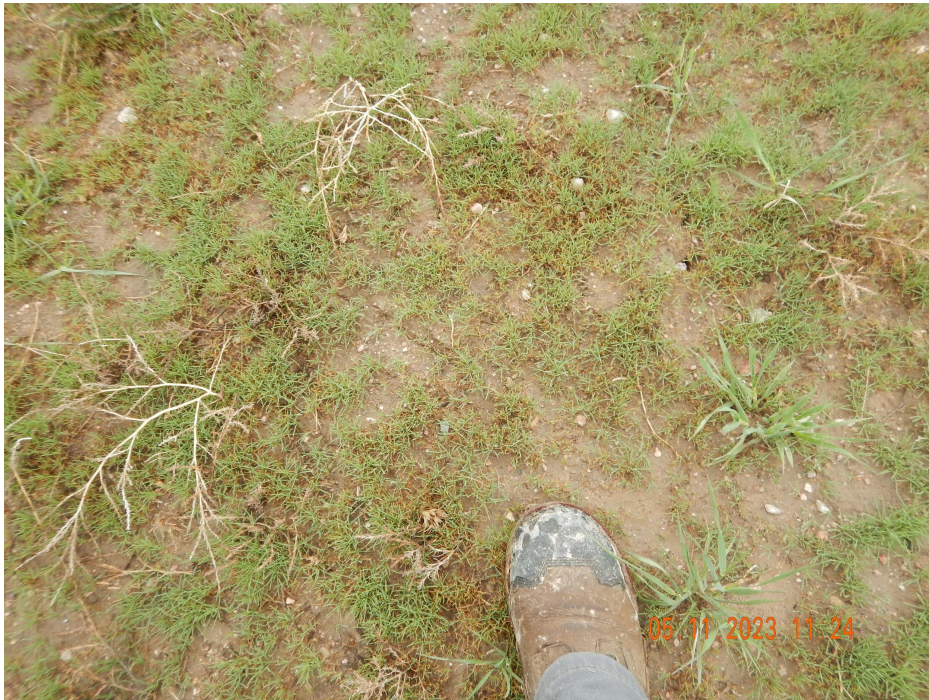
Photo 14. Photo taken from a portion of the access road, illustrating Russian thistle seedling growth.

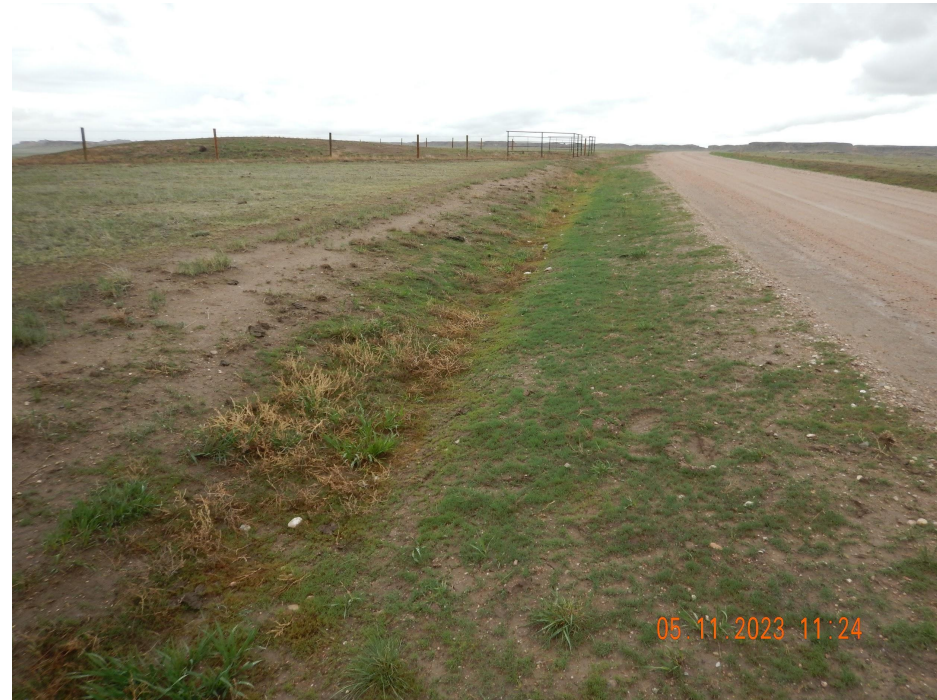
Photo 15. Photo taken from a portion of the access road, illustrating Russian thistle seedling growth along both sides of the roadside ditch area. This was observed throughout the approximate 1.5 mile section of access road.

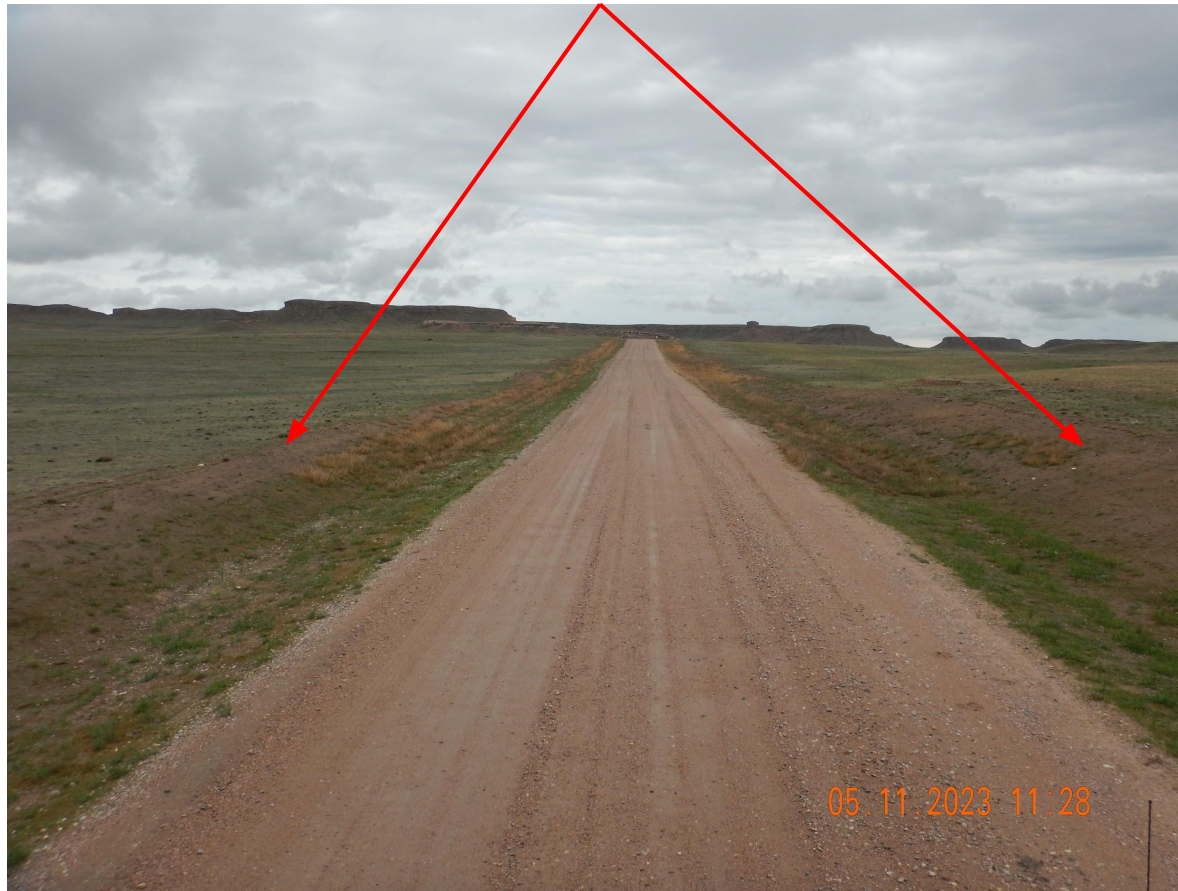
Photo 16. Photo taken from a portion of the access road approximately at the 4.6 mile marker, facing North. Photo illustrates an approximate 0.7 miles of Russian thistle weed pulling has not been completed.

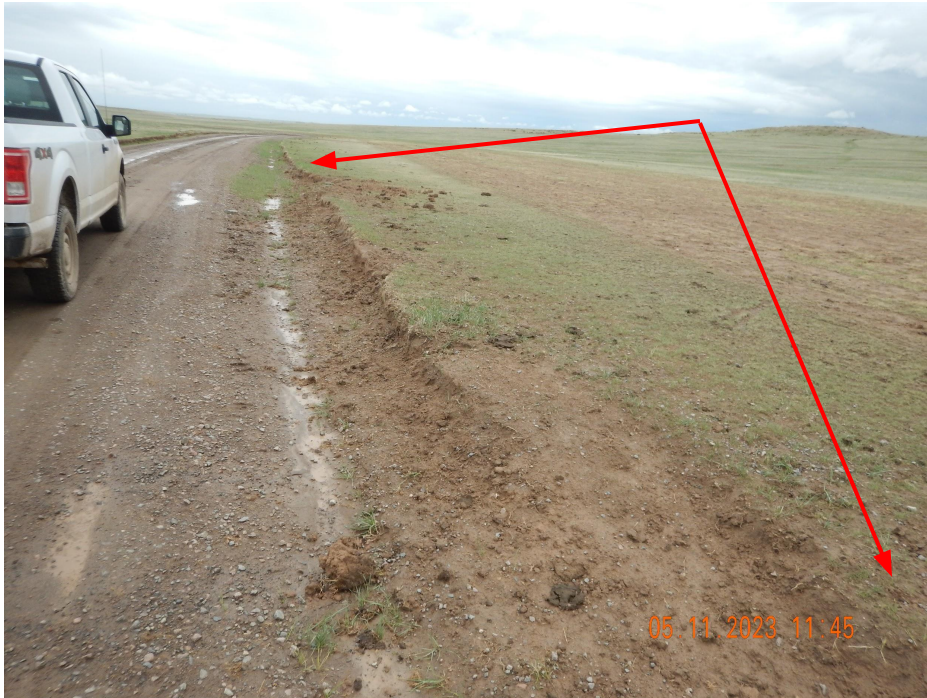
Photo 17. Photo taken from a portion of the access road approximately at the 3.7 mile marker, facing East. Photo illustrates the reclamation of access road repairs have not been completed. Photo illustrates the roadside area has been disturbed during snow removal by Upland.

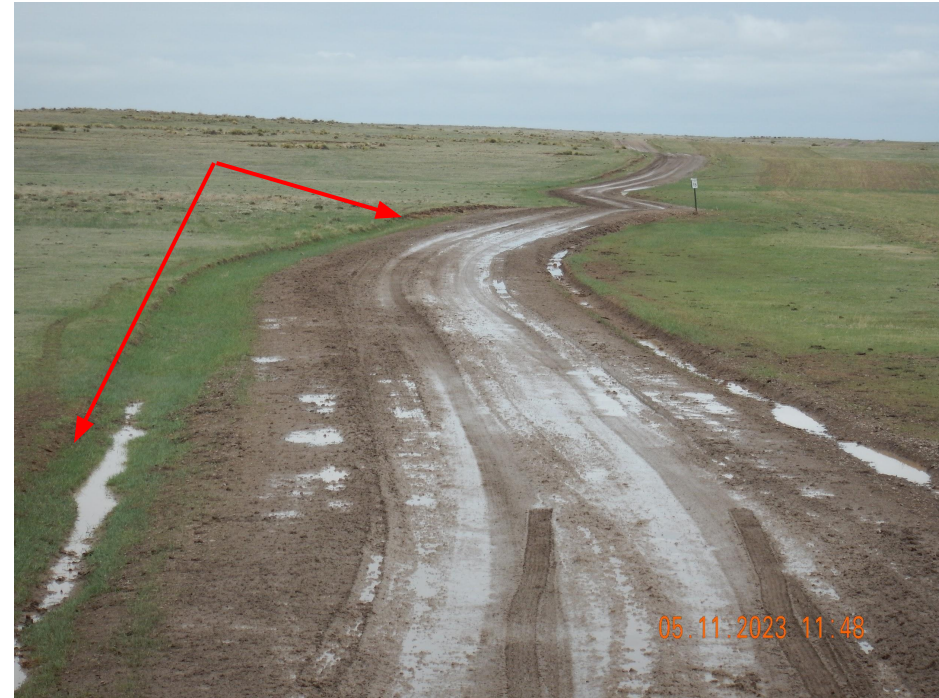
Photo 18. Photo taken from a portion of the access road approximately at the 3.5 mile marker, facing East. Photo illustrates the reclamation of access road repairs have not been completed.

This photo is comparing the north and south roadside areas. The north roadside area between the red arrows was not impacted by snow removal and has established perennial vegetation; the south roadside area illustrates road repairs have not been completed and gravel remains in the pasture.

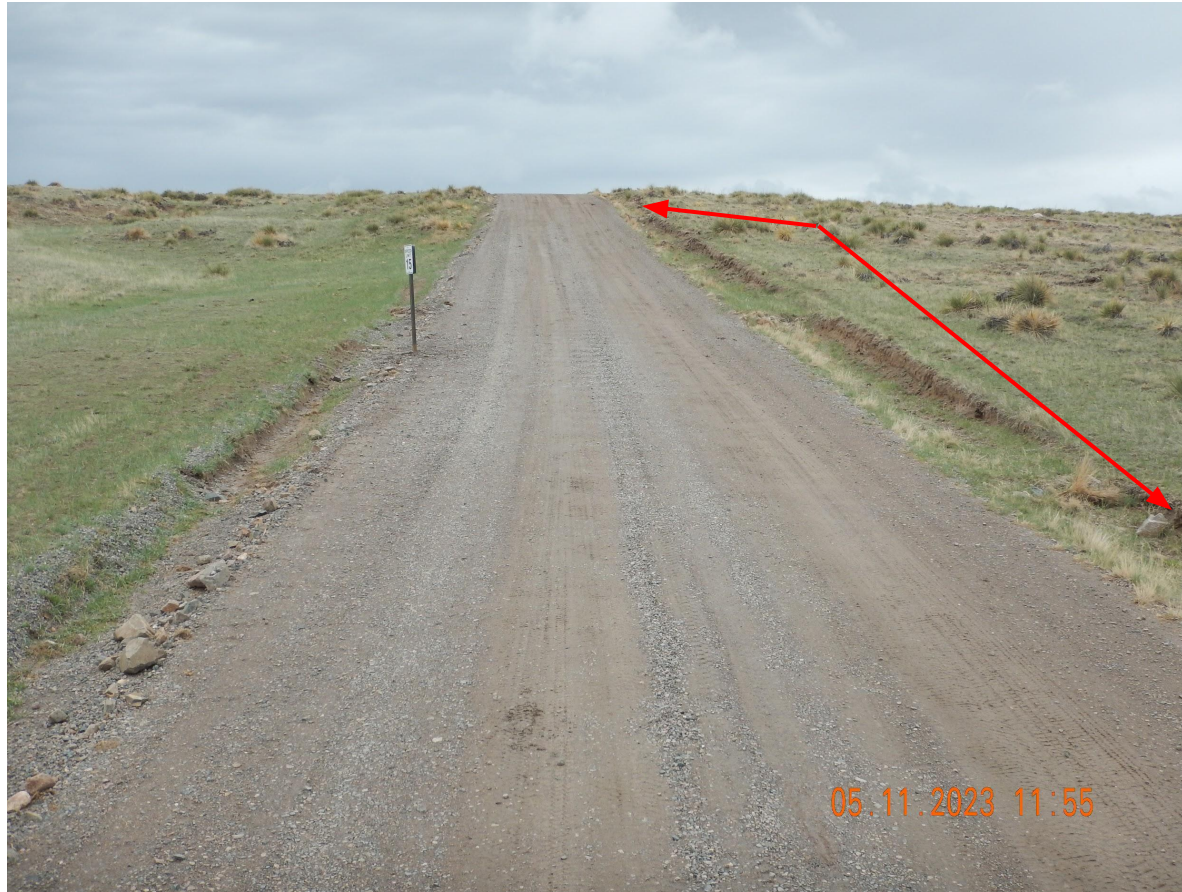
Photo 19. Photo taken from a portion of the access road approximately at the 2.4 mile marker, facing West. Photo illustrates the reclamation of access road repairs have not been completed.

This photo is comparing the north and south roadside areas. The north roadside area between the red arrows was not impacted by snow removal and has established perennial vegetation with riprap check dams; the south roadside area illustrates road repairs have not been completed and riprap check dams have not been re-installed.
