Interim Reclamation and Stormwater Inspection

Location ID: 462919

Inspection Document #: 697504670

Inspection Photos
Location Name: Little Lady 21/South Well Pad
Location ID: 462919

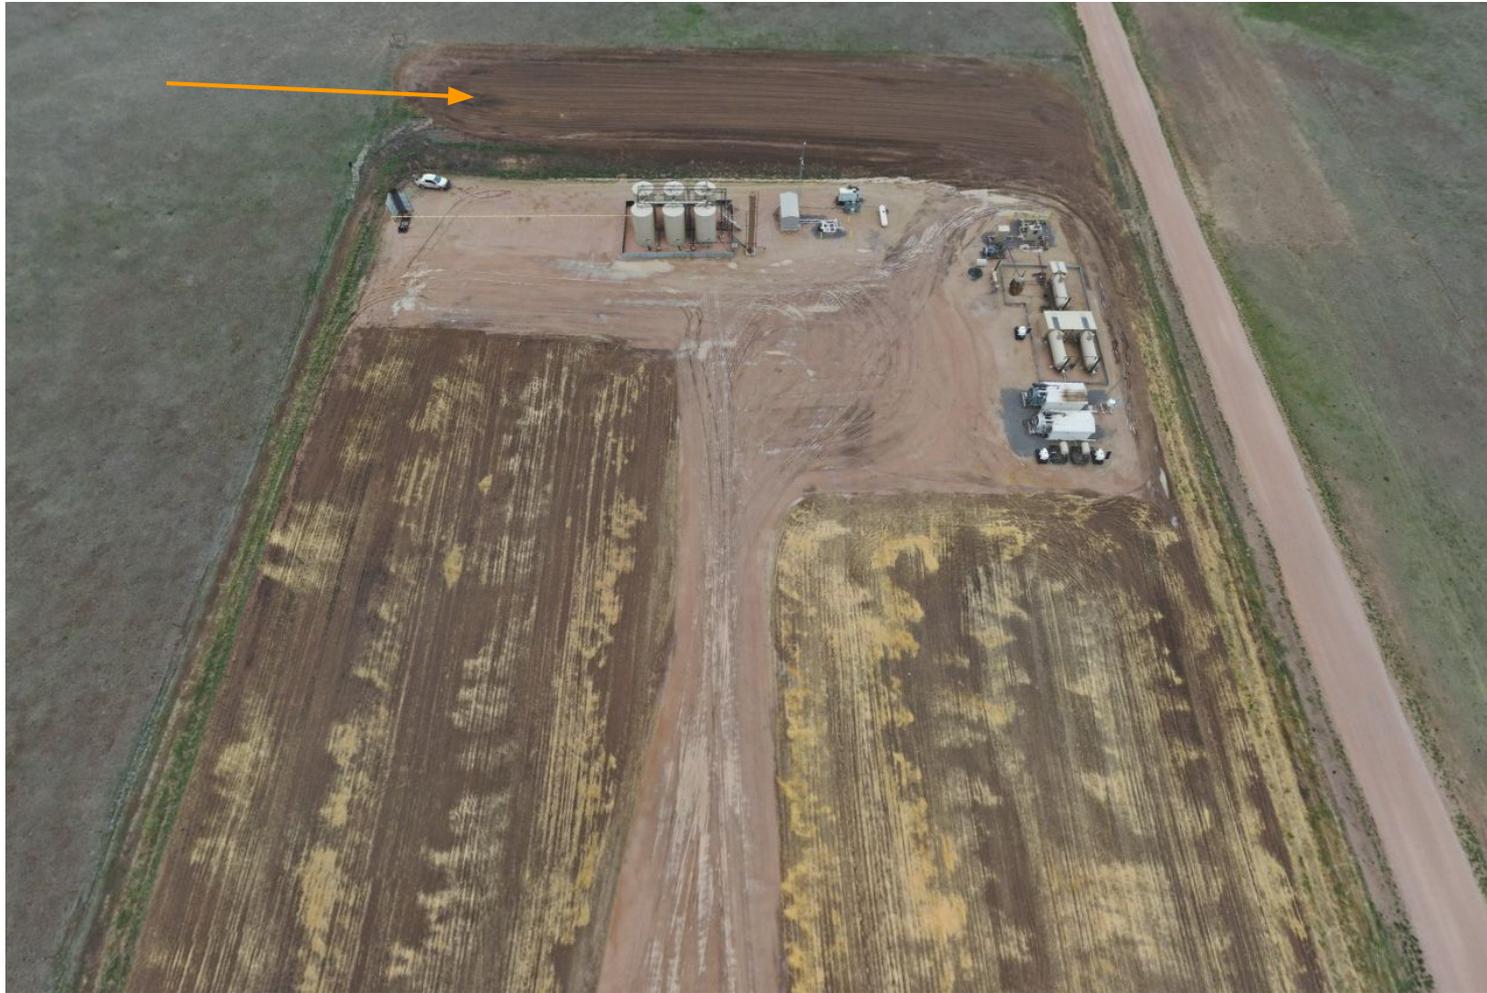
Photo 1. Drone aerial imagery illustrates the northern half of the location. Photo illustrates interim reclamation has been performed; however, interim reclamation is not complete due to the lack of soil stabilization on the topsoil stockpile (orange arrow) and throughout portions of the interim reclamation area.

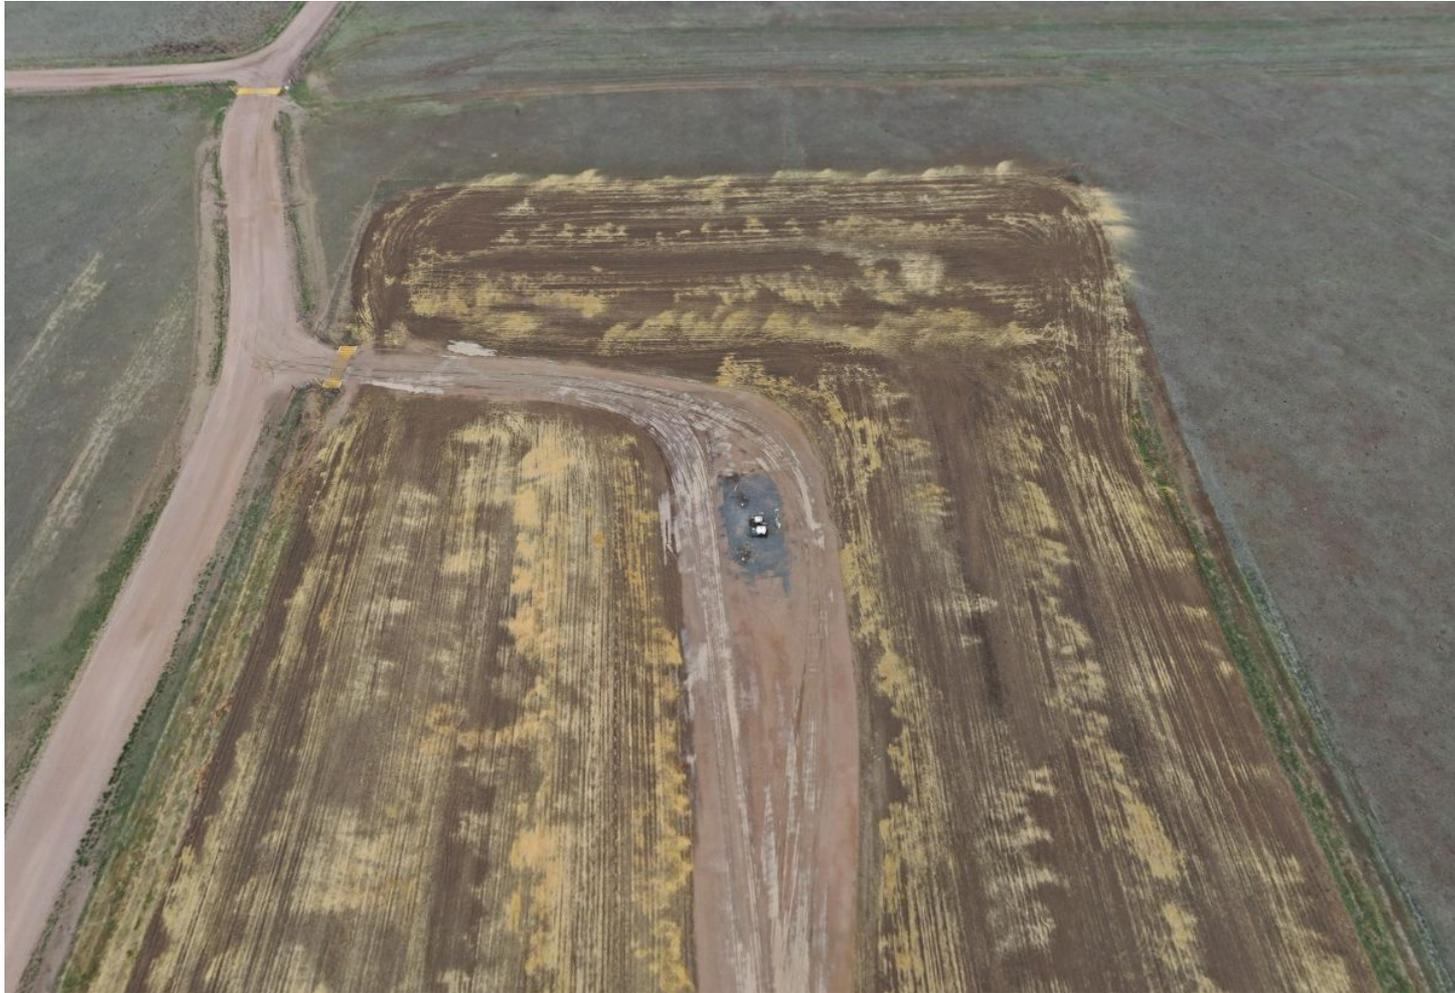
Photo 2. Drone aerial imagery illustrates the southern half of the location. See comments under Photo 1.

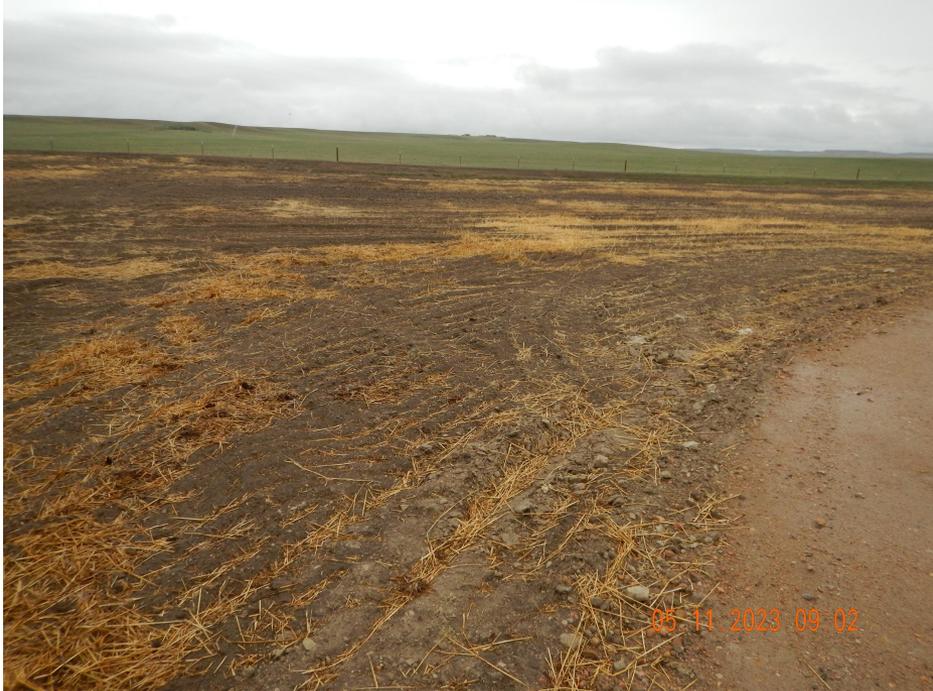
Photo 3. Photo taken from the southern location, facing West. See comments under Photo 1.

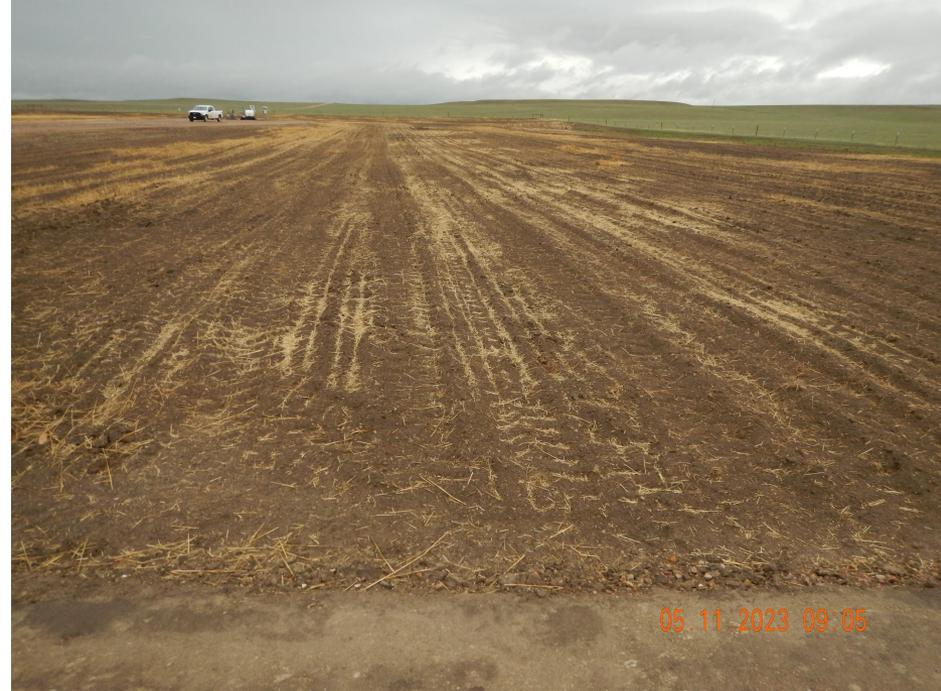
Photo 4. Photo taken from the northwestern location, facing South. See comments under Photo 1.

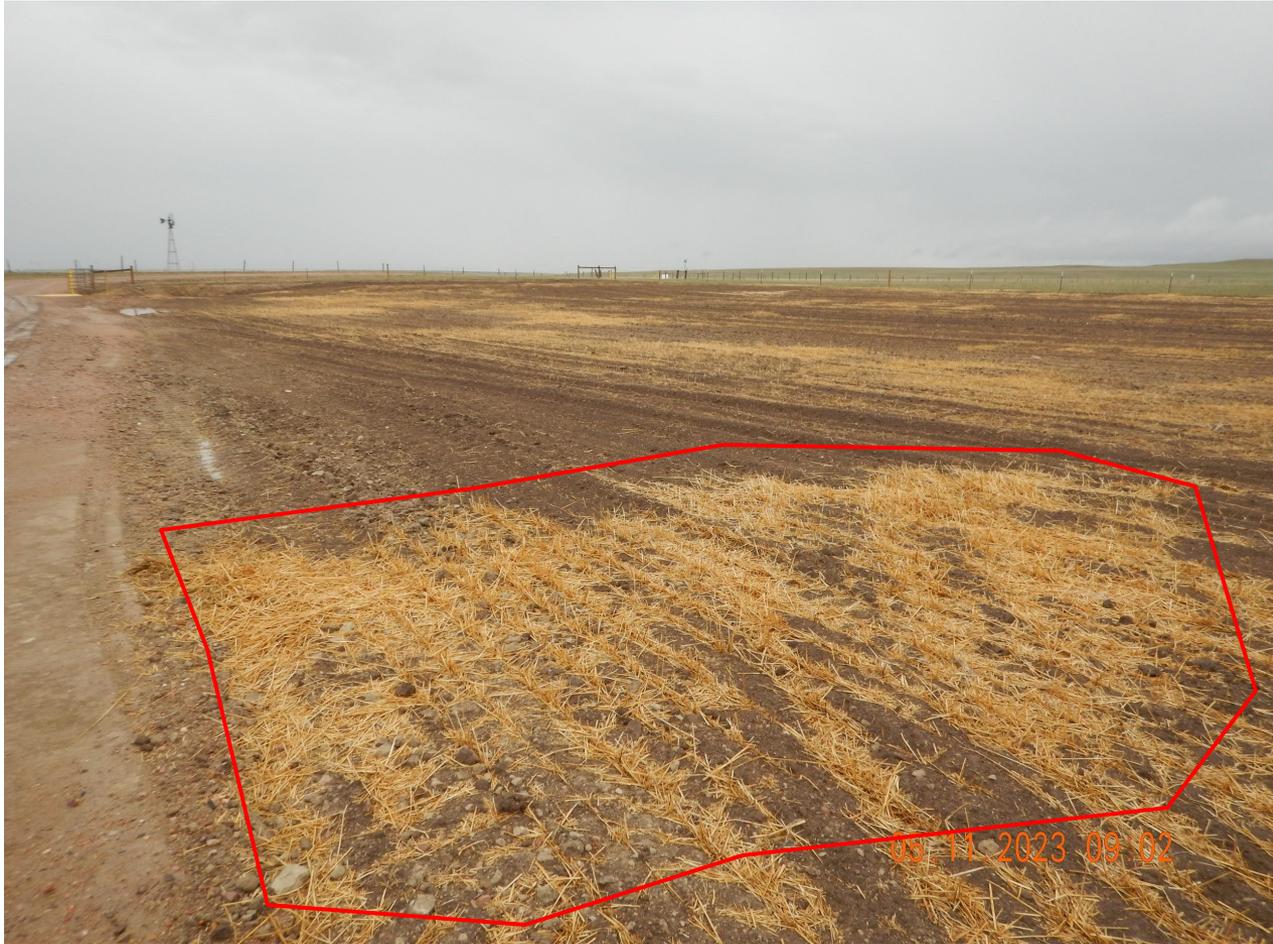
Photo 5. Photo taken from the southern interim reclamation area, facing East. Photo illustrates an area highlighted in red. This area is an example of COGCC's expectation of soil stabilization that shall be reflective throughout the interim reclamation areas, including the topsoil stockpile.

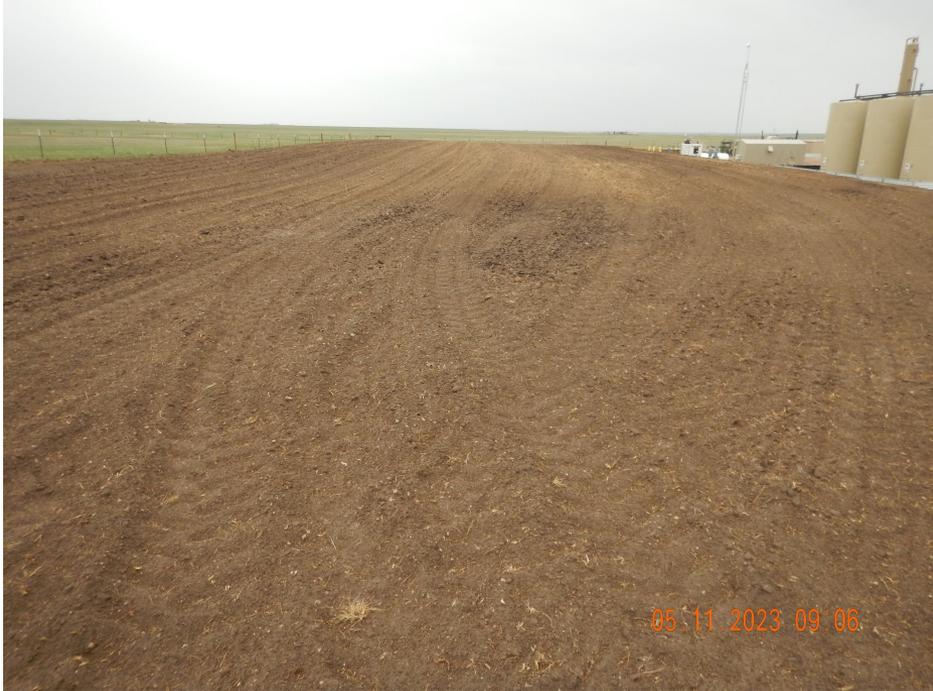
Photo 6. Photo taken from the topsoil stockpile, facing East. Photo illustrates the topsoil stockpile which has been seeded; however, the topsoil stockpile lacks soil stabilization.

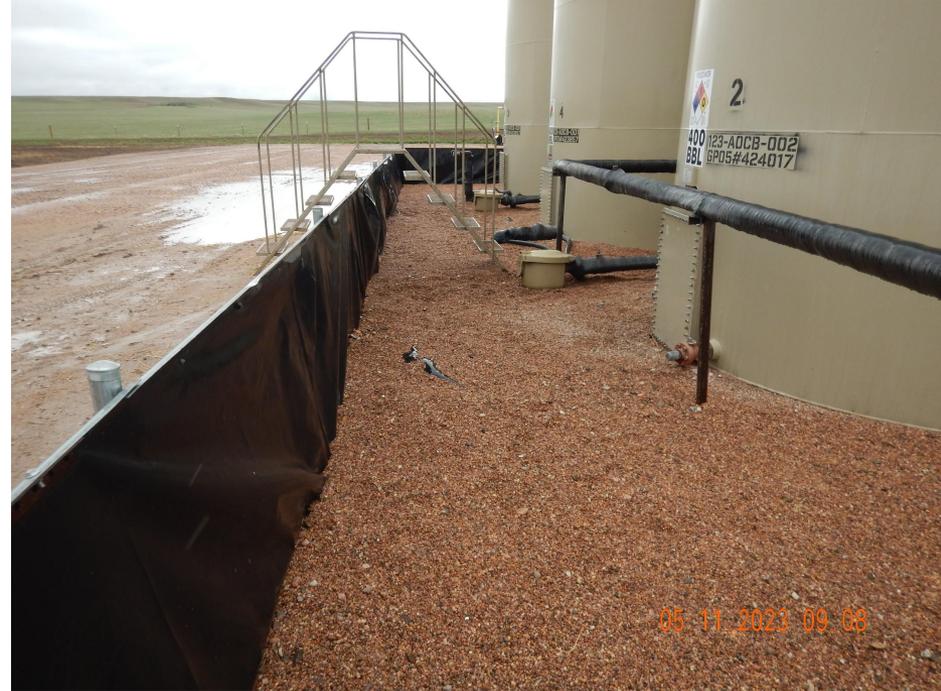
Photo 7. Photo taken from the facility location, facing West. Photo illustrates unused equipment (hose) has been removed from within secondary containment.

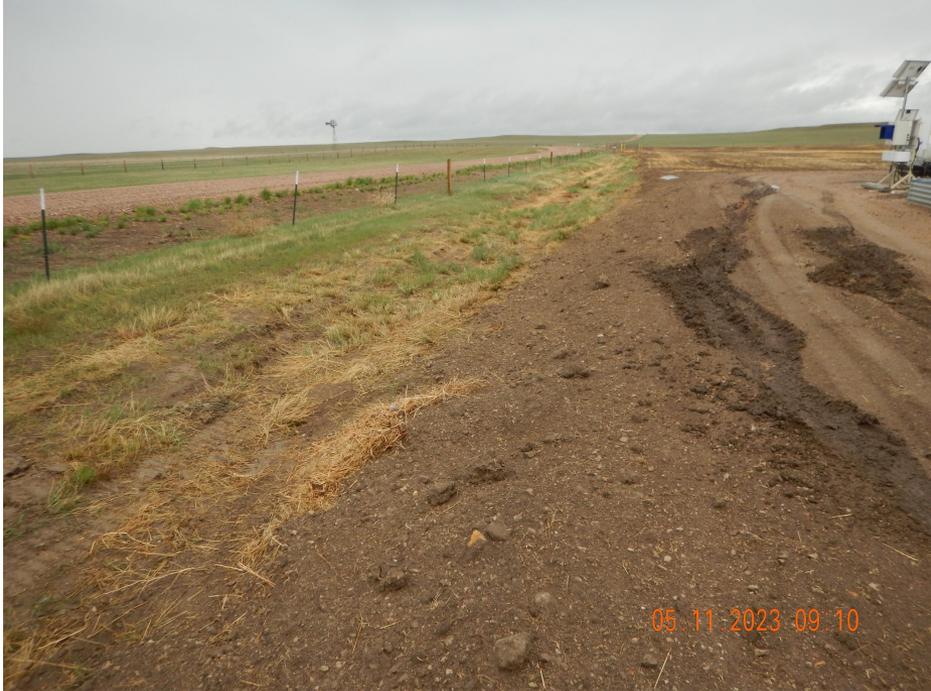
Photo 8. Photo taken from the northeastern location, facing South. Photo illustrates the eastern perimeter has been mowed; however, weed growth was observed and weed debris has not been properly disposed of. Piles of weed debris were observed throughout the eastern perimeter.

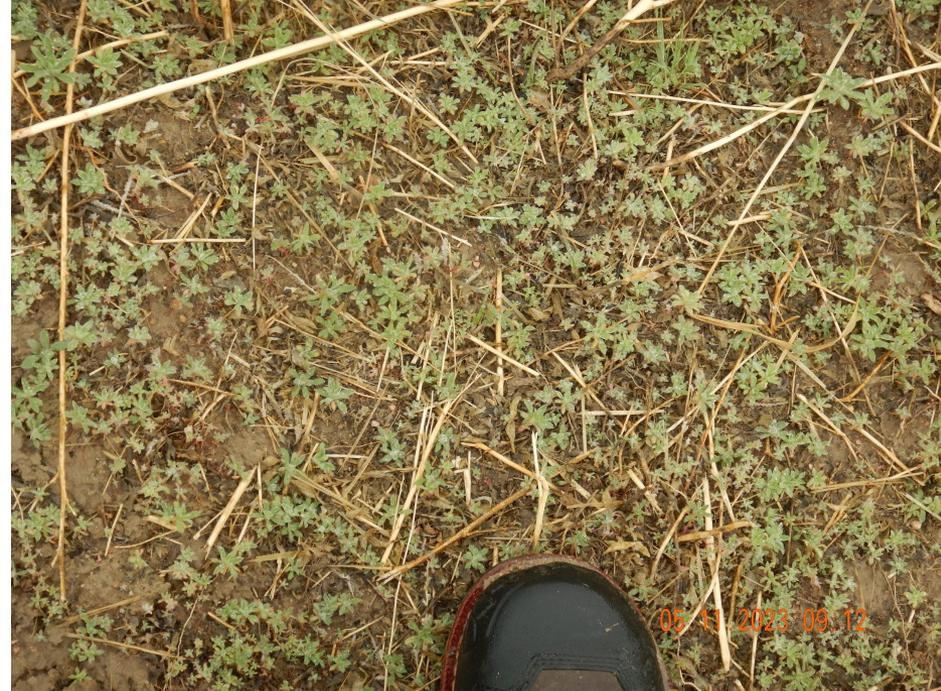
Photo 9. Photo taken from the eastern perimeter of location. Photo illustrates Kochia seedling growth.

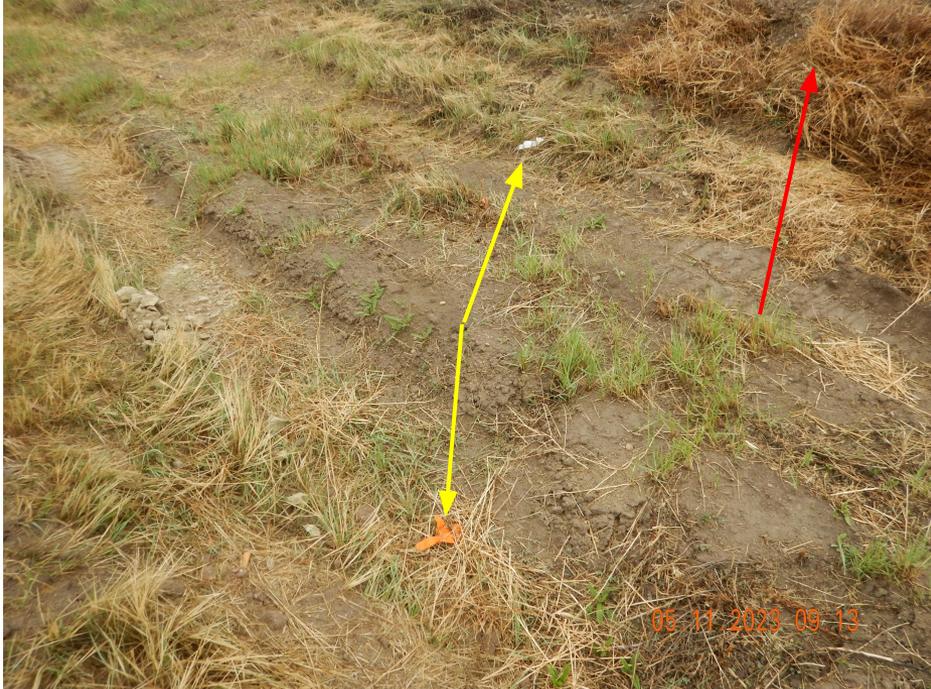
Photo 10. Photo taken from the eastern perimeter of location. Photo illustrates a pile of Kochia weed debris (red arrow), which is a weed seed source, and trash (yellow arrows).

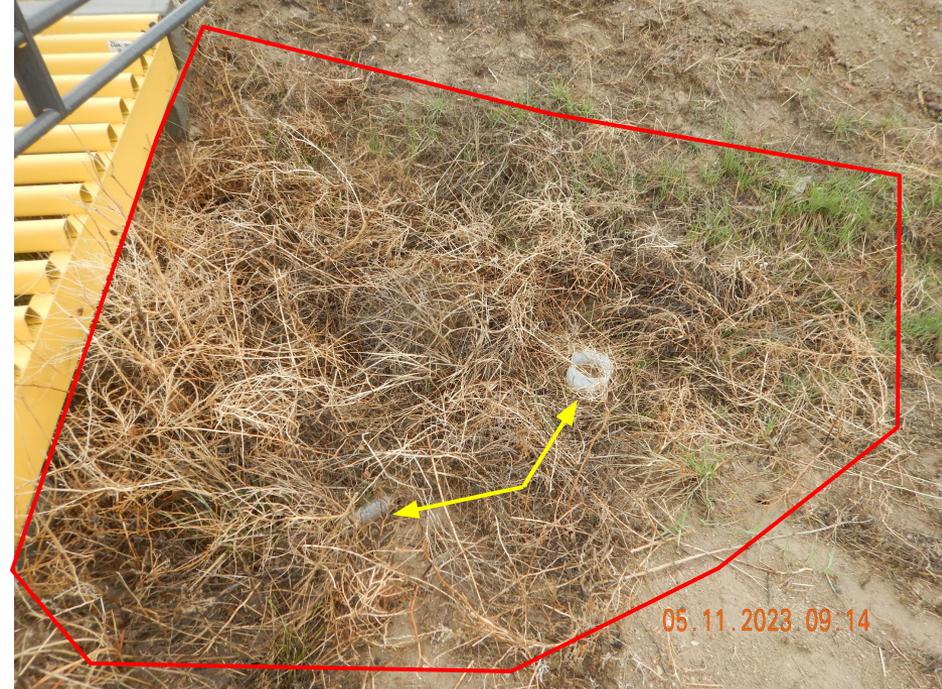
Photo 11. Photo taken from the entrance of location. Photo illustrates a pile of weed debris (red polygon) and trash (yellow arrows).
