# Stormwater Management and Erosion control

## Location Name: CAERUS PICEANCE LLC BENTLEY-67S95W /11SWNE

### Location #: 334625

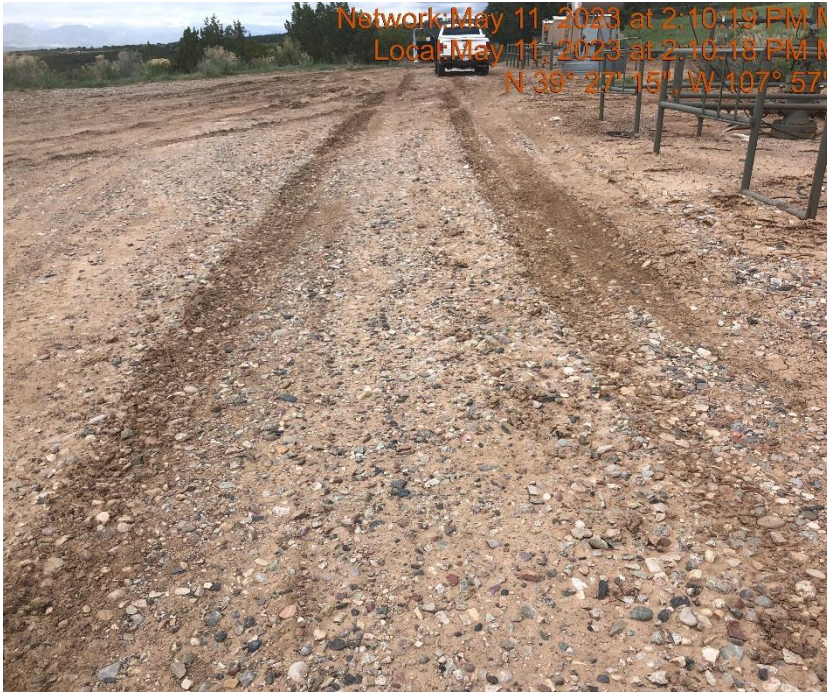
**Photo #9948 Location lacks stabilization.**

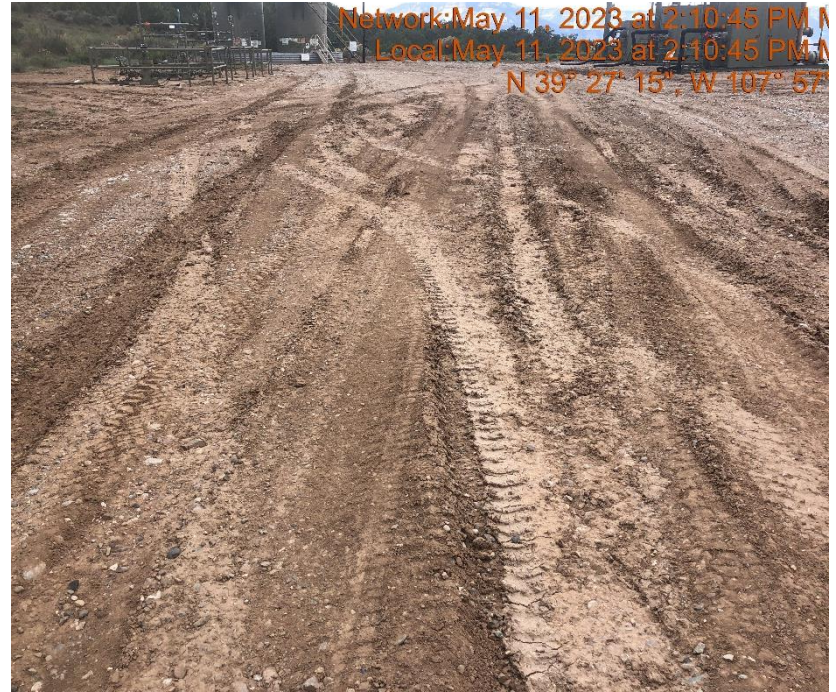
**Photo #9949 Location lacks stabilization.**

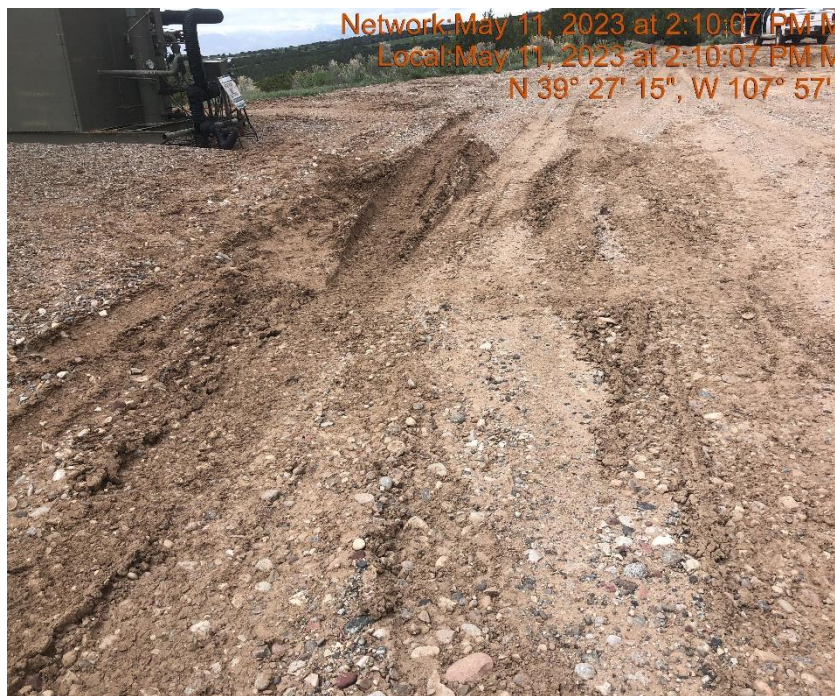
**Photo #9947 Location lacks stabilization.**

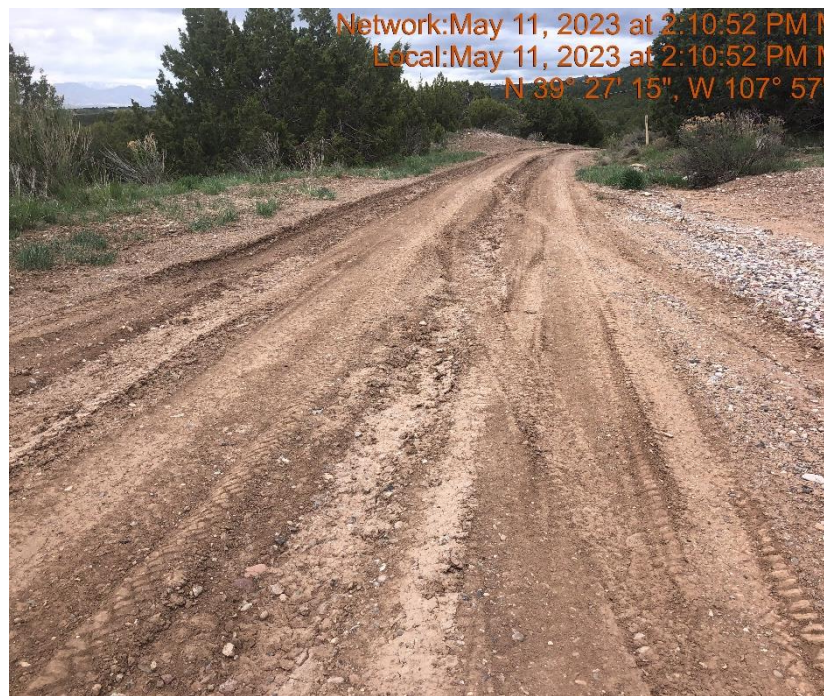
**Photo #9950 Insufficient tracking BMP at entrance to minimize the transport of sediment.**

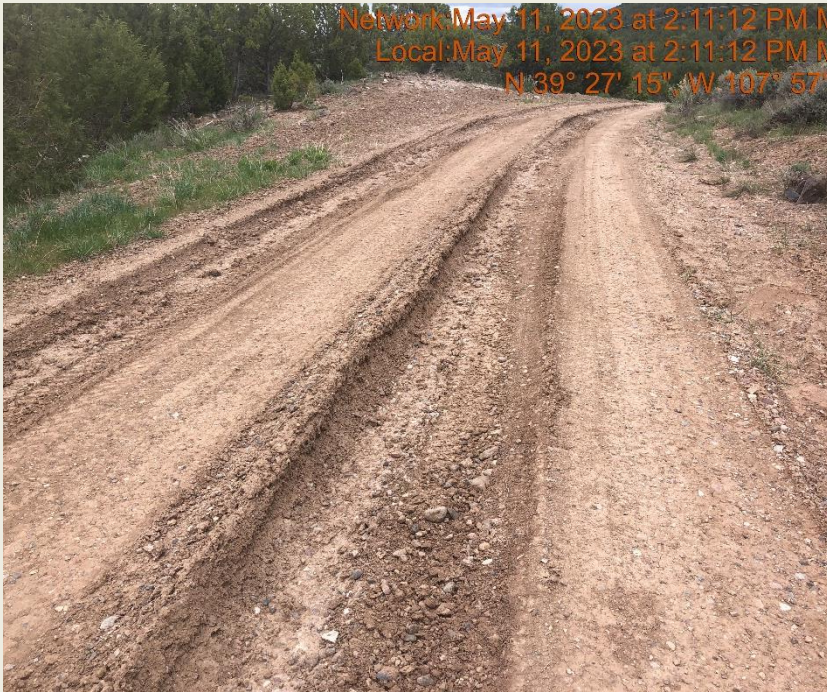
Photo #9952 Access road lacks stabilization.

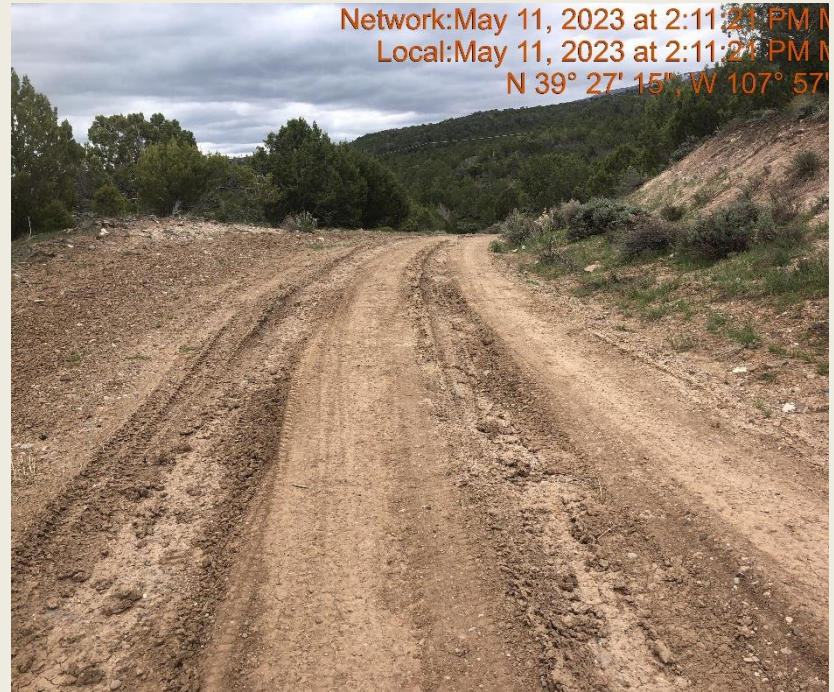
Photo #9953 Access road lacks stabilization.

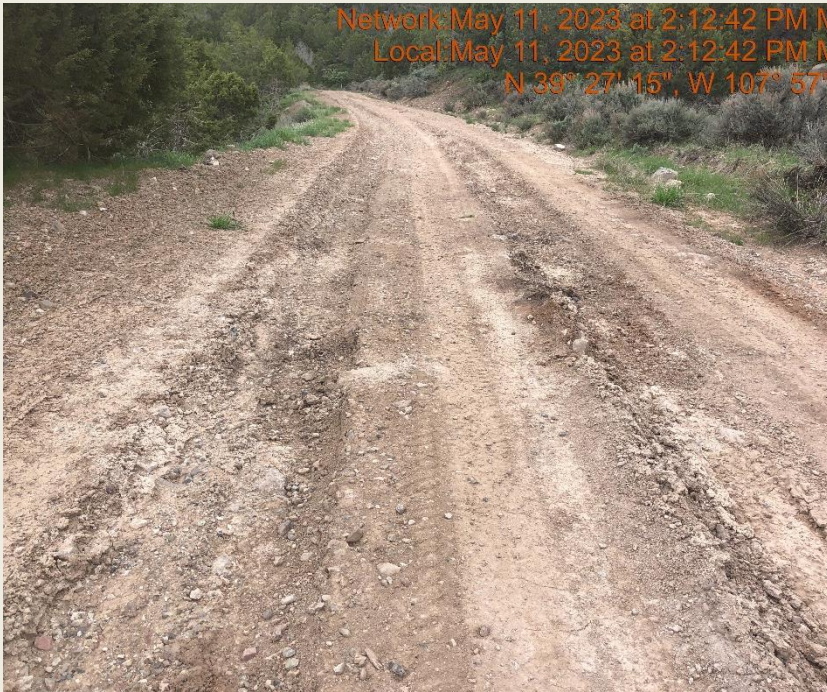
Photo #9954 Access road lacks stabilization.

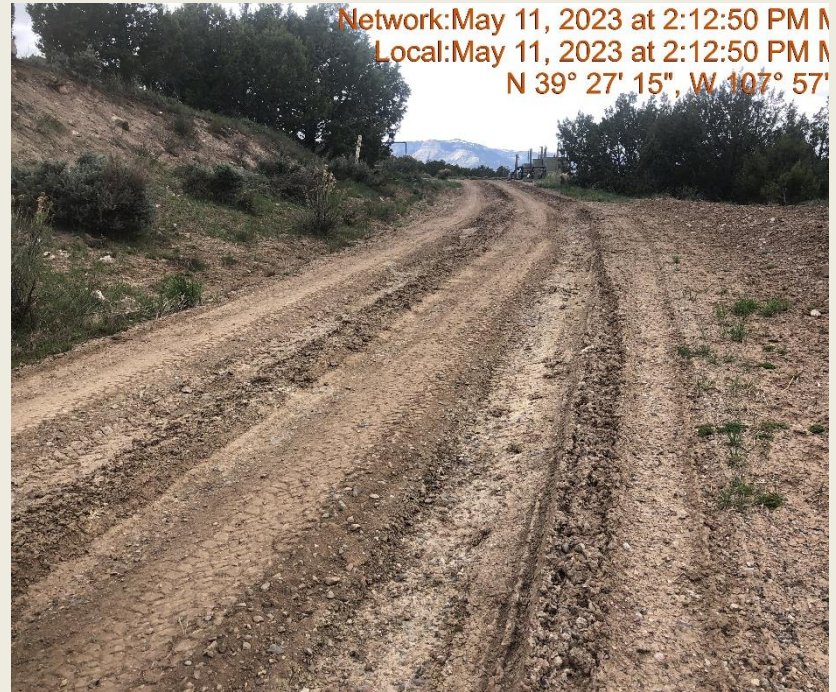
Photo #9955 Access road lacks stabilization.

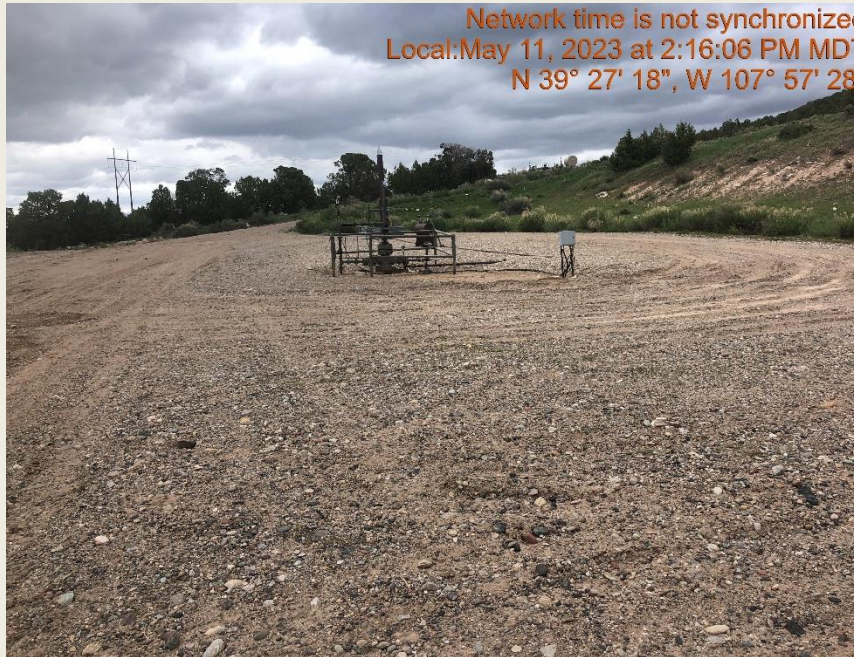
**Photo #9958 Insufficient tracking BMP at entrance to access road to minimize the transport of sediment.**
