**Storm water Management and Erosion control**  
**Location Name: CAERUS PICEANCE LLC K8E Pad**  
**Location #: 334798**

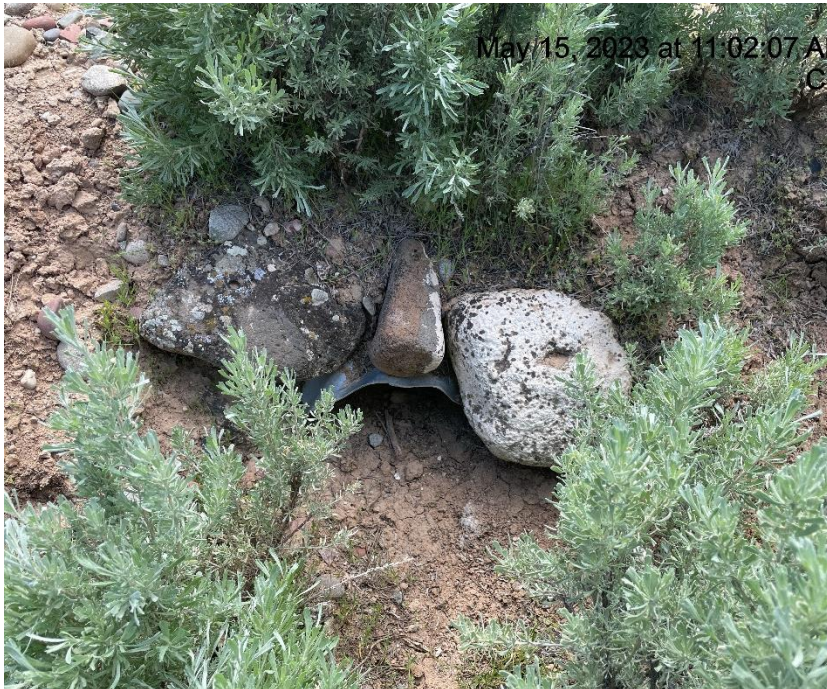
**Photo # 7808 Culvert needs maintenance (Culvert is near entrance to location)**

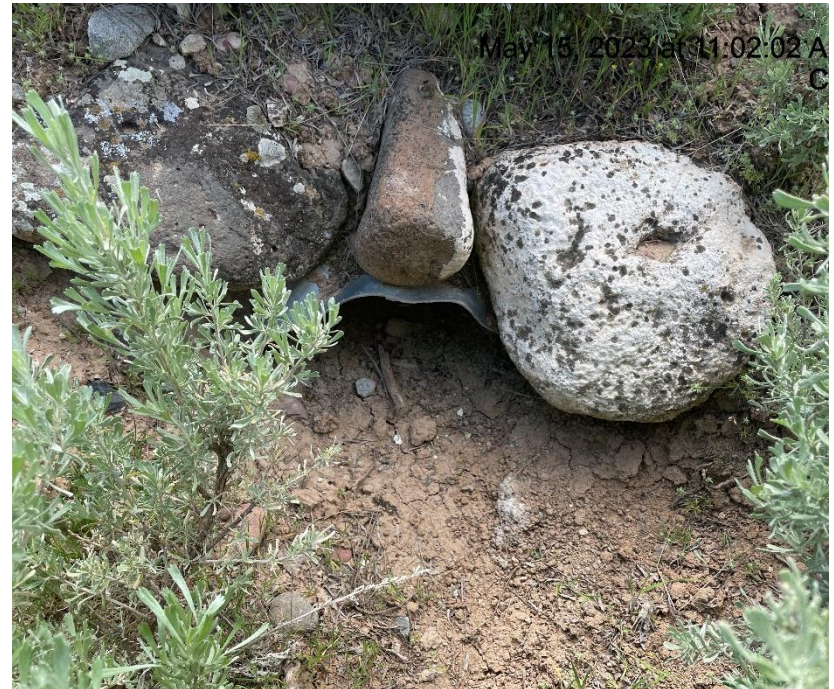
**Photo # 7809 Culvert needs maintenance (Culvert is near entrance to location)**

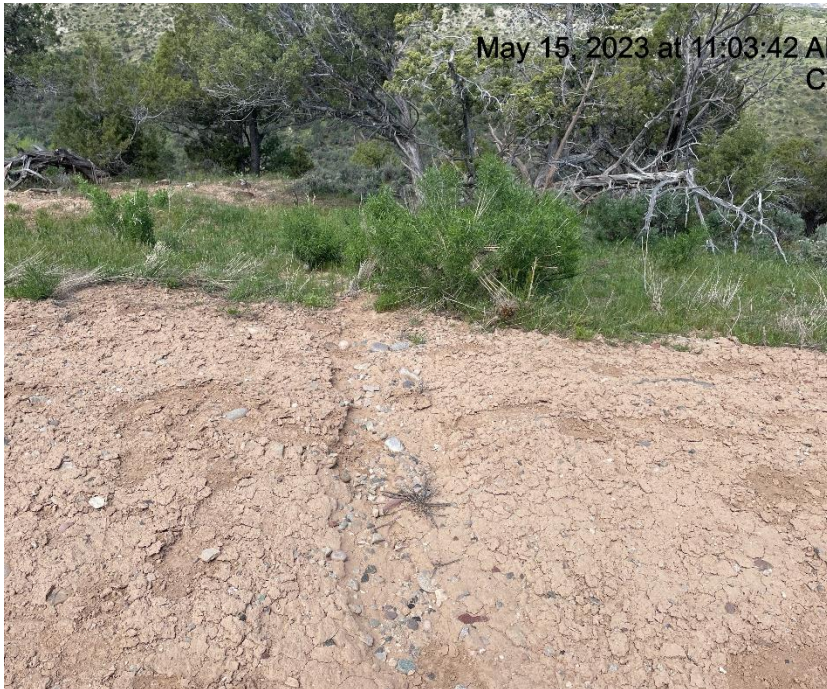
**Photo # 7810 Erosion & transport of sediment off location**

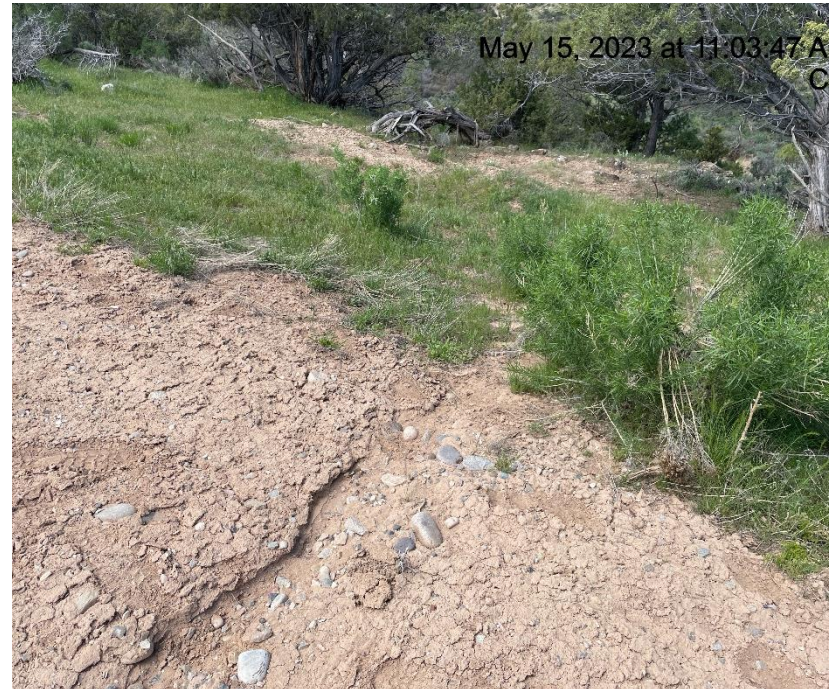
**Photo # 7811 Erosion & transport of sediment off location**

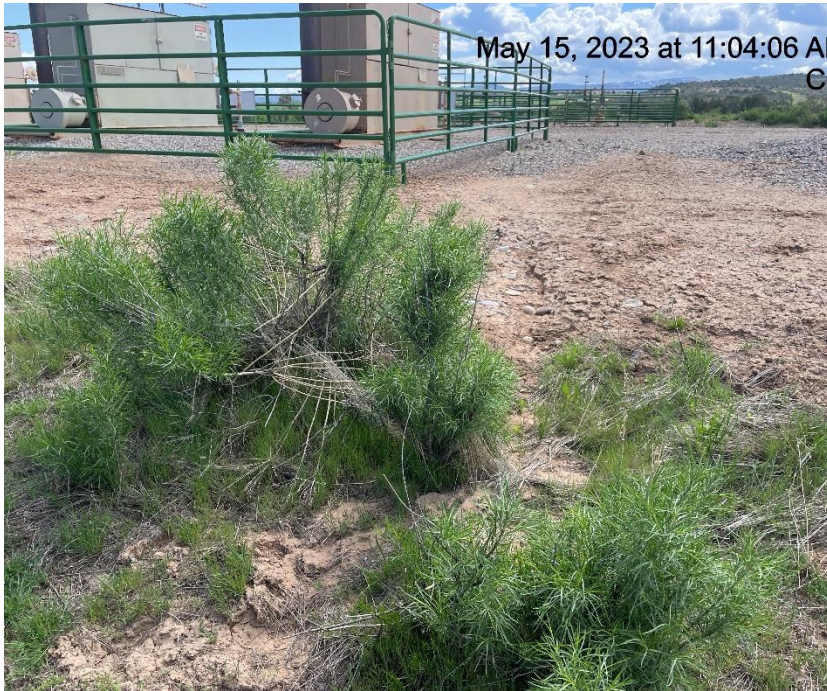
**Photo # 7812 Erosion & transport of sediment off location/choking off vegetation**

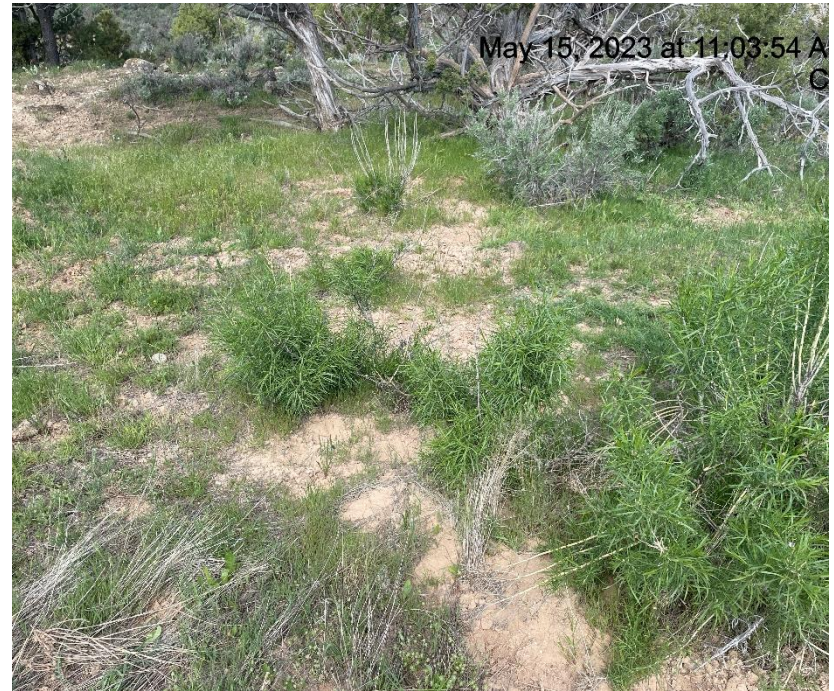
**Photo # 7813 Erosion & transport of sediment off location/choking off vegetation**
