Inspection Photos

API: 061-05145

Operator: WESTERN OPERATING COMPANY

Inspection Date: 5/15/2023

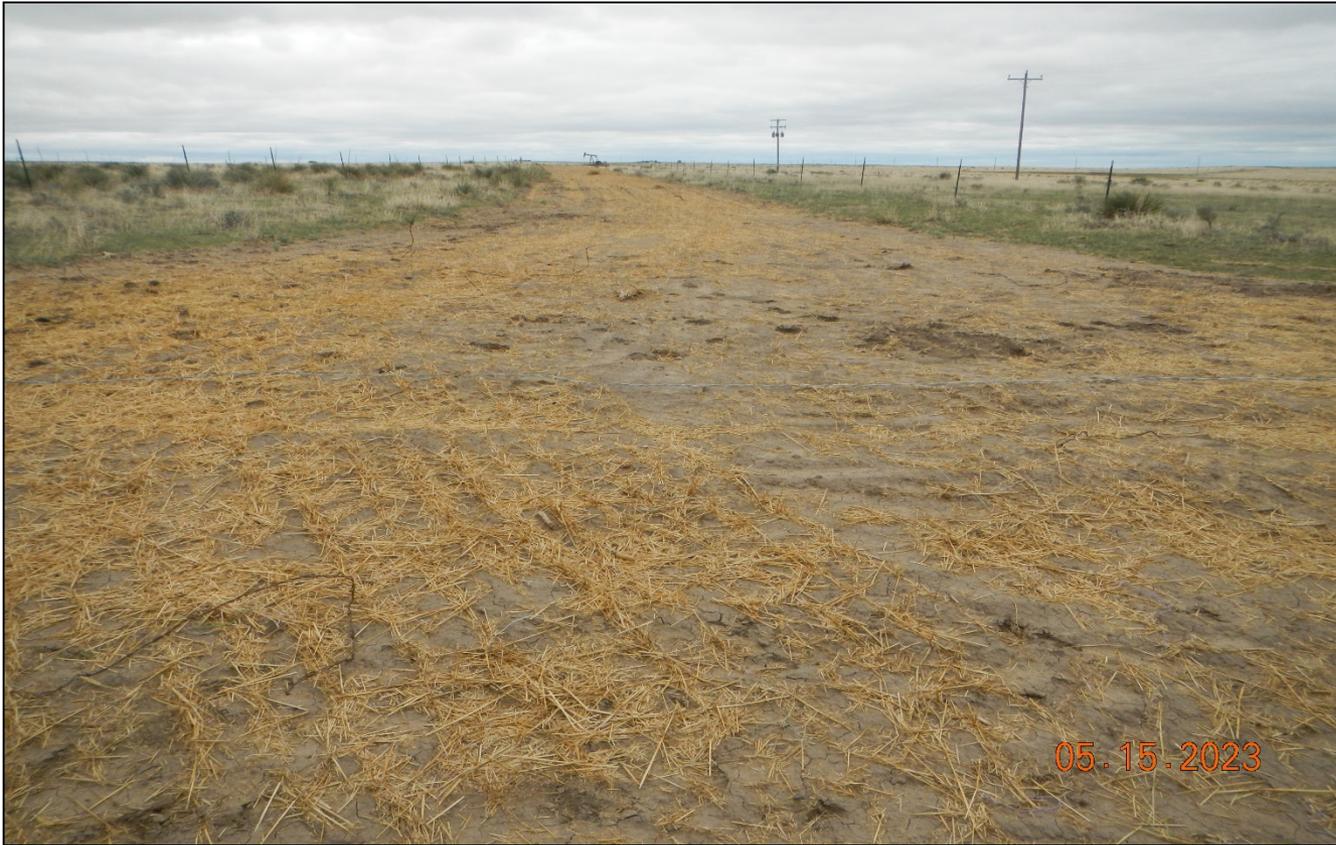
Photo 1. Facing south toward the access road. There has been soil hauled in to bring the road back to contour. Soils have been seeded and straw mulched.

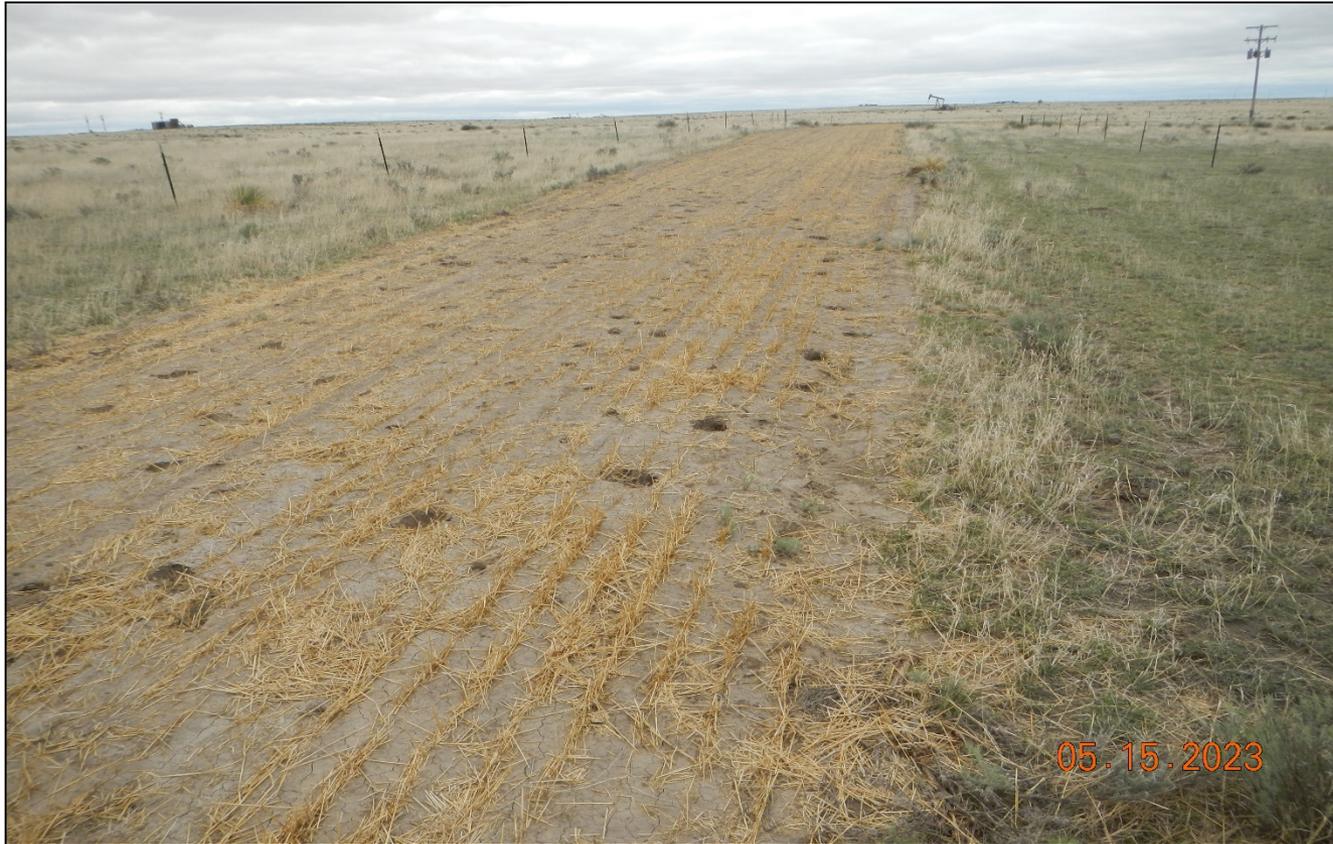
Photo 2. There has been soil hauled into bring the road back to contour. Soils have been seeded and straw mulched.

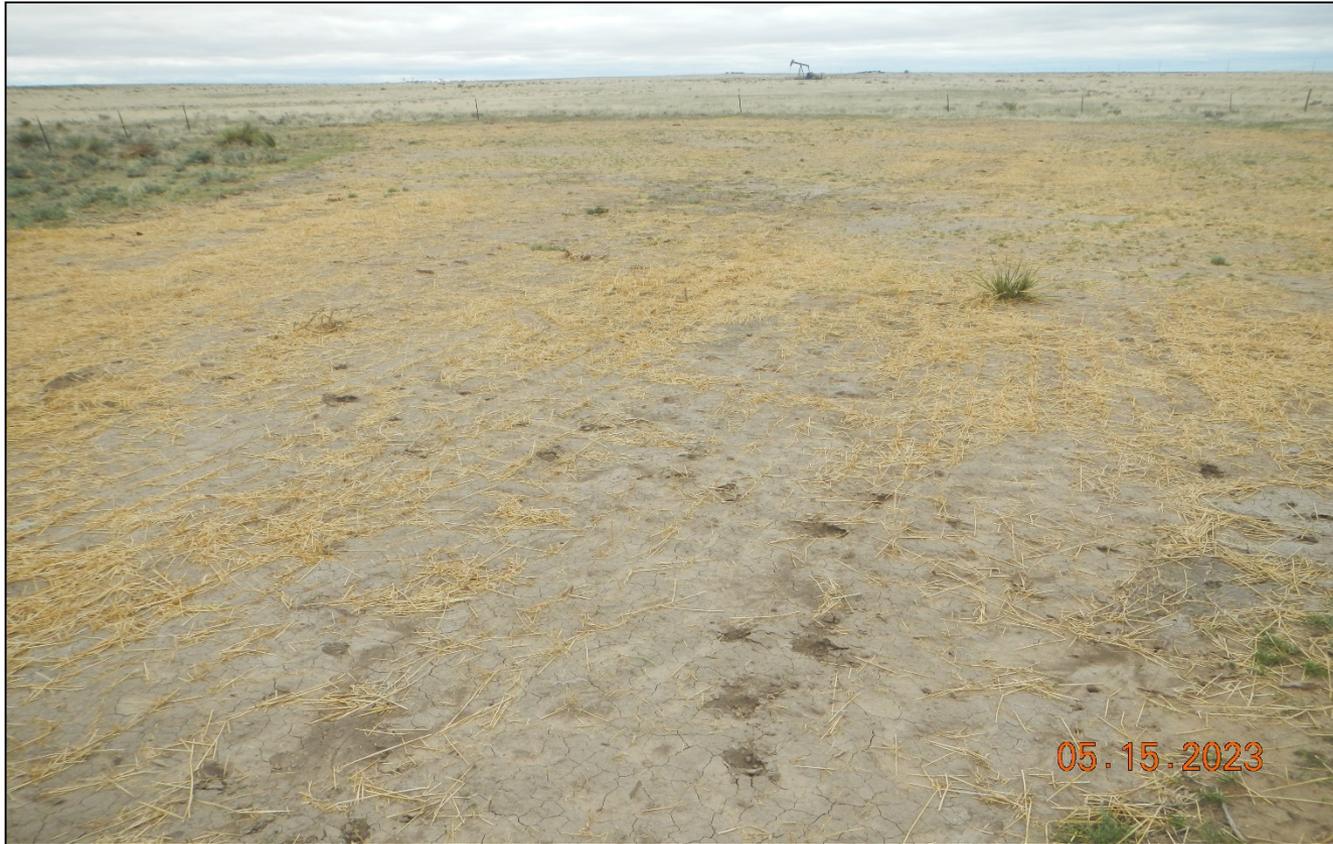
Photo 3. Facing south toward the location which has been reclaimed.

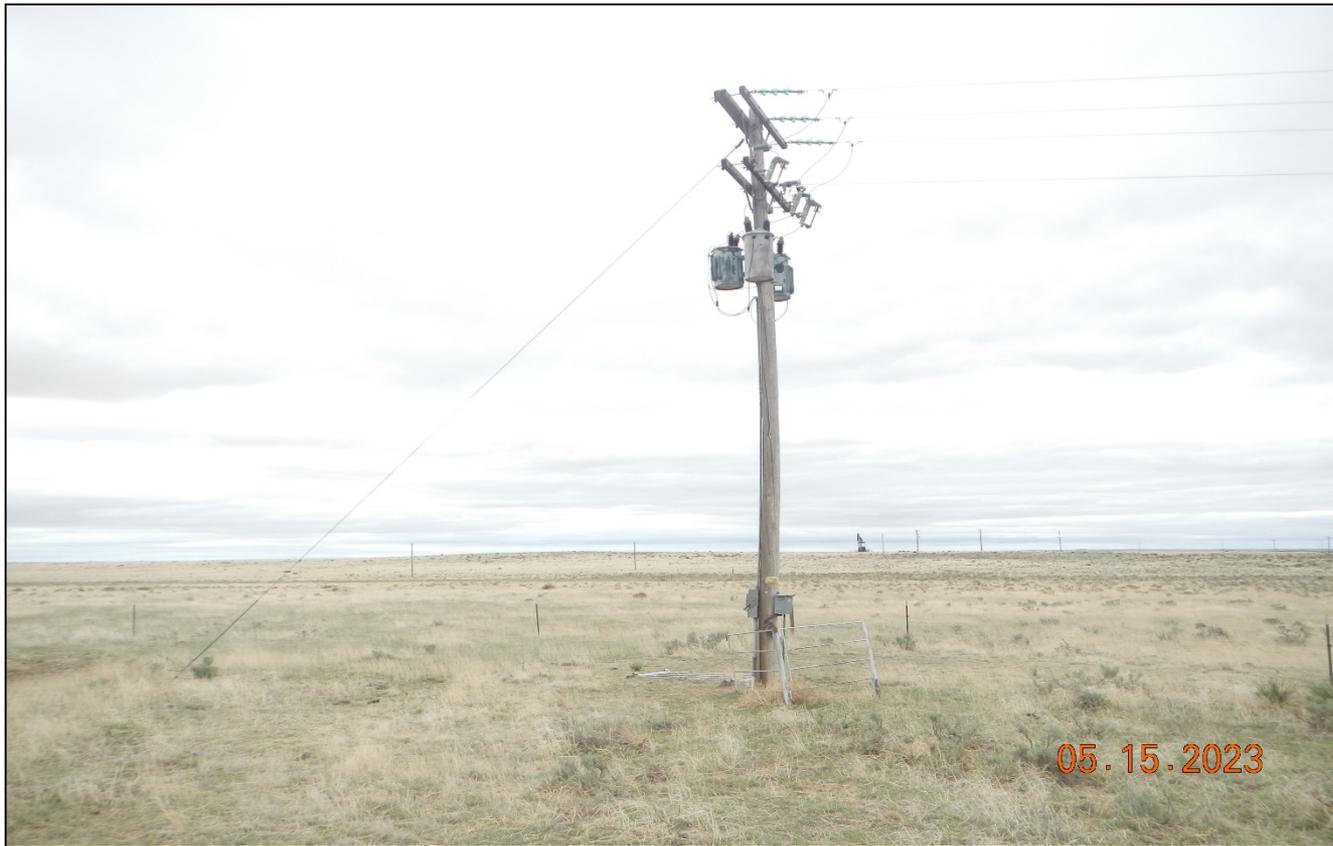
Photo 4. The electric powerline which dead ends at the location must be removed.

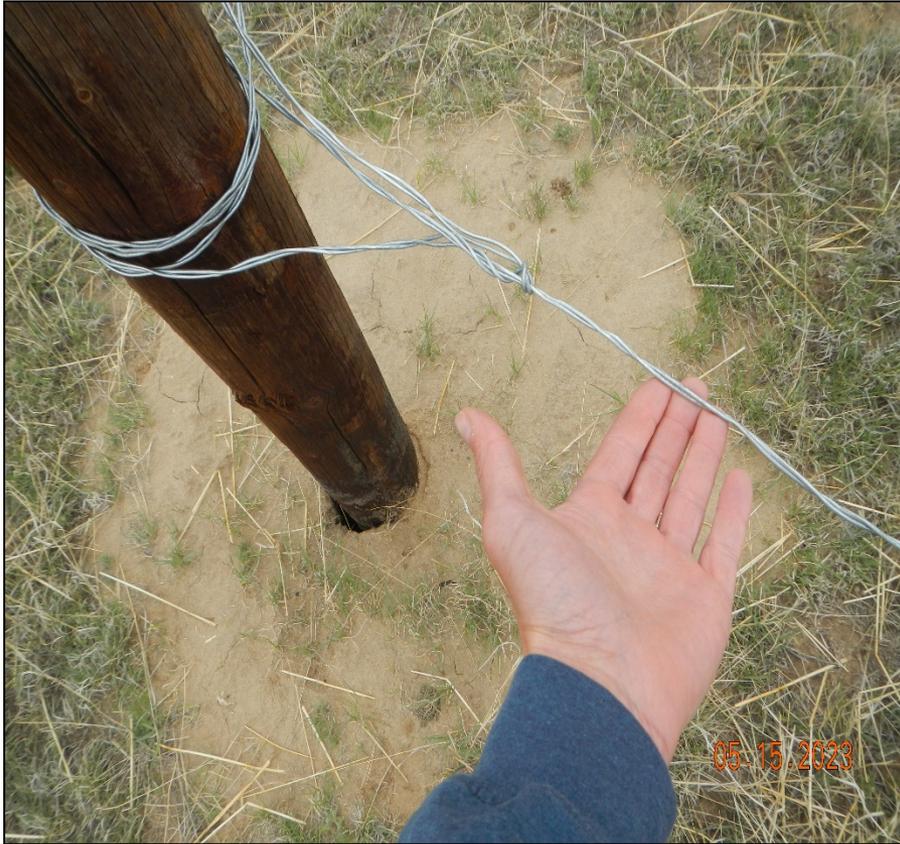
Photo 6. The electric wire does not have any current flow down the line. No insulators were used on the wood posts.

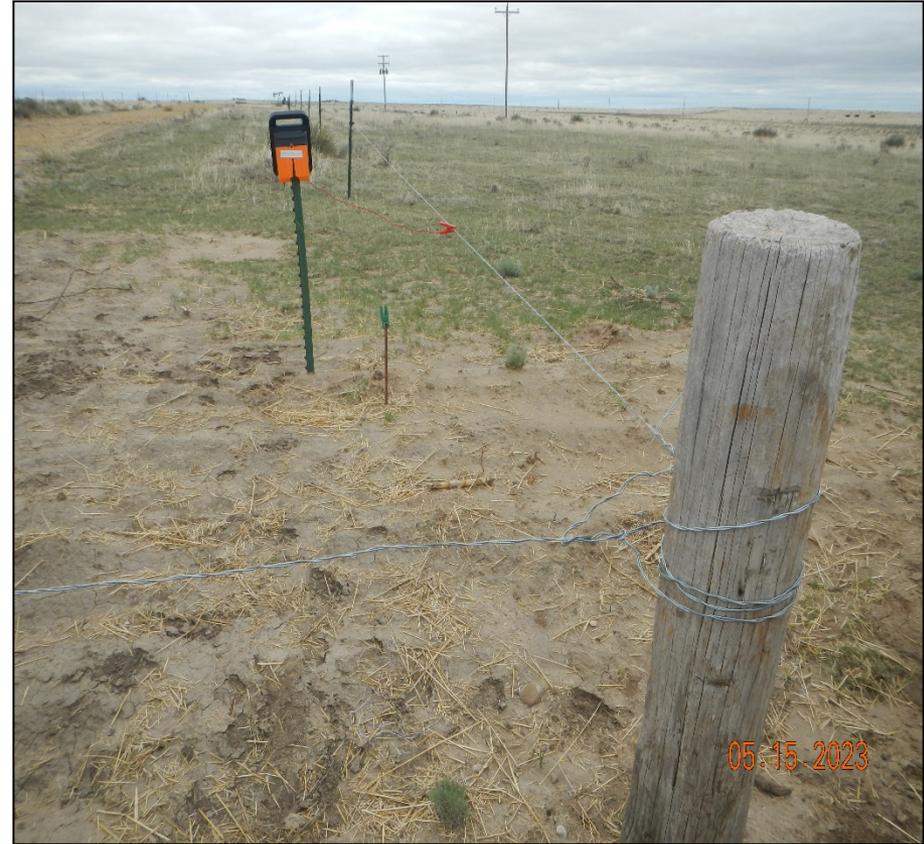
Photo 7. The electric wire does not have any current flow down the line. No insulators were used on the wood posts. Another solar charger should be used for this long stretch of wire.
