Inspection Photos

API: 061-06041

Operator: WESTERN OPERATING COMPANY

Inspection Date: 5/15/2023

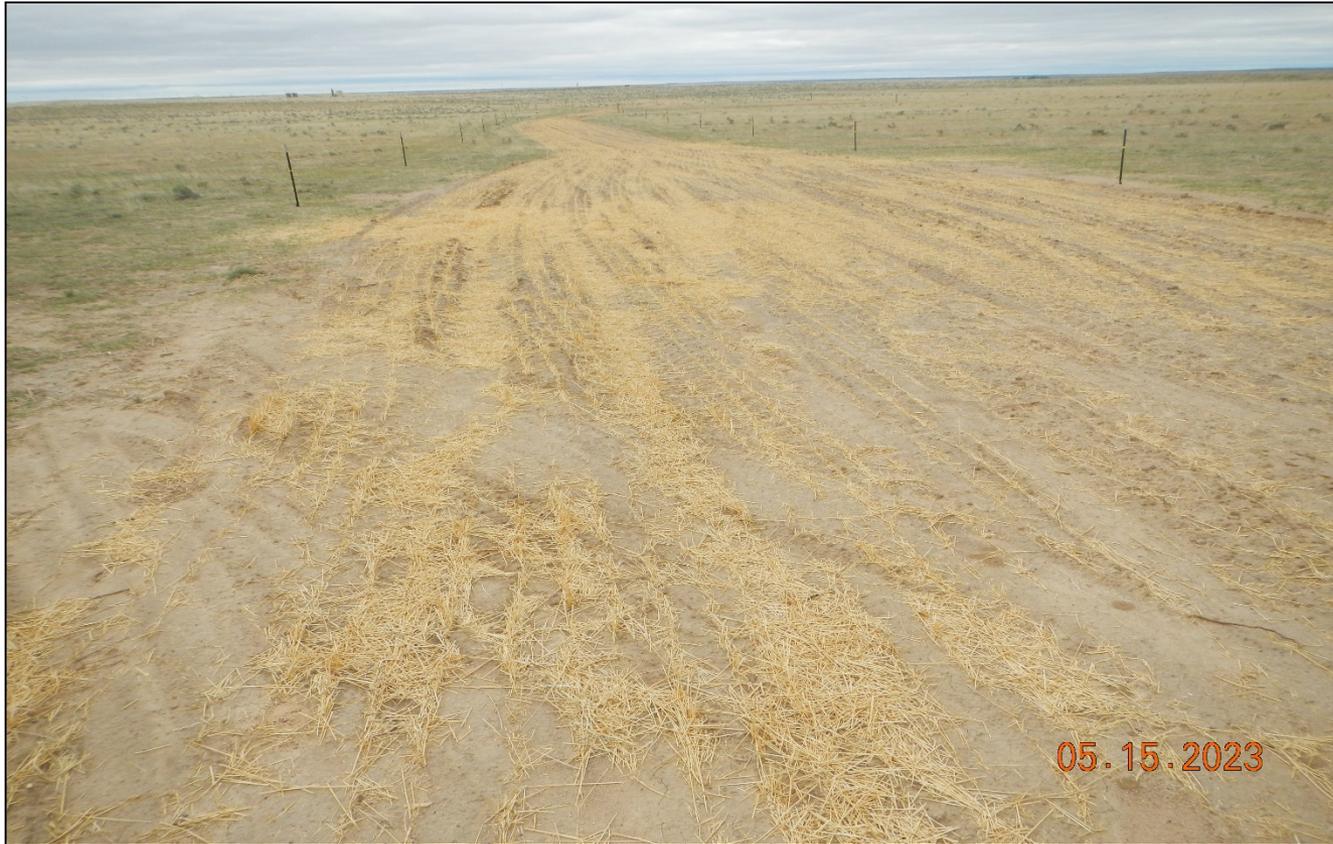
Photo 1. Facing west at the beginning of the access road. The cattleguard has been removed and the road regraded and reclaimed.

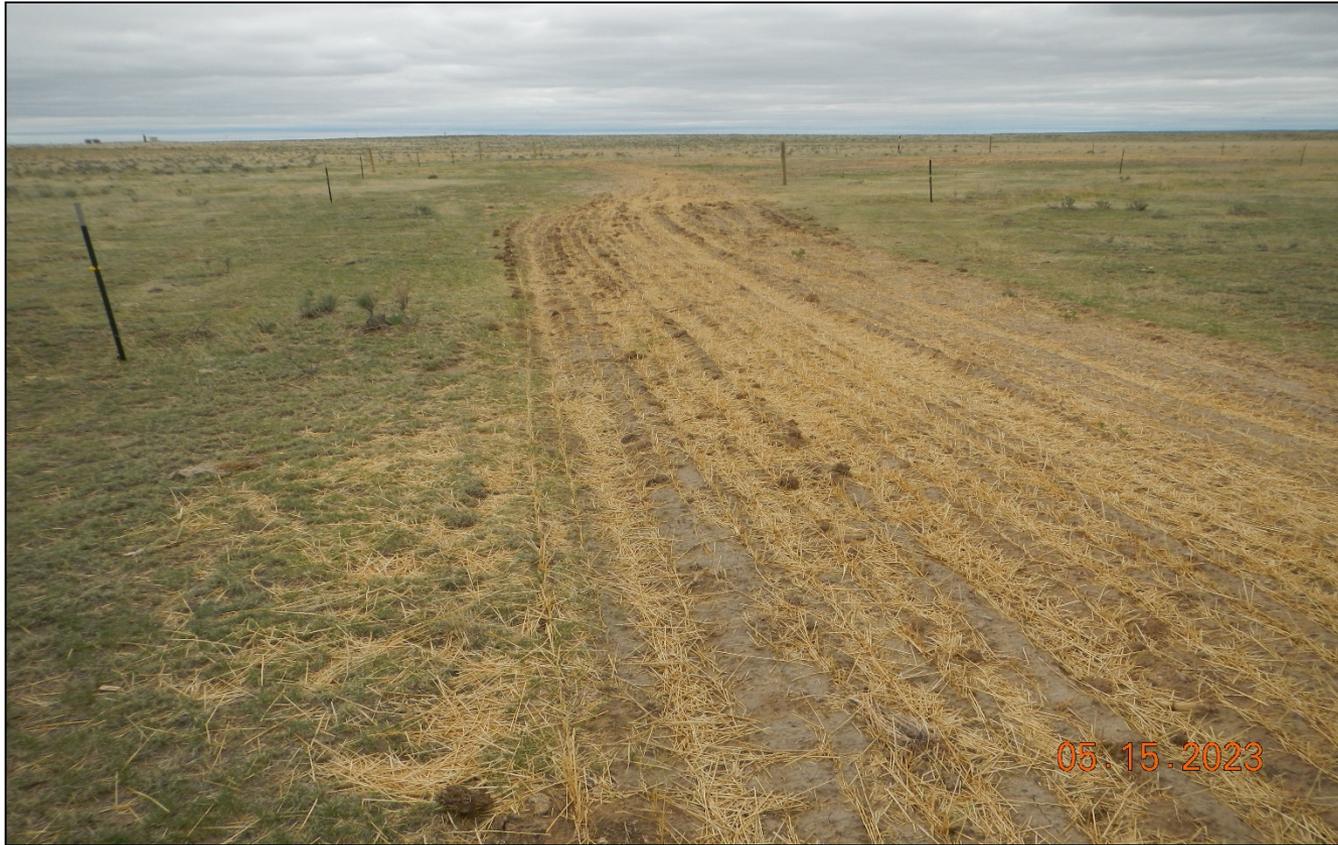
Photo 2. Facing west toward the access road which has been reclaimed. There is a 1 strand electric fence around the reclaimed area.

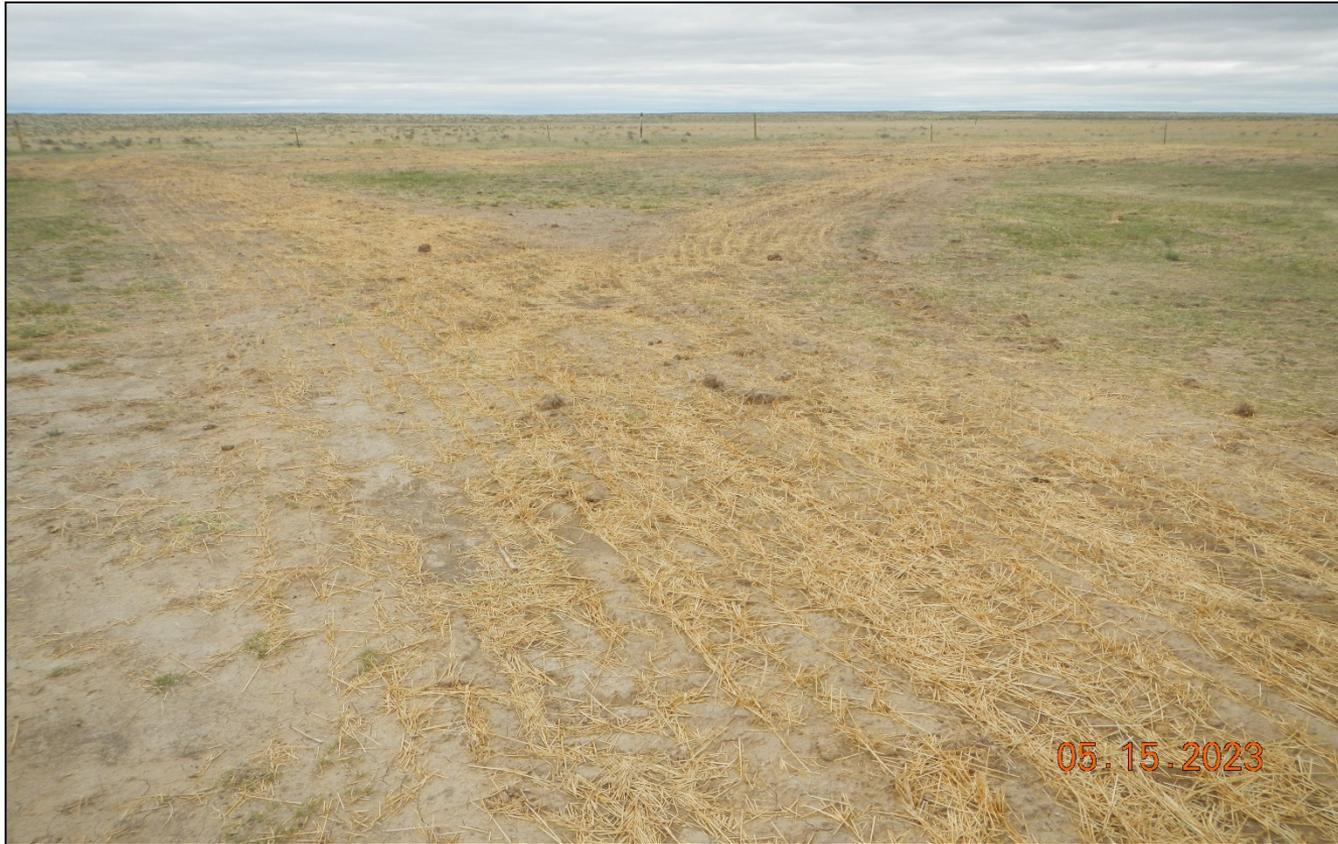
Photo 3. Facing northwest toward the location which has been seeded and straw mulched.

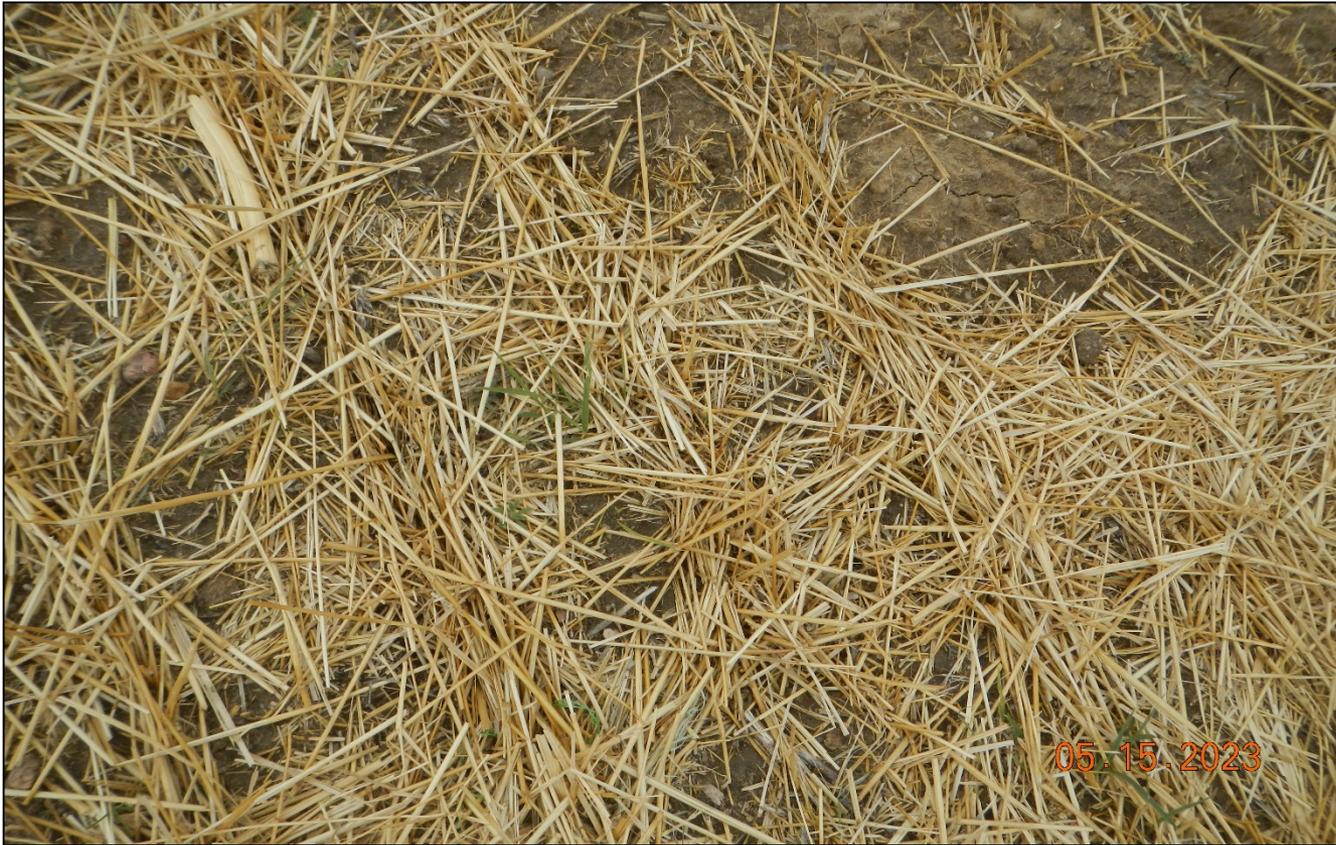
Photo 4. There was some seed germination seen in the mulch. Continue to monitor to ensure vegetation fully re-establishes.
