Inspection Photos

API: 061-05138

Operator: WESTERN OPERATING COMPANY

Inspection Date: 5/15/2023

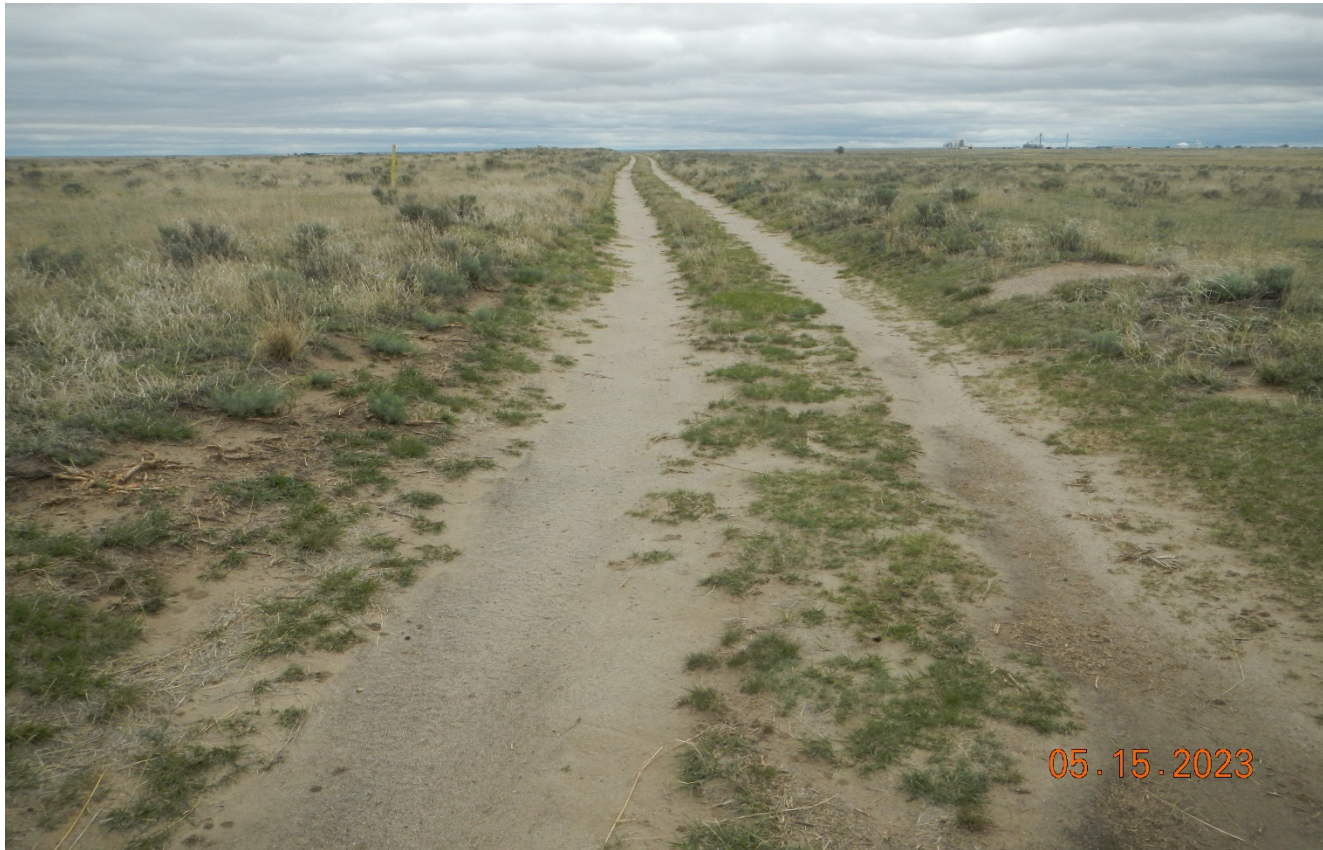
Photo 1. Facing north along the access road. This portion of the road has not been recontoured and reclaimed. Previous corrective action not completed.

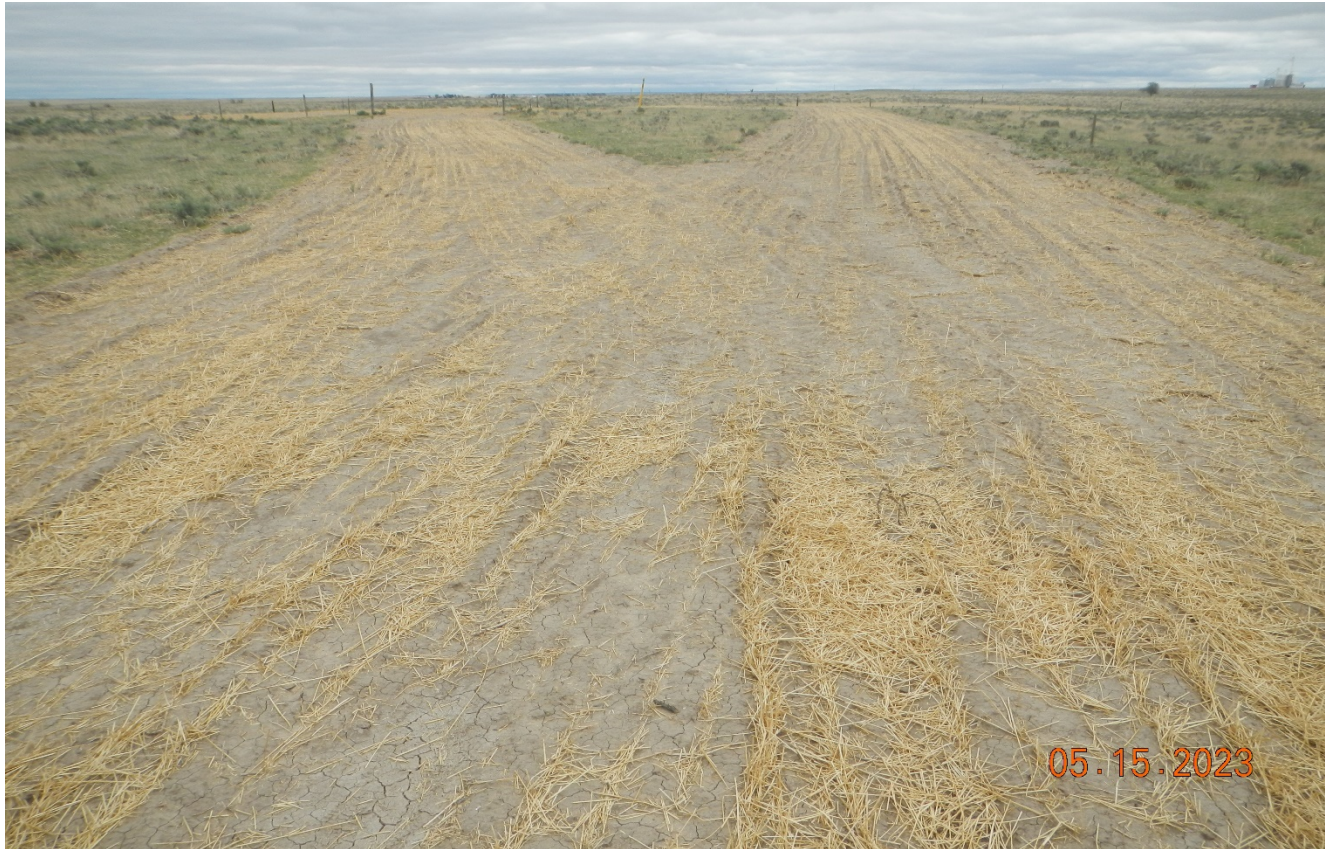
Photo 2. Facing northwest toward the two access road to the former tank battery and wellsite. There has been soil hauled in to bring the road back to contour. Soils have been seeded and straw mulched.

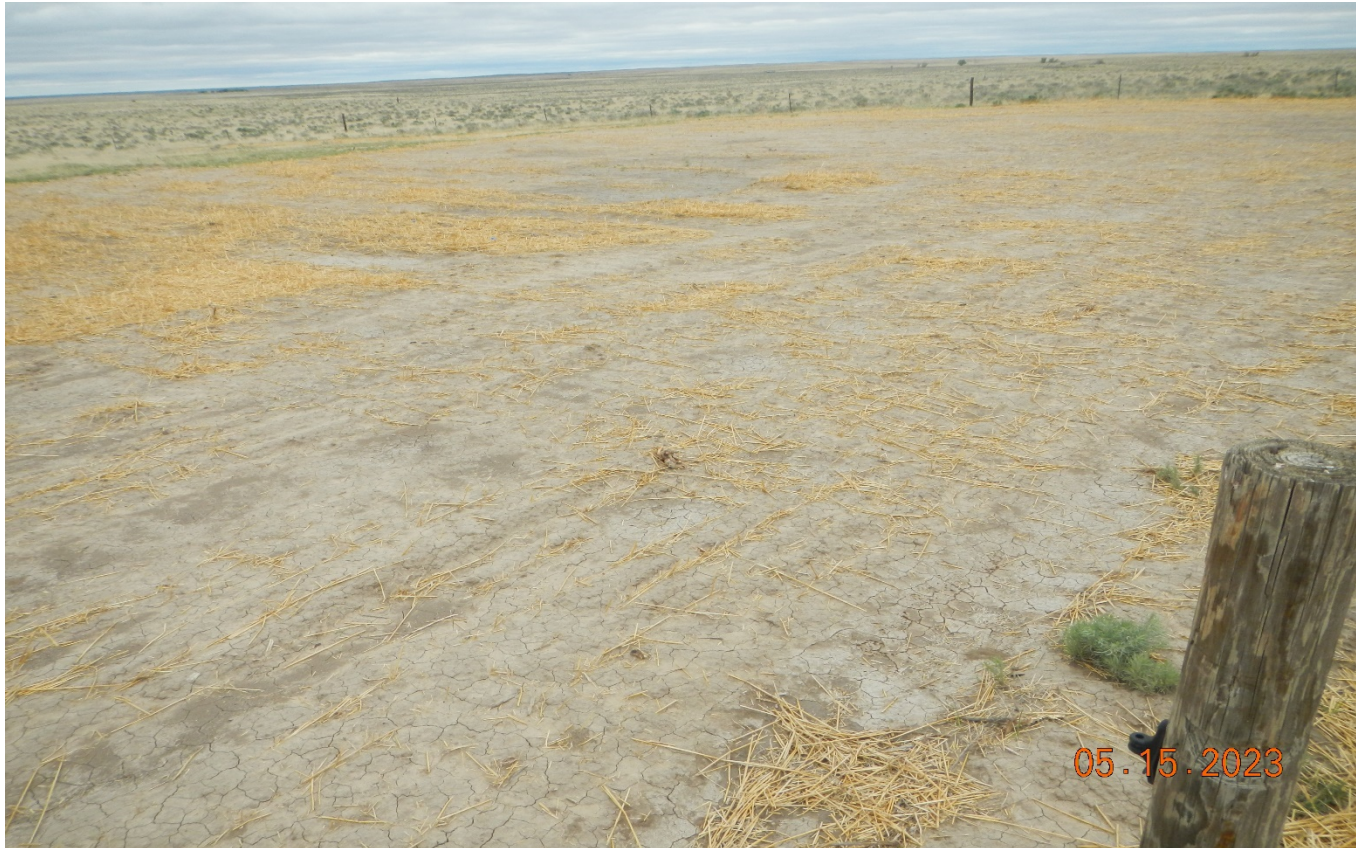
Photo 3. Facing northwest toward the former tank battery site located 300' southwest of the well site. Soils have been seeded and straw mulched. Straw mulch is sparse which will not

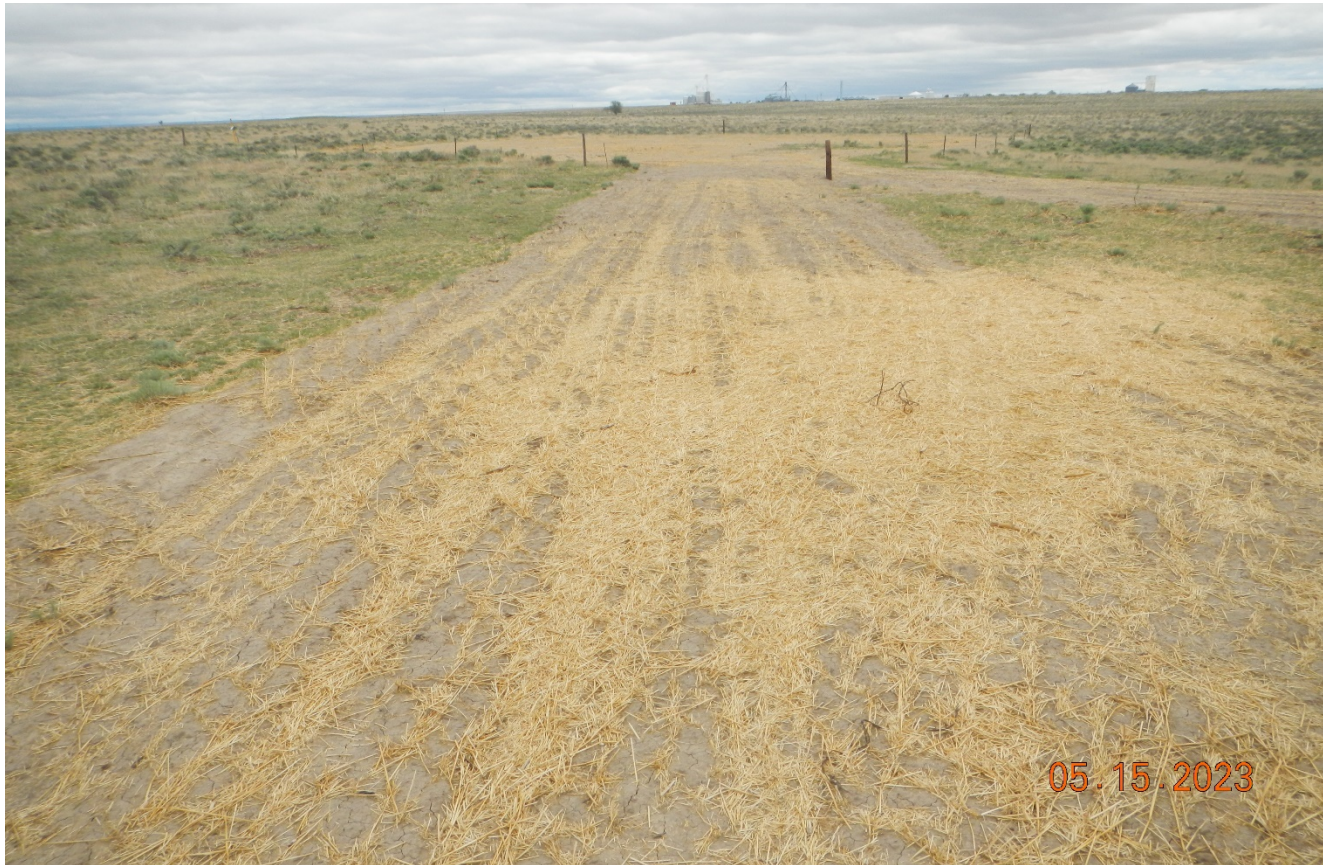
Photo 4. Facing northeast toward the access road to the former wellsite. There has been soil hauled into bring the road back to contour. Soils have been seeded and straw mulched.

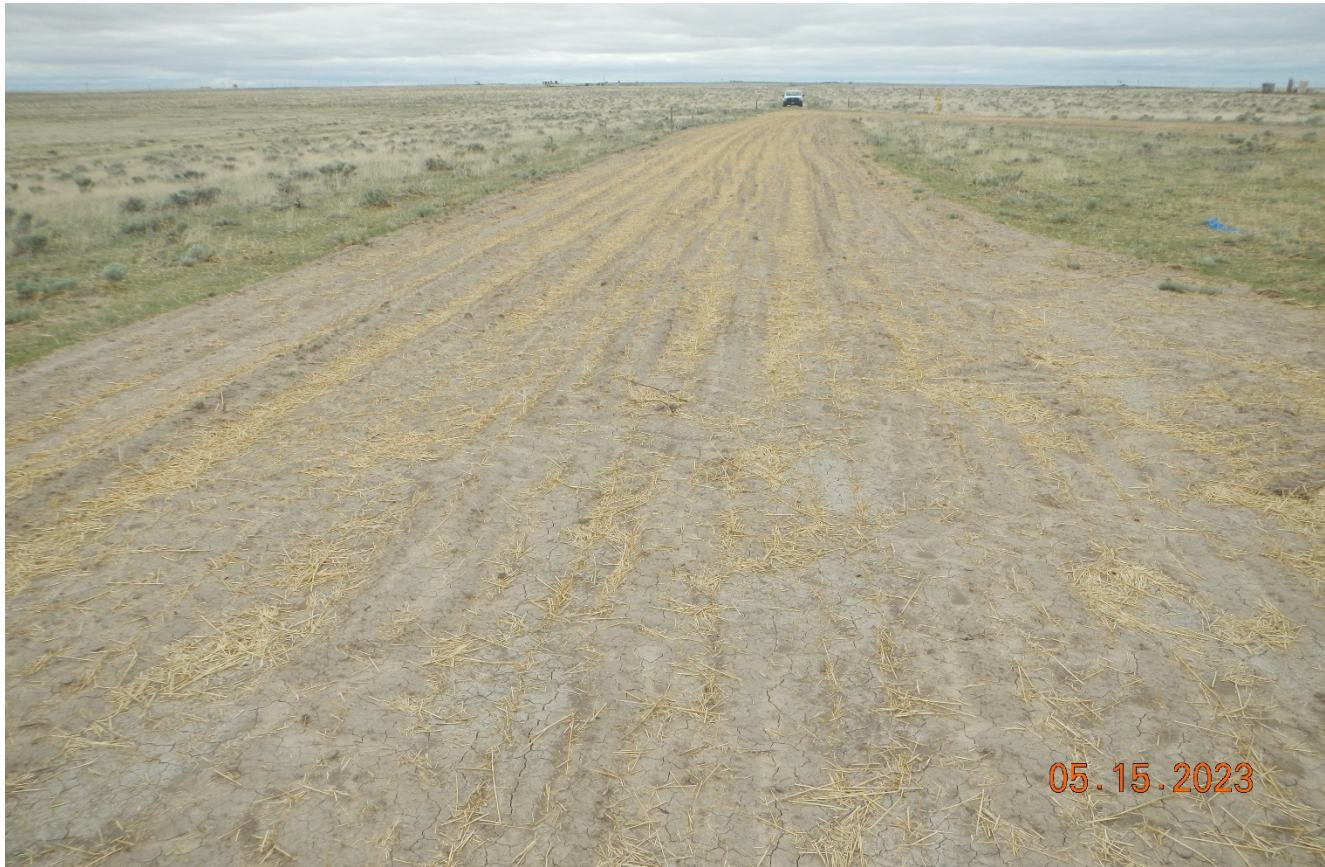
Photo 5. Facing back south toward the access road. There has been soil hauled into bring the road back to contour for this portion of the road. Soils have been seeded and straw mulched.
