Inspection Photos

API# 061-06023

Operator: WESTERN OPERATING COMPANY

Inspection Date: 5/15/2023

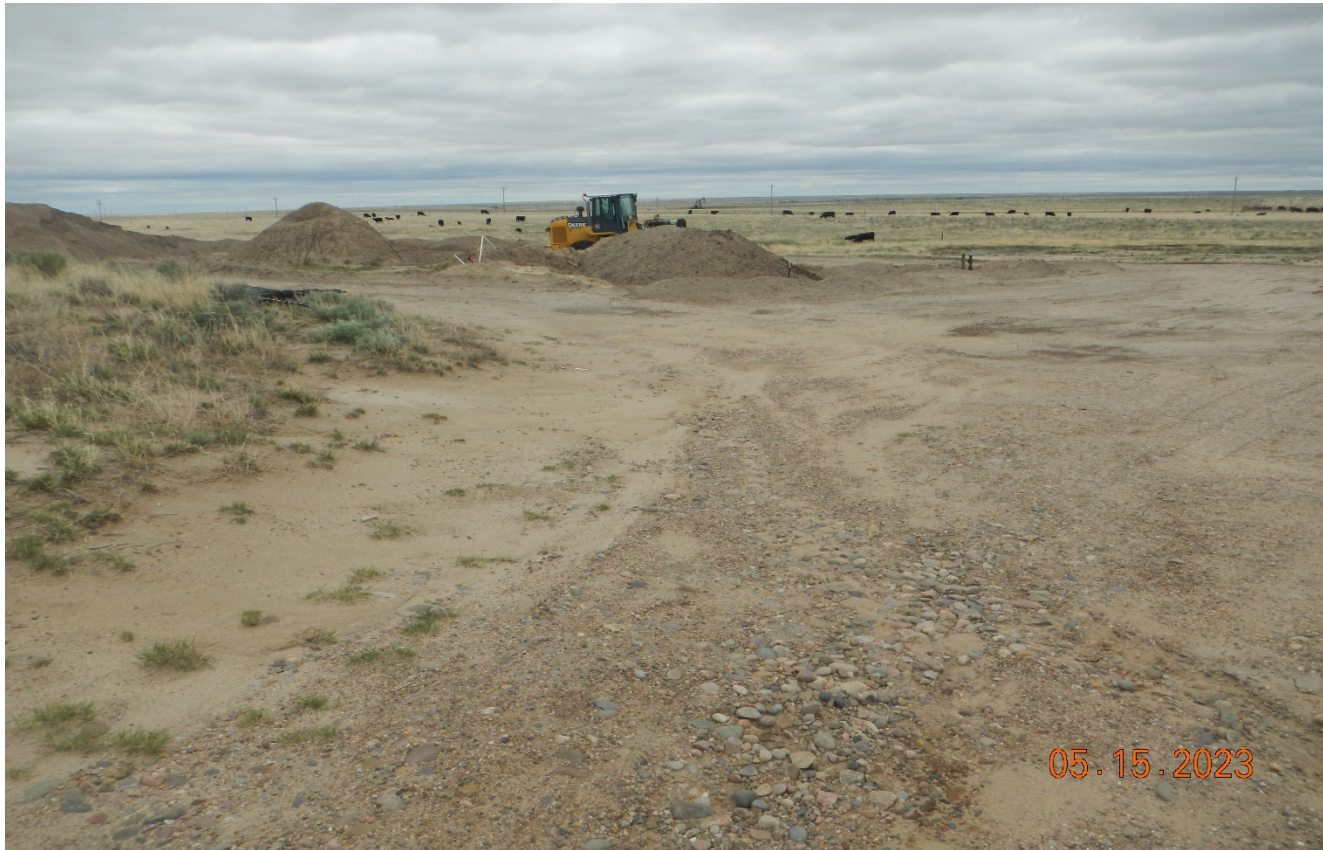
Photo 1. Facing southwest at the DAWSON A 1 tank battery facility. The tank was removed and soils have been excavated in this area. Remediation project: 20712

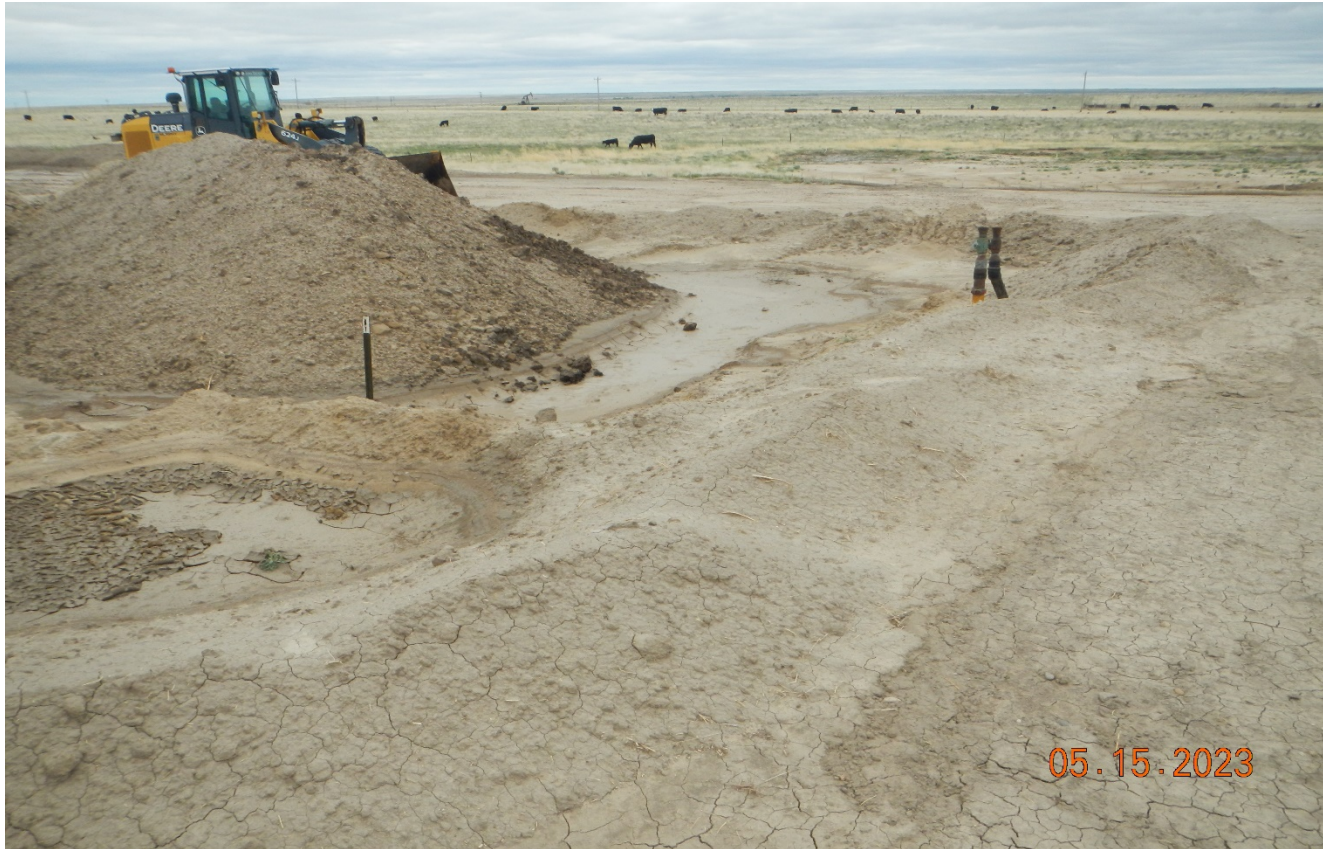
Photo 2. Facing southwest toward the tank battery facility. The tank was removed and soils were excavated in this area. It appears soils have been backfilled into the excavated area where tanks were located. There is still a pile of contaminated material improperly stored at the location.

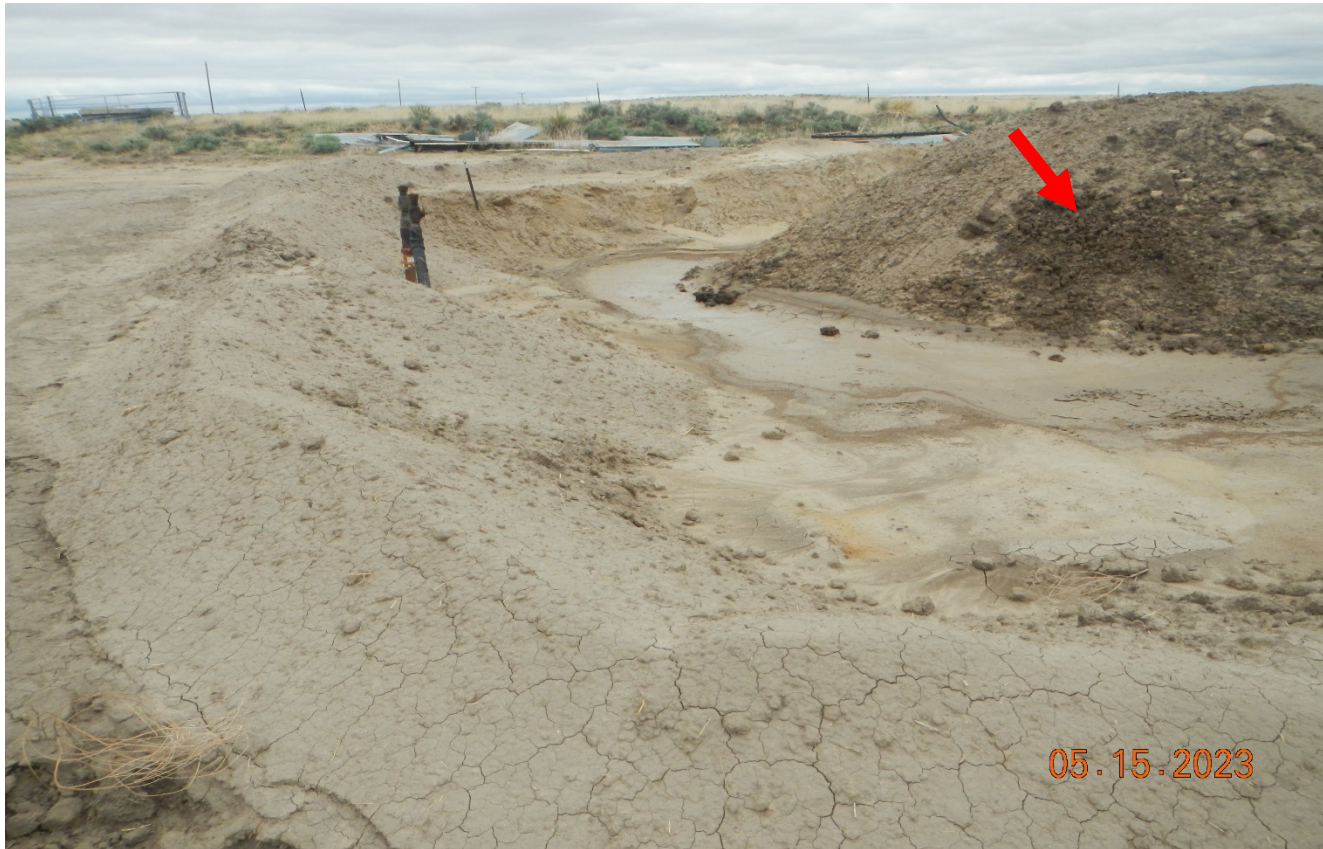
Photo 3. Facing southeast toward the tank battery facility. The tank was removed and soils were excavated in this area. It appears soils have been backfilled into the excavated area where tanks were located. There is still a pile of contaminated material improperly stored at the location. Red arrow points to black hydrocarbon soils.

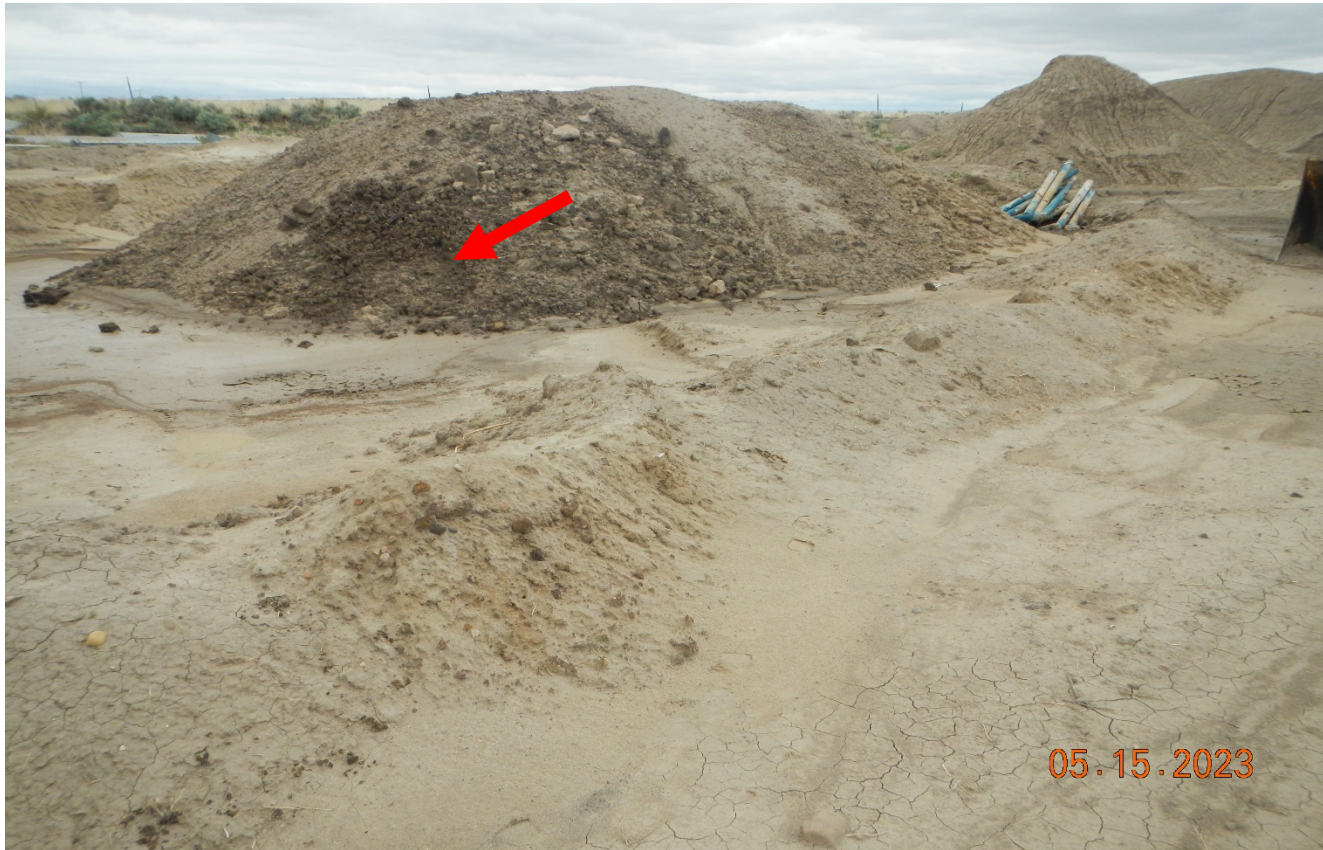
Photo 4. There is no liner observed under the contaminated soils which are not being properly stored. The berms around the material are not compacted or adequately constructed. Contaminated soils need to be removed and properly disposed. Red arrow points to black hydrocarbon soils.

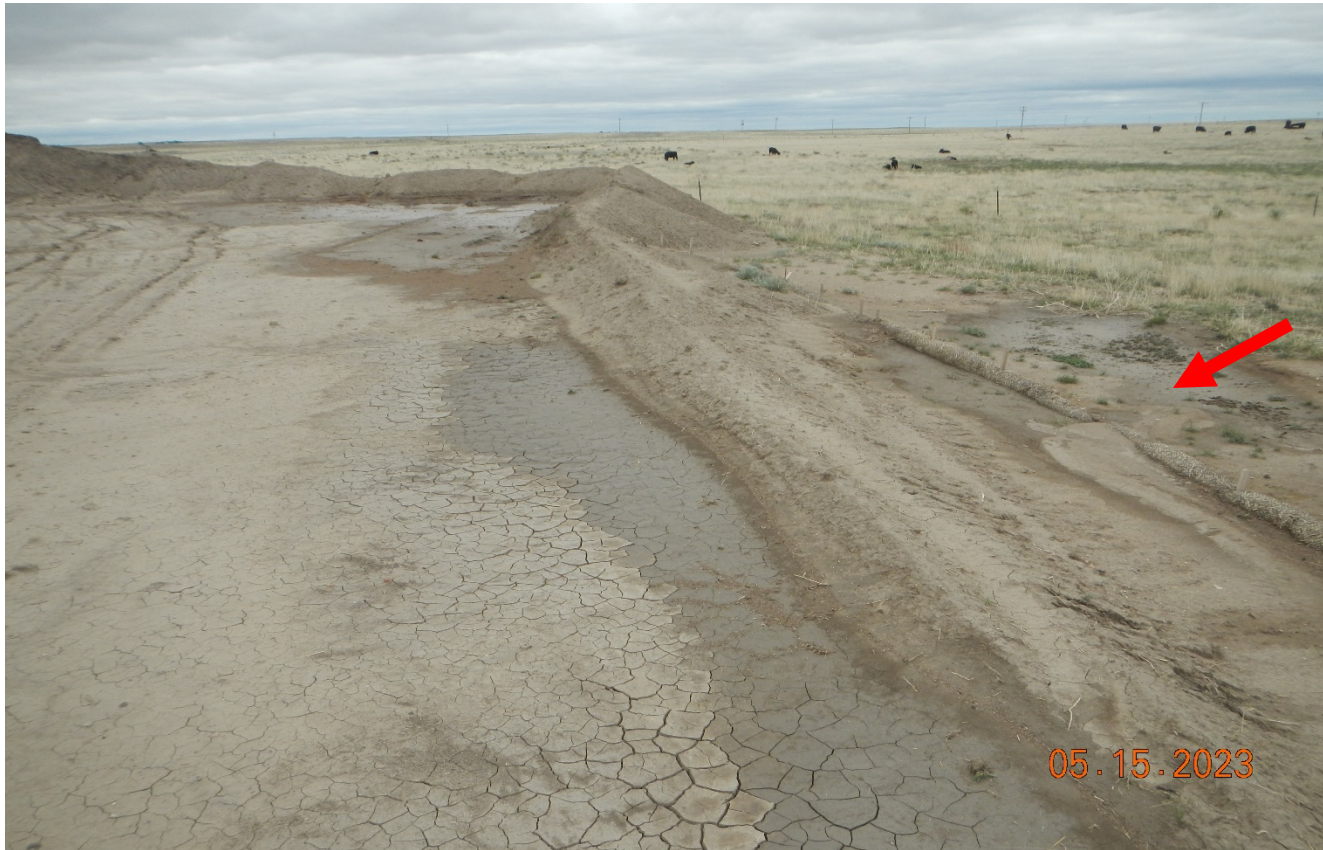
Photo 5. Facing south at the tank battery facility. There is insufficient stormwater controls in this area and the wattles at red arrow has filled in has overtopped the wattles moving sediment offsite.

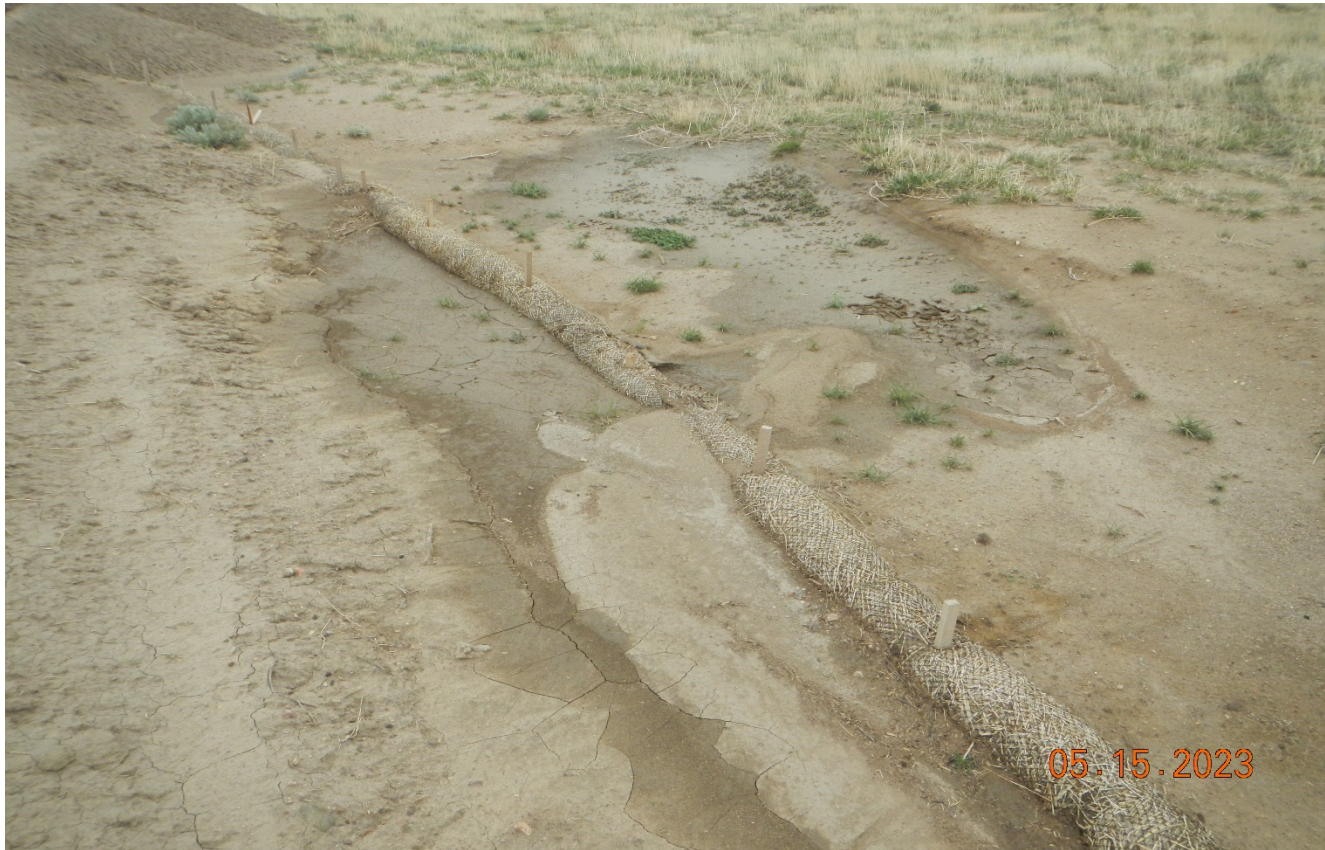
Photo 6. View of wattle which sediment has filled in and overtopped the wattles moving sediment offsite.

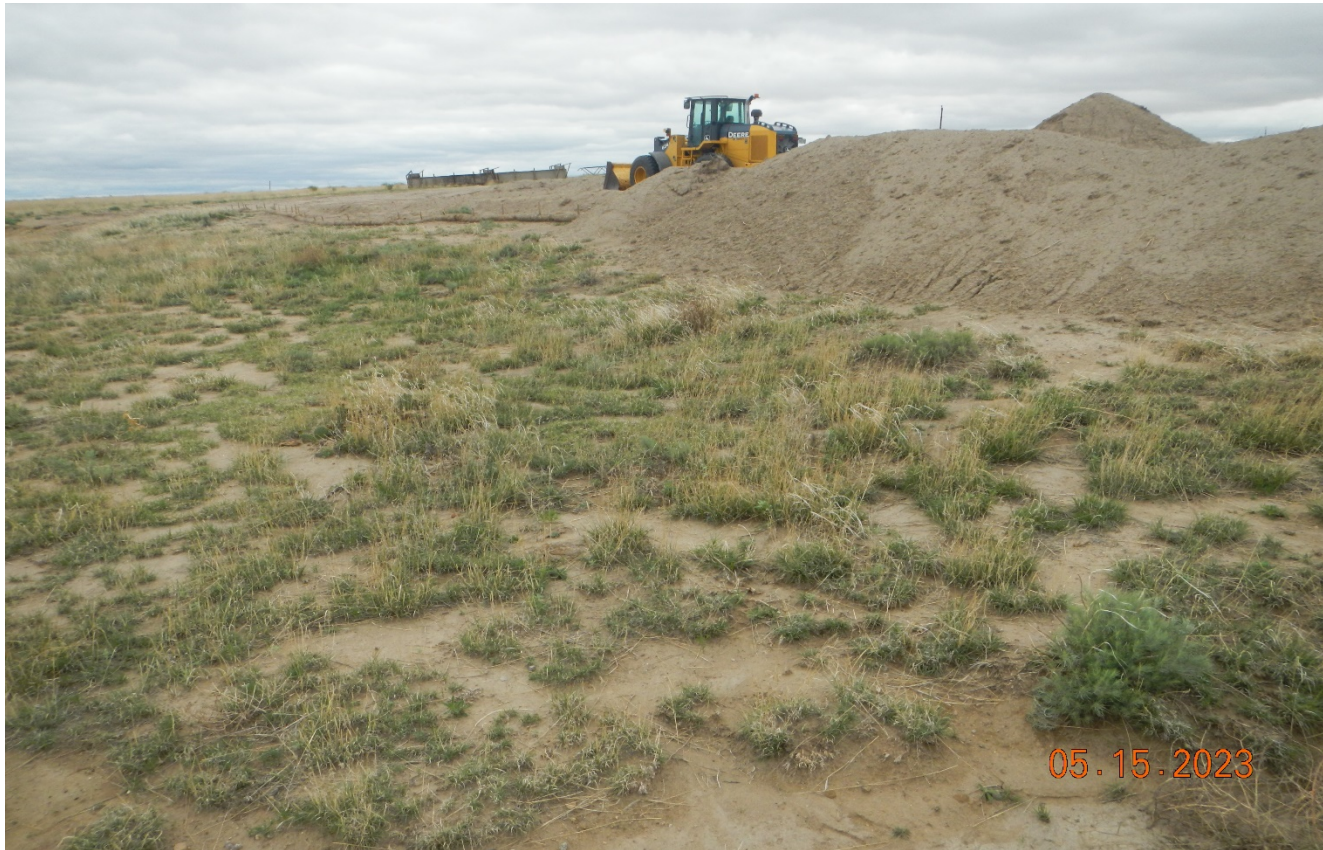
Photo 7. There have been soils brought in and stockpiled at the south side of the location. There is inadequate stormwater BMP's to prevent erosion of the stock piled soil. Previous corrective action was not completed.

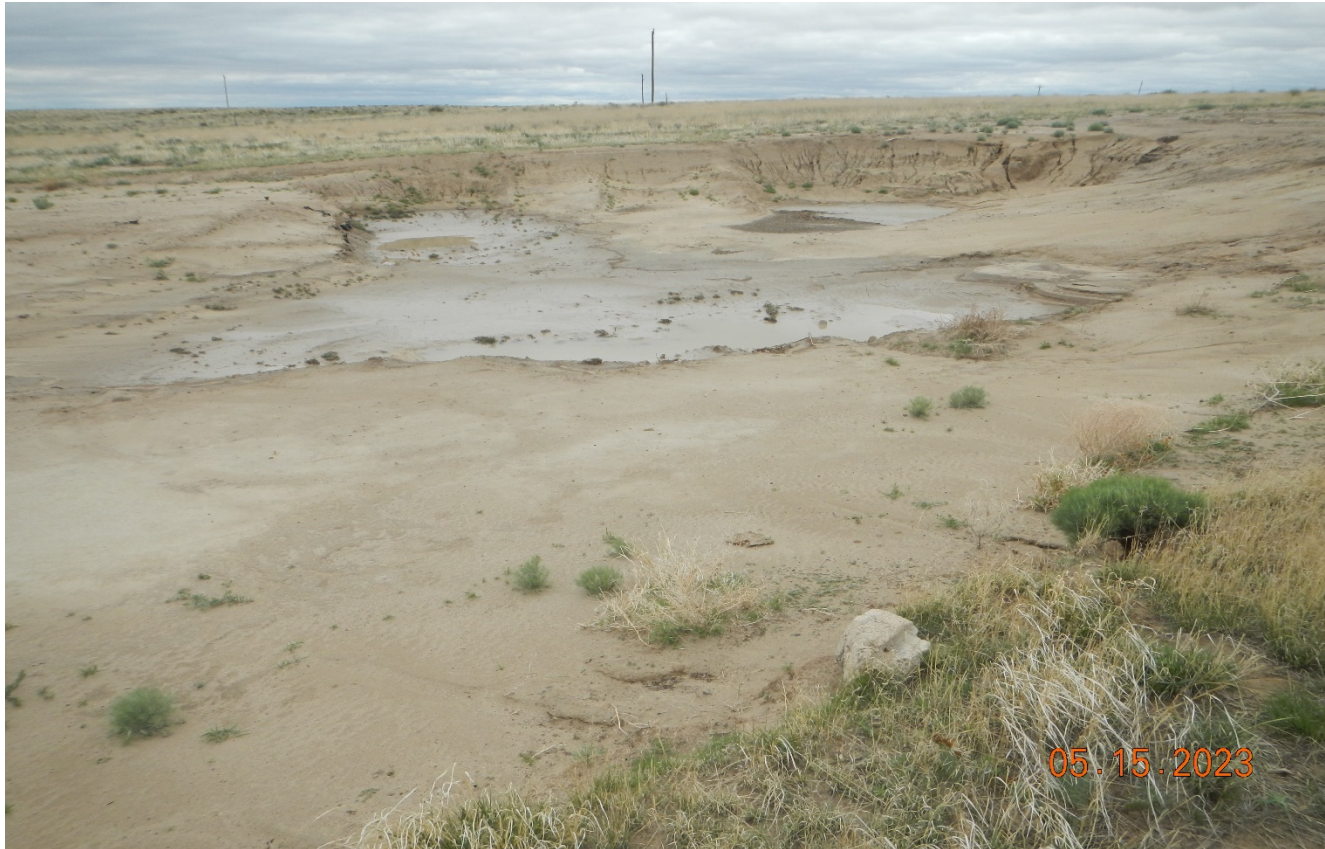
Photo 8. Facing west of the battery site toward the area where the spill occurred February of 2022, Remediation project: 20712.

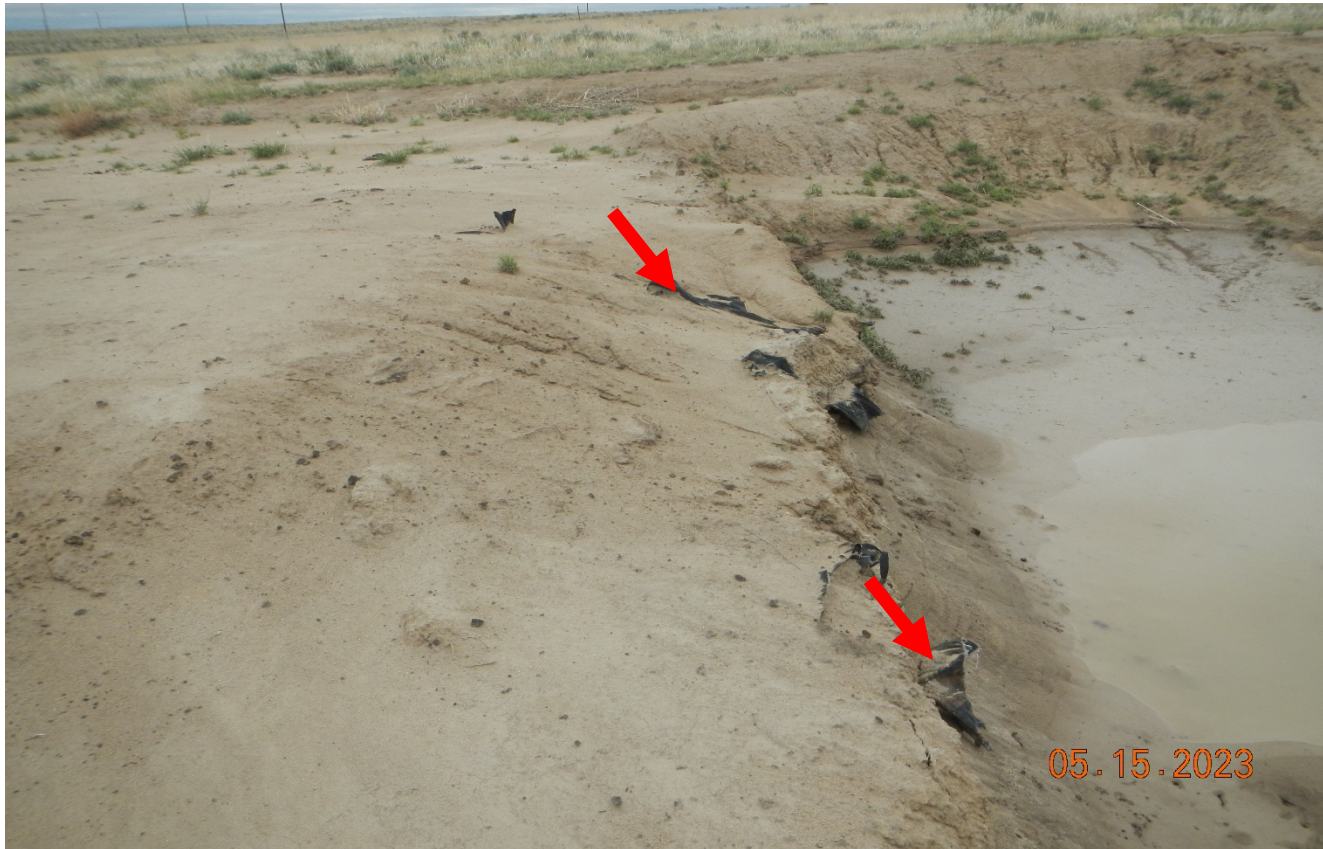
Photo 9. Facing southwest toward the area where the spill occurred. Remediation project: 20712. Some areas have been excavated more than other areas. There are still areas of impacted soils observed. Red arrow points to liner material and stained soil.

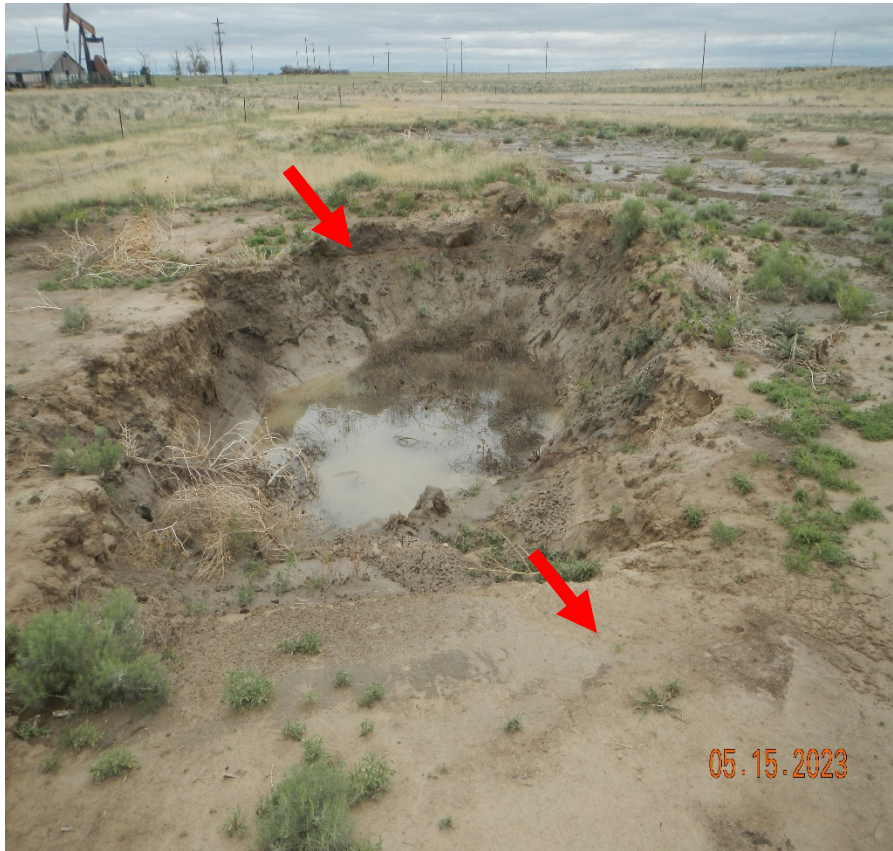
Photo 10. Located at the western side of the spill area. There is an excavated hole at this area approximately 12'x12'6'. There are still areas of oil stained soils at the surface (Bottom left) and 2ft. Down into the excavation area (right photo). Further excavation is needed.

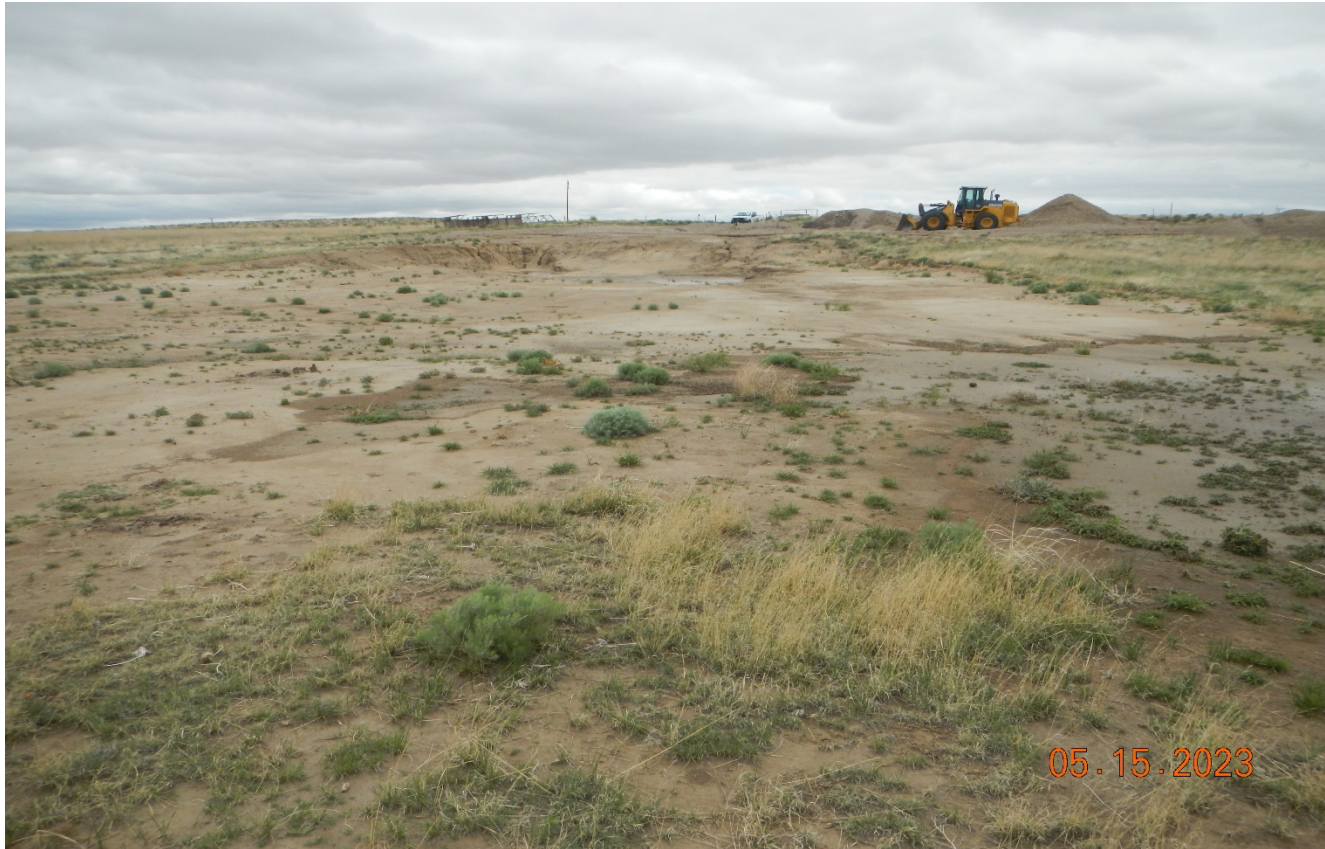
Photo 11. Facing east toward the area where the spill occurred February of 2022, Remediation project: 20712.

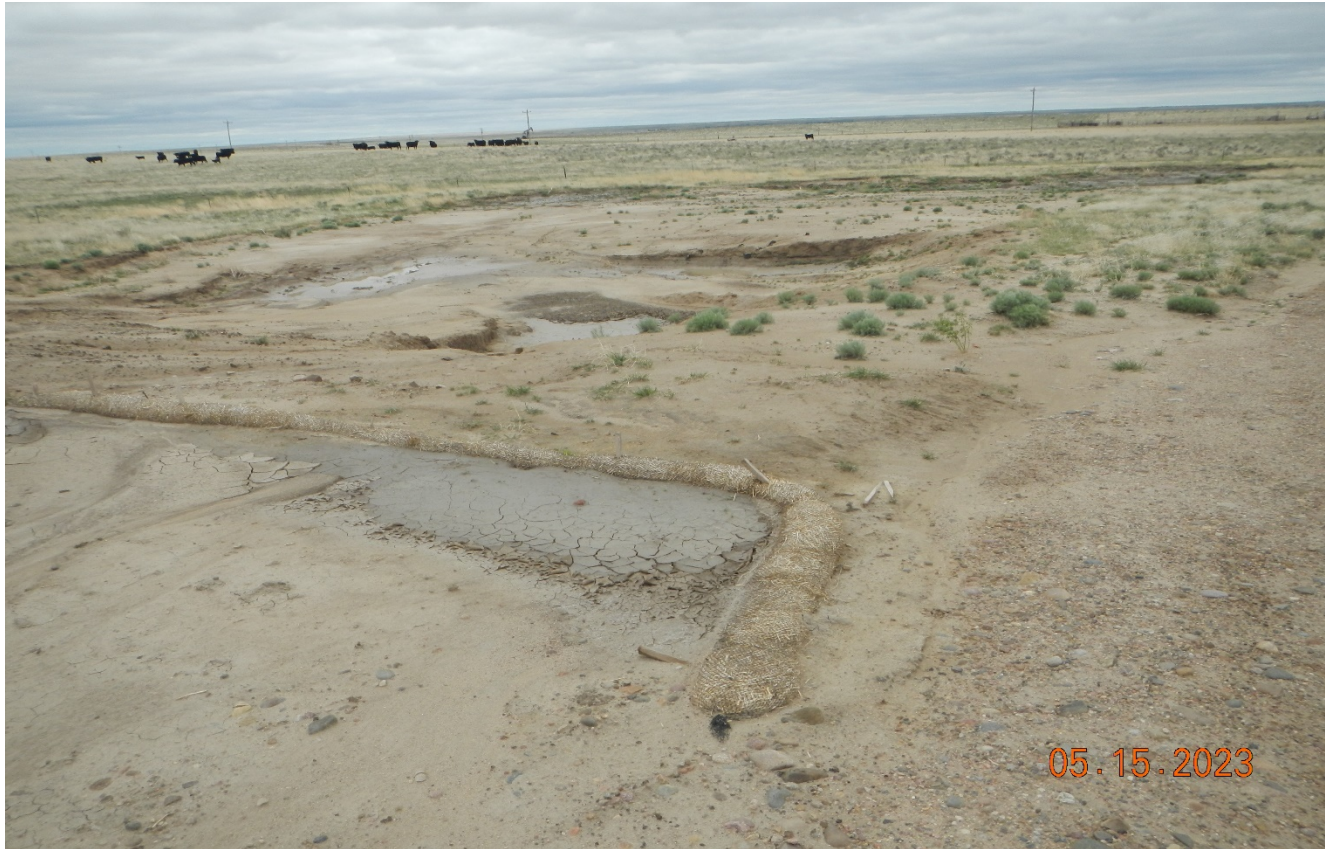
Photo 12. Facing southwest toward the area where the spill occurred. Remediation project: 20712. Some areas have been excavated more than other areas.

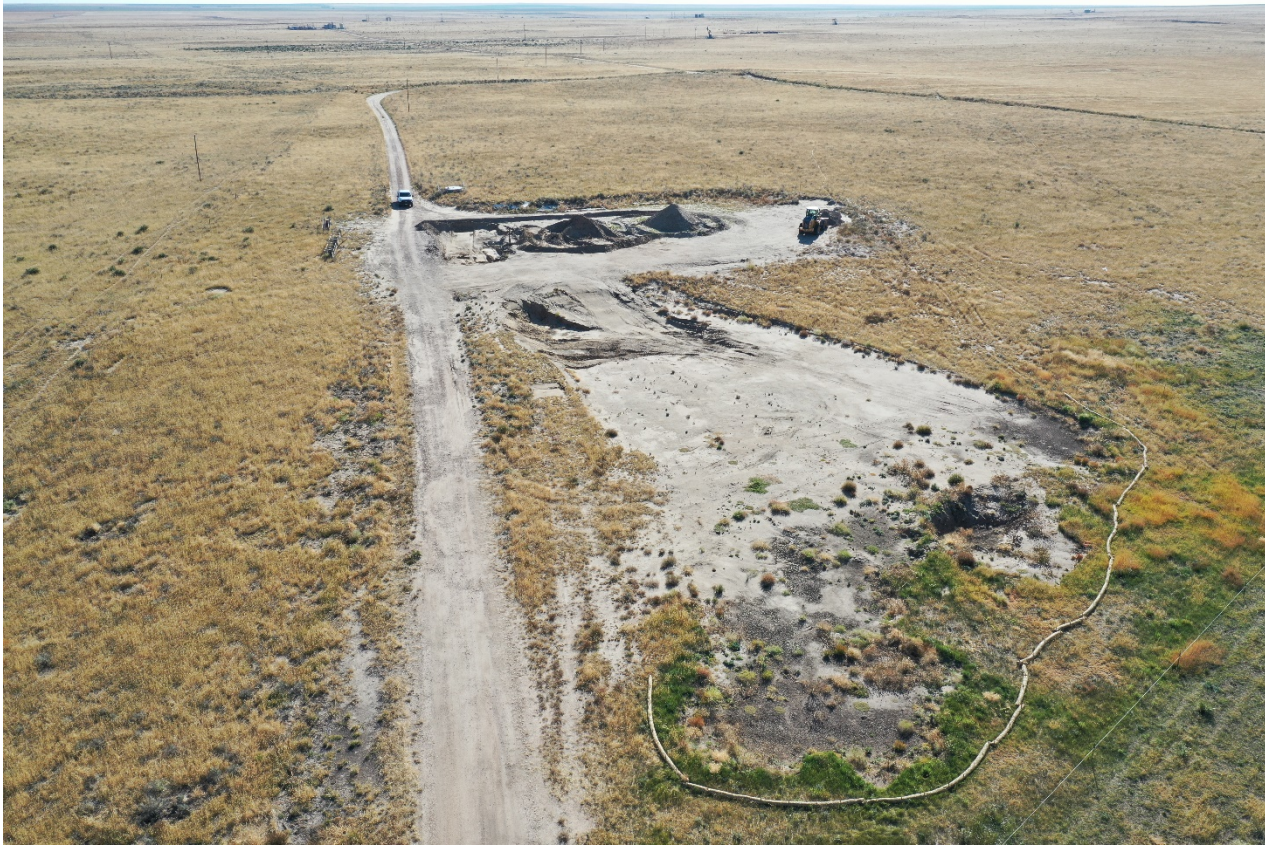
Photo 14. Drone aerial photo facing east toward the battery and remediation project. Photo taken on 10/12/2022.
