Inspection Photos

5/15/2023

Operator: OXY USA INC - 66561

Location Number: 312529

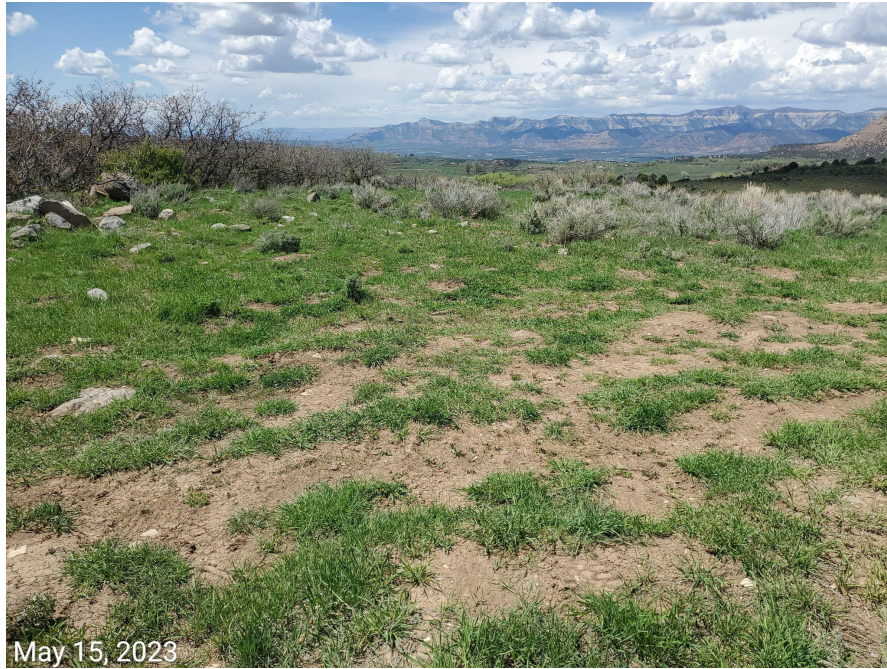
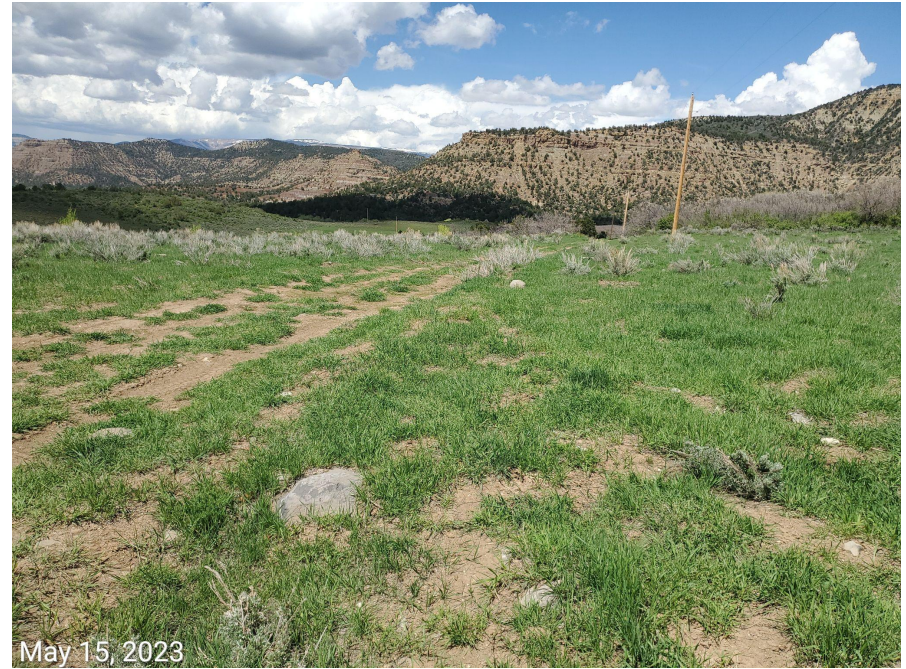
Photo 1: Photos 1-2 taken from the south end of the Location. Photos provide an overview of the Location from west, northwest, northeast to east.

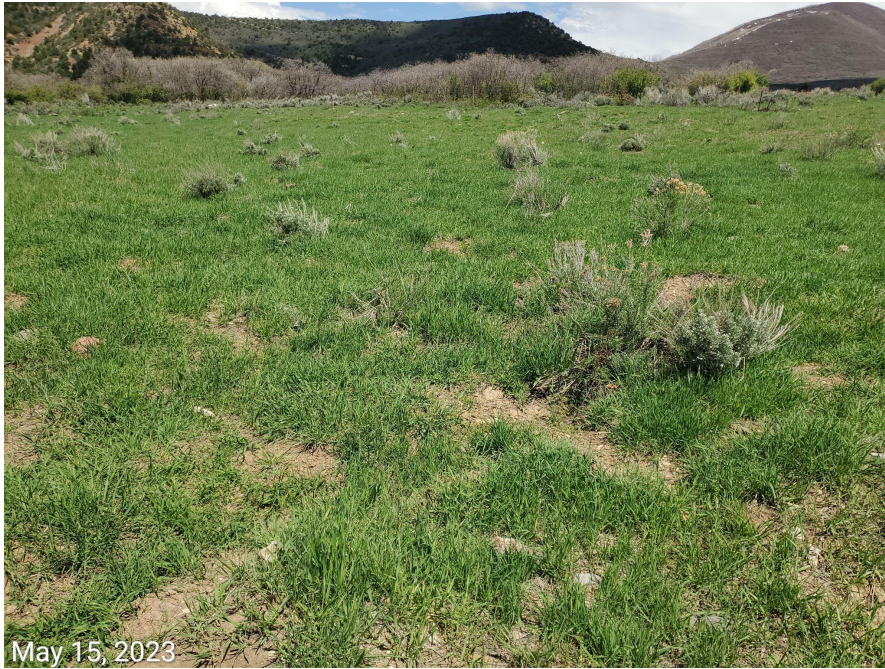
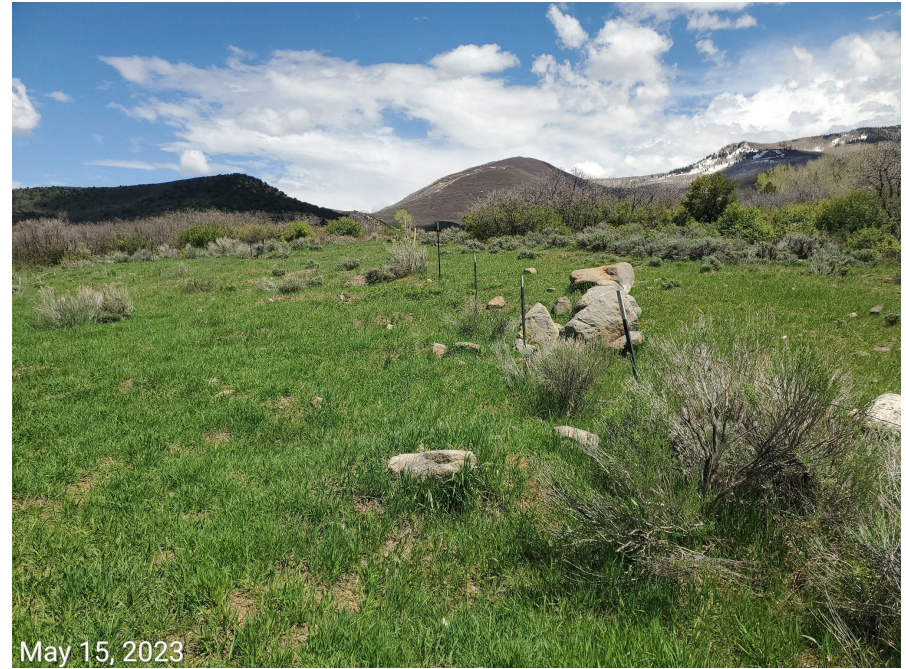
Photo 2: See comments under photo 1.

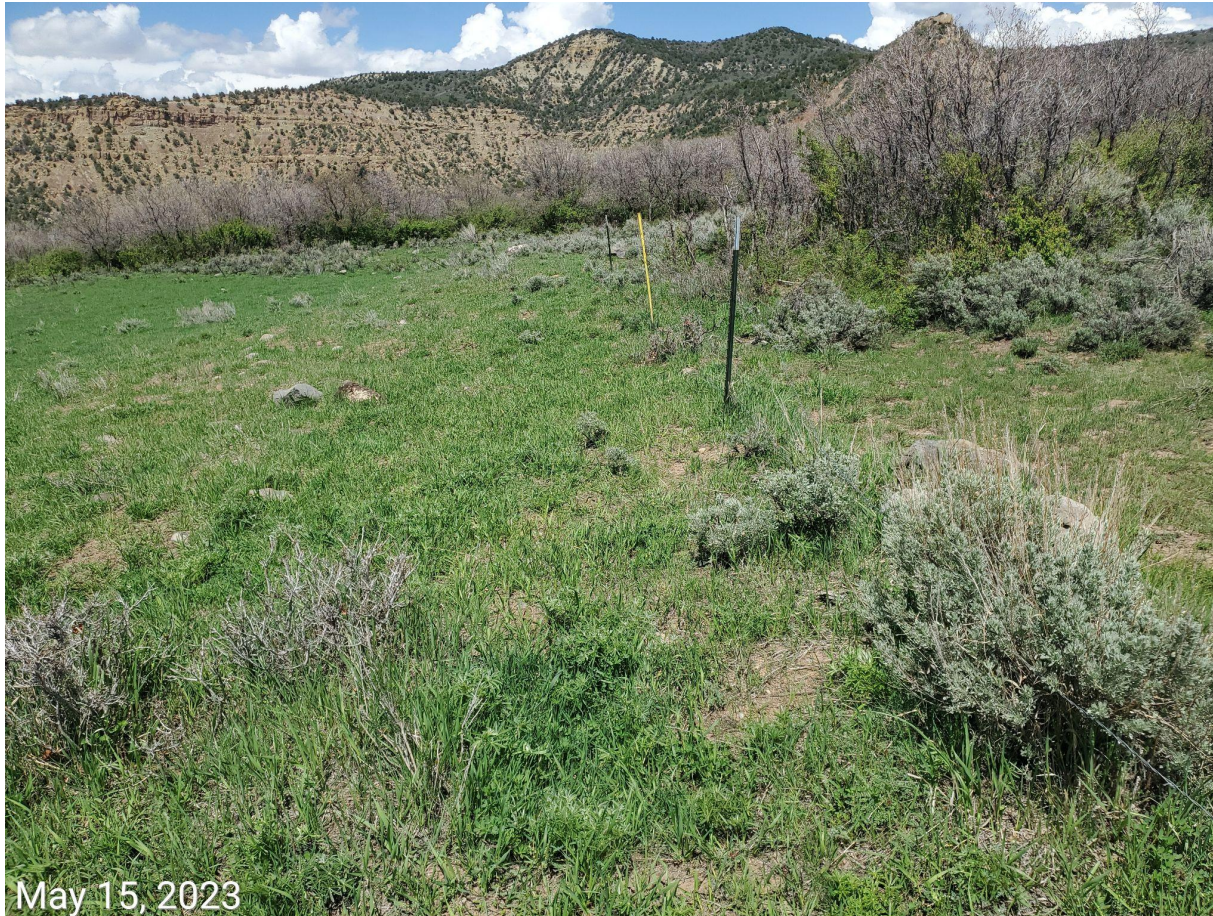
Photo 3: Photo example showing Fence along the perimeter of the Location has not been maintained. Fence requires maintenance or removal.

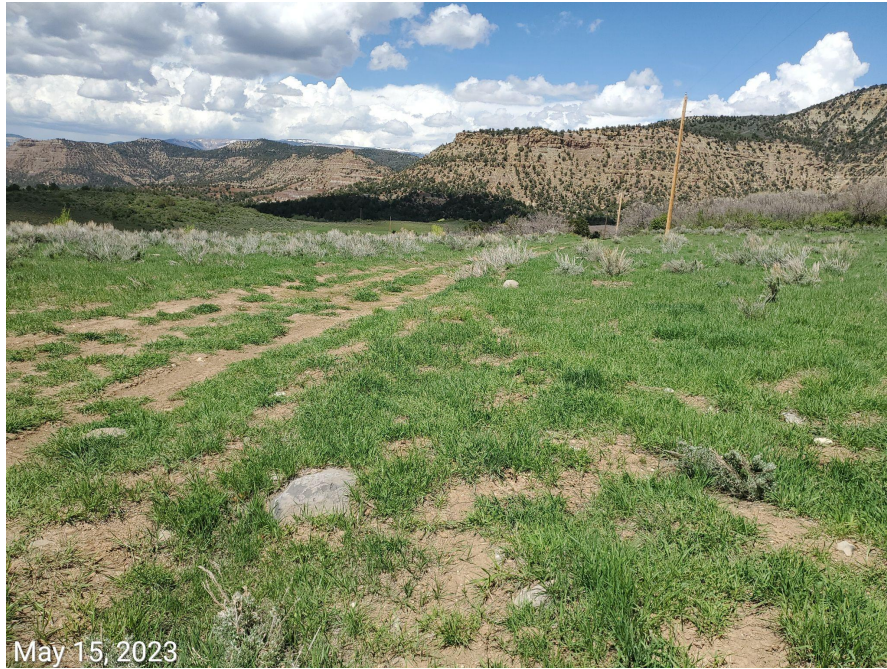
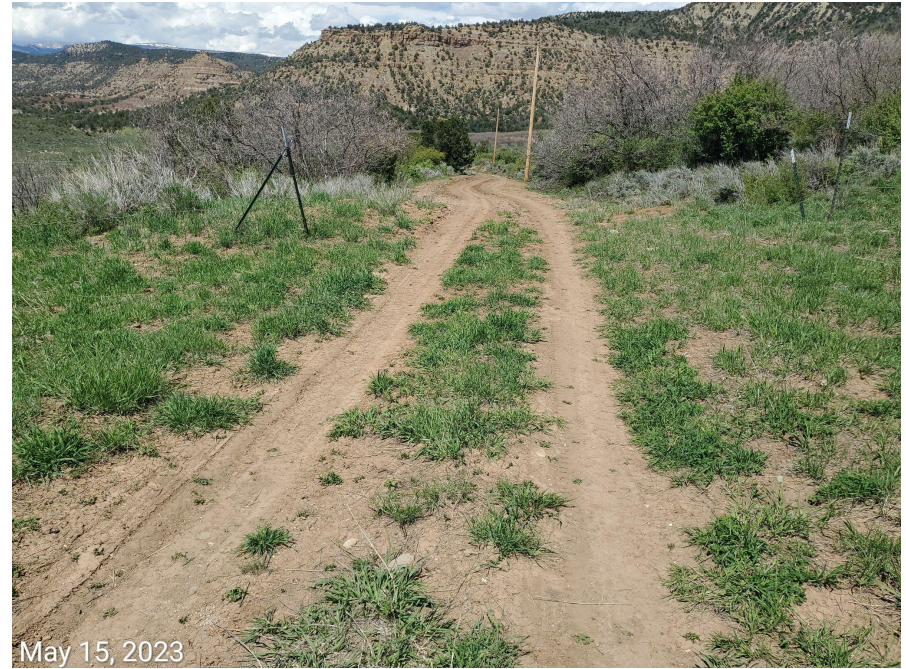
Photo 4: Photos 4-6 examples showing the access road has not been reclaimed in accordance with 1004 requirements.

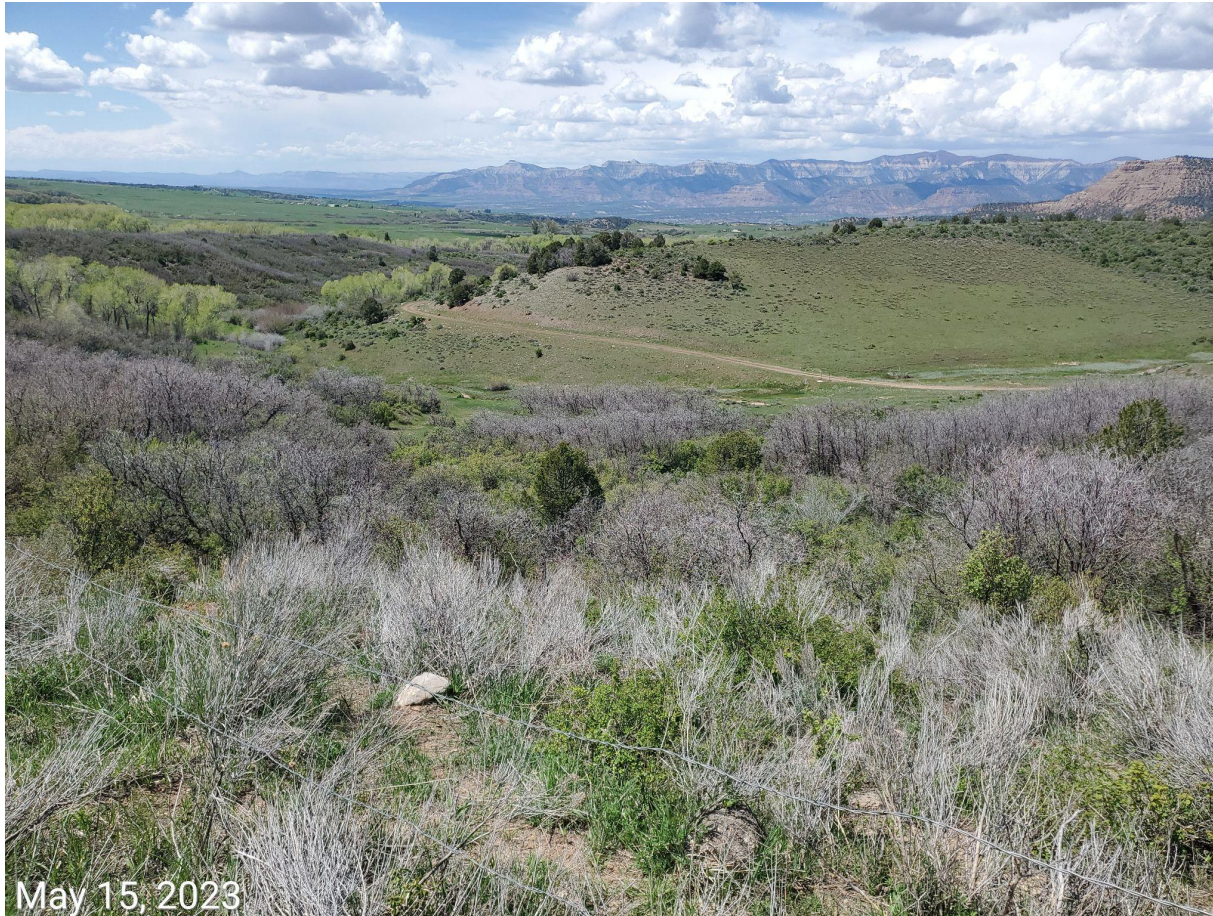
Photo 5: See comments under photo 4.

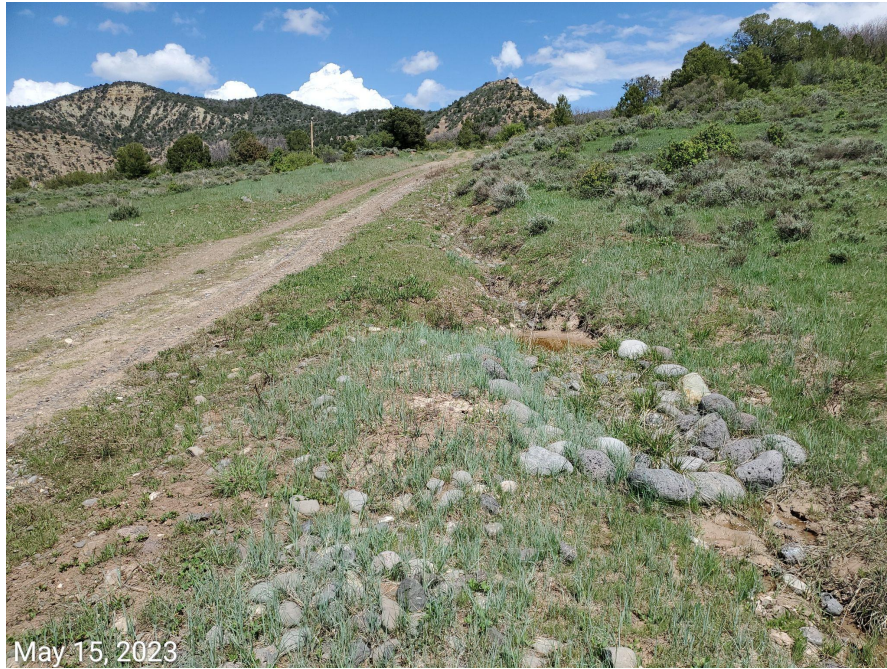
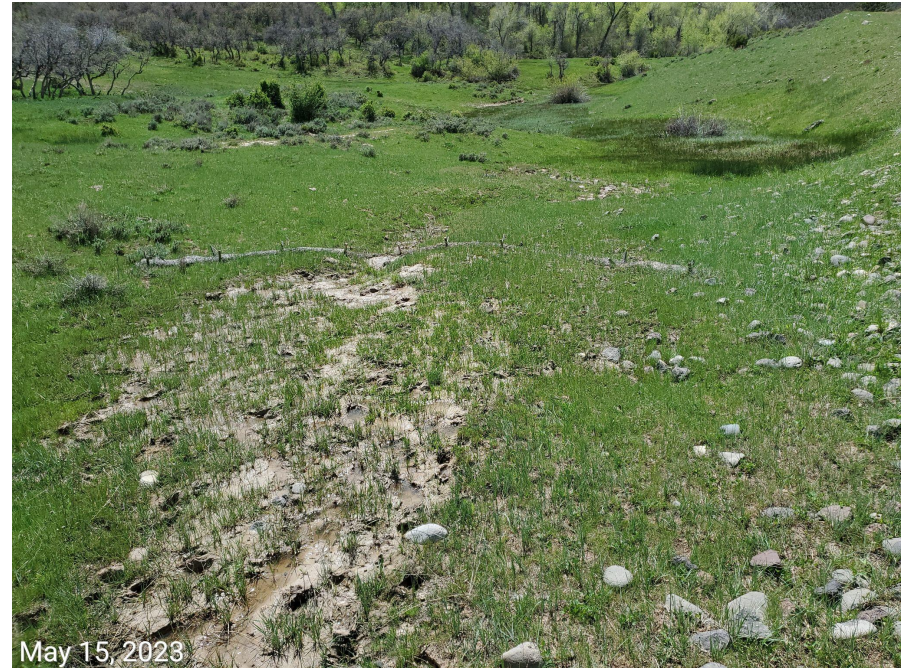
Photo 6: See comments under photo 4. Photo also shows stormwater and erosion control BMPs are insufficient to manage runoff; runoff from access road resulting in sediment deposition within a drainage and wetland area

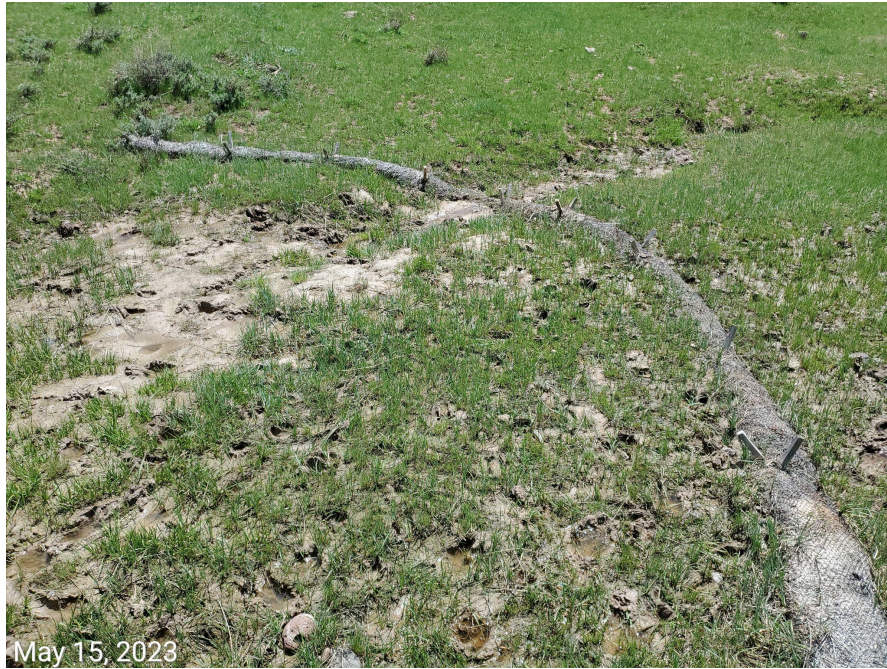
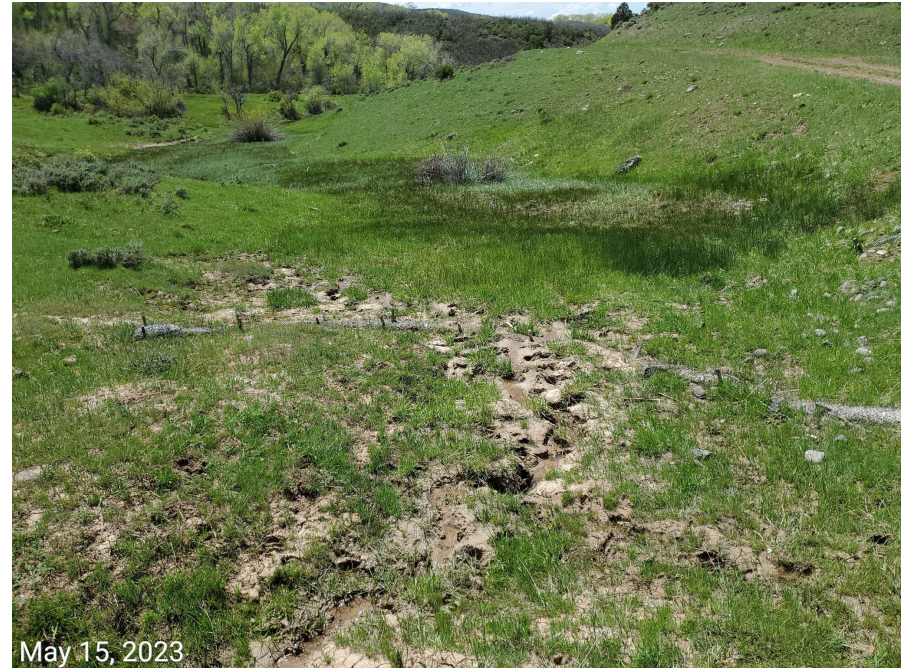
Photo 7: Sediment discharge and deposition from the access road.

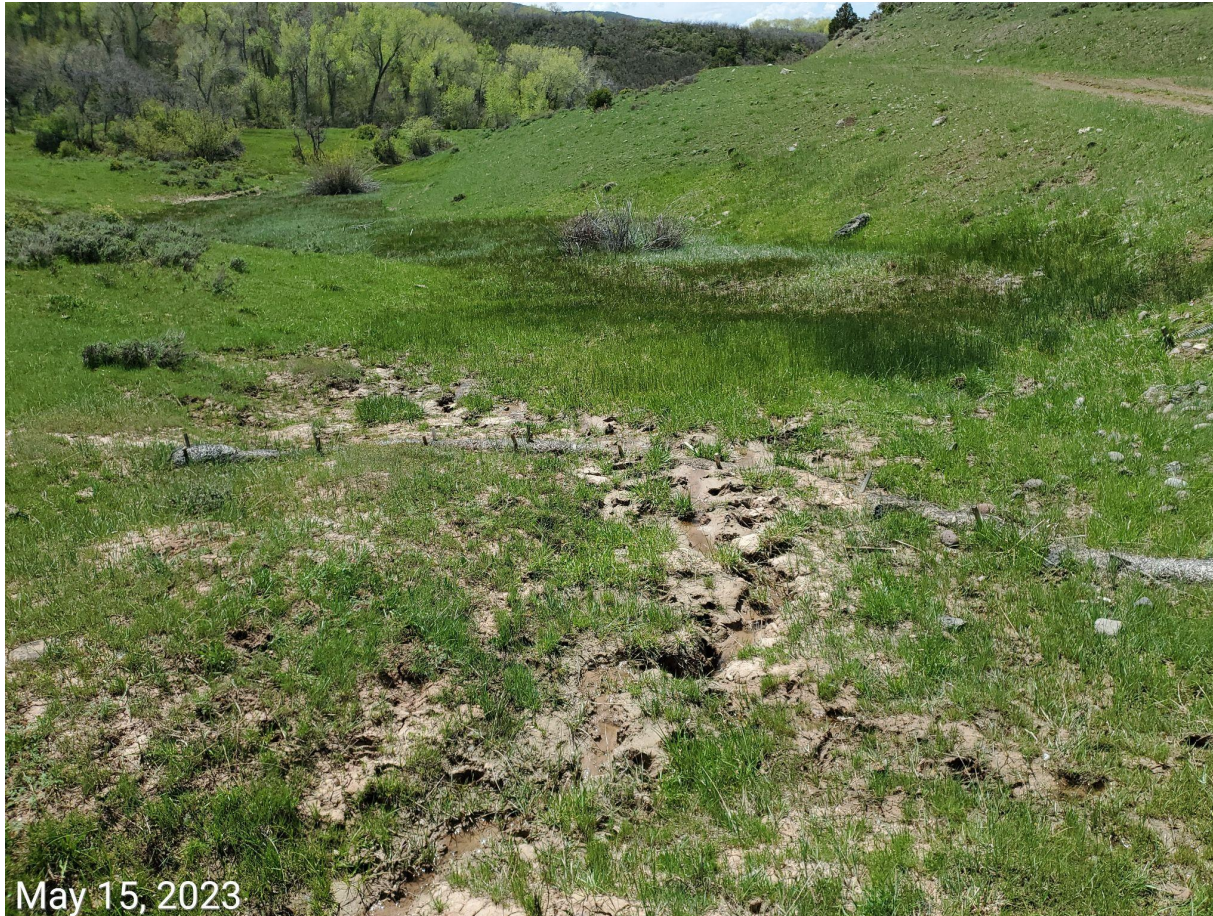
Photo 8: Sediment discharge and deposition from the access road.

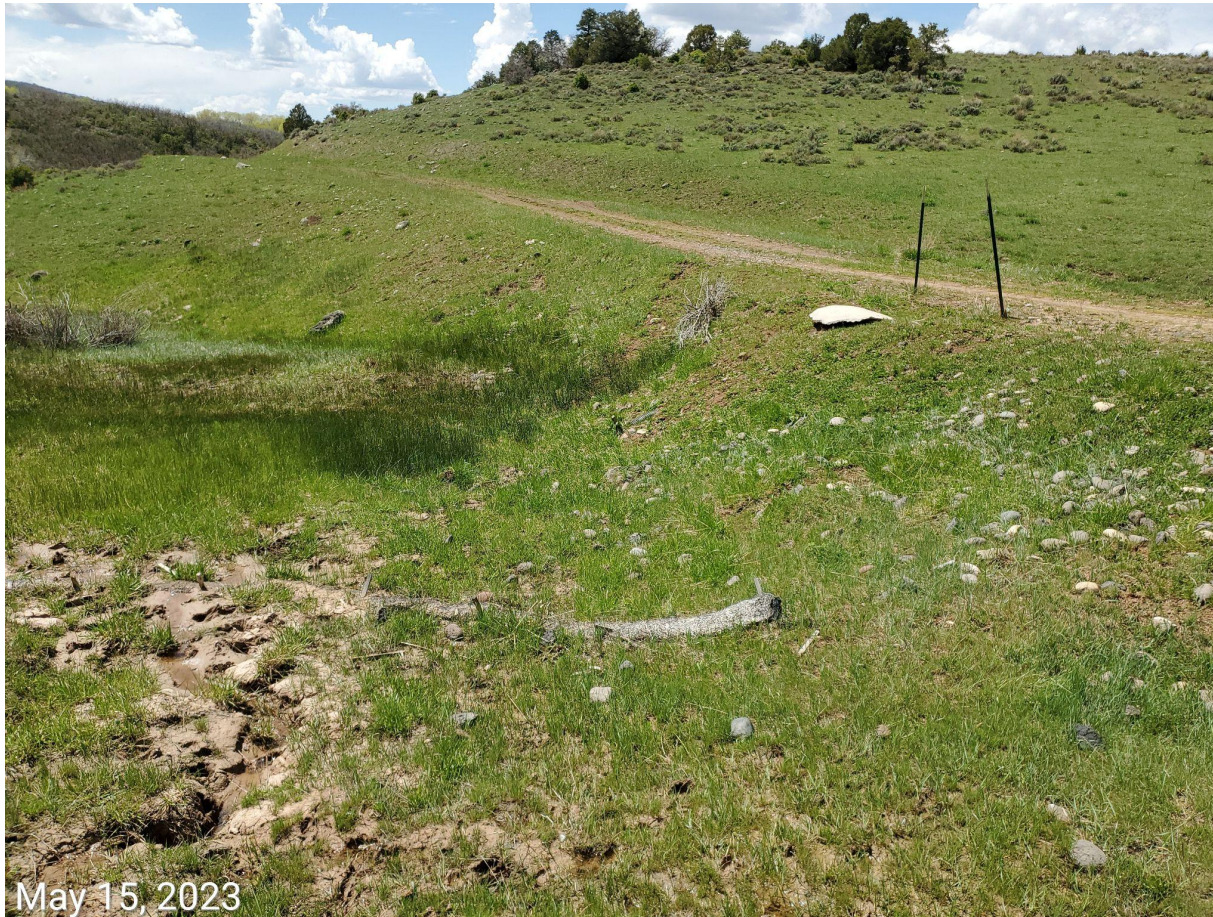
Photo 9: Photo shows access road has not been reclaimed; drainage has not been recontoured/regraded to its original relative grade. Culvert remaining.

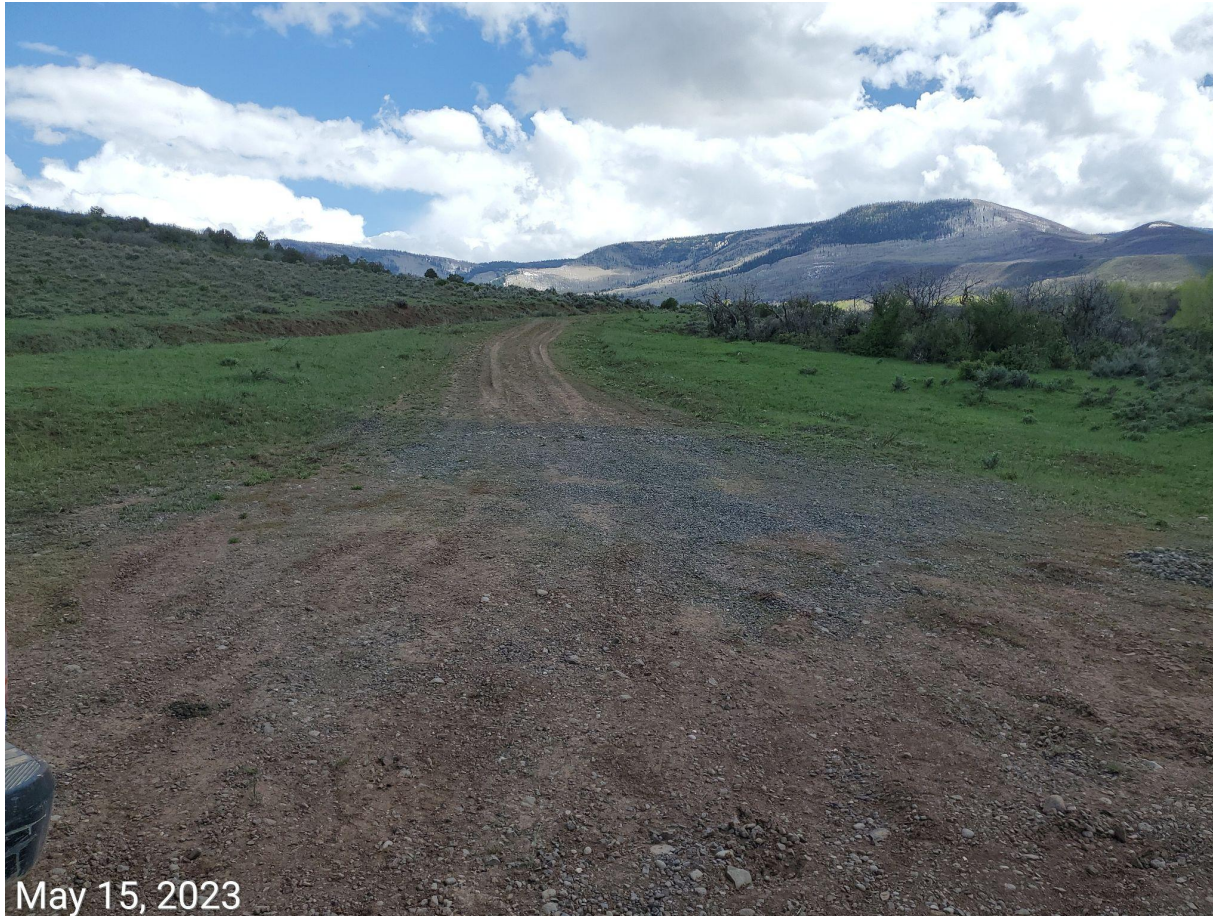
Photo 10: Photo showing the access road has not been reclaimed in accordance with 1004 requirements.
