Inspection Photos

API: 05-061-06076

Operator: CHEMCO INC

Inspection Date: 5/15/2023

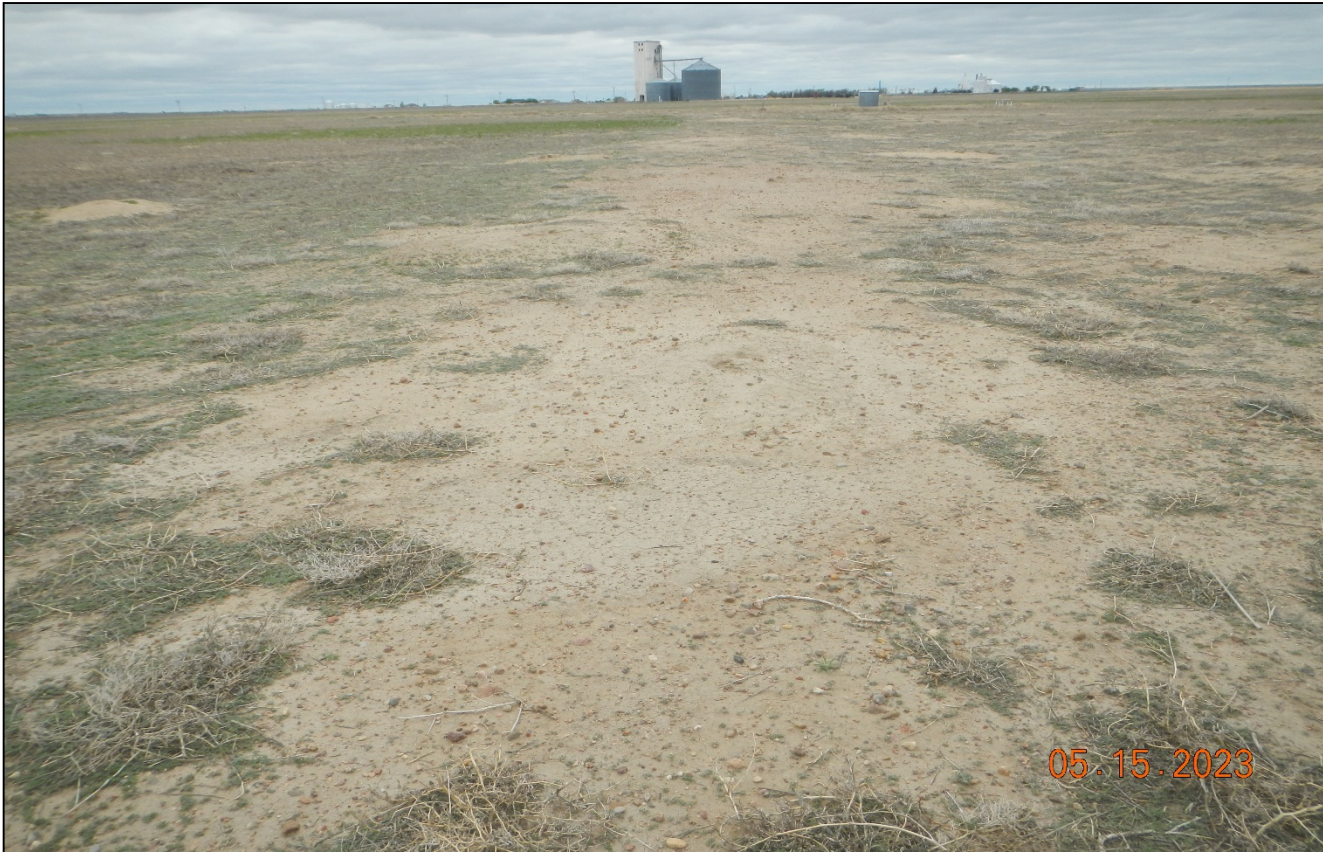
Photo 1. Facing southwest along the access road which has not been reclaimed. The crop has not re-established and there are undesirable weeds.

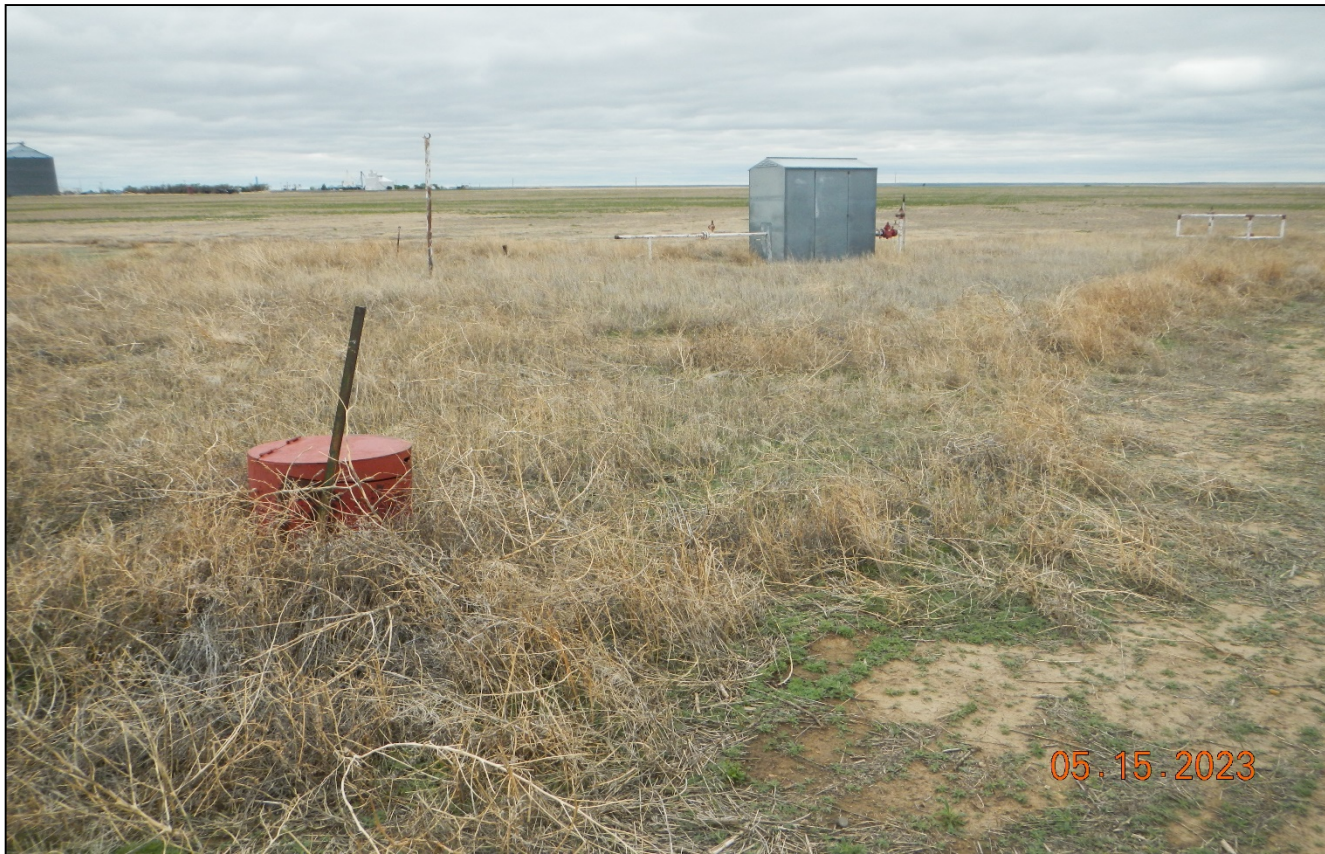
Photo 2. Facing southwest at the location. There is equipment that still remains at the location. Previous corrective action not completed.

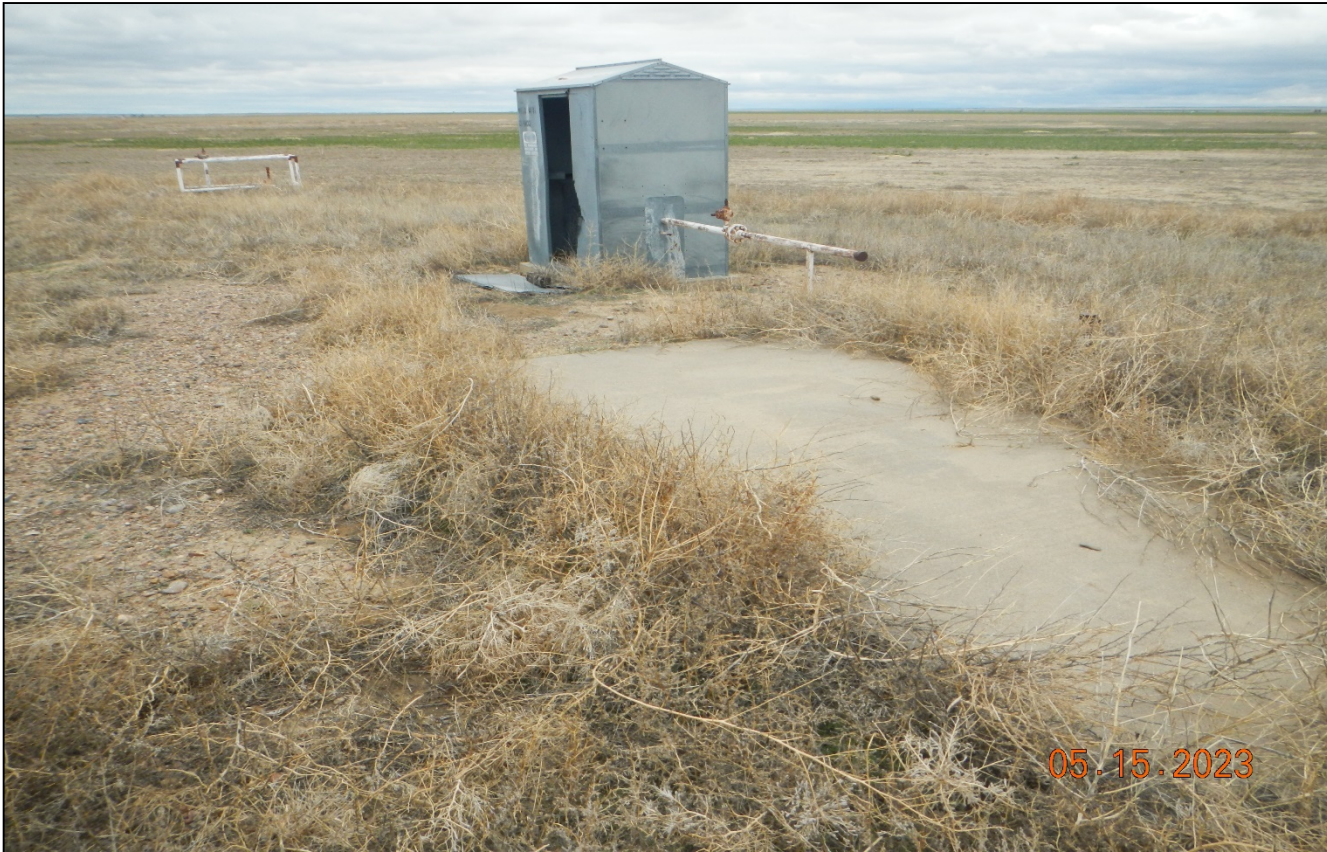
Photo 3. Facing northwest at the location. There is equipment and a cement pad that still remains at the location. Previous corrective action not completed.

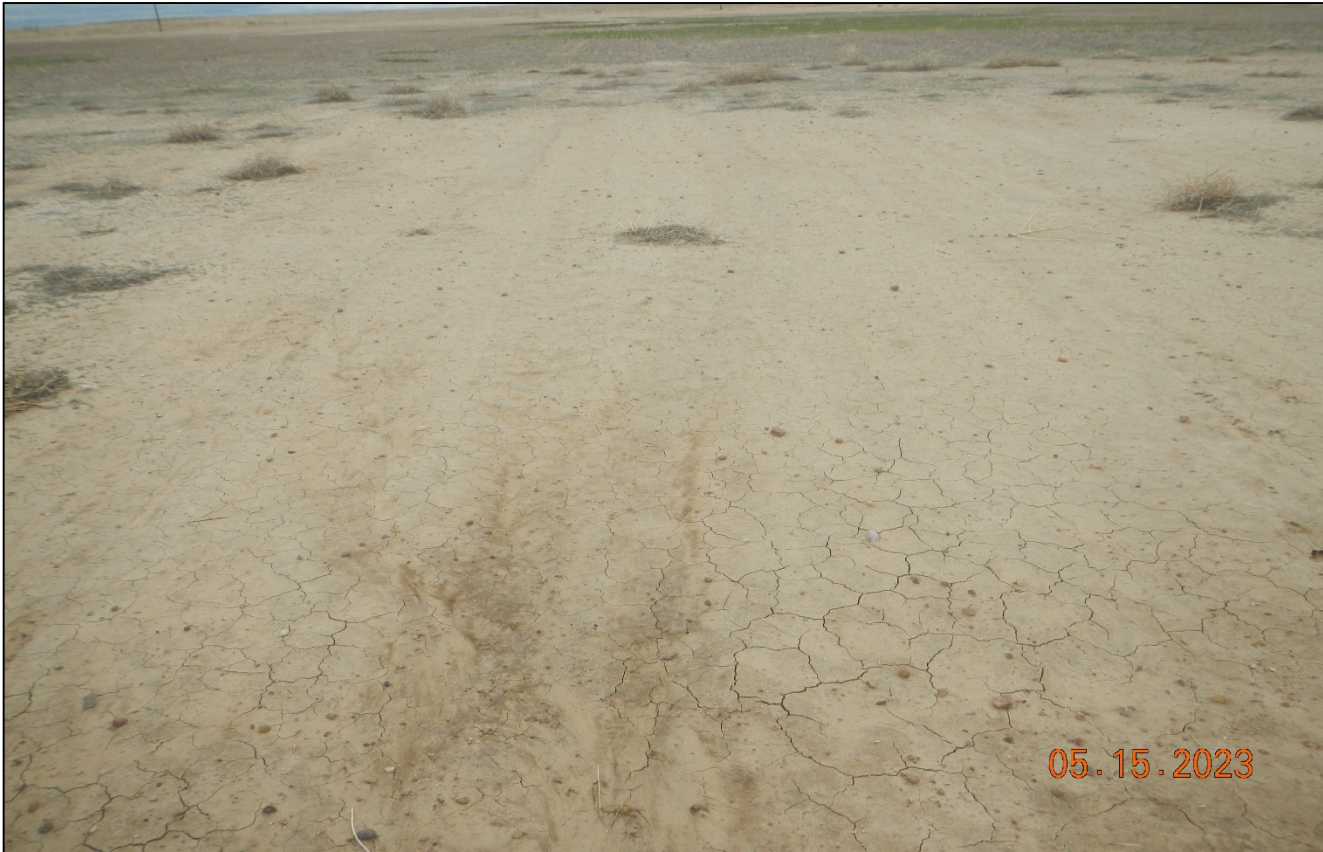
Photo 4. Facing east at the location. This area approx. 75'x75' is bare of vegetation with no crop growth.

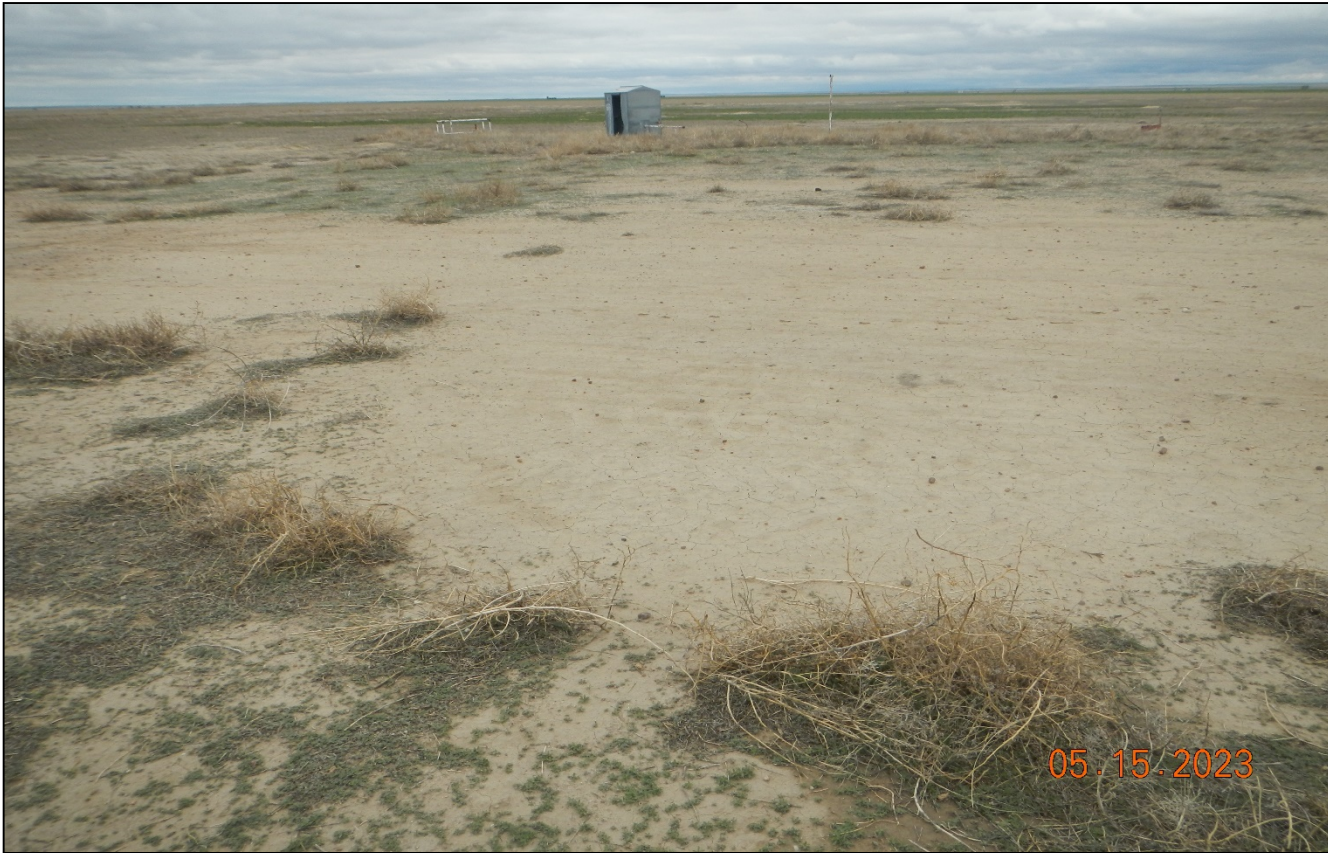
Photo 5. South side of the location facing north. This area approx. 75'x75' is bare of vegetation with no crop growth.

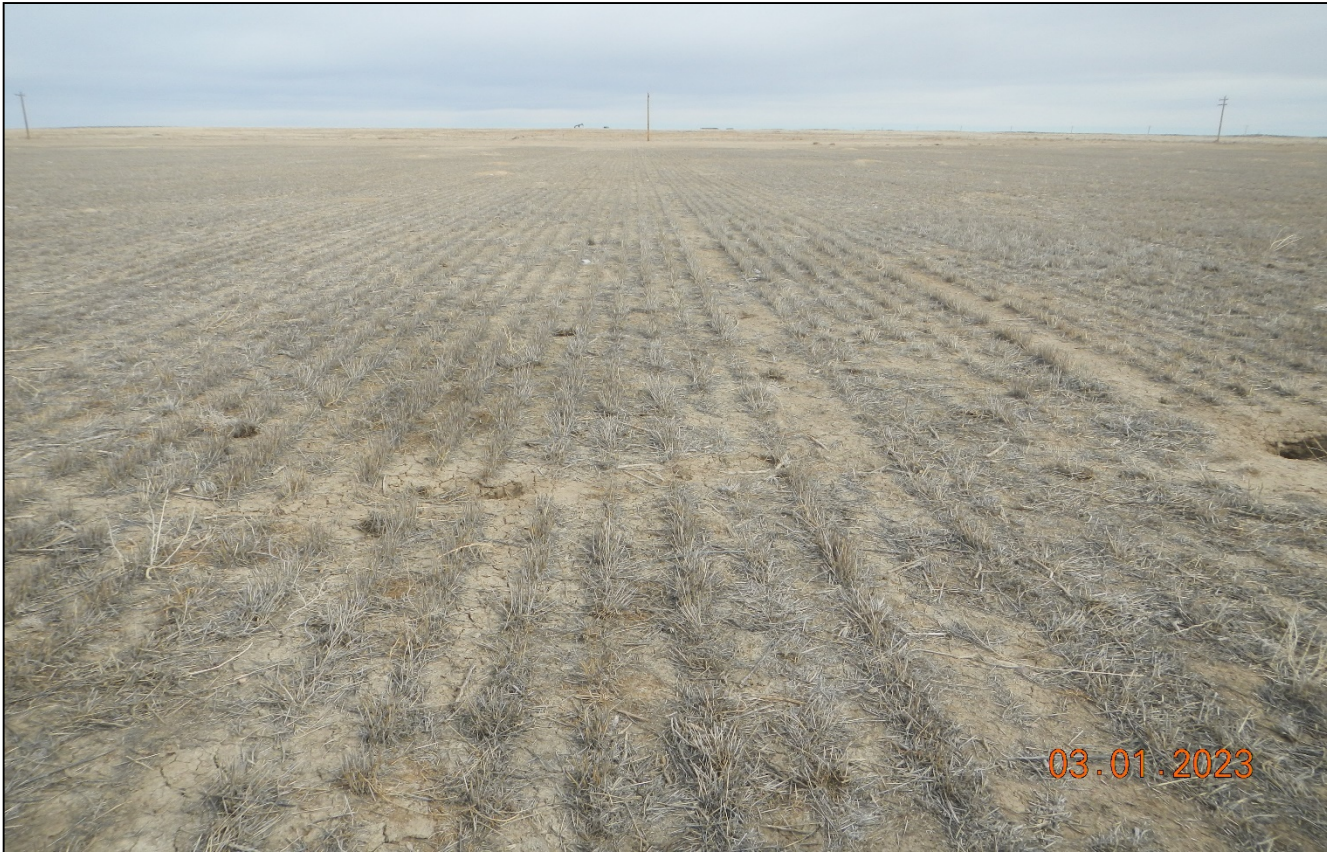
Photo 6. Facing east toward the surrounding undisturbed crop field. Wheat stubble is shown to be uniformly established.
