Interim Reclamation and Stormwater Inspection

Operator: PADCO LLC - 24500

Location ID: 317037

Inspection Photos
Location Name: Fassler 1
Location ID: 317037

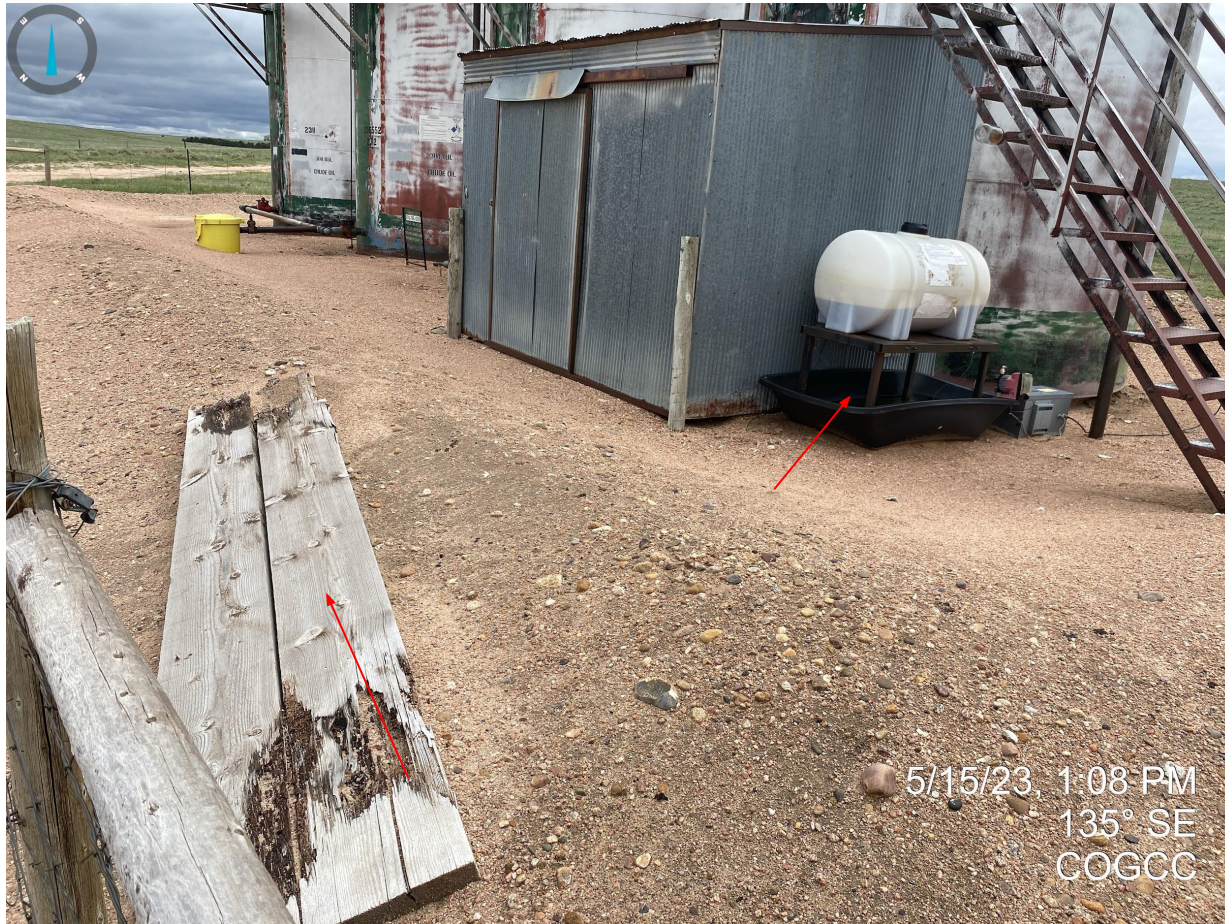
Photo 1. Wood debris will need to be removed; day tank near shed does not appear to have wildlife exclusion device installed.

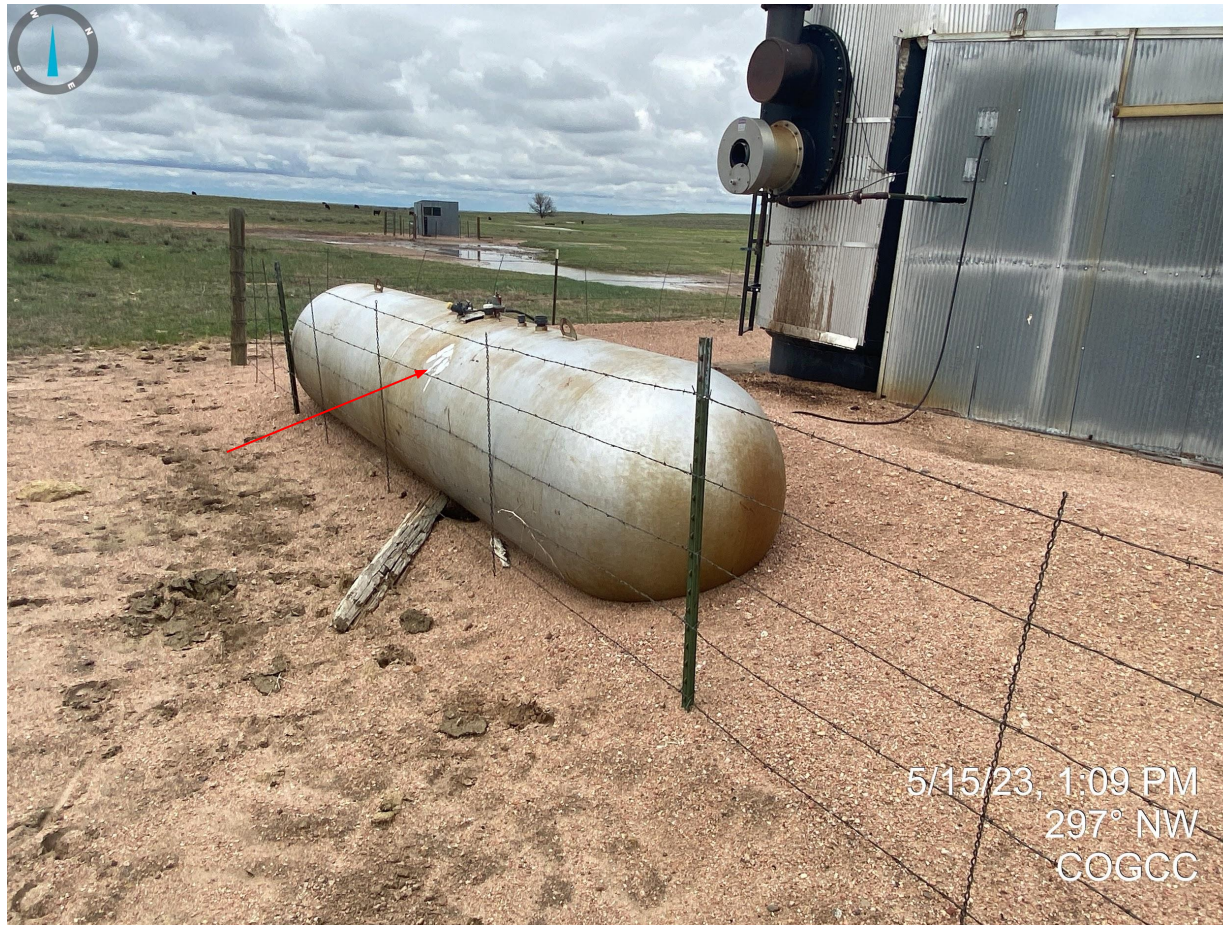
Photo 2. NFPA placards are faded, peeling, and/or not legible and will need to be replaced.

Photo 3. See comments in Photo 2.

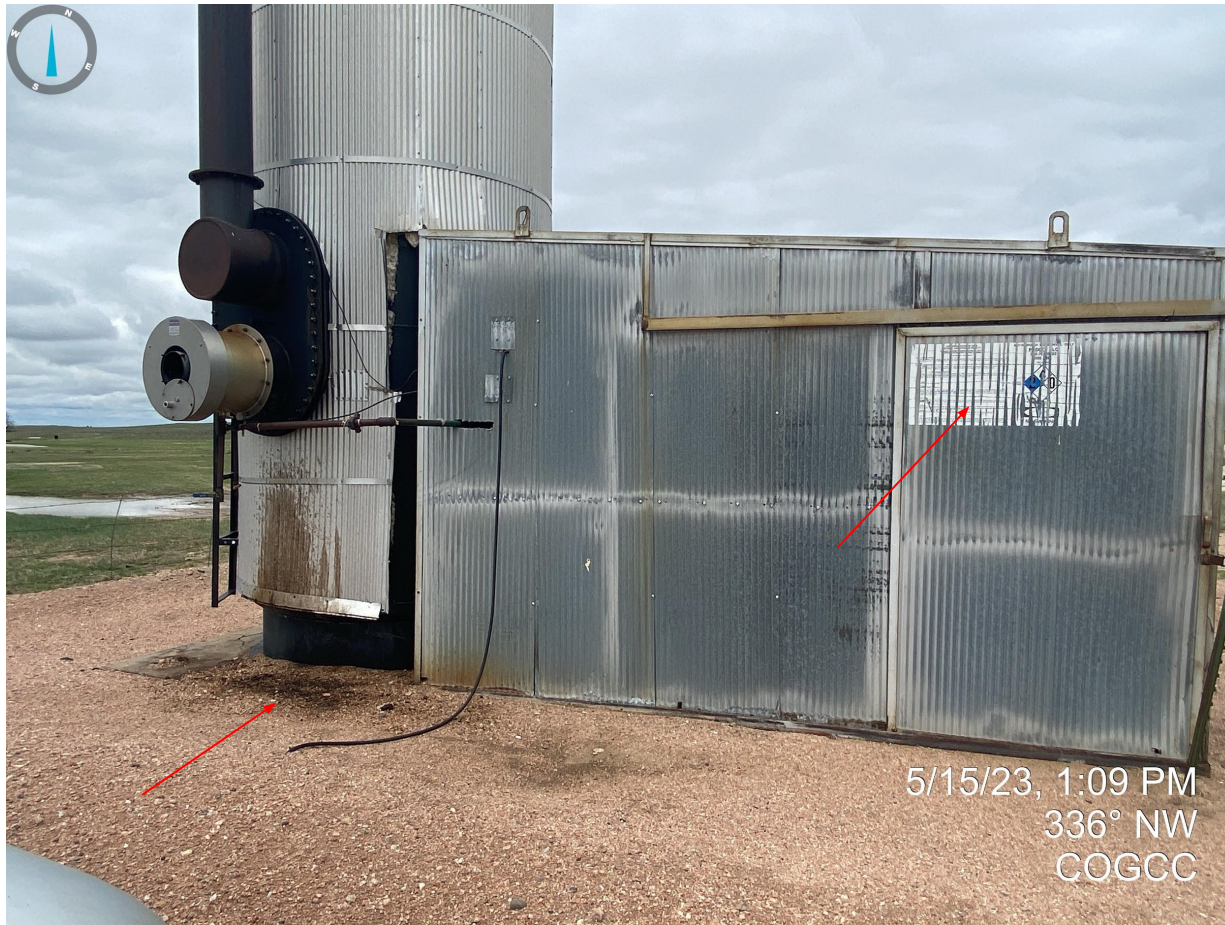
Photo 4. Stained soil will need to be properly cleaned up and disposed of. See comments in Photo 2 for label/placard.

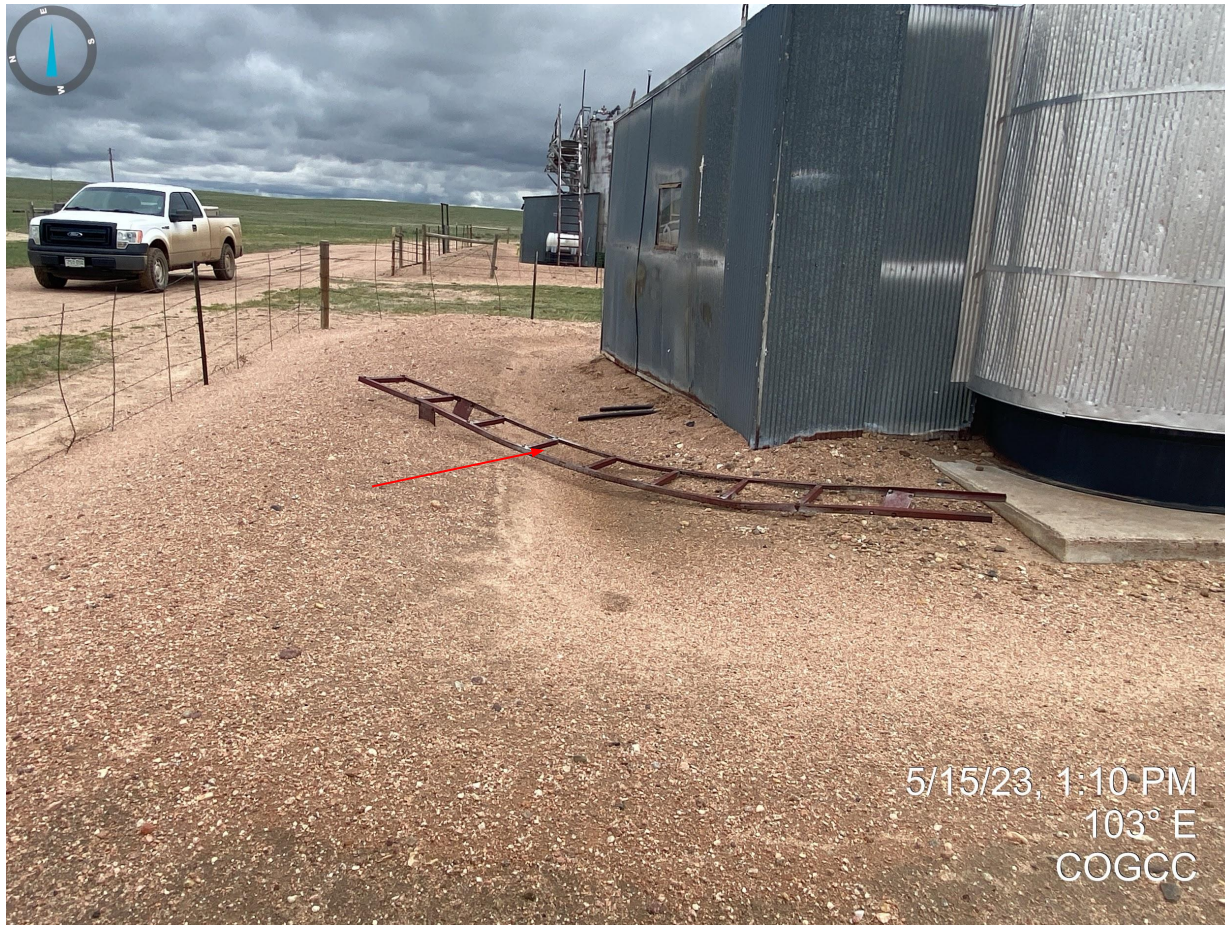
Photo 5. Unused equipment will need to be removed.

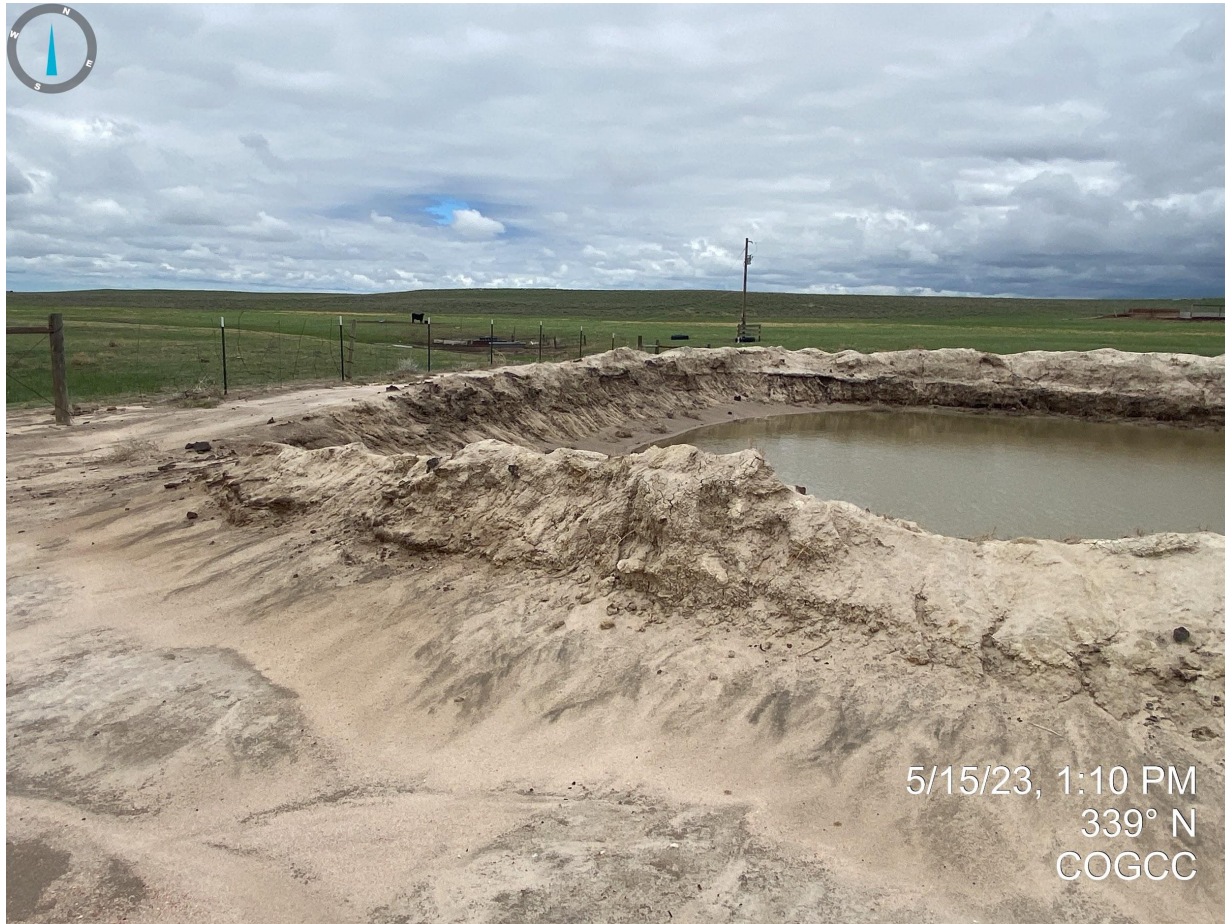
Photo 6. Pit berms/walls do not appear to be properly stabilized as unconsolidated material and rill erosion was evident throughout. As a result, sediment laden stormwater exited outside of the fenced areas onto adjacent lands. More robust stormwater BMPs will need to be implemented to stabilize the material.

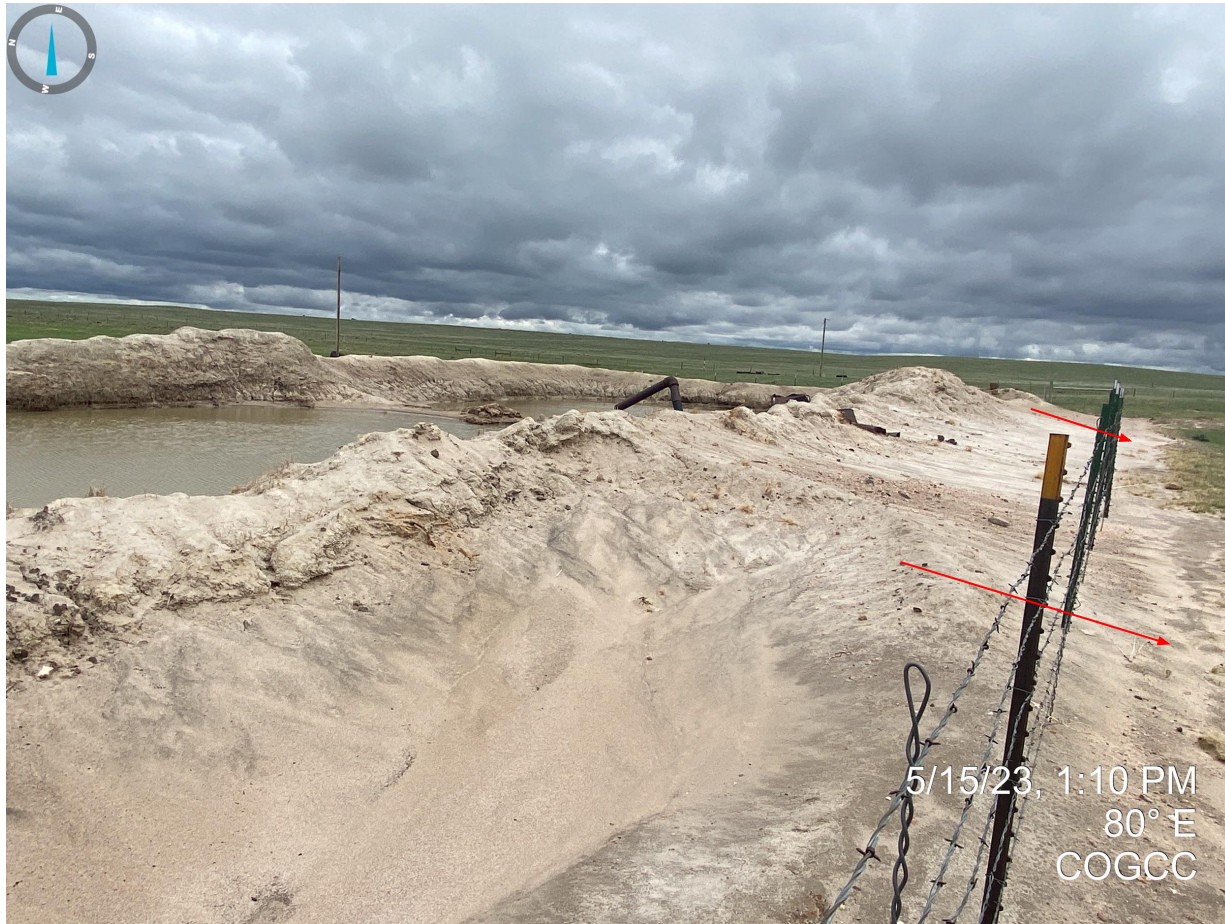
Photo 7. See comments in Photo 6.

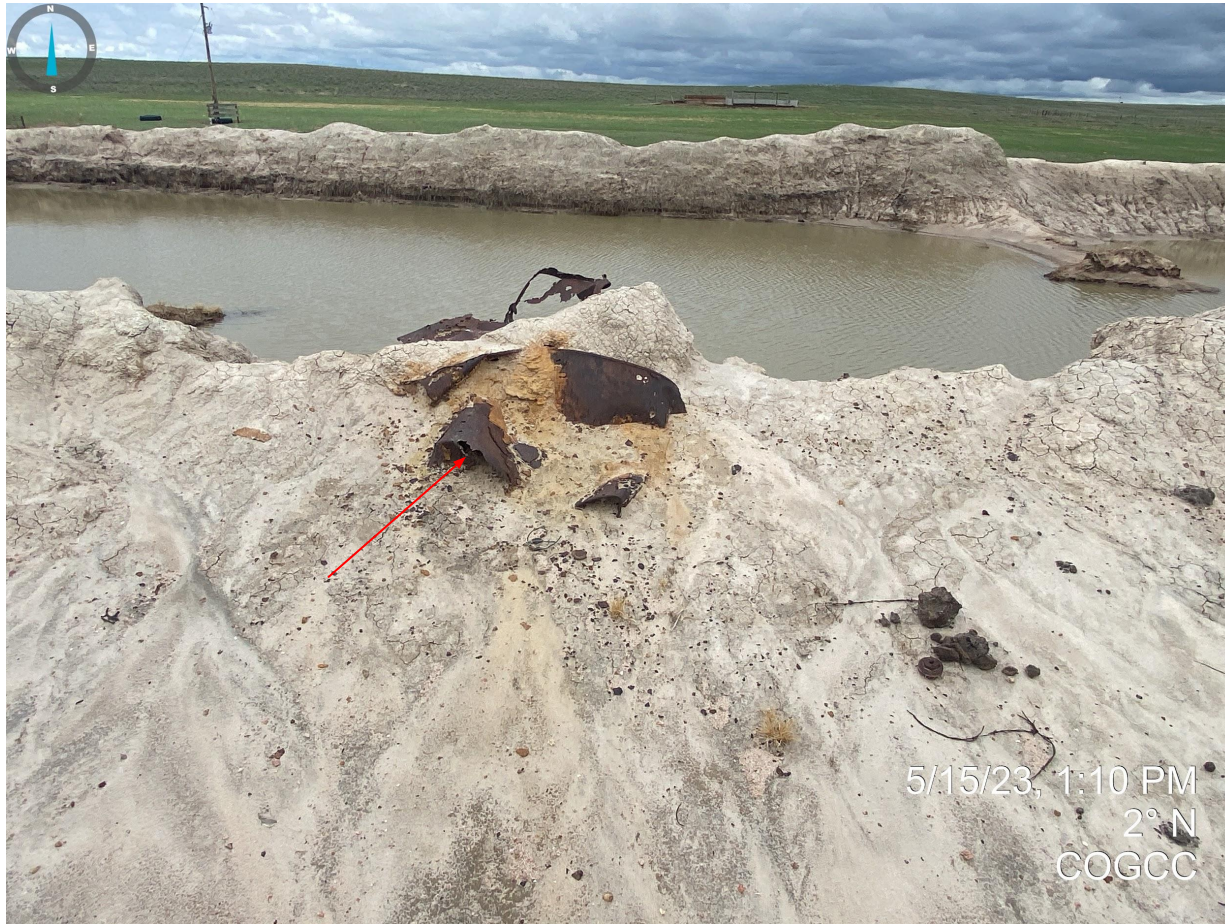
Photo 8. Metal debris observed buried in pit walls will need to be removed.

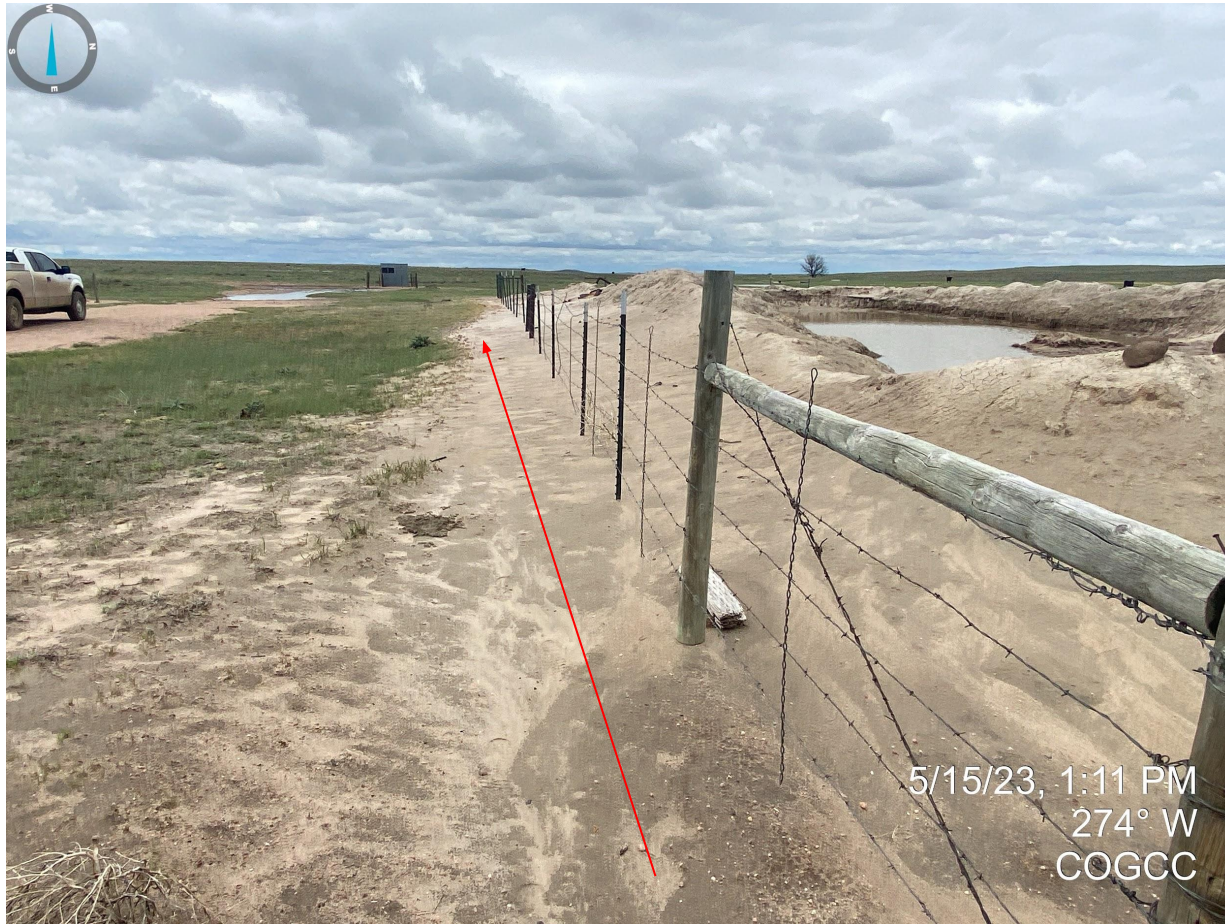
Photo 9. See comments in Photo 6.

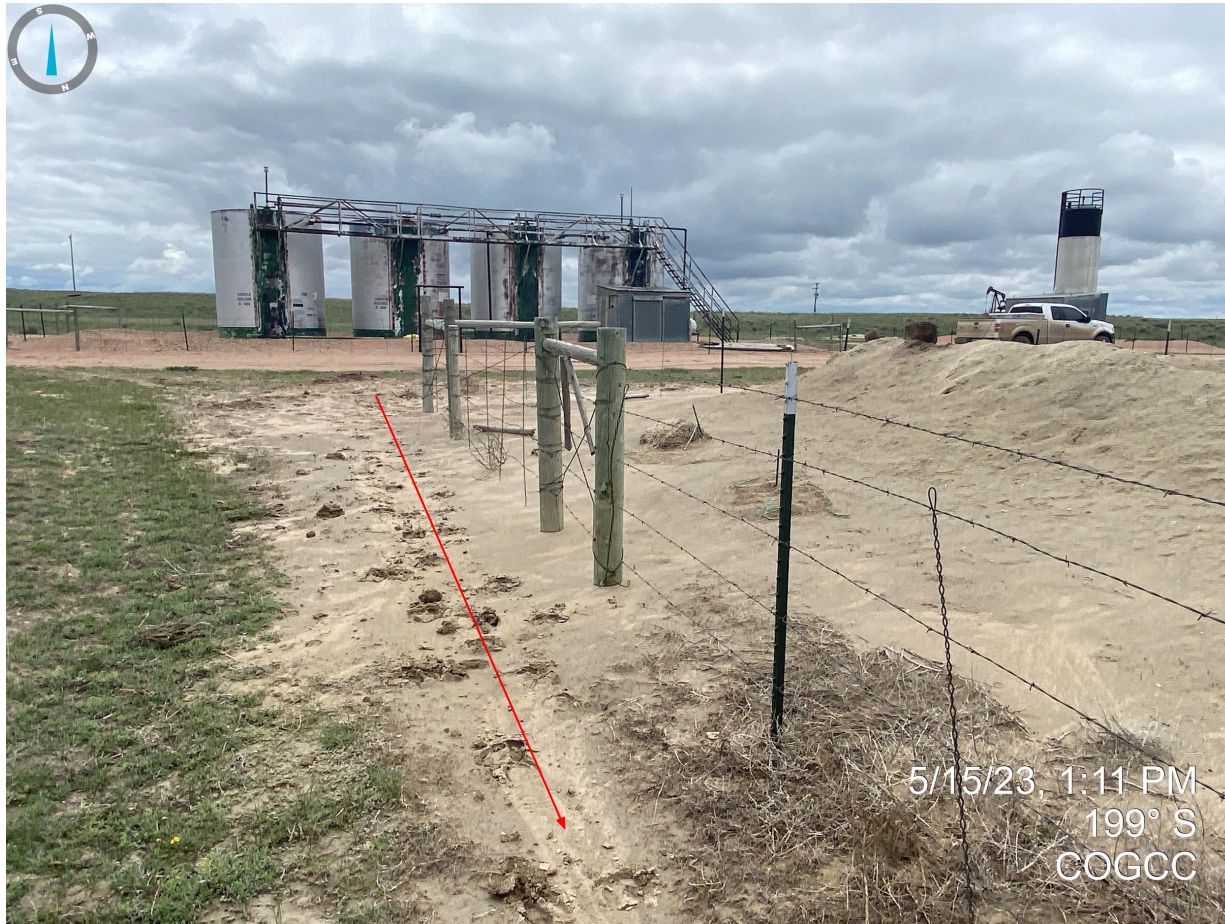
Photo 10. See comments in Photo 6.

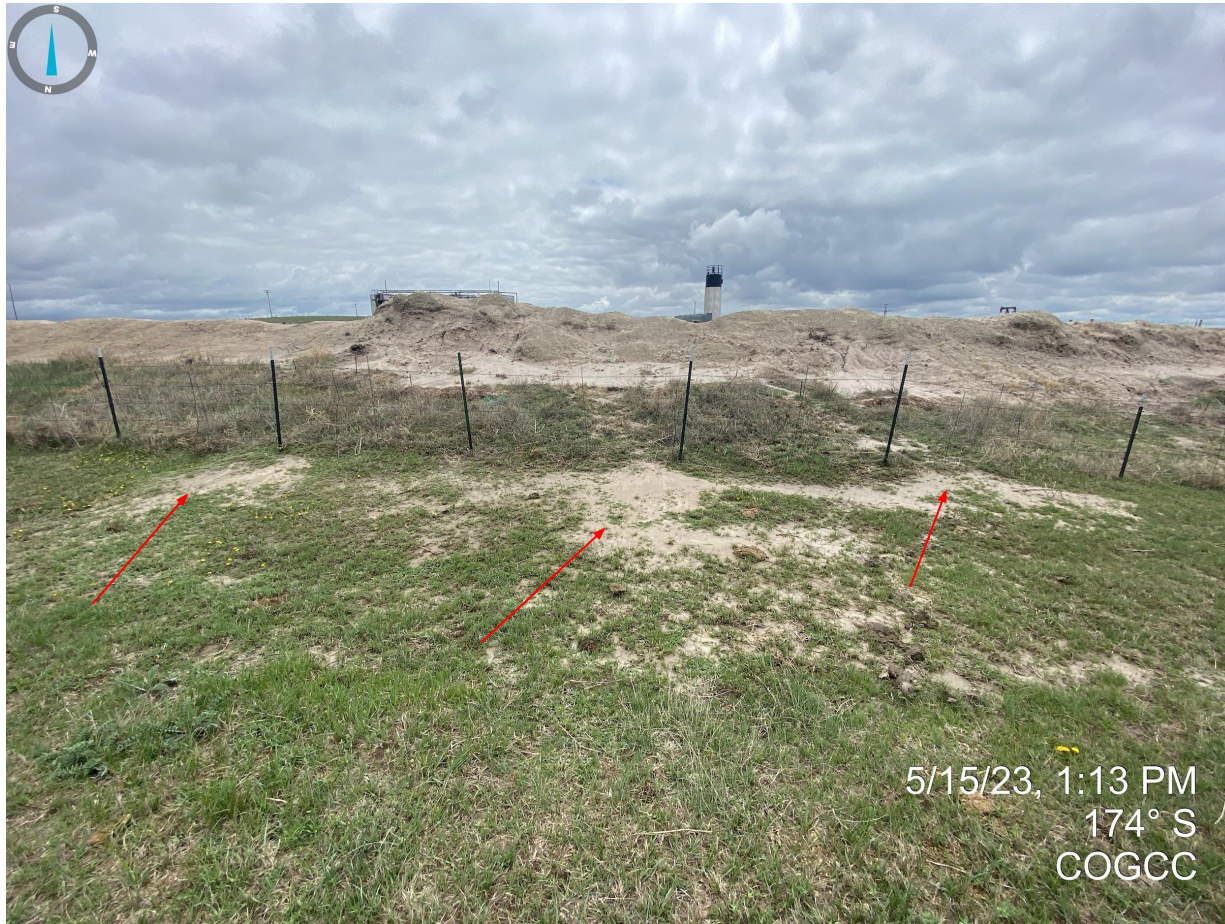
Photo 11. See comments in Photo 6.

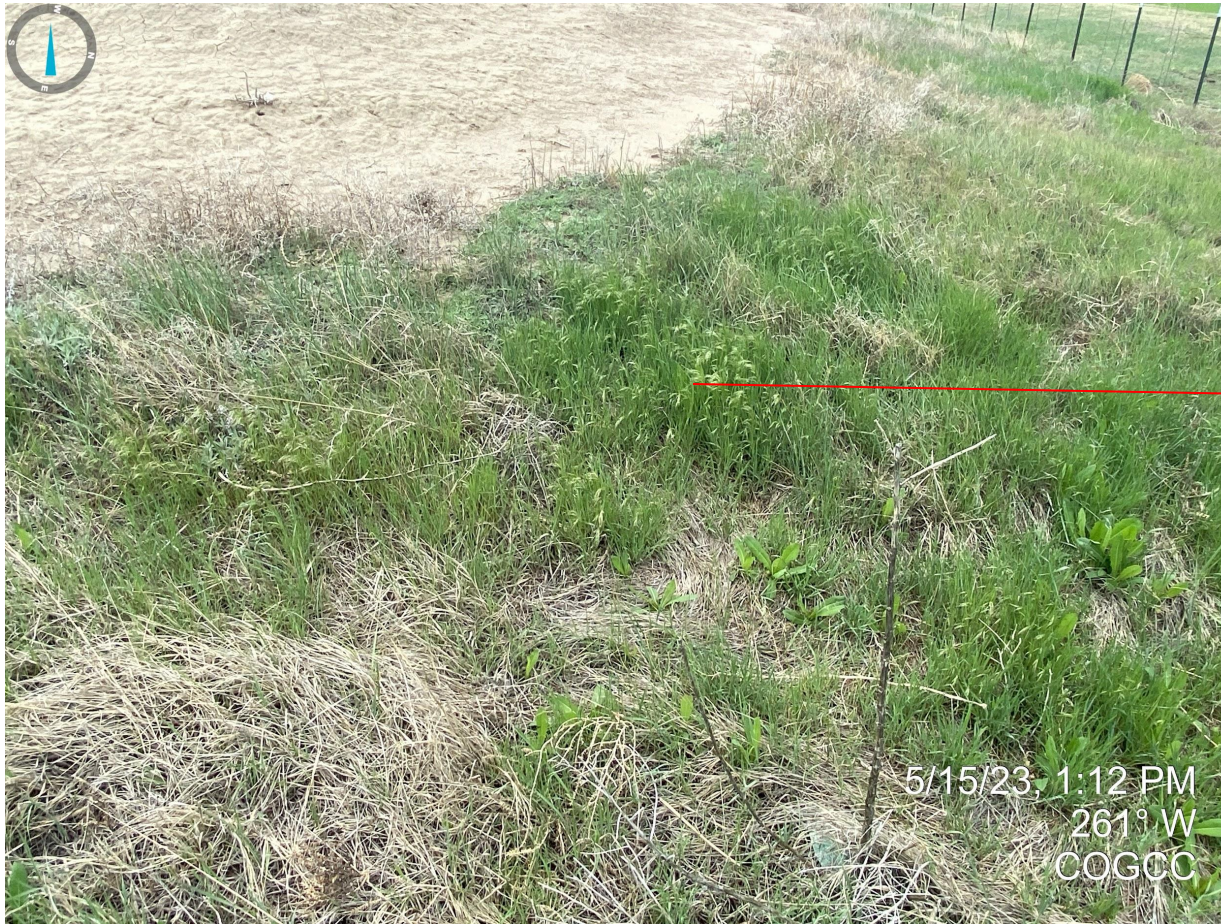
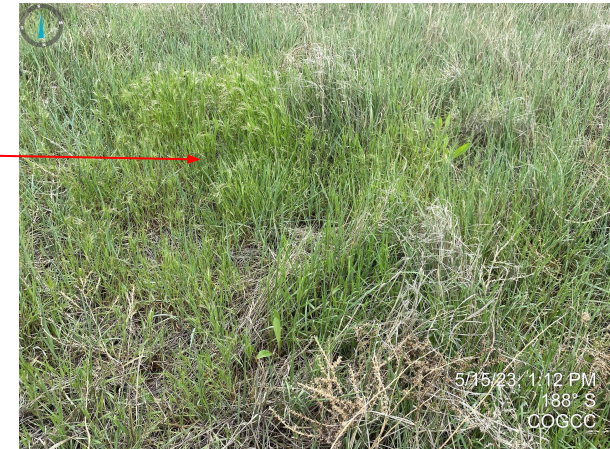
Photo 12. Cheatgrass, a Colorado List C Noxious Weed will need to be managed for immediately to prevent spread onto adjacent rangeland. Other undesirable vegetation (e.g. kochia and russian thistle) was observed throughout the location and will also need to be managed.

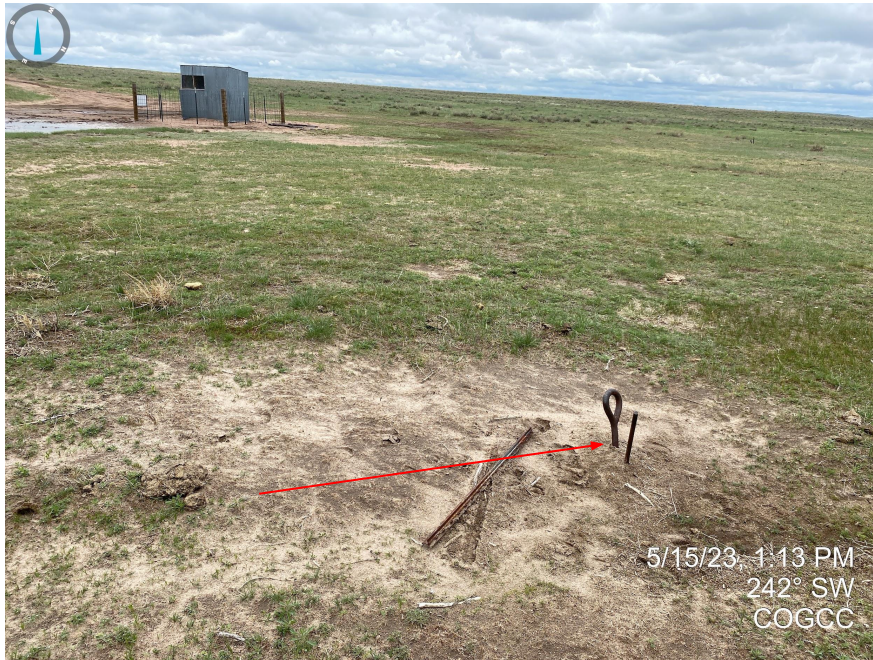
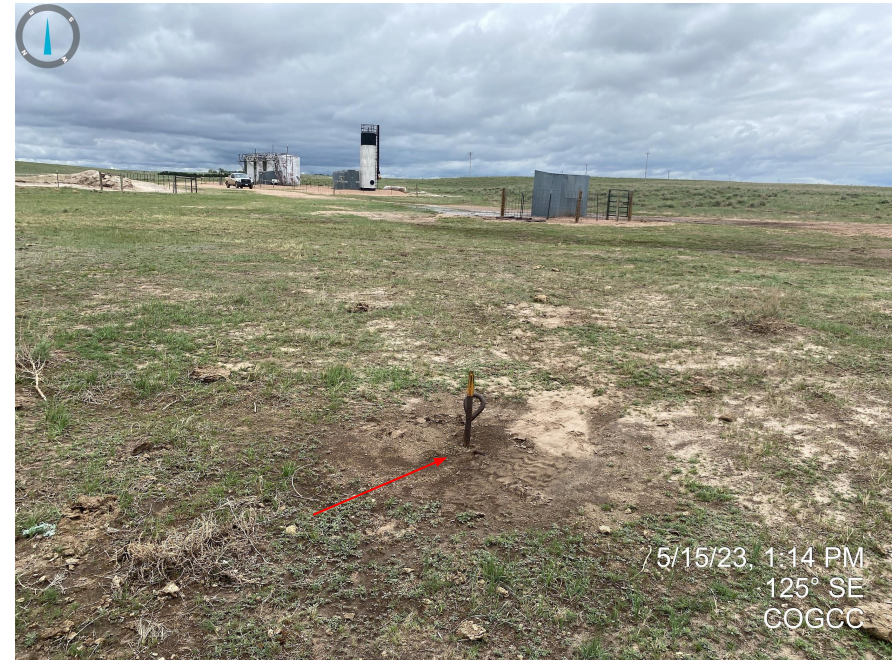
Photo 13. Guy line anchors do not appear to be properly marked.

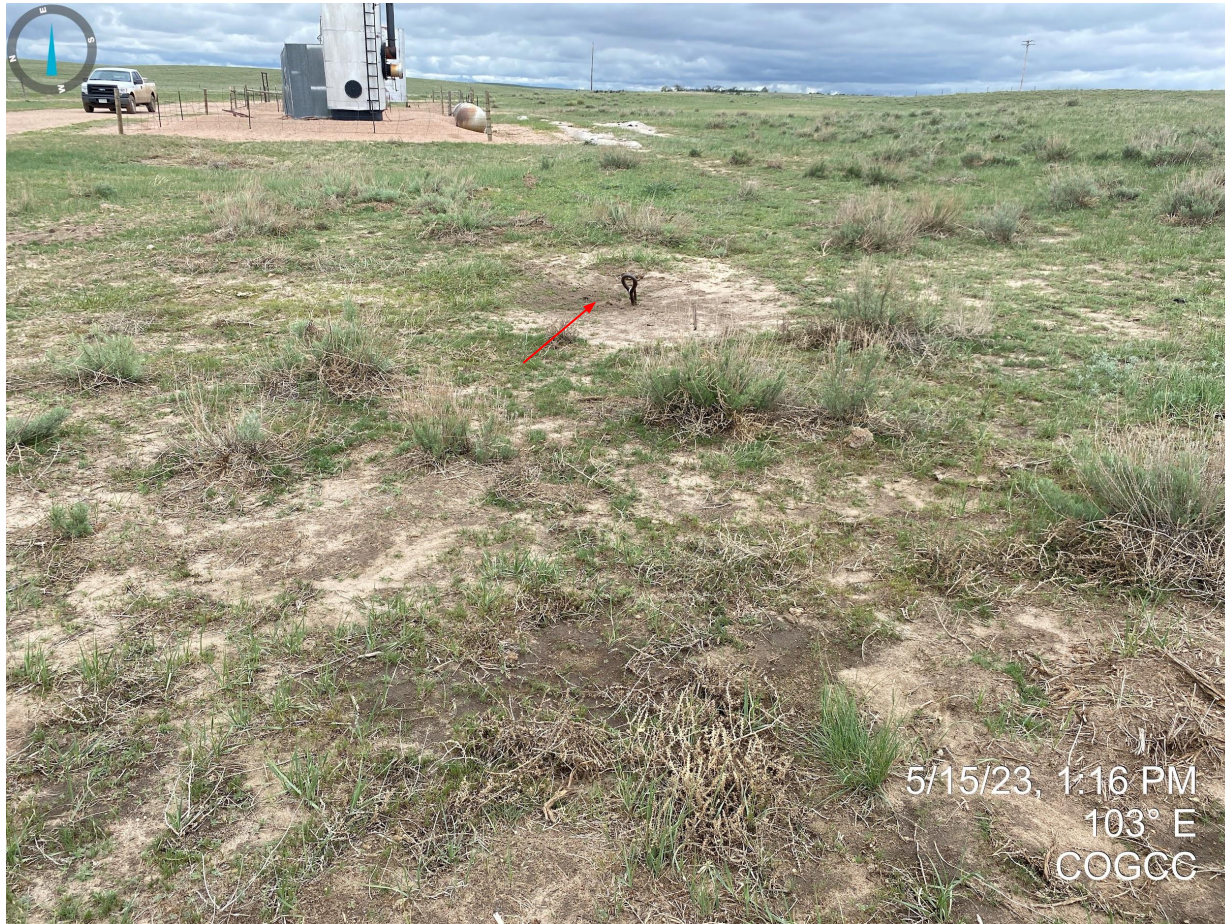
Photo 14. See comments in Photo 13.

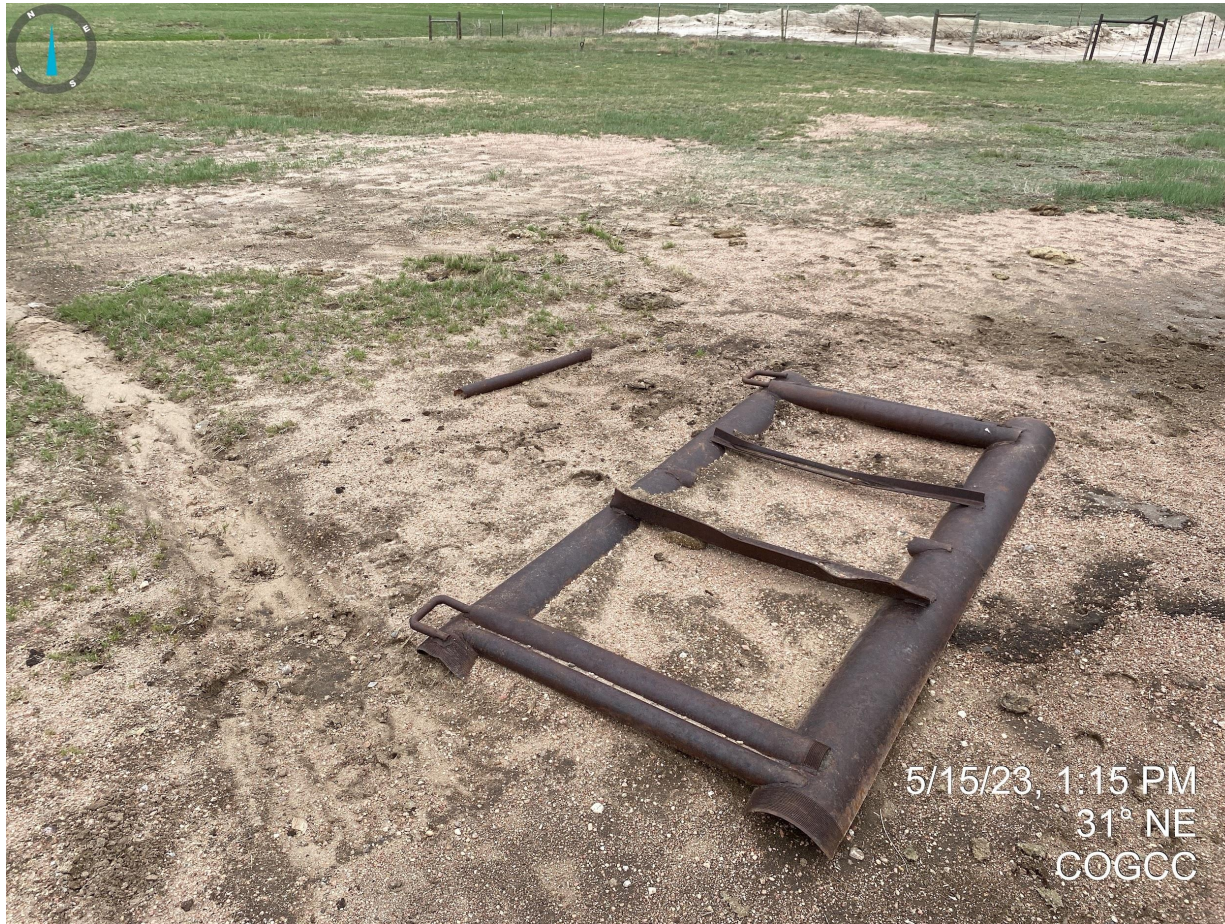
Photo 15. Road drag/maintainer observed being stored on location. Equipment cannot be stored on location.
