TEP ROCKY MOUNTAIN LLC, FEDERAL-66S96W/35NESE

Location #335148

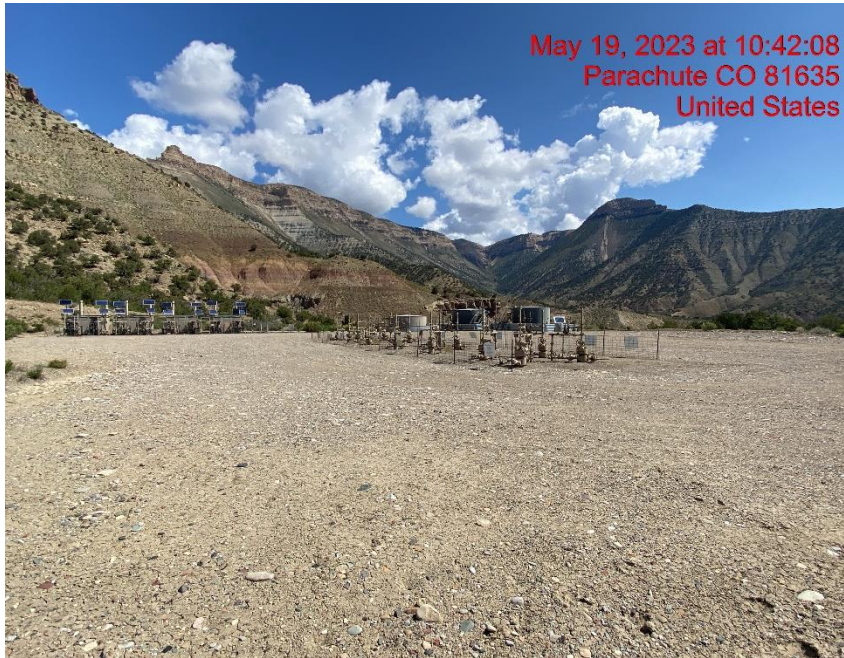
SW Corner of Location – Photo #03610

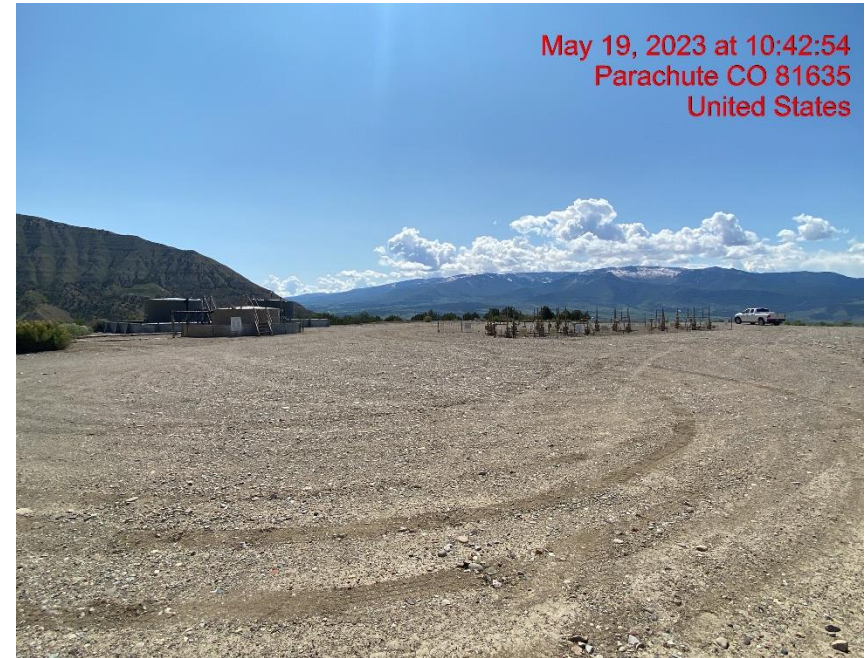
NW Corner of Location – Photo #03611

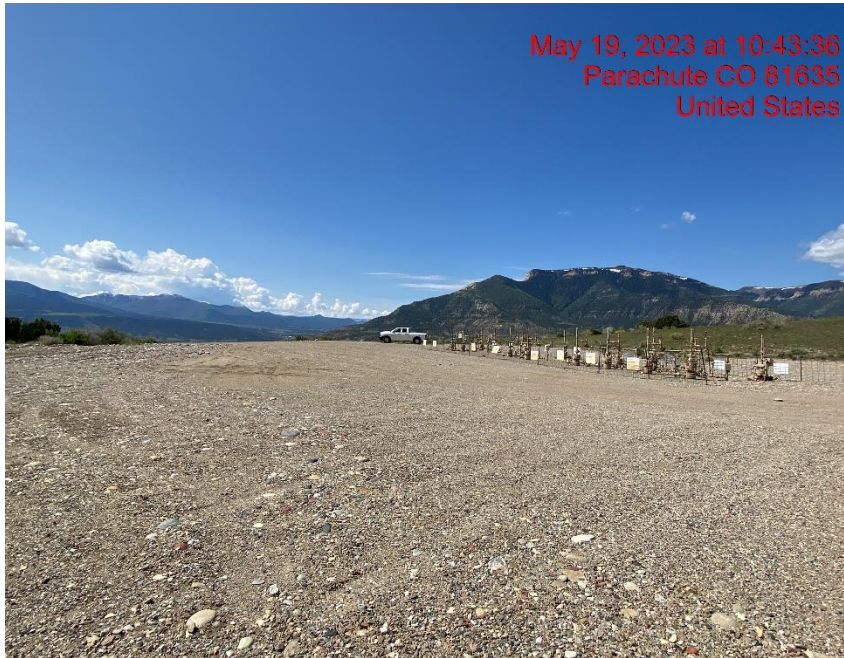
NE Corner of Location – Photo #03612

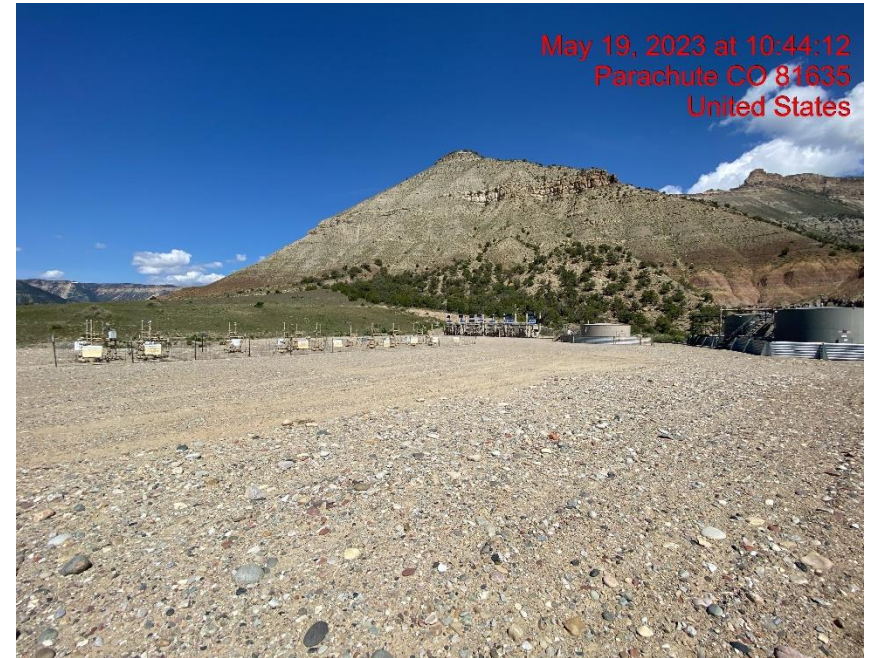
SE Corner of Location – Photo #03613

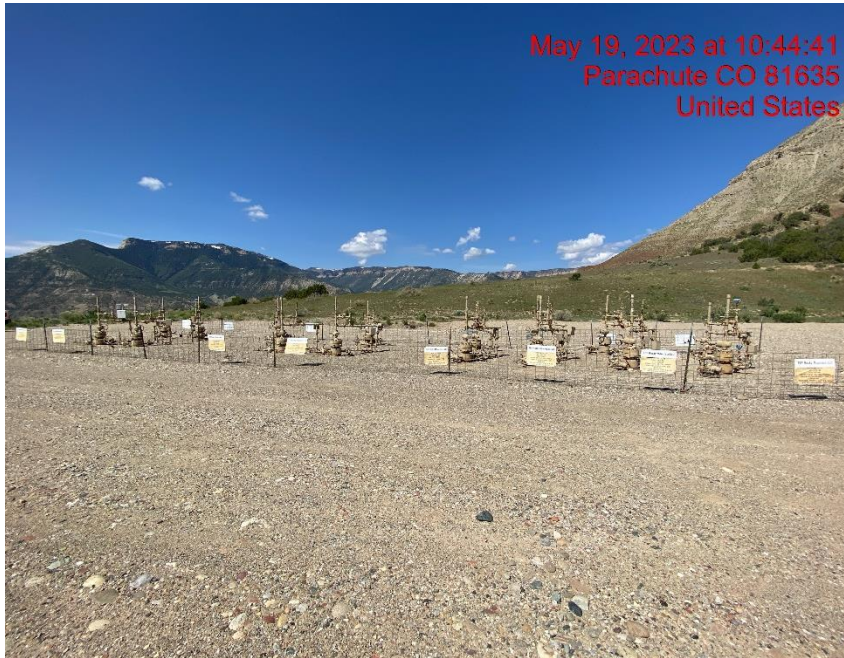
Wellheads – Photo #03614

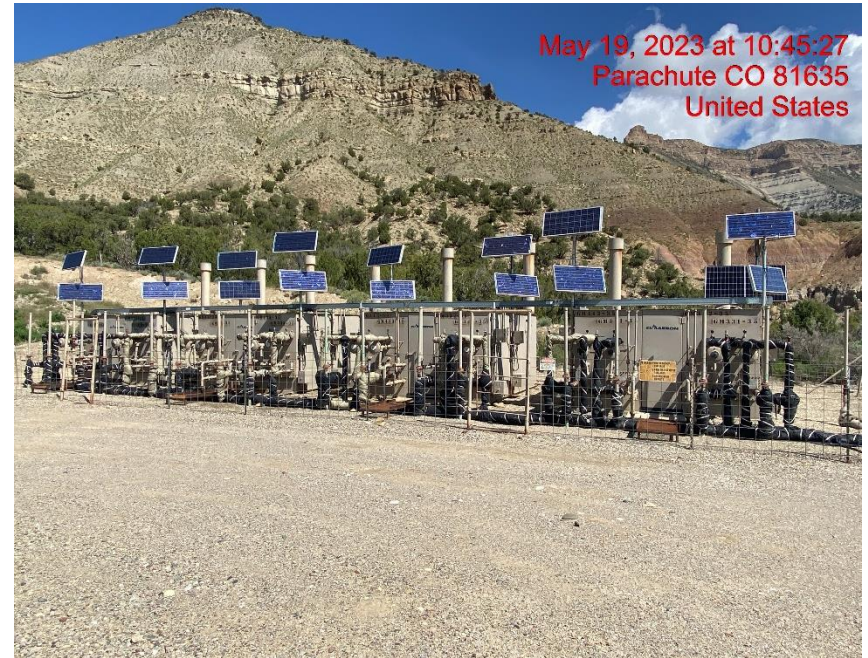
Separators – Photo #03616

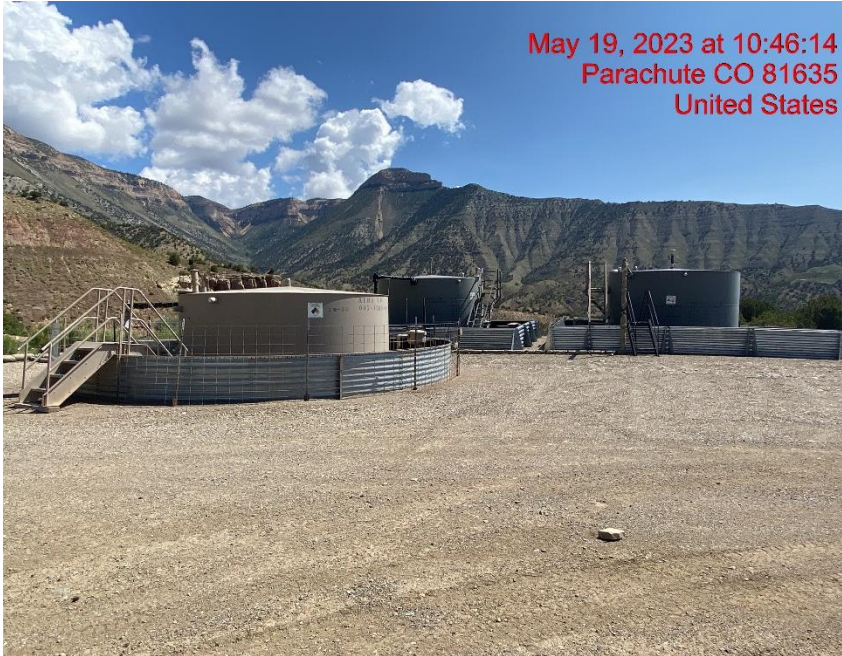
Tank Battery – Photo #03617

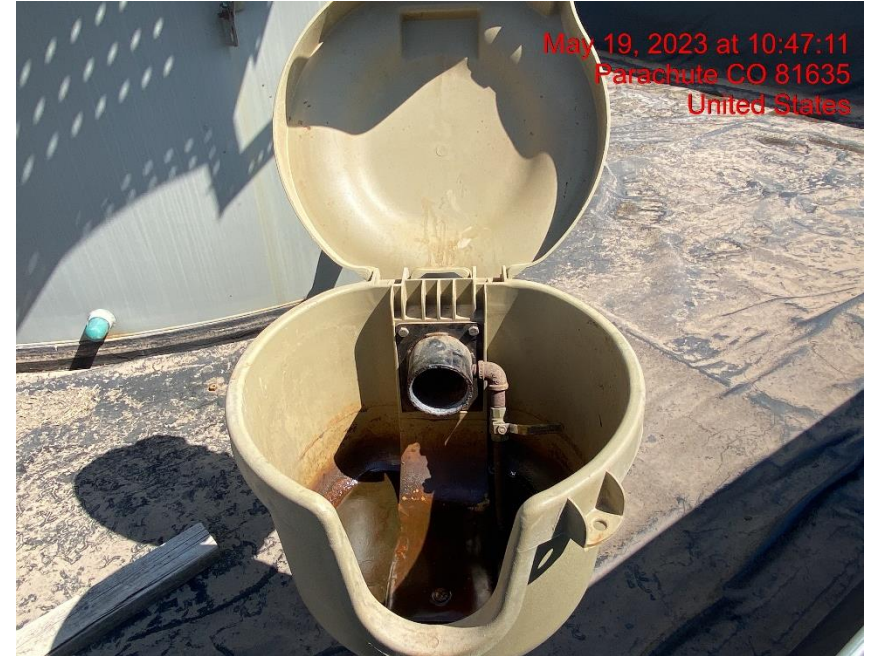
Open-Ended Load Line – Photo #03622

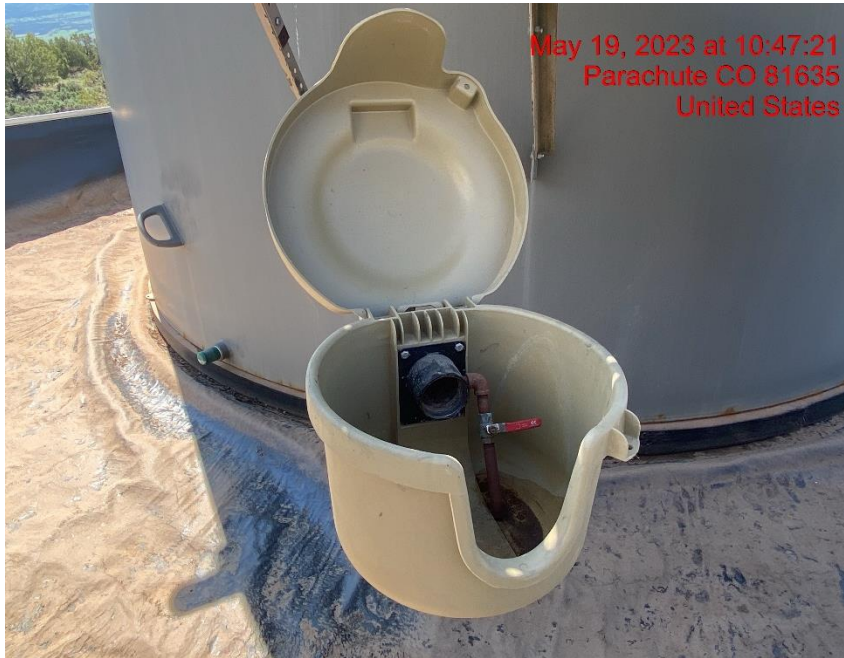
Open-Ended Load Line – Photo #03623

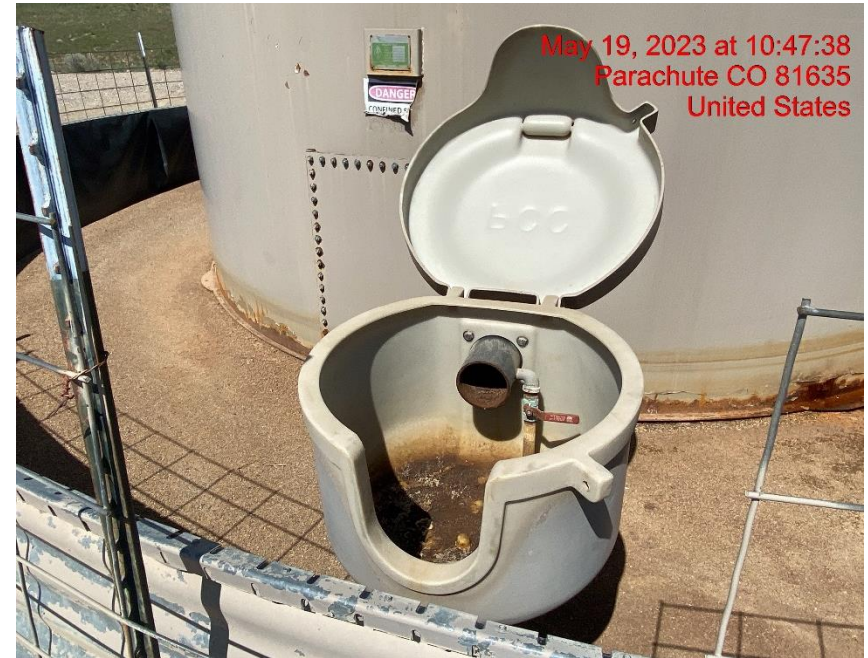
Open-Ended Load Line – Photo #03624

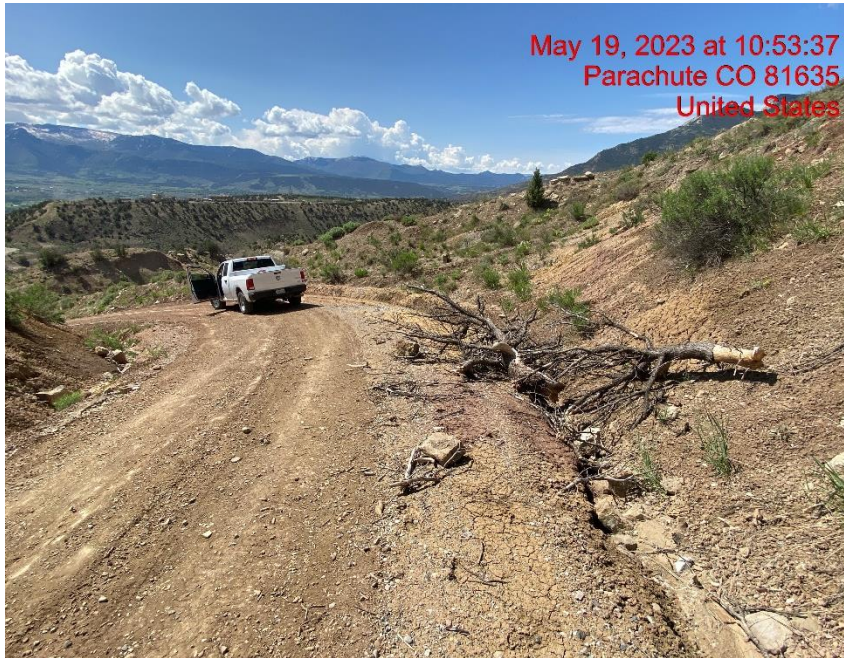
Lease Road Degradation – Photo #03628

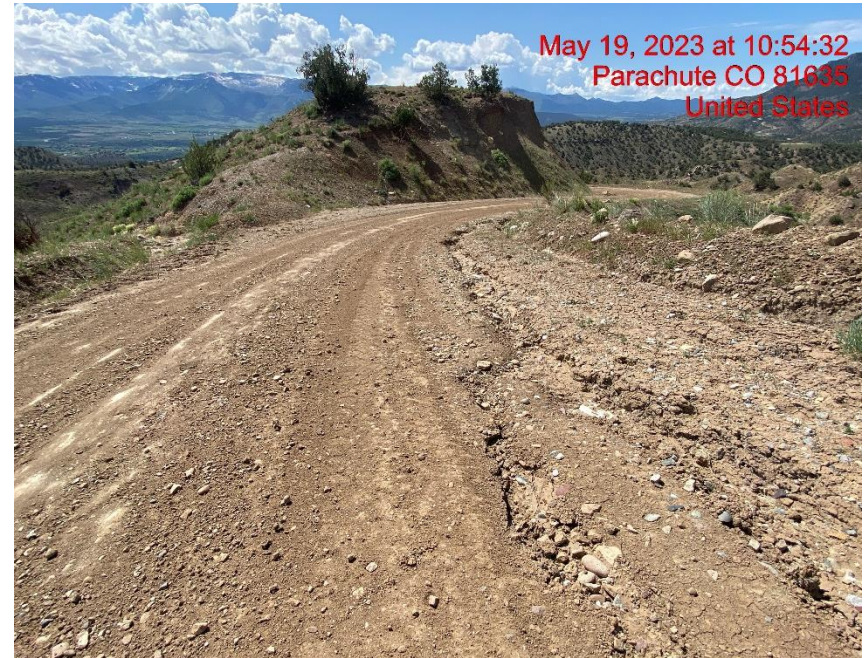
Rill Erosion Transporting Sediment – Photo #03629

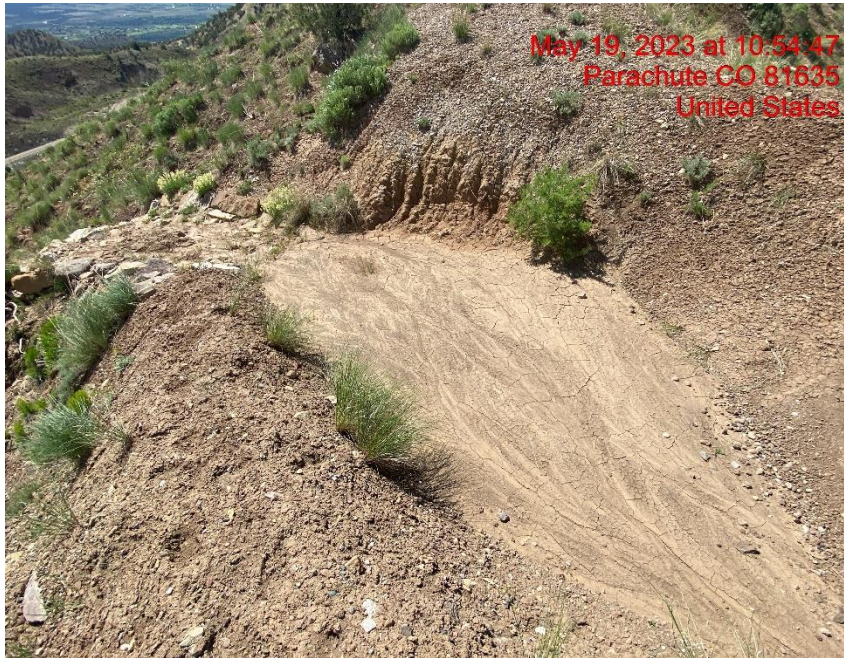
Sediment Trap Full & Needs Maintenance– Photo #03630

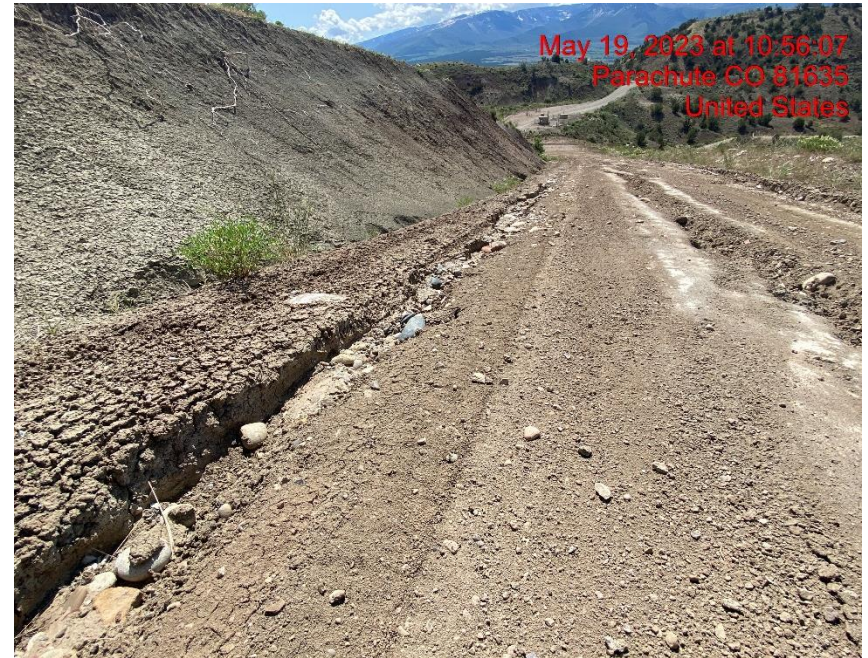
Rill Erosion Transporting Sediment – Photo #03632

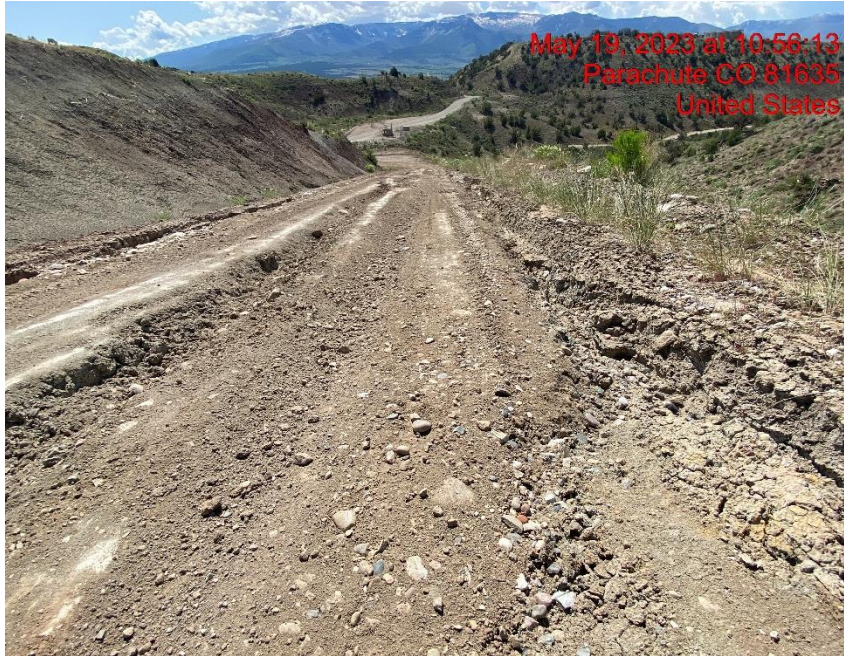
Rill Erosion/Degradation – Photo #03623

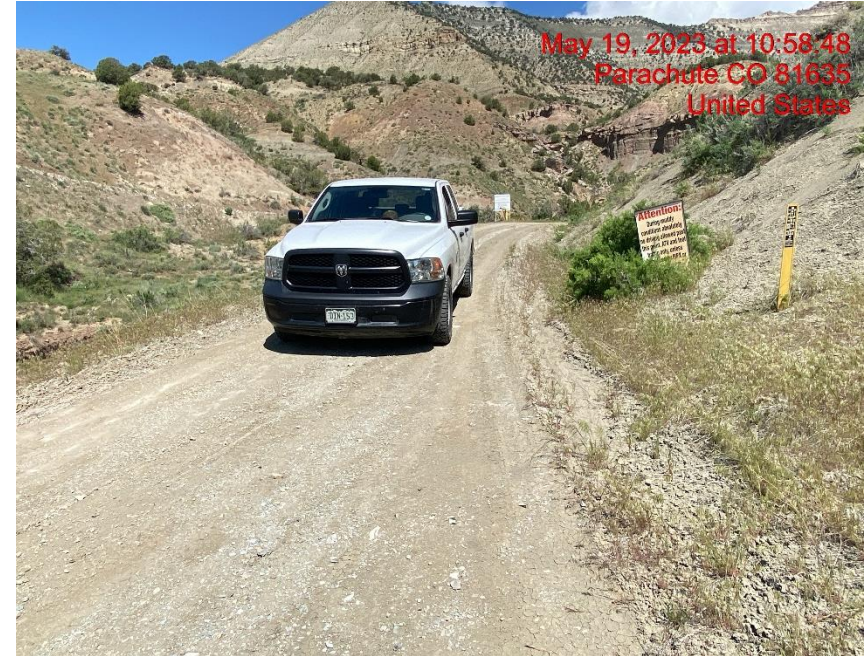
Insufficient Vehicle Tracking BMPs at Location Entrance/Exit – Photo #03636
