Inspection Photos
Petrox Candelaria 33-5 #10-1
API 007-06278

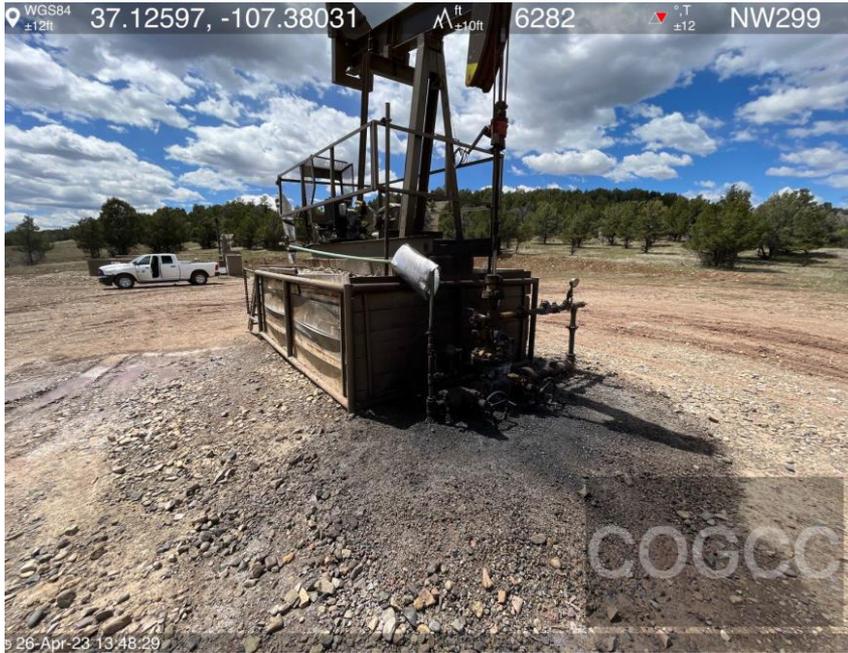
Photo #1. View of Corrective Action identified in Doc. #712700059.

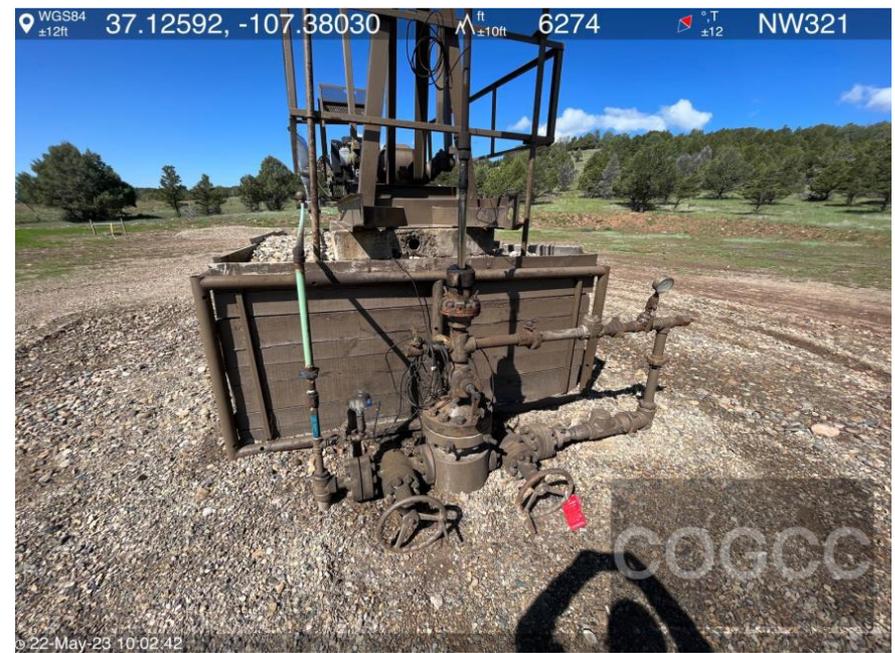
Photo #2. View of completed corrective action.

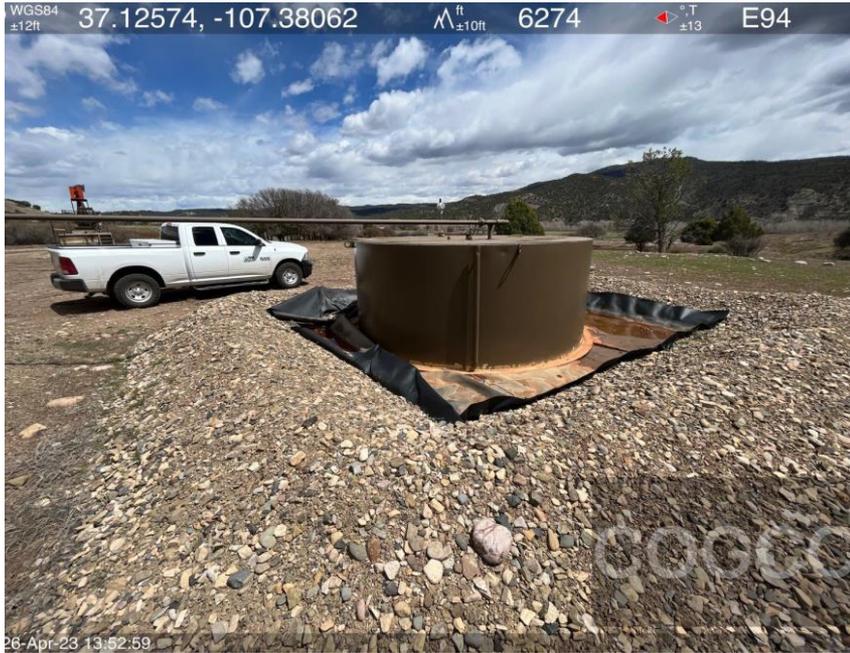
Photo #3. View of Corrective Action identified in Doc. #712700059.

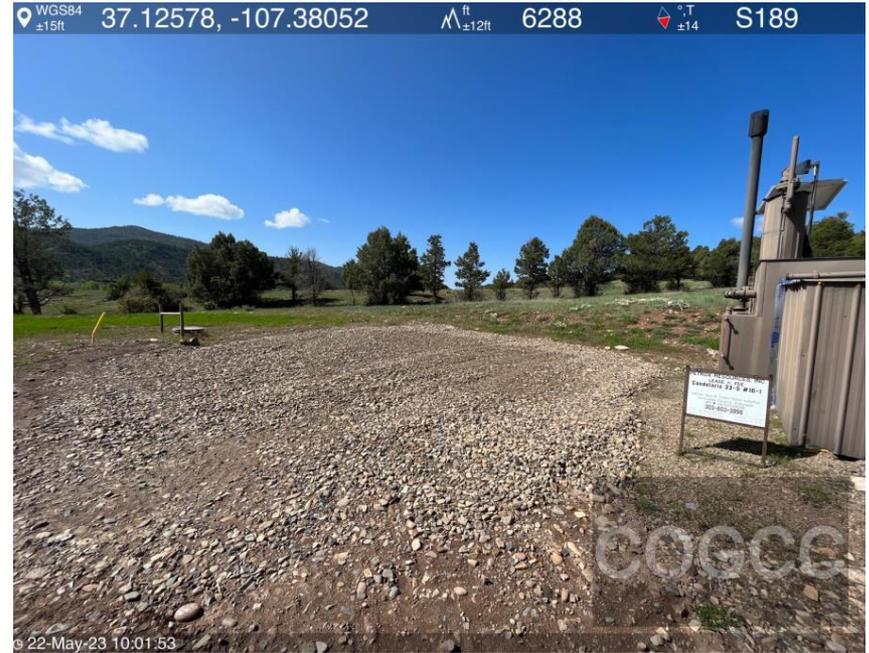
Photo #4. View of completed Corrective Action .
