Inspection Photos

API: 043-06182

Operator: INCREMENTAL OIL & GAS
(FLORENCE) LLC

Inspection Date: 5/22/2023

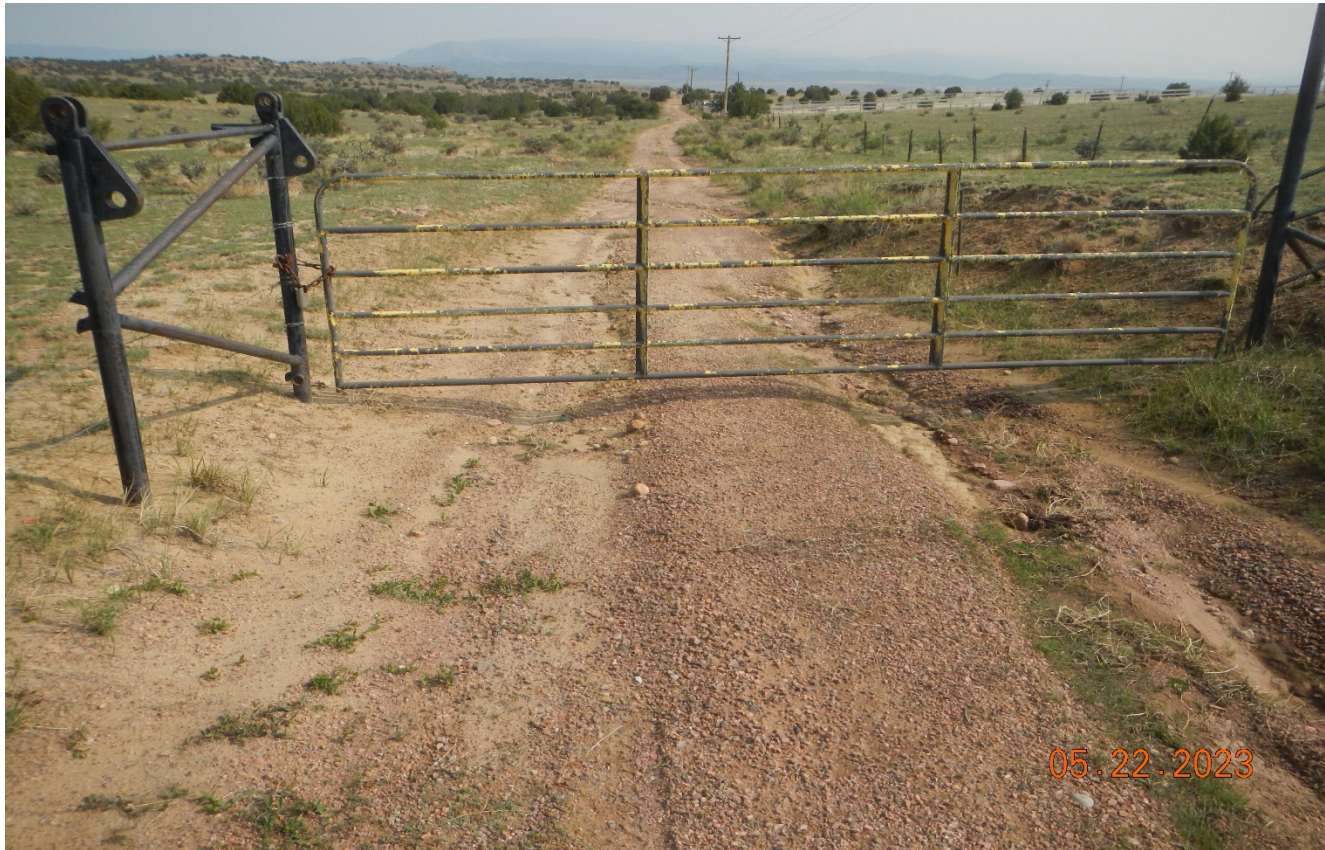
Photo 1. Facing north along the access road. There is erosion that has occurred along the road that needs to be repaired and stabilized.

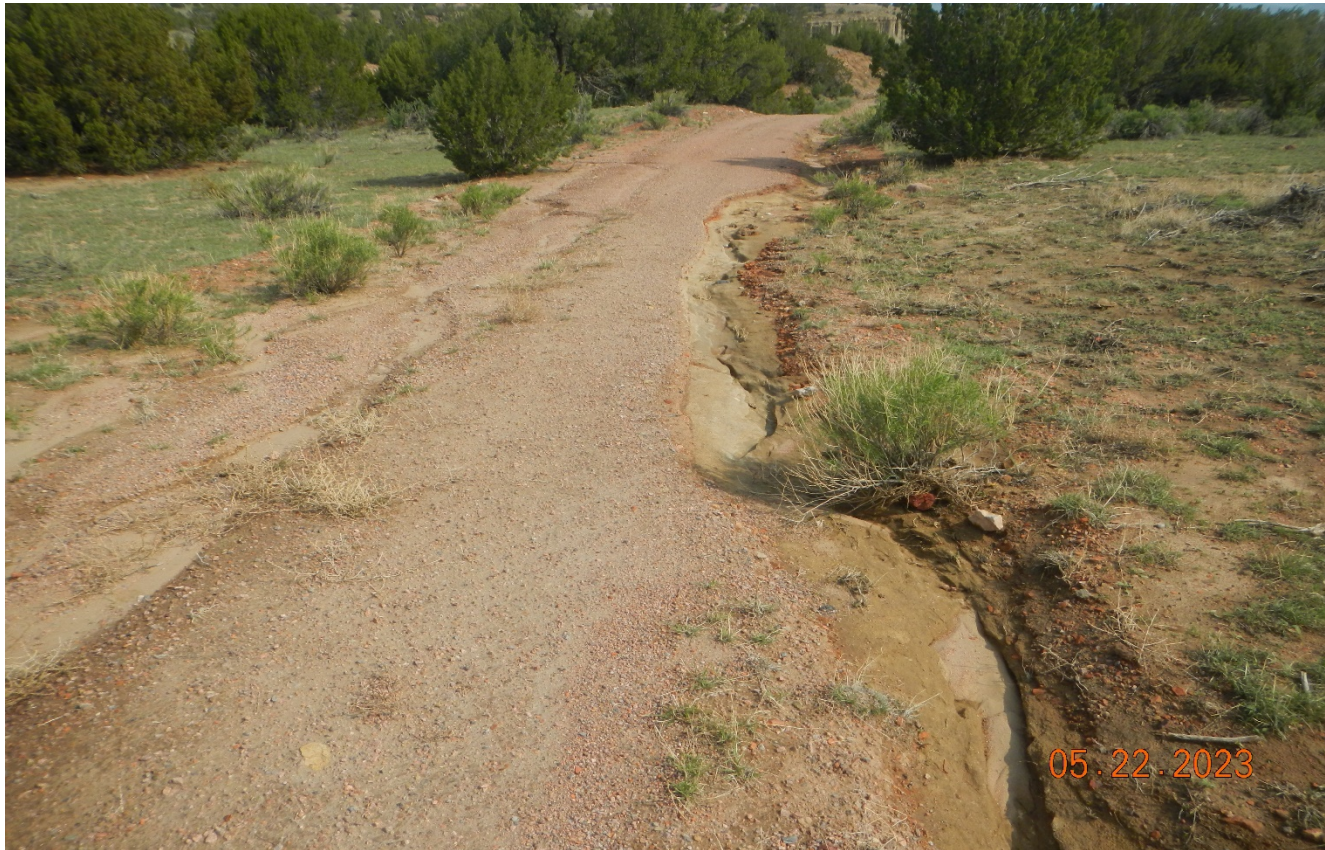
Photo 2. Facing northwest further along the access road. A recent storm event has created an erosion channel down the road which needs to be repaired.

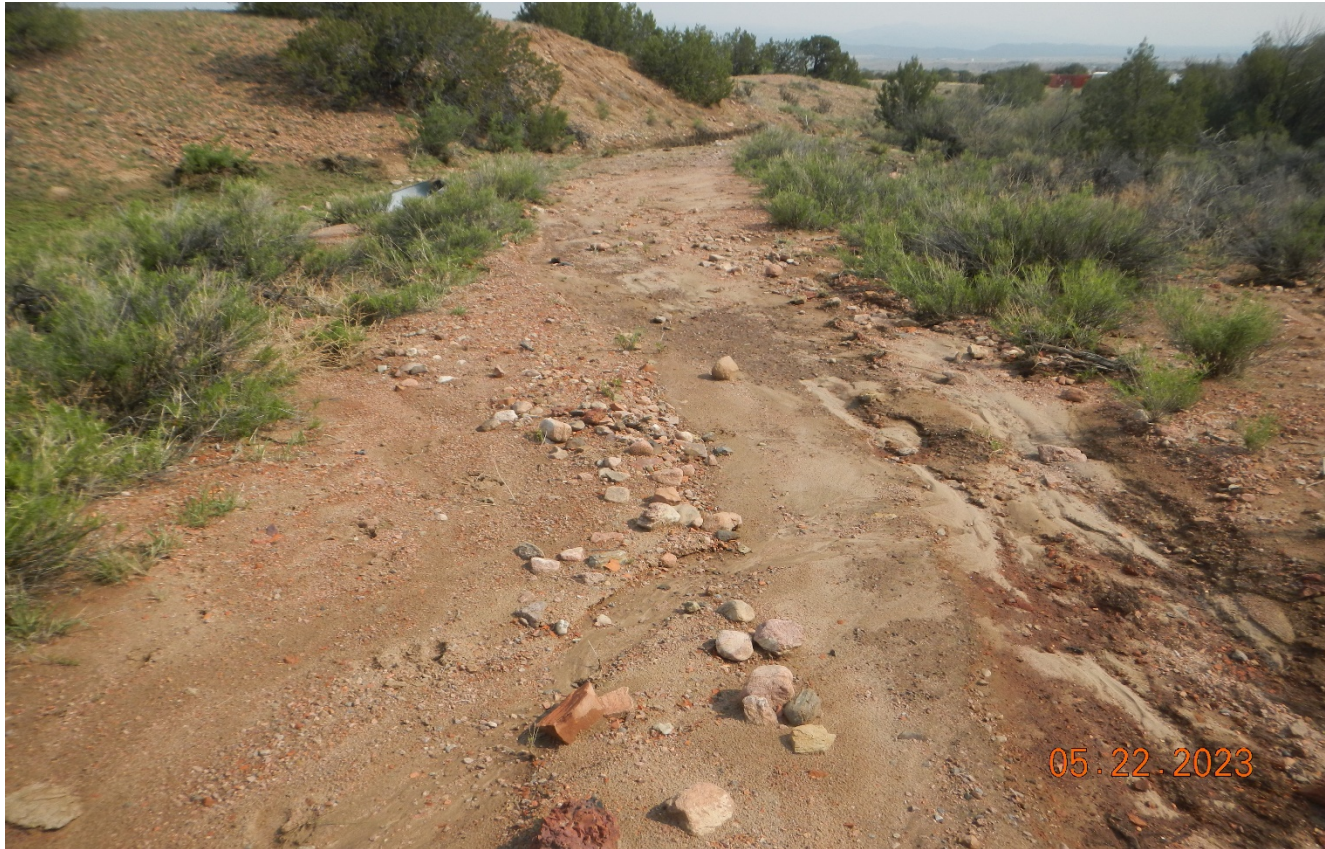
Photo 3. Facing north at the drainage crossing along the road. Stormwater has caused erosion of the road and has washed gravel and sediment off the road.

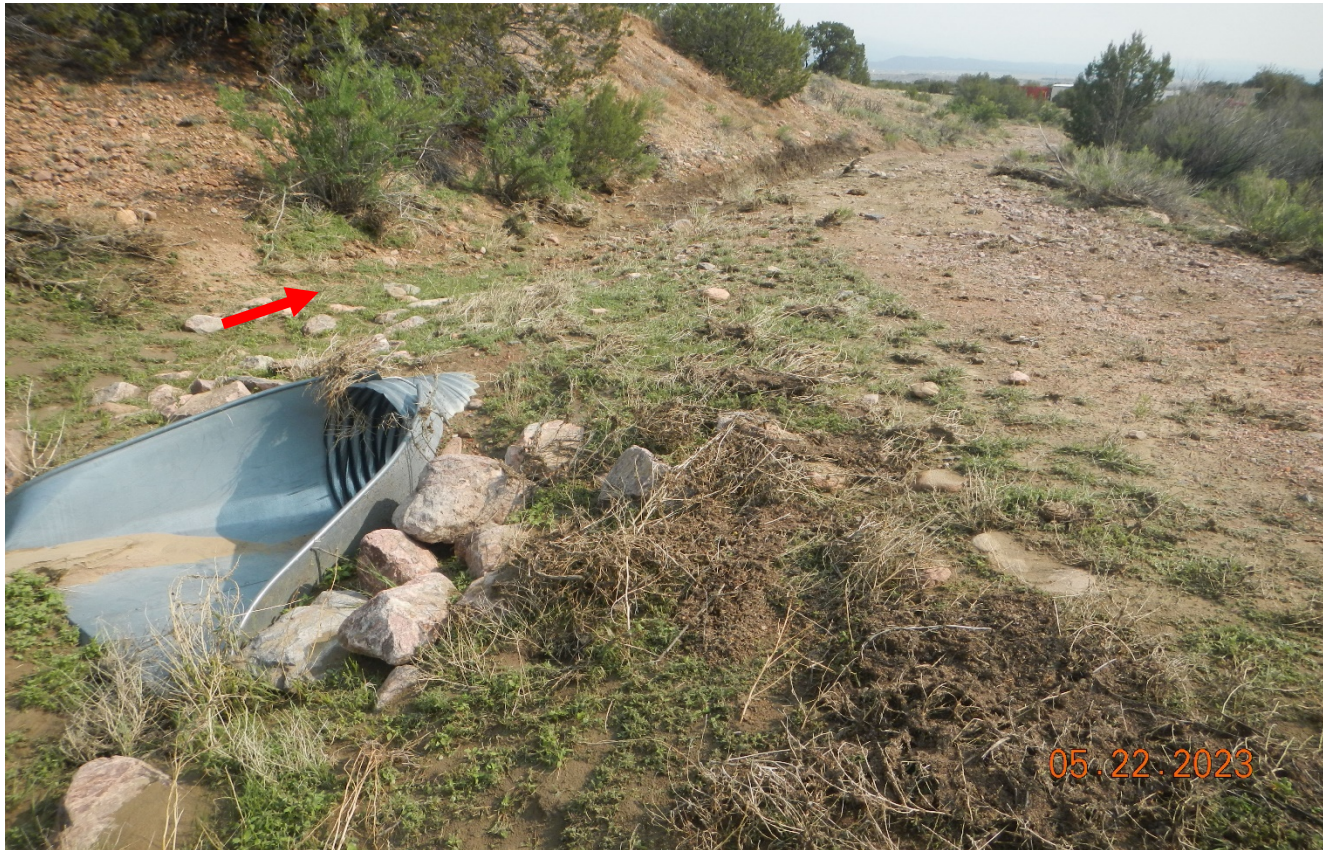
Photo 4. Facing toward the culvert at the drainage crossing. The recent storm event directed stormwater past the culvert at the red arrow causing erosion further down the road shown in the next photo.

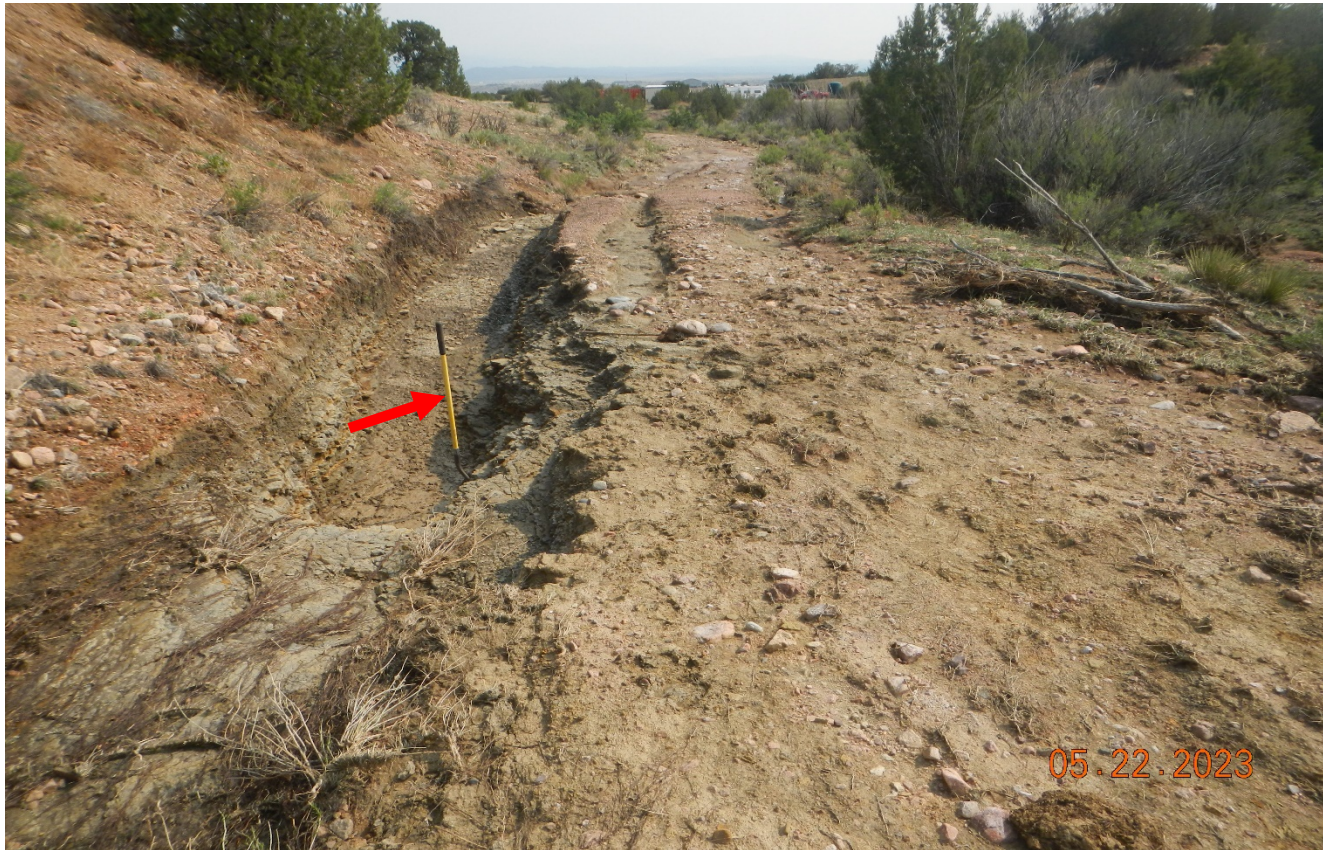
Photo 5. There was significant erosion of the road that occurred from the recent storm event. There is an approximate 4' gully along the road side in this area. Red arrow points to 4.5 ft. shovel placed in the gully.

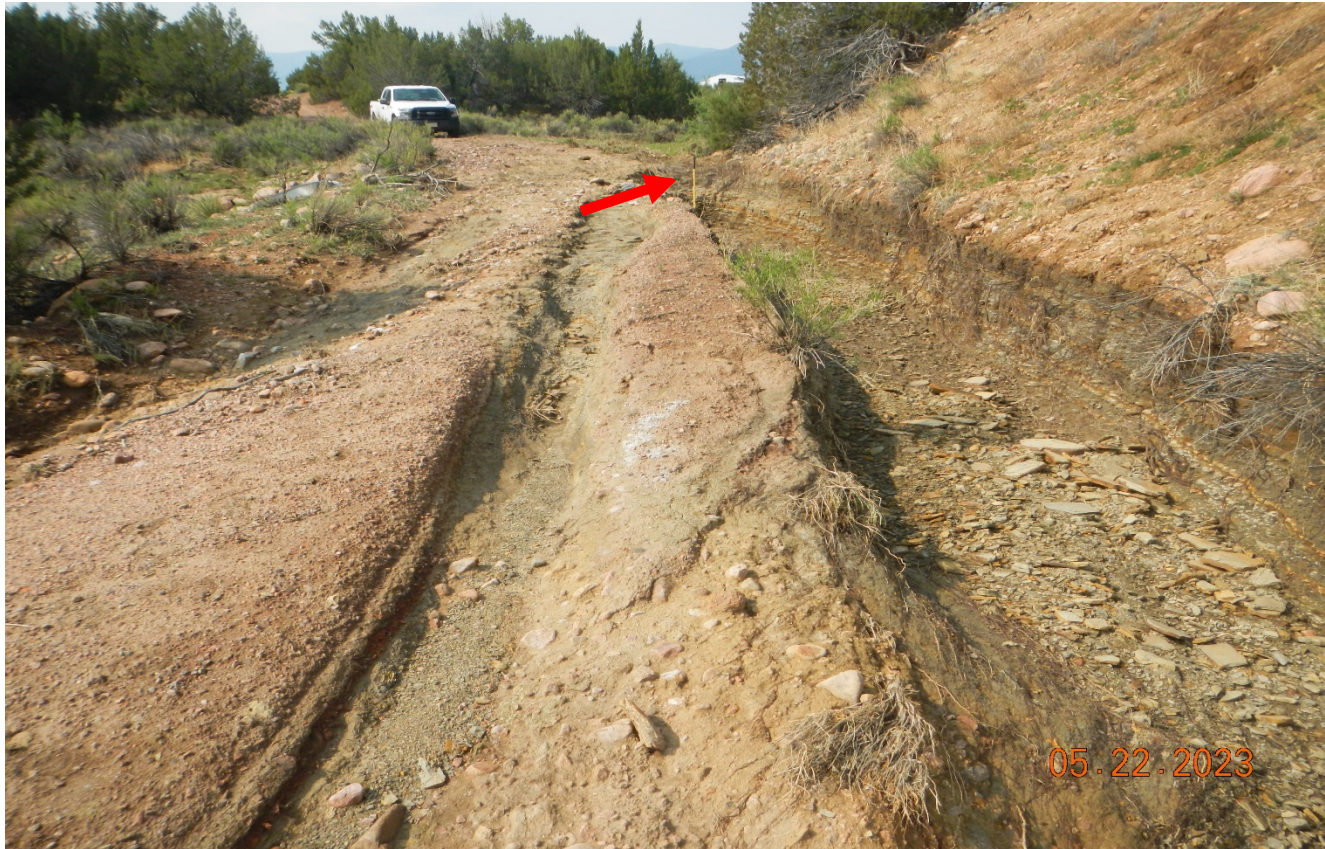
Photo 6. Facing back to the area of the road that has been washed out. Red arrow points to the shovel shown in the same place as previous photo.

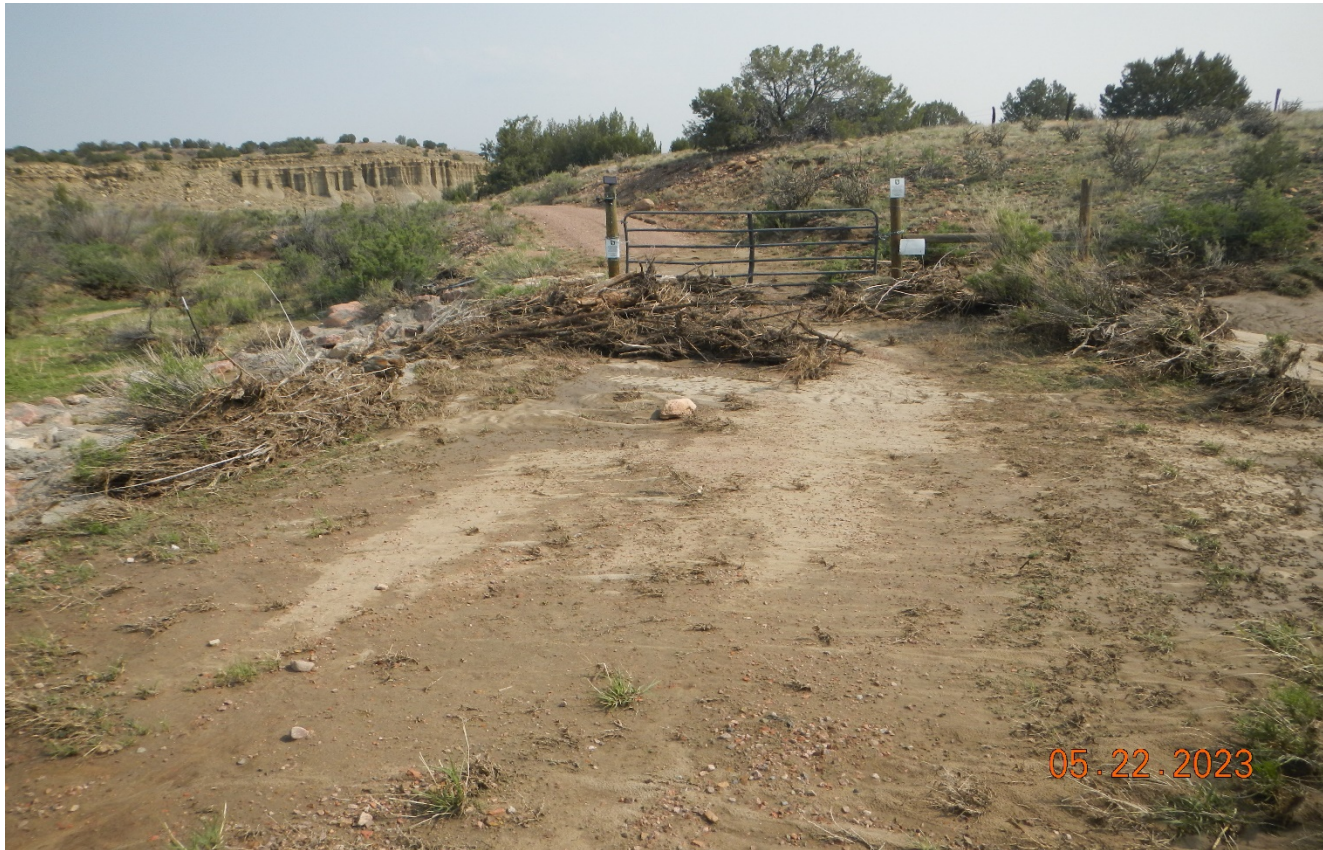
Photo 7. Further north along the access road at the second drainage crossing. Stormwater flowed over the culvert in this area which washed up debris in this area that will need to be cleaned up and removed.

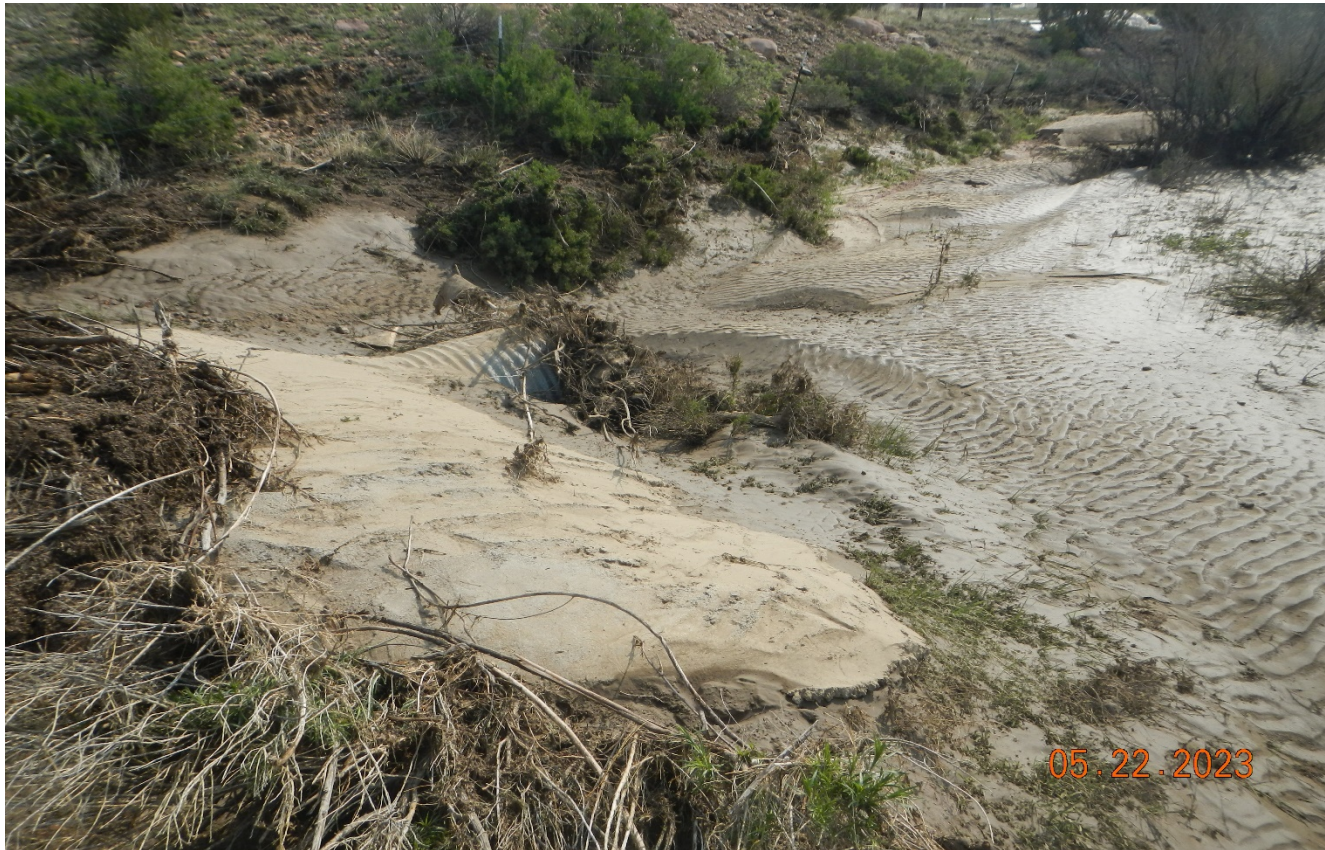
Photo 8. The culvert at this drainage crossing has filled in with sediment and debris.

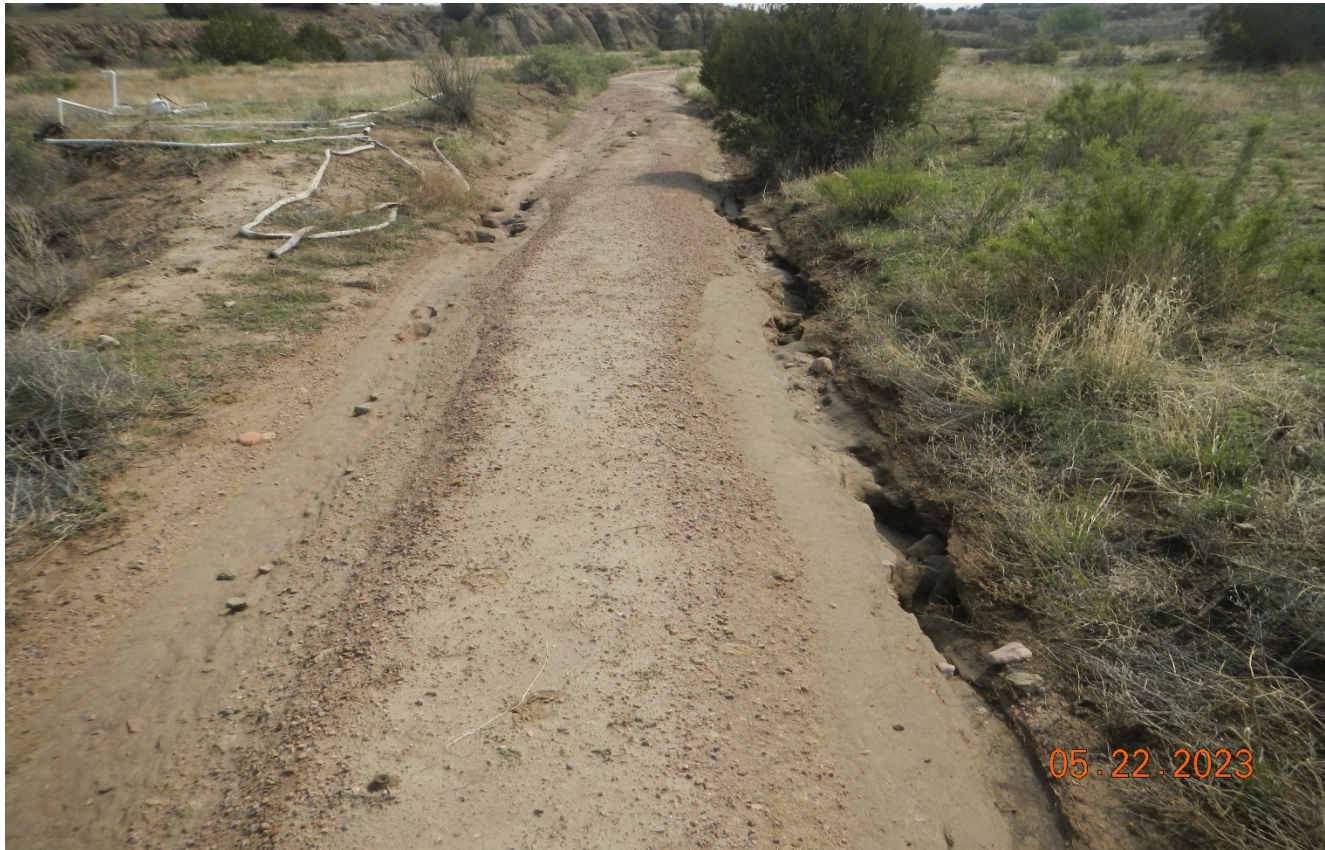
Photo 9. Facing northeast along the access road near the location. Stormwater has caused an erosion channel along the road that needs to be repaired.

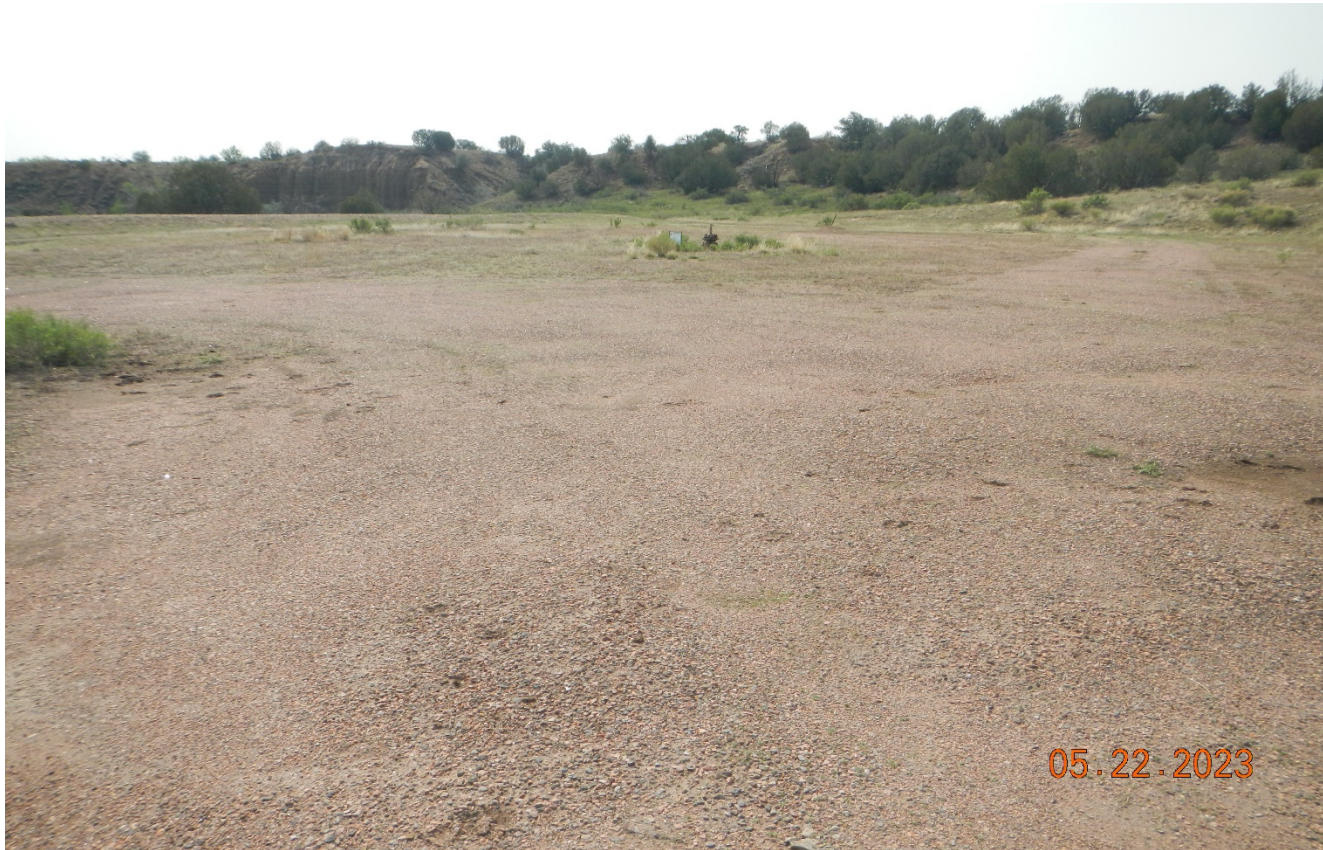
Photo 10. Facing southeast toward the wellsite.

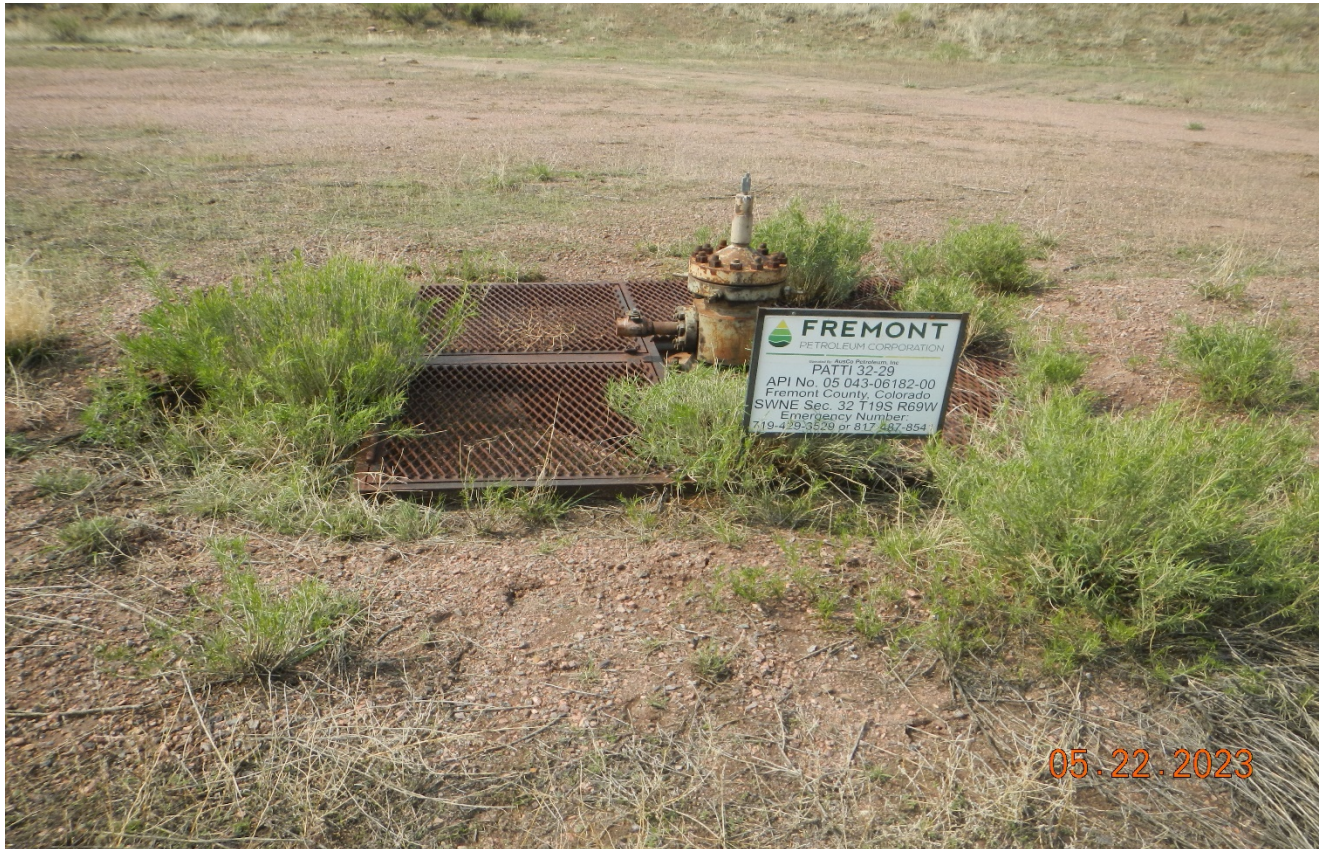
Photo 11. Well sign is posted at the wellhead.

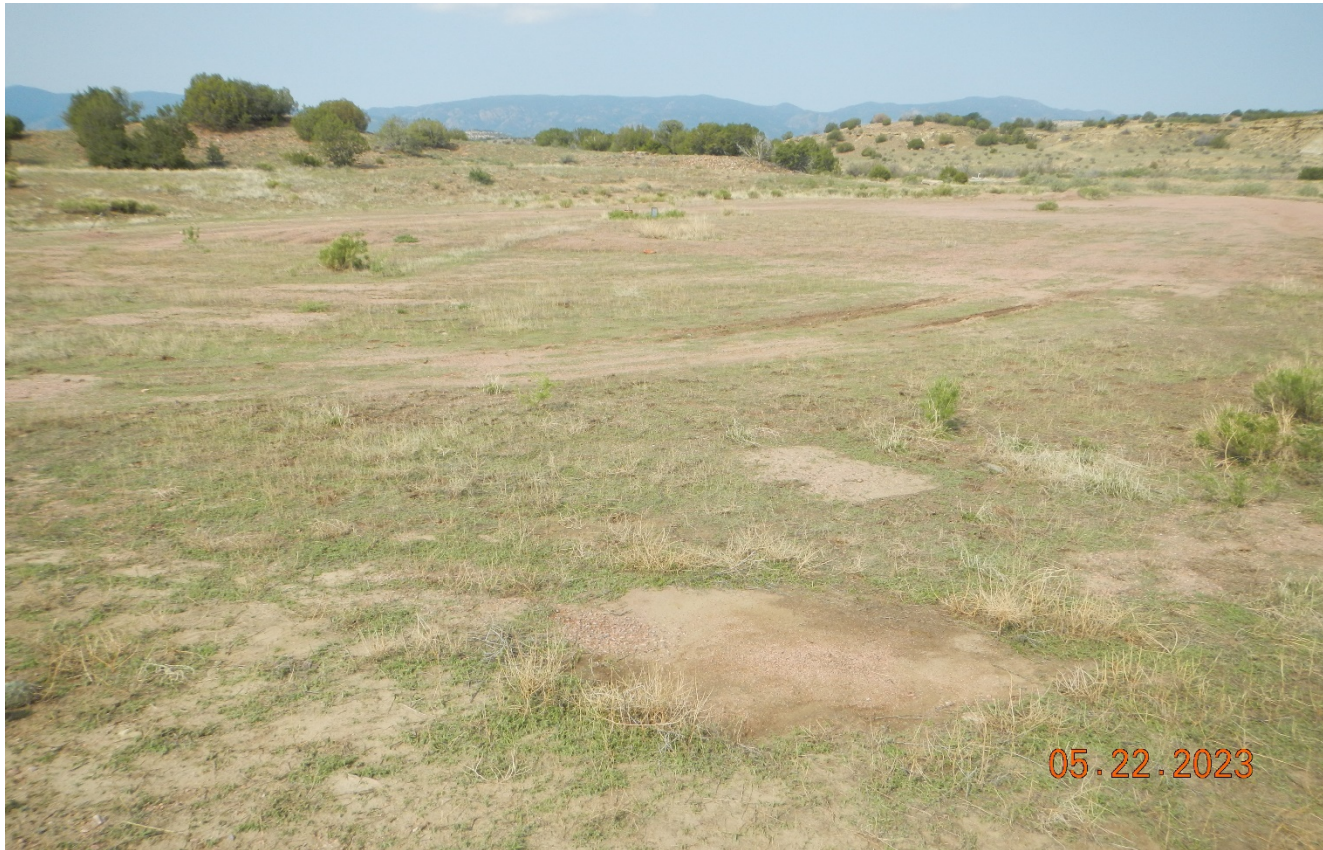
Photo 12. East side of the location facing west. The location is not reclaimed and needs to be reduced in size.

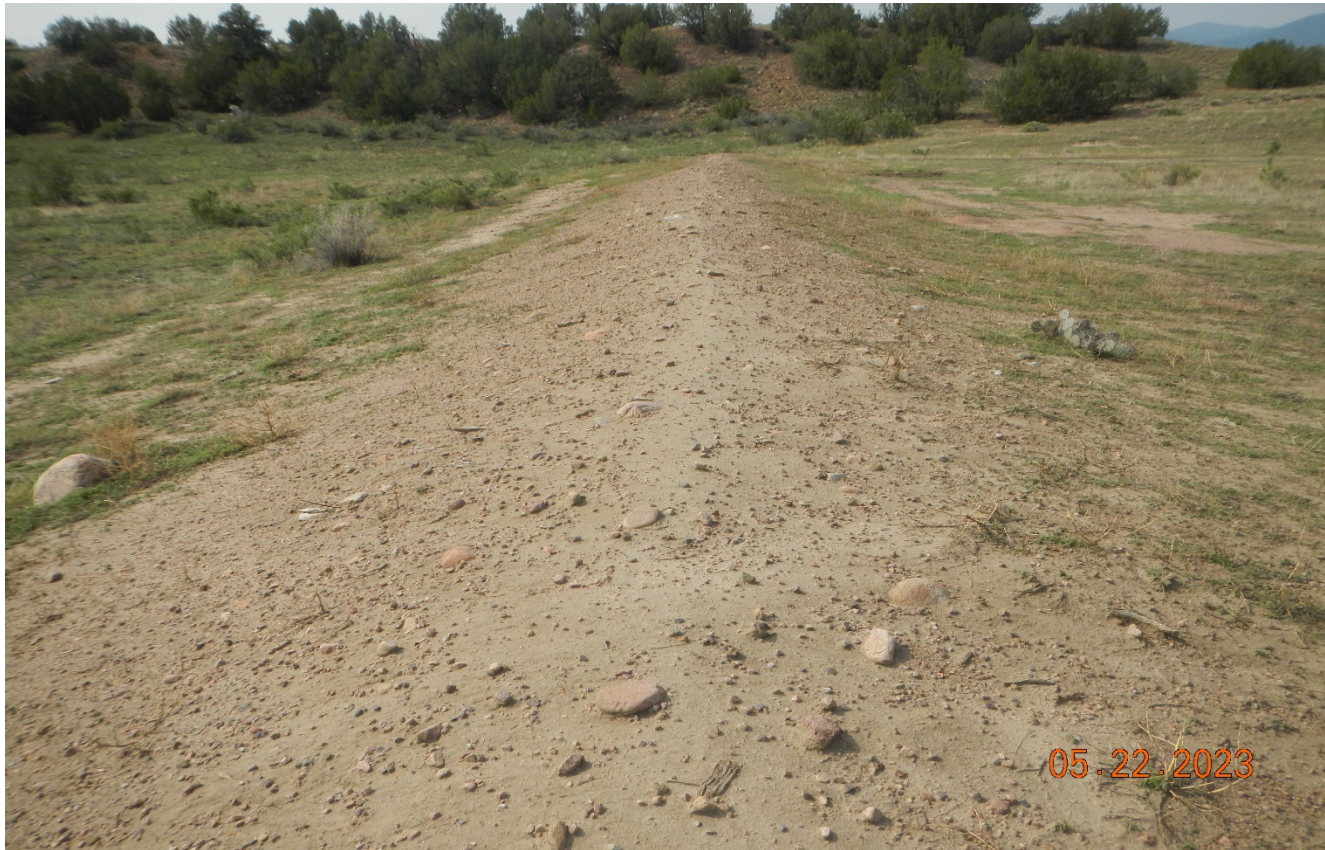
Photo 2. Facing toward the topsoil pile at the east side of the location.

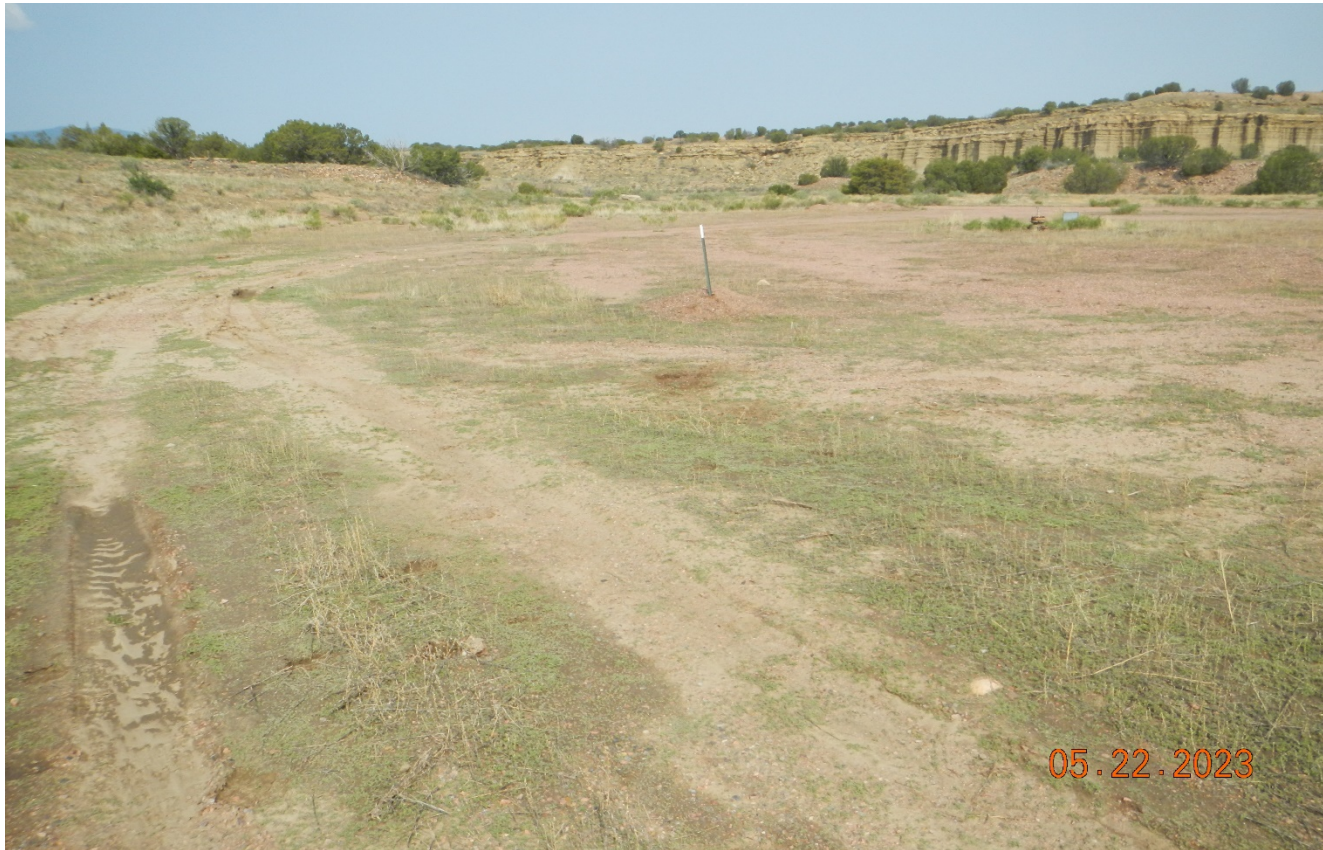
Photo 14. Southeast side of the location facing northwest. The location is not reclaimed and needs to be reduced in size.

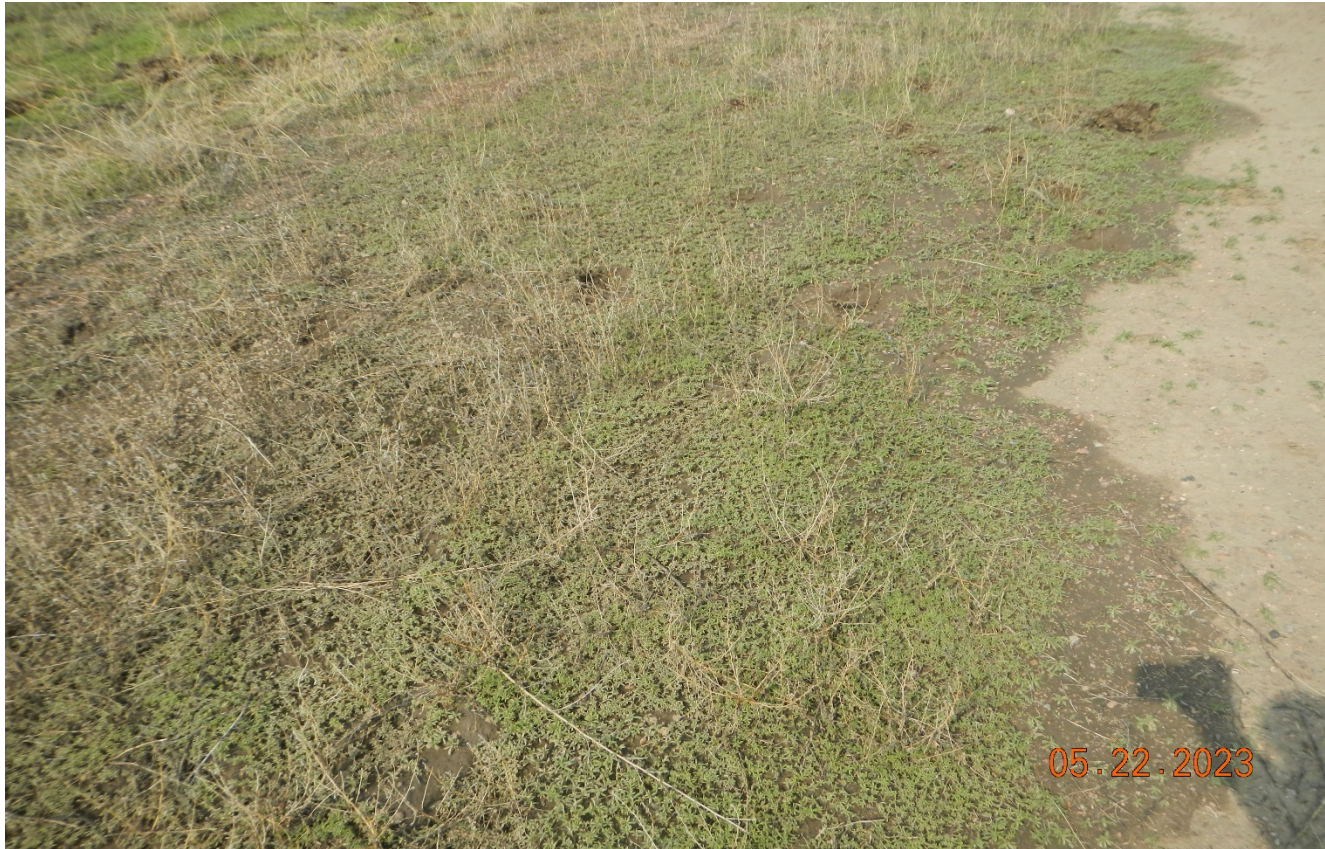
Photo 15. There are undesirable weeds (Kochia sp.) throughout the location which will need to be controlled.

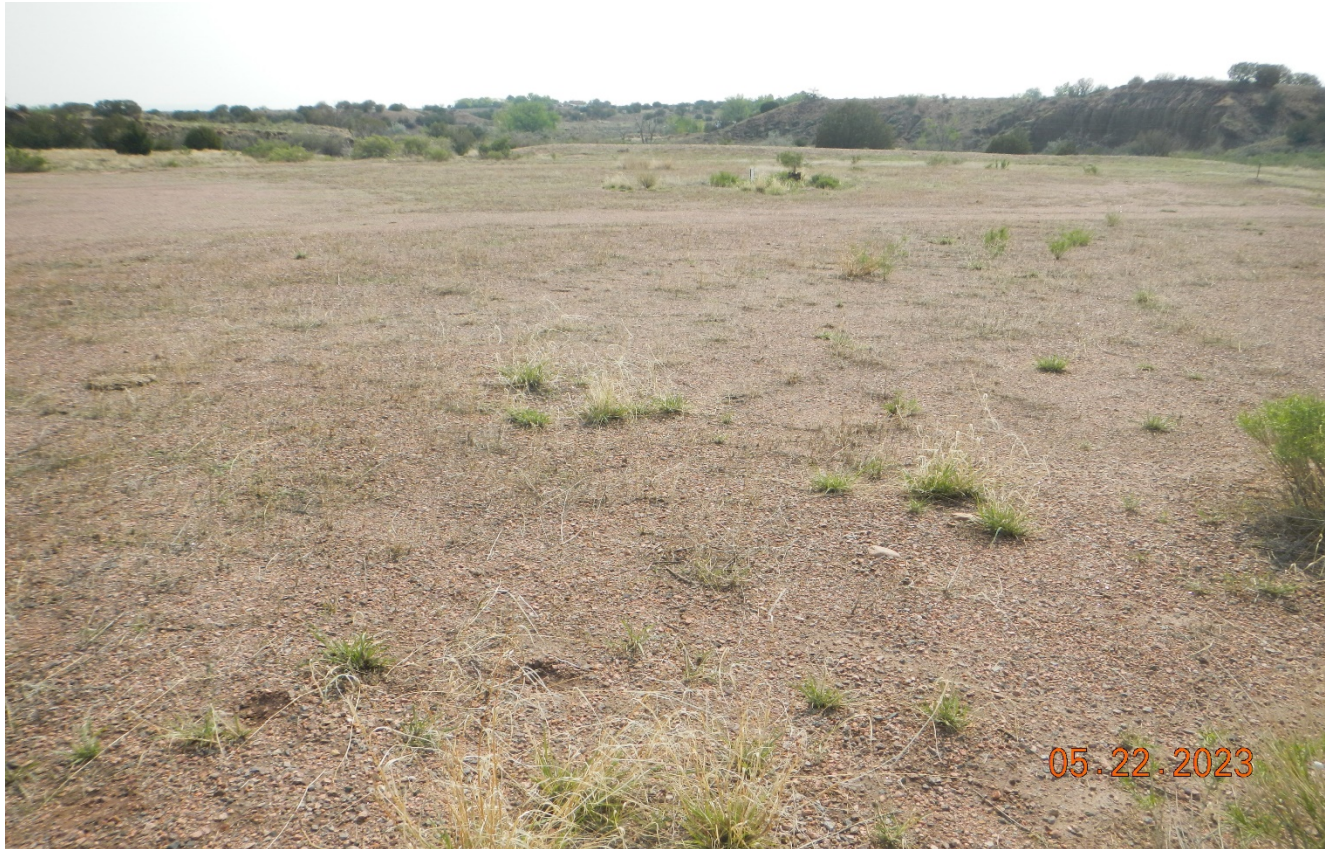
Photo 16. Southwest side of the location facing northeast. The location is not reclaimed and needs to be reduced in size. Gravel remains along unused areas of the location.
