# Inspection Photos

API: 043-40001

Operator: JAVERNICK OIL

Inspection Date: 5/22/2023

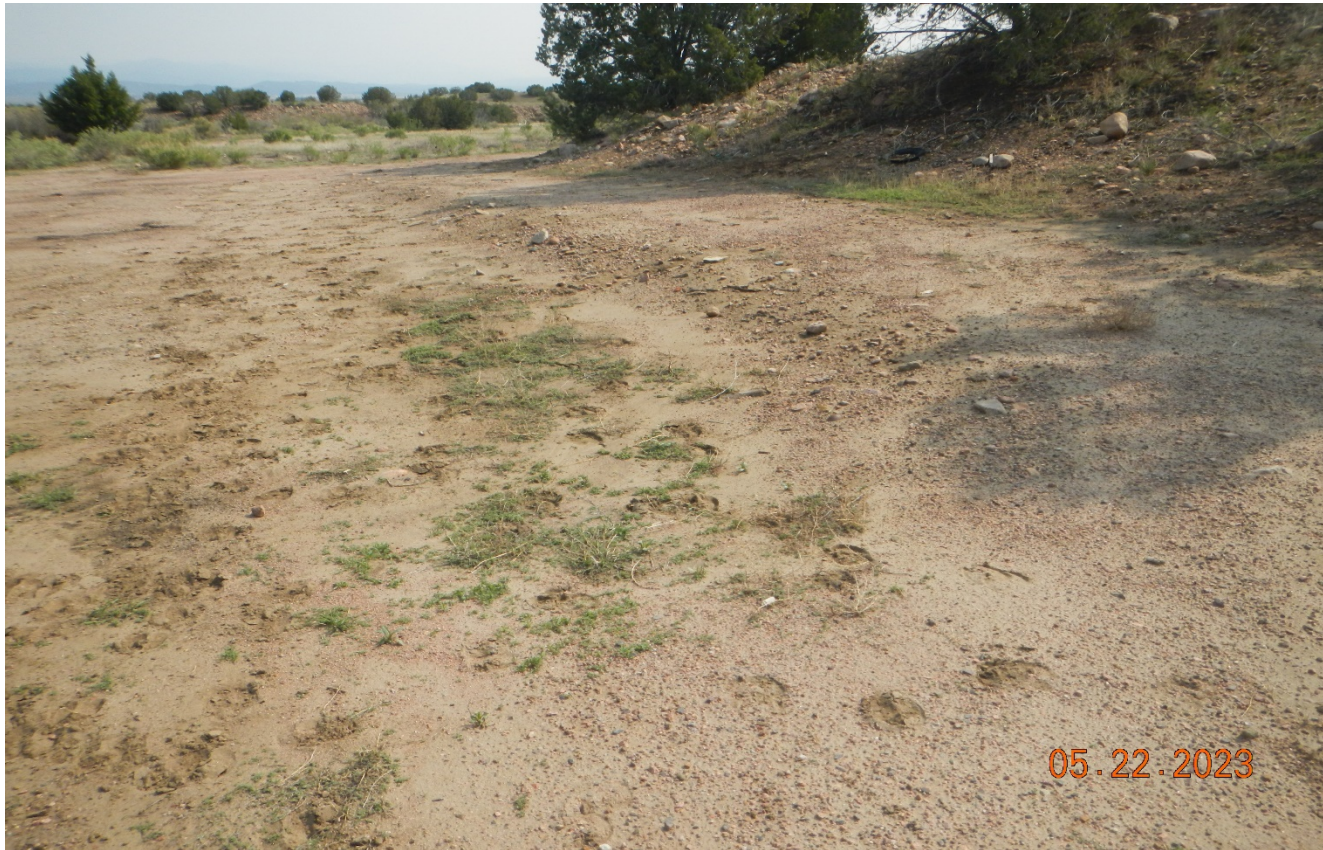
**Photo 1.** Facing northeast at the abandoned well site. The location has not been reclaimed and soils are bare of vegetation.

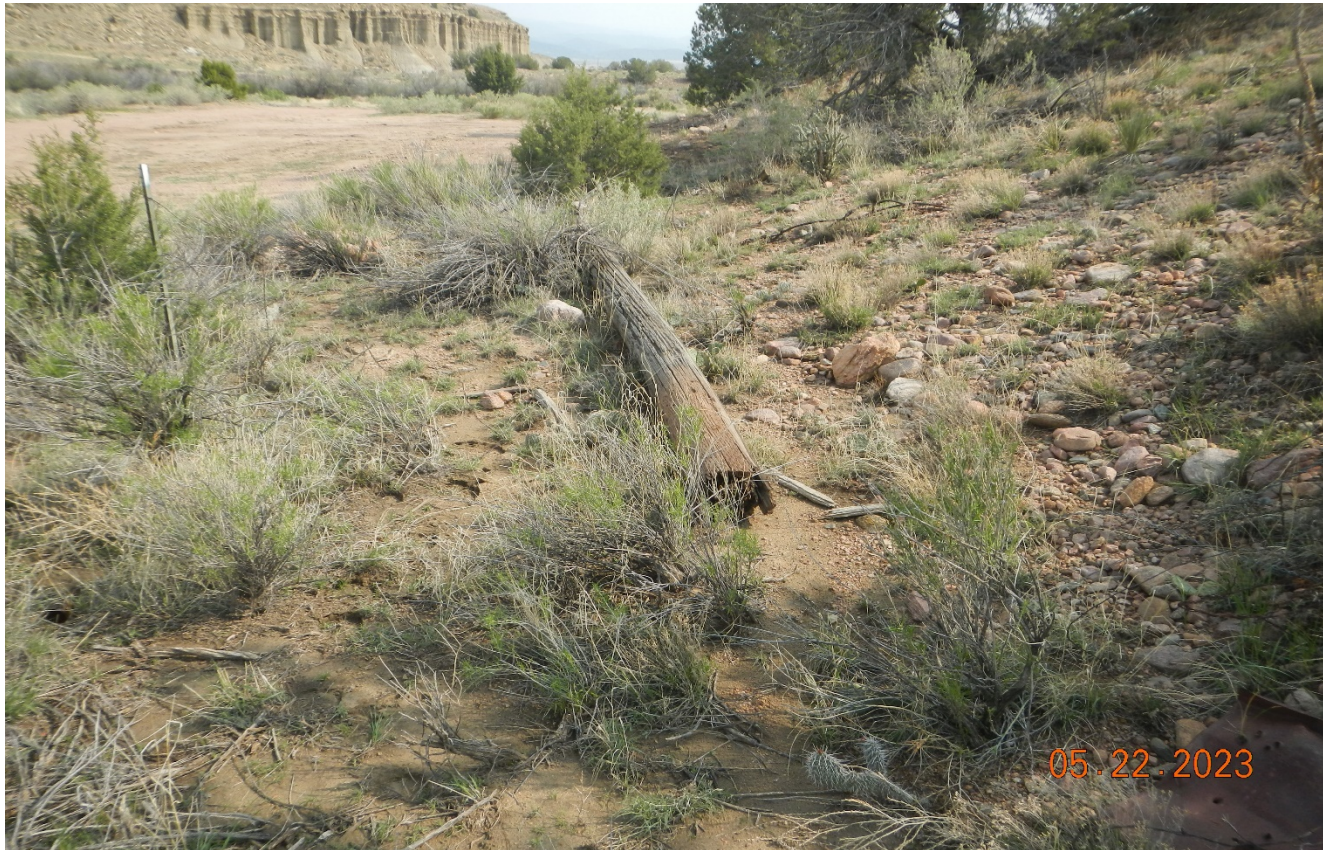
**Photo 2.** There is an abandoned powerpole that remains which needs to be removed.

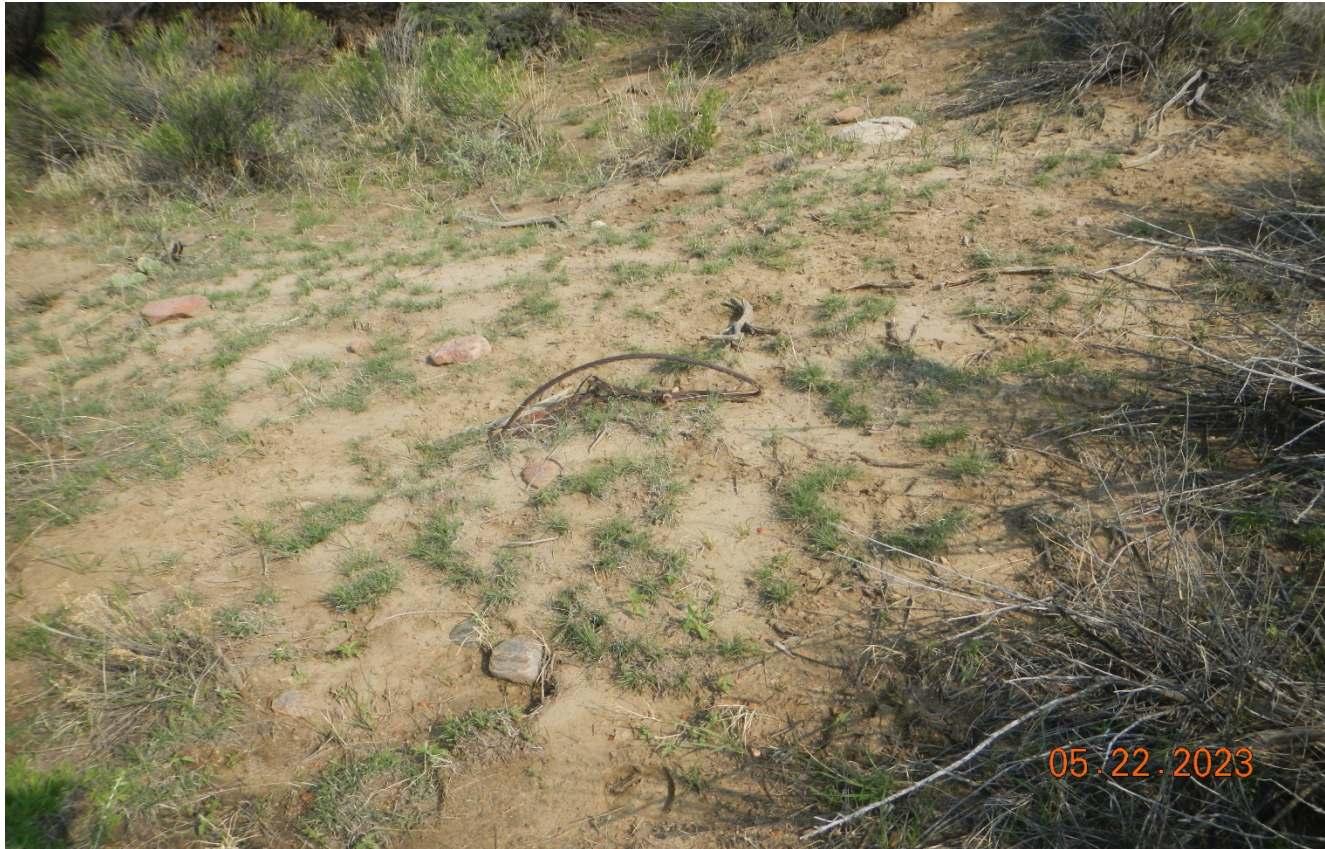
**Photo 3.** There is guyline anchor cable that remains at the southeast side of the location.

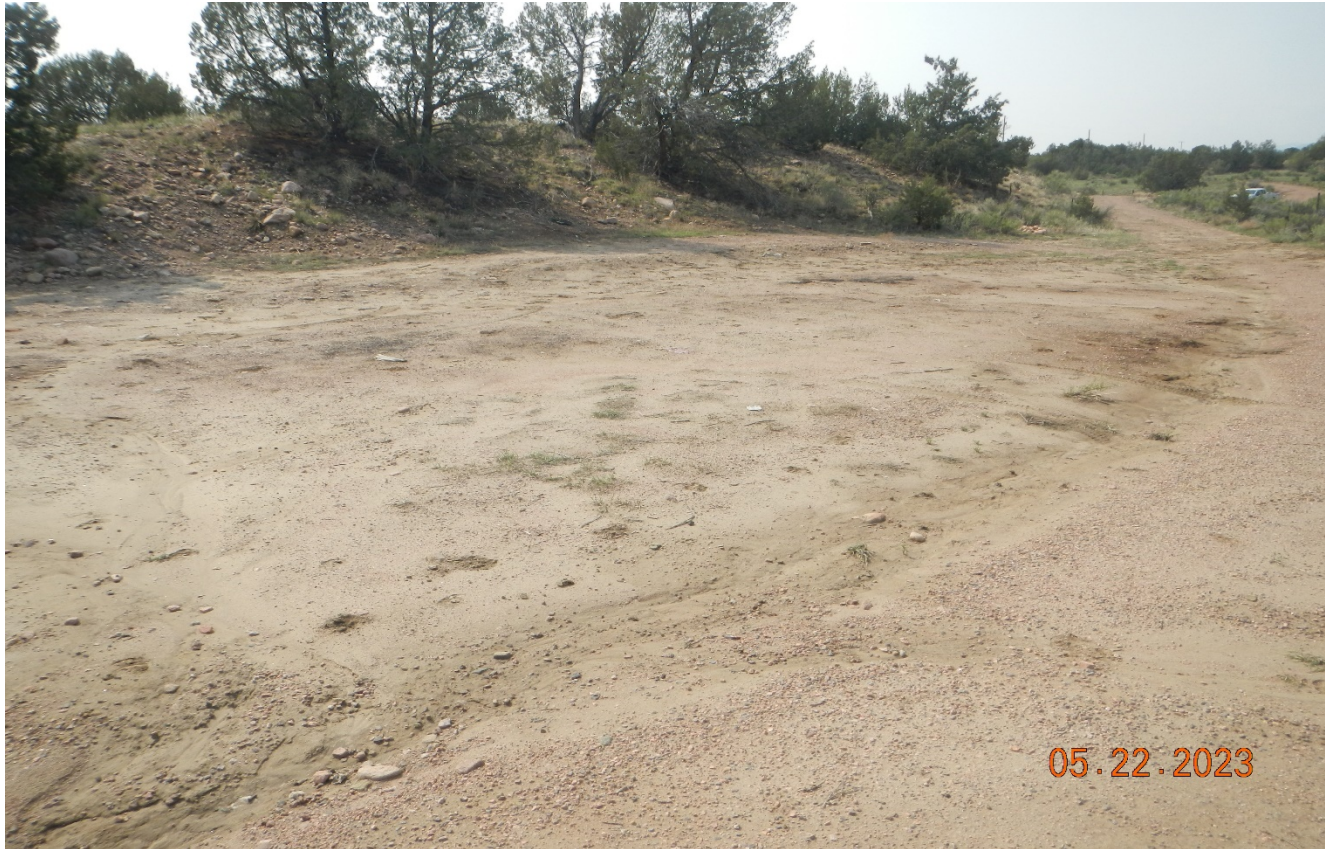
**Photo 4.** Facing southeast at the abandoned well site. The location has not been reclaimed and soils are bare of vegetation.

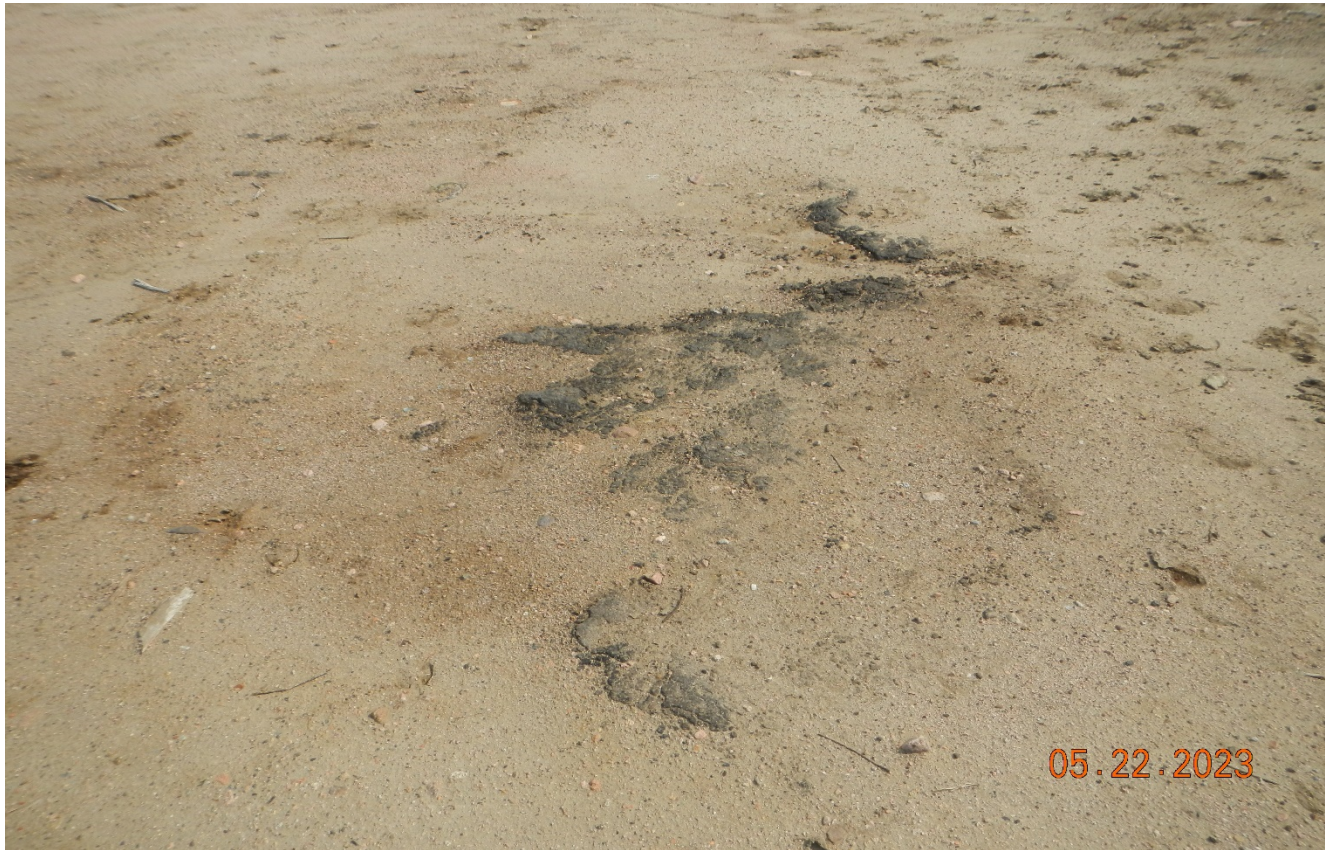
**Photo 5.** There is oil stained soils at center of location that needs to be cleaned up.

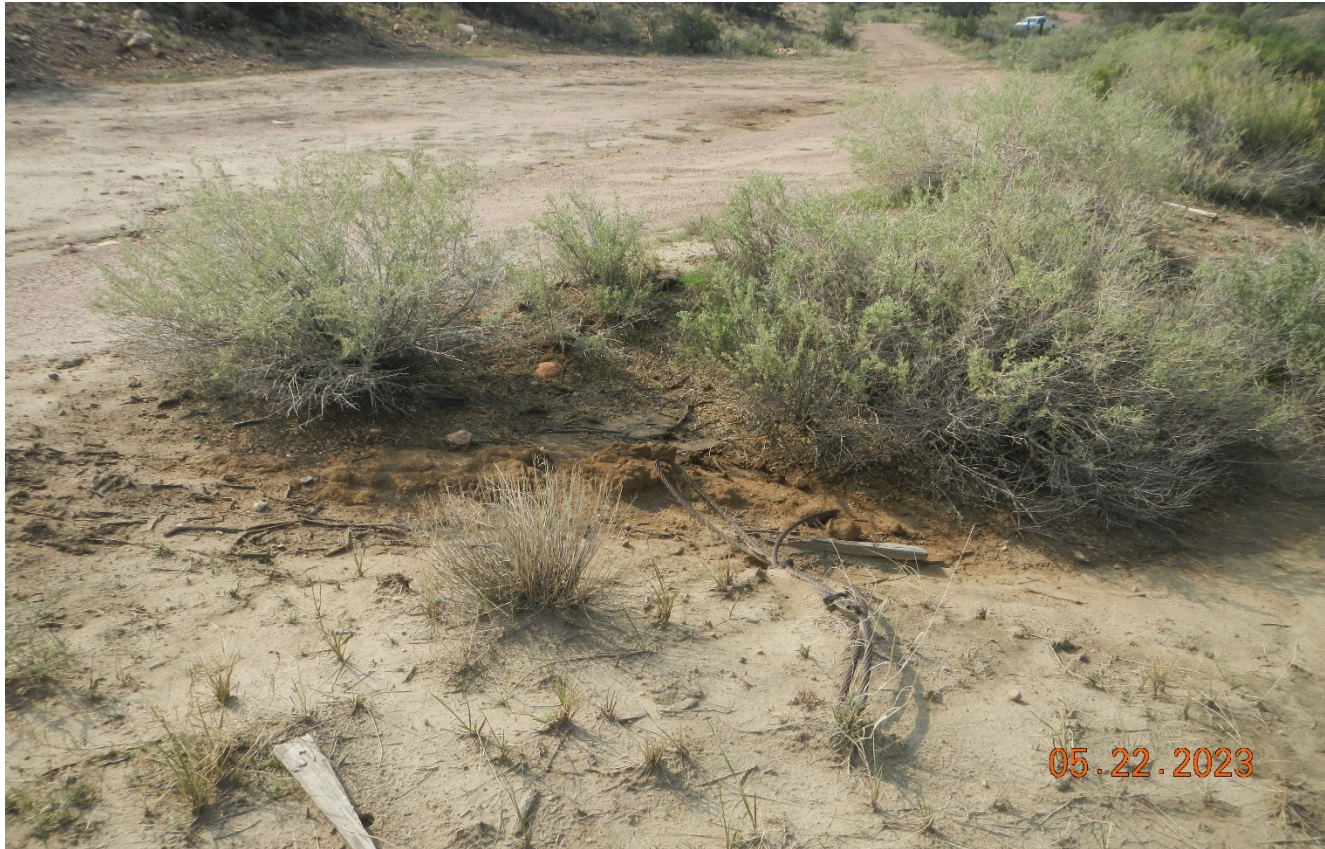
**Photo 6.** There is another guyline anchor cable that remains at the southwest side of the location.
