# Inspection Photos

API: 043-06124

Operator: JAVERNICK OIL

Inspection Date: 5/22/2023

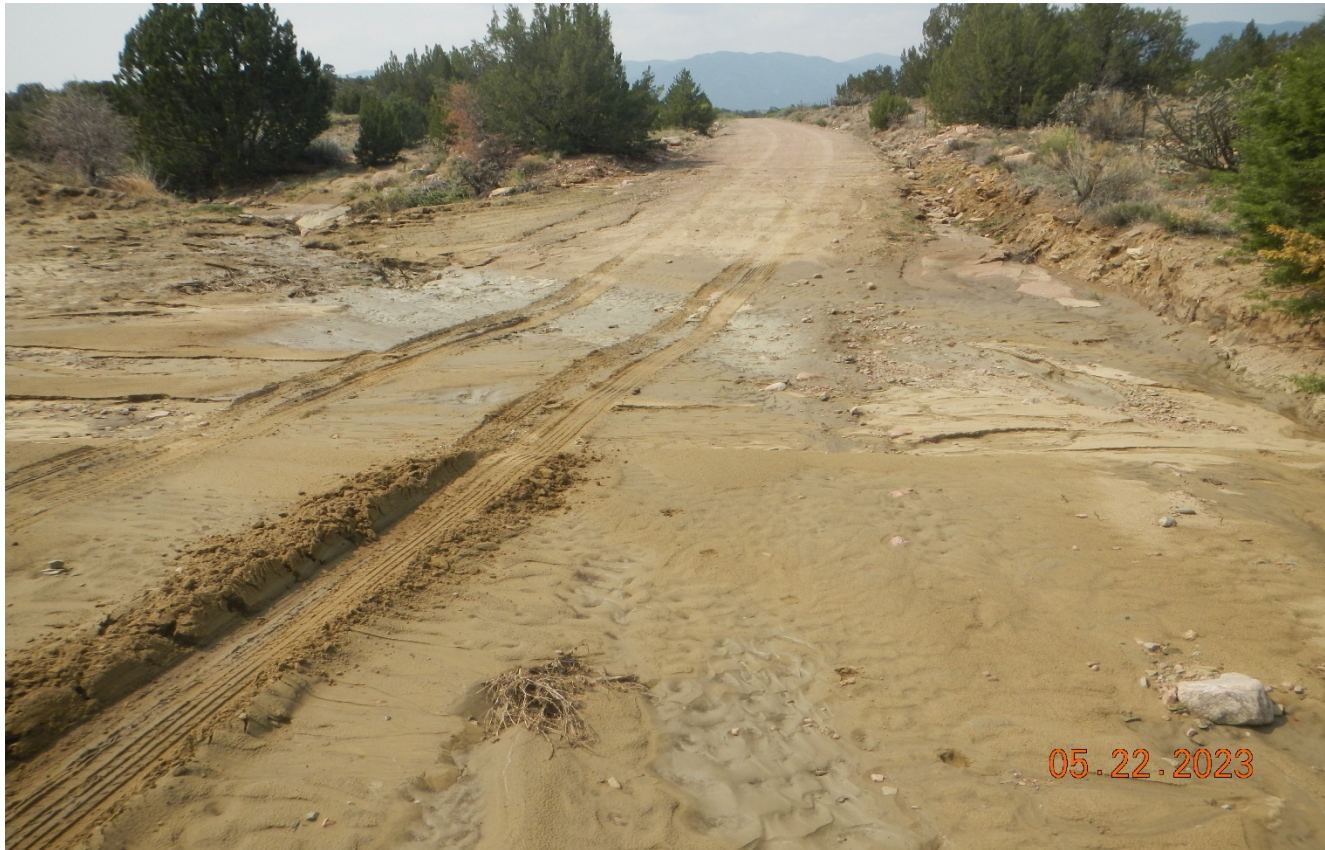
**Photo 1.** Facing south along the access road. There is erosion that occurred at the drainage crossing from recent storm event. The road has been washed out and needs to be repaired and BMP's need to be installed at the drainage crossing such as an adequately sized culvert.

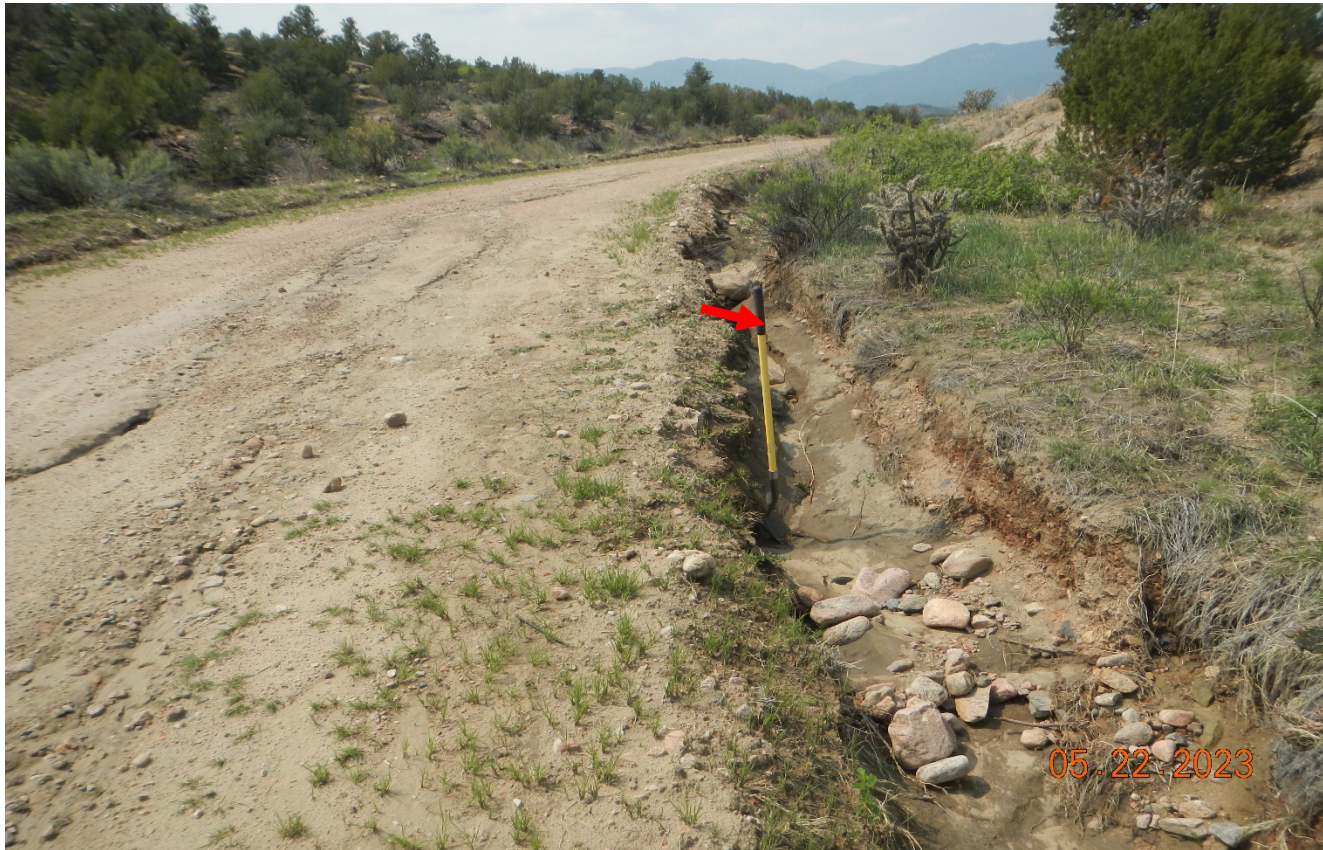
**Photo 2.** There is erosion along the road side that needs to be repaired and stabilized with BMP's. Red arrow points to 4.5' shovel for scale. There is a long stretch from this point further along the road with no culverts to divert stormwater off the road. Additional BMP's need to be installed along the road.

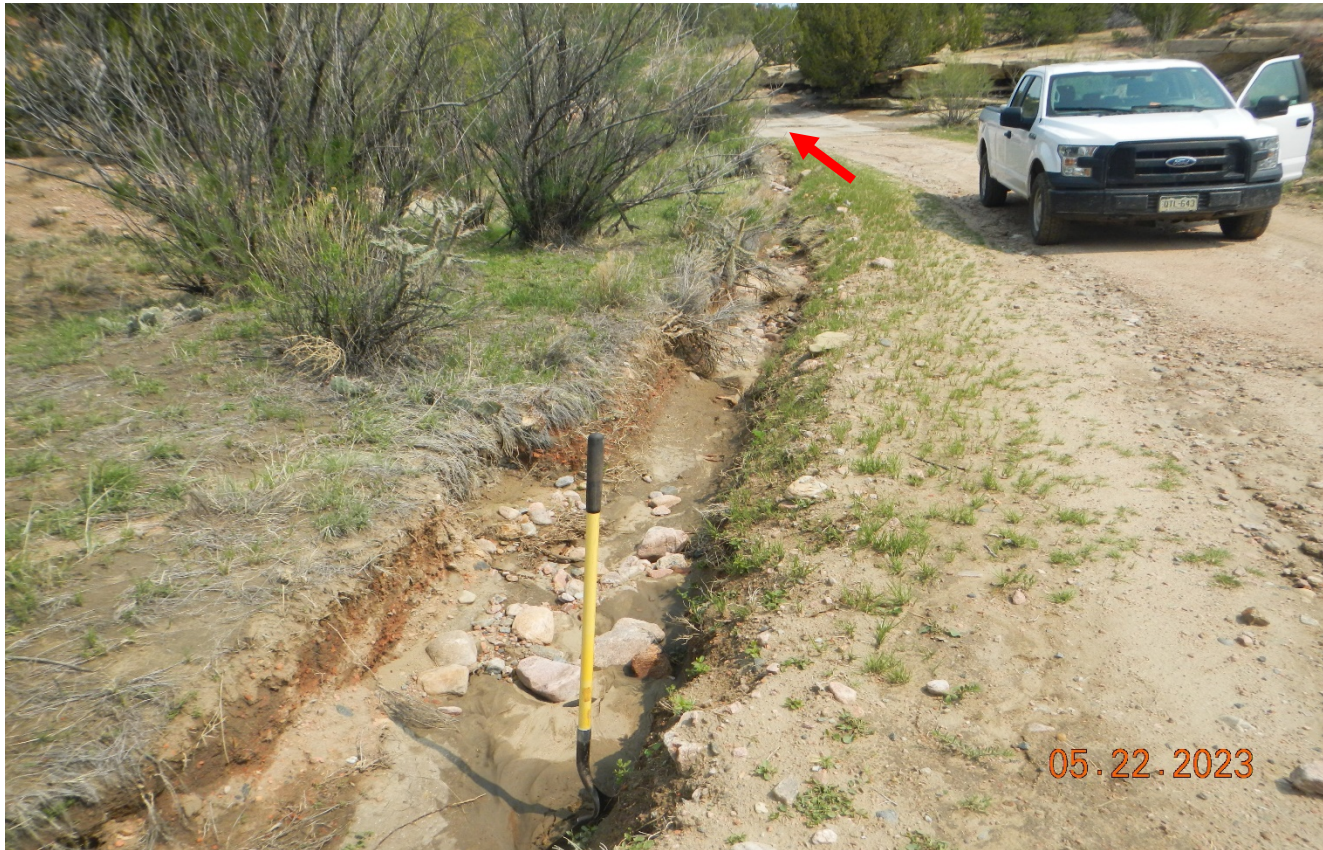
**Photo 3.** Facing back north at same area of erosion shown in previous photo. Stormwater and sediment is directed toward the creek drainage and needs to be repaired and stabilized to prevent erosion.

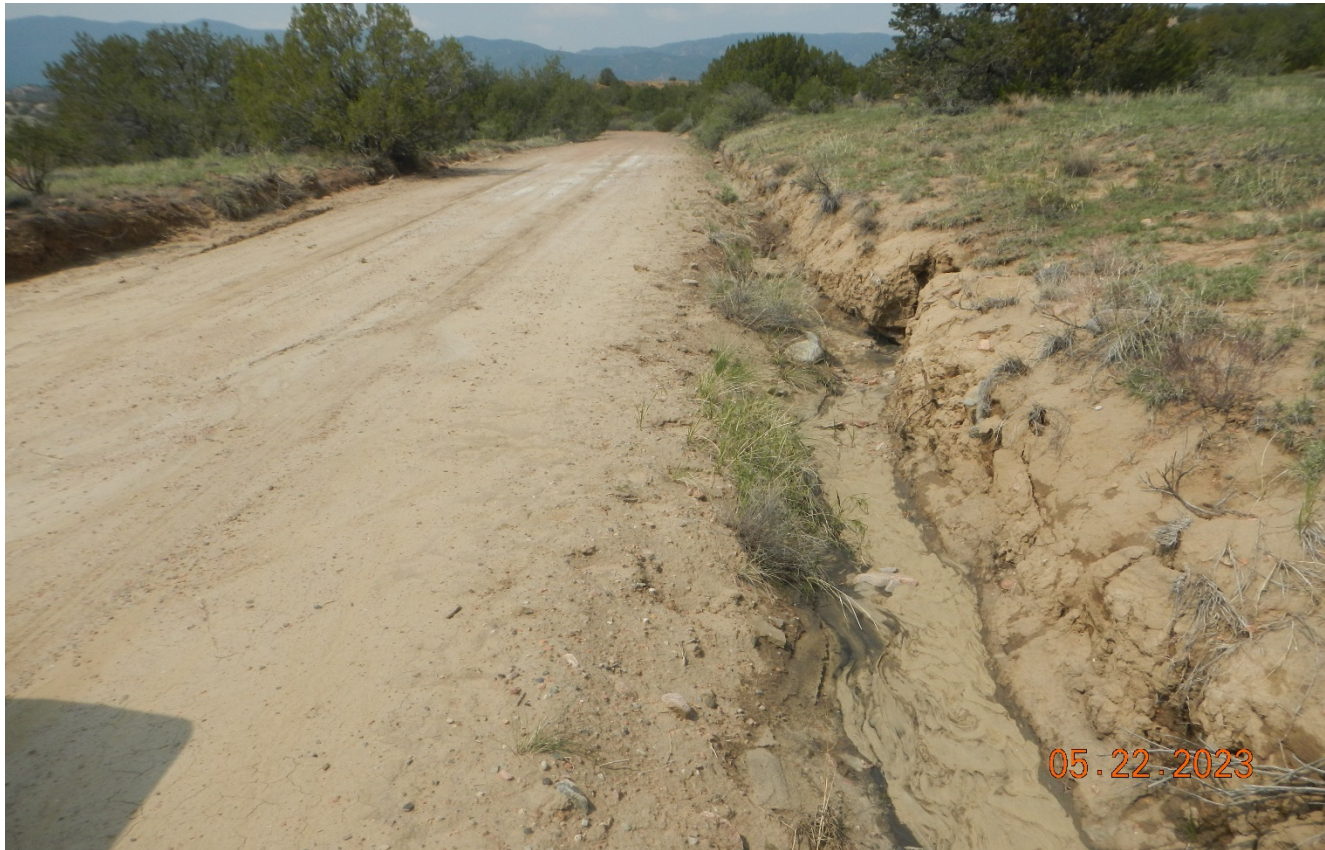
**Photo 4.** Further along the road is additional erosion on the road side that needs to be repaired and stabilized with BMP's.

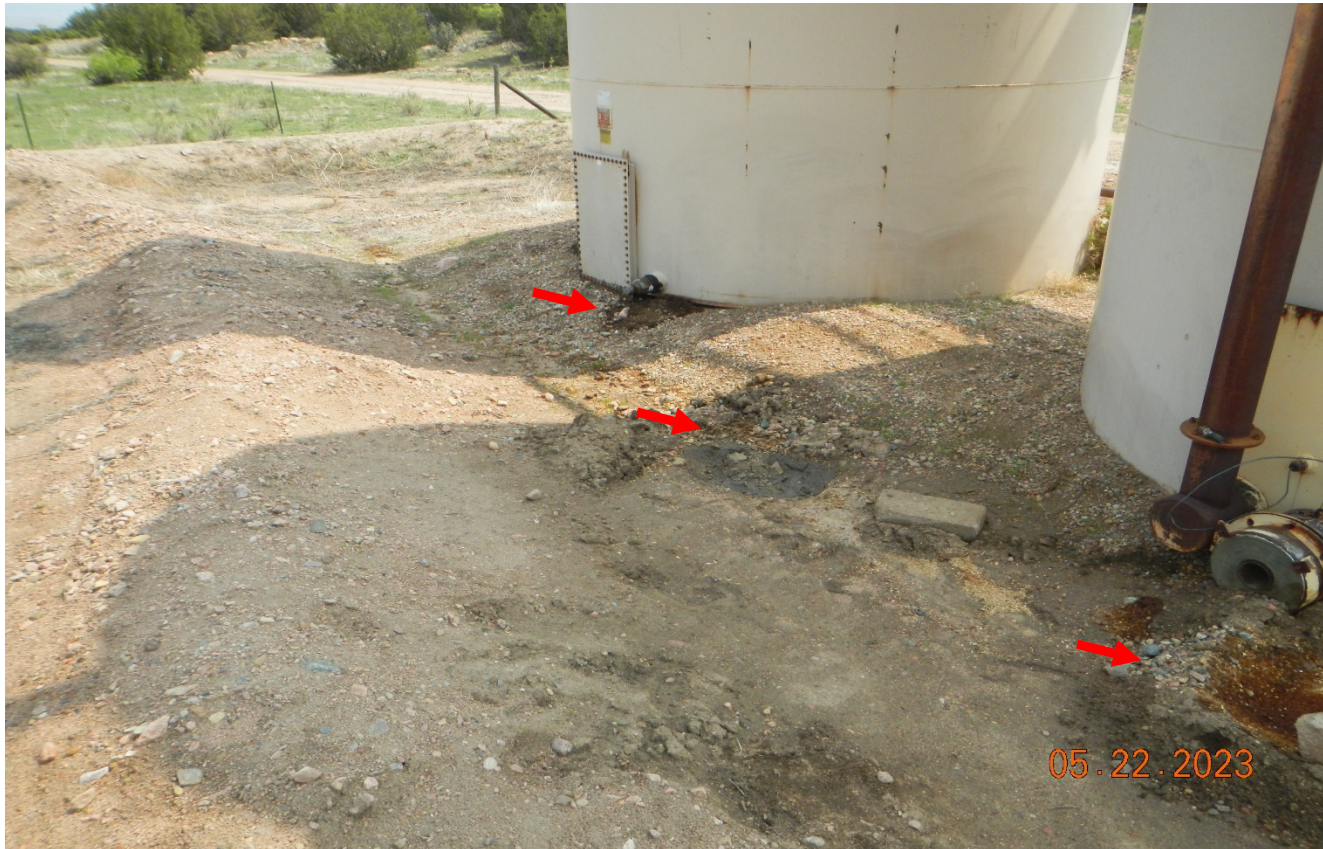
**Photo 6.** There is oil stained soils at back side of tanks shown at red arrows.

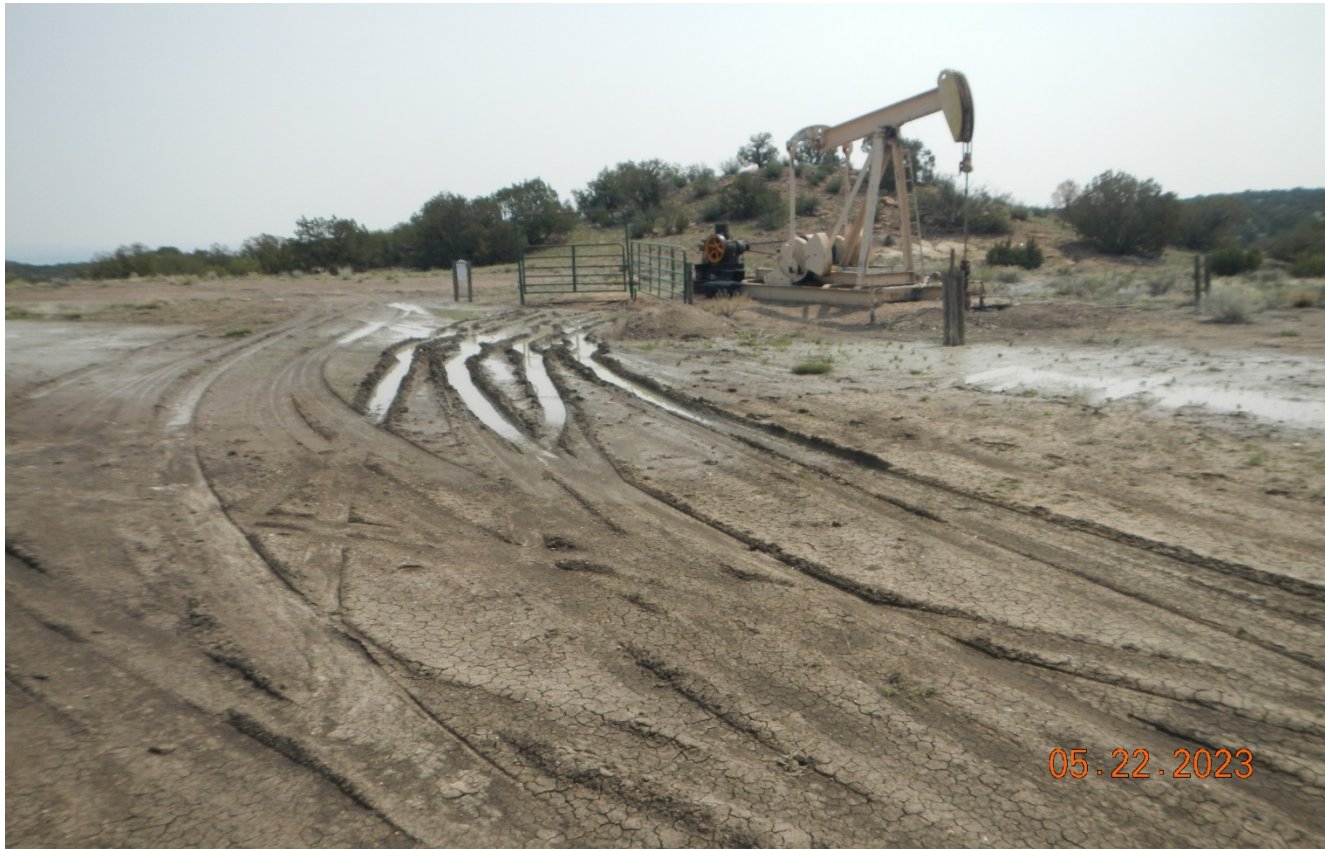
**Photo 7.** Facing northeast toward the wellsite. There is vehicle rutting at the location which is not stabilized.
