# Interim Reclamation and Stormwater Inspection

Date: 05/17/2023

Operator: VERDAD RESOURCES LLC - 10651

Location ID: 466345

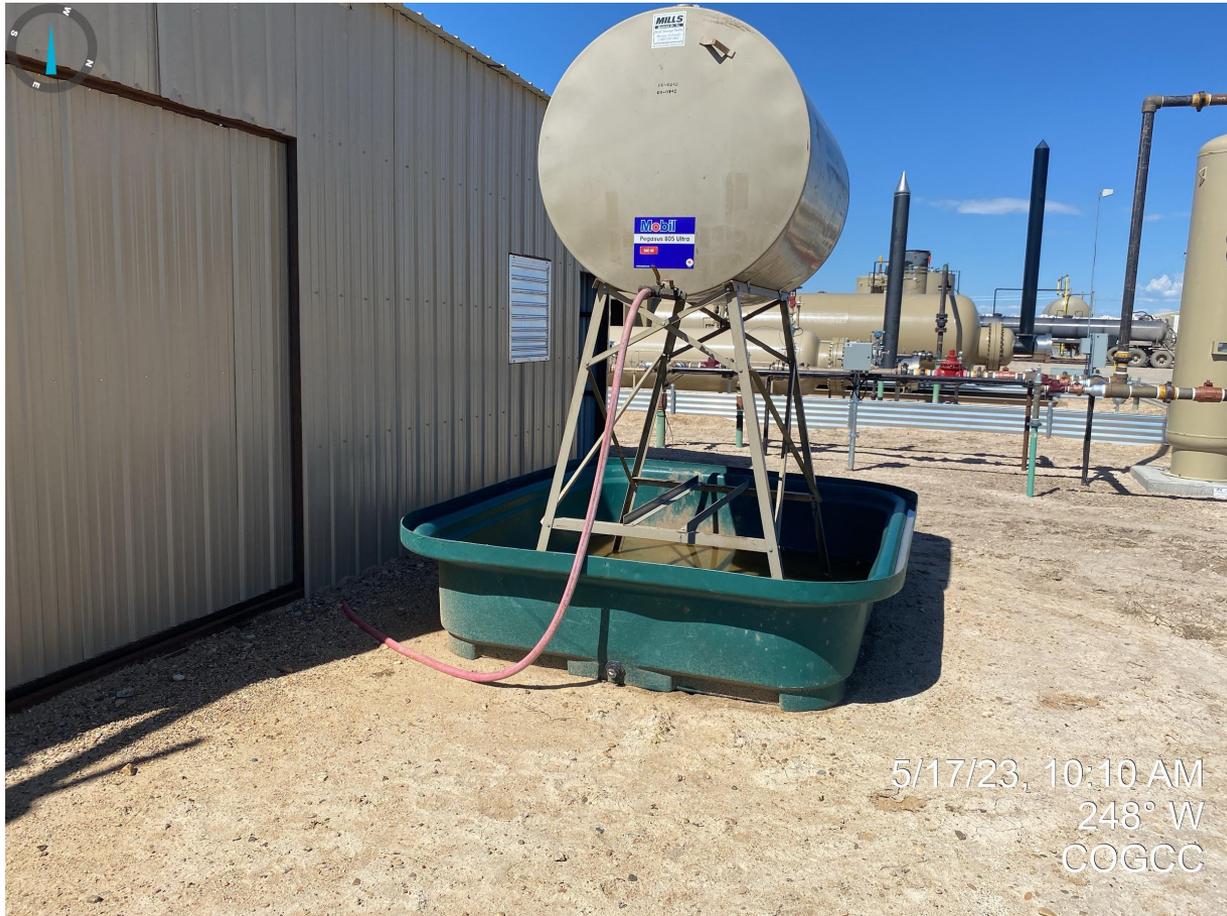
**Photo 1.** No wildlife netting observed at day tank.

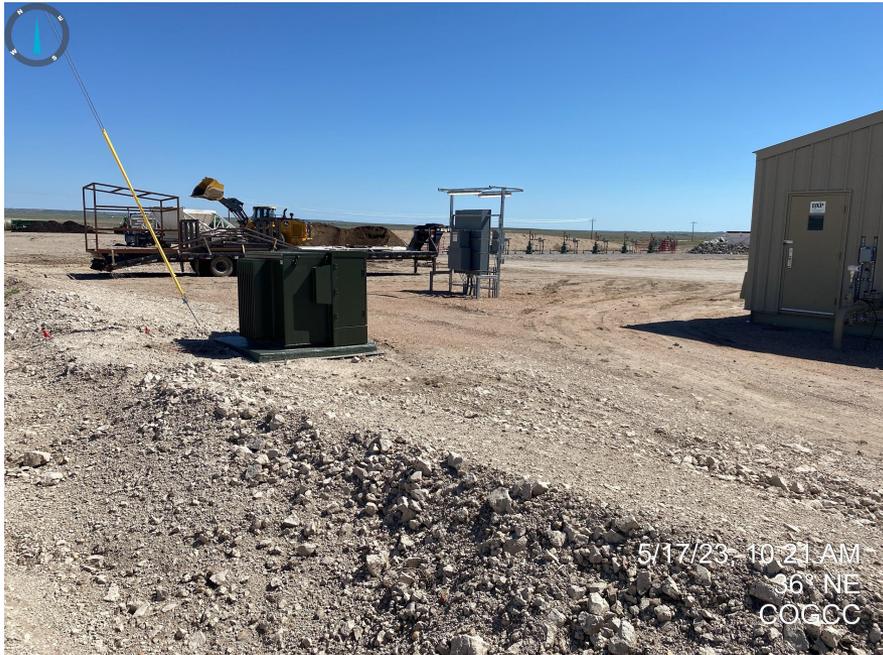
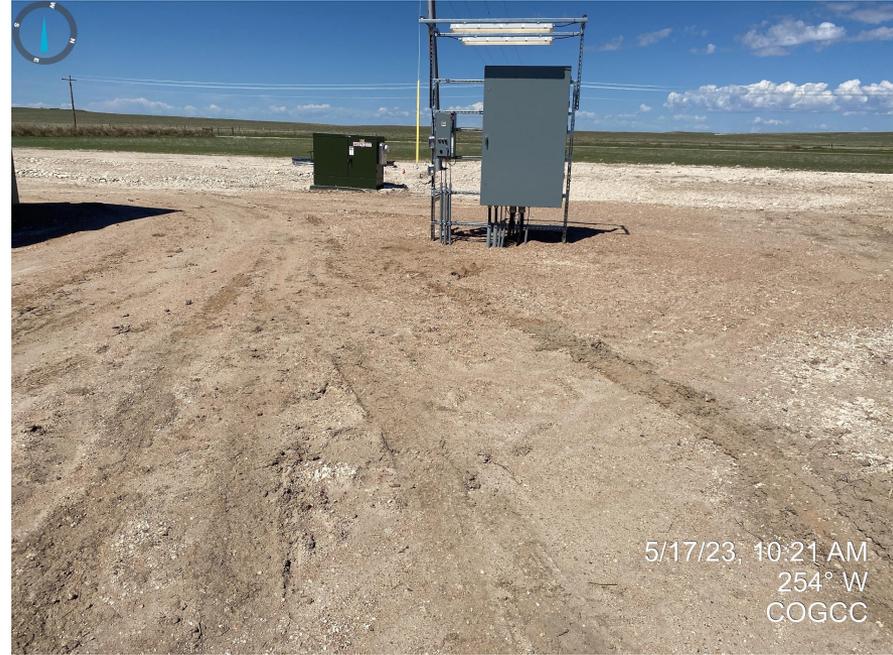
Photos 2 & 3. Open excavation/trenching previously identified appears to have been corrected.

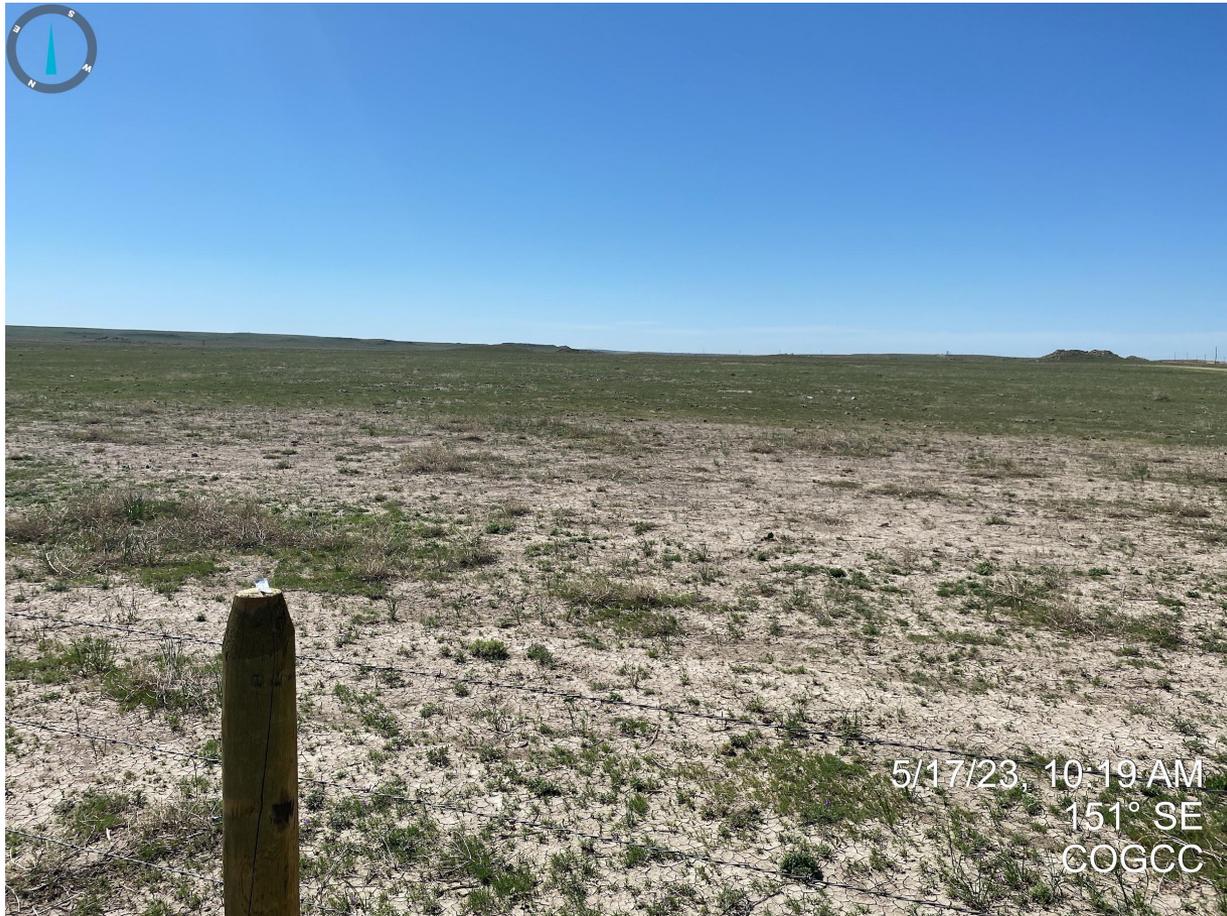
**Photo 4.** Appears the Operator has removed the trash previously identified.

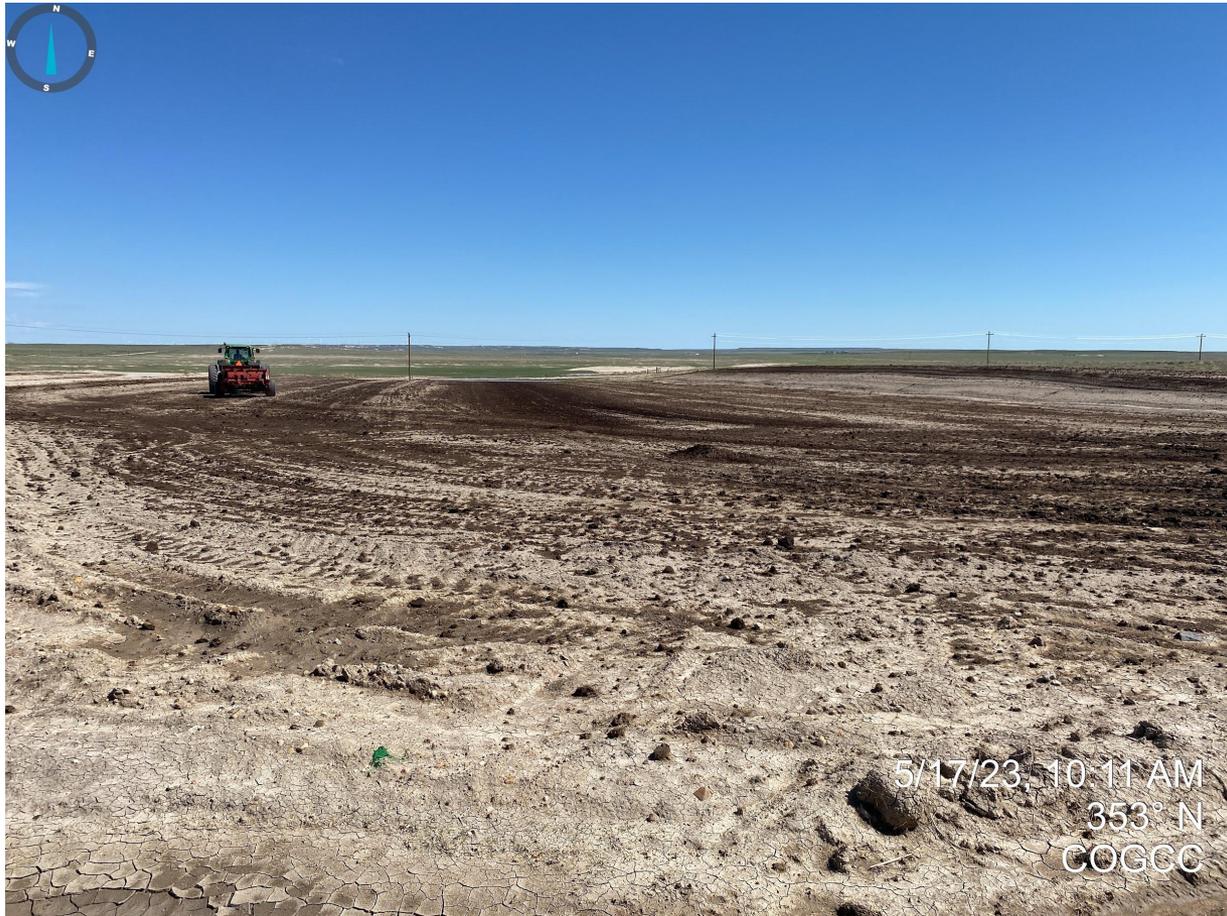
**Photo 5.** Facing north towards the interim areas. Appears the production area has been reduced in size, topsoil have been placed back to its relative position and recontoured. Crews were observed to be performing reclamation activities at the time of this inspection, therefore this is being left “In-Process”.

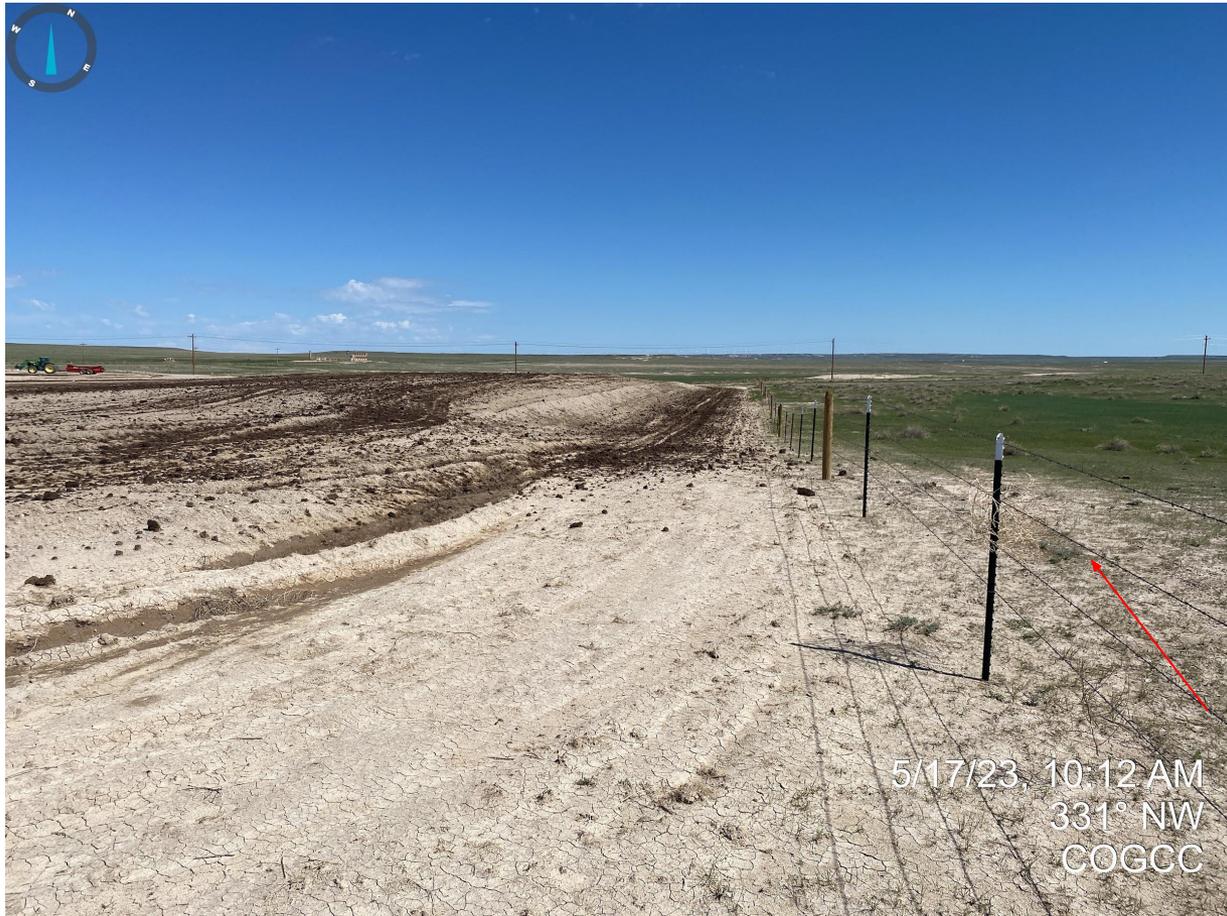
**Photo 6.** Facing northwest from the southeast corner. No apparent stormwater BMPs were identified around the perimeter of the location or around the topsoil stockpile. Blow sand evident and is indicated by red arrow.

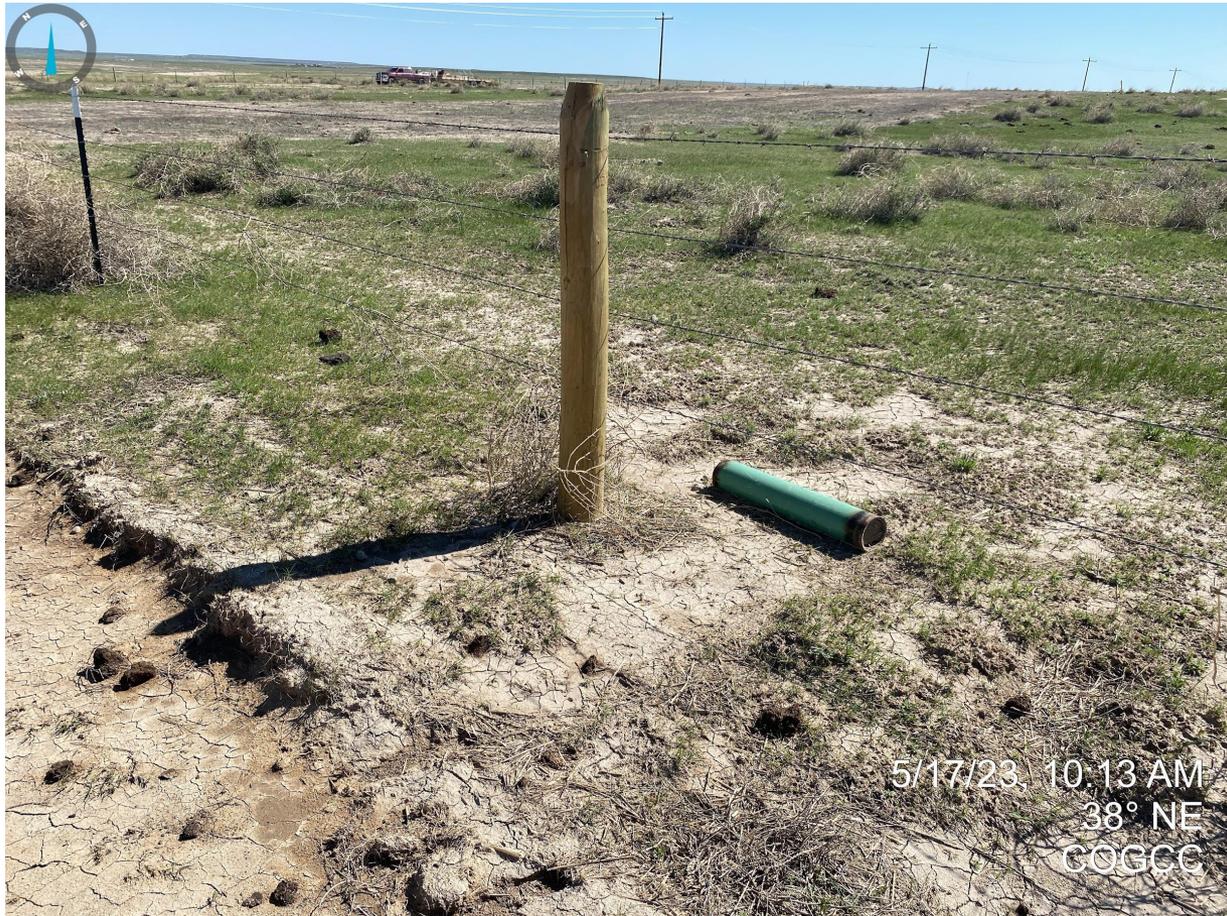
**Photo 7.** Unused equipment/debris will need to be removed.

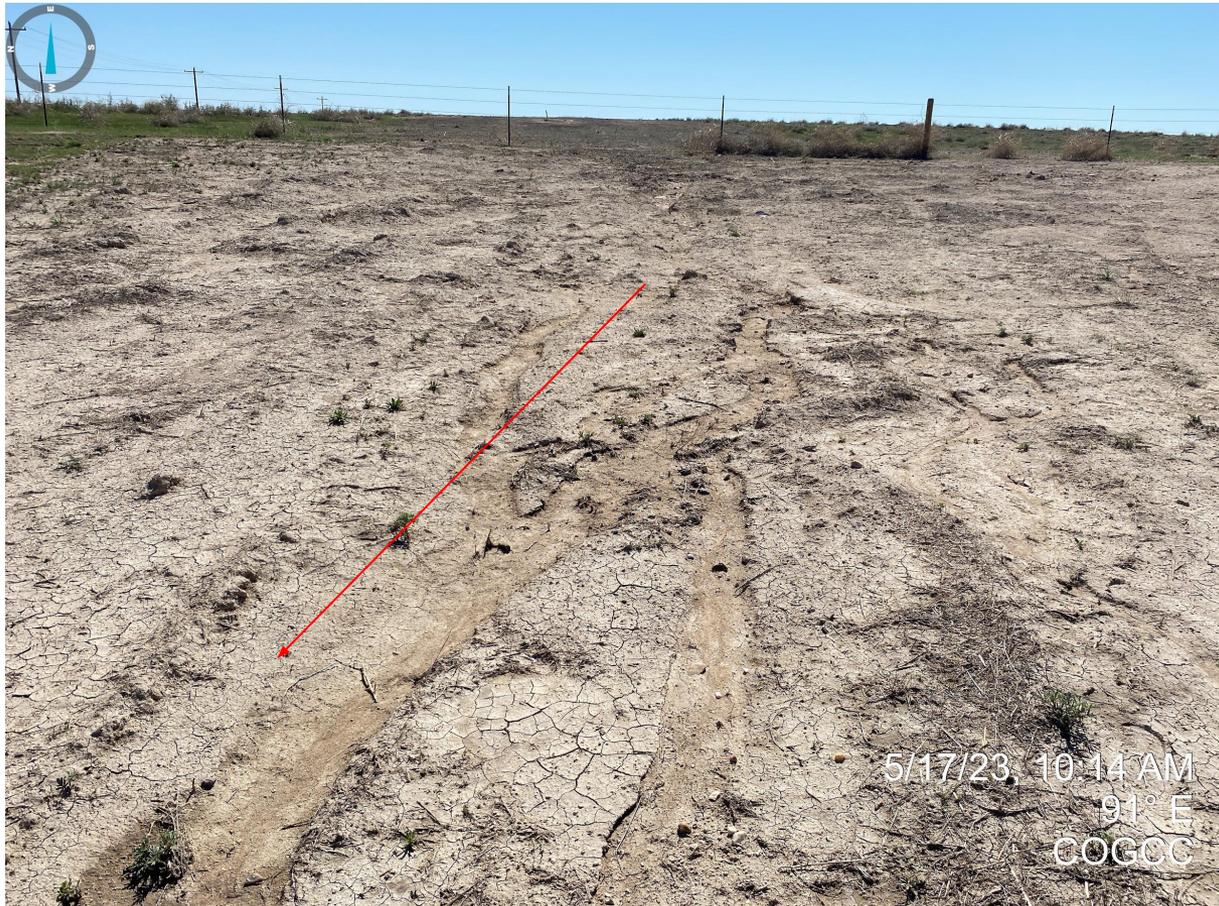
**Photo 8.** Staff observed that areas being actively reclaimed, and other portions of the location in the northeast corner, had evidence of rill erosion and sediment transport. No apparent stormwater controls were identified on the northeastern portion of the location. More robust stormwater BMPs should be implemented to prevent sediment laden stormwater from entering adjacent lands.

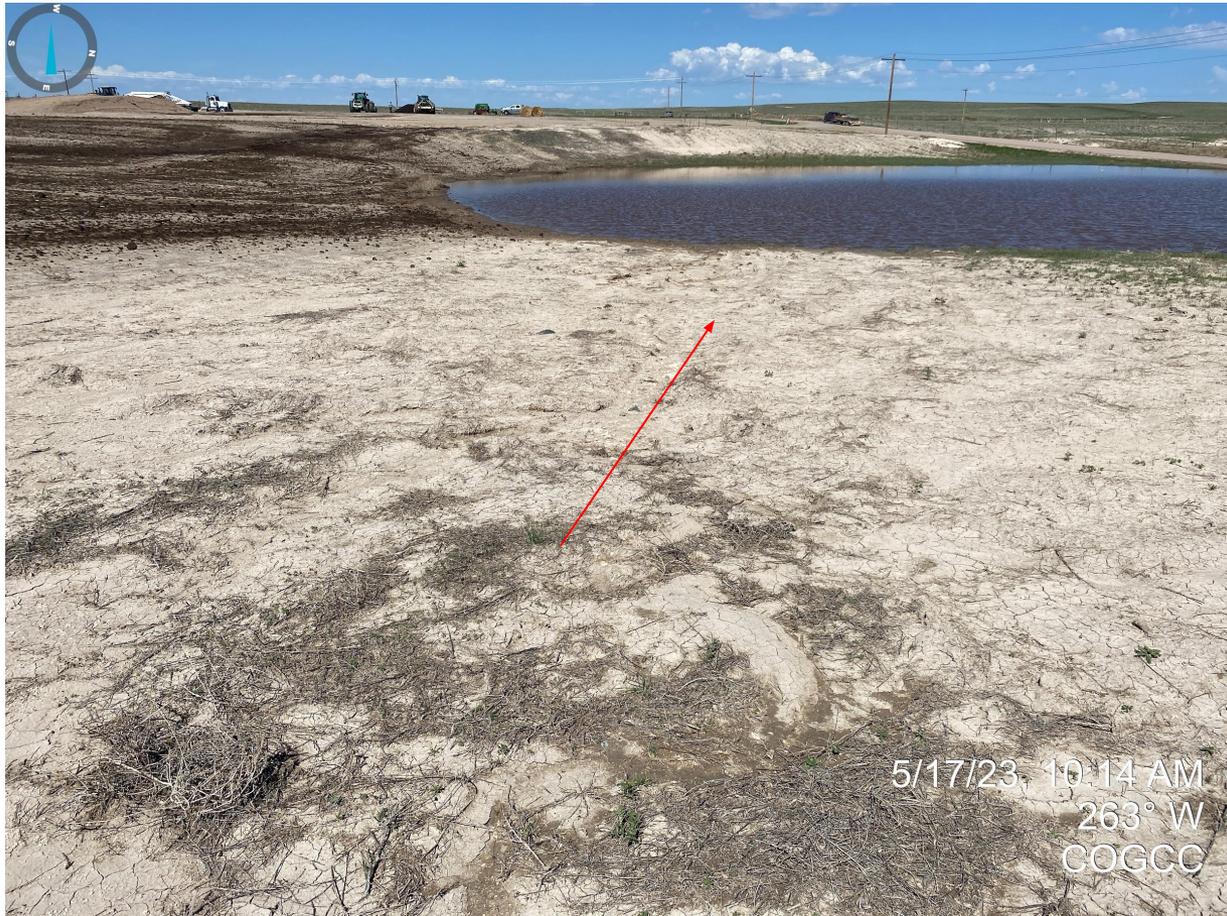
**Photo 9.** Continued from previous photo, facing west; See comments in Photo 8.

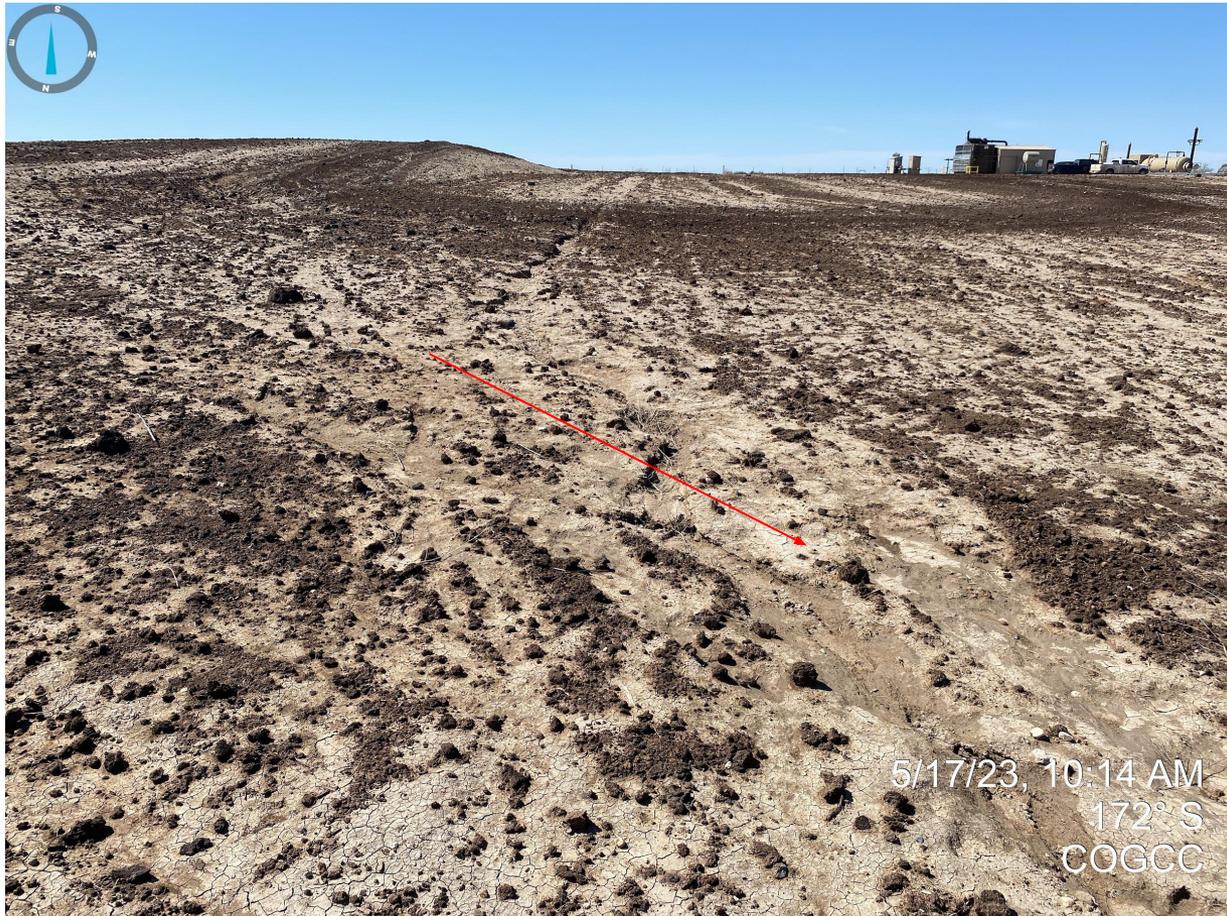
Photo 10. See comments in Photo 8.

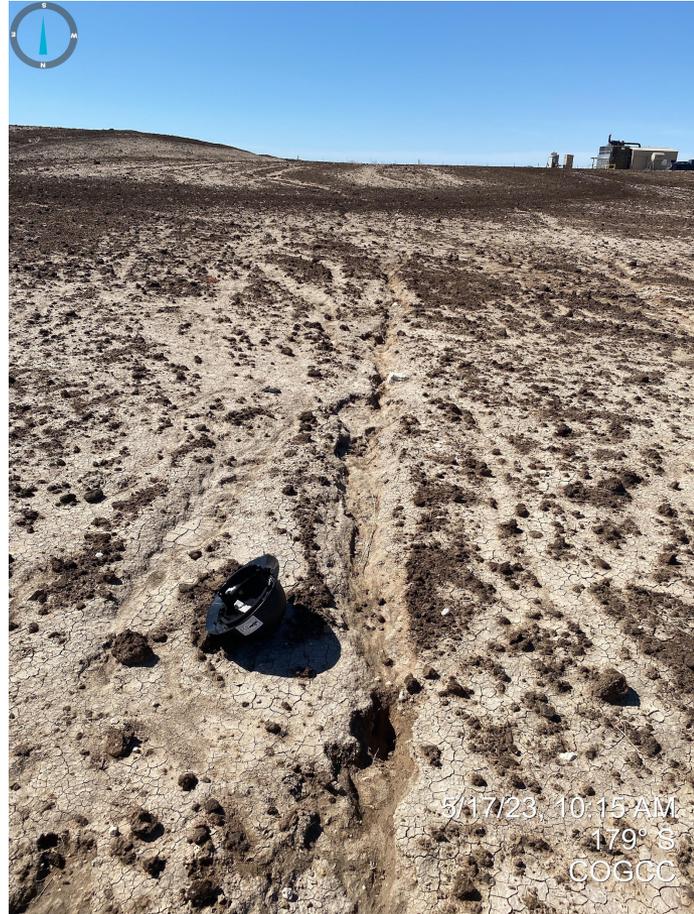
**Photo 11.** See comments in Photo 8.

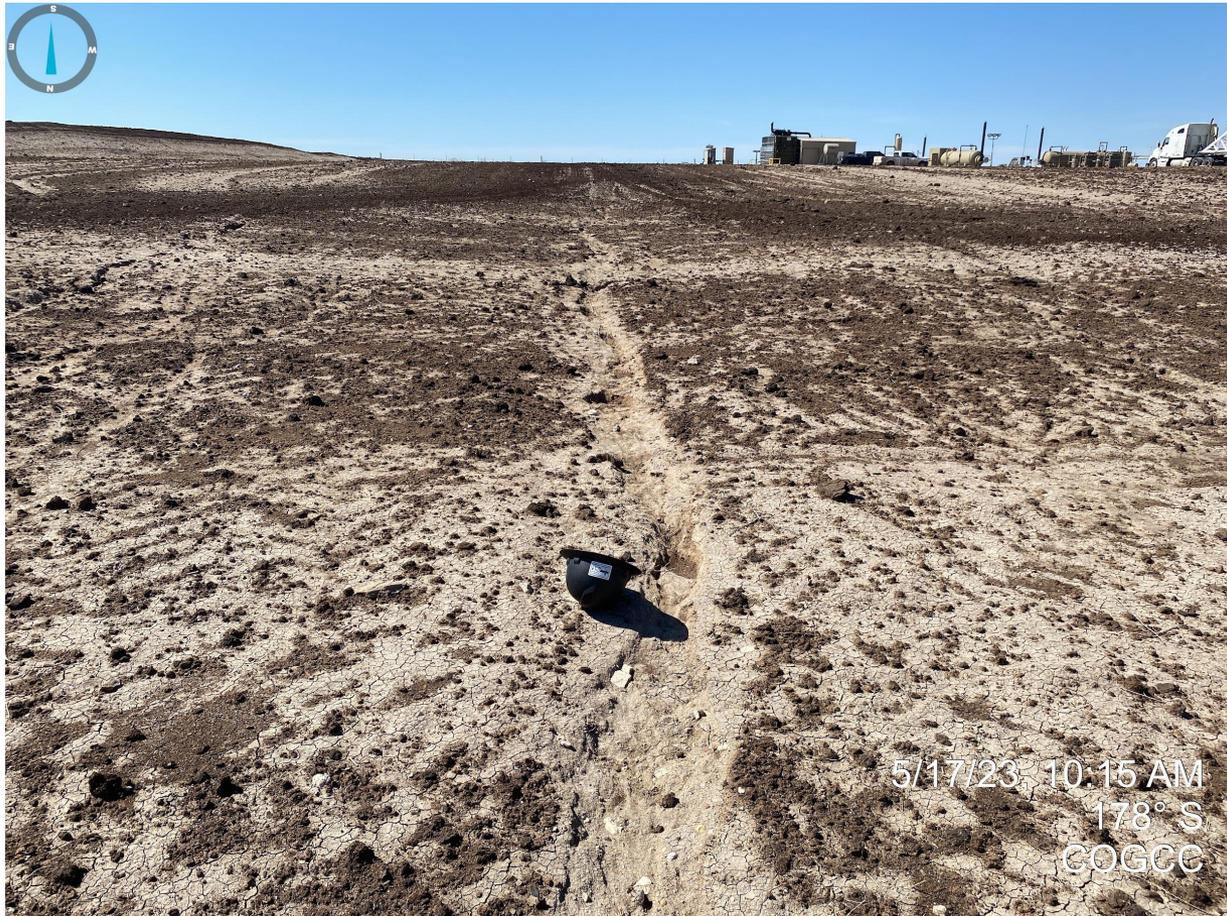
Photo 12. See comments in Photo 8.

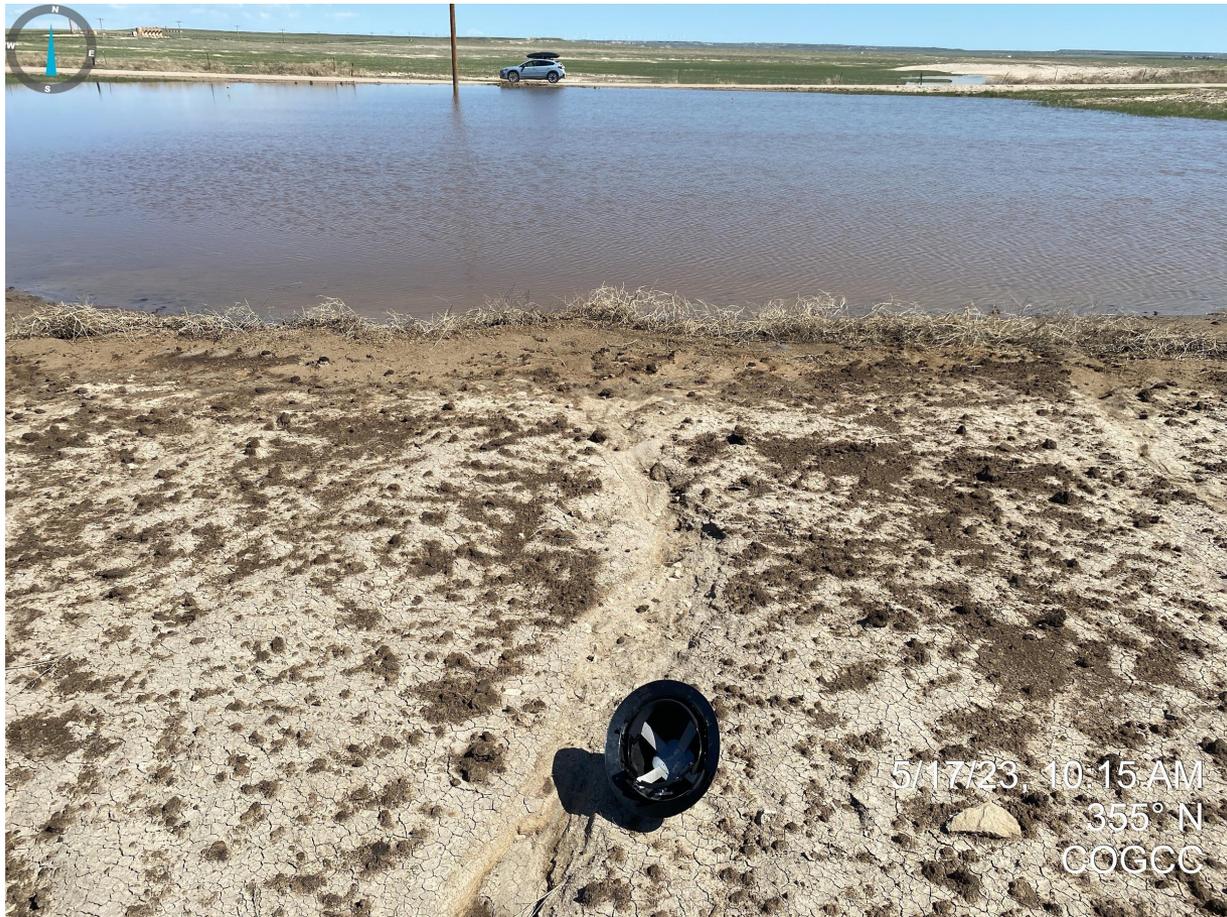
**Photo 13.** Continued from previous photo; see comments in Photo 8.

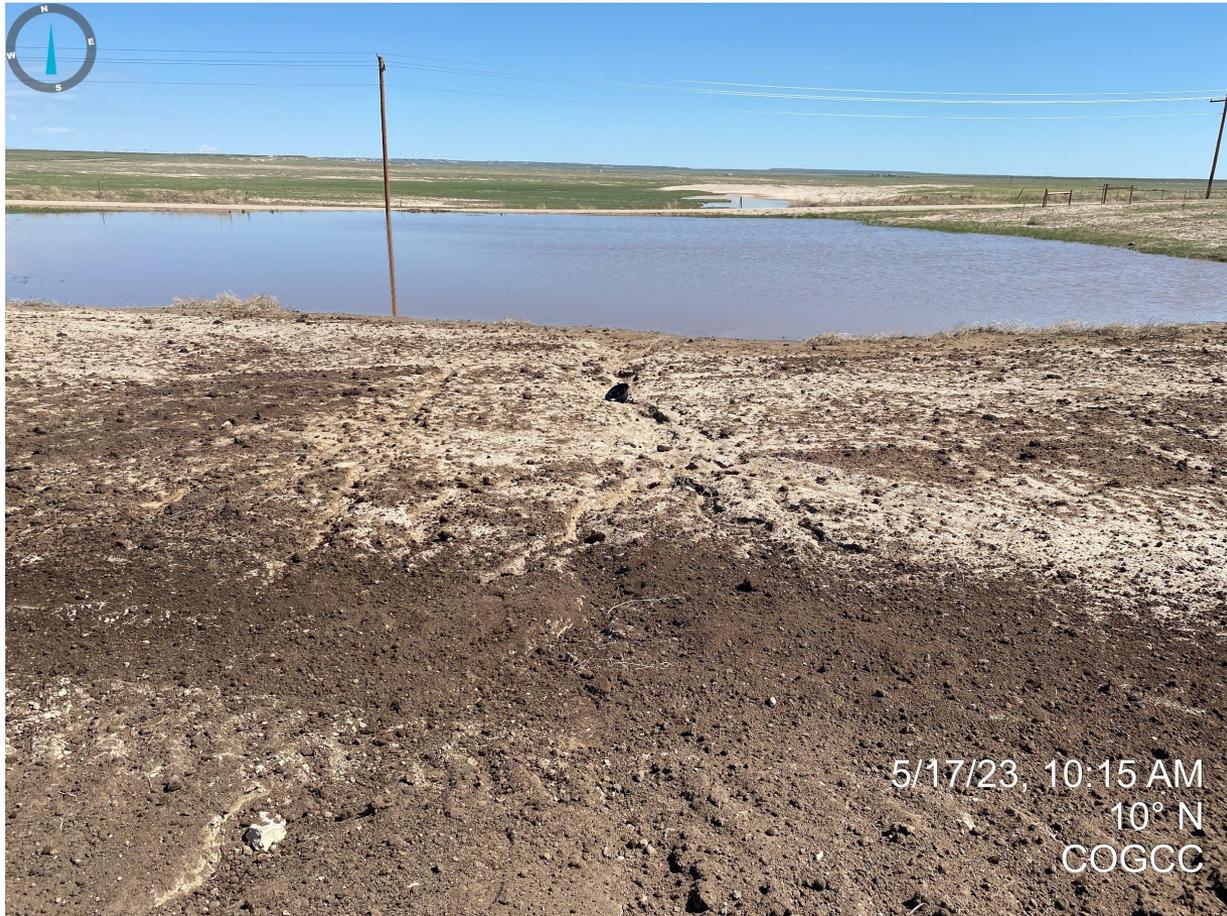
**Photo 14.** Continued from Photos 12 and 13; see comments in Photo 8.

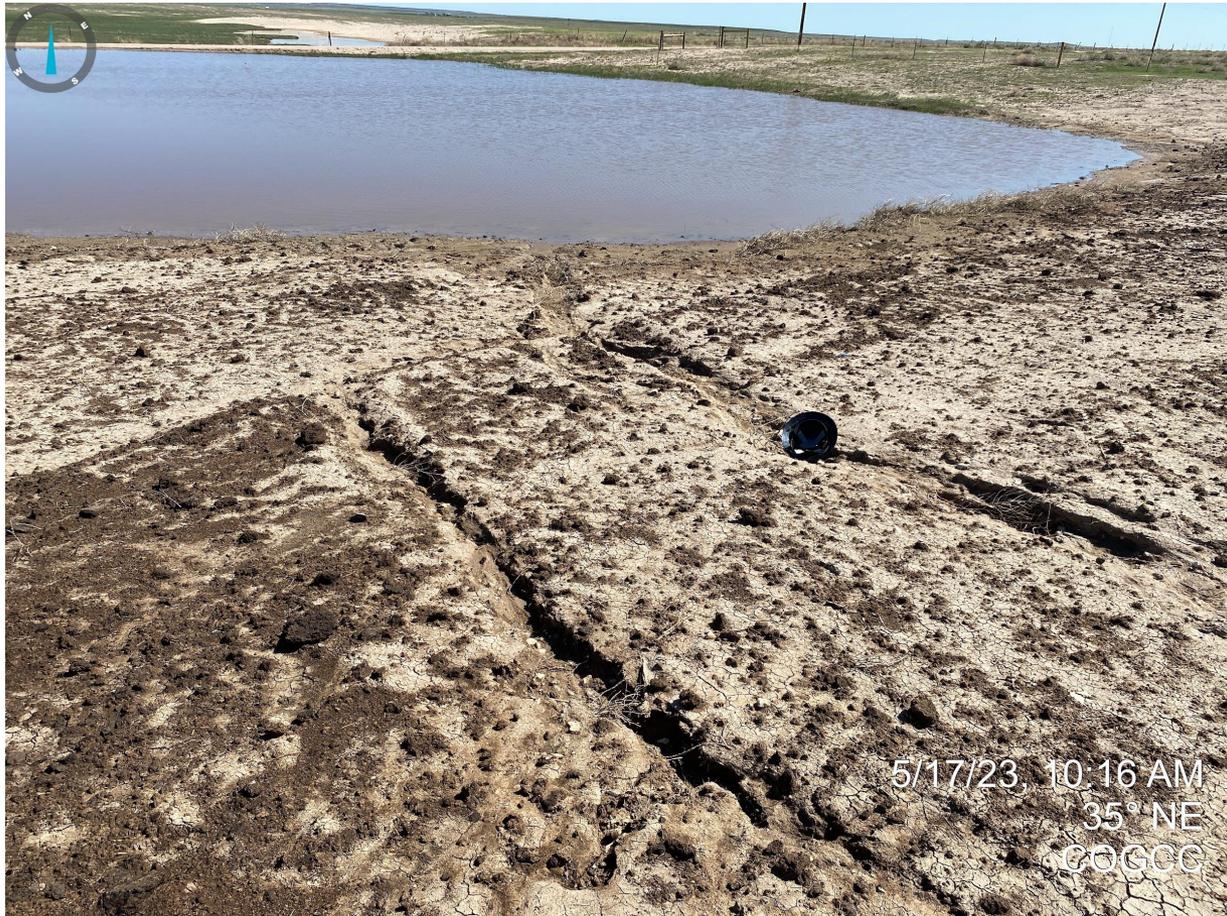
Photo 15. See comments in Photo 8.

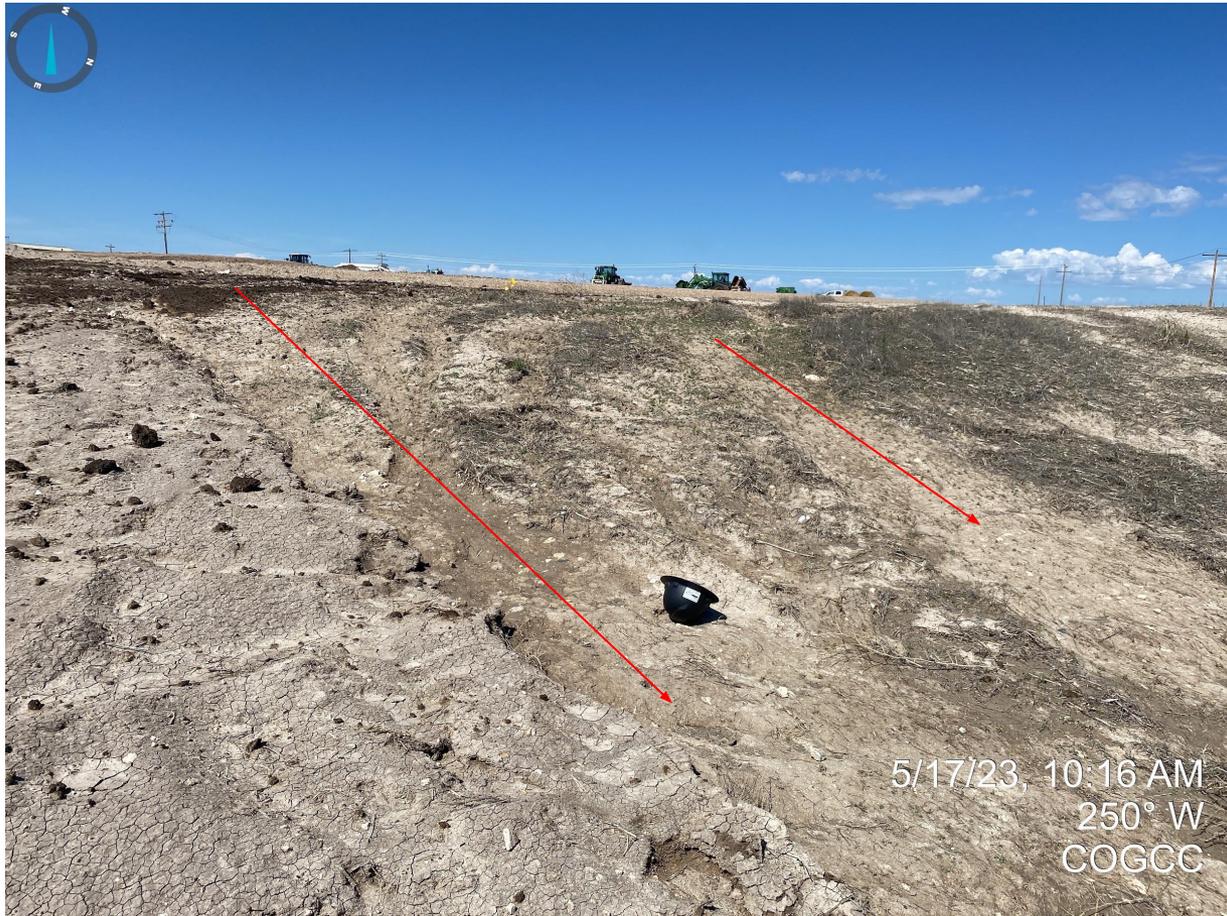
Photo 16. See comments in Photo 8.

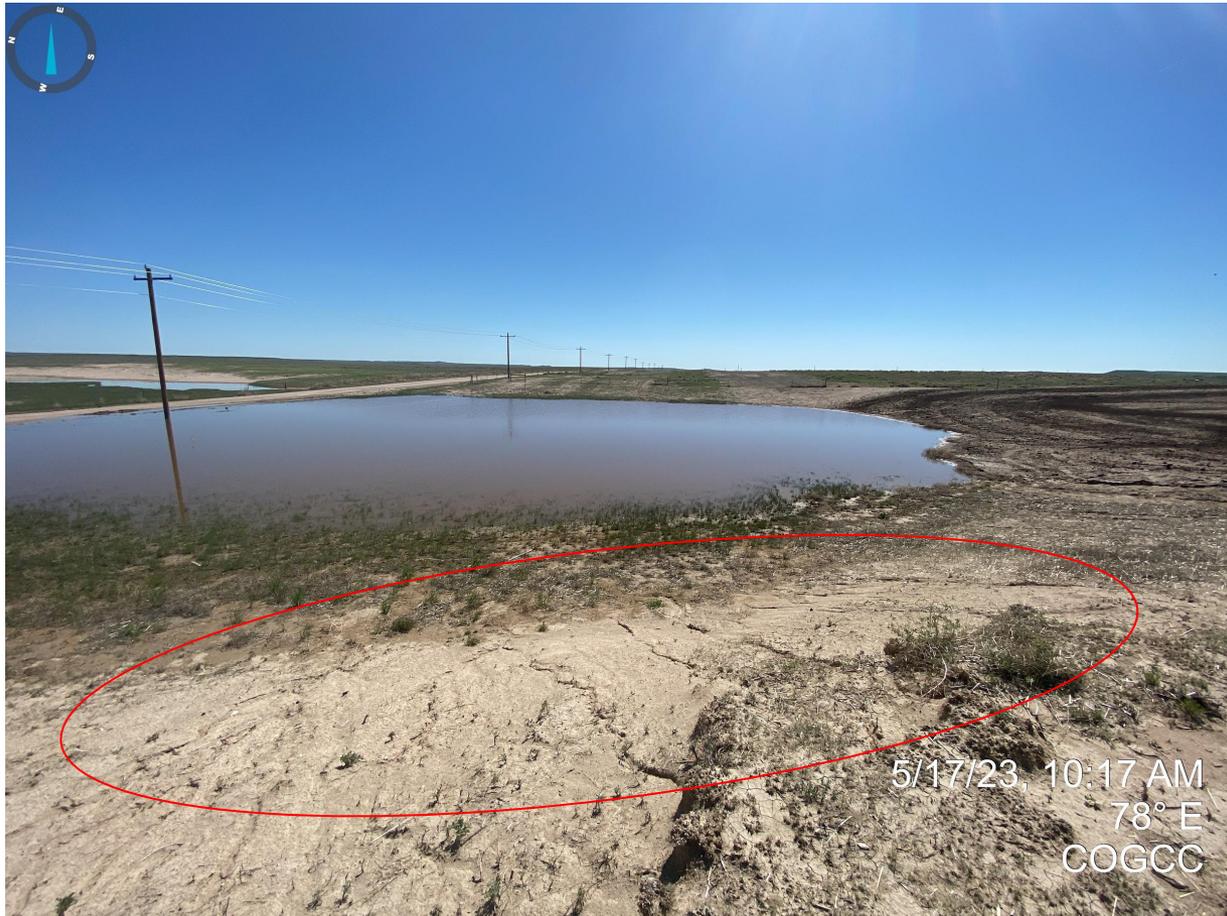
**Photo 17.** See comments in Photo 8.
