# Fulcrum Energy Operating – North Park Basin

Surprise Damfino S6 Pad - 10/21/2022

Attachment F - Photolog

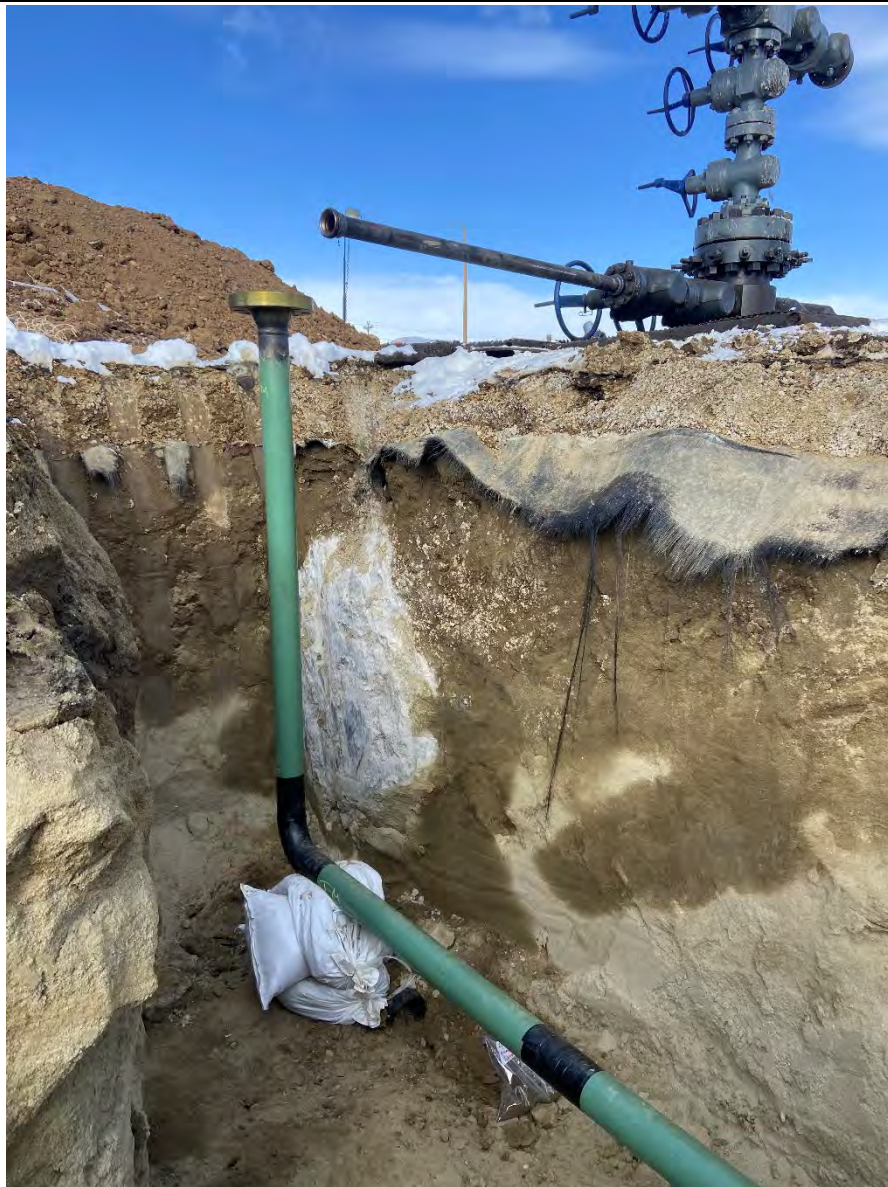
PHOTO No 1: VISUAL STAINING ON SIDEWALL OF NORTHERN MOST WELLHEAD. SAMPLE LOCATION OF SS\_WELLHEAD.

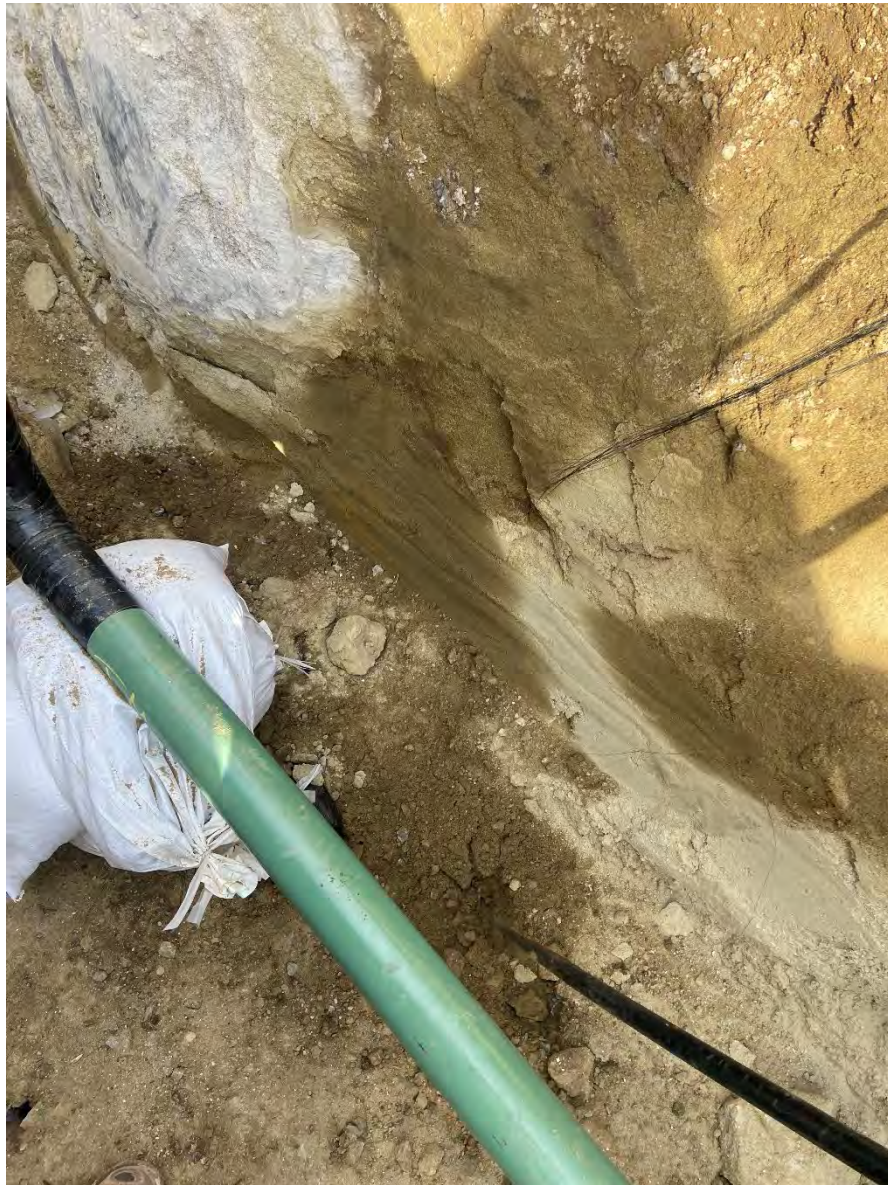
PHOTO NO 2: BOTTOM OF TRENCH AT SAMPLE LOCATION SS\_WELLHEAD WHERE VISUAL STAINING WAS OBSERVED.

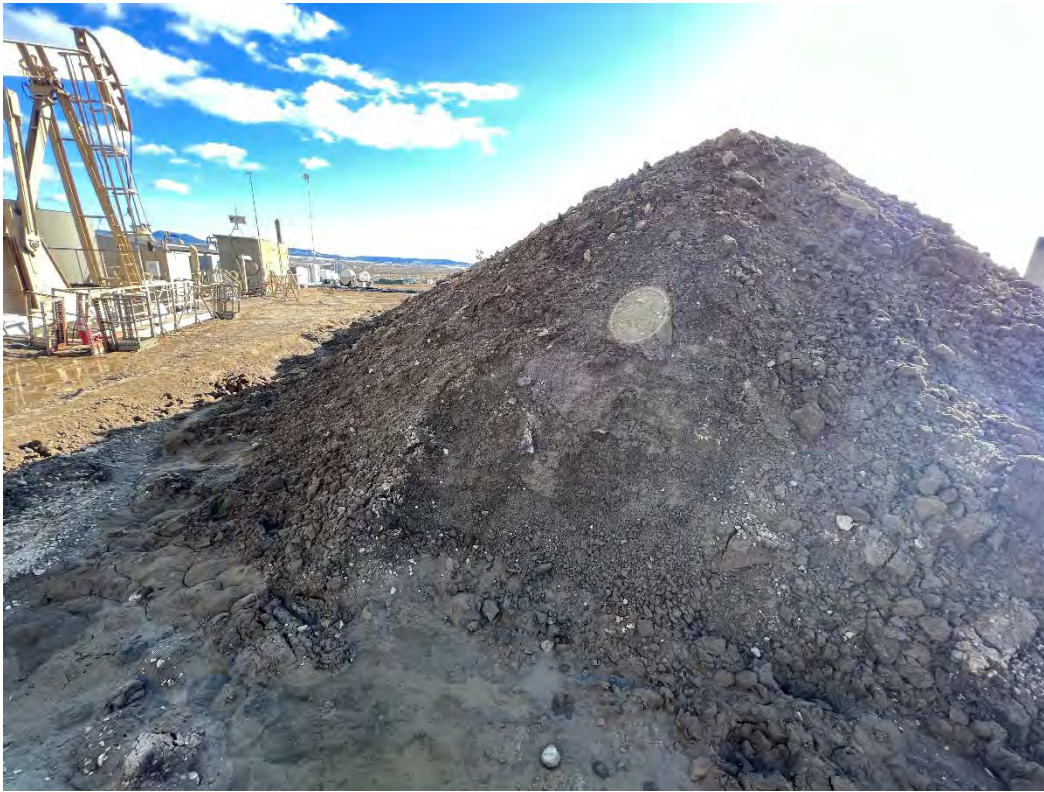
PHOTO NO 5: STOCKPILED CONTAMINATED SOIL PILE
