Inspection Photos

Loc: 429093

Operator: AUSCO PETROLEUM INC

Inspection Date: 5/22/2023

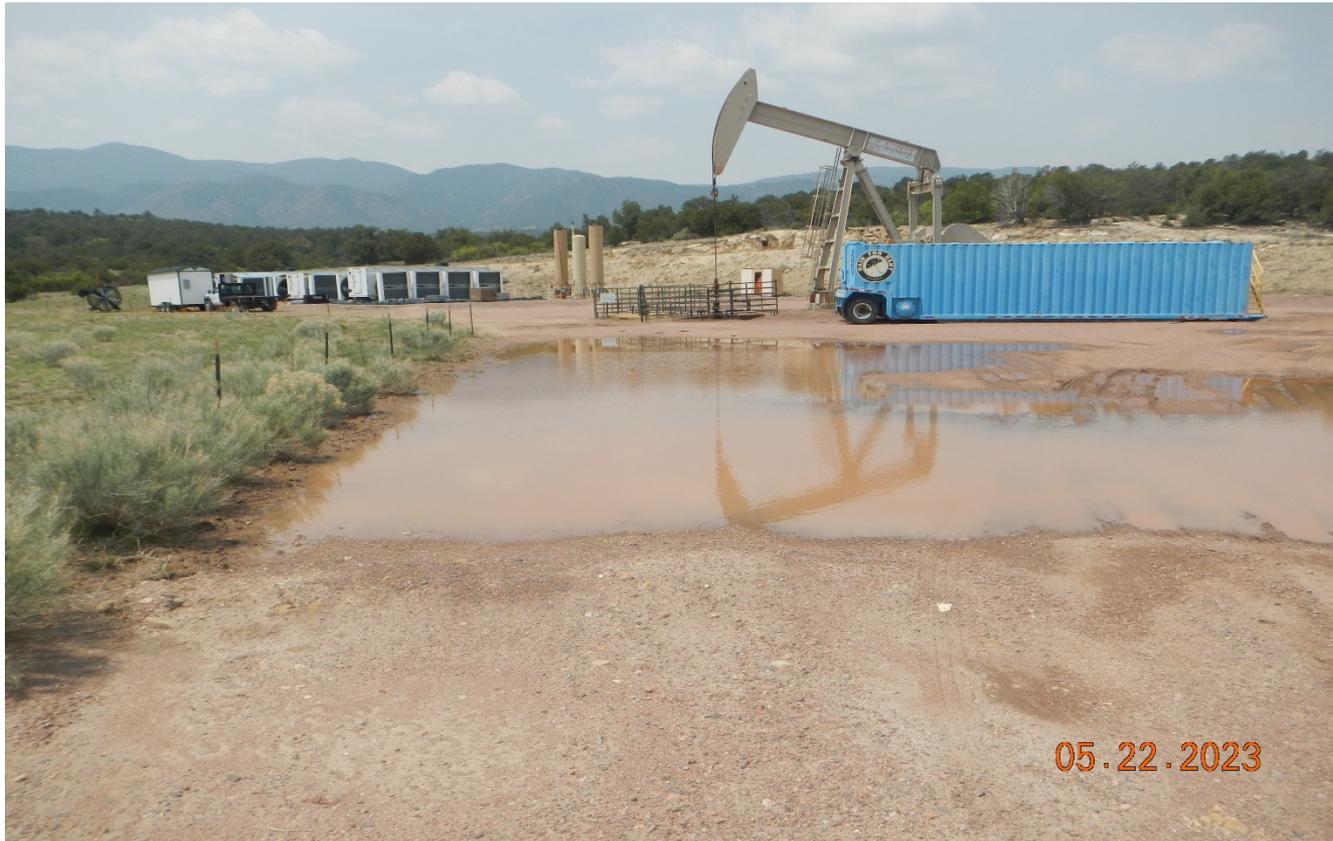
Photo 1. Facing southwest toward the location.

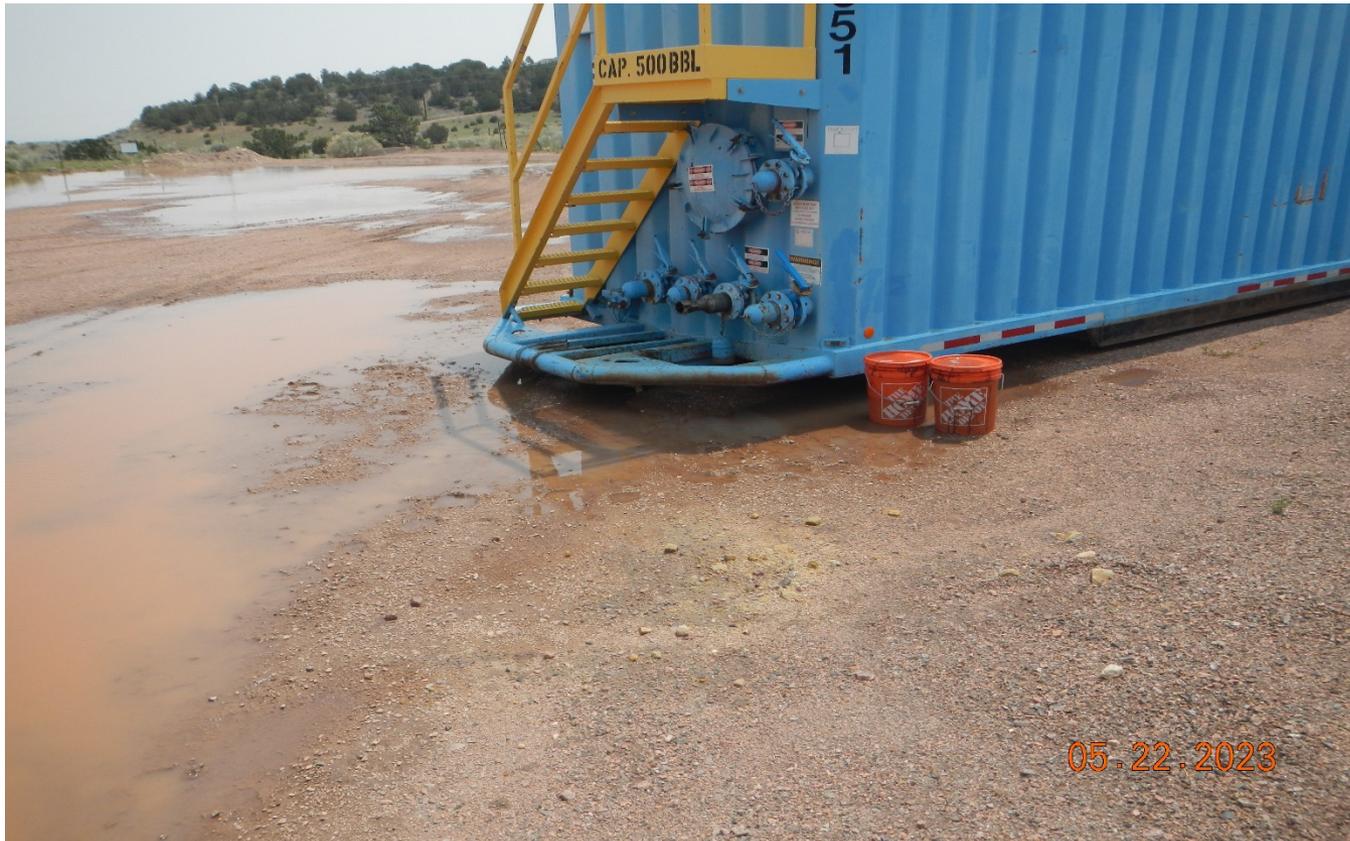
Photo 2. The blue frac tank does not have secondary containment and needs to be removed. There is 2 orange buckets that appear to have oil with no labeling and no containment.

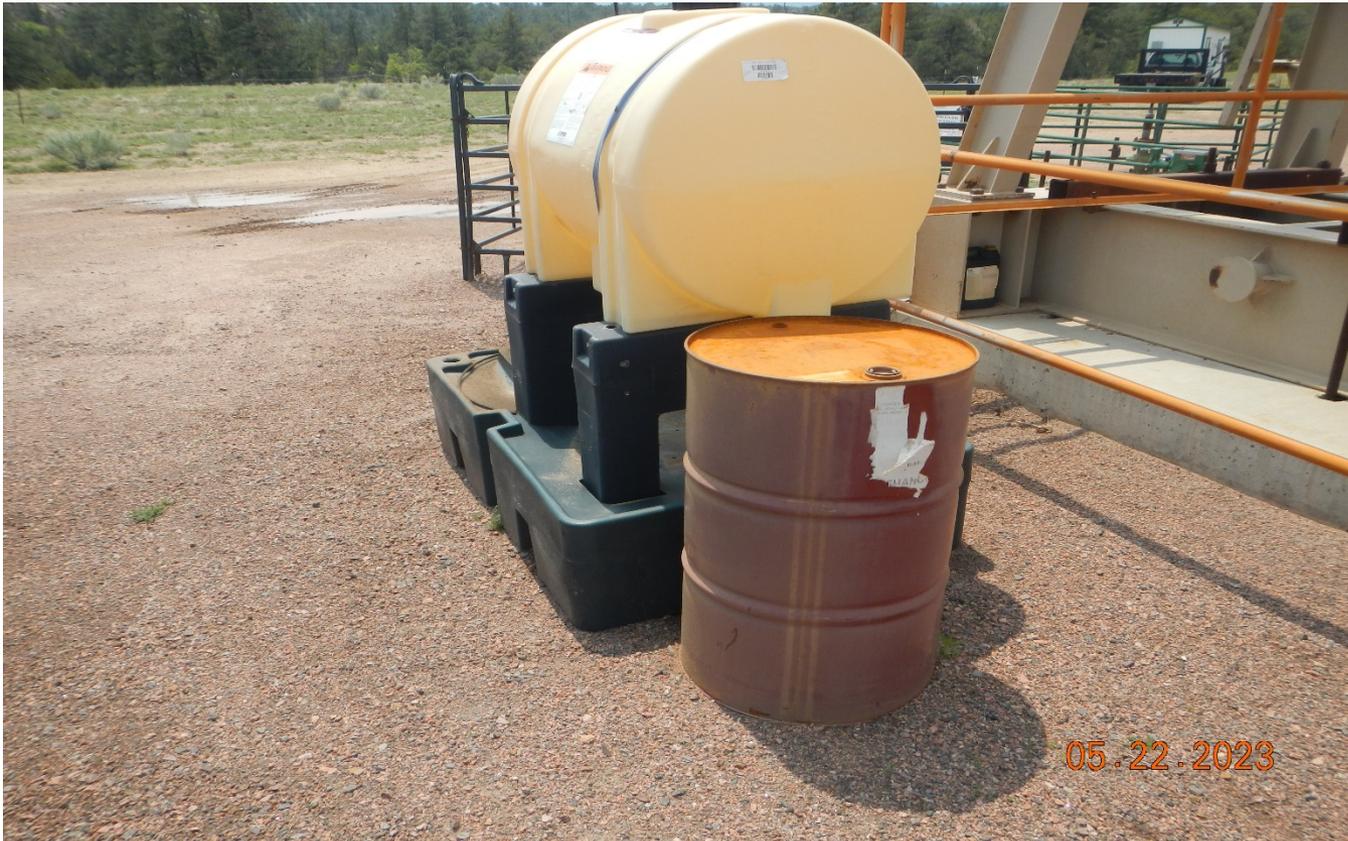
Photo 3. There is an unknown barrel with no labeling or containment.

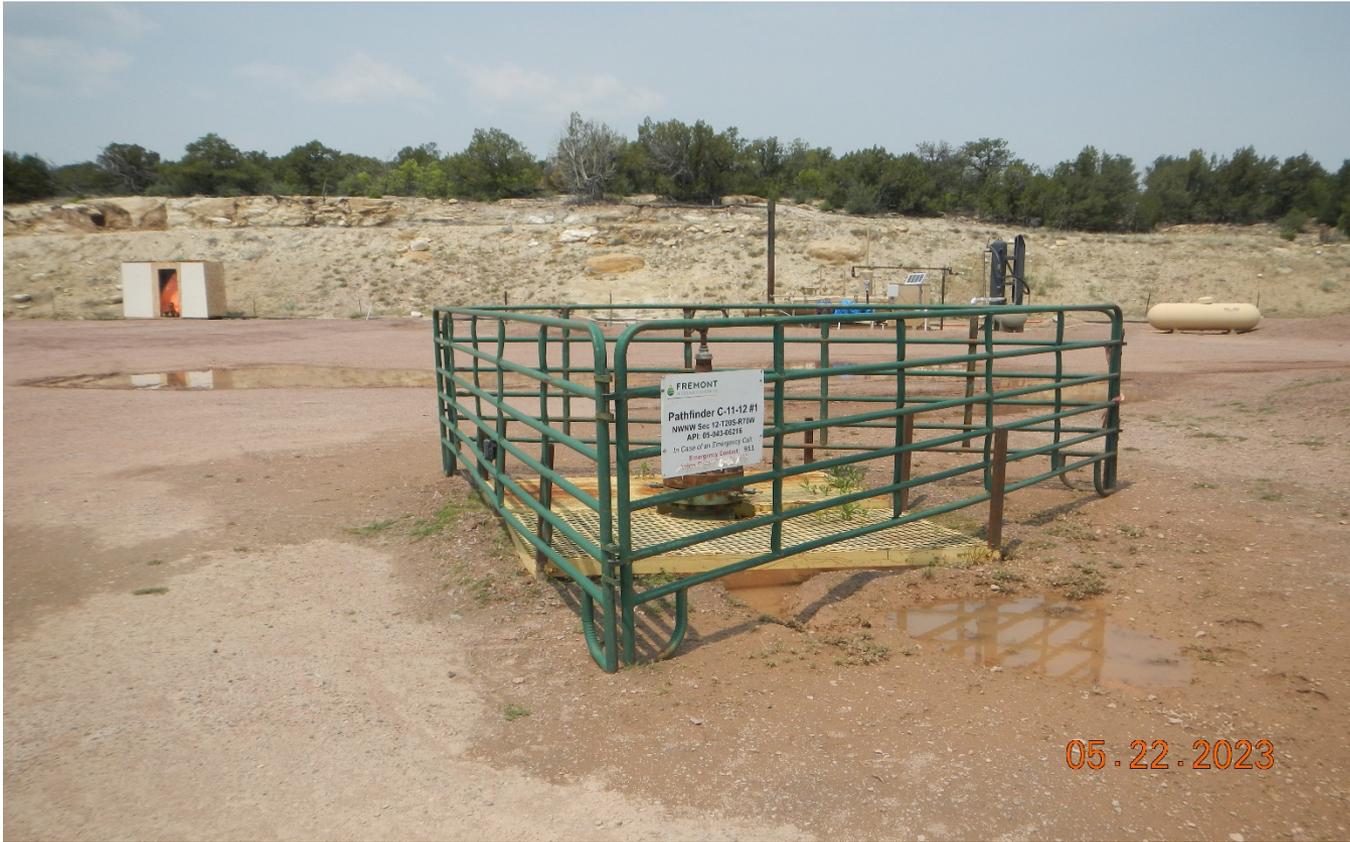
Photo 4. Well sign is posted at wellhead.

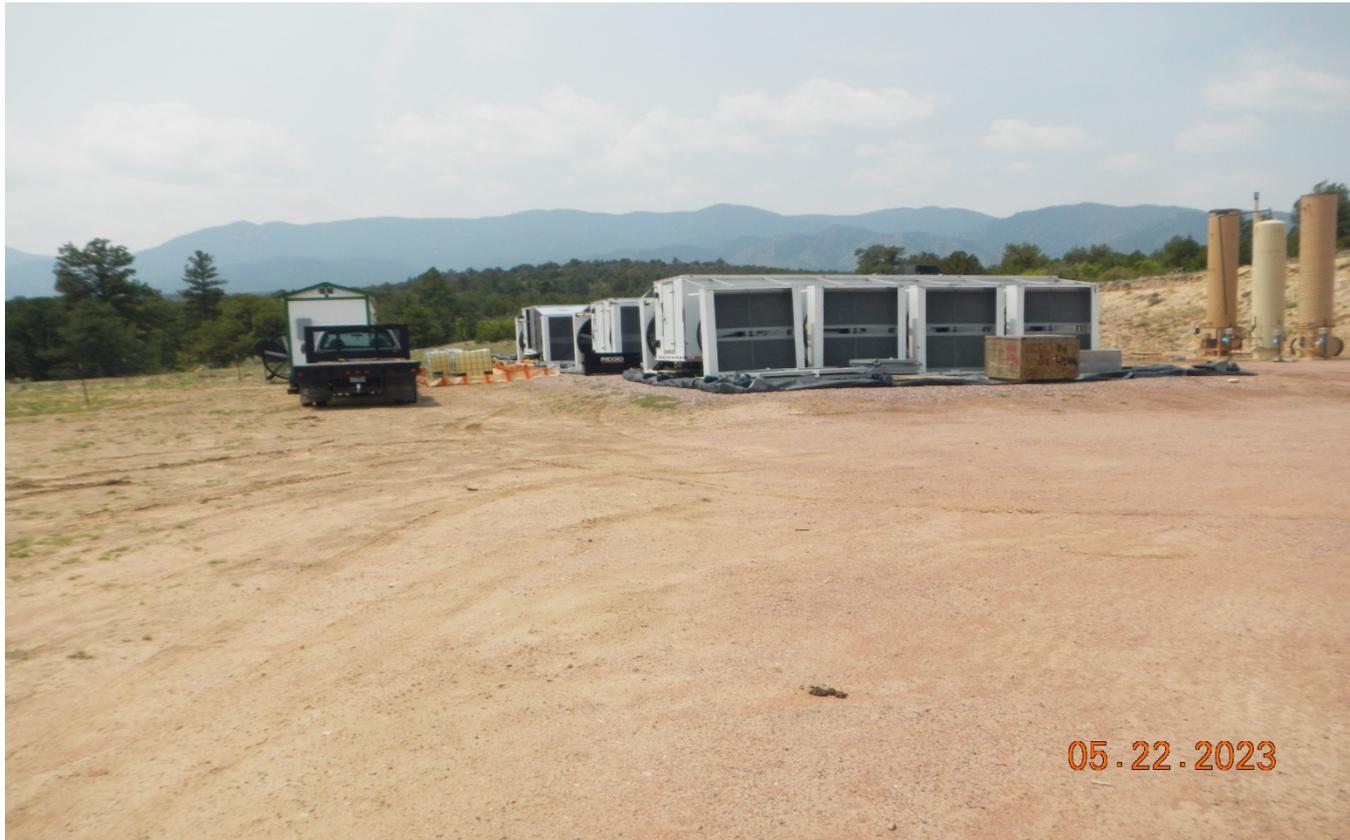
Photo 5. Facing southwest toward the bitcoin equipment at the location.

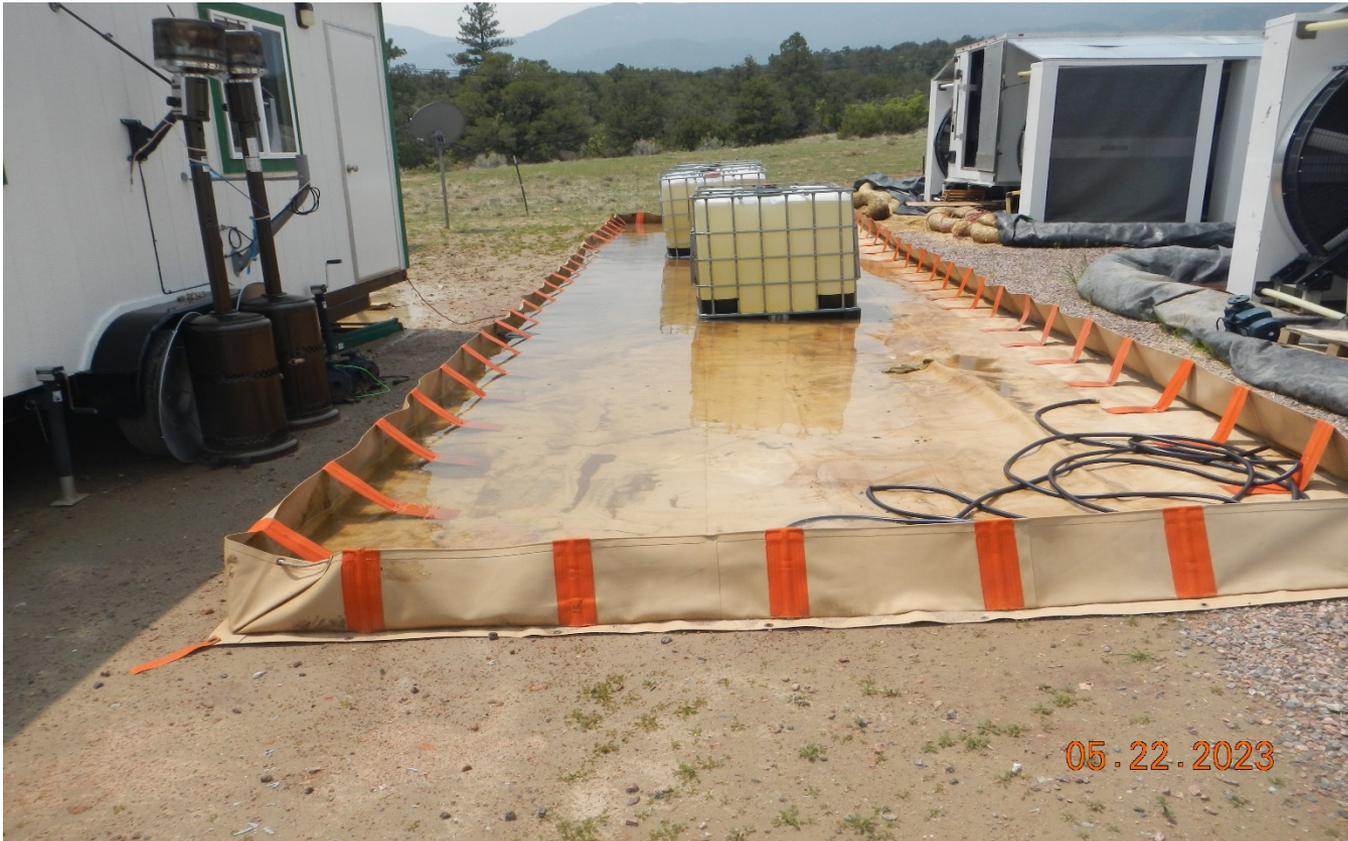
Photo 6. There is a portable secondary containment installed for the 2 chemical totes. The water needs to be removed to allow appropriate freeboard containment.

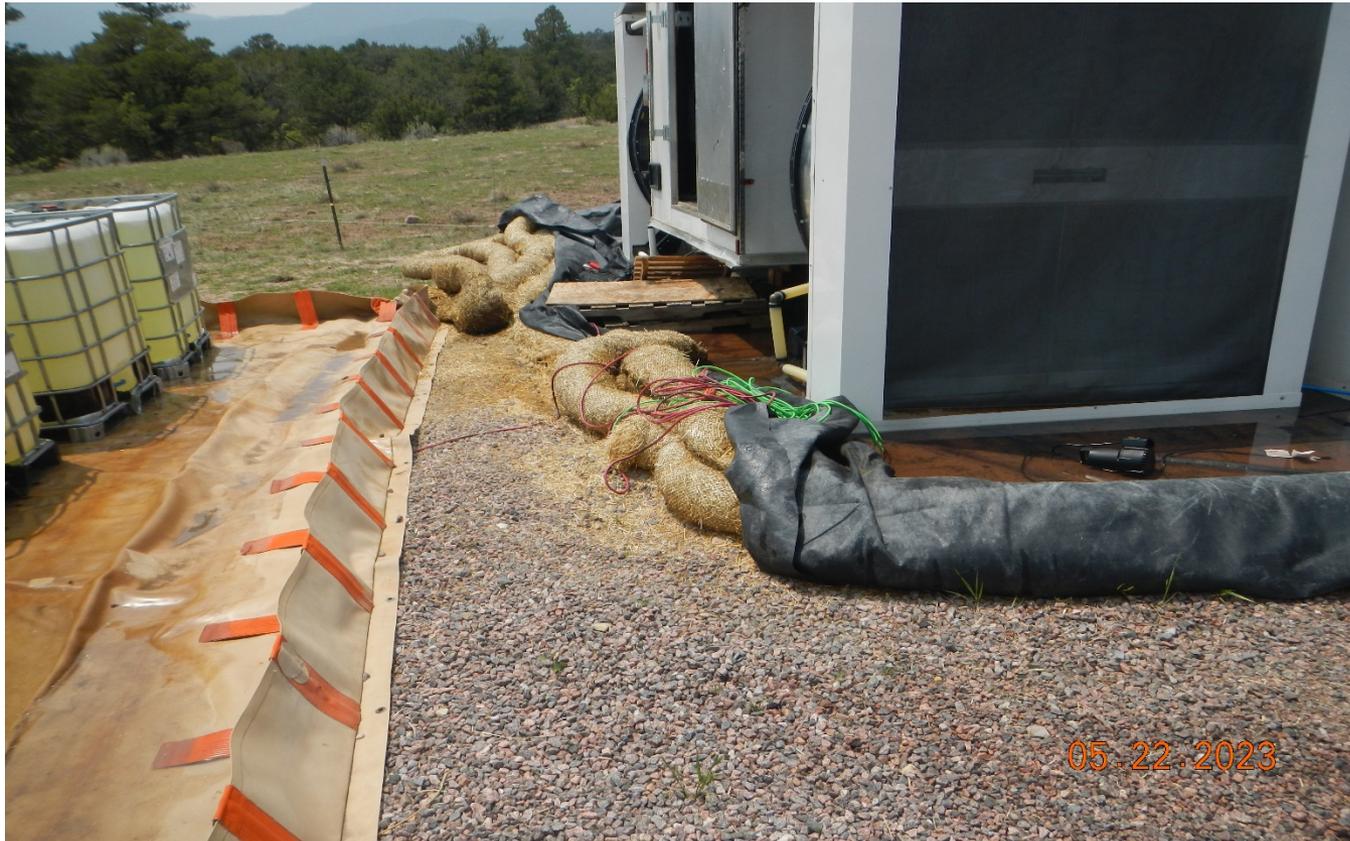
Photo 7. The plastic liner has become folded over needs to be repaired.

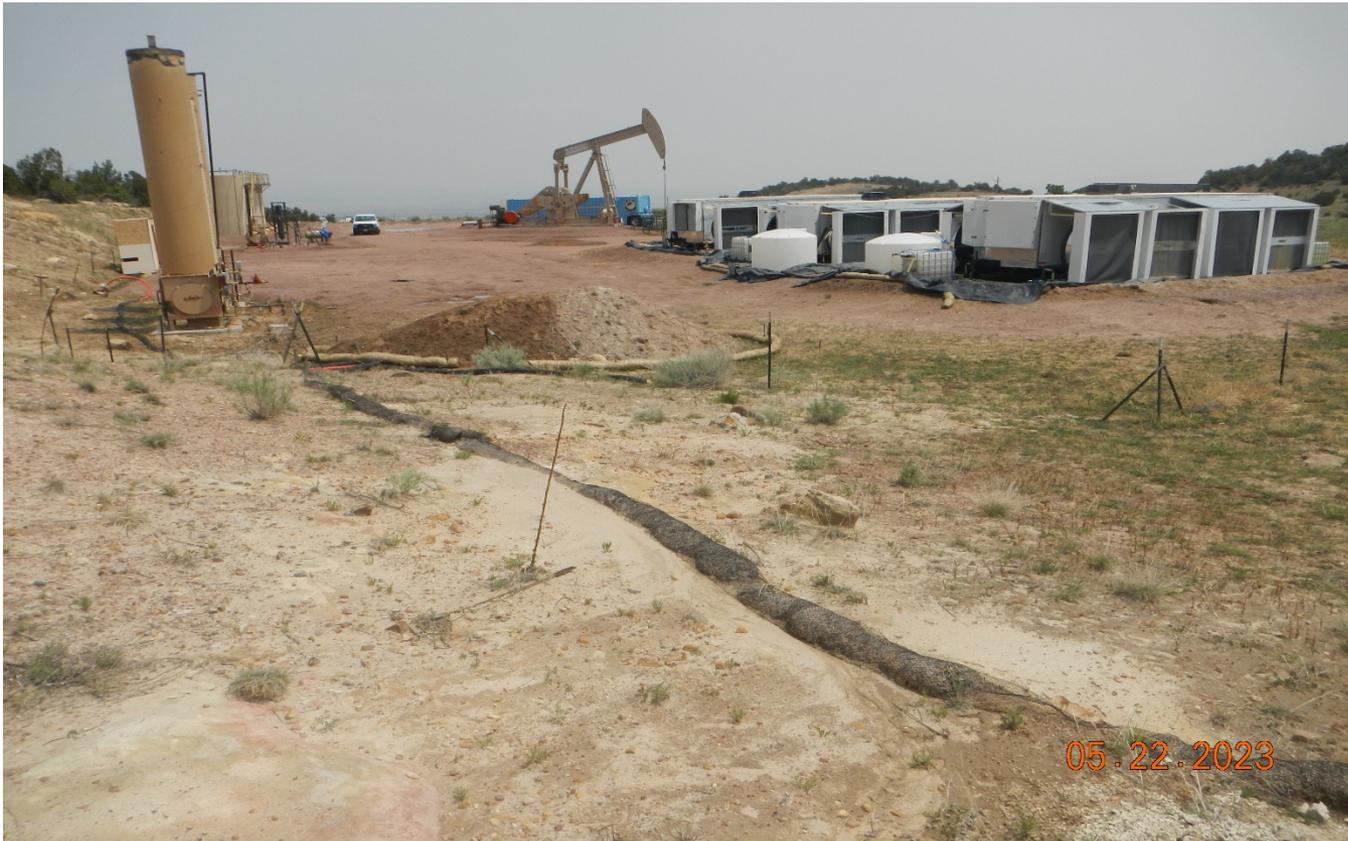
Photo 8. South side of the location facing northeast. The old wattles in this area need to be replaced or removed.

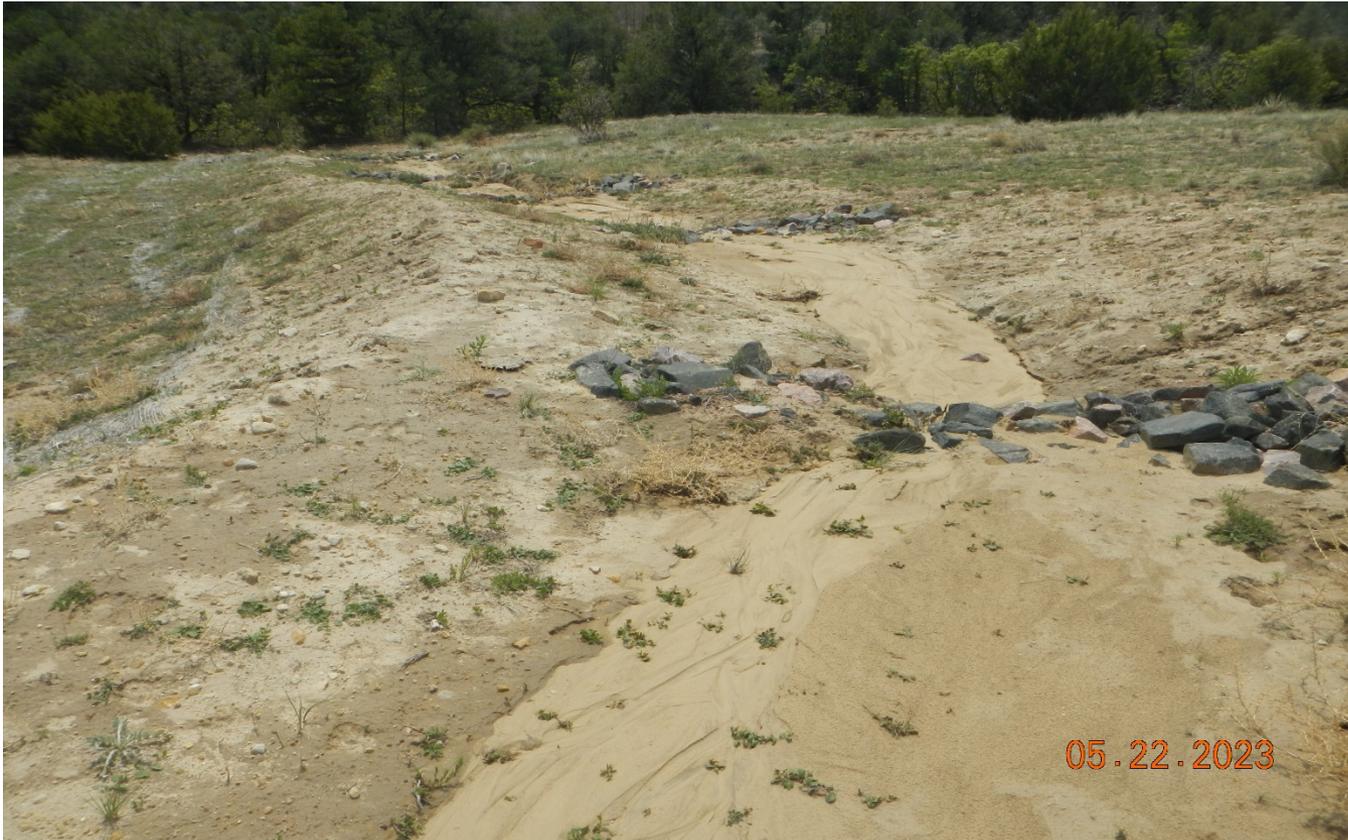
Photo 9. Facing south at the perimeter ditch. The check dams have filled in with sediment and need to be cleaned out.

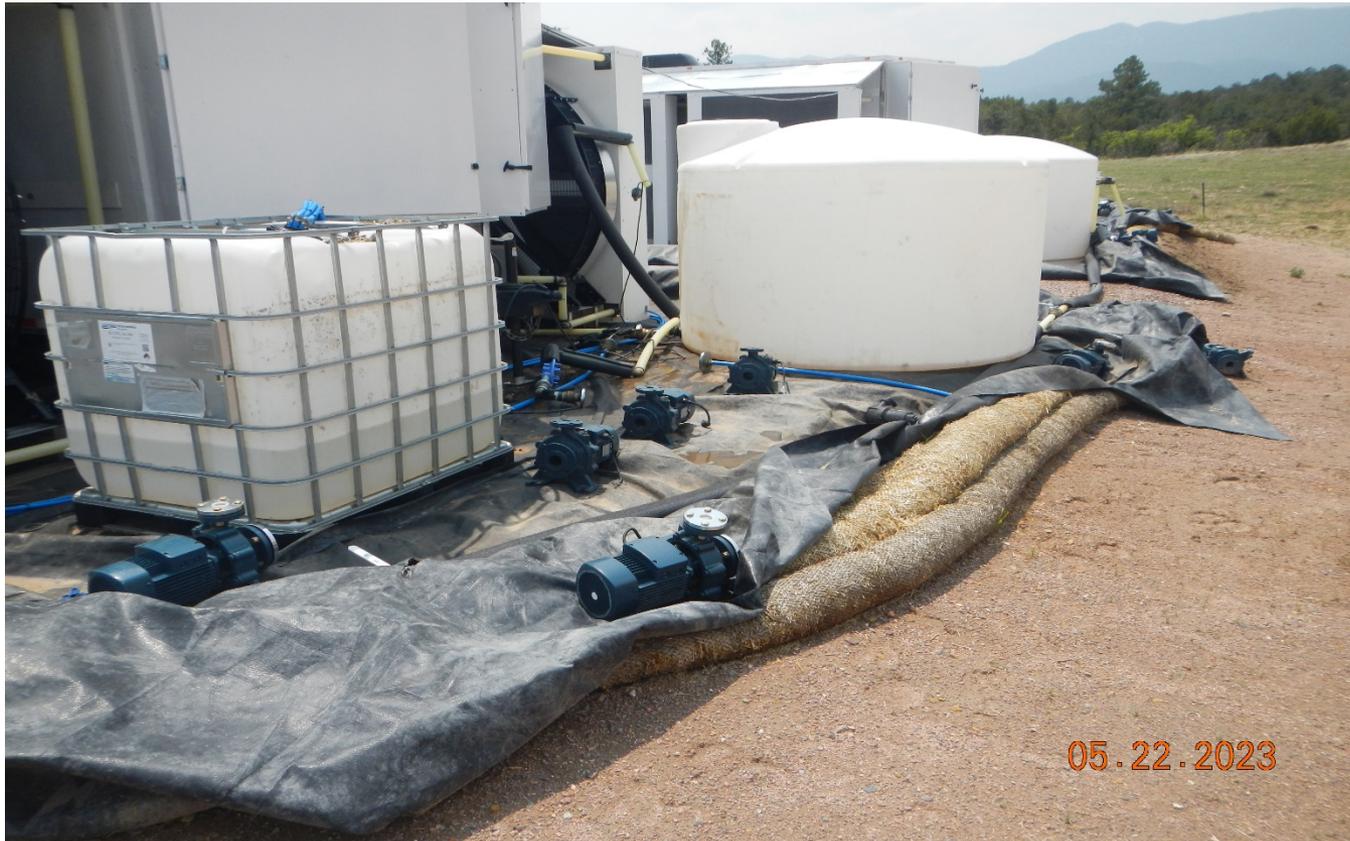
Photo 10. The plastic liner has become folded over needs to be repaired. There are water pump used to hold down the liner and should be removed if not need. Liner should be properly staked down.

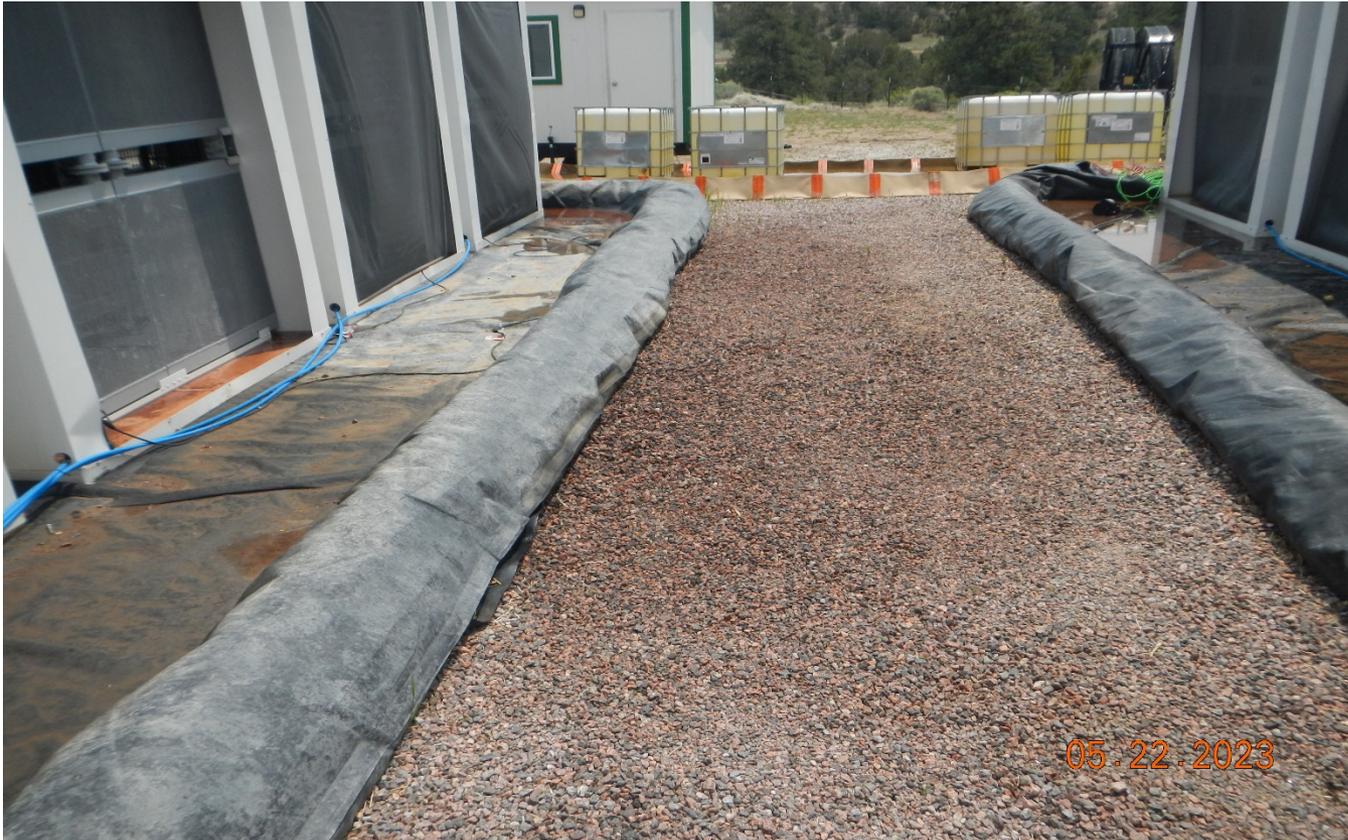
Photo 11. It appears in between the equipment there is darkened gravel from a possibly leak.

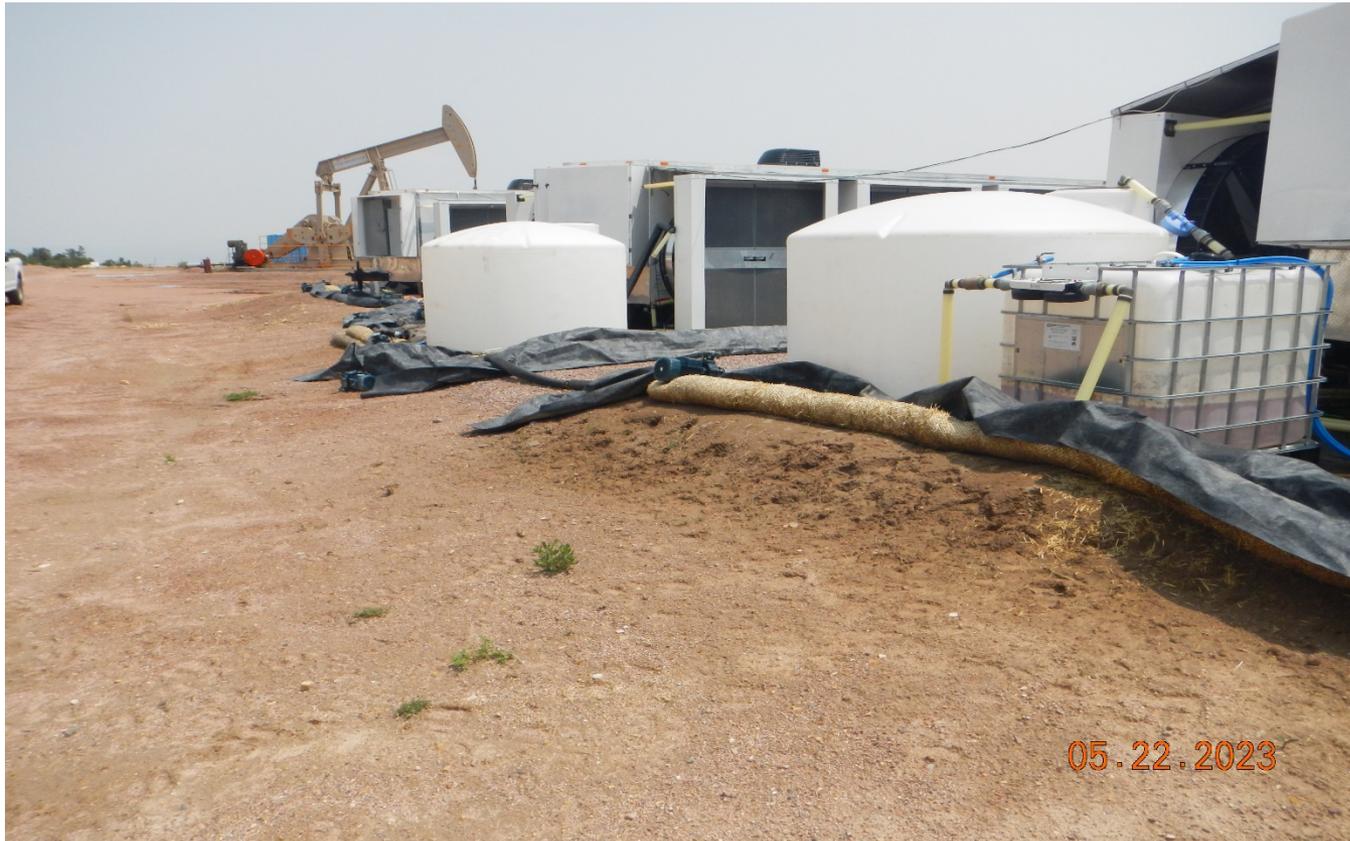
Photo 12. Facing northeast toward the bitcoin equipment.
