Construction and Stormwater Inspection

Date: 05/17/2023

Operator: VERDAD RESOURCES LLC - 10651

Inspection Photos
Location Name: Peanut Fed 3403
Location ID: 481827

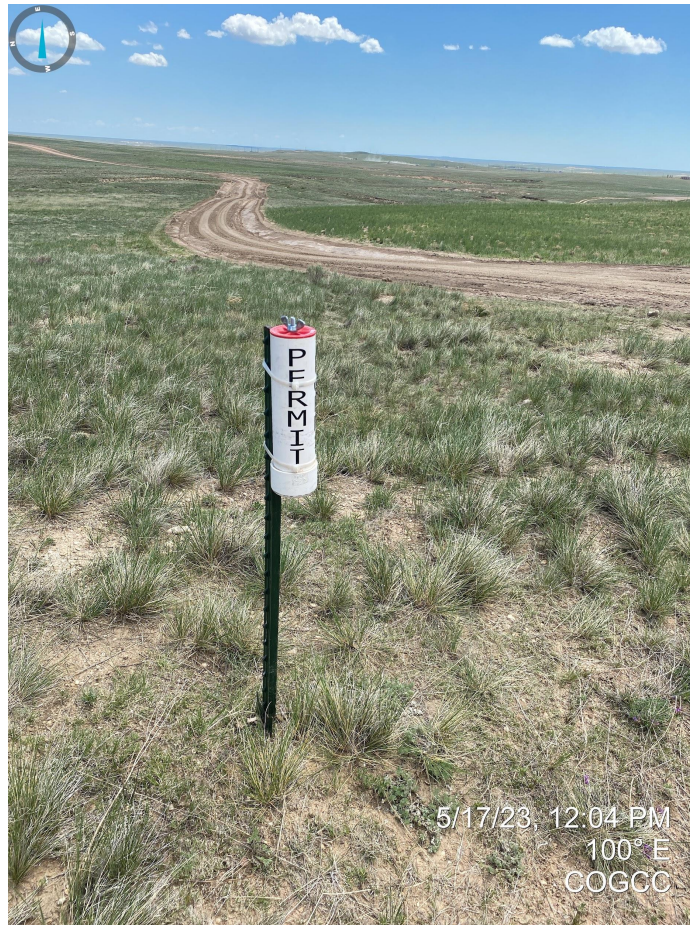
Photo 1. A copy of the approved Form 2A was posted at the location entrance.

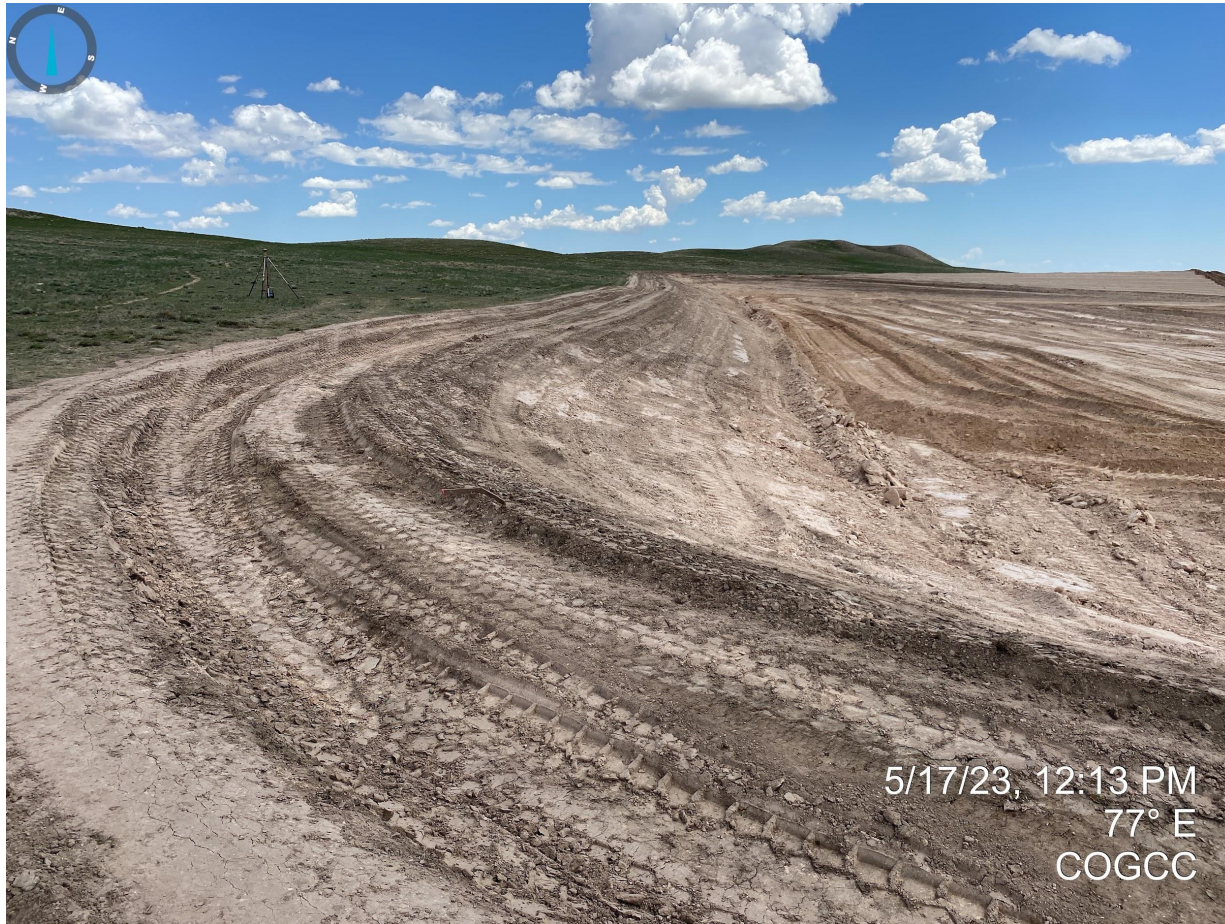
Photo 2. Northwest corner. Stormwater ditch and berm BMP installed. Also pictured, cut and fill operations after the topsoil has been salvaged.

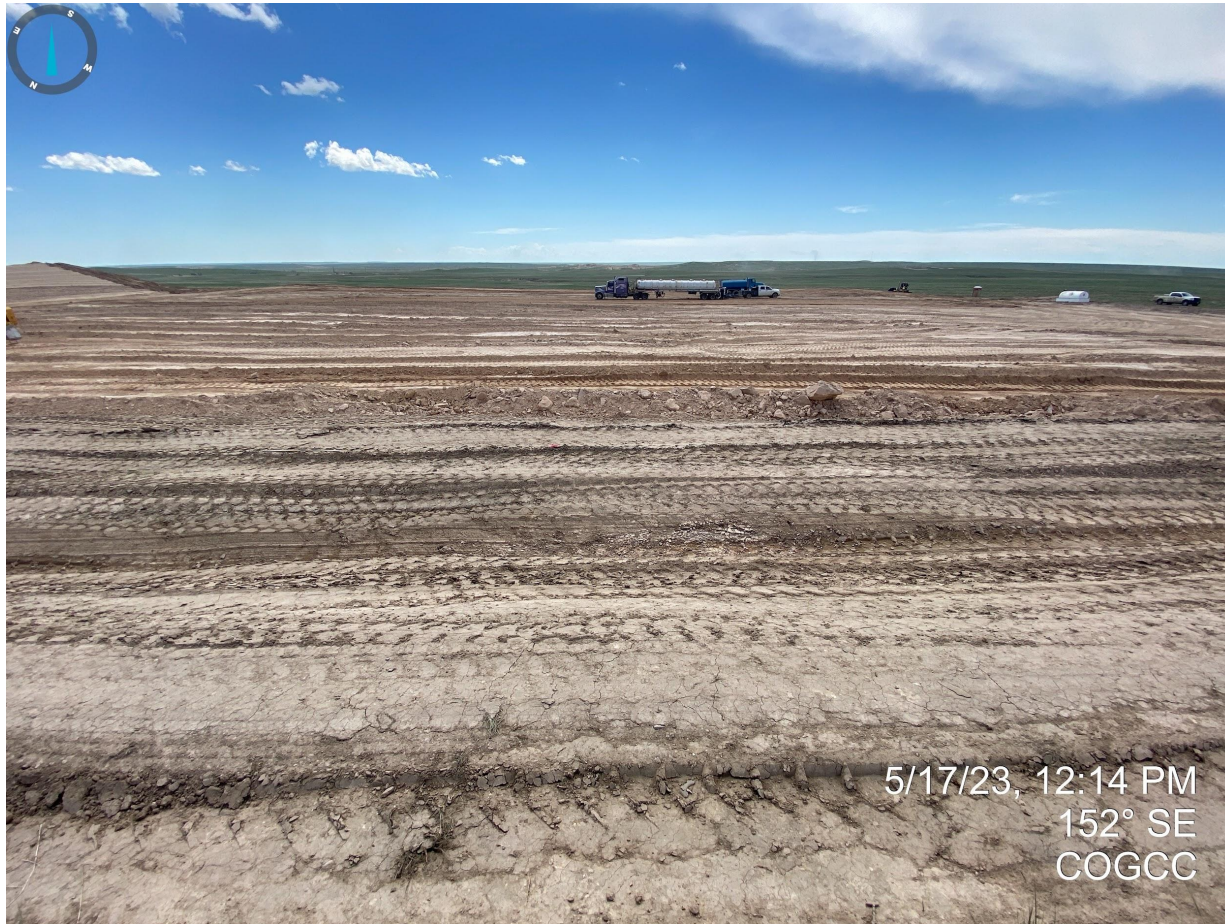
Photo 3. See comments in Photo 2.

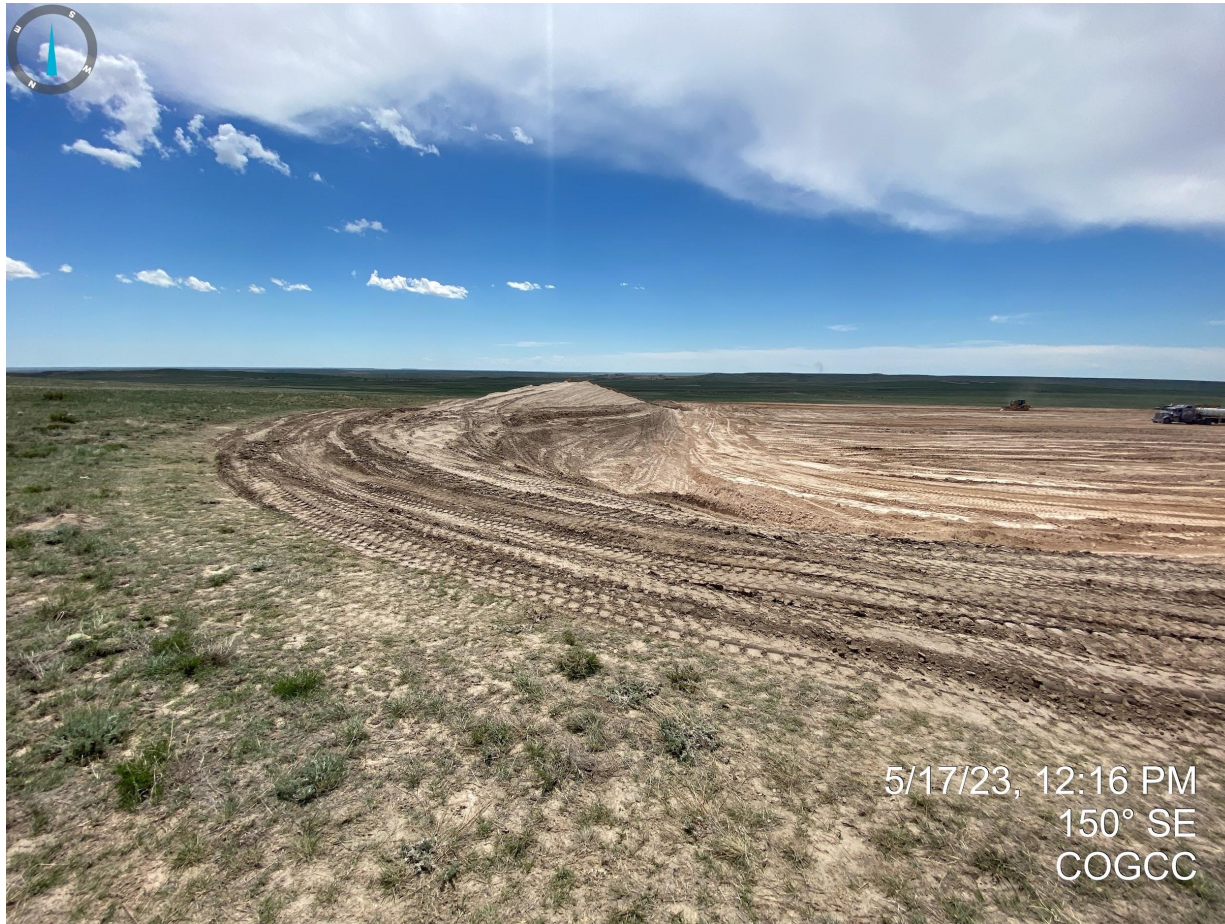
Photo 4. Northeast corner. See comments in Photo 2. Also pictured, topsoil stockpile in the background.

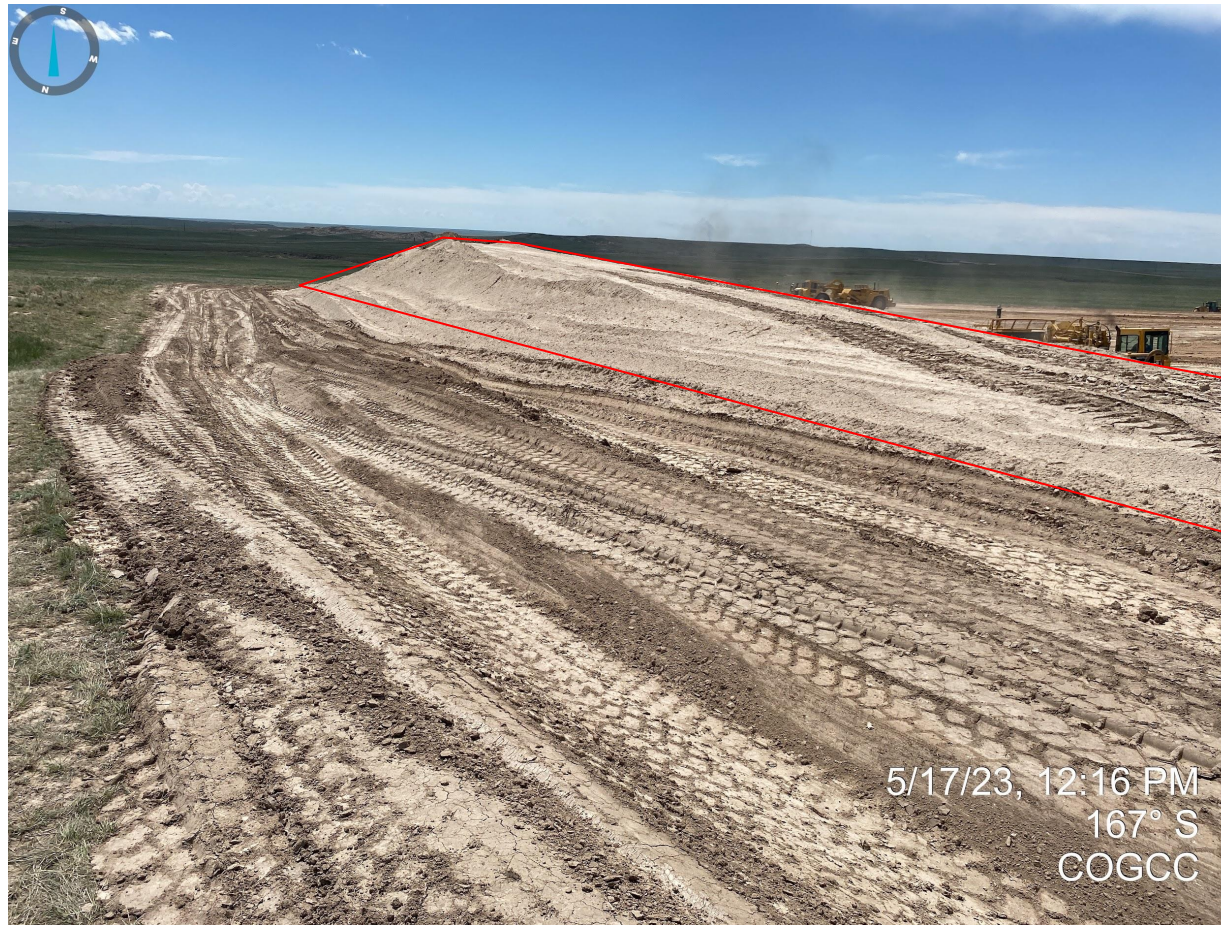
Photo 5. Facing south towards the topsoil stockpile. Photo illustrates that at the time of this inspection, the stockpile did not and any evidence of stabilization BMPs (e.g. equipment tracking). Subsequent photos illustrates evidence of rill erosion on the stockpile.

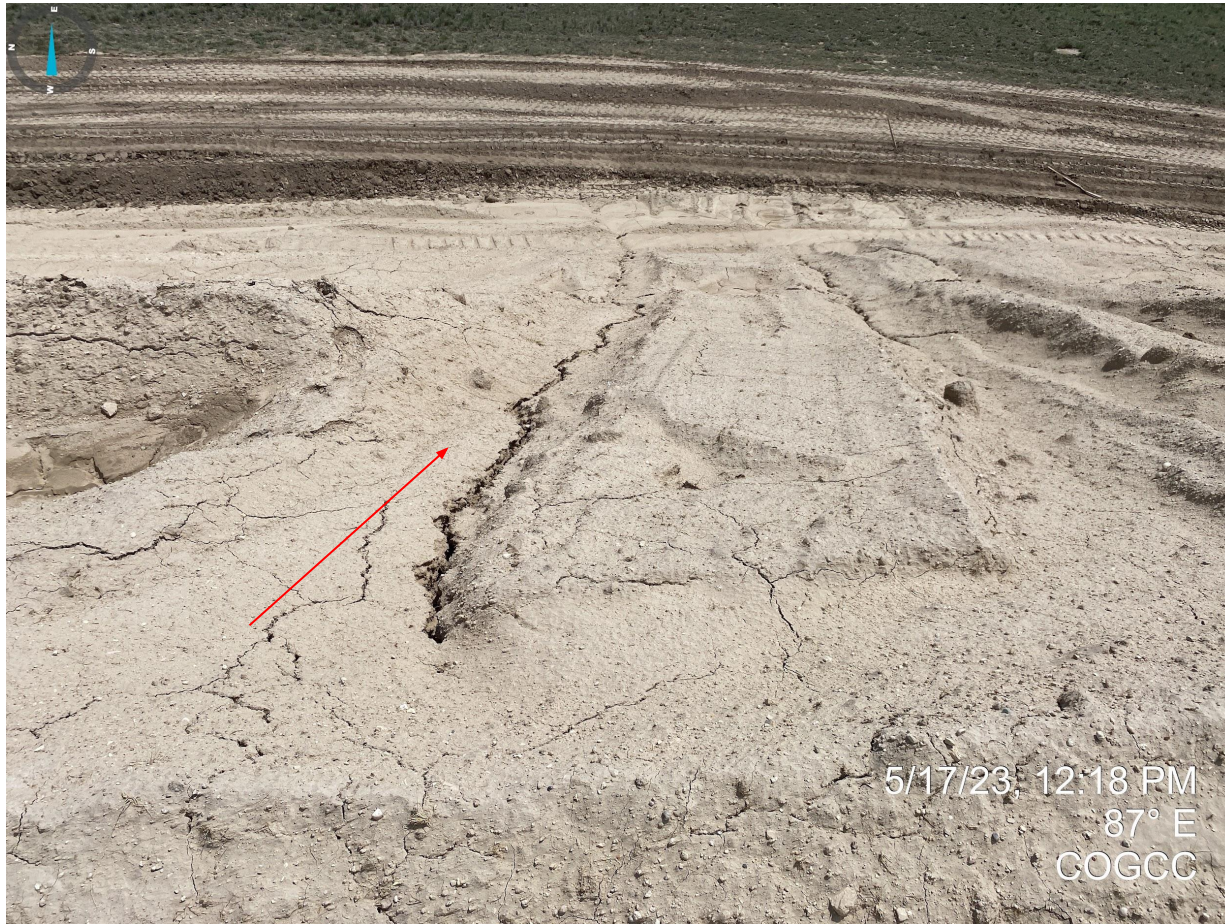
Photo 6. East side of stockpile; rill erosion identified. See comments in Photo 5.

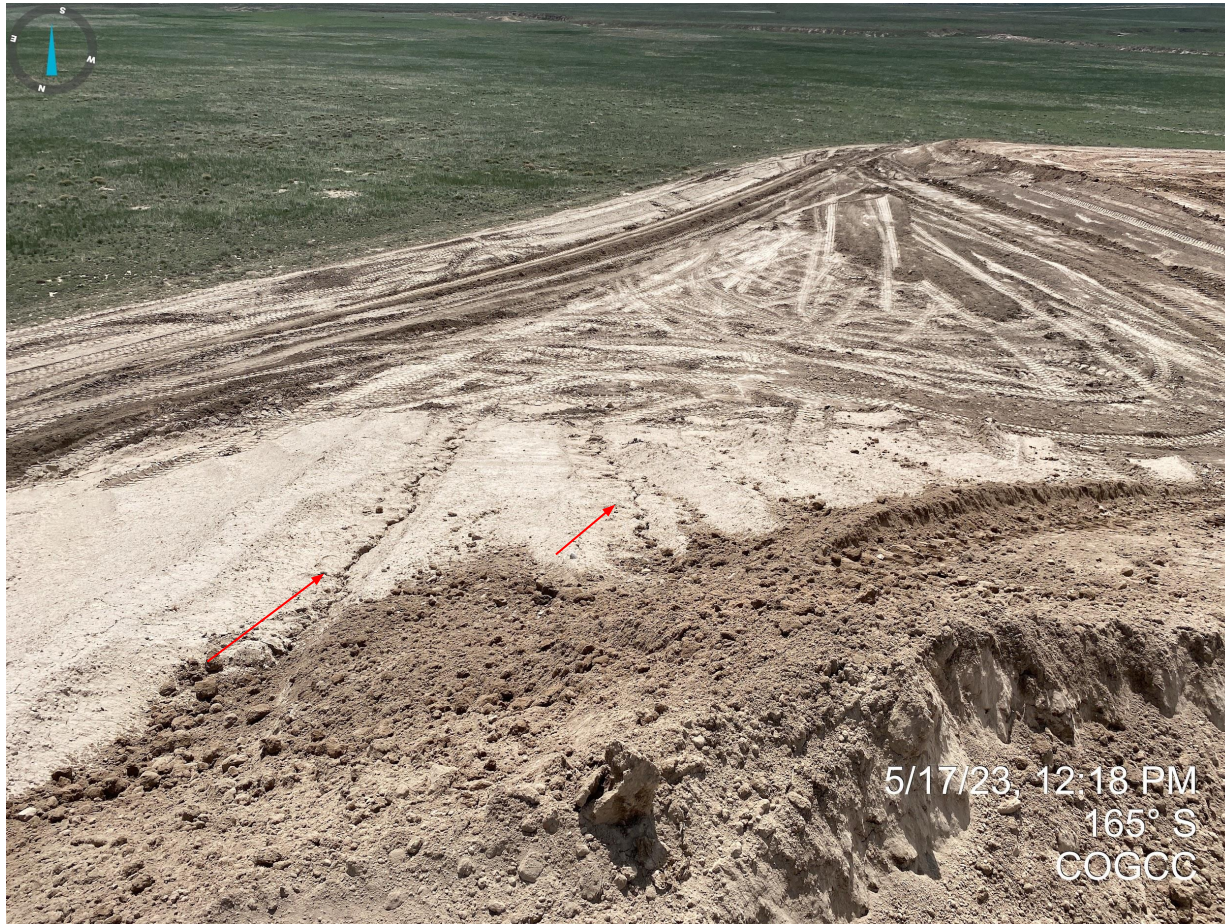
Photo 7. South side of stockpile, rill erosion identified. See comments in Photo 5.

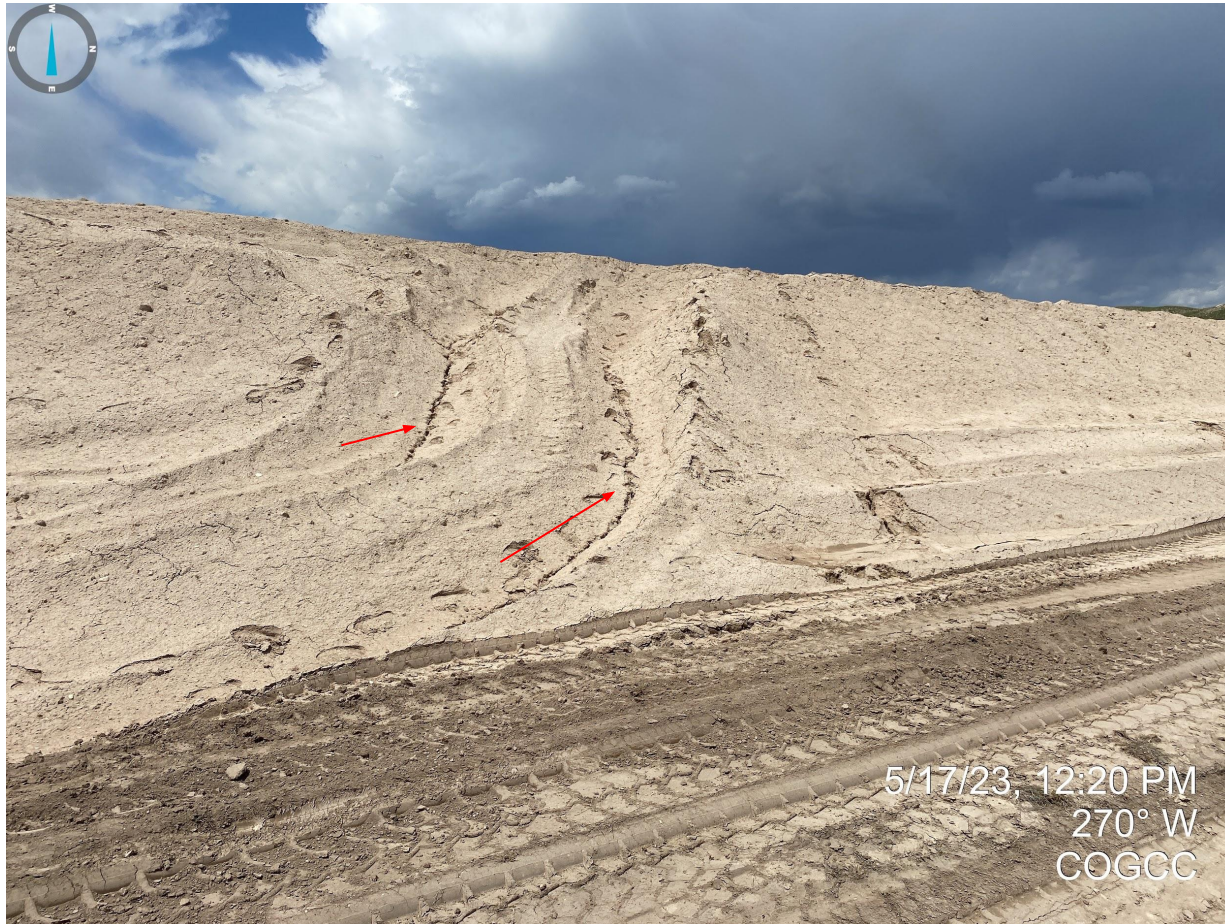
Photo 8. East side of stockpile, rill erosion identified. See comments in Photo 5.

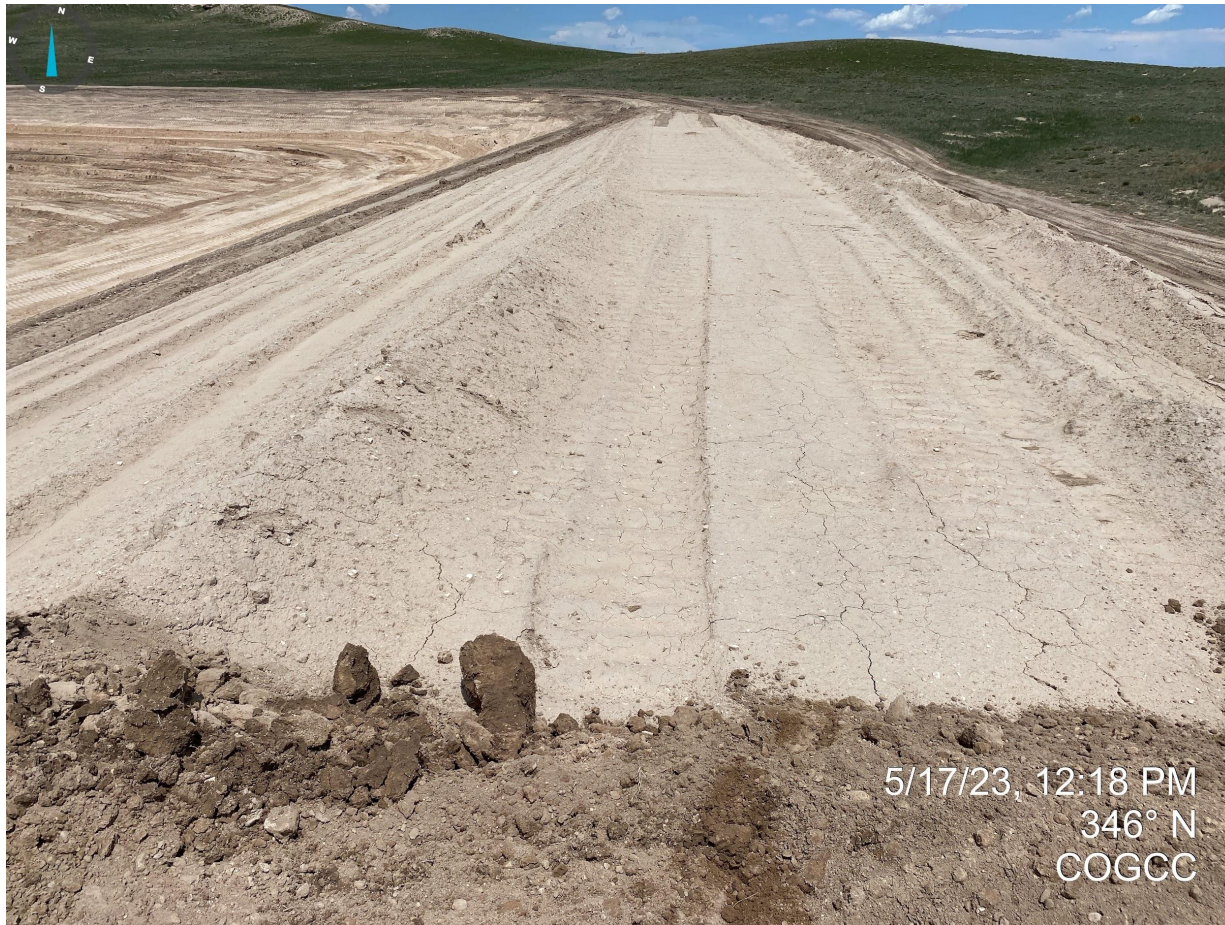
Photo 9. Taken from the southern end of the stockpile; see comments in Photo 5.

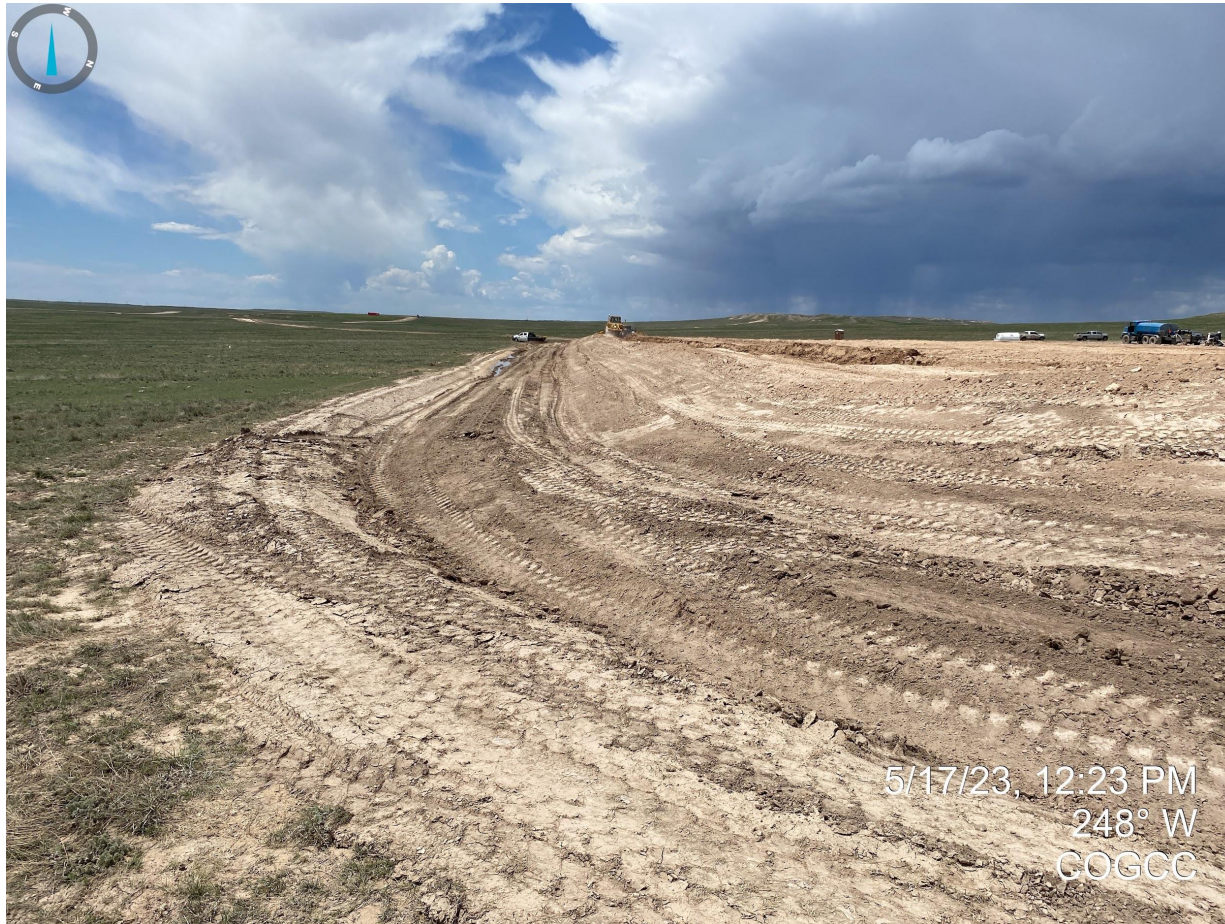
Photo 10. Southeast corner, stormwater ditch and berm pictured. See comments in Photo 2.

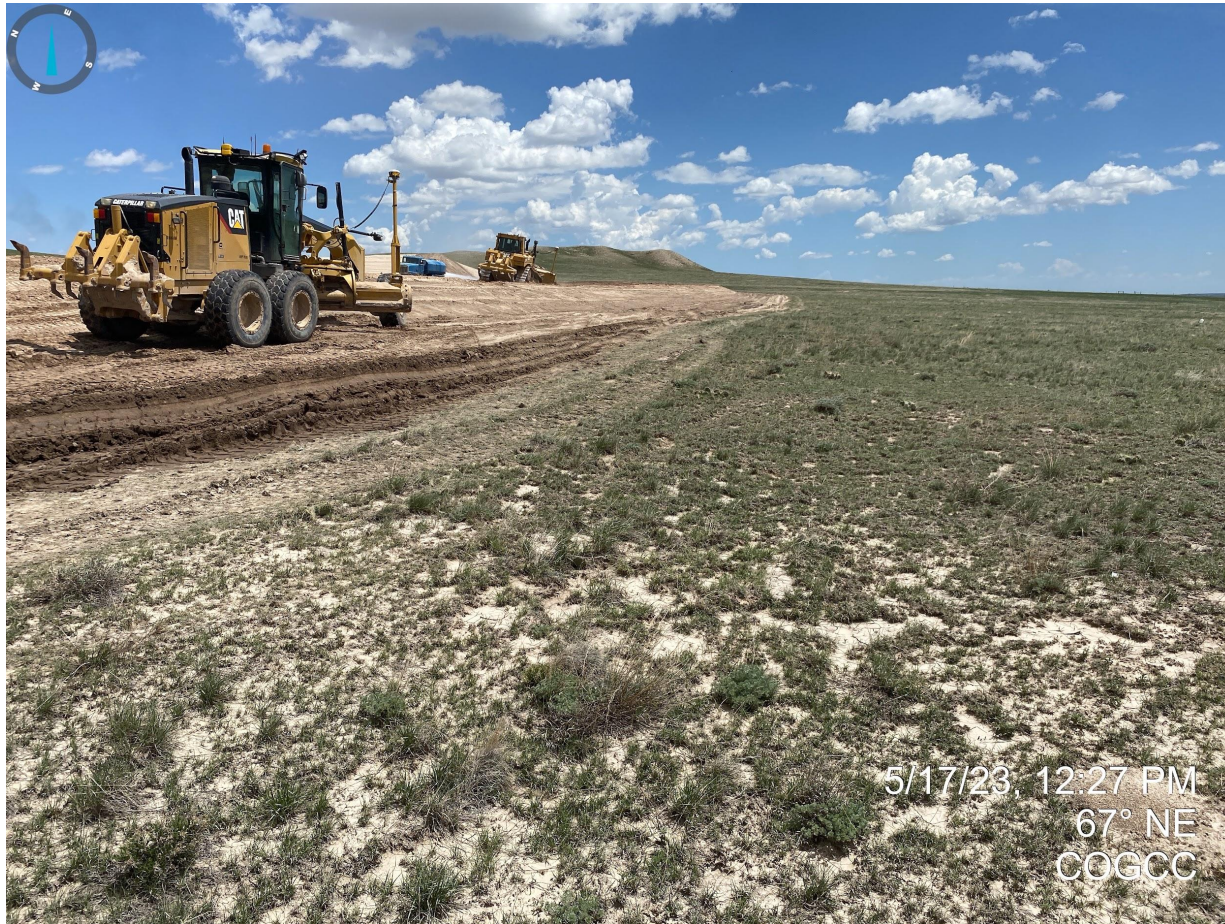
Photo 11. Southwest corner. On site crews were in the process of shaping fill areas and constructing the sediment trap/detention area at the time of this inspection. A follow-up inspection will be conducted at a later date to ensure compliance with 1002.f Rules and Operator submitted stormwater management plan.

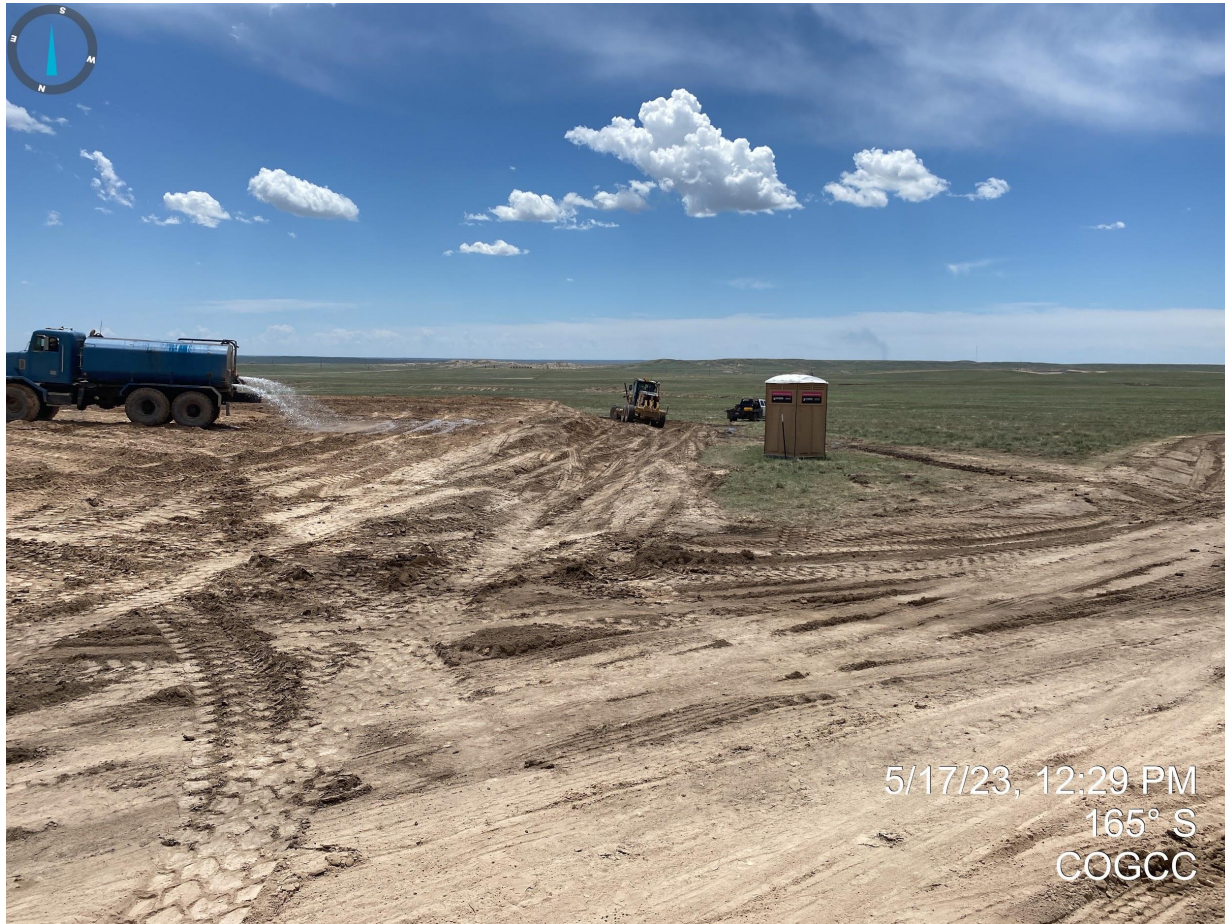
Photo 12. During this inspection, Staff observed a water truck on location to mitigate the fugitive dust occurring from construction activities.
