Inspection Photos
Location Name: Weber #1
API #069-06078

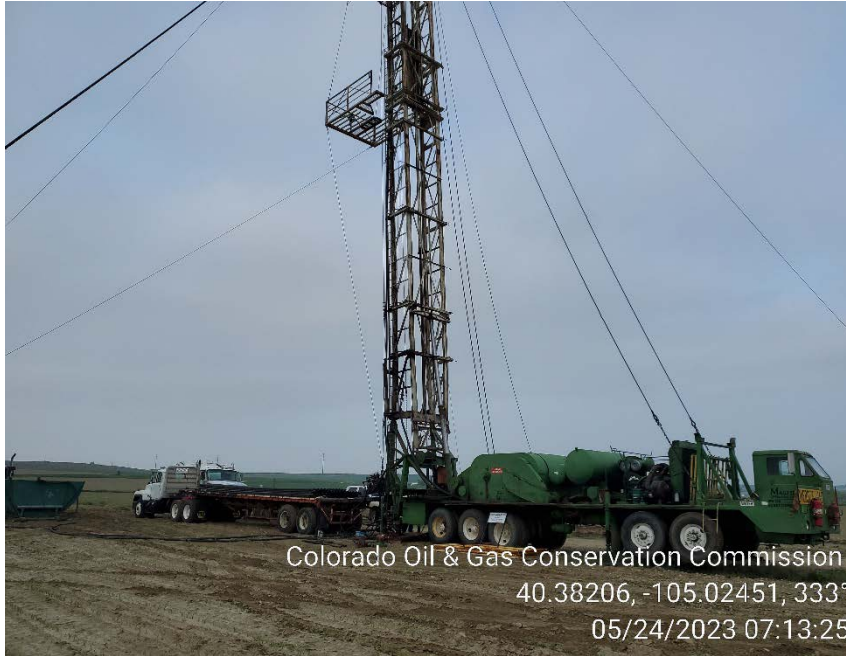
Plugging operations

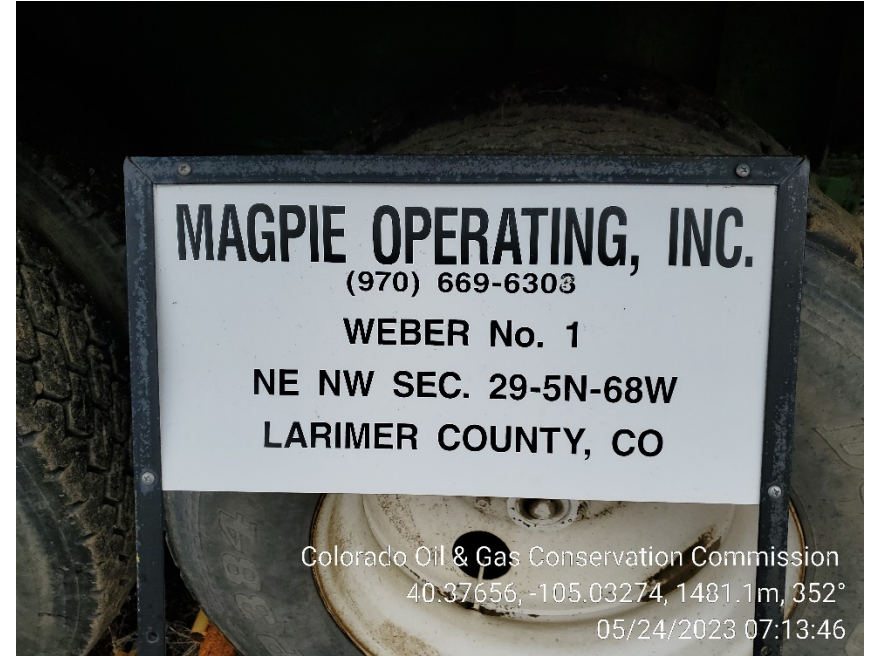
Wellhead sign
