Inspection Photos
Location Name: King-Pyles 4
API: 05-061-06117

Insp #701007009 performed in accordance with Complaint Doc #403326099, 403326120, 403326134

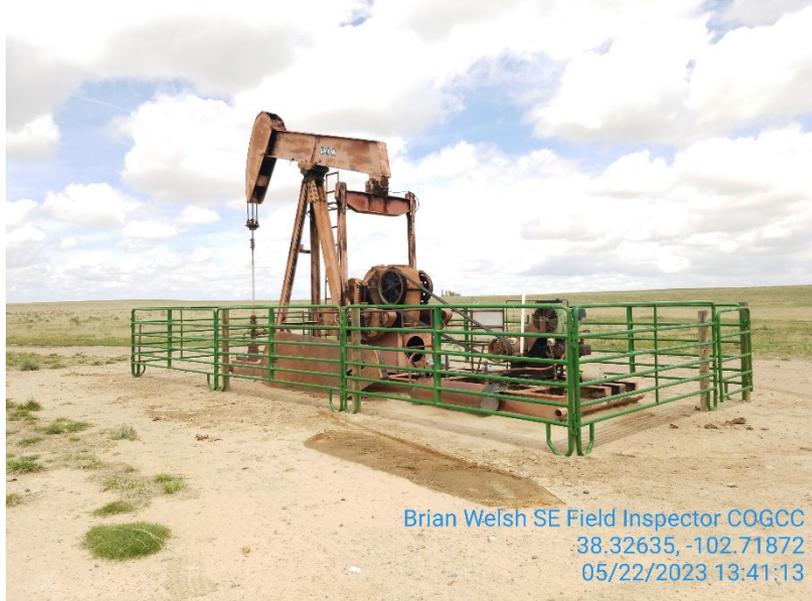
1. Belt guard at pumping unit has been moved to inside fenced area

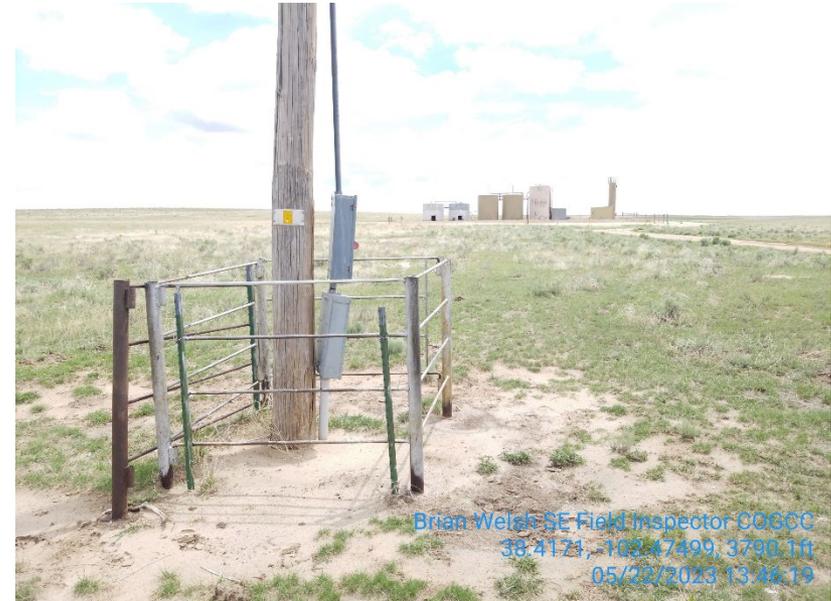
2. Electric panel on REA pole not secured to pole. Fence is installed around REA pole.
