Inspection Photos

API: 071-06396

Operator: OGRIS OPERATING LLC

Inspection Date: 5/24/2023

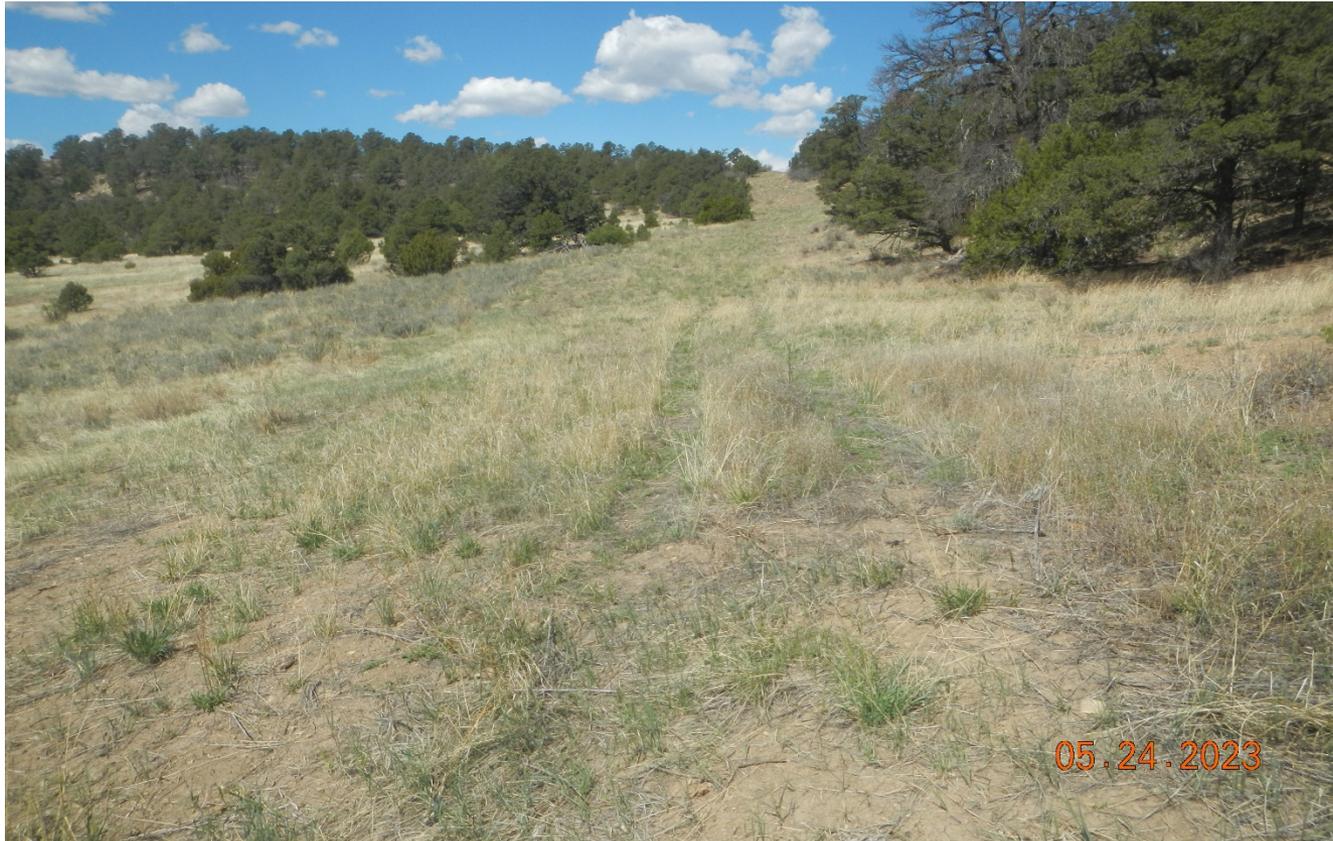
Photo 1. Facing west along the reclaimed access road. The perennial vegetation is progressing well along the former road.

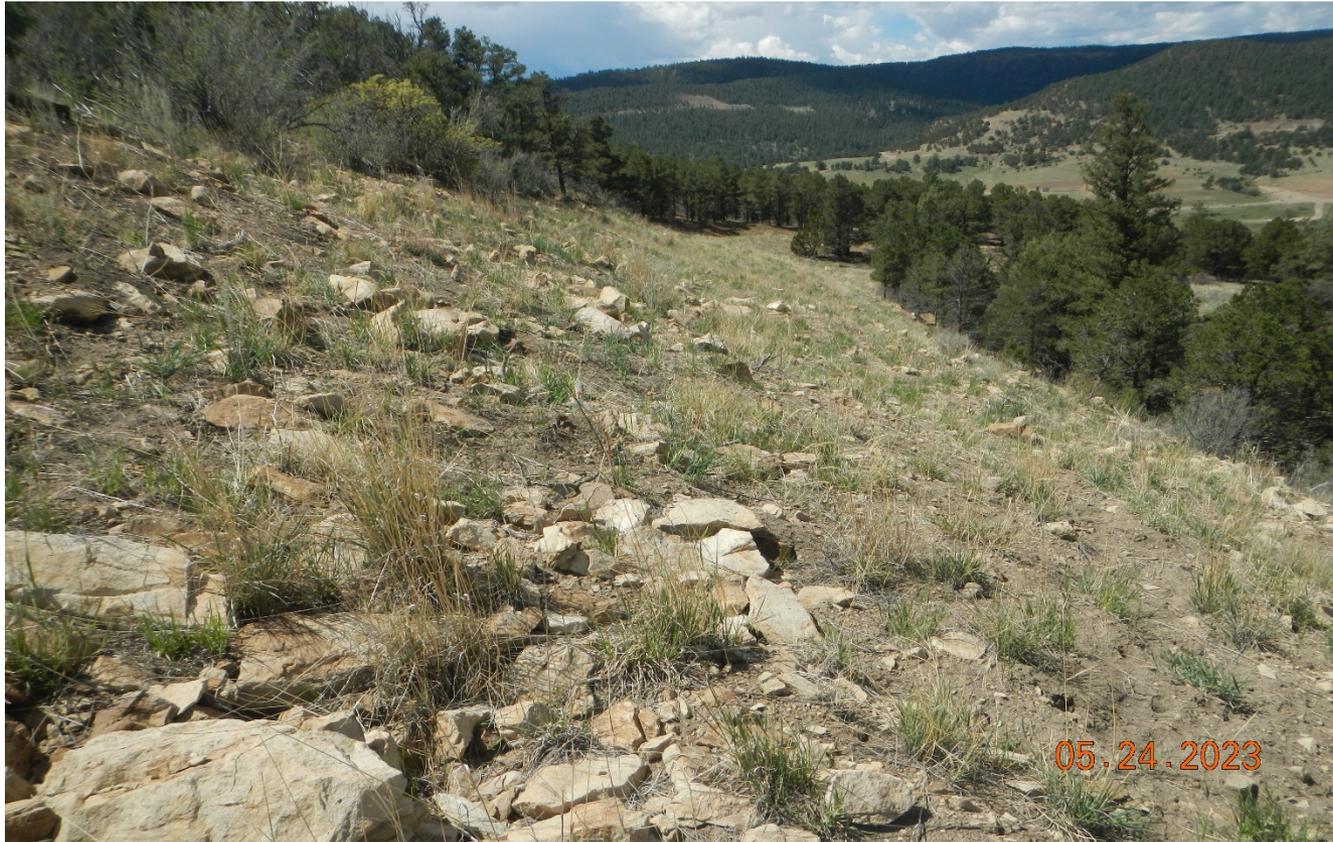
Photo 2. Facing southwest. The perennial vegetation is progressing well along the reclaimed road.

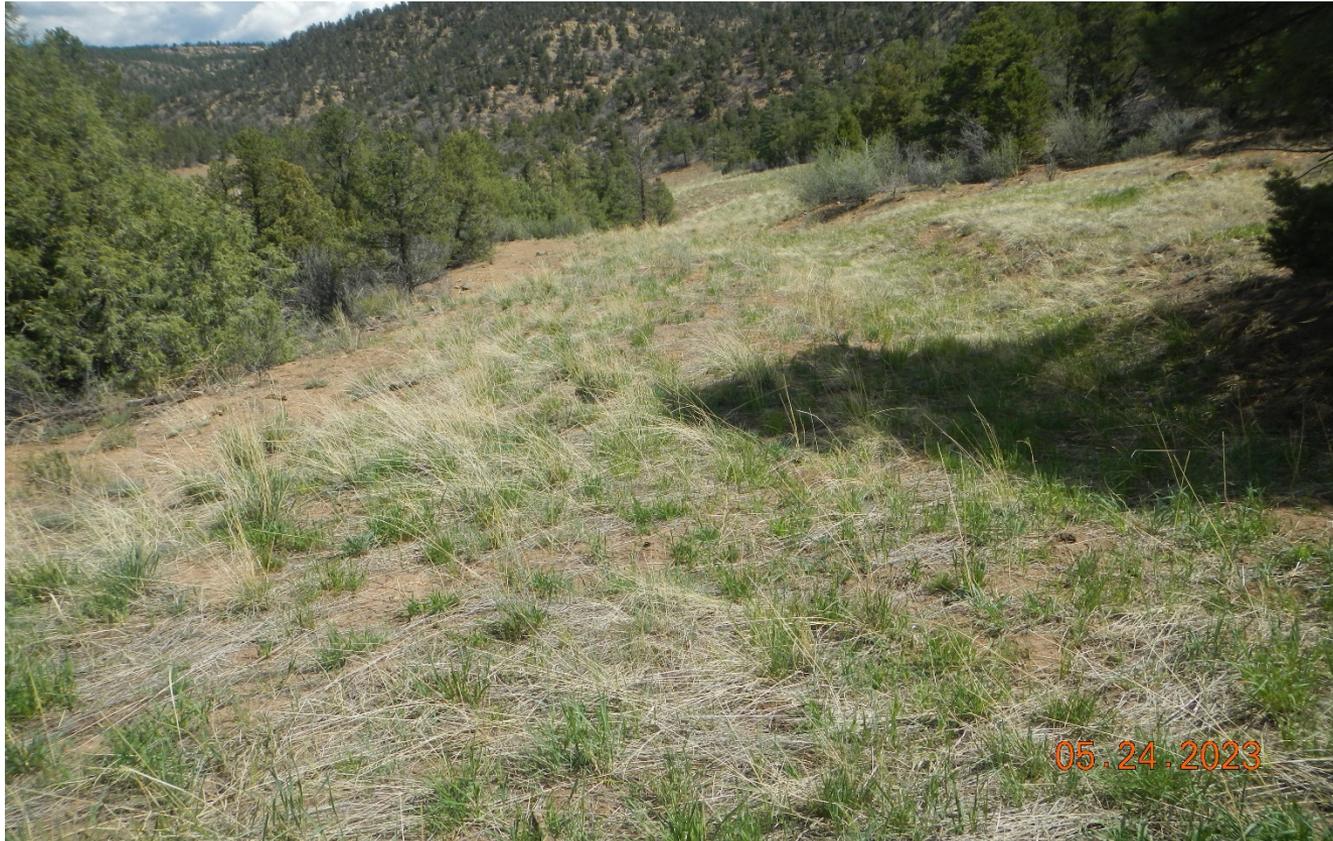
Photo 3. Facing northwest further along the road. The perennial vegetation is progressing well along the reclaimed road.

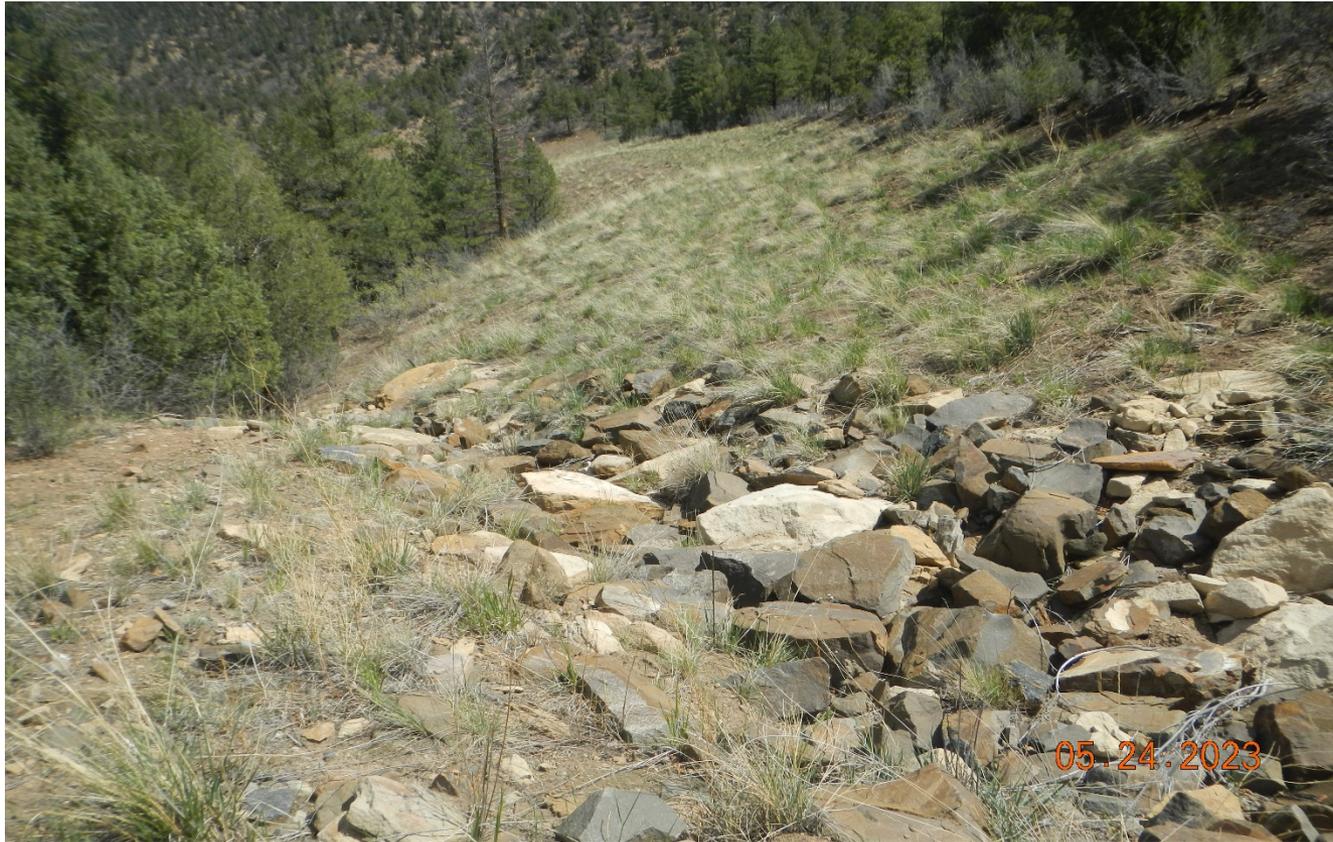
Photo 4. Facing north along the reclaimed road. There is rock rip/rap installed in the drainages.

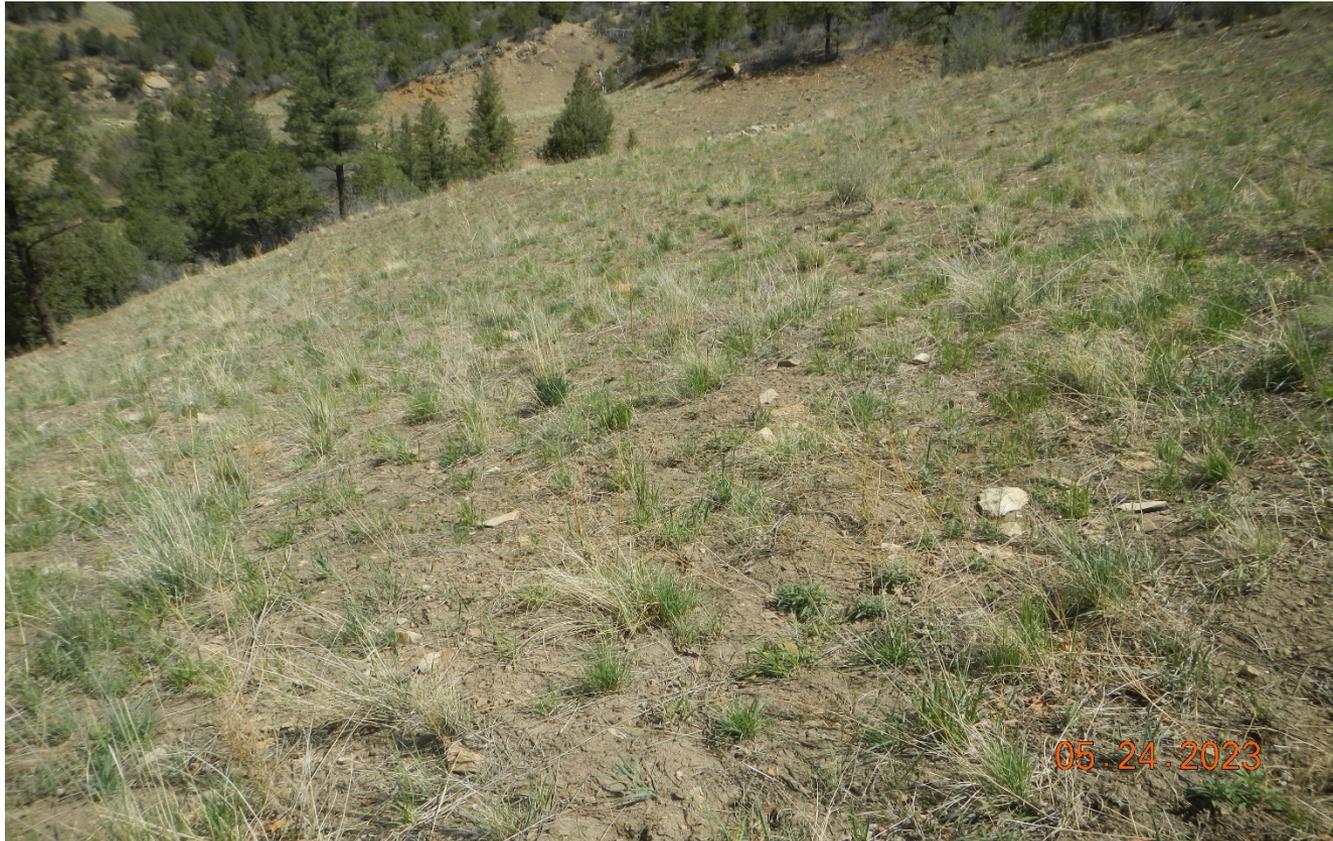
Photo 5. Facing northwest at the location. Vegetation is progressing well at the location.

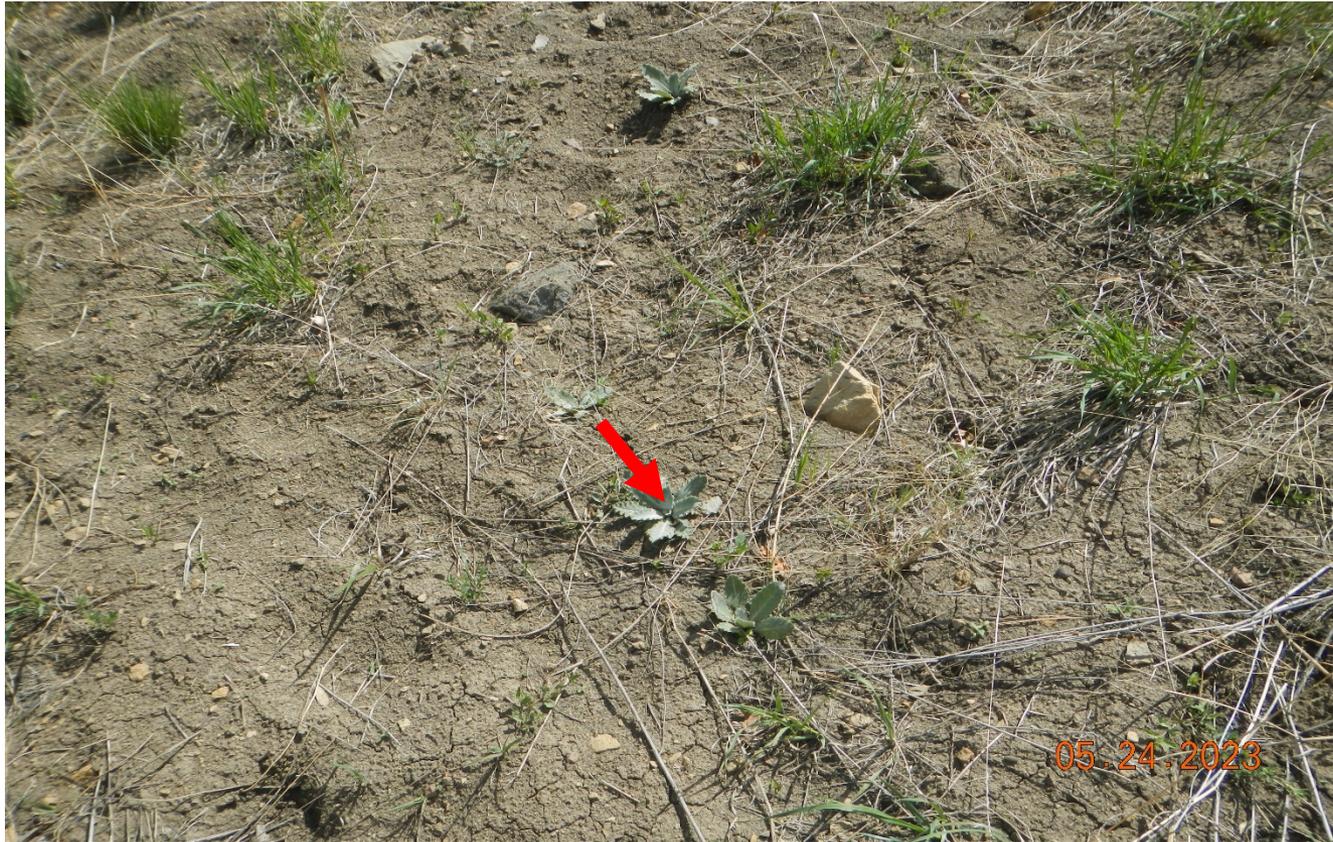
Photo 6. Facing north just past the reclaimed wellsite on the reclaimed road. There are noxious weeds (Scotch thistle) in this area that are starting to sprout up.
Lat/Long:37.15370, -104.90250
