Storm Water Management and Erosion control
Location Name: TEP ROCKY MOUNTAIN LLC GM 41-3 pad
Location ID: 323965

**Location Overview: Location is approximately 55 yards from
Parachute Creek
Section/Township/Range: 3 7S96W**

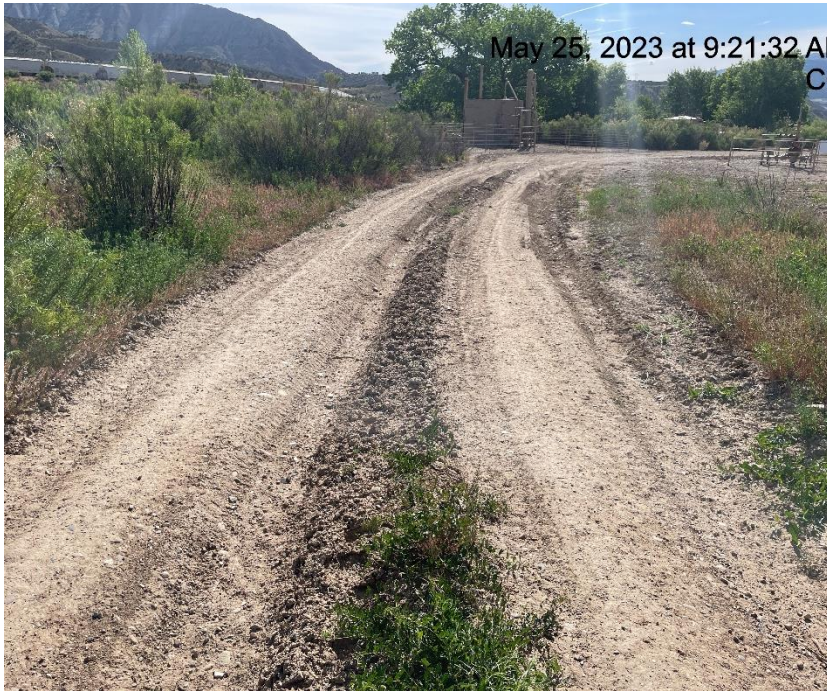
Photo # 8720 Lack of Stabilization/Compaction on location

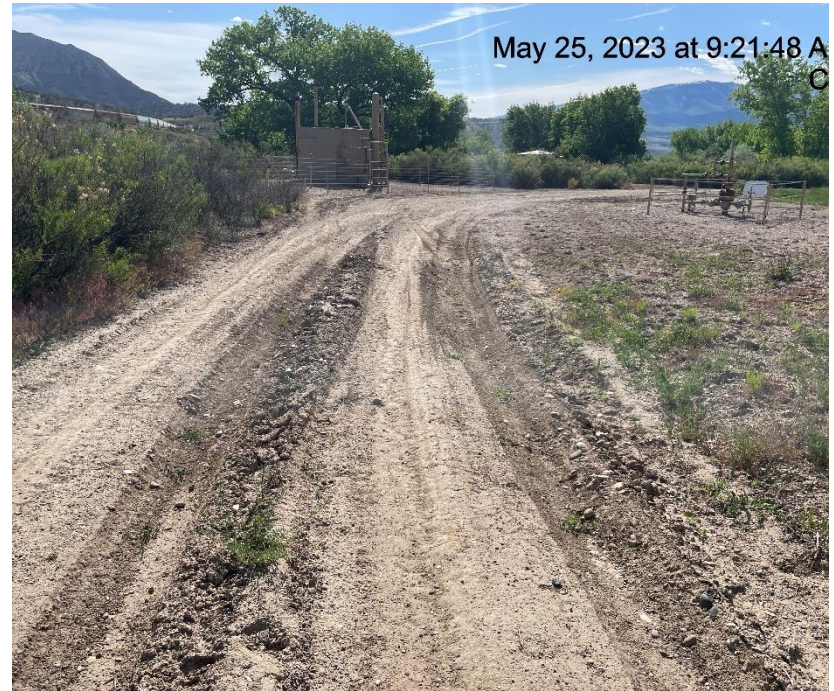
Photo # 8721 Lack of Stabilization/Compaction on location

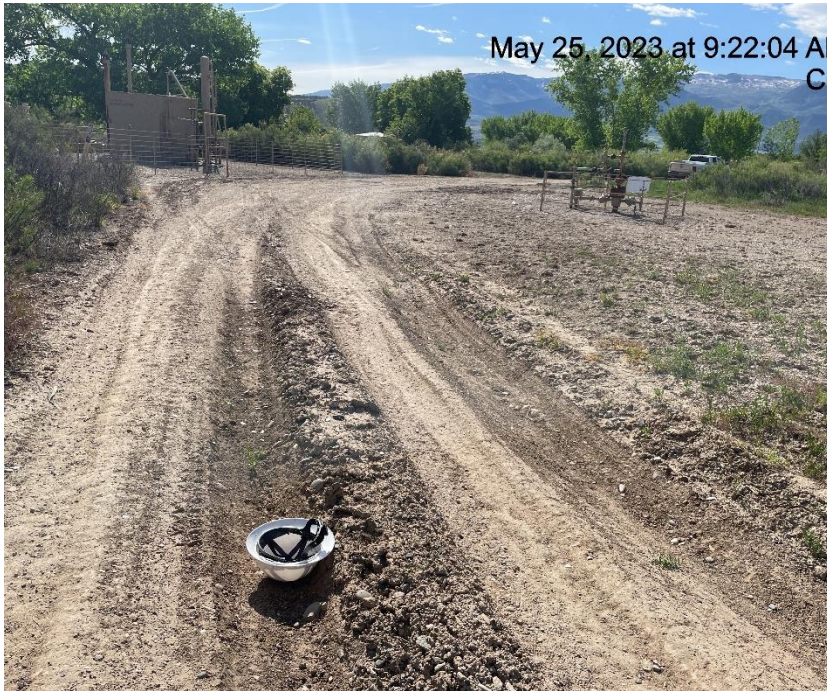
Photo # 8722 Lack of Stabilization/Compaction on location

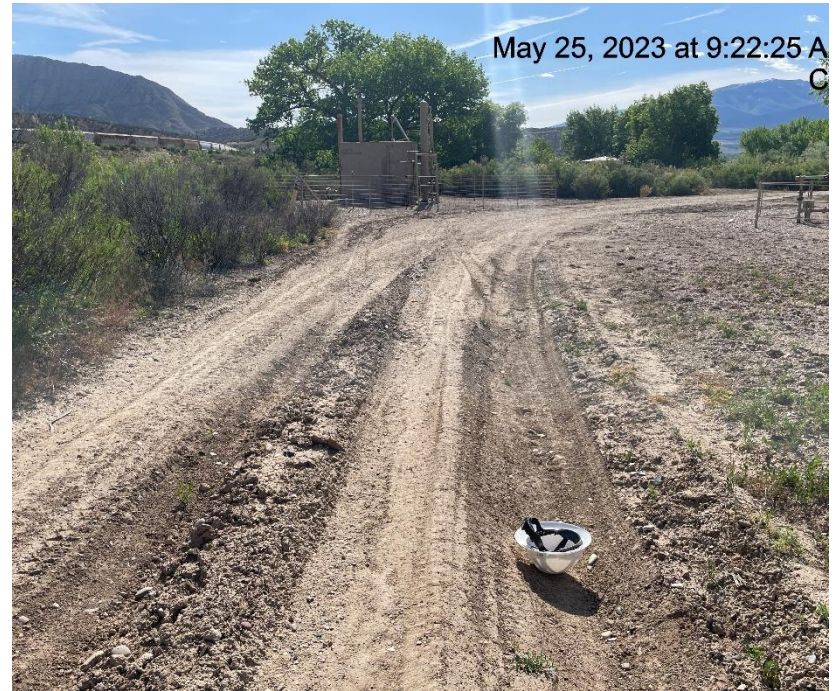
Photo # 8723 Lack of Stabilization/Compaction on location

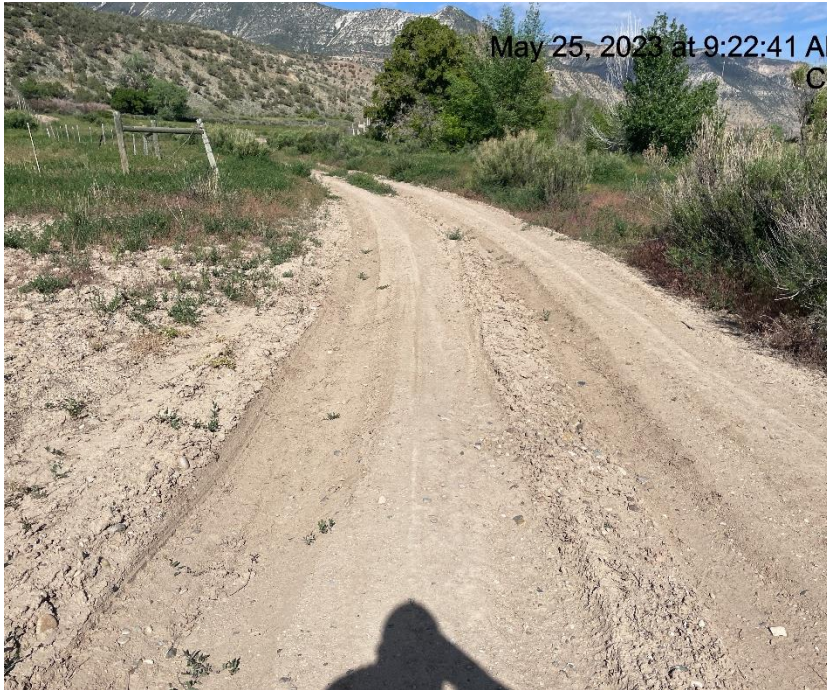
Photo # 8724 Lack of Stabilization/Compaction on location

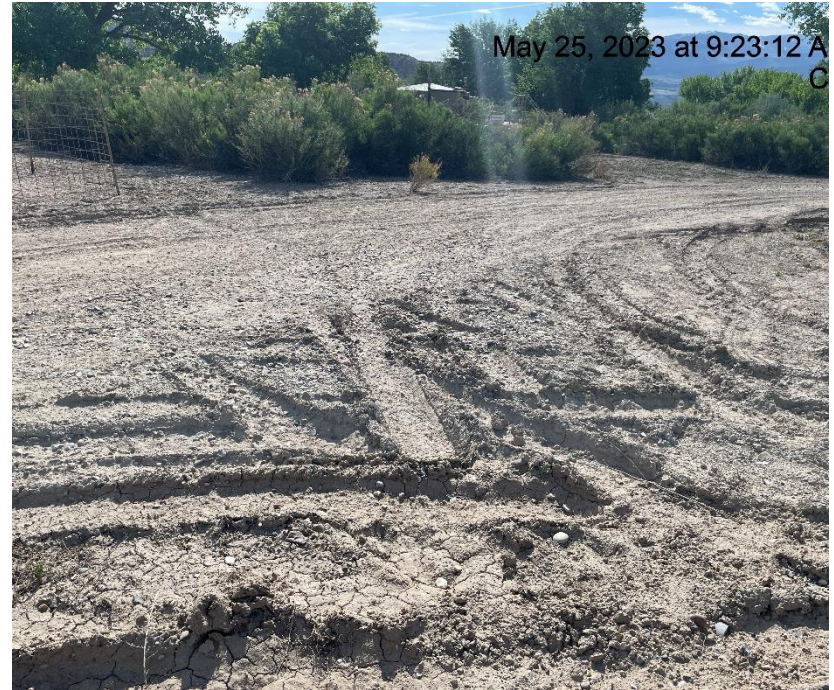
Photo # 8727 Lack of Stabilization/Compaction on location

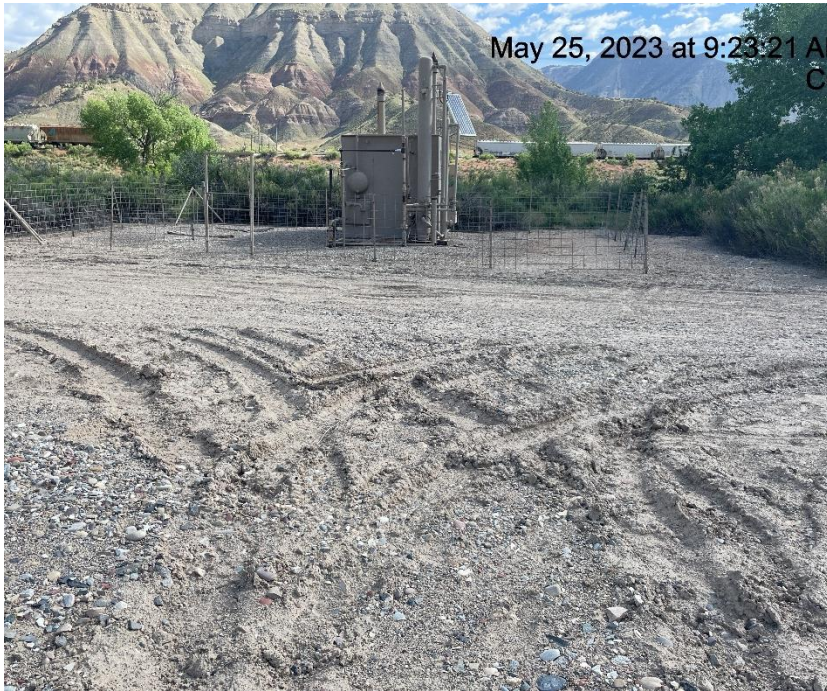
Photo # 8728 Lack of Stabilization/Compaction on location

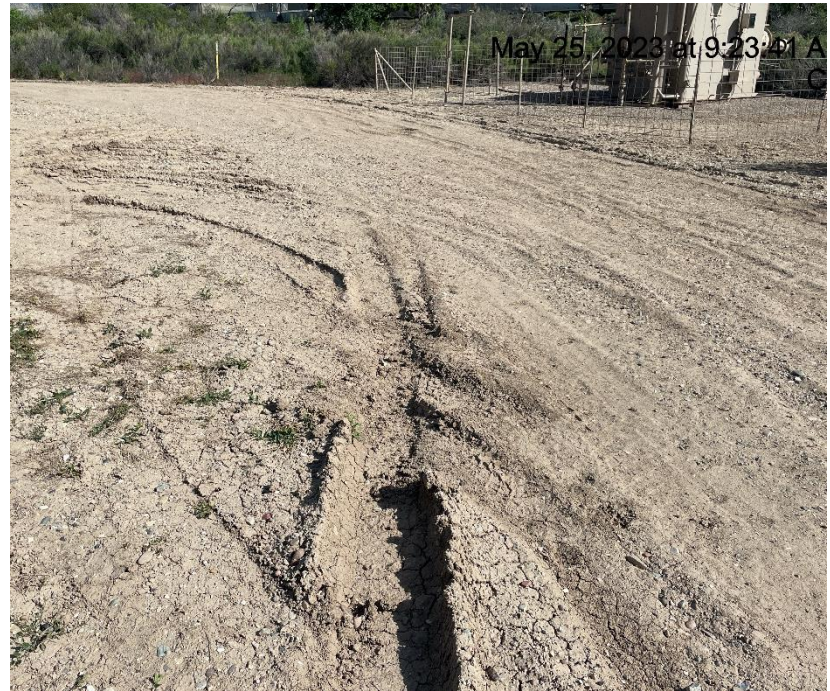
Photo # 8730 Lack of Stabilization/Compaction on location

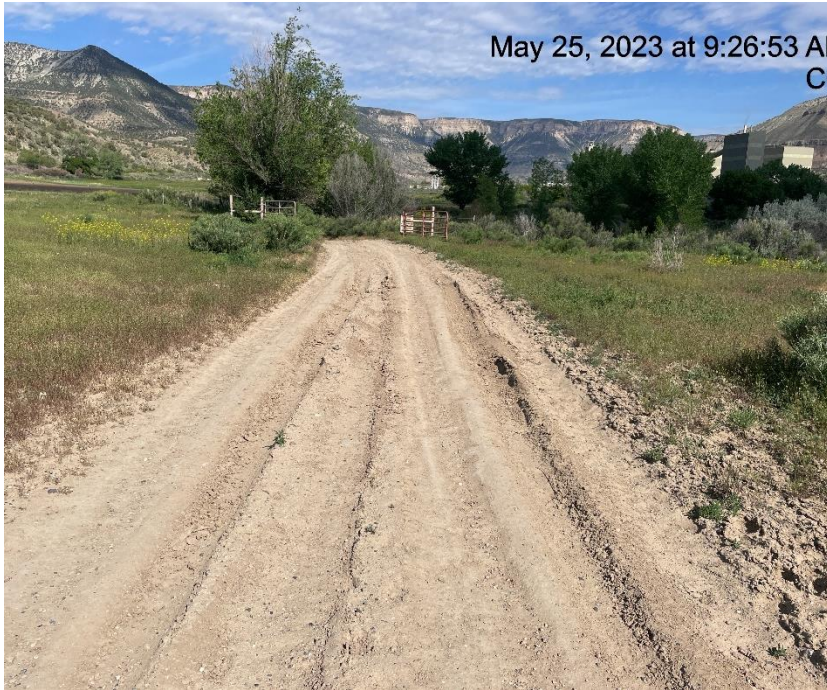
Photo # 8734 Lack of Stabilization/Compaction on spur road

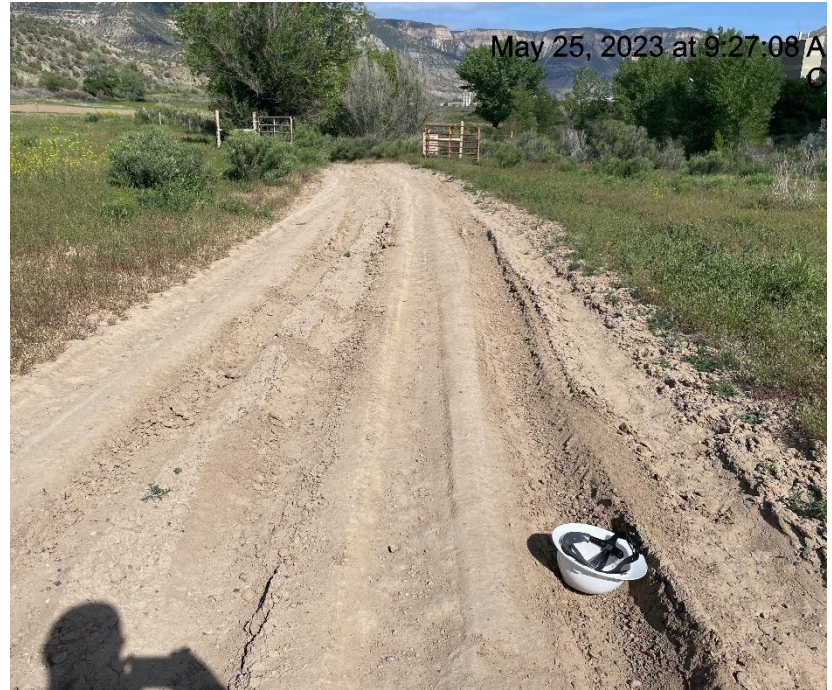
Photo # 8735 Lack of Stabilization/Compaction on spur road

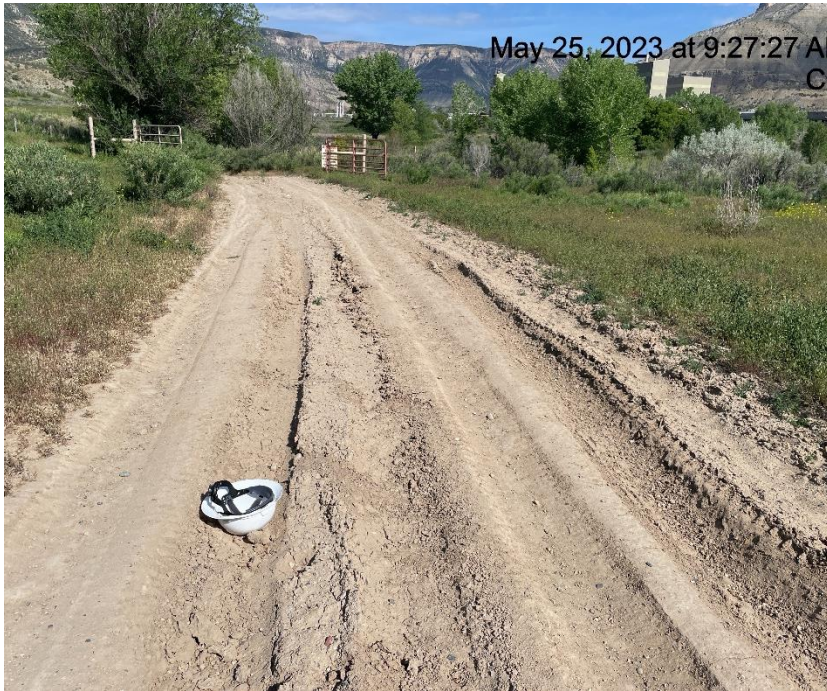
Photo # 8736 Lack of Stabilization/Compaction on spur road

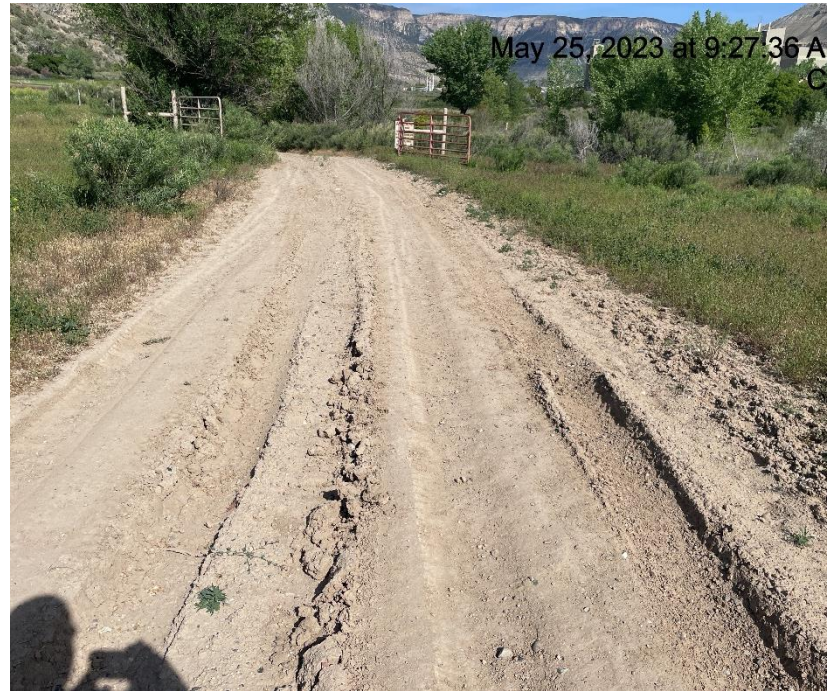
Photo # 8737 Lack of Stabilization/Compaction on spur road

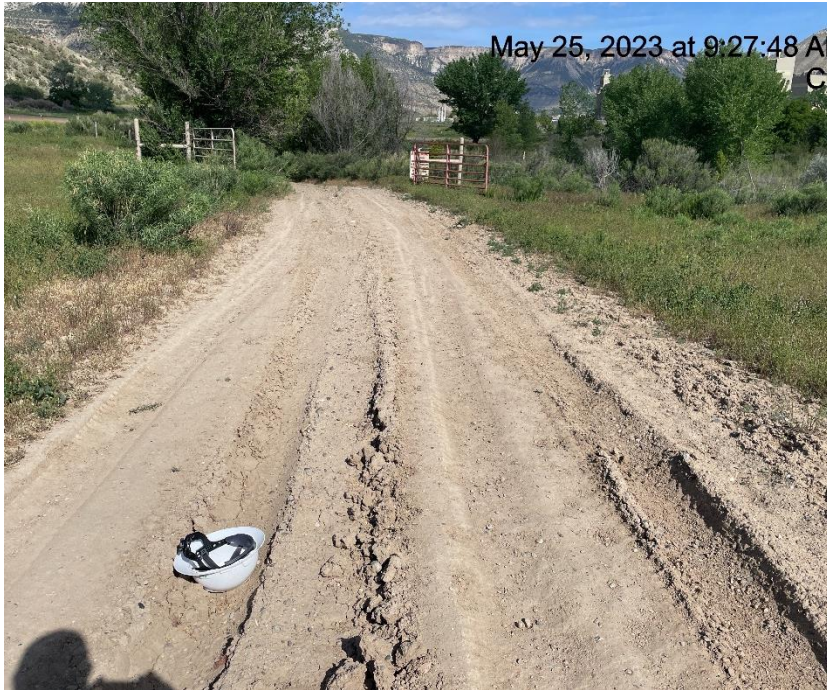
Photo # 8738 Lack of Stabilization/Compaction on spur road

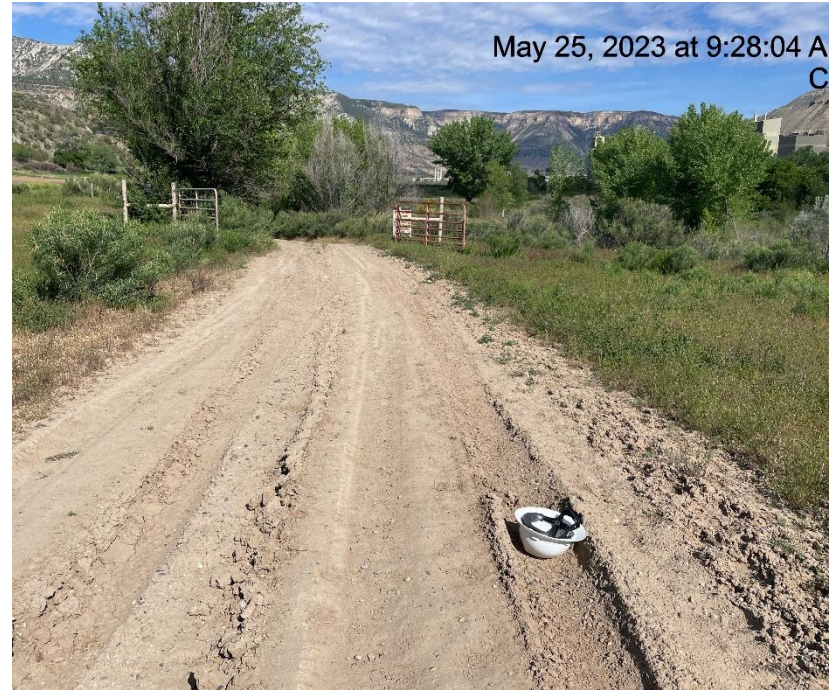
Photo # 8739 Lack of Stabilization/Compaction on spur road

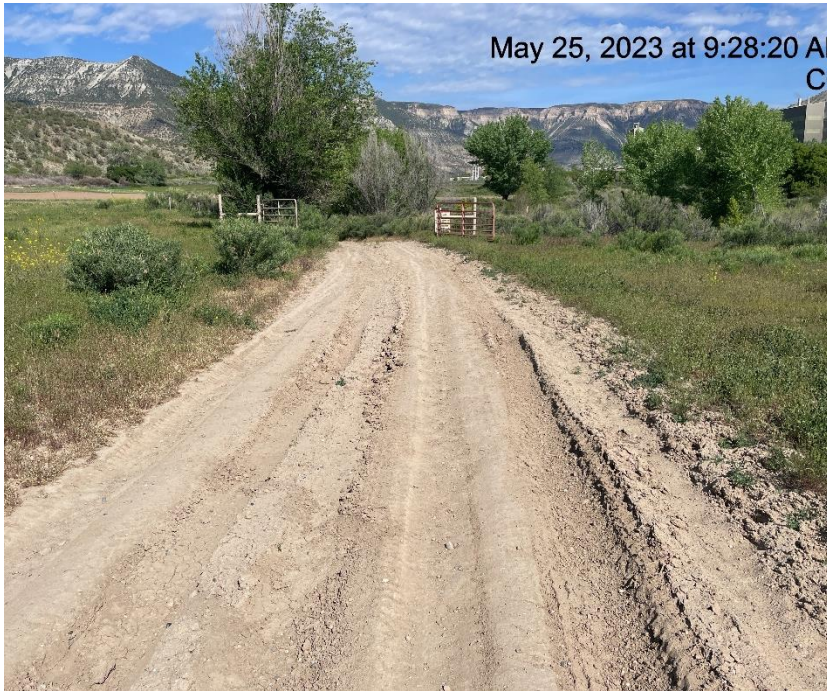
Photo # 8740 Lack of Stabilization/Compaction on spur road

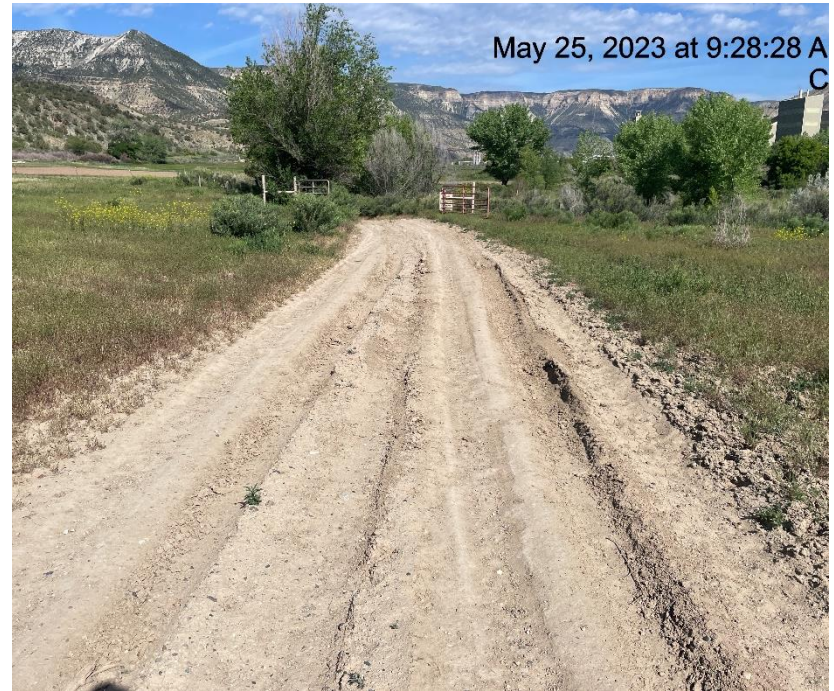
Photo # 8741 Lack of Stabilization/Compaction on spur road
