Well Name: Carpenter 32-6-3 2/Carpenter 32-6-3 15
Document Number: 712700091
Inspector: Curtis Pattillo

Location ID 438700

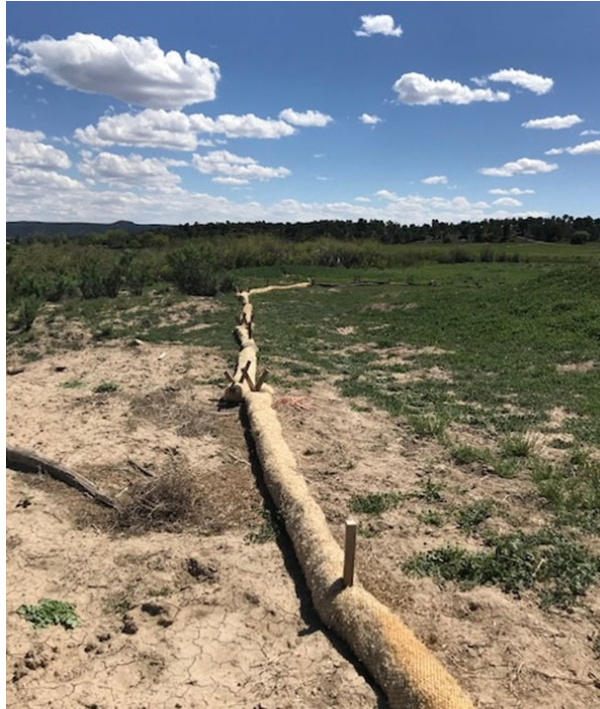
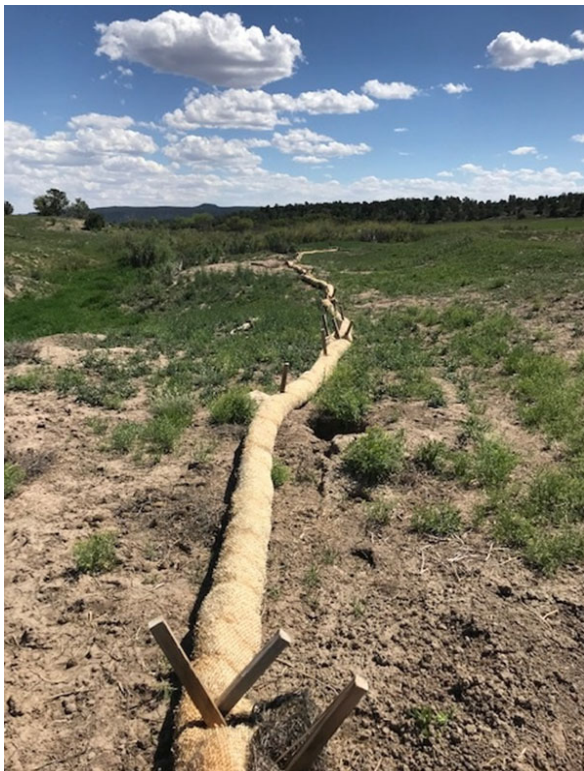
Installed wattles along eastern side of location berms must be maintained or removed. Previous inspection on 1/11/2022 required the installation of BMPs and spot seeding. The area has not been stabilized, reseeding as not been successful. Contact the SW Reclamation Specialist Ryan Costa regarding interim reclamation. See Photos #2 & #3.

Action Taken: Contacted SW Reclamation Specialist Ryan Costa regarding interim reclamation. Currently attempting to contact landowner to get permission to fence location to keep livestock away from reclamation areas. Plan to re-seed once permission is received to fence off location. Installed new wattles/repositioned existing wattles surrounding location.
