## Inspection Photos

Location Name: TEP ROCKY MOUNTAIN LLC JUHAN-66S94W /34SESW

Location ID: 323986

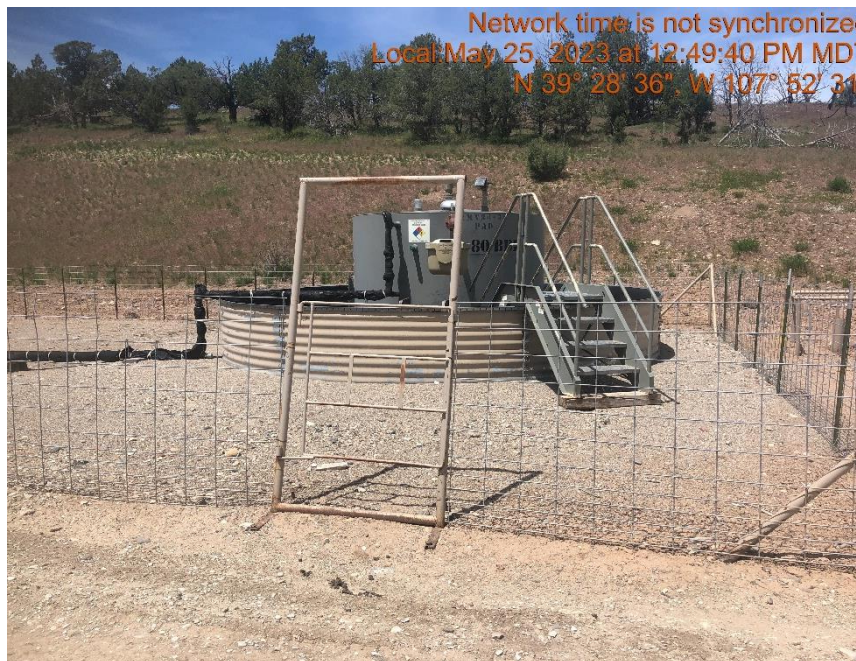
Photo #129 From entrance to location.

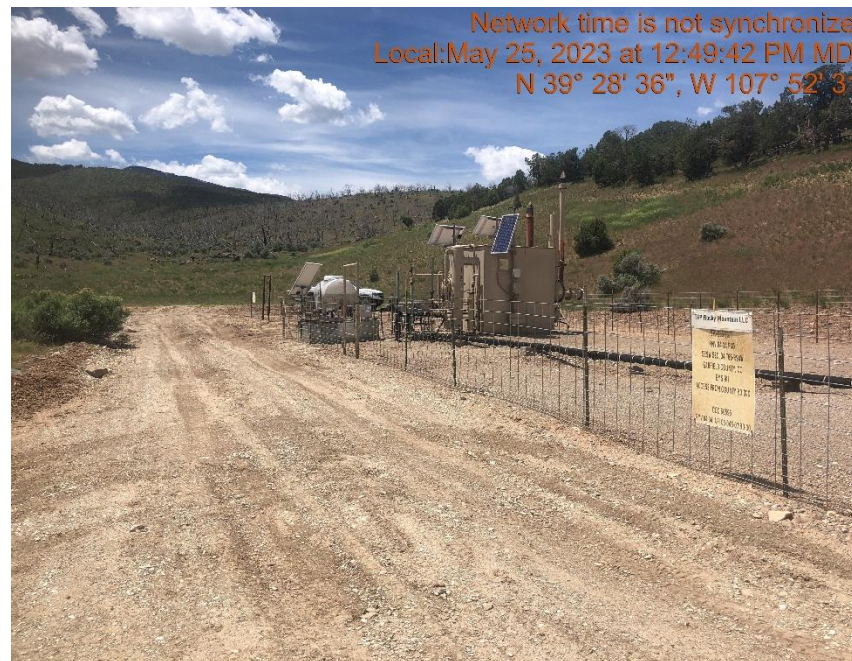
Photo #130 From entrance to location

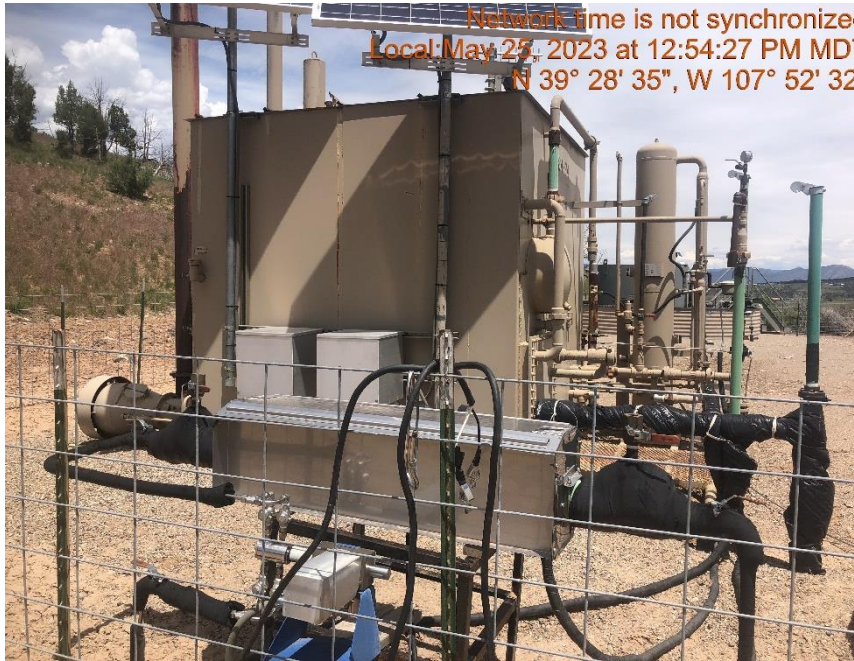
**Photo #136 Calibration cards not conspicuously posted.**

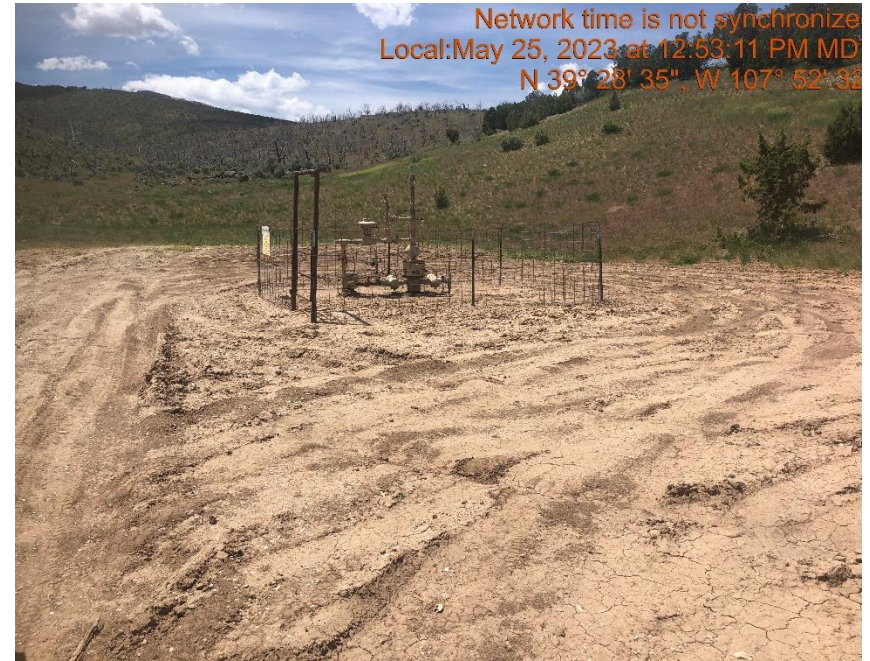
**Photo #133 Location lacks stabilization.**

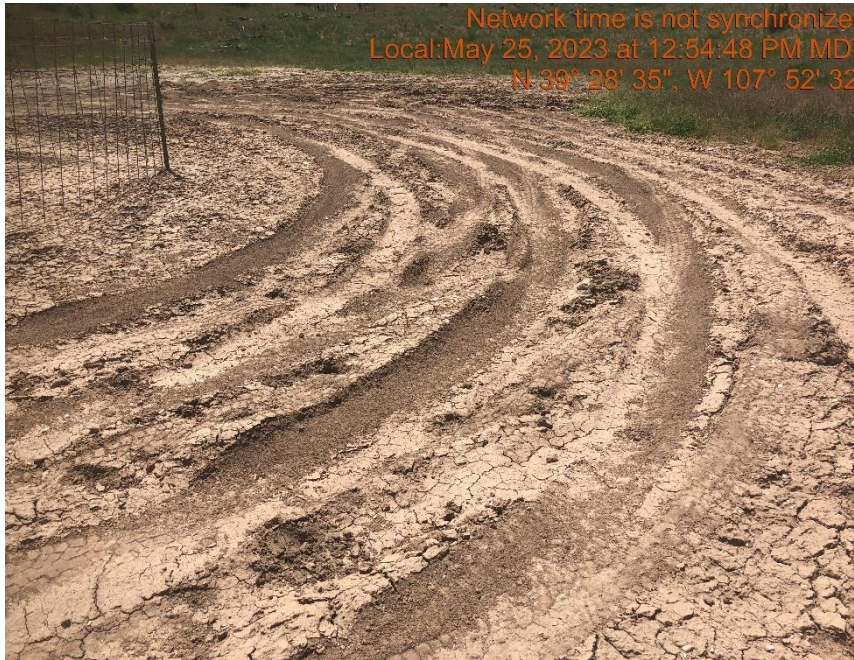
**Photo #137 Location lacks stabilization**

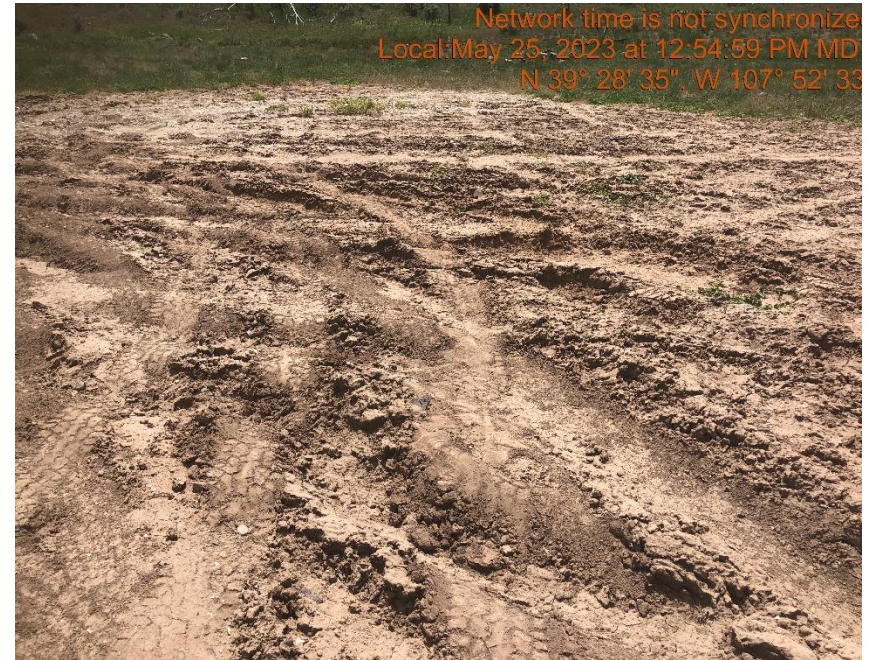
**Photo #138 Location lacks stabilization.**

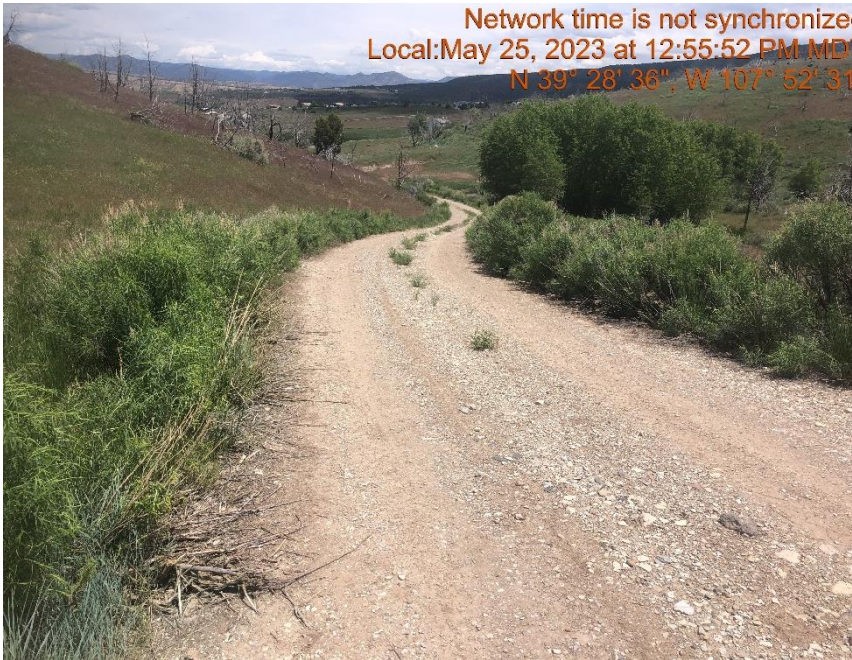
**Photo #140 -Insufficient tracking BMP at entrance to location. To minimize the transport of sediment**
