Inspection Photos

API: 071-08769

Operator: WAPITI OPERATING LLC

Inspection Date: 5/30/2023

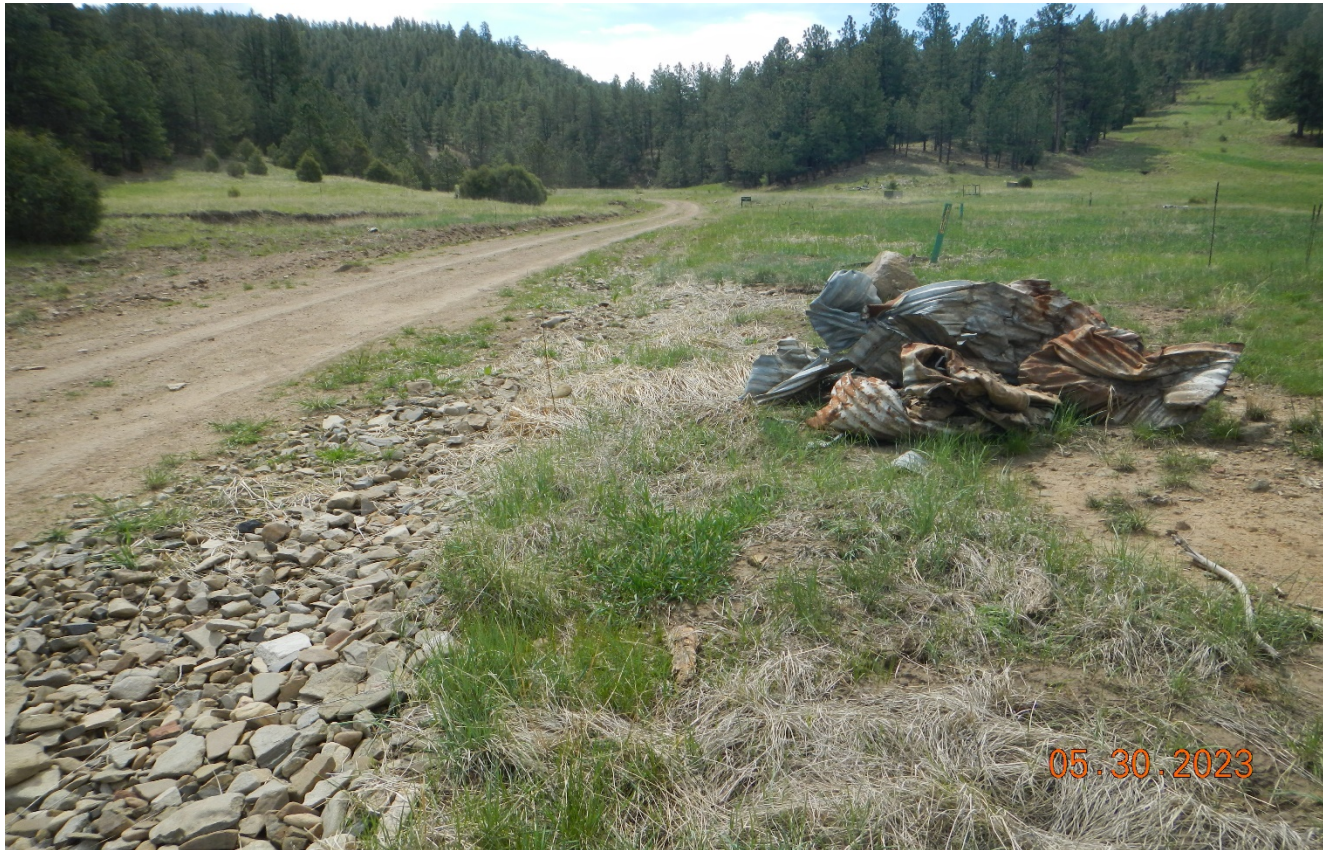
Photo 1. Facing southeast along the main access road. There is damaged culvert debris that remains along the road that must be removed.

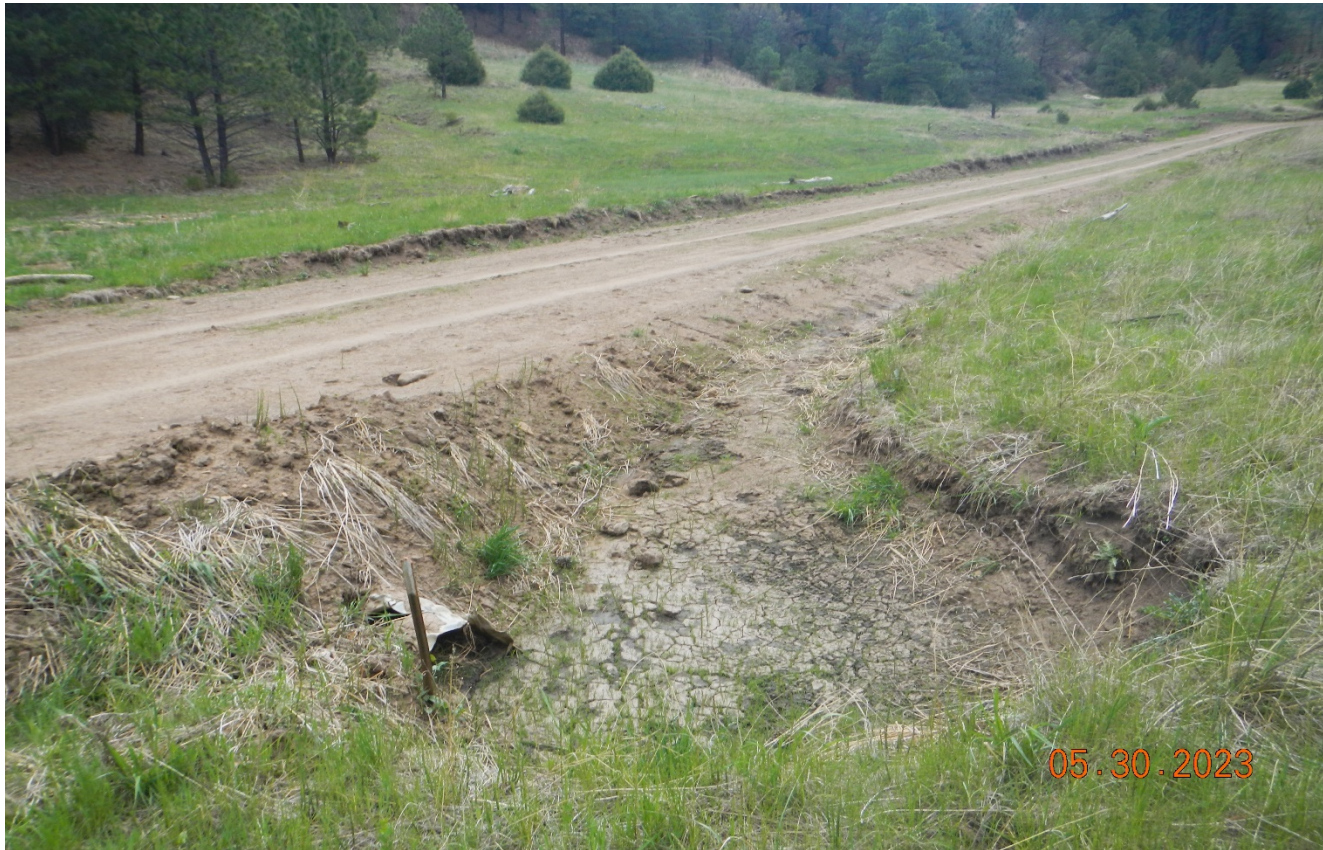
Photo 2. This culvert inlet was cleaned out by the Operator however, the culvert is full of sediment and the inlet has filled back in with sediment. Previous corrective action was not completed. Lat/Long:37.00581,-104.83861.

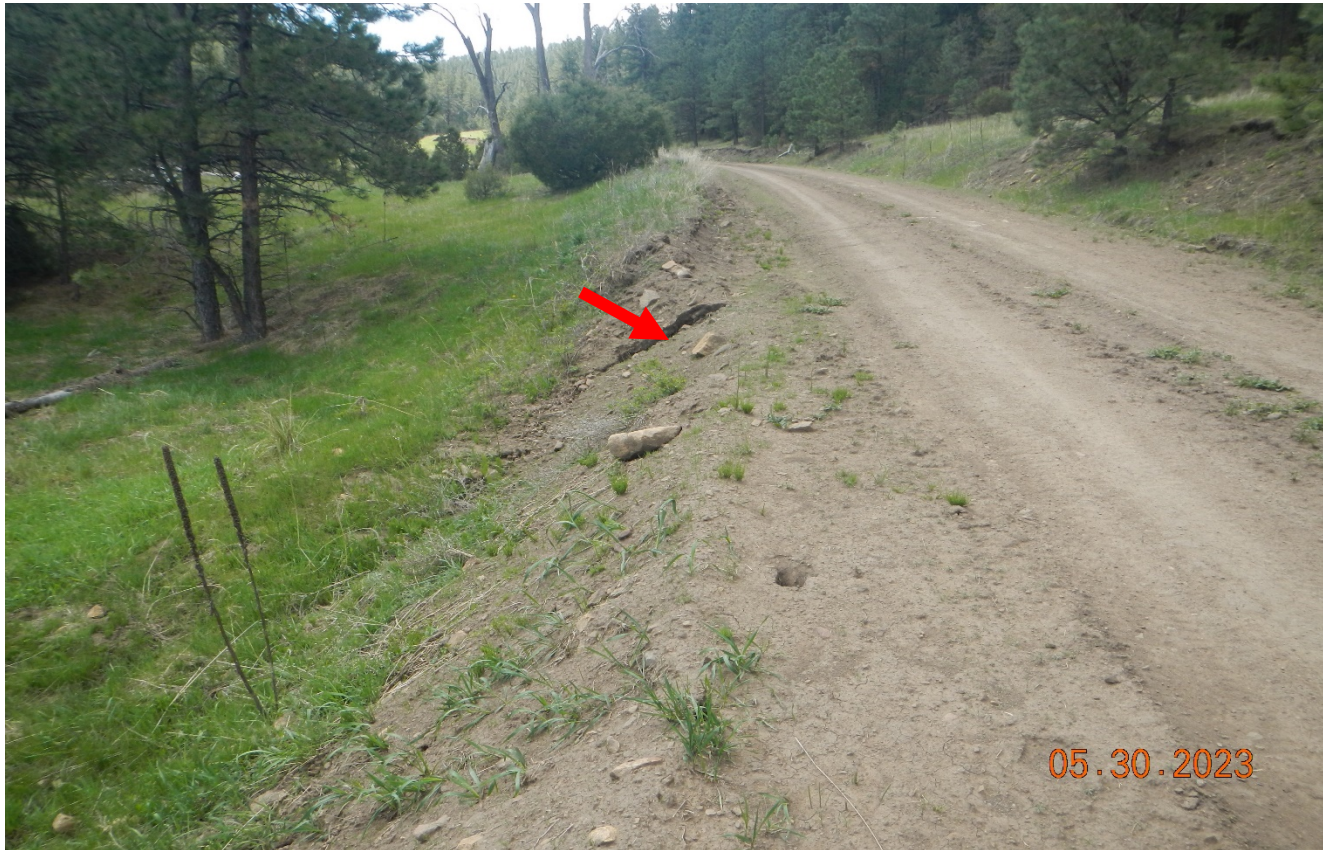
Photo 3. There was an erosion gully along the road that has been partially filled in however it was never stabilized. Erosion is beginning to occur in occur again which is transporting sediment into the stream drainage. Previous corrective action was not completed.

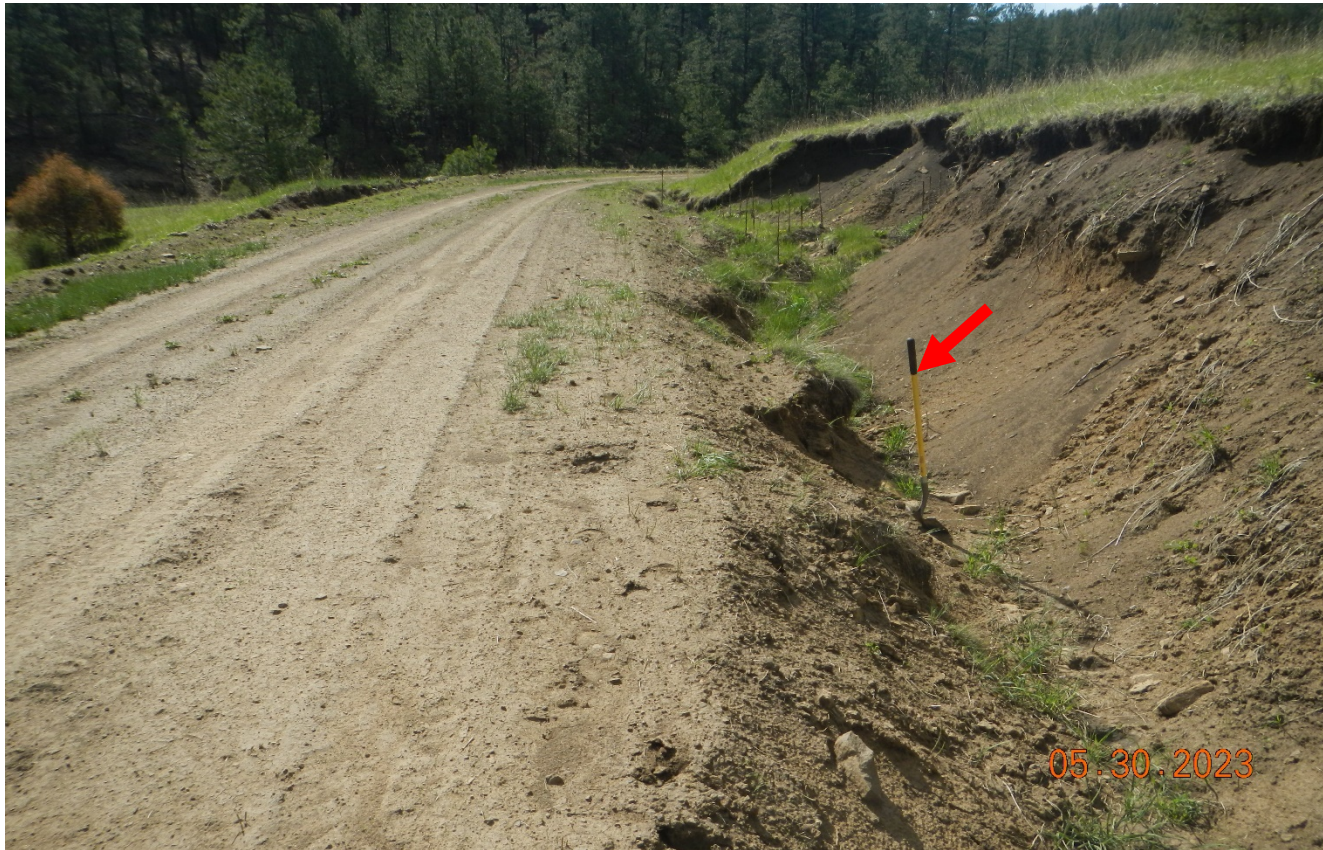
Photo 4. The side of the road is eroded and not stabilized. Erosion head cutting is continuing to occur further back into the slope. This area needs to be repaired and stabilized. Previous corrective action not completed. Red arrow points to 4.5 ft. shovel for scale. Lat/Long:36.99952,-104.83425.

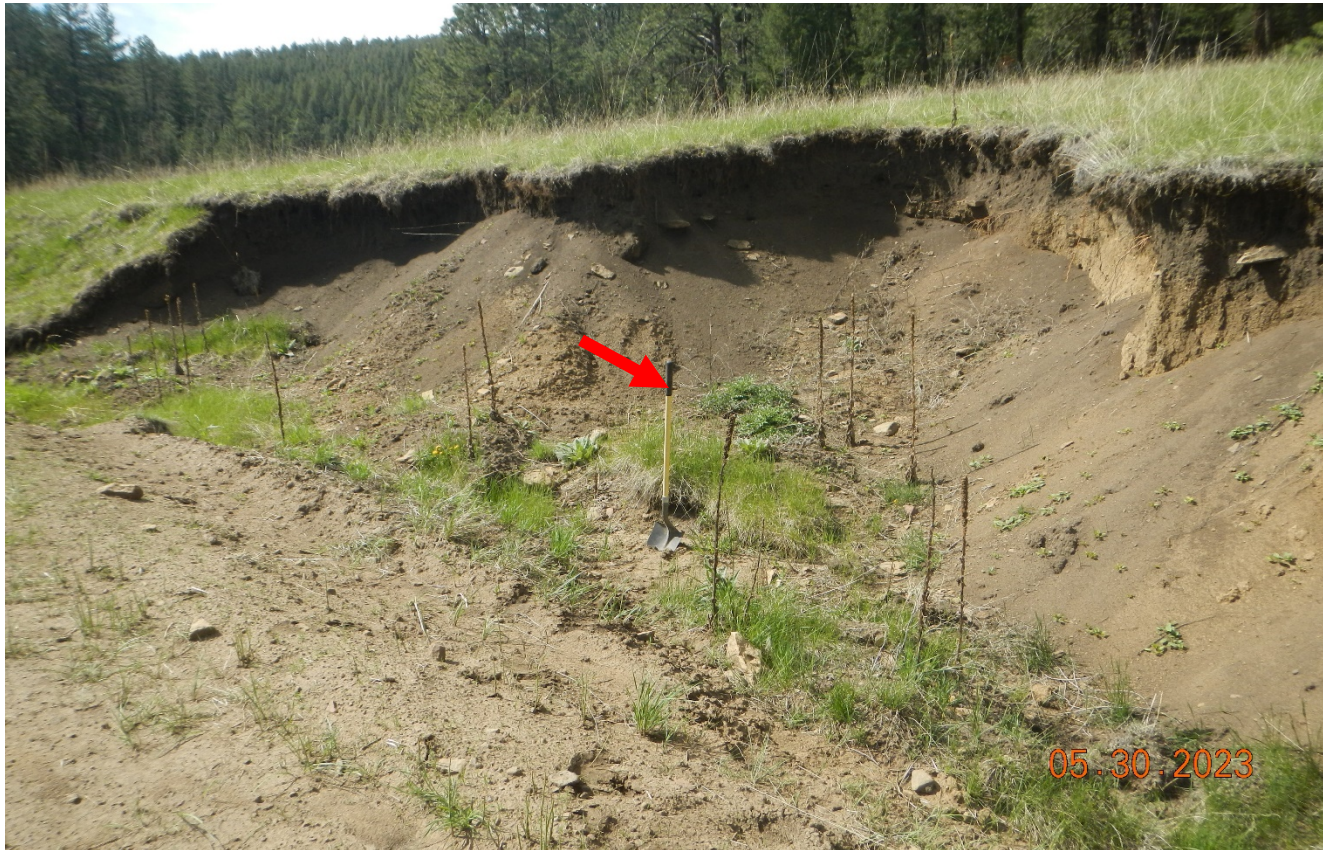
Photo 5. The side of the road is eroded and not stabilized. Erosion head cutting is continuing to occur further back into the slope. This area needs to be repaired and stabilized. Previous corrective action not completed. Red arrow points to 4.5 ft. shovel for scale. Lat/Long:36.99952,-104.83425.

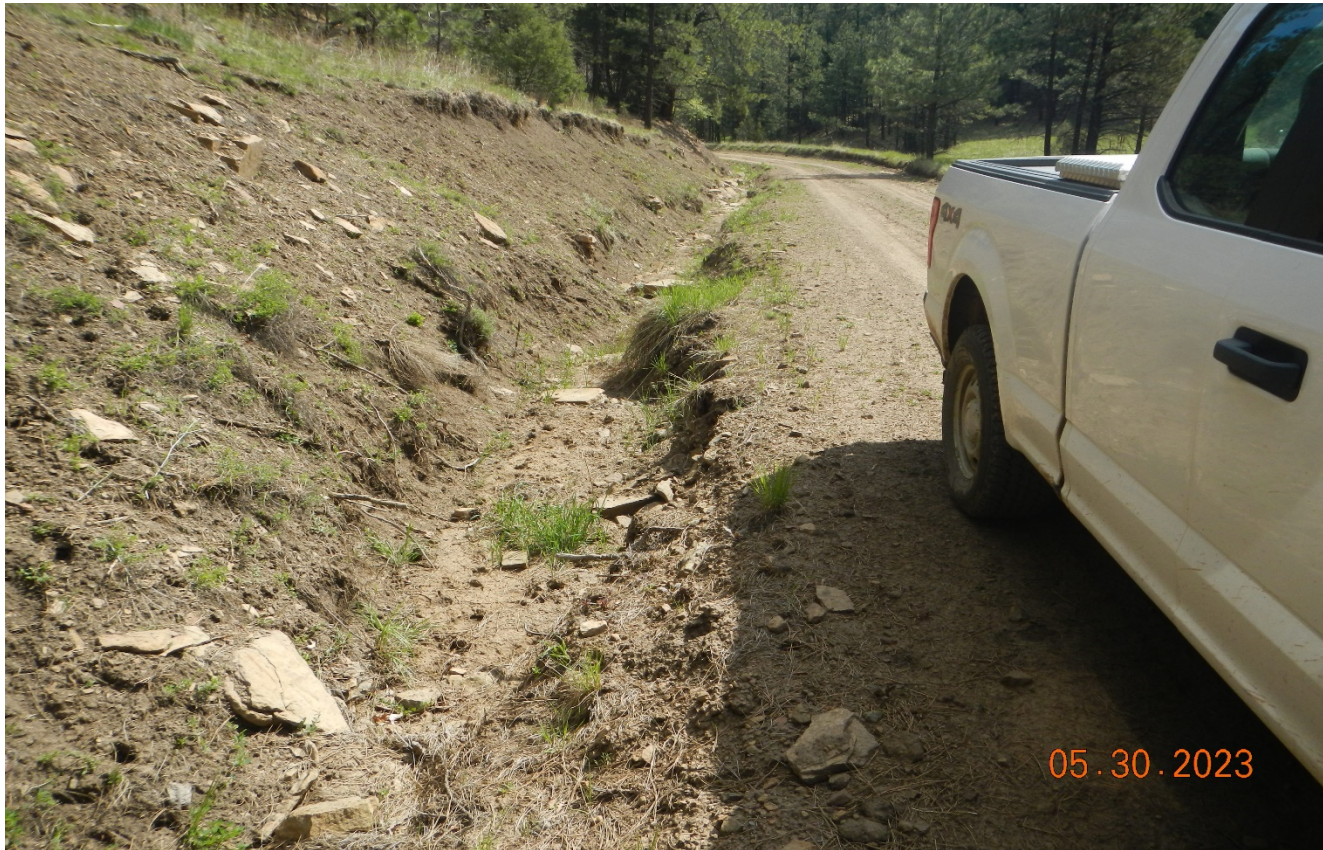
Photo 6. Further along the road near the Colorado line. The roadside and road is eroded and needs to be repaired and stabilized. Previous corrective action not completed.

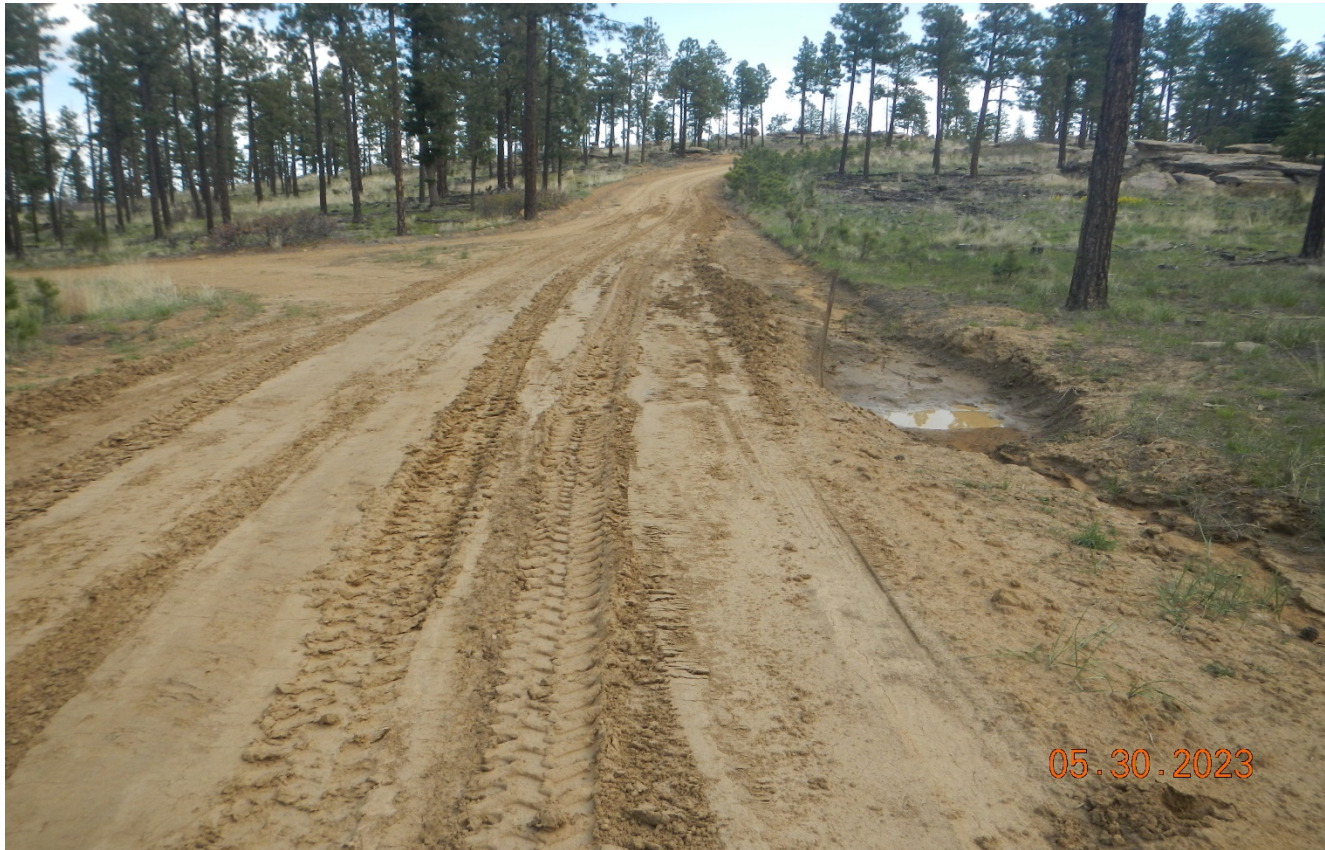
Photo 7. Facing northeast along the main access road. This culvert is filled in with sediment and stormwater is accumulating in this area causing erosion and vehicle tracking.

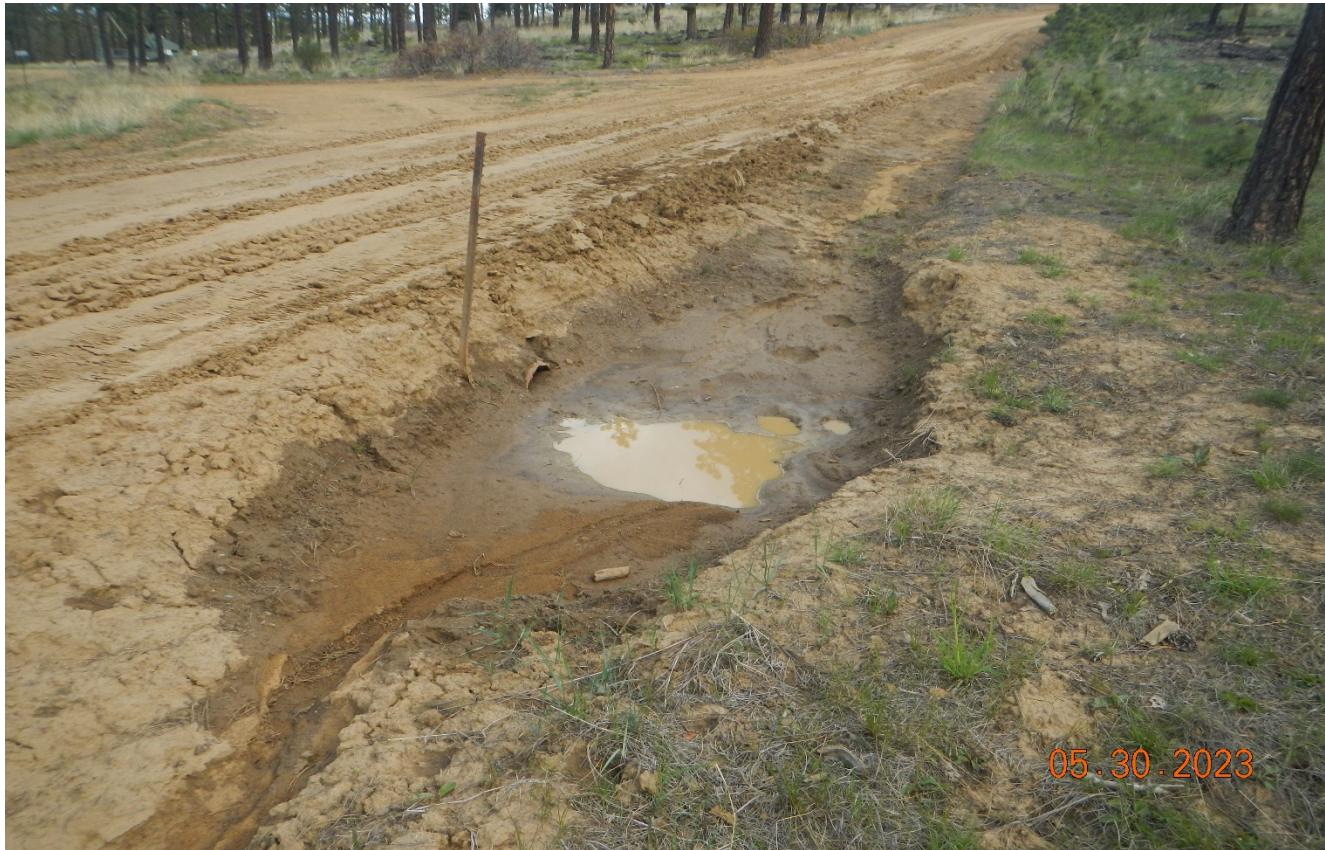
Photo 8. This culvert is full of sediment which needs to be cleaned out.
Lat/Long:36.99405,-104.84710. Previous corrective action not completed.

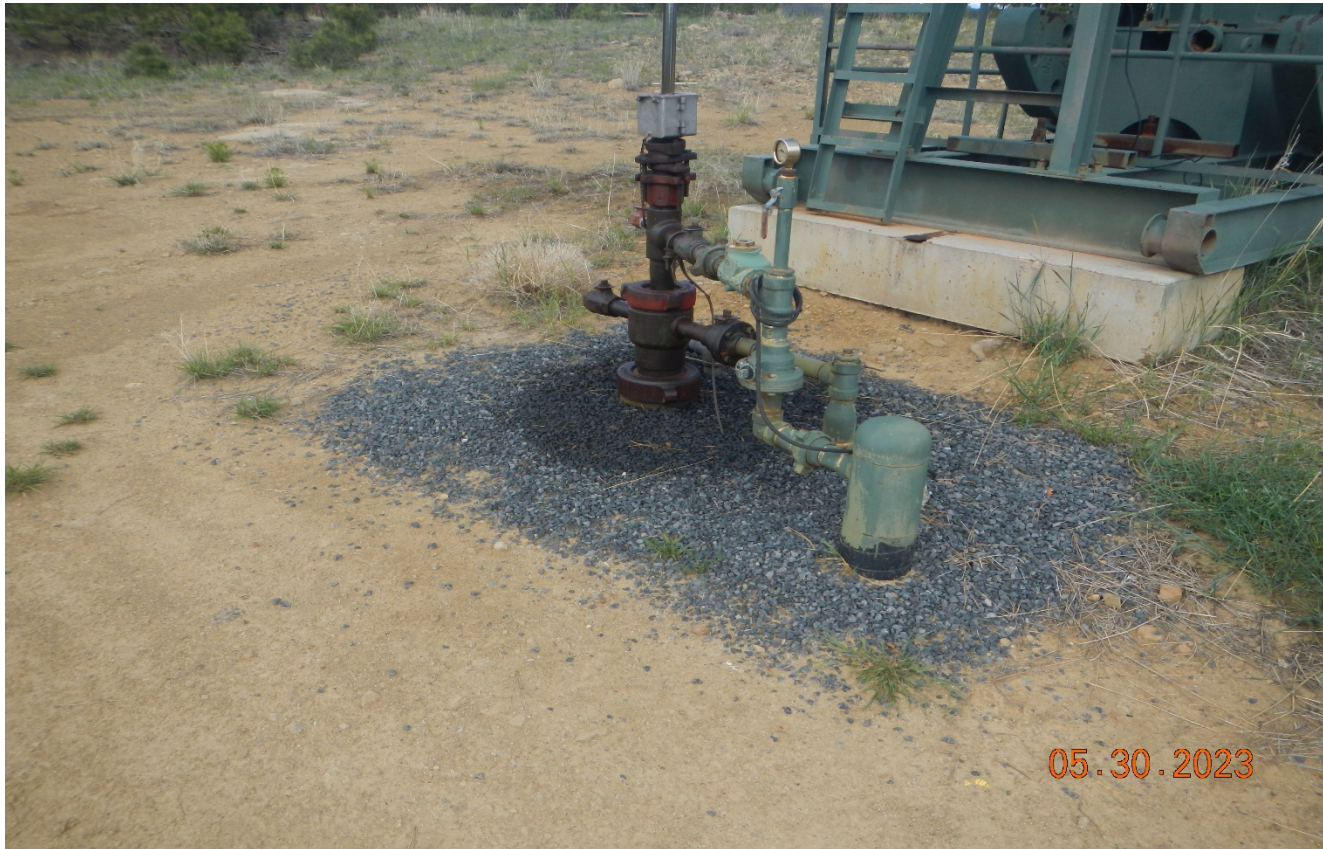
Photo 10. There is stained soil at the wellhead that needs to be cleaned up.
