# Inspection Photos

API: 071-09838

Operator: WAPITI OPERATING LLC

Inspection Date: 5/30/2023

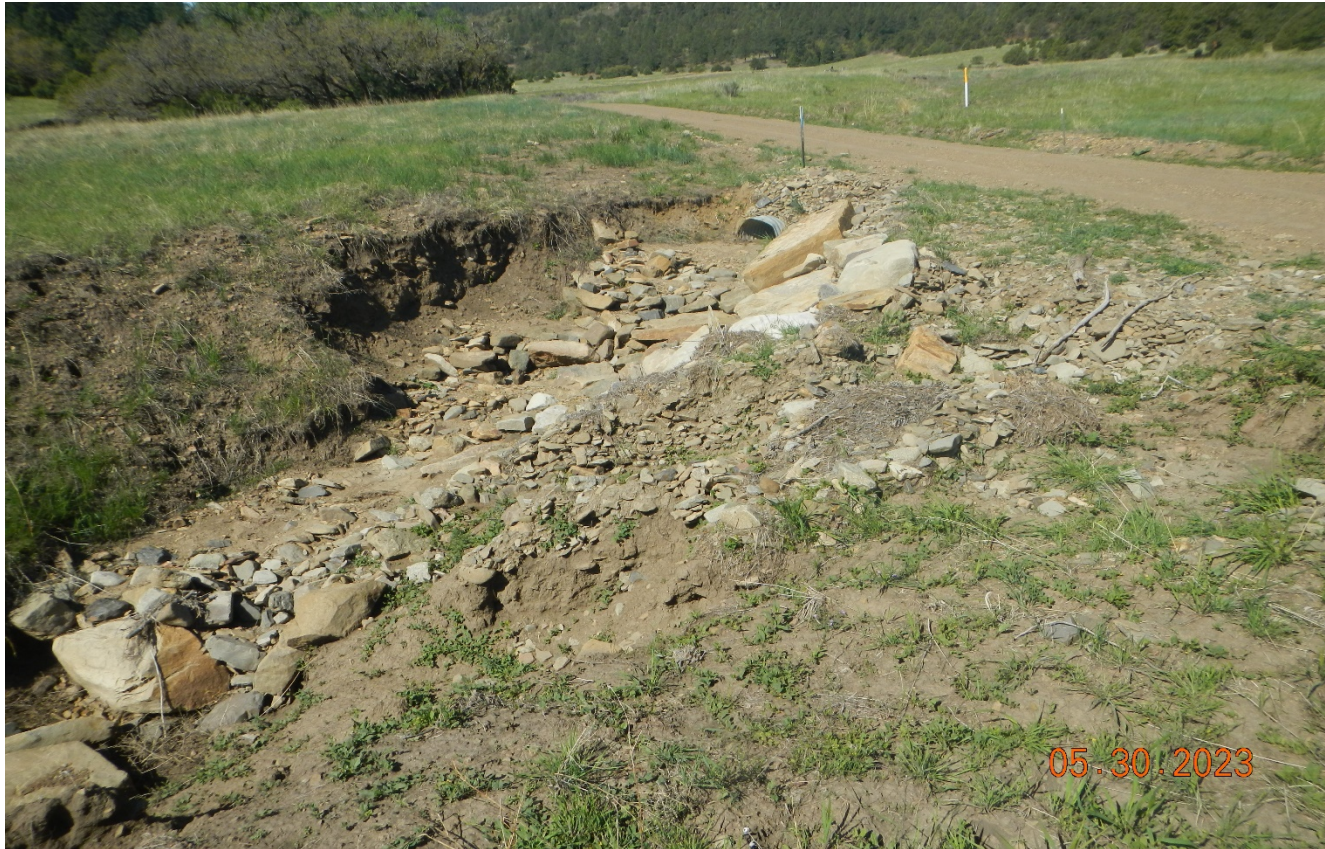
**Photo 1.** The culvert outlet has eroded and needs to be repaired.

Lat/Long:37.02423,-104.82909.

Previous corrective action was not completed.

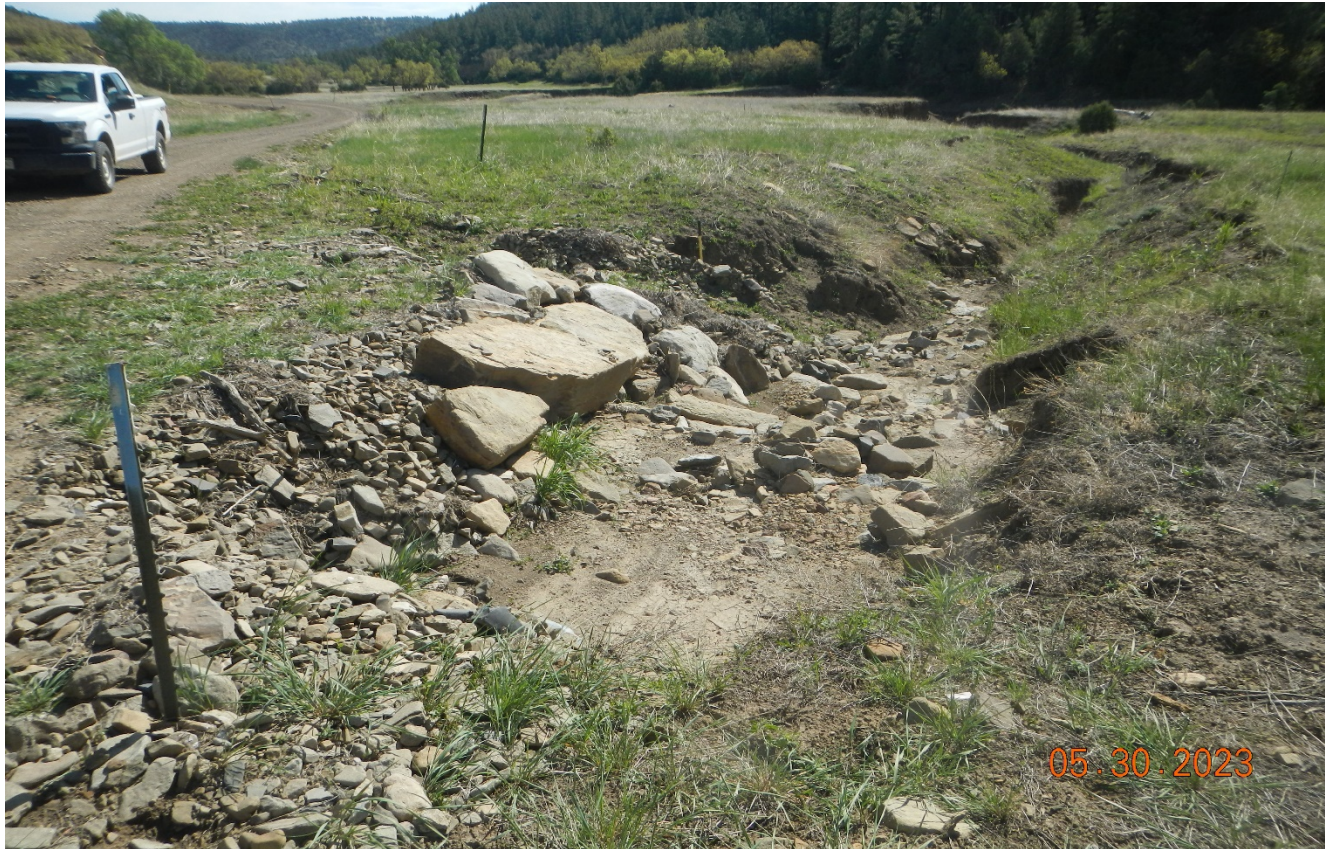
**Photo 2.** Facing toward the culvert outlet. The culvert outlet has eroded and needs to be repaired. Previous corrective action was not completed. BMP's must be installed per good engineering practice. (E.g. Rock outlet protection should include geotextile fabric)

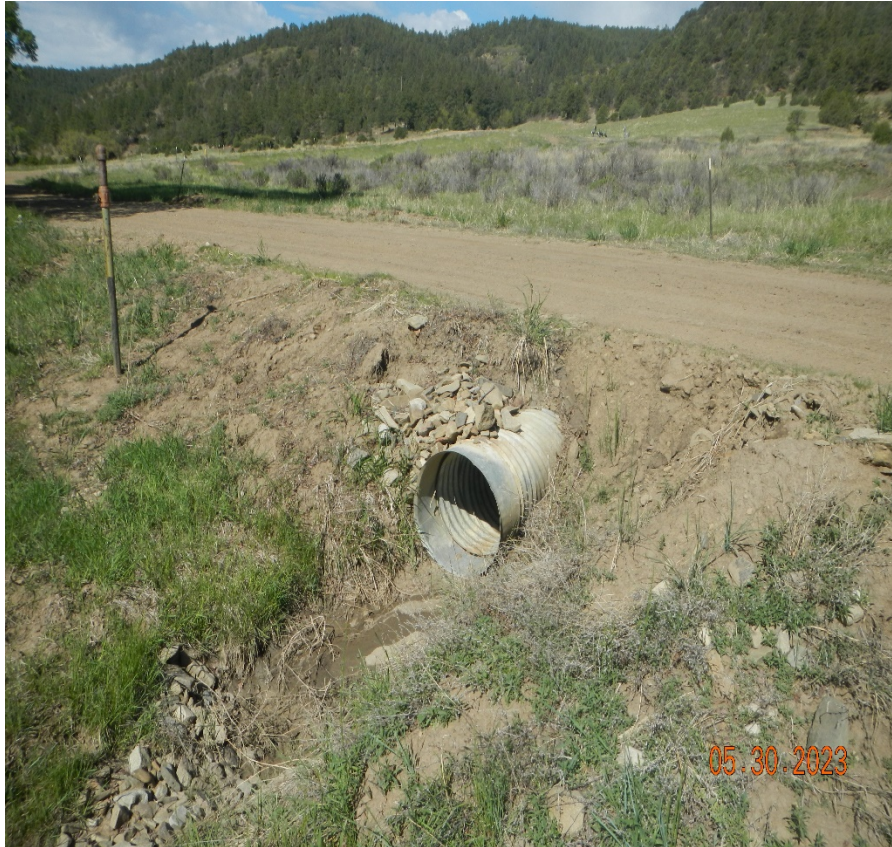
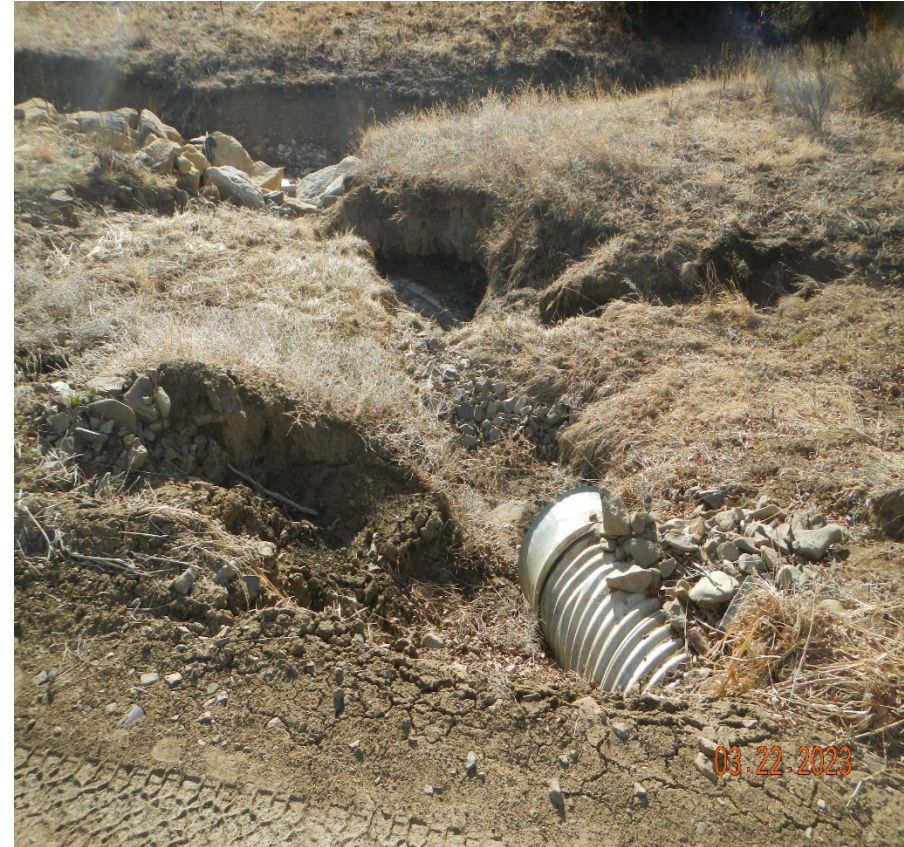
**Photo 3.** The next culvert along the road is also eroded at the culvert outlet with no outlet protection. Previous corrective action was not completed.

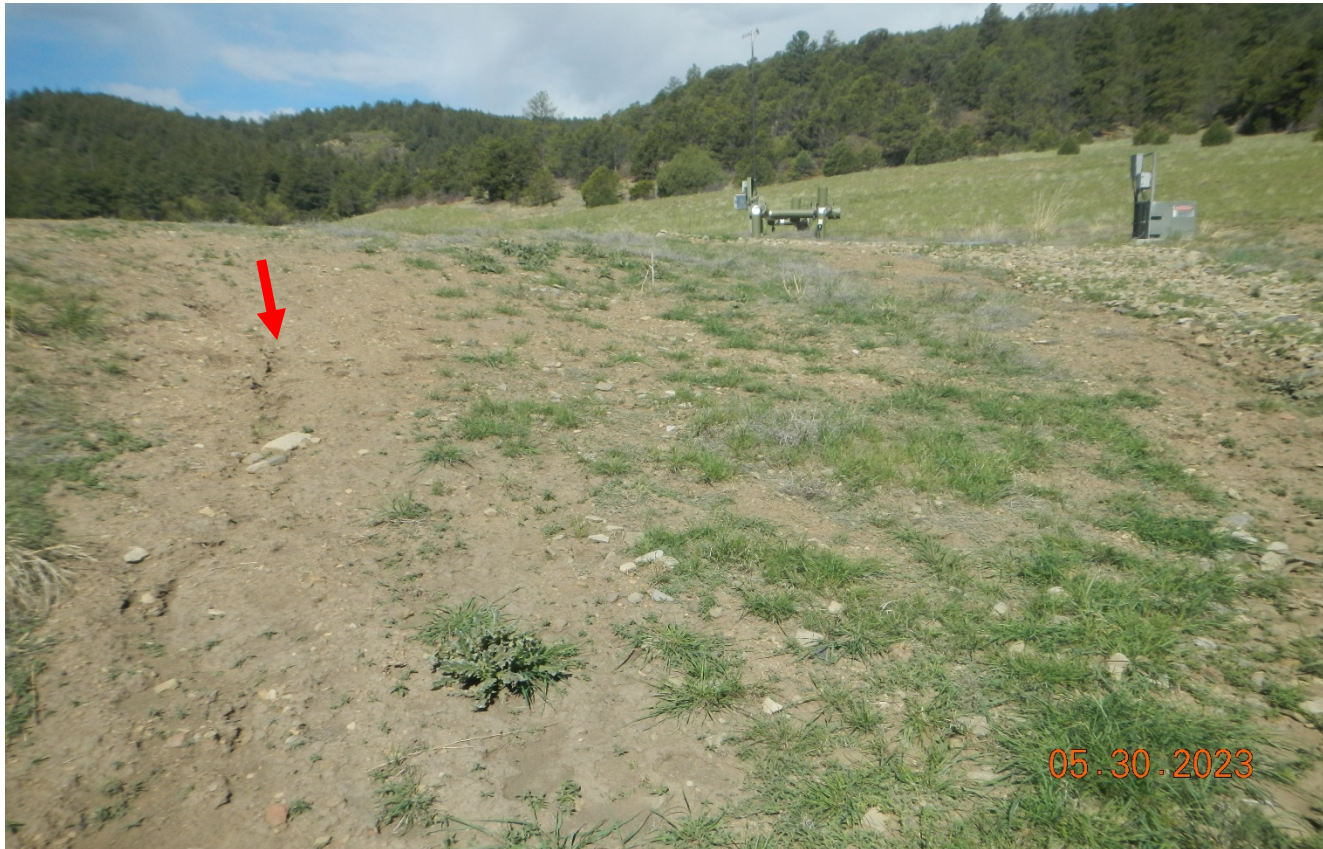
**Photo 4.** Facing southwest at the location. There is erosion occurring off the northeast side of the location which is not stabilized with vegetation. Additional BMP's need to be installed in this area including reseeding.

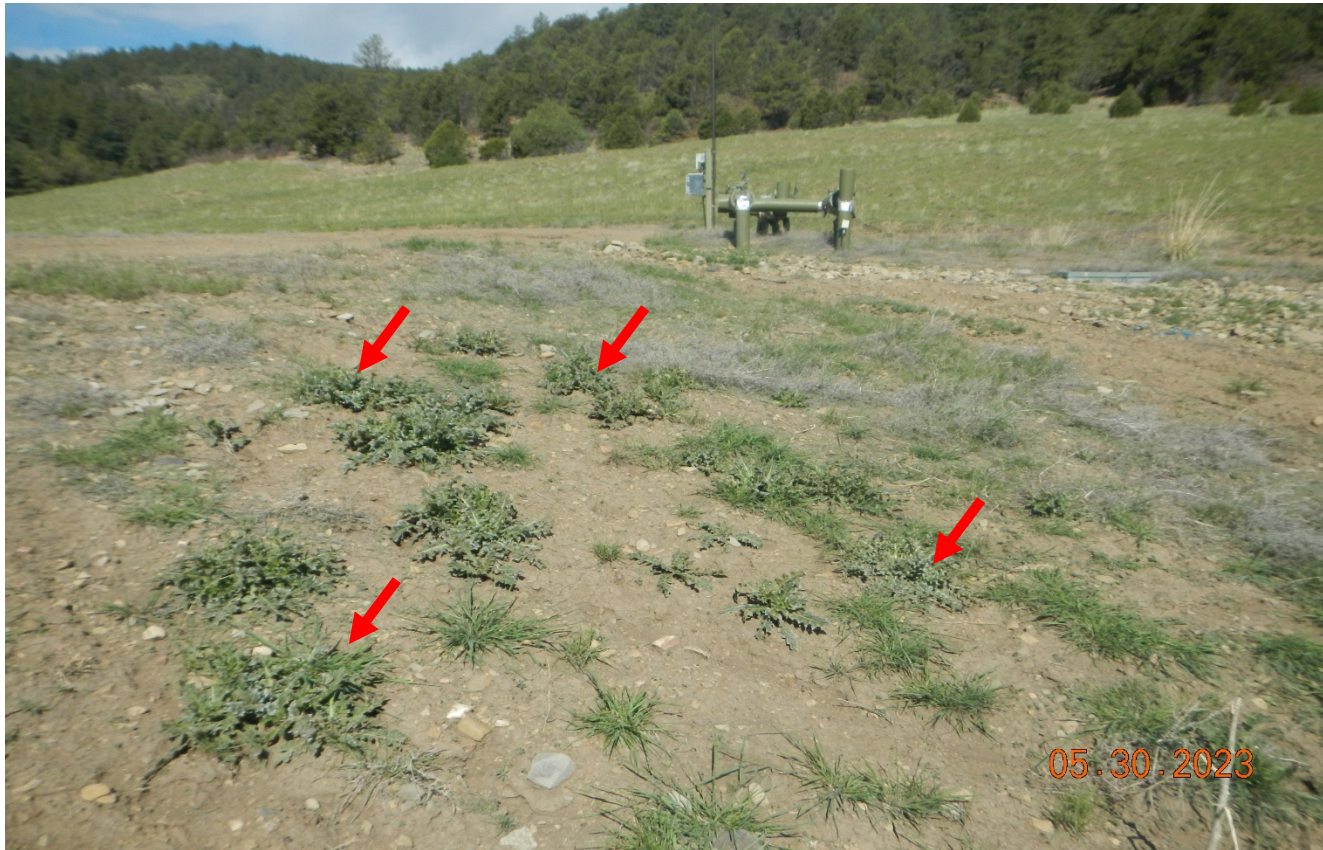
**Photo 5.** Facing southwest at the location. There are numerous noxious weeds along the access road that have not been controlled. The red arrows points to List B noxious weed – Musk thistle.

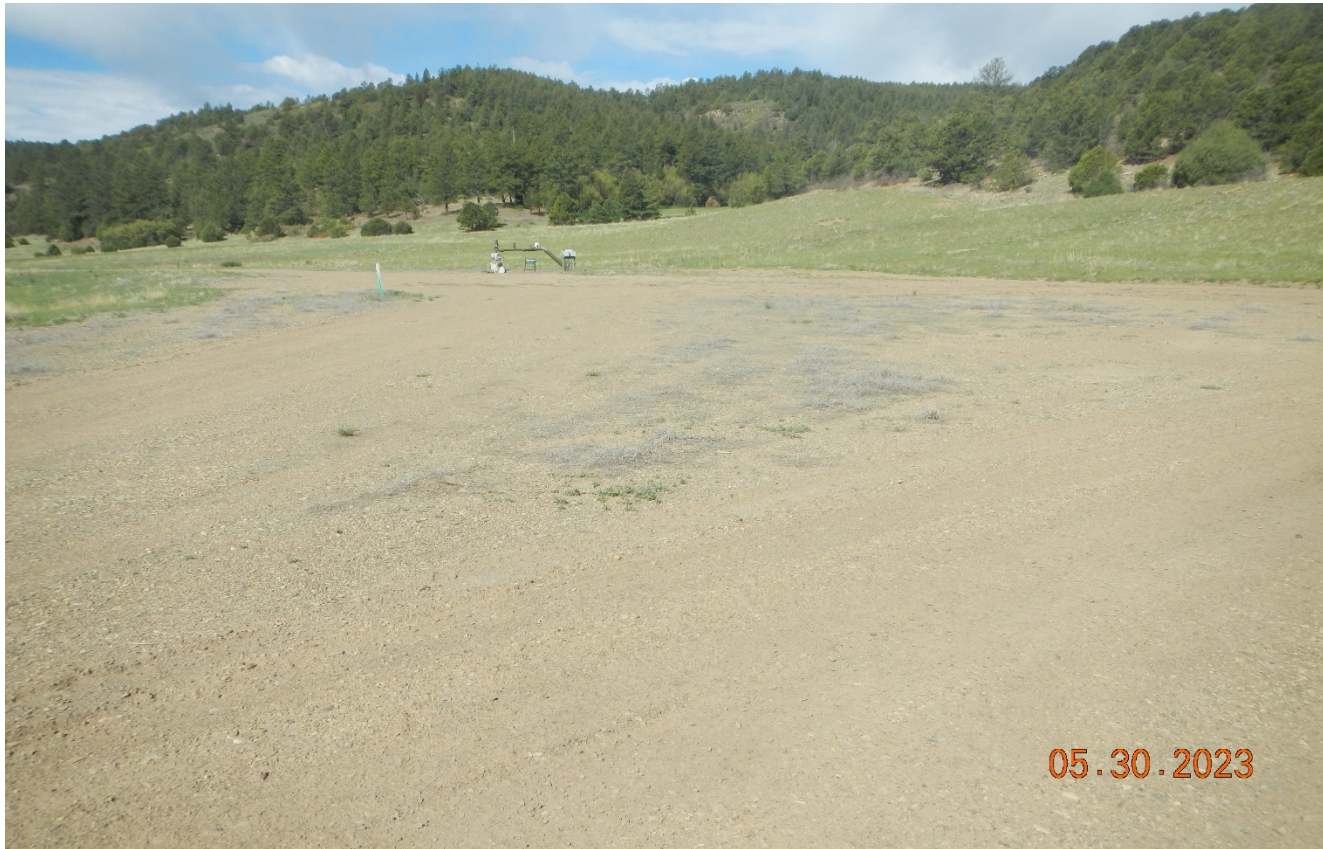
**Photo 6.** Facing northwest toward the wellsite.

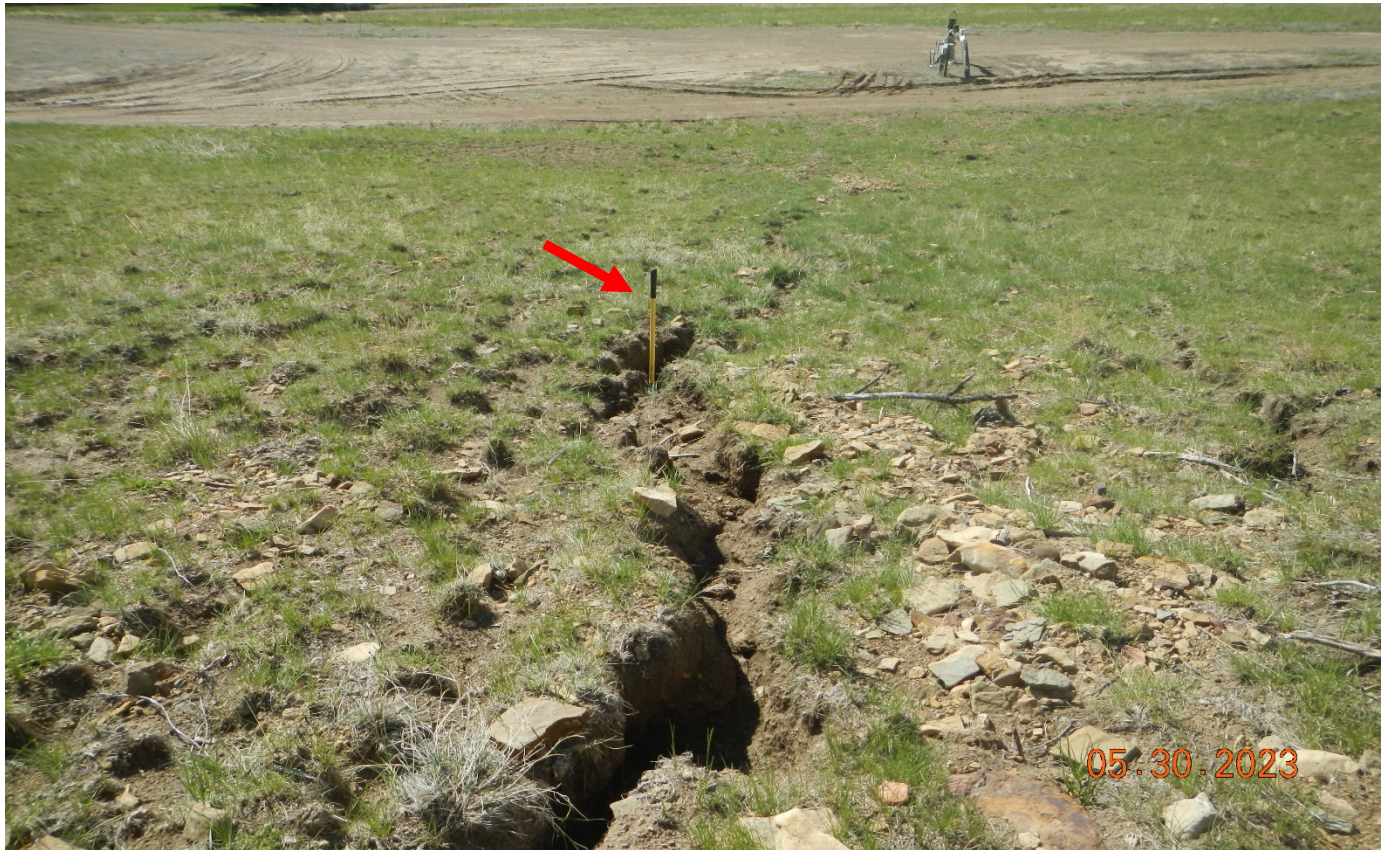
**Photo 7.** Facing southeast toward the location at the upper cut slope area. Stormwater run-on is causing erosion and is not properly diverted by the perimeter ditch. This area needs to be repaired and stabilized. Previous corrective action is not completed.

Red arrow points to 4.5 ft. shovel placed in the erosion channel for scale.

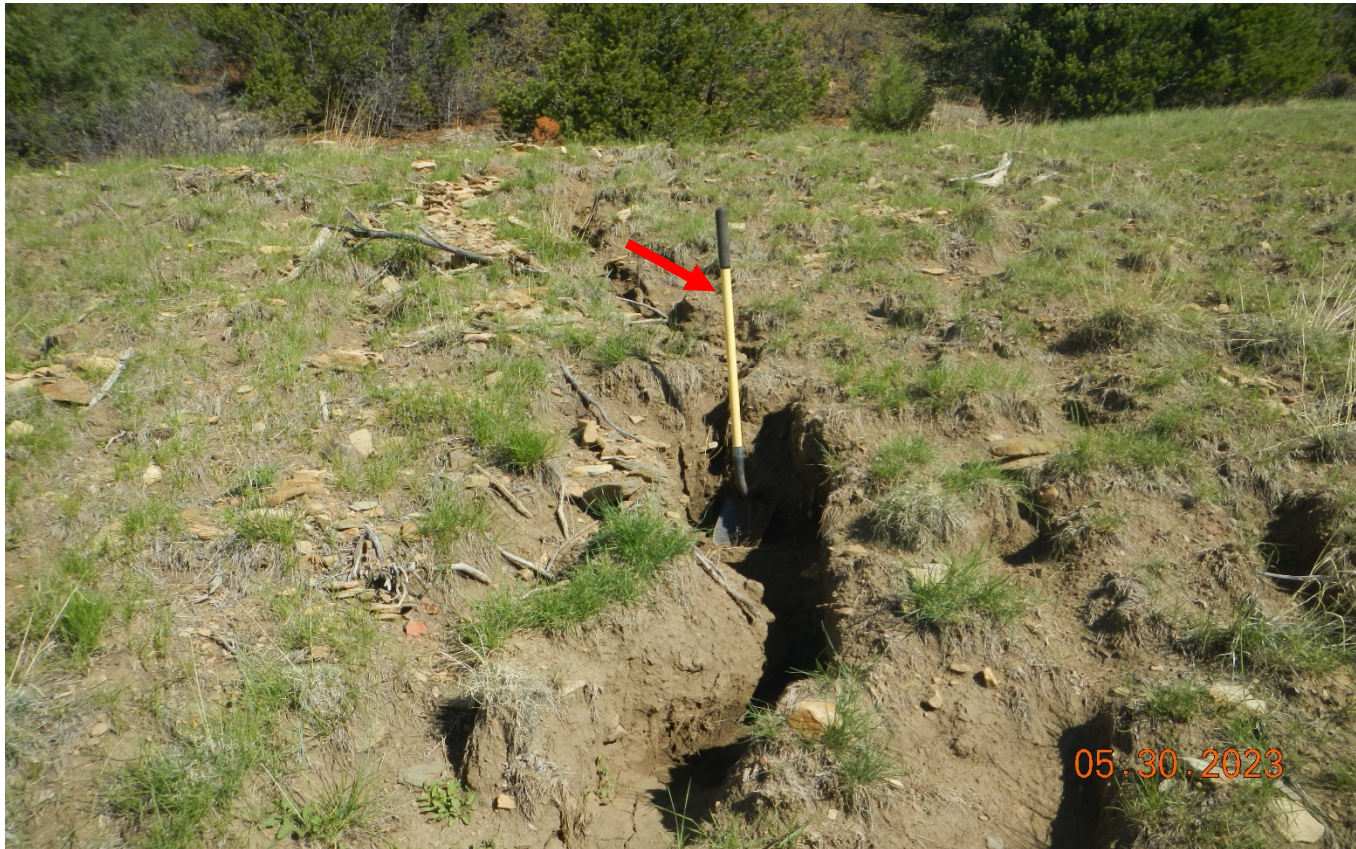
**Photo 8.** Facing northwest at the upper cut slope area. Stormwater run-on is causing erosion and is not properly diverted by the perimeter ditch. This area needs to be repaired and stabilized. Previous corrective action is not completed.

Red arrow points to 4.5 ft. shovel placed in the erosion channel for scale.

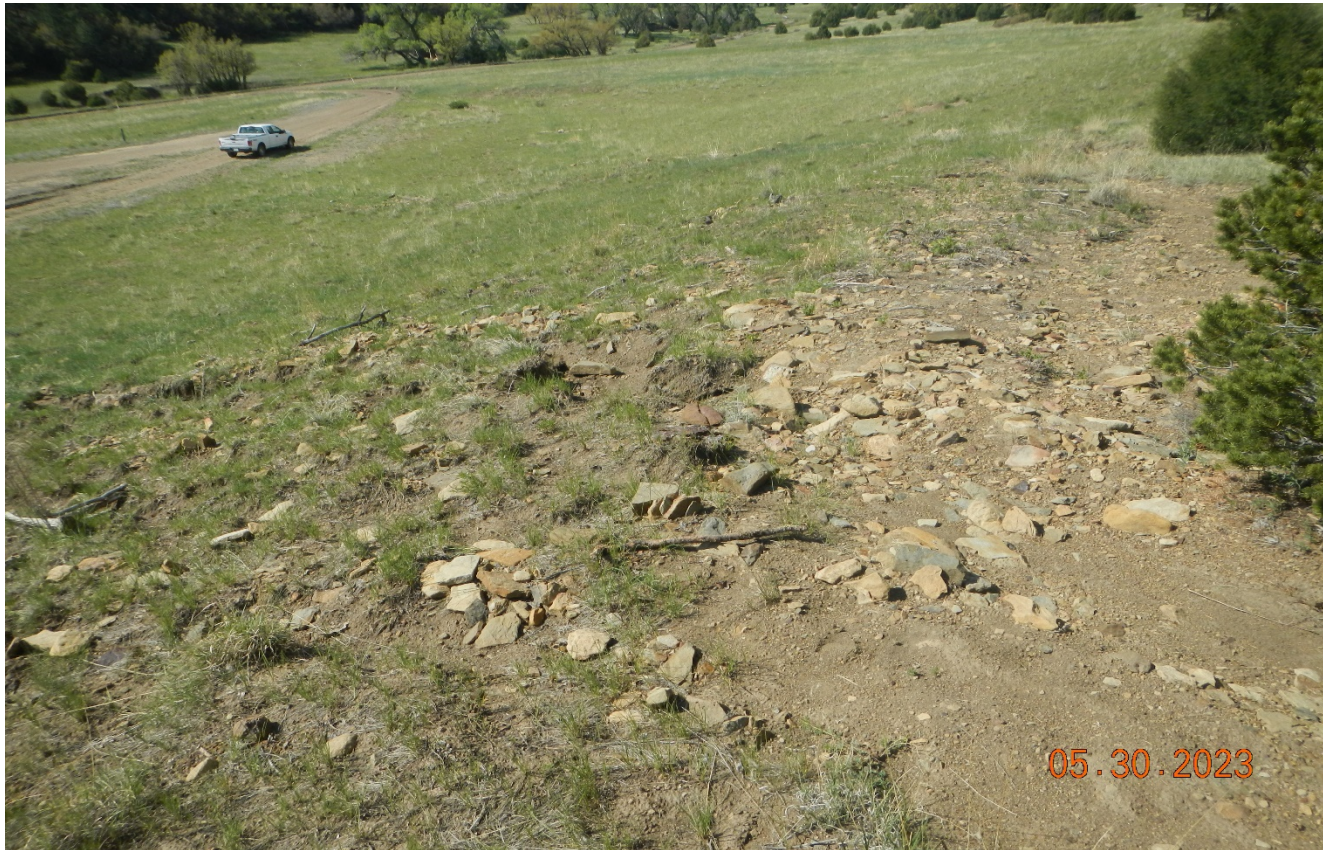
**Photo 9.** Facing south toward the run-on ditch which is filled in with sediment causing erosion of the cut slope. Previous corrective action is not completed.

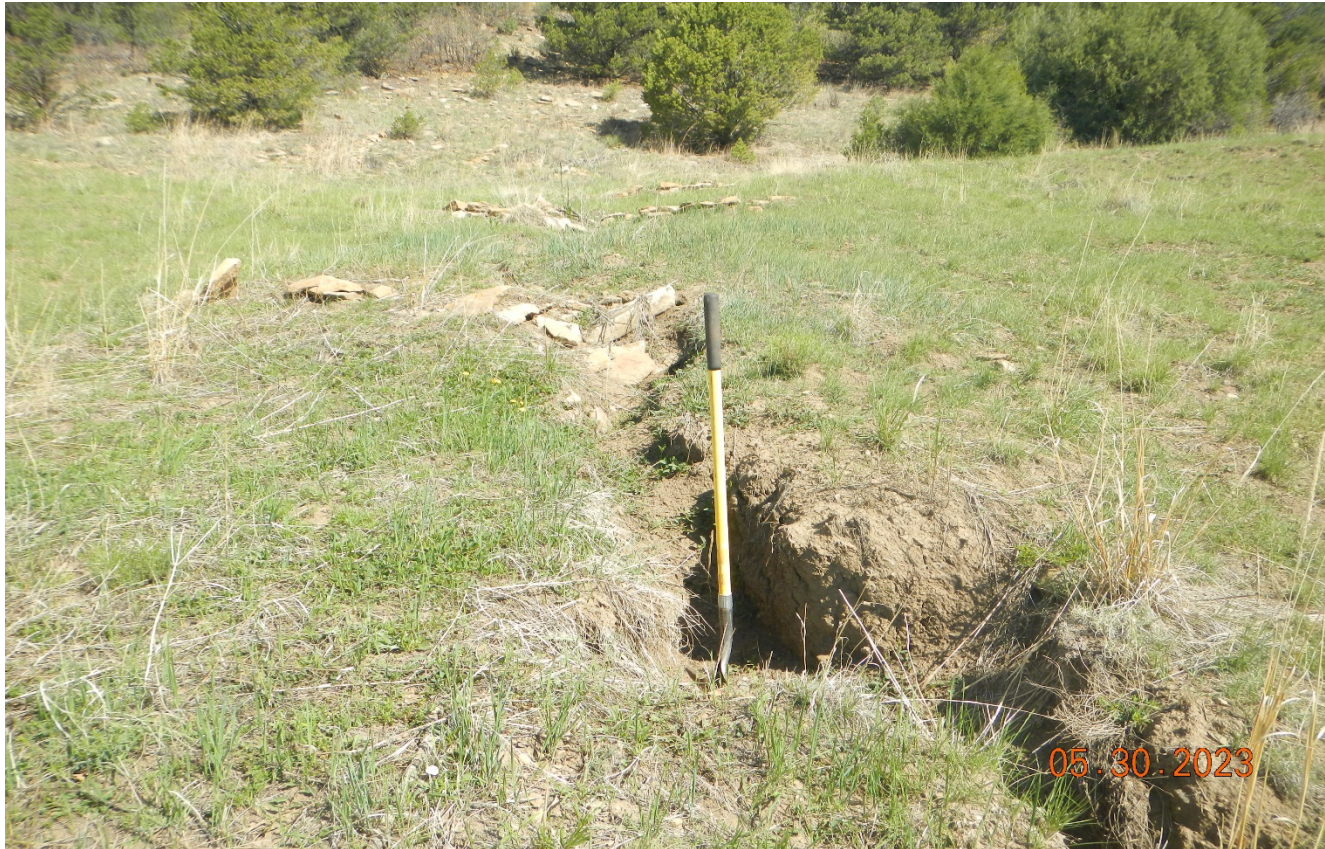
**Photo 10.** There are additional erosion channels along the south side of the location. Previous corrective action is not completed.

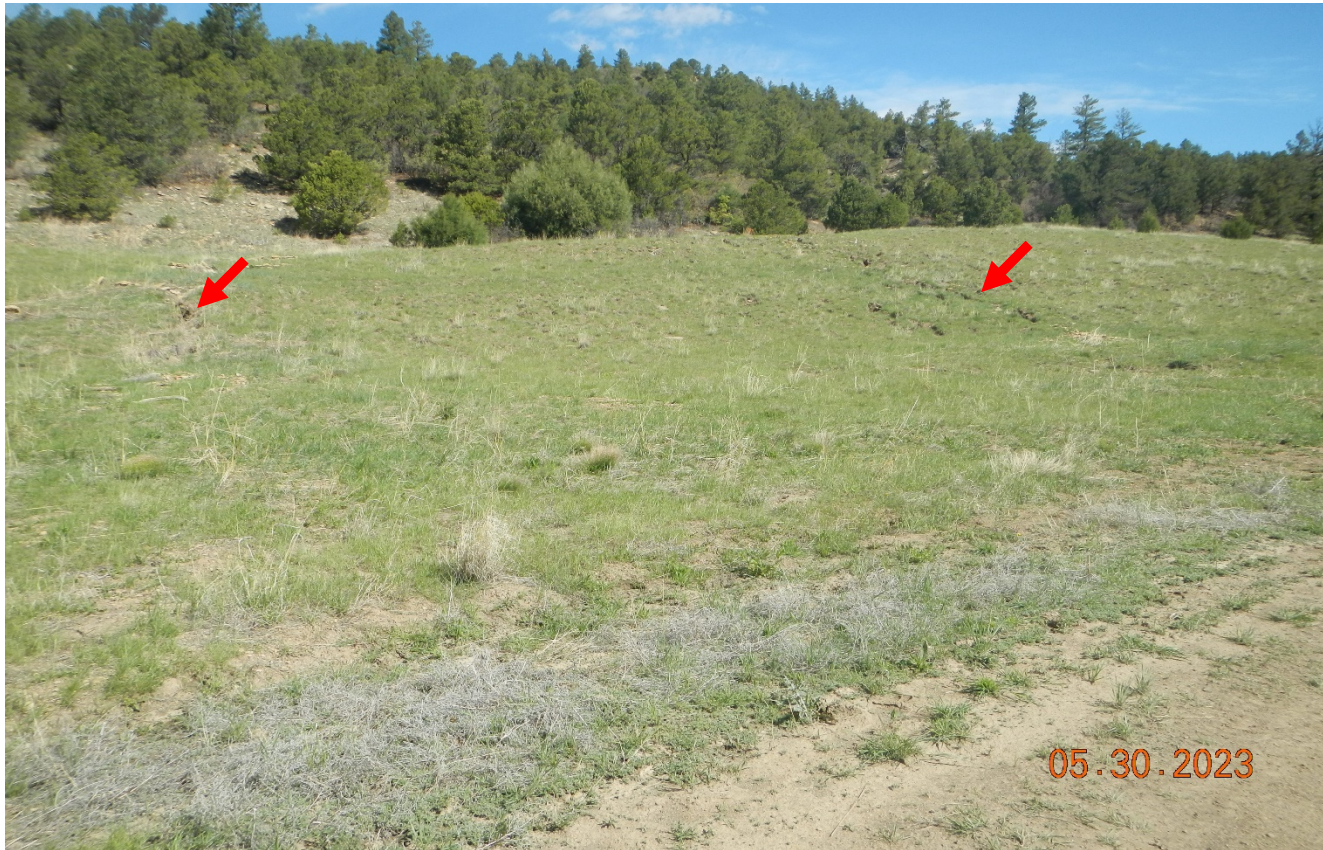
**Photo 11.** Facing north at the wellsite. Areas of erosion are visible at red arrows along the cut slope.
