Inspection Photos

API: 071-07915

Operator: WAPITI OPERATING LLC

Inspection Date: 5/30/2023

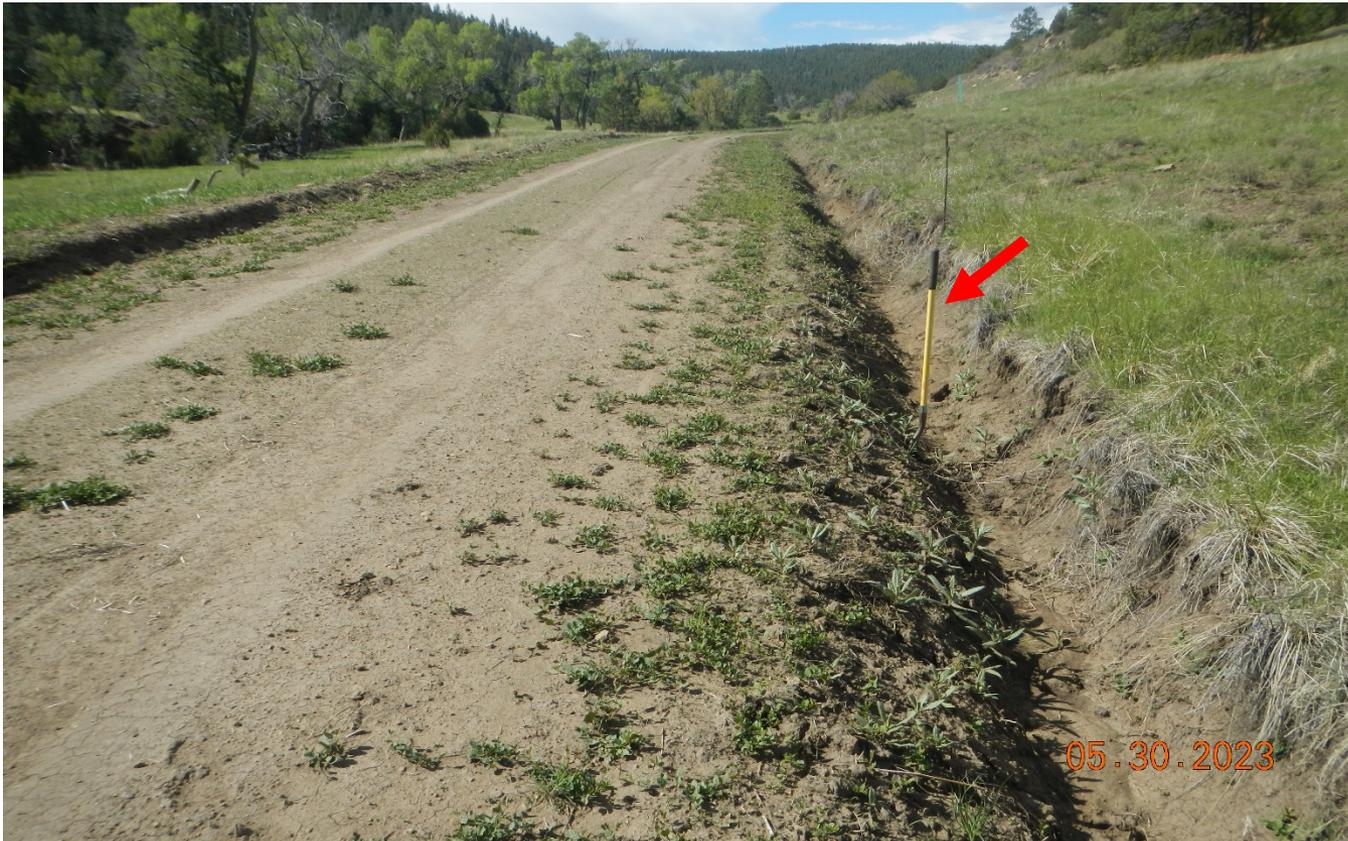
Photo 1. Facing south along the main road. There is erosion occurring along the road side. BMP's need to be installed to prevent erosion. Red arrow points to 4.5' shovel. Previous corrective action not completed.

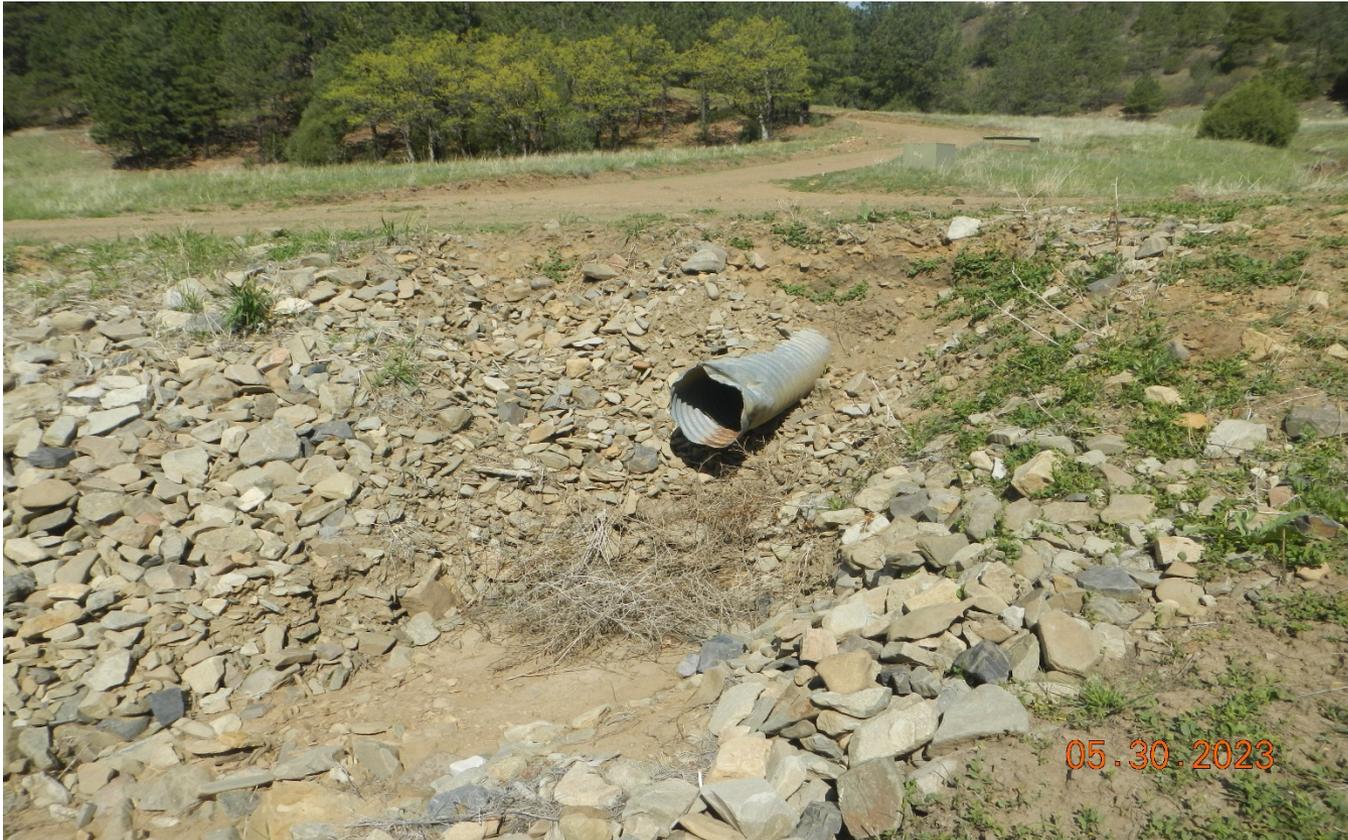
Photo 2. Facing west toward near the access road ascending the hillside. The culvert outlet has been washed out from recent storm event. It appears a larger culvert is needed along with larger rock rip/rap outlet protection. Previous corrective action not completed.

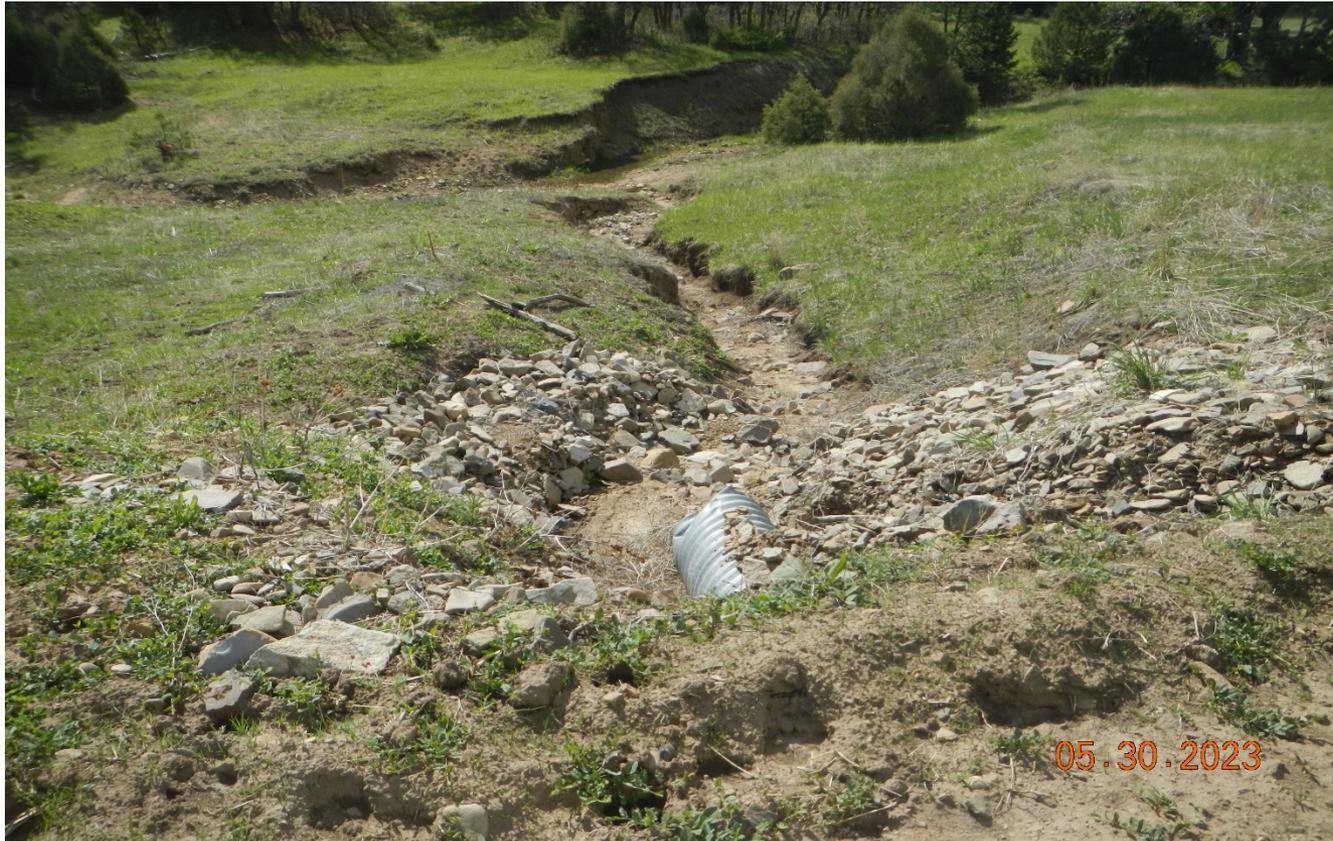
Photo 3. The culvert inlet is filled in with sediment and debris. It appears a larger culvert is needed at this area to handle stormwater coming off the road and drainage. Previous corrective action not completed.

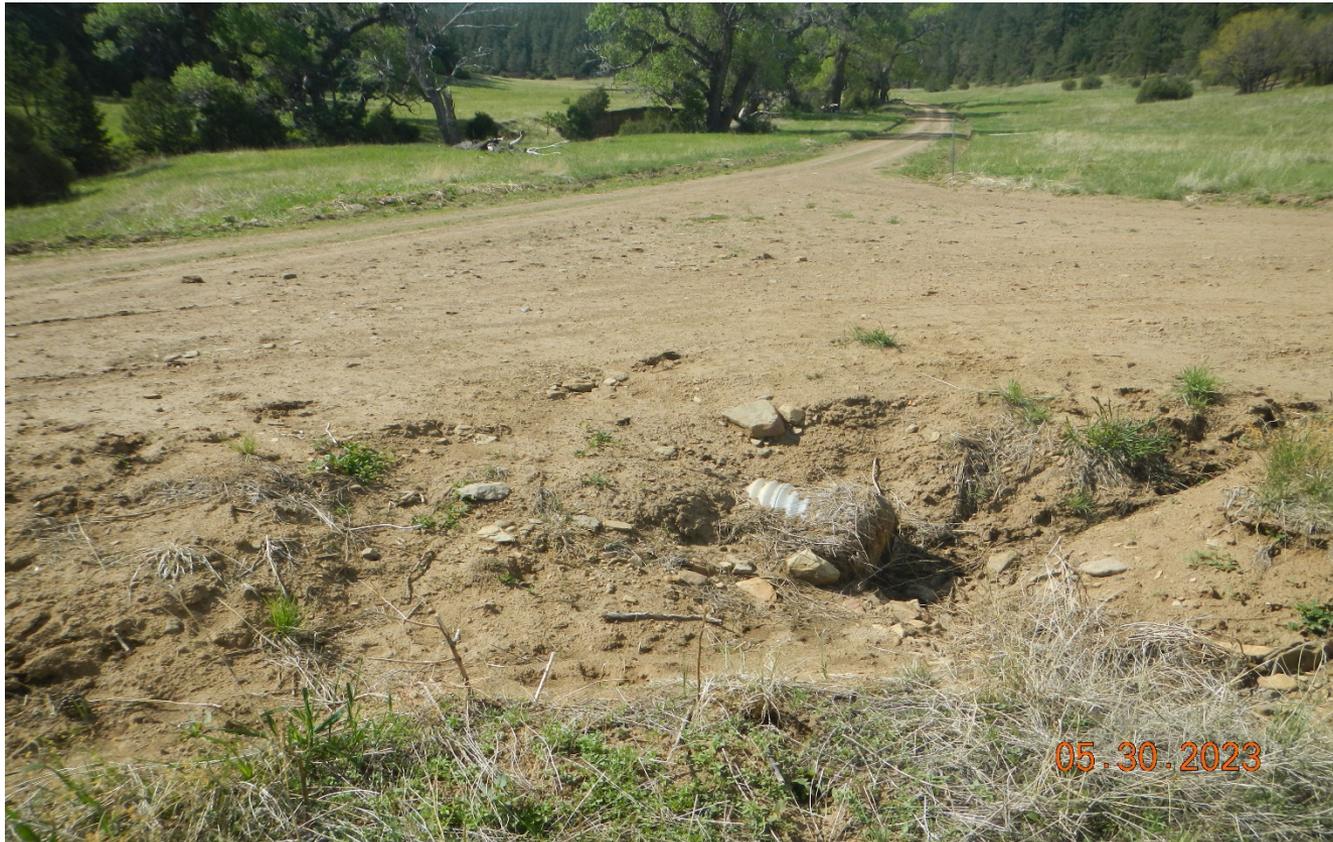
Photo 4. The culvert inlet is filled in with sediment and debris. It appears a larger culvert is needed at this area to handle stormwater coming off the road and drainage. Previous corrective action not completed.

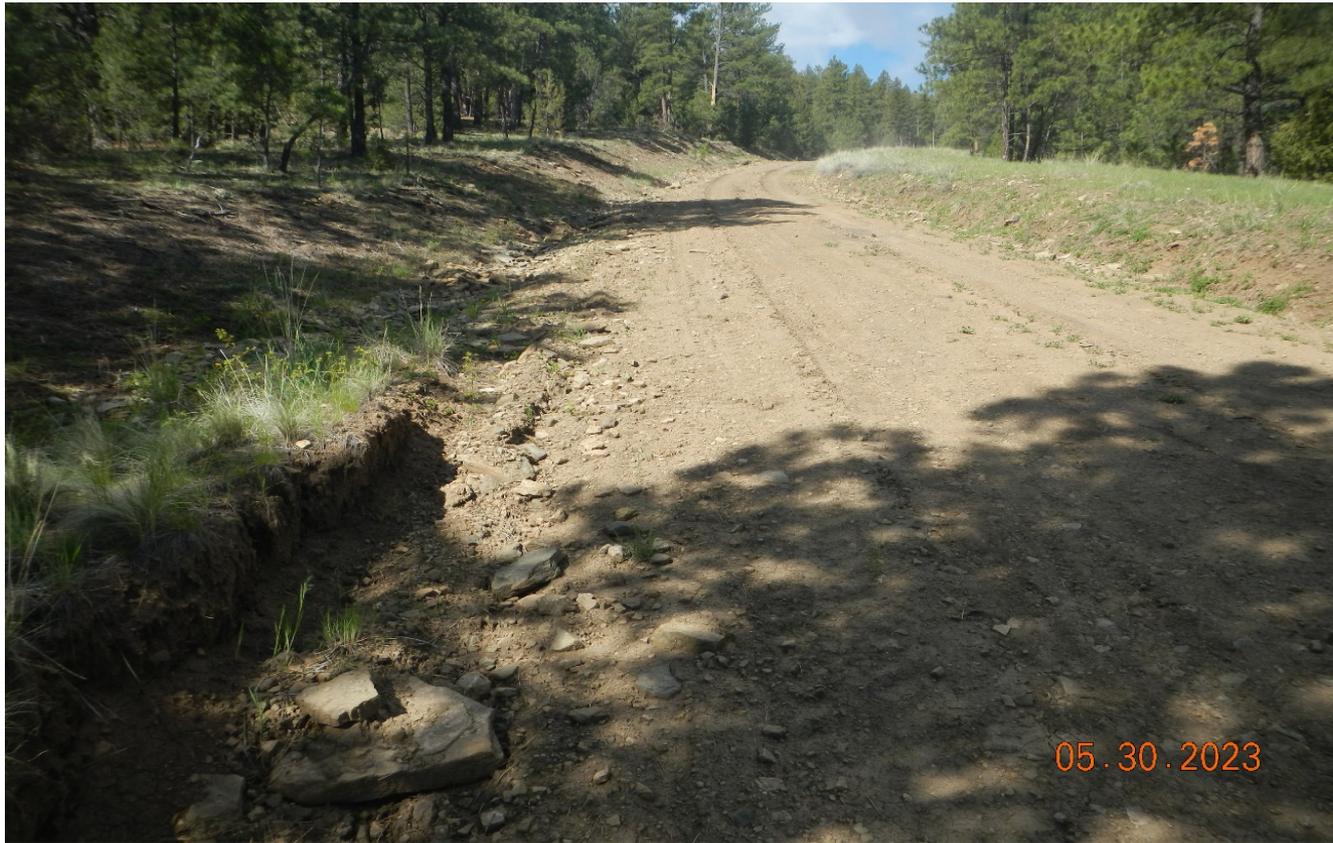
Photo 5. There are signs stormwater is flowing down the road causing erosion. This area has been a problem before and needs to be stabilized. Stormwater is not being properly diverted off the road. Additionally the road is very slick and vehicle rutting is occurs frequently.

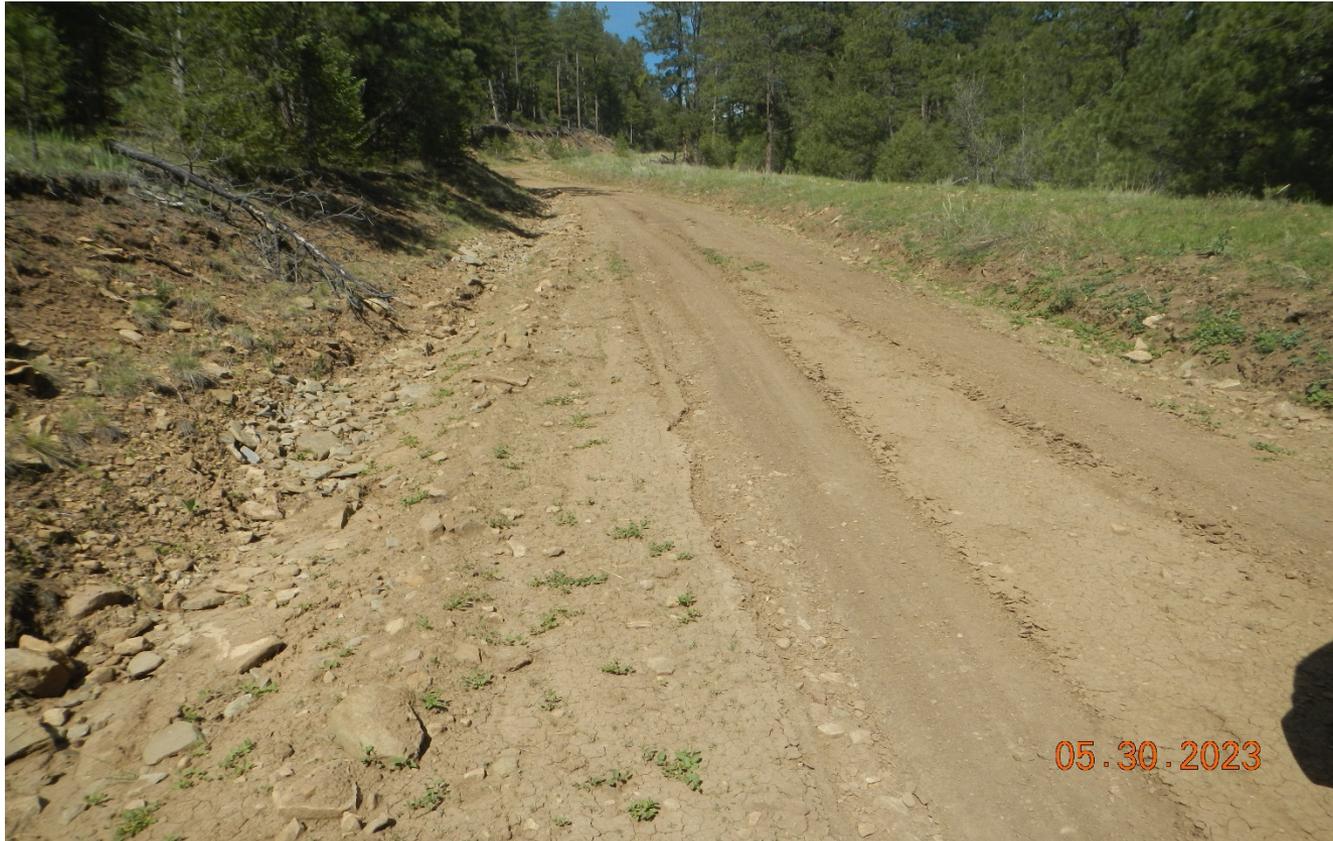
Photo 6. Facing west along the access road. Some of the rock check dams previously installed have washed out and there is insufficient BMP's to prevent erosion.

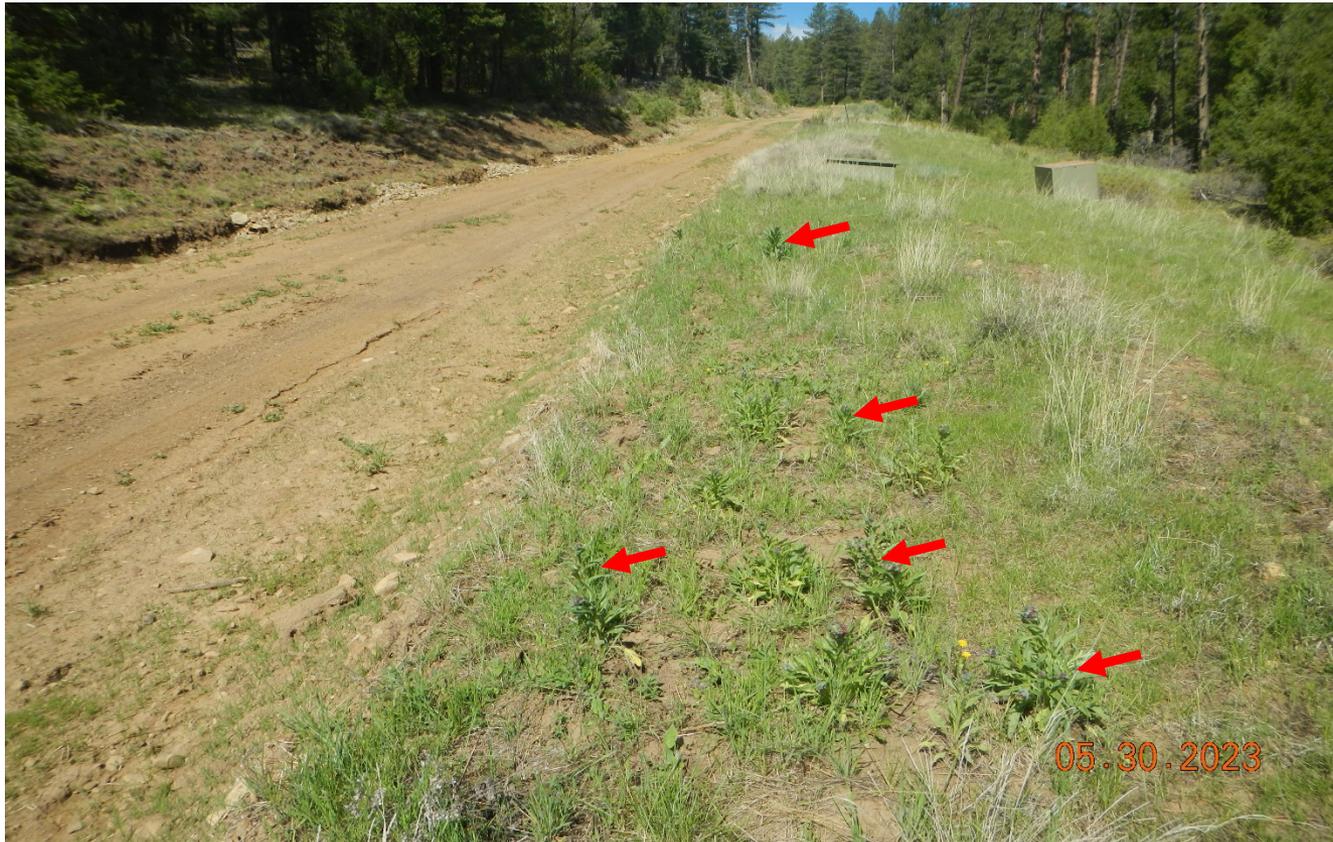
Photo 7. Facing west along the access road. There are numerous noxious weeds along the access road that have not been controlled. The red arrows points to List B noxious weed - Houndstongue.

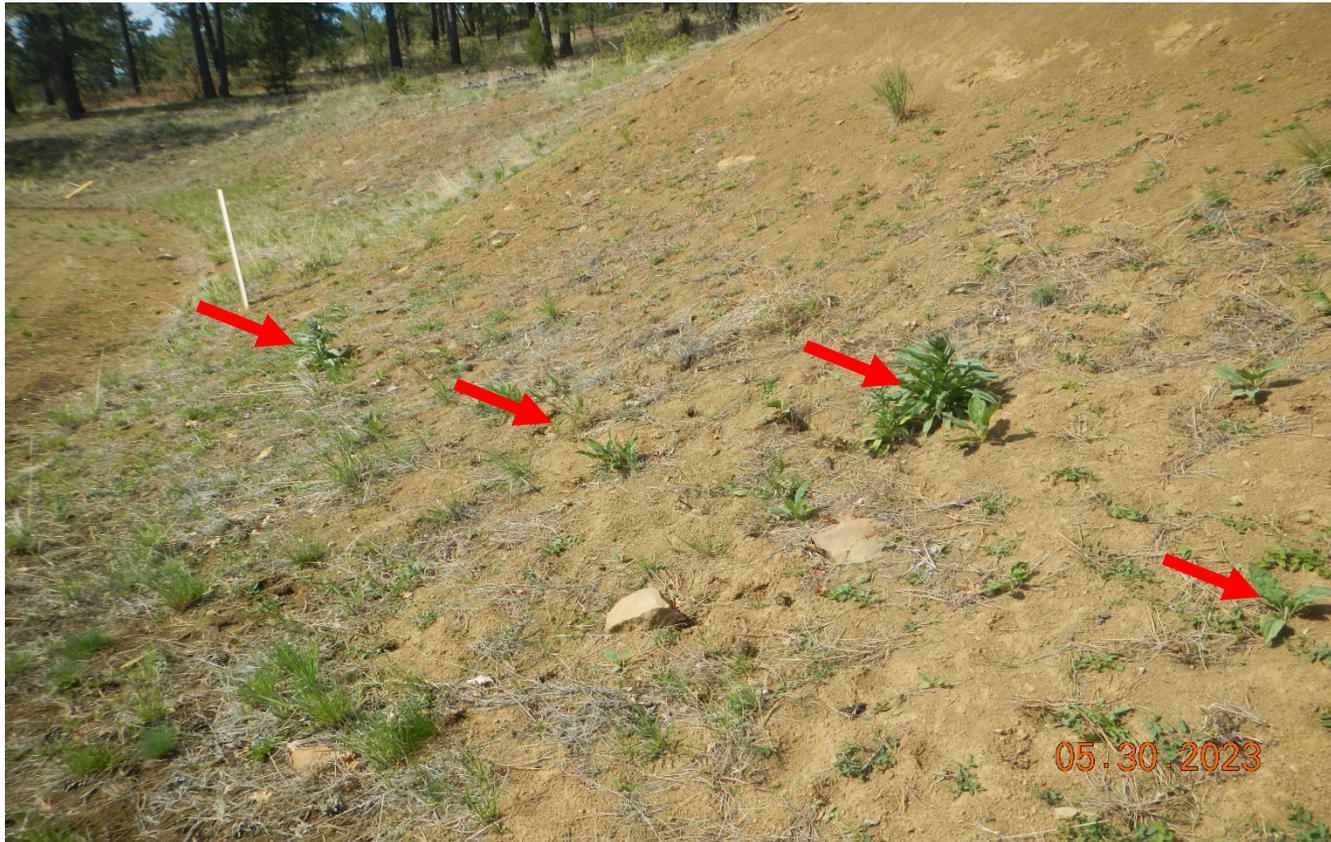
Photo 9. Facing southwest toward the cut slope. There are numerous noxious weeds that have not been controlled. The red arrows points to List B noxious weed - Houndstongue.

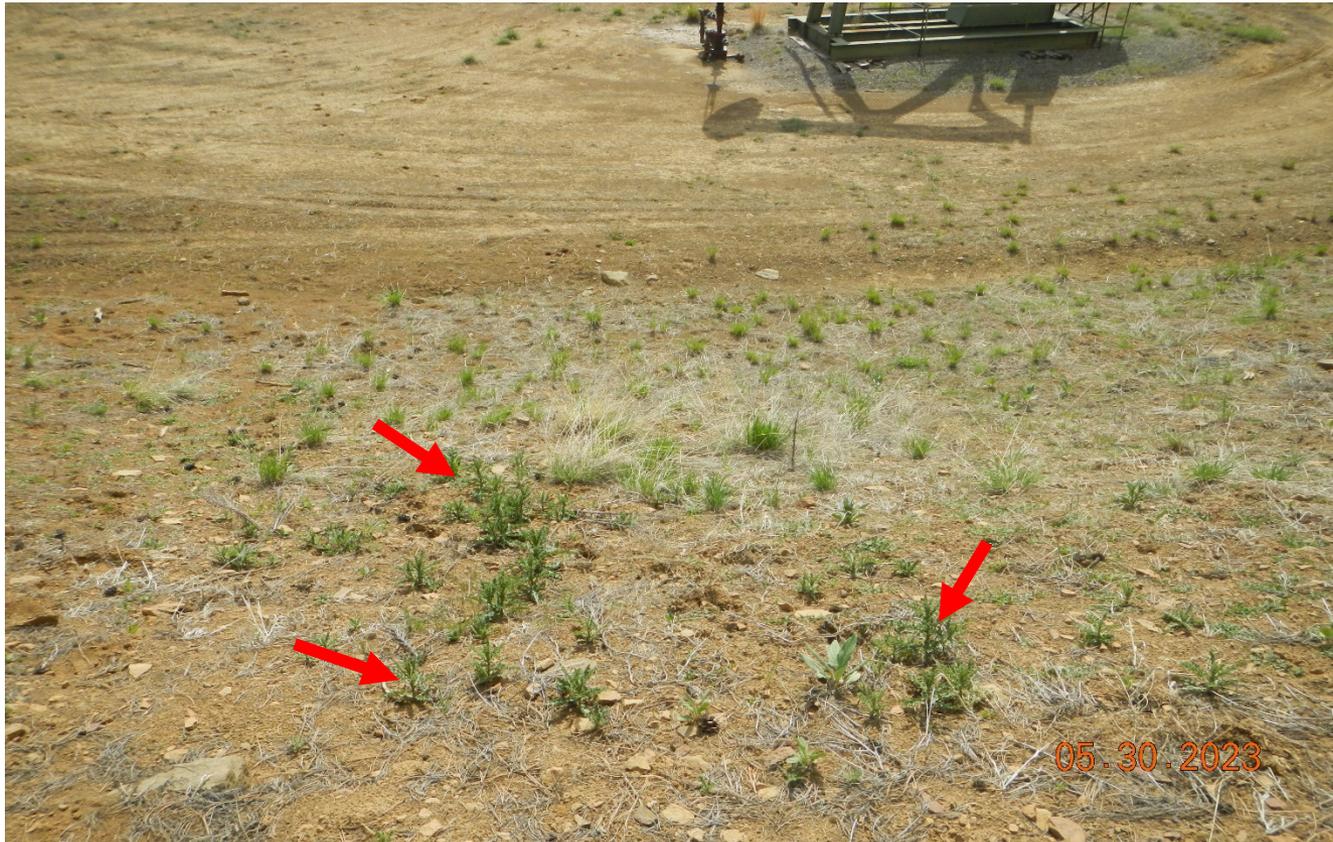
Photo 10. There are numerous noxious weeds at the location that have not been controlled. The red arrows points to List B noxious weed – Canada thistle.
