Inspection Photos

Location: Verdad Resources LLC / Shull 1-35-9-60

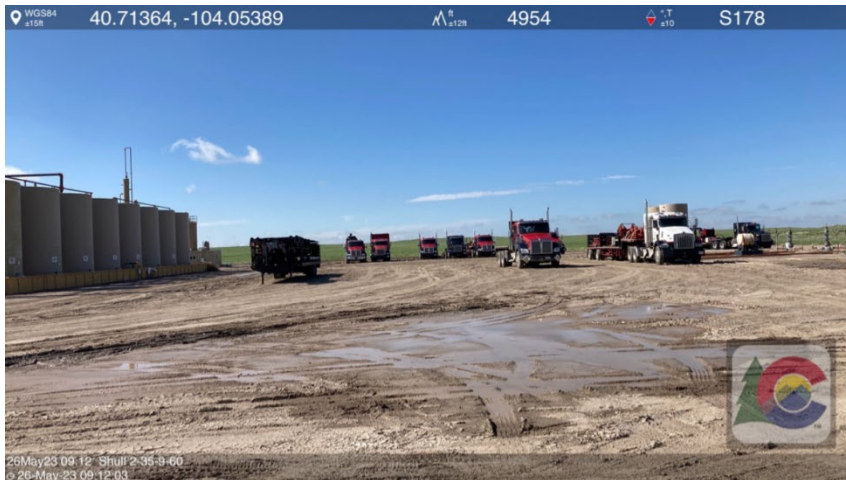
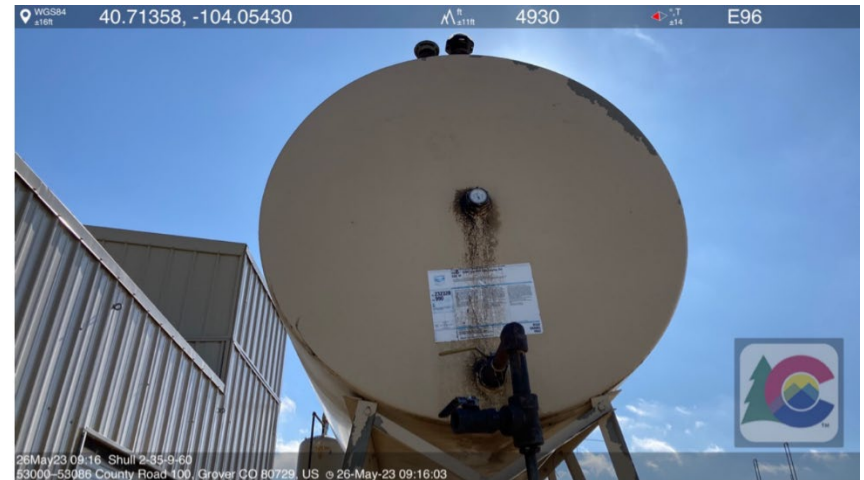
Photo 1 – Unused equipment stored on location

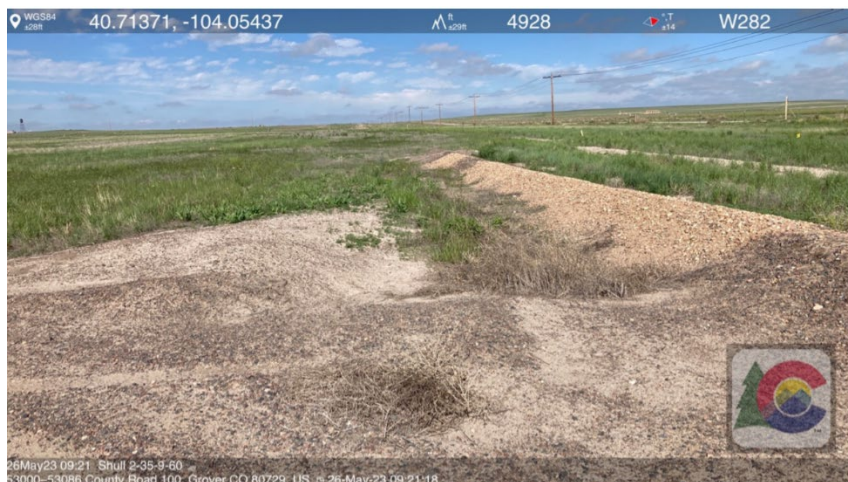
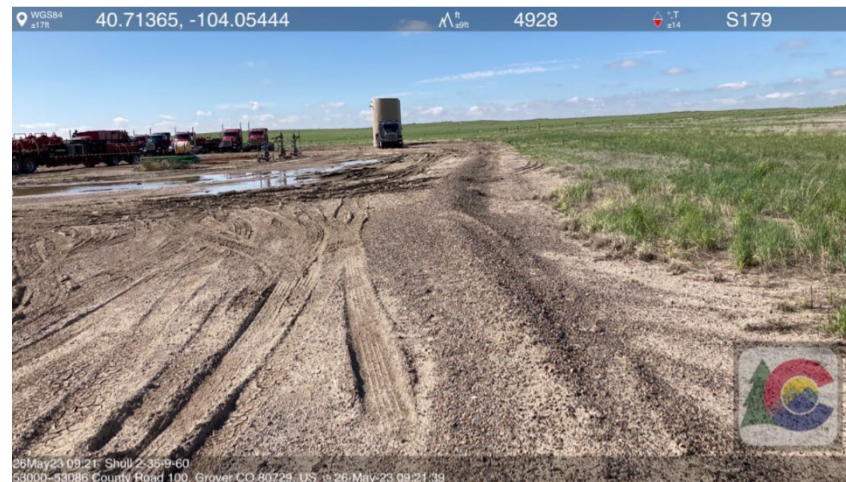
Photo 3 – Earthen berm around pad – inadequate

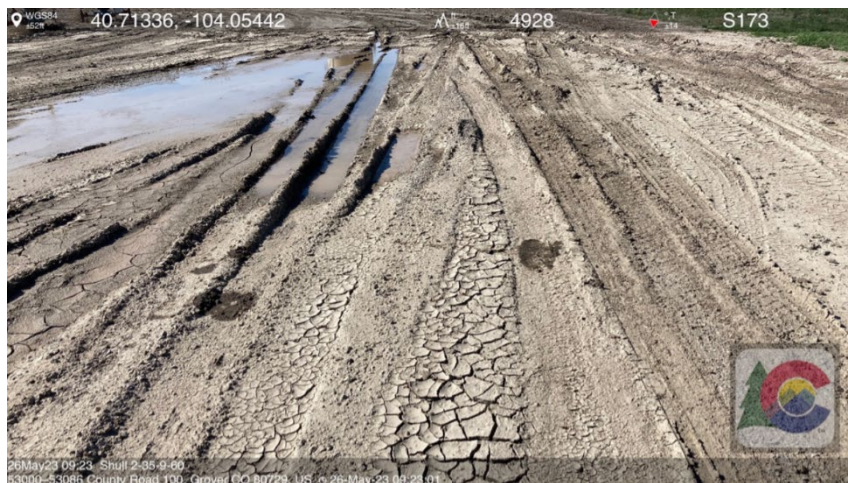
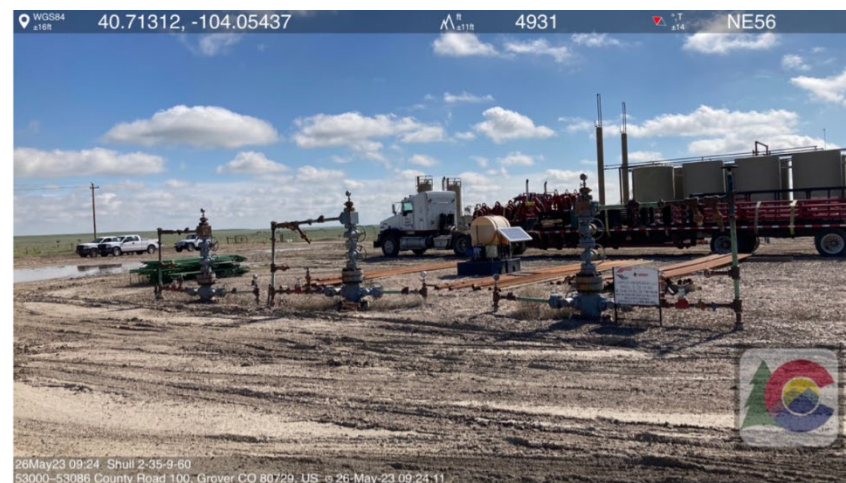
Photo 5 – Soil staining present

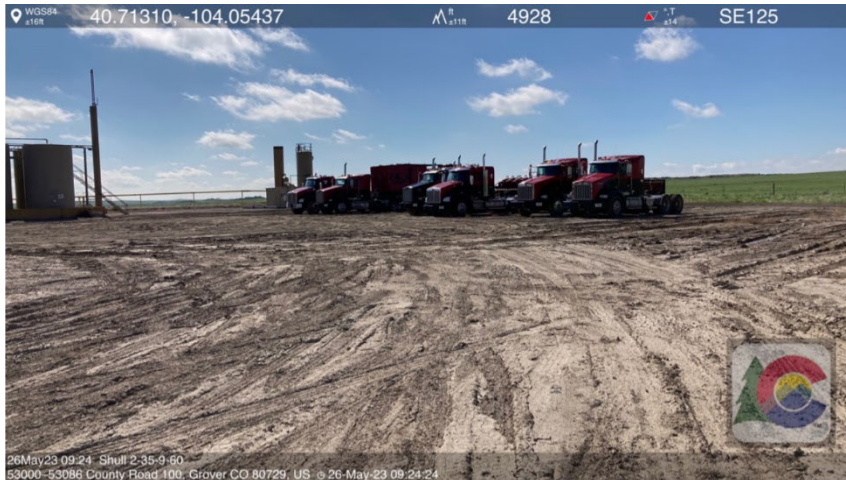
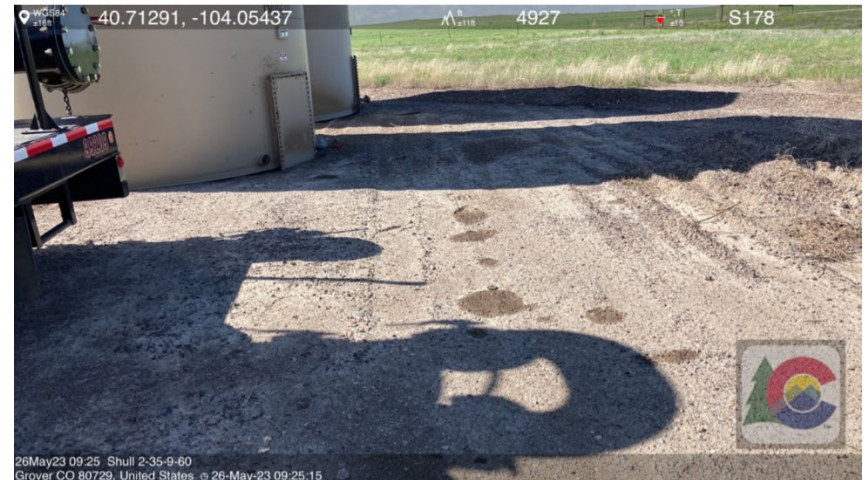
Photo 7 – Unused equipment stored on location

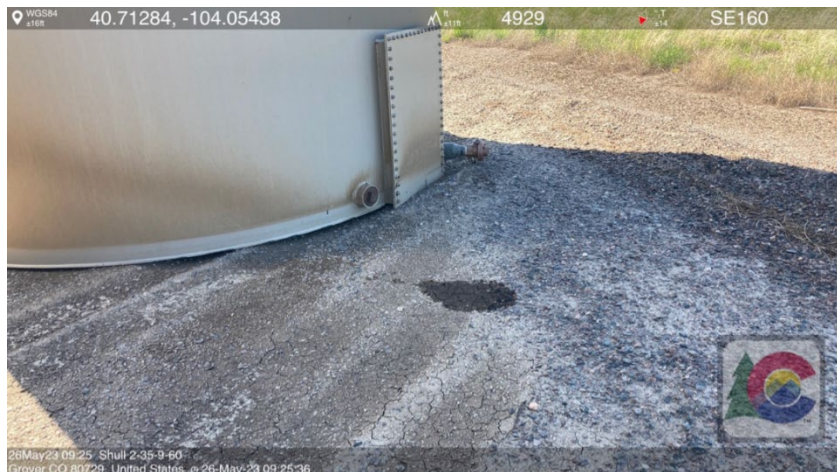
Photo 9 – Soil staining present

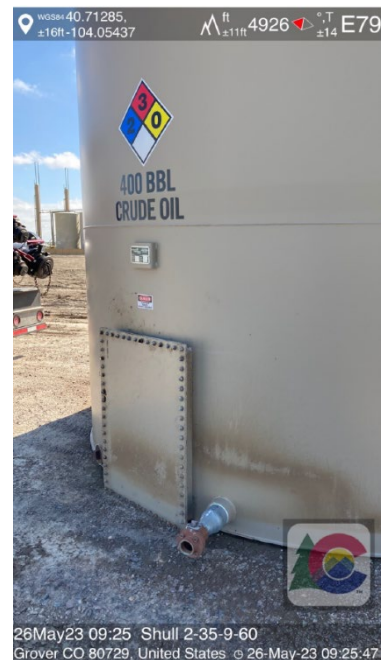
Photo 10 – Unused equipment – (2) 400-bbl crude oil above-ground storage tanks (ASTs) stored on location with no out of service locks/tags (OOSLAT)

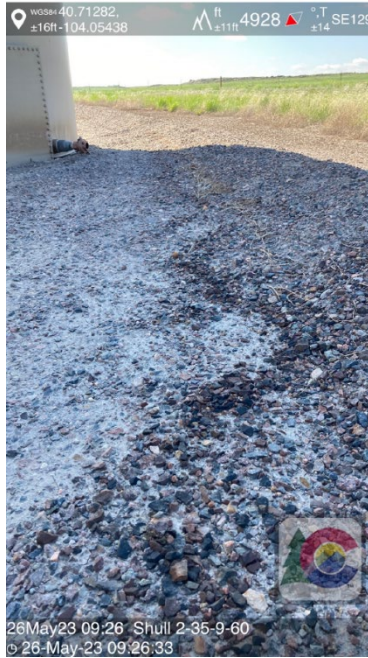
Photo 11 – Stained soil observed along locations earthen secondary containment berm - staining appears to be from previously observed impacts as noted Inspection Doc #708200264.

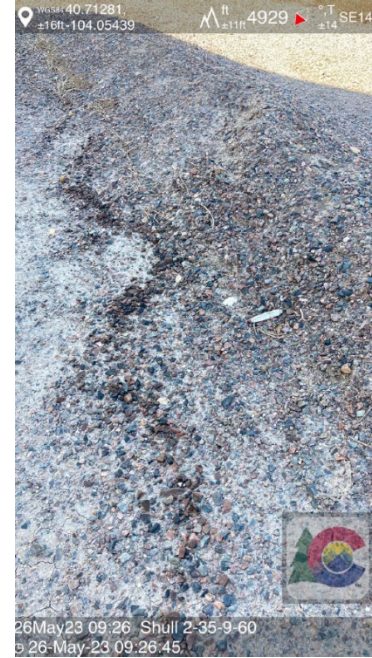
Photo 12 – Stained soil observed along locations earthen secondary containment berm - staining appears to be from previously observed impacts as noted Inspection Doc #708200264.

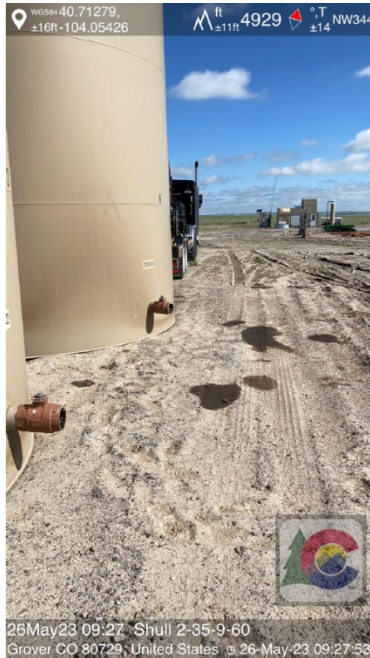
Photo 13 – Soil staining present & no OOSLAT on (2) 400-bbl crude oil ASTs

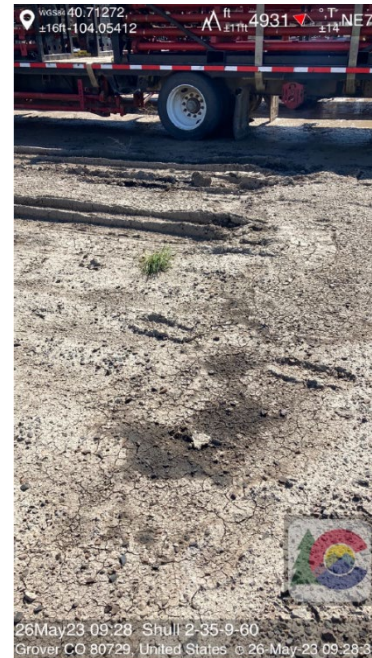
Photo 14 – Stained soil observed along locations earthen secondary containment berm - staining appears to be from previously observed impacts as noted Inspection Doc #708200264.

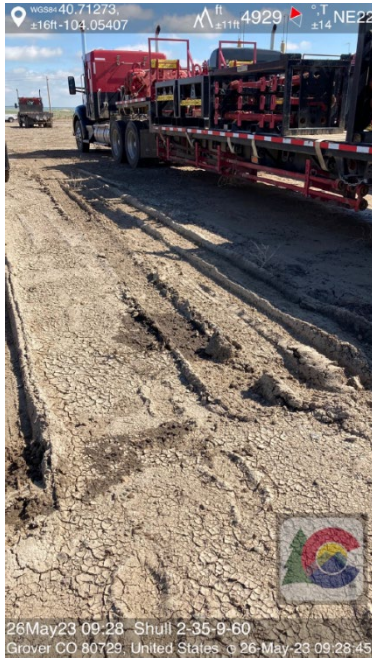
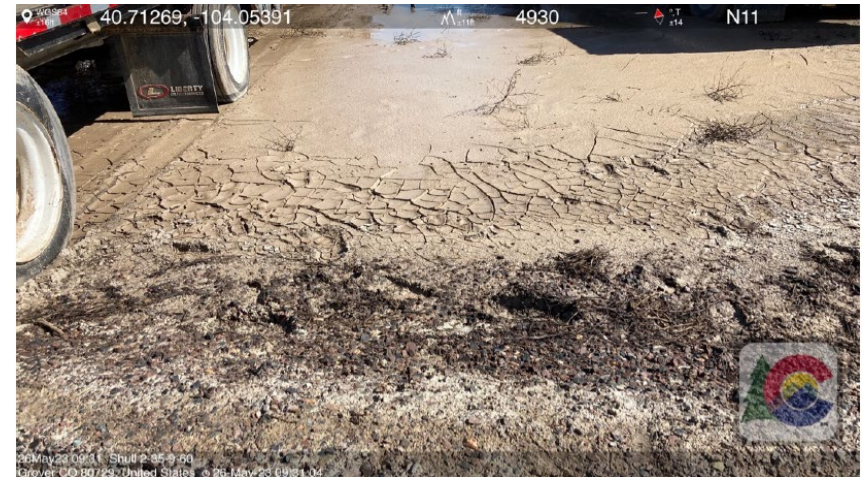
Photo 15 – Stained soil observed along locations earthen secondary containment berm - staining appears to be from previously observed impacts as noted Inspection Doc #708200264.

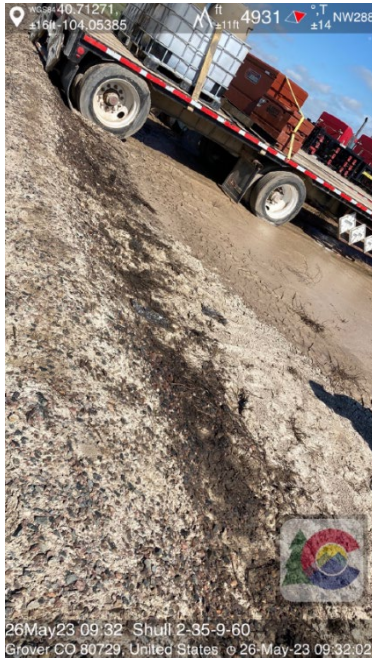
Photo 17 – Stained soil observed along locations earthen secondary containment berm - staining appears to be from previously observed impacts as noted Inspection Doc #708200264.

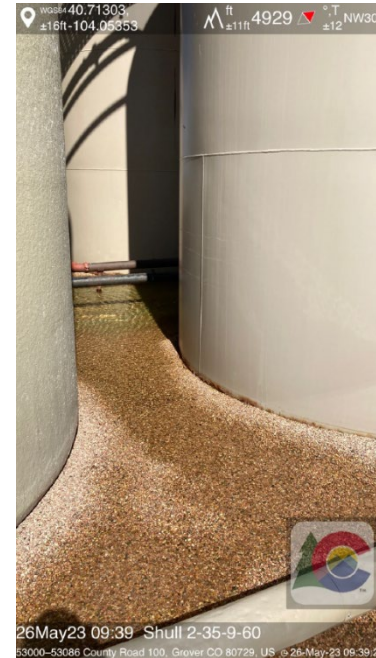
Photo 18 – Standing water in secondary containment for crude oil and produced water ASTs & corroded tank bottoms observed on all crude oil ASTs

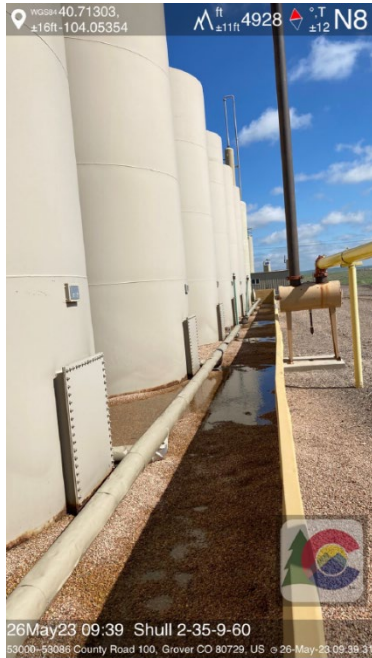
Photo 19 – Standing water in produced water & crude oil AST secondary containment

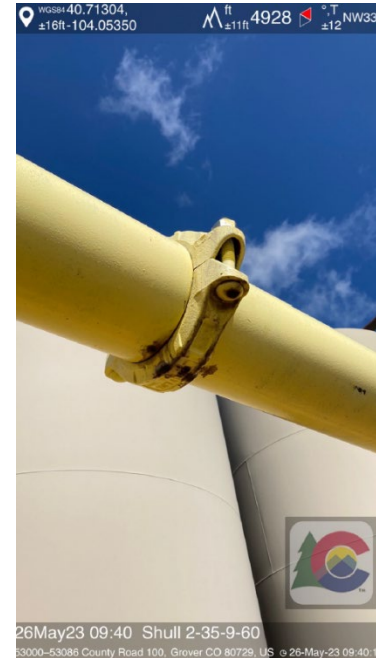
Photo 20 – Location of audible and olfactory leak on line running to ECD

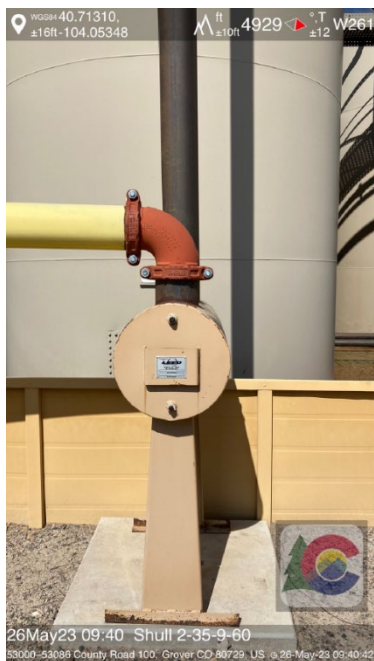
Photo 21 – Location of audible and olfactory leak (coupling on red elbow)

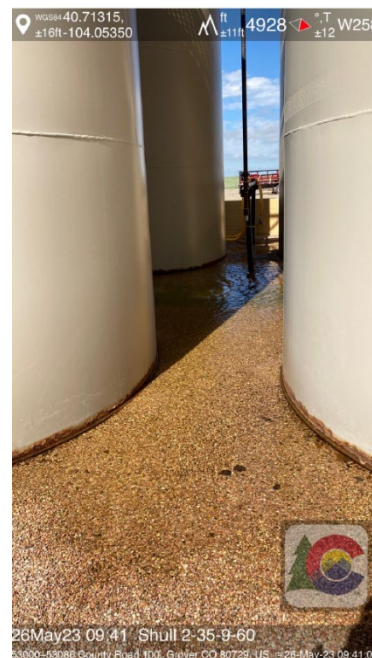
Photo 22 – Standing water in secondary containment for crude oil and produced water ASTs & corroded tank bottoms observed on all crude oil ASTs

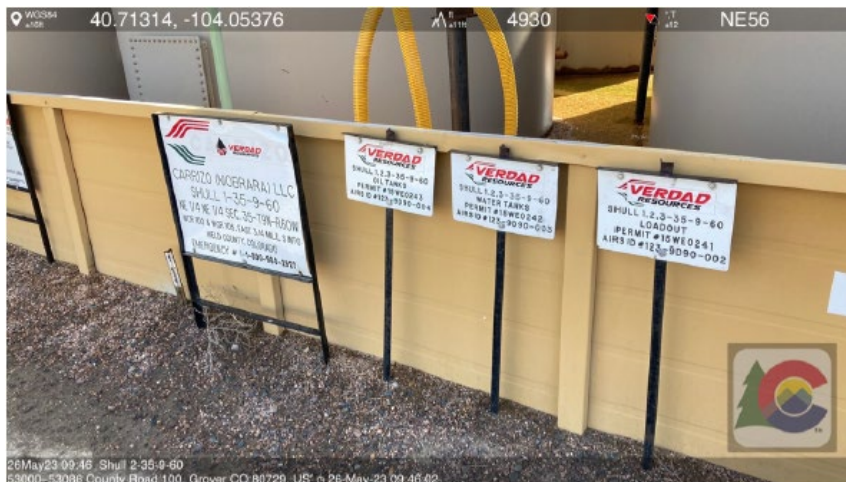
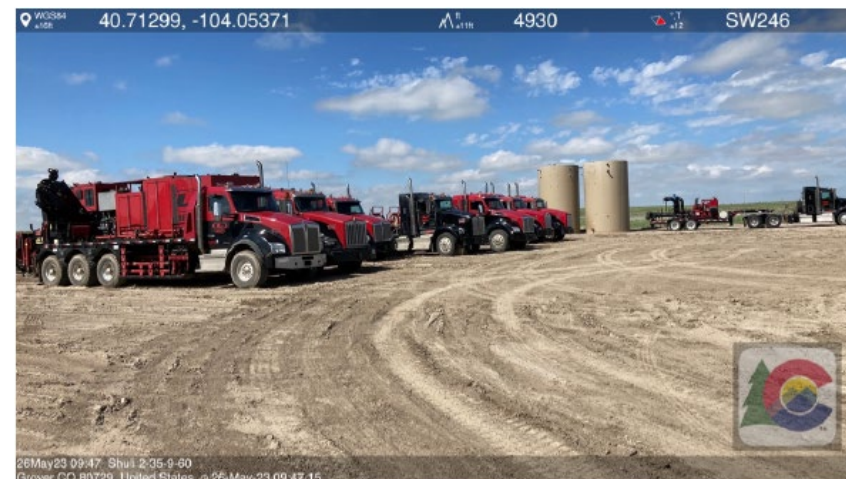
Photo 23 – Signage around tank battery. Note: Former Operator (Carrizo (Niobrara) LLC listed along with current Operator (Verdad Resources).

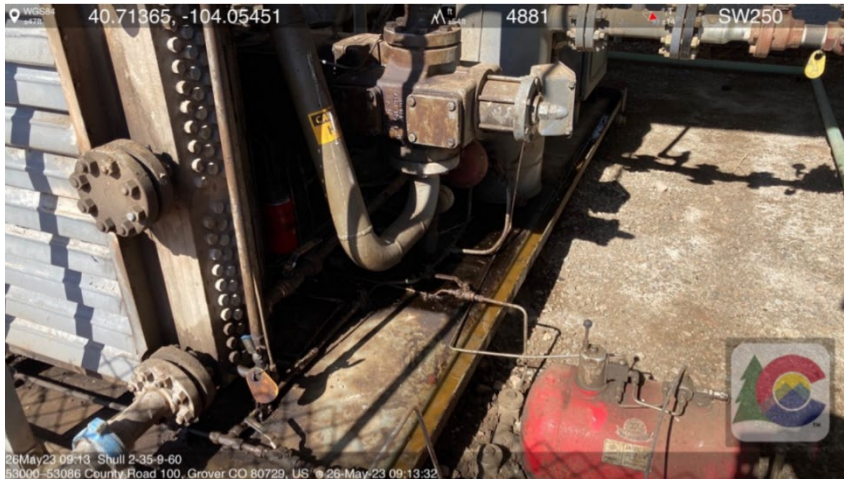
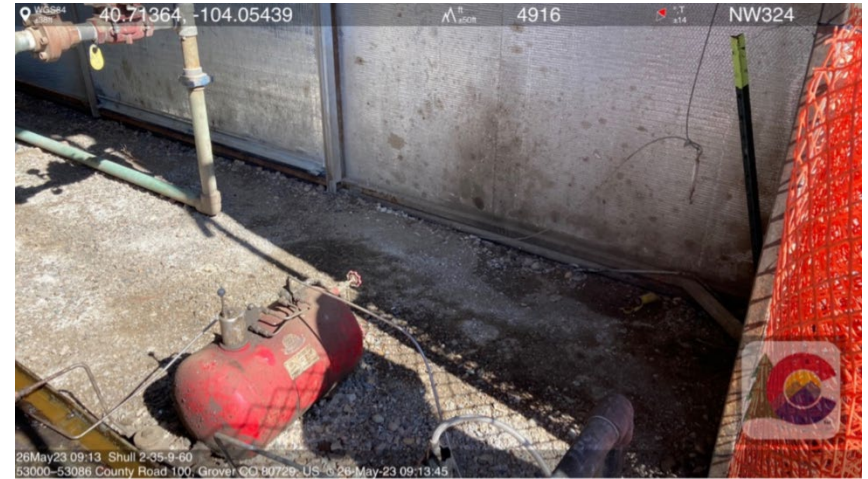
Photo 27 – Hydrocarbons present on compressor skid
