**Stormwater Management and Erosion control**  
**Location Name: TEP ROCKY MOUNTAIN LLC FEDERAL-66S95W /31NENW**  
**Location #: 335171**

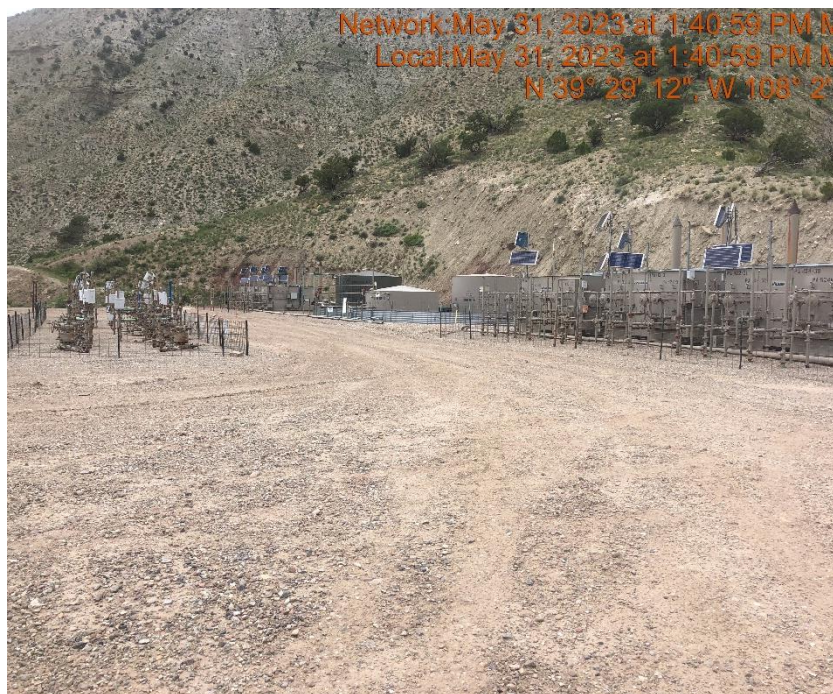
**Photo #158 From entrance to location.**

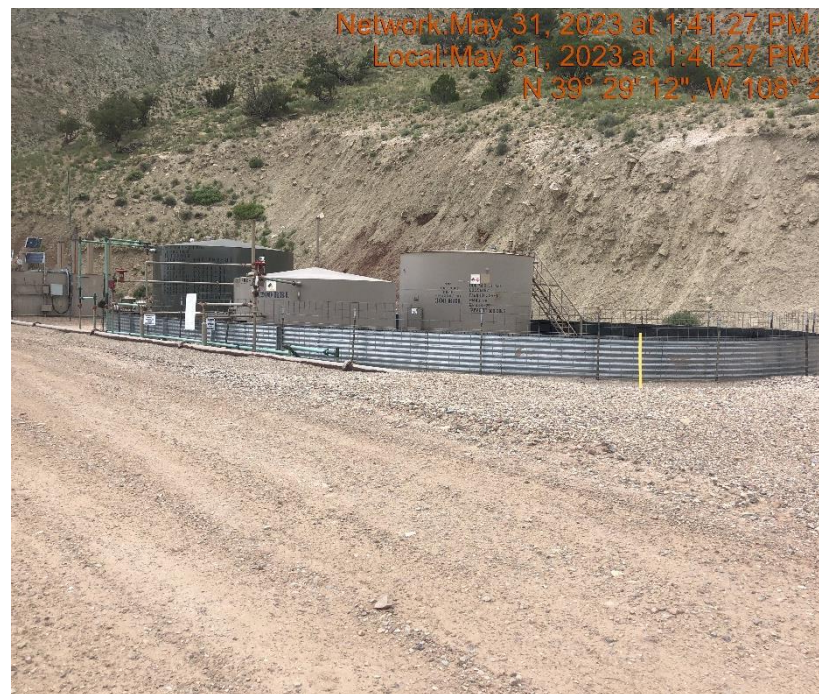
**Photo #160 from entrance to location**

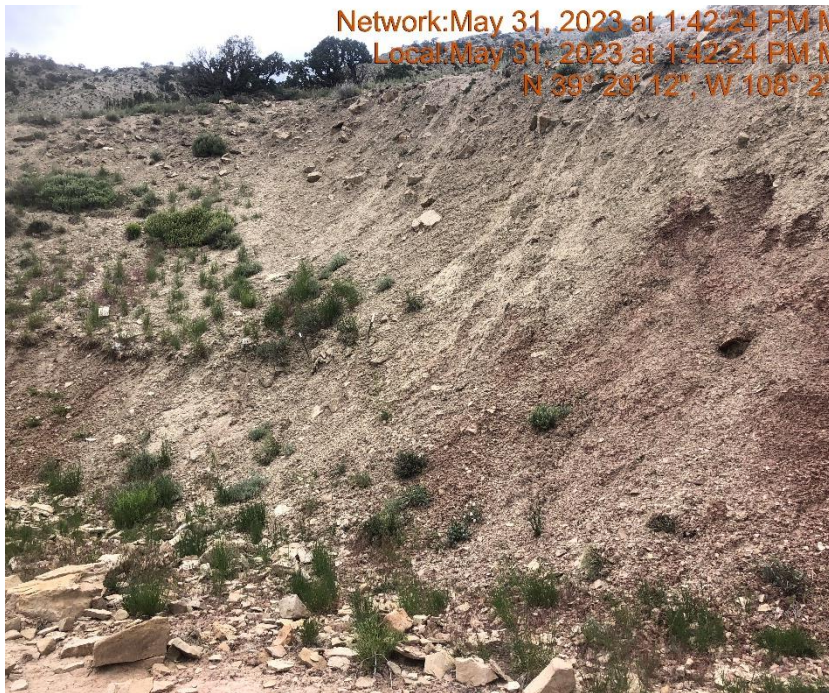
**Photo #162 Cut slope lacks stabilization.**

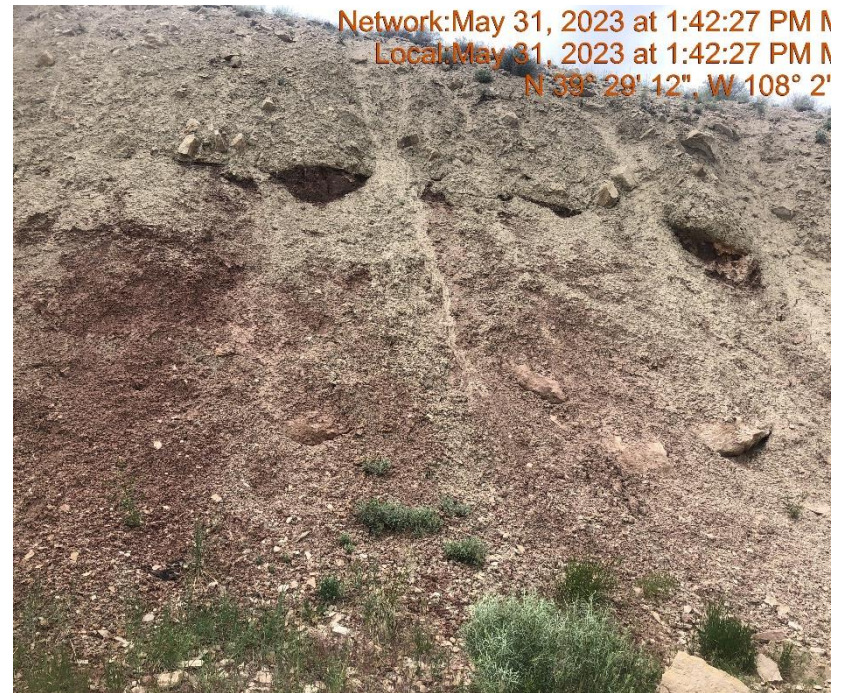
**Photo #163 Cut slope lacks stabilization**

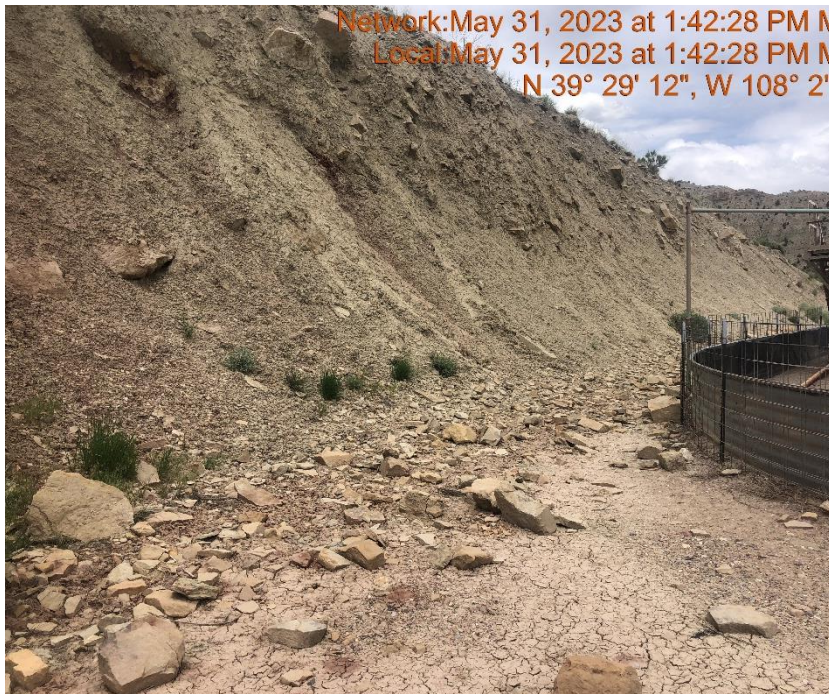
**Photo #164 Run on to location is not being controlled.**

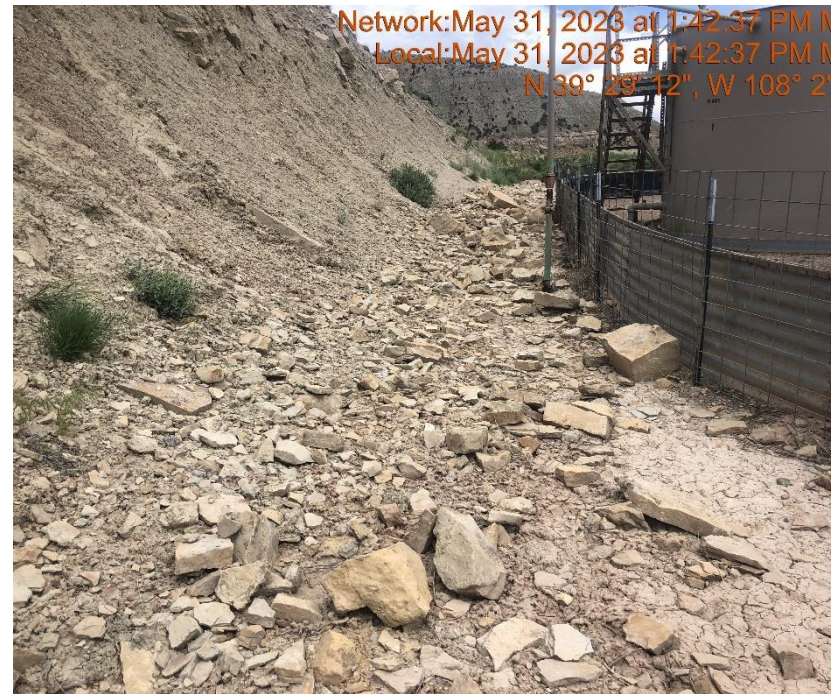
**Photo #165 Run on to location is not being controlled.**

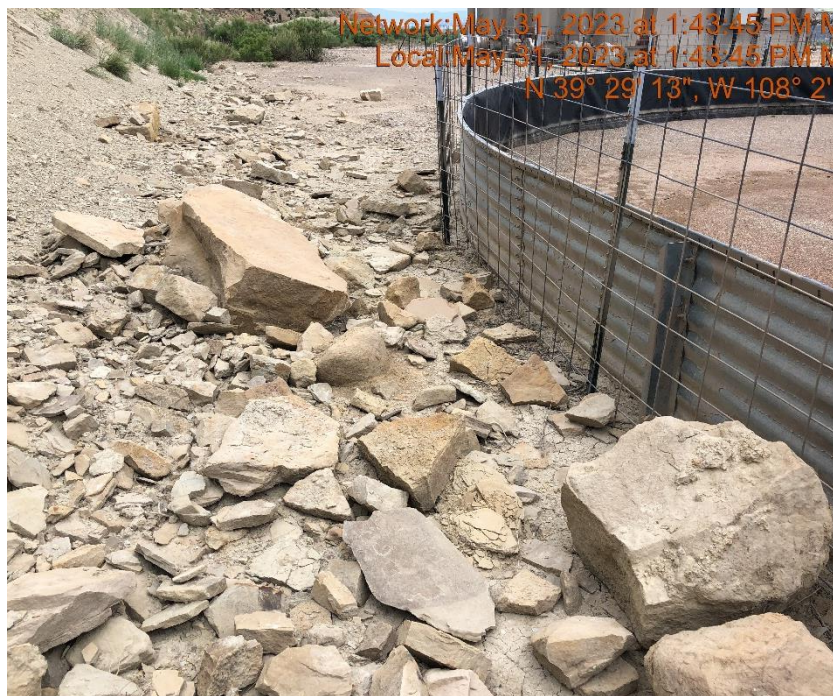
**Photo #169 Rocks and sediment encroaching on tank containment.**

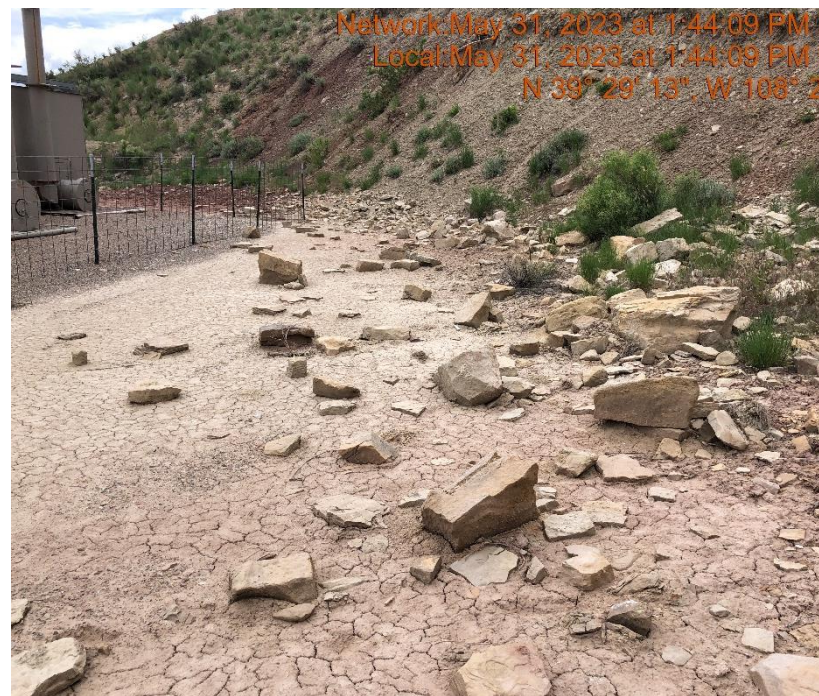
**Photo #170 Rocks and sediment encroaching on equipment.**
