Interim Reclamation and Stormwater Inspection

Operator: FUNDARE RESOURCES OPERATING
COMPANY LLC - 10773

Location ID: 430313

Inspection Photos
Location Name: Razor 27L Pad
Location ID: 430313

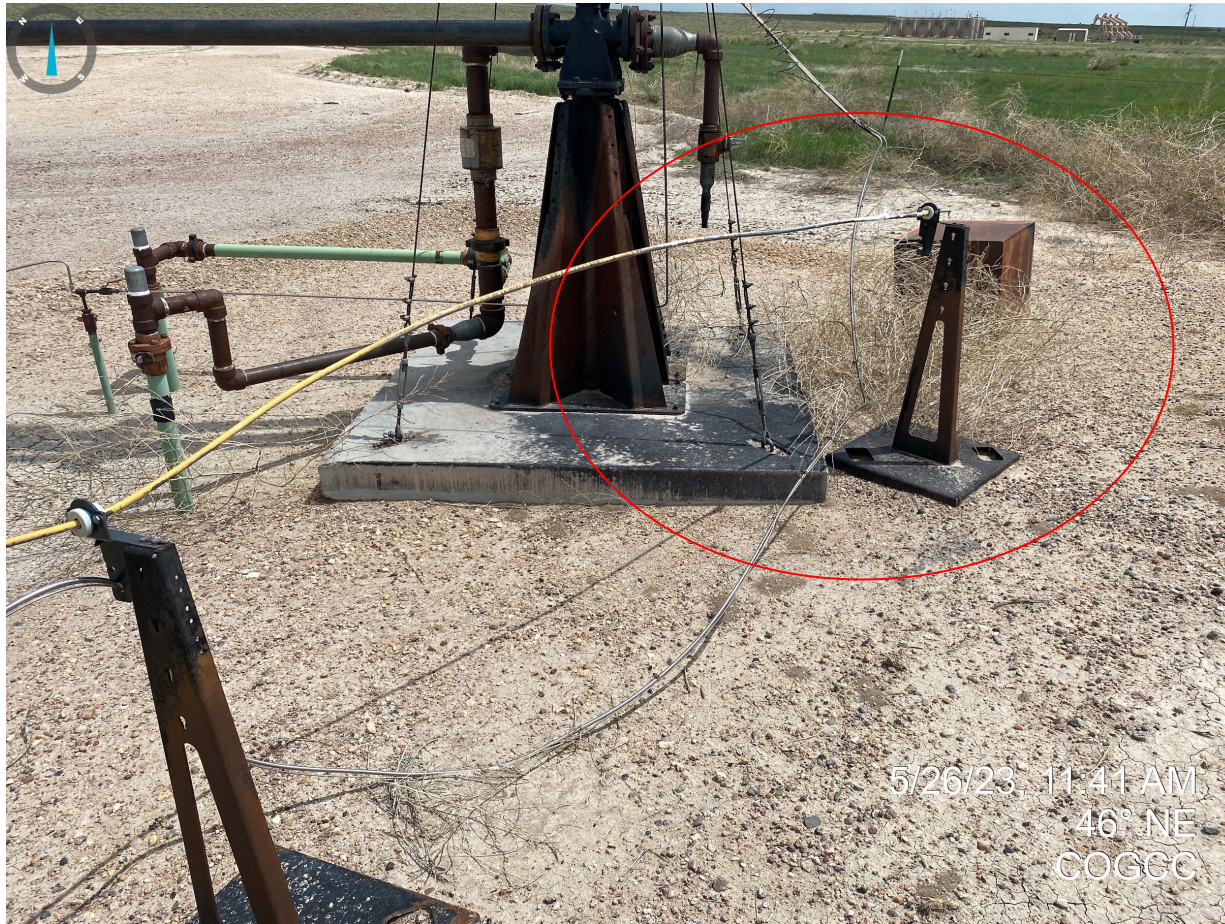
Photo 1. Tumbleweed accumulation around flare will need to be removed as they present a fire hazard.

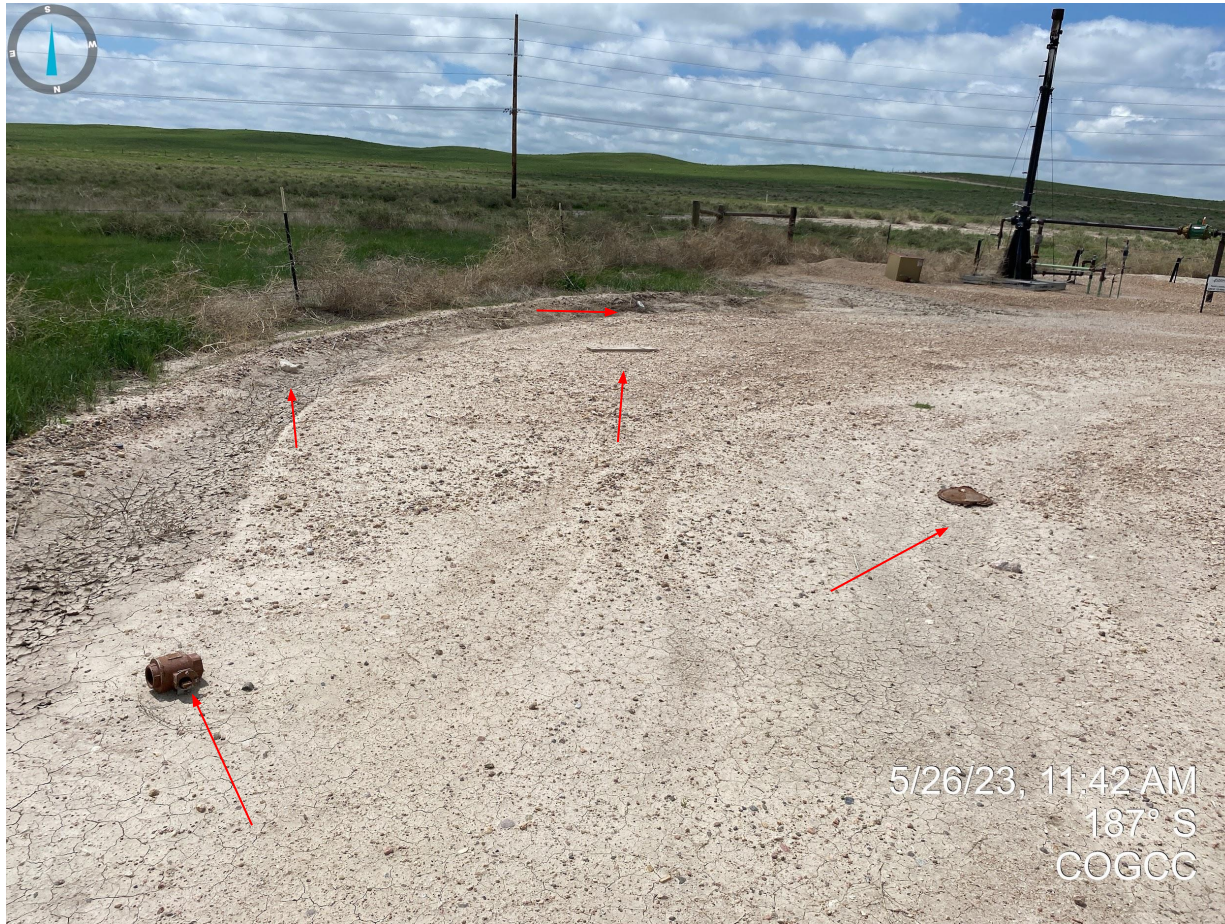
Photo 2. Examples of debris/trash observed on location. The Operator shall self inspect the entire location to identify and remove any trash/debris.

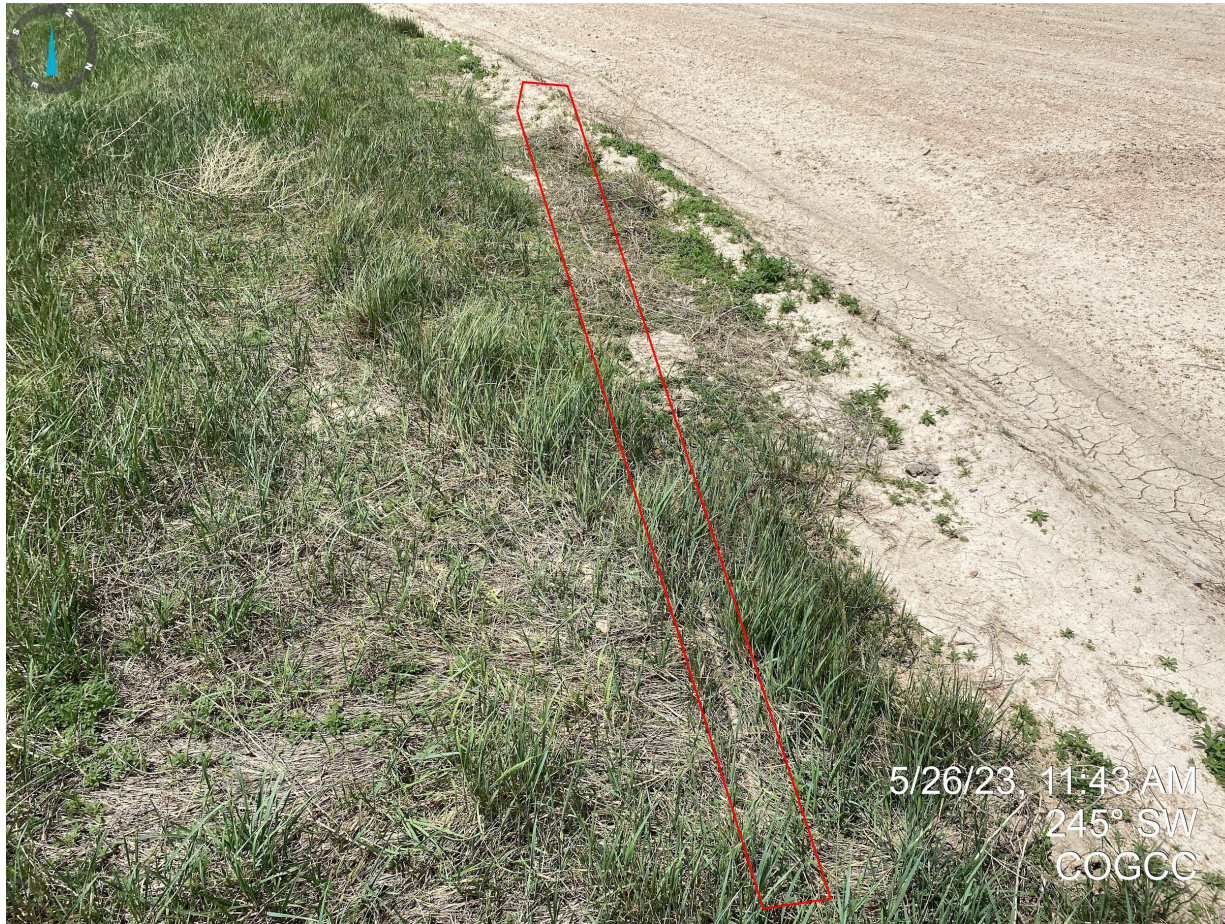
Photo 3. Buried suck rod observed on the east end of the location, highlighted by red outline. All debris/trash/unused equipment will need to be removed from location.

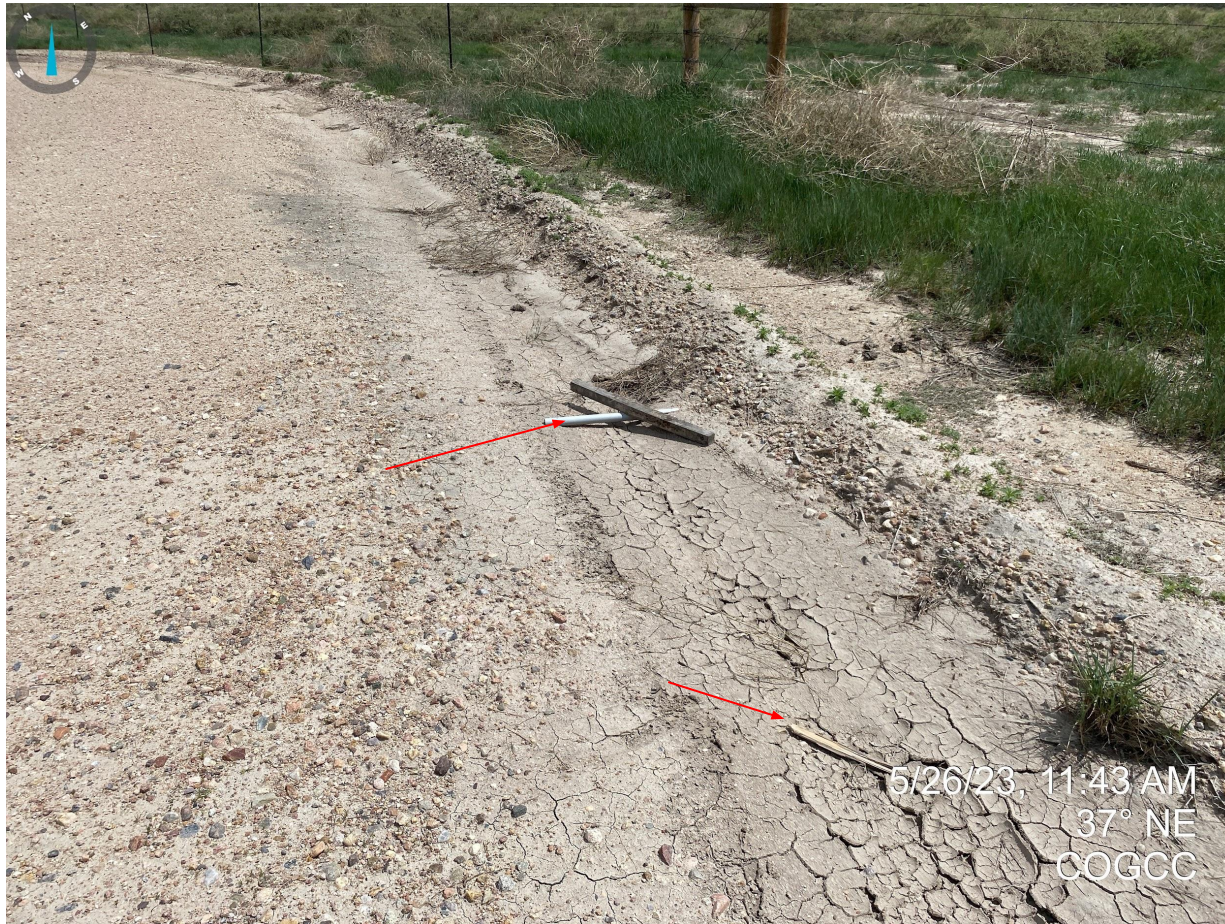
Photo 4. See comments in Photo 2.

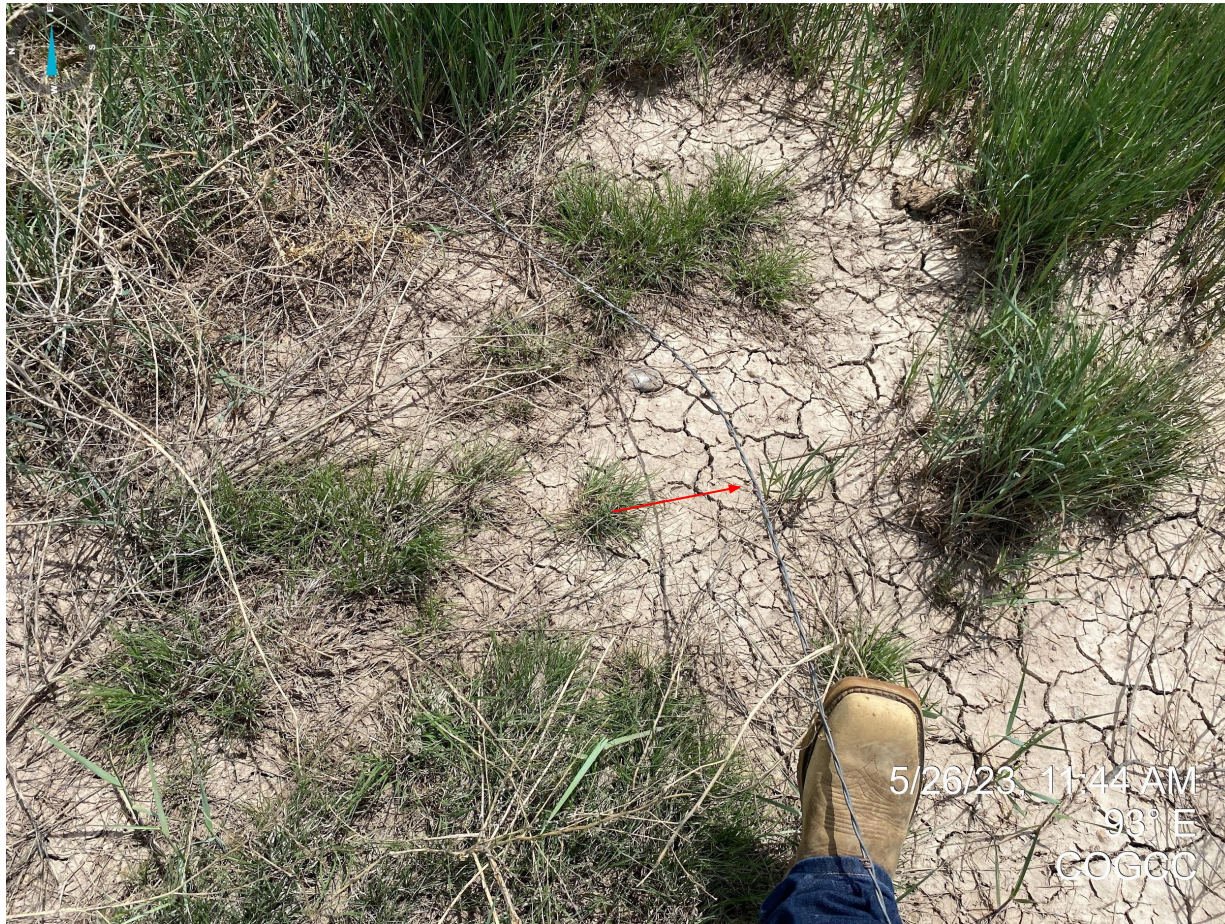
Photo 5. Loose/unstrung barb wire observed on the northern end of the location will need to be repaired and/or removed as it poses a hazard to personnel and wildlife.

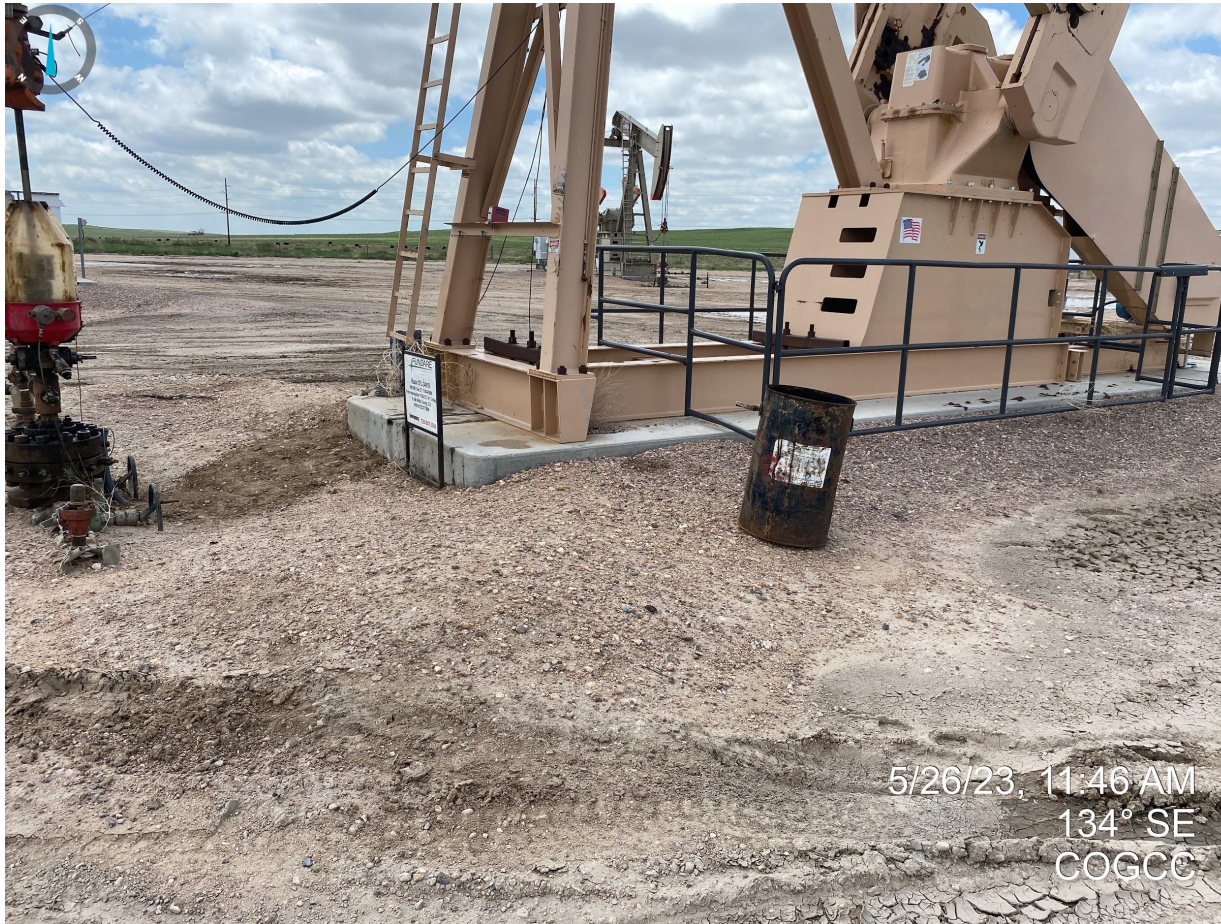
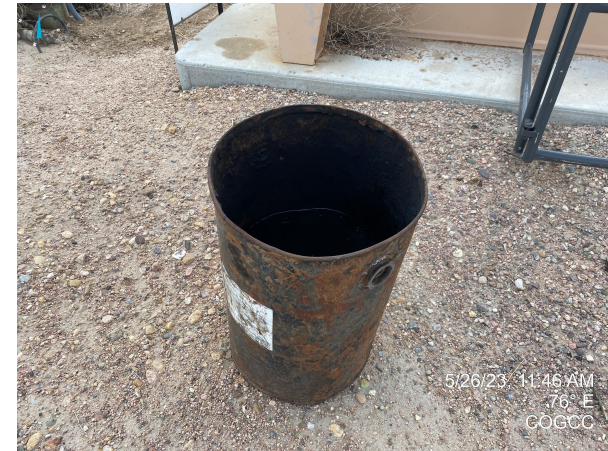
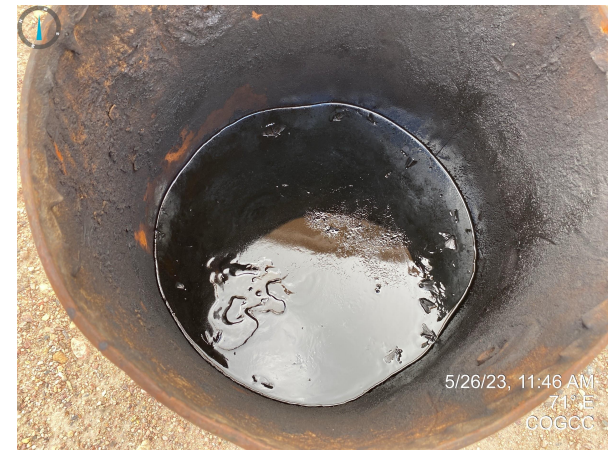
Photo 6. Open top drum observed next to pumpjack had free fluids (apparent hydrocarbons) and was not placed in secondary containment or had a lip/top. This will either need to be removed and properly disposed of, or placed in secondary containment with a lid to prevent/exclude wildlife entry.

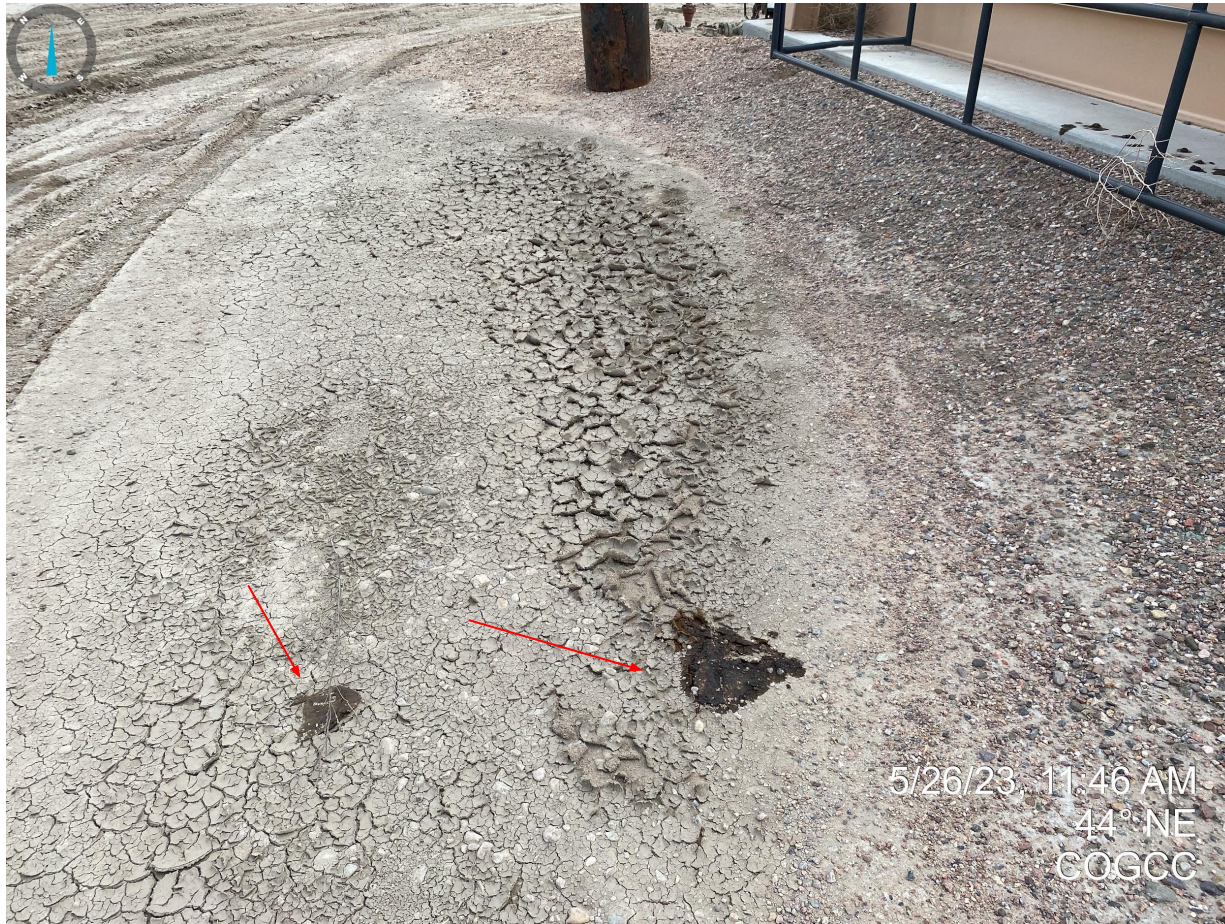
Photo 7. Stained soil will need to be properly cleaned and disposed of per Rule 905.e.

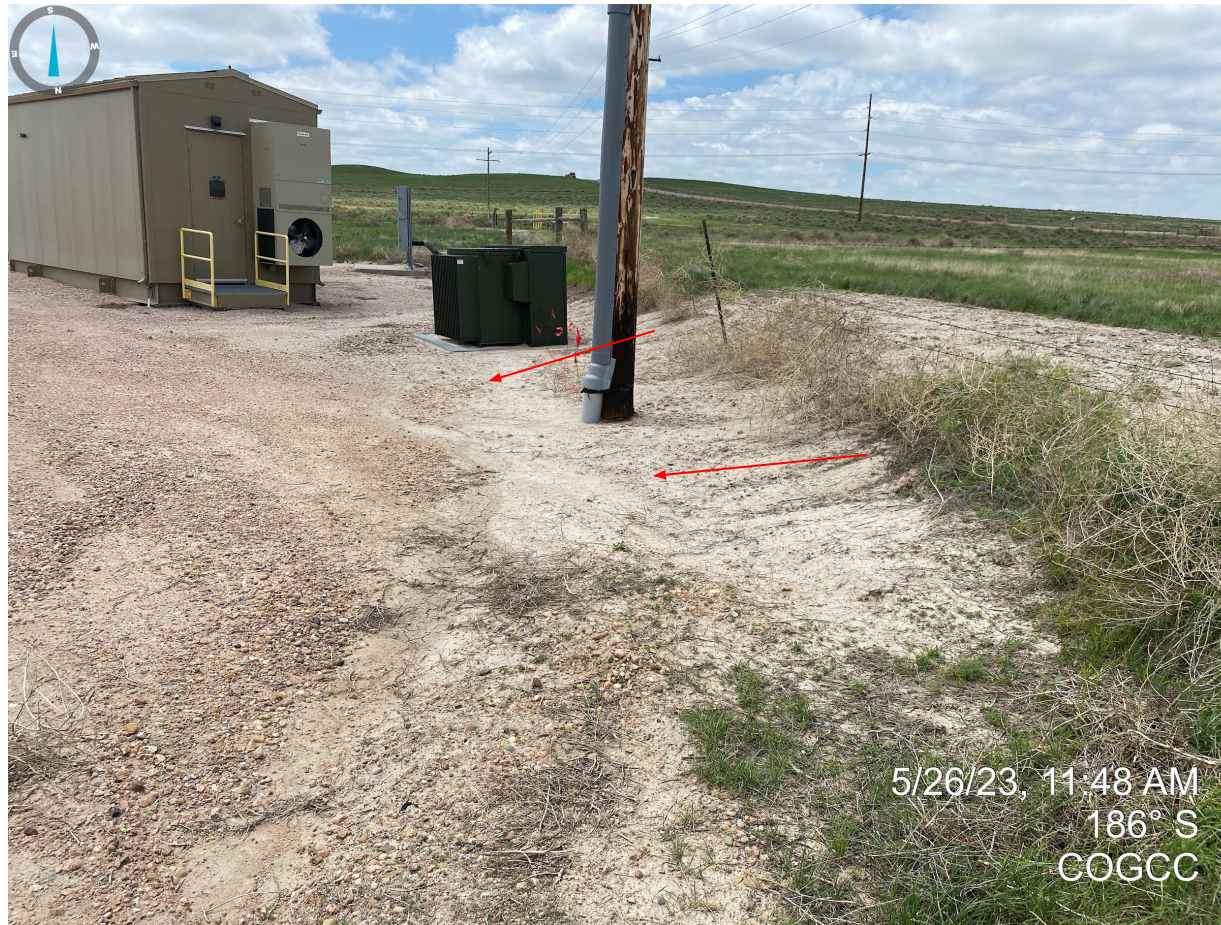
Photo 8. Western portion of location. Evidence of sediment transport onto the location from unstabilized bank/soils. Additional repair or implementation of stormwater BMPs is required to prevent further erosion from occurring.

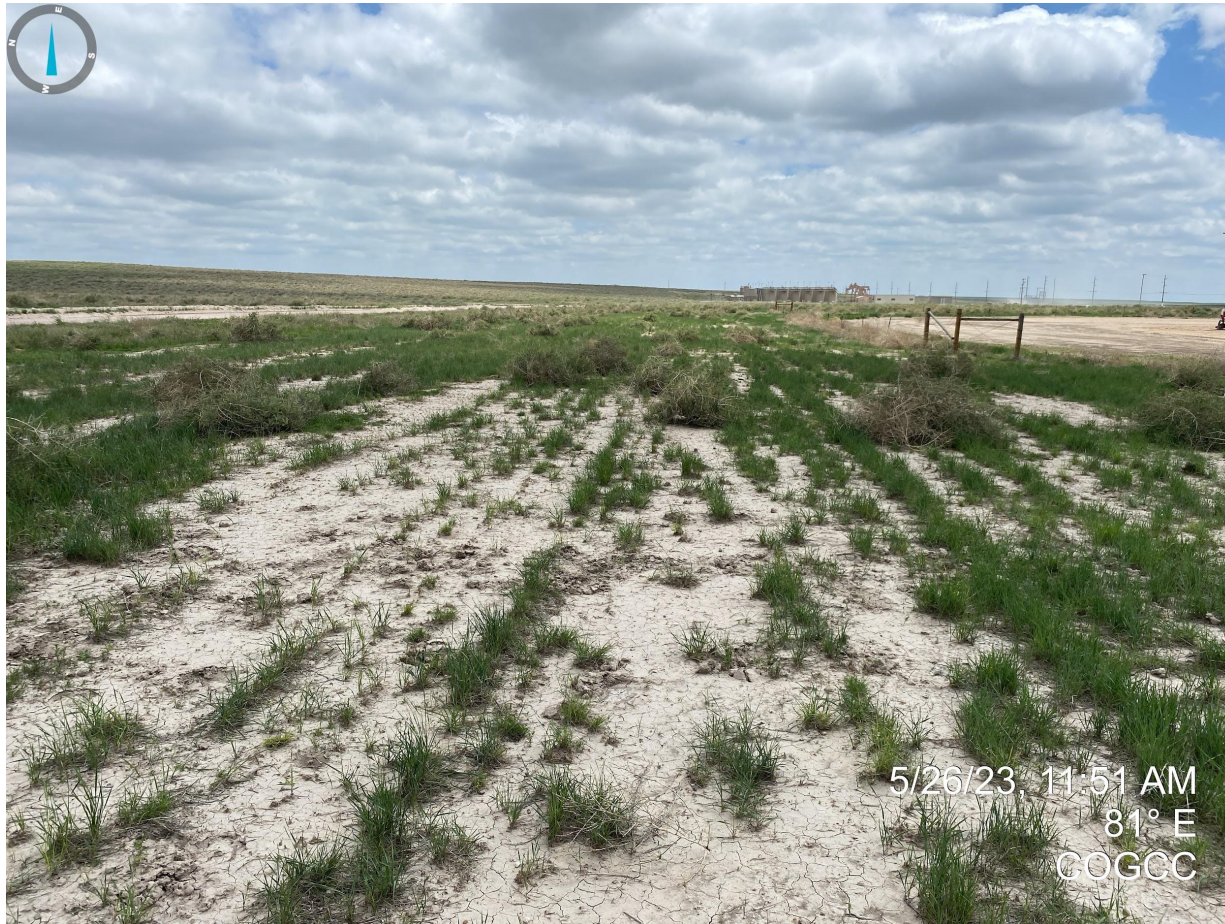
Photo 9. Northern interim reclamation area. The interim areas are not progressing towards Rule 1003 standards with evidence of non-uniform vegetation cover resulting in bare soil and areas of undesirable vegetation (e.g. kochia). Additional reclamation activities are required.

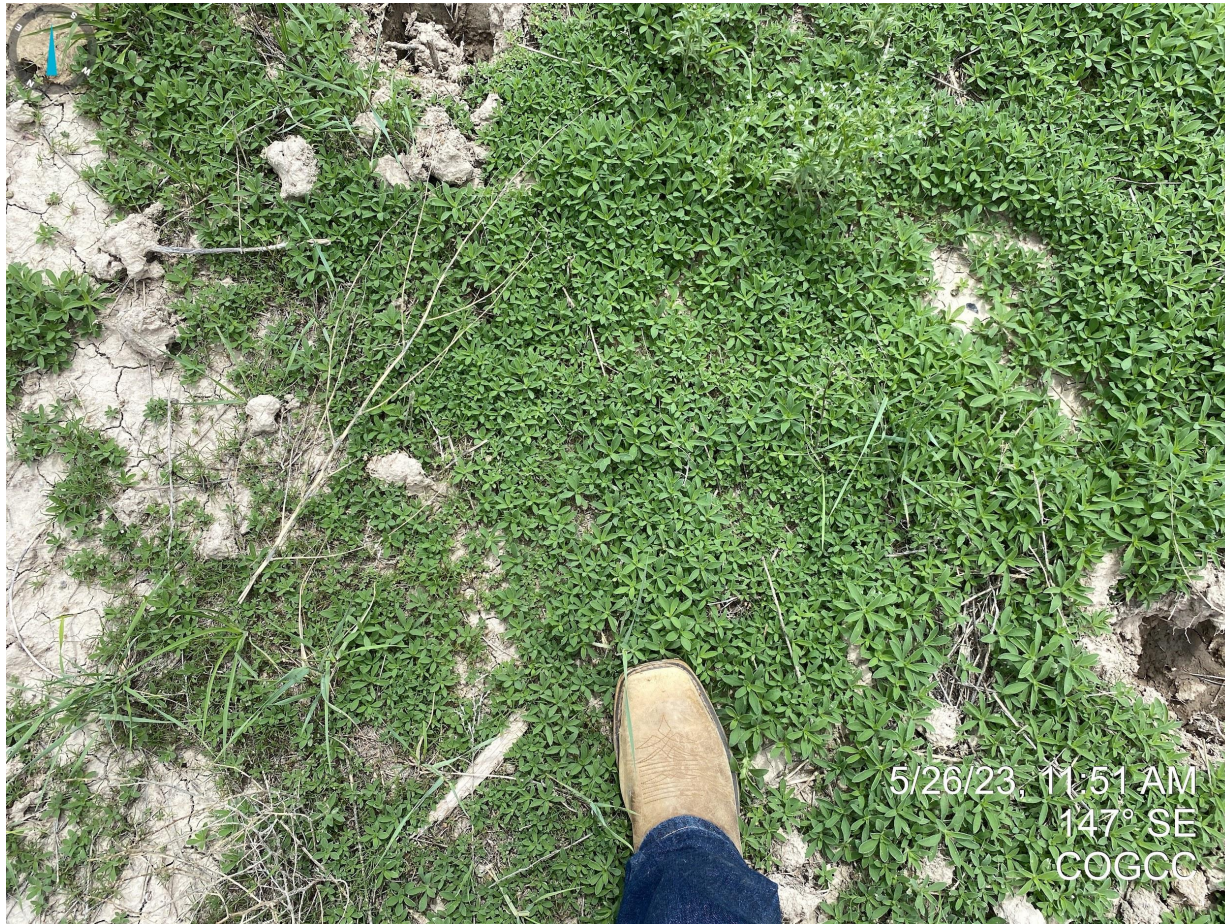
Photo 10. Close up photo of undesirable vegetation (e.g. kochia).

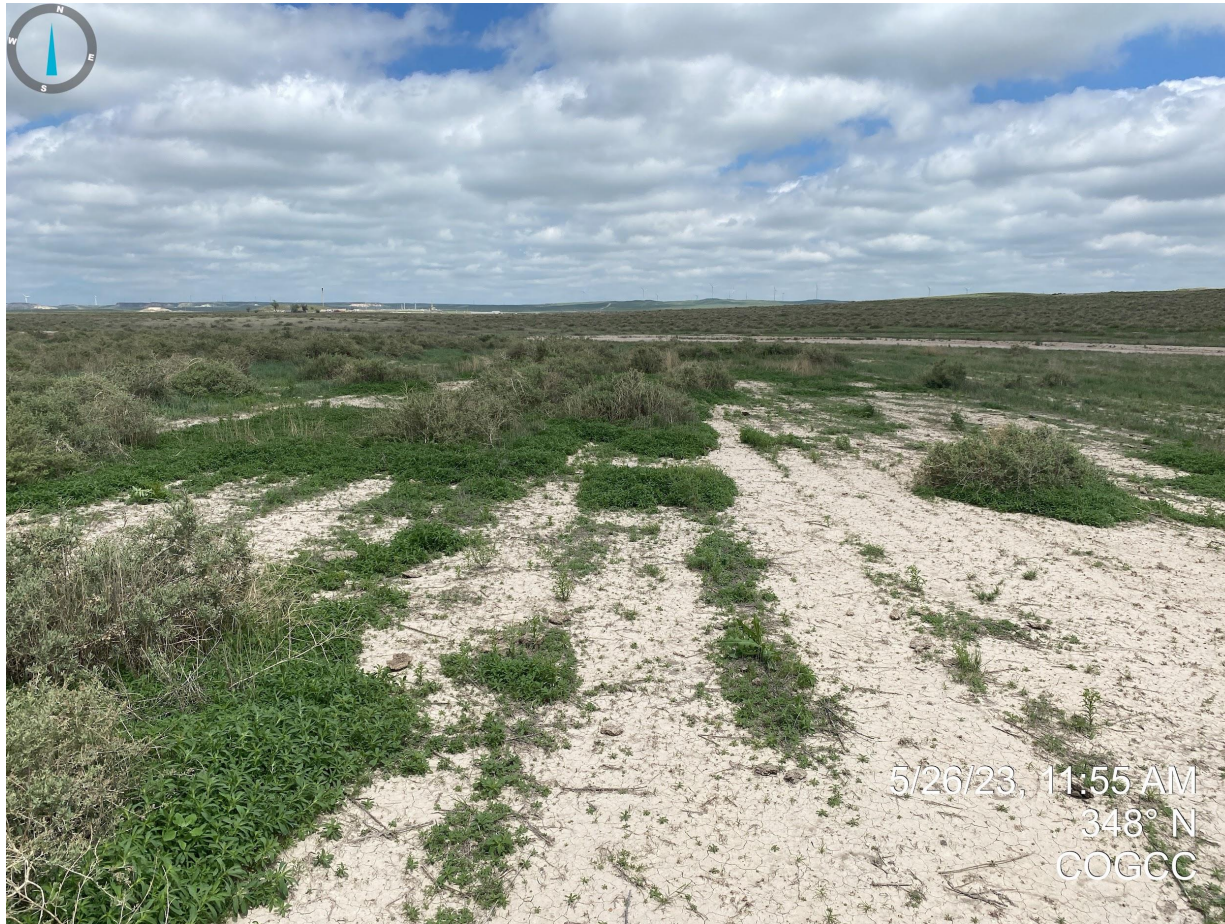
Photo 11. Eastern interim area; see comments in Photo 9.

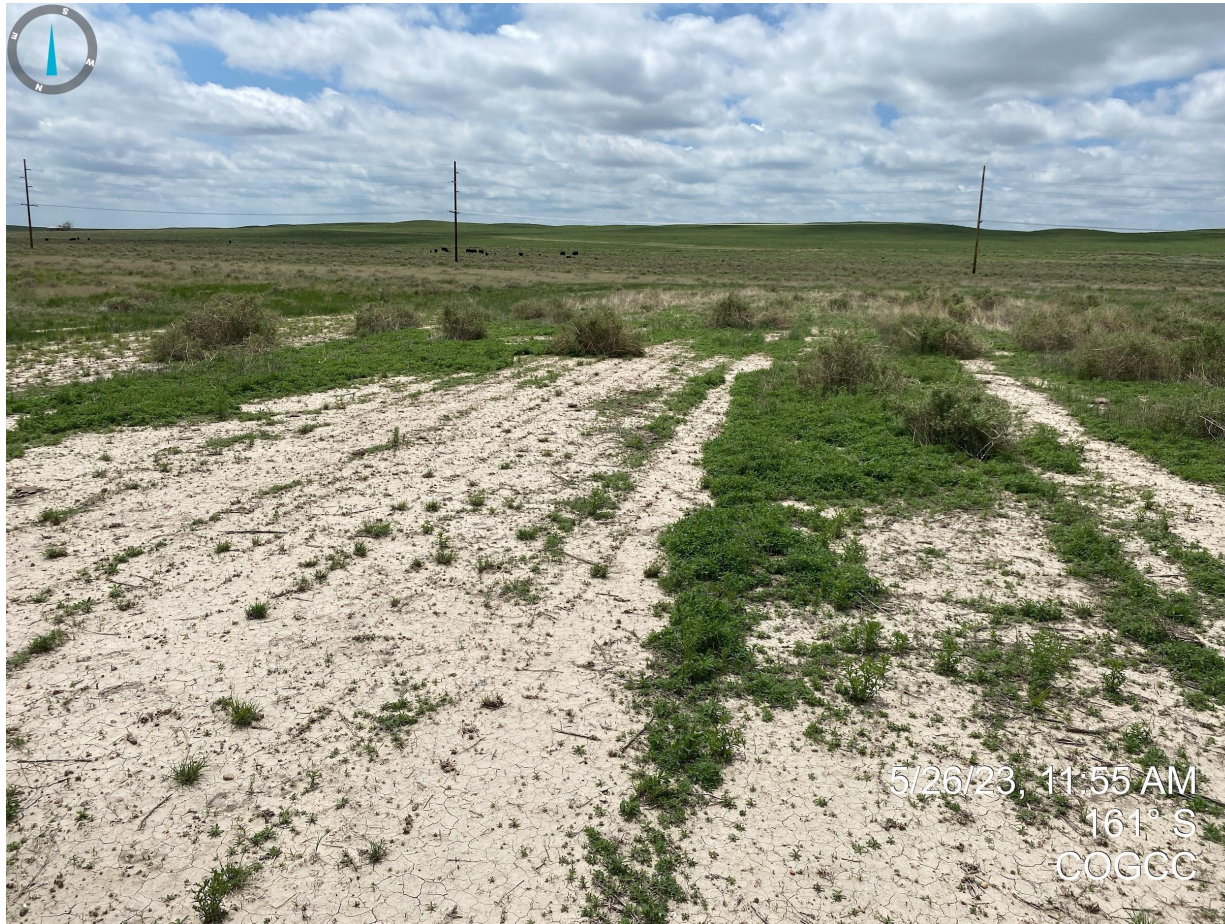
Photo 12. Southeastern interim area; see comments in Photo 9.
