Interim Reclamation and Stormwater Inspection

Date: 05/26/2023

Operator: FUNDARE RESOURCES OPERATING
COMPANY LLC - 10773

Inspection Photos
Location Name: Razor 27K-3407A
Location ID: 431782

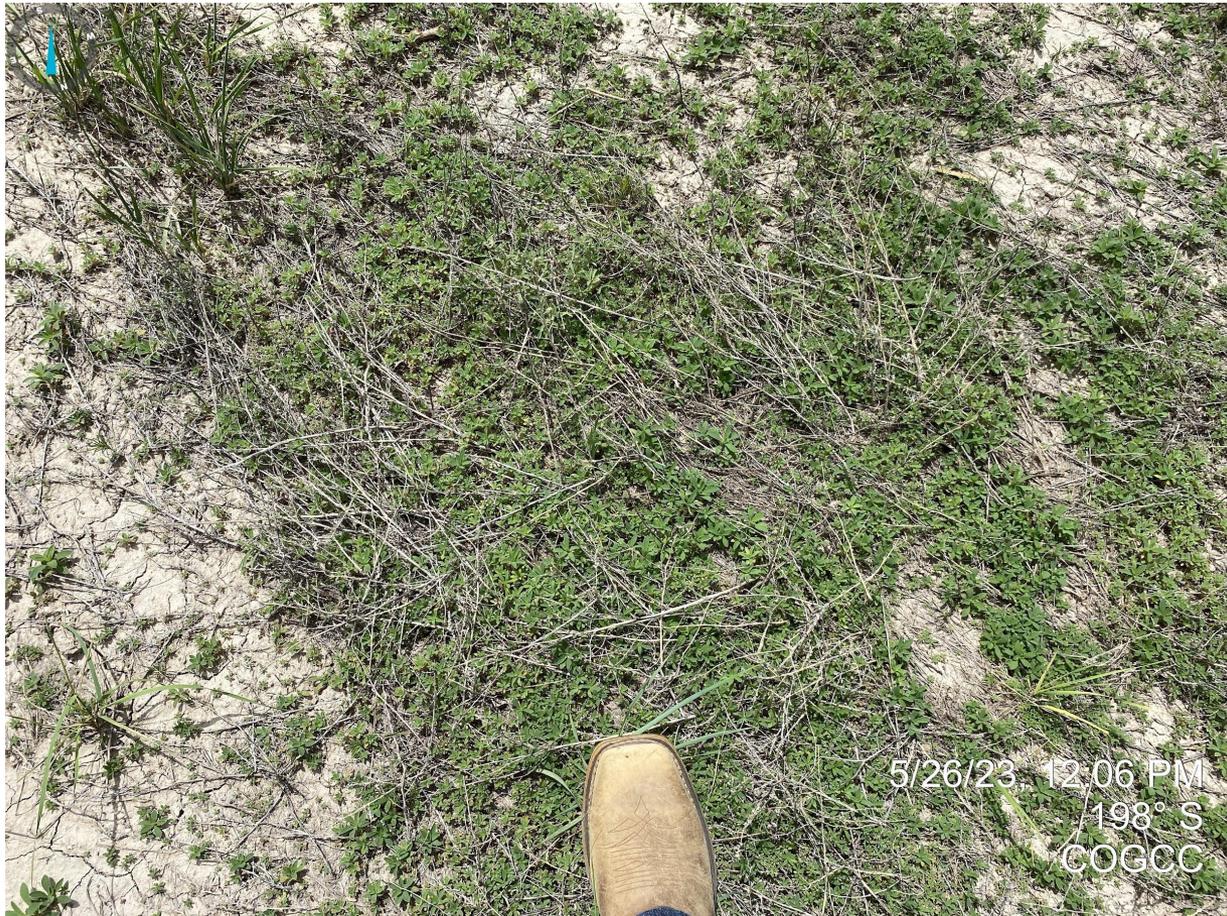
Photo 1. Close up photo of undesirable species (e.g. kochia) observed throughout the interim reclamation areas. The Operator will need to manage the location for undesirable weed species during the growing season.

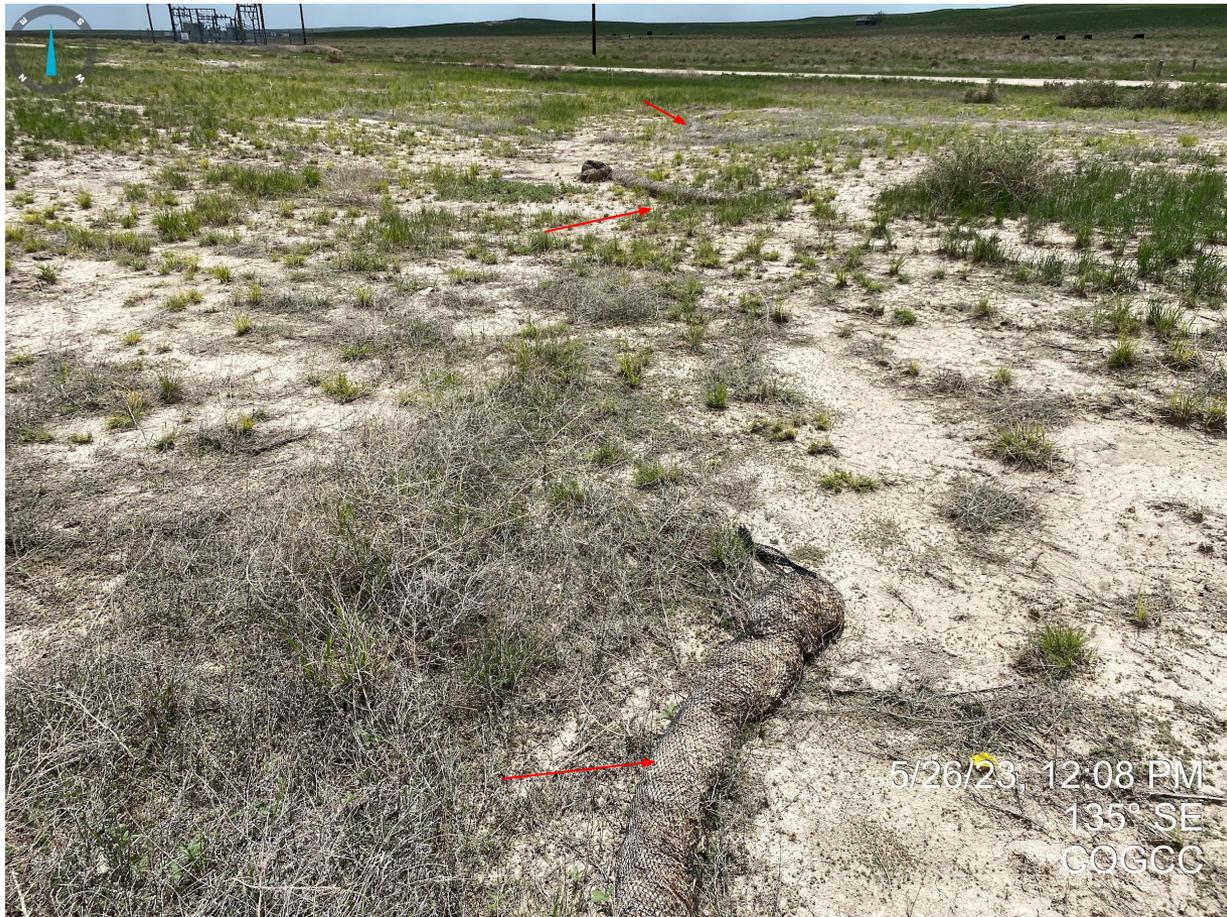
Photo 2. Southern portion of location. Degraded straw wattles are now considered debris and will need to be removed.

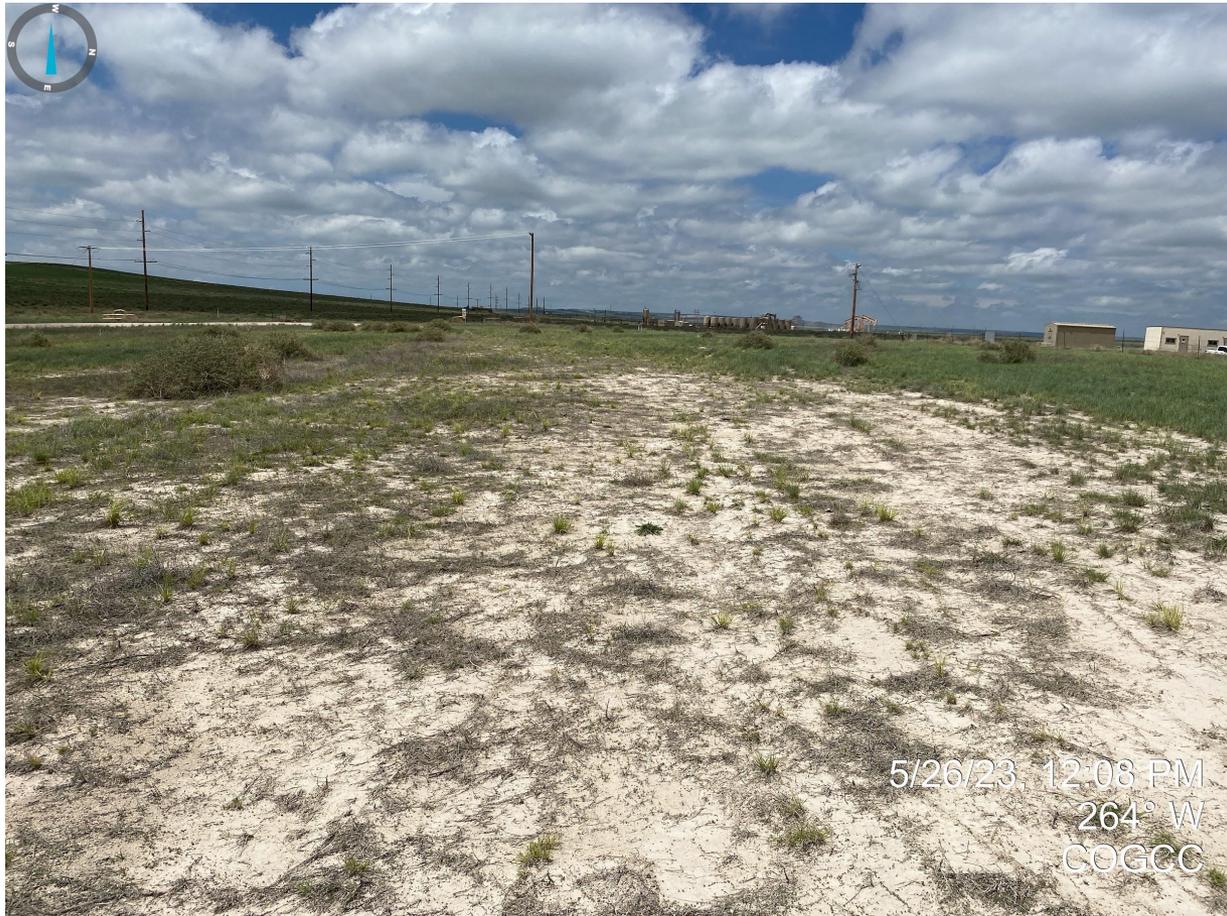
Photo 3. Southern interim area. The interim areas are not progressing towards reclamation standards with evidence of non-uniform vegetation cover resulting in areas of bare soil and undesirable vegetation (e.g. kochia) was observed growing throughout. Additional reclamation activities are required in order to meet Rule 1003 standards.

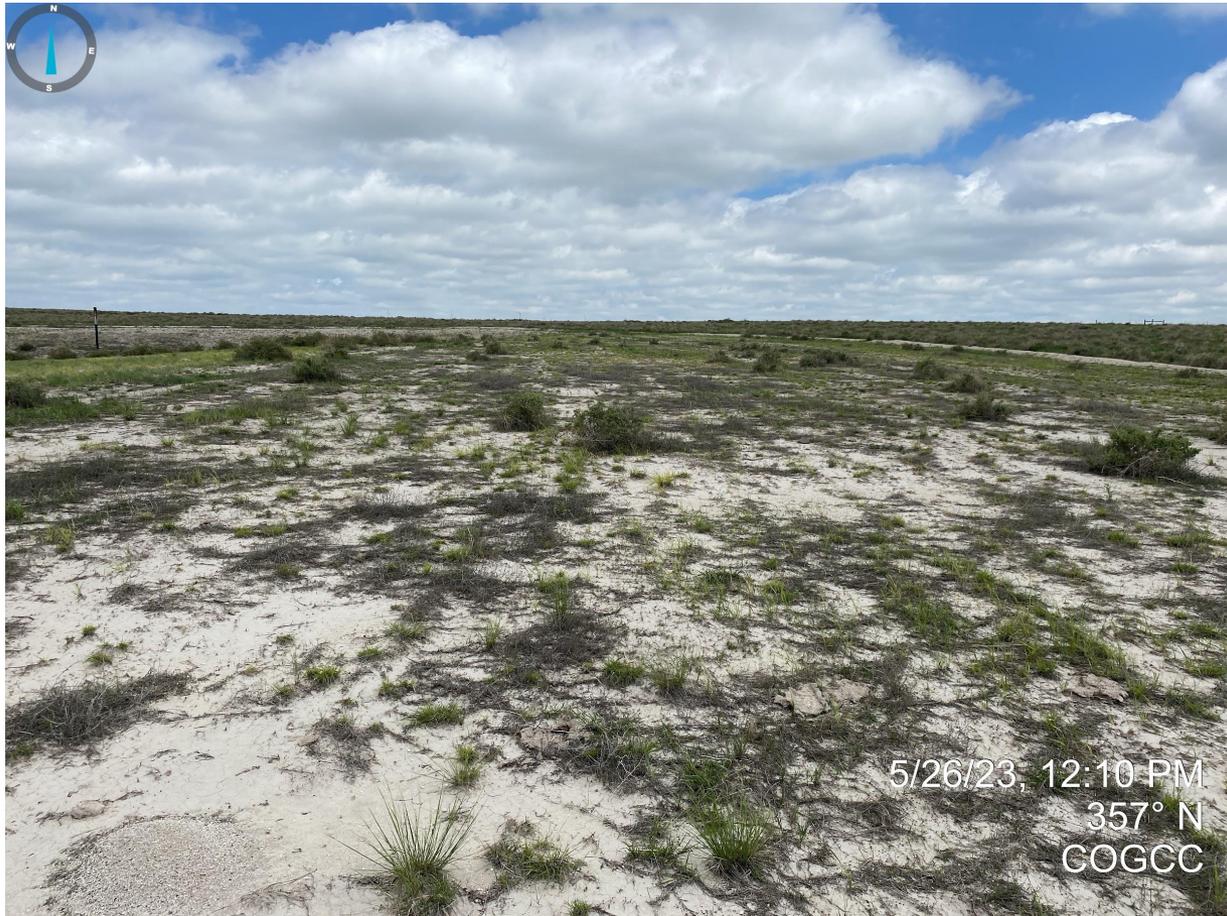
Photo 4. Eastern interim areas; see comments in Photo 3.

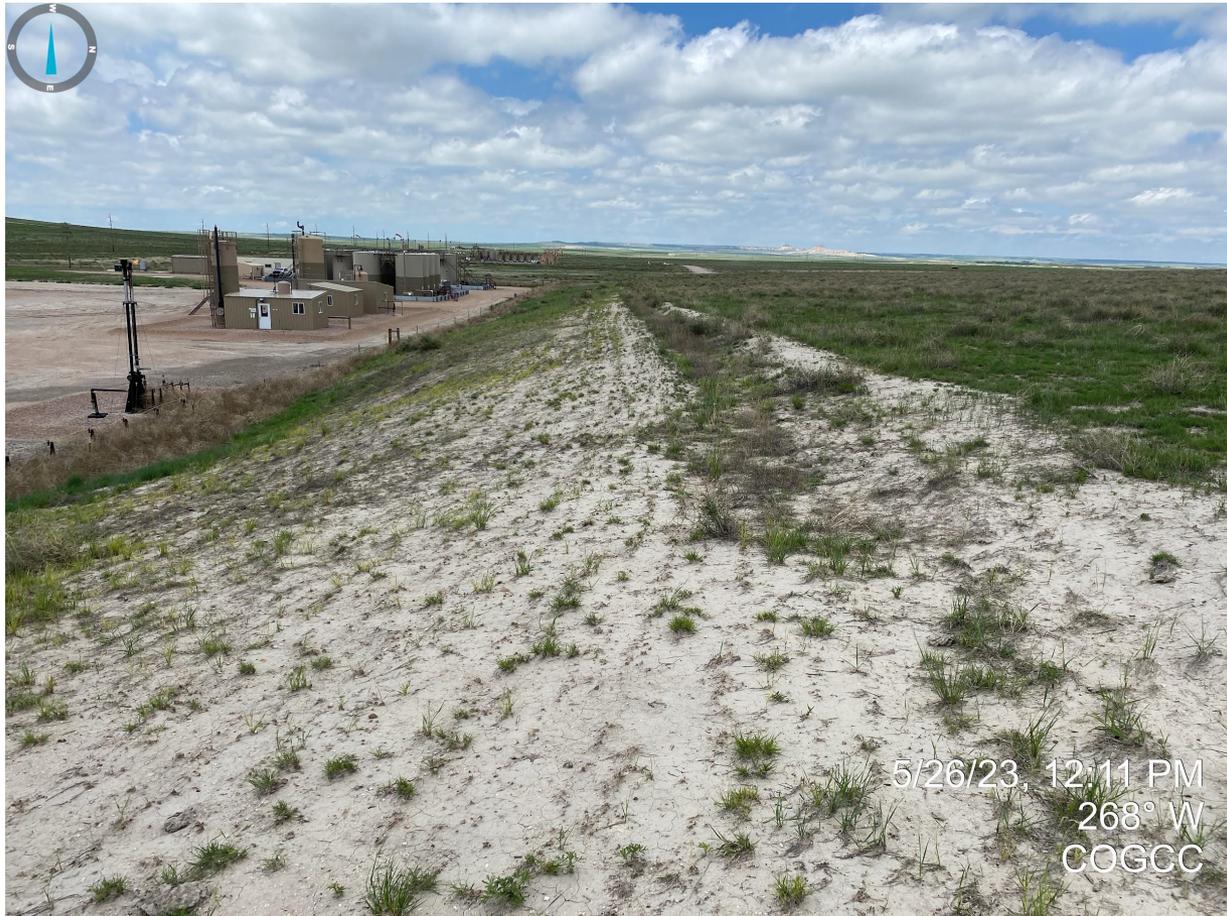
Photo 5. Northern interim areas; see comments in Photo 3.

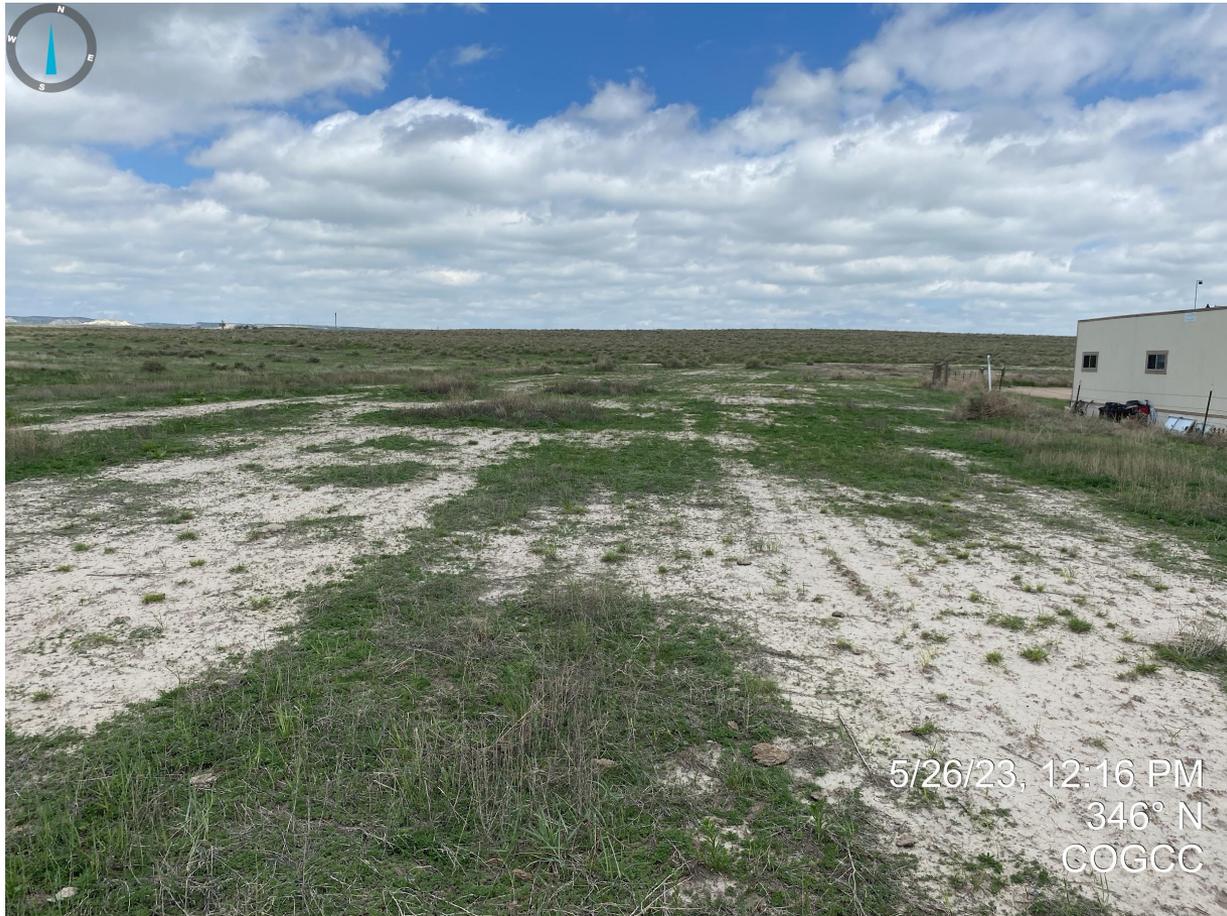
Photo 6. Western interim/topsoil stockpile area; see comments in Photo 3.

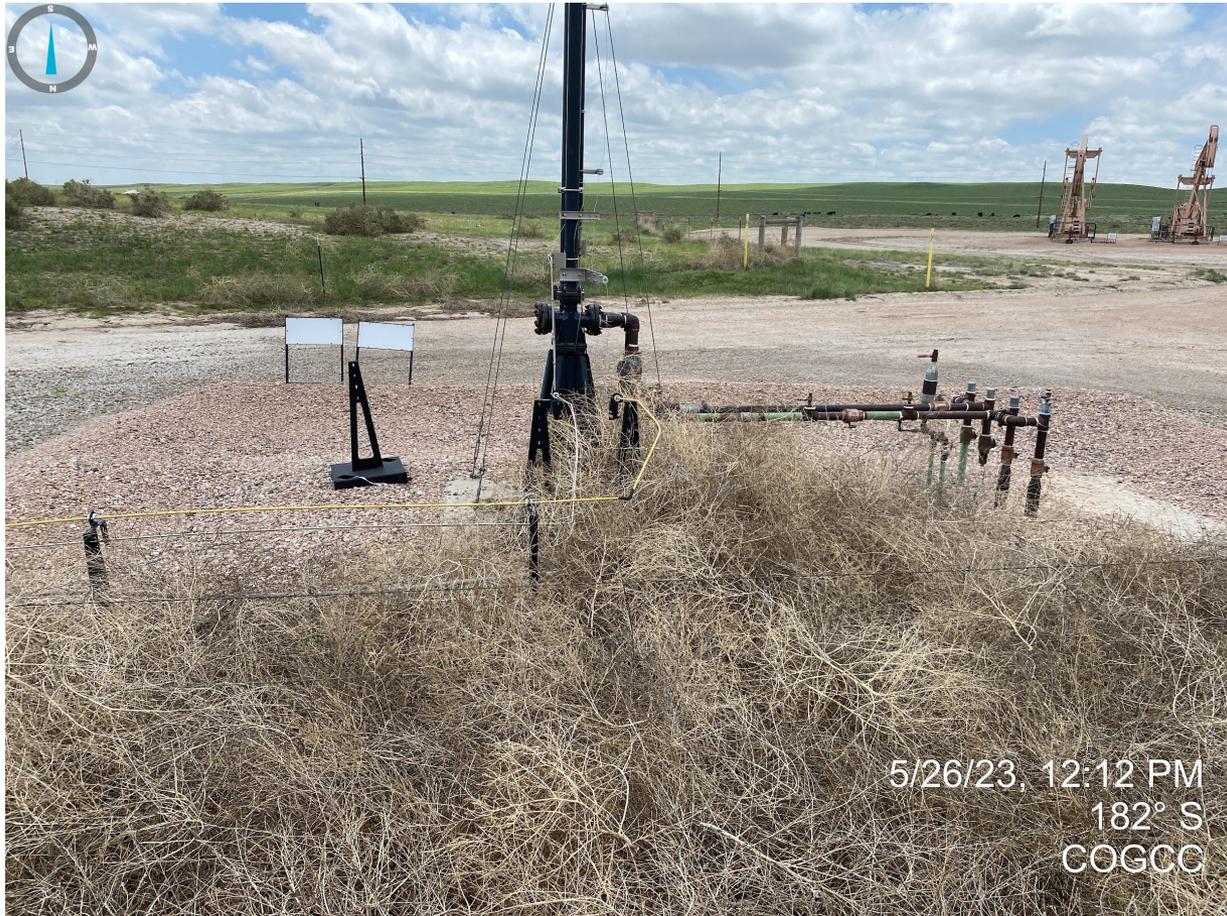
Photo 7. Tumbleweed accumulations around flare unit will need to be removed as they present a fire hazard.
