# Inspection Photos

API: 055-06017

Operator: OXY USA INC

Inspection Date: 6/1/2023

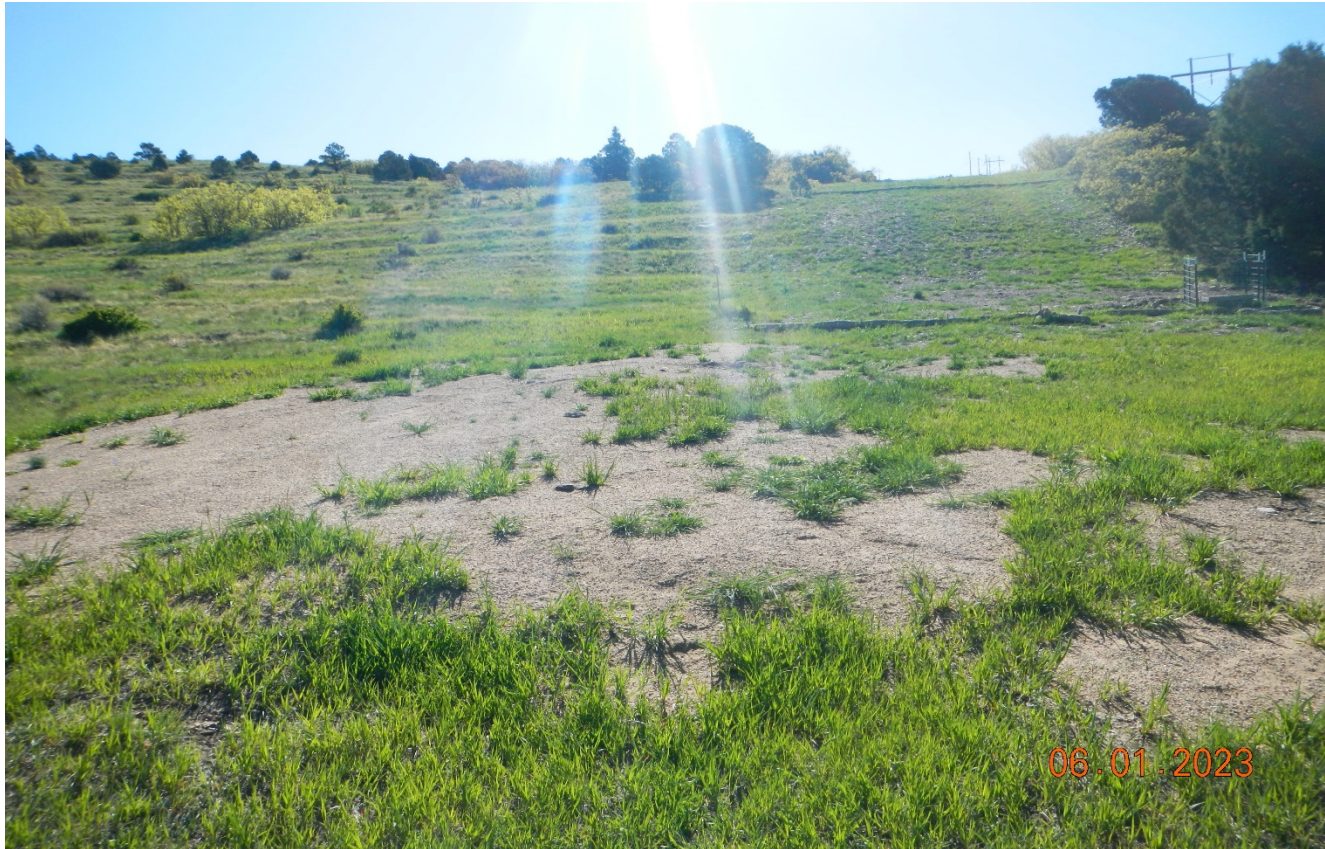
**Photo 1.** Just west wellsite along the flowline where there was recent disturbance and reclamation. This area has not established vegetation and there is still backfill gravel that remains. This area needs additional reclamation and gravel removal. Lat/Long: 37.6997, -105.20816.

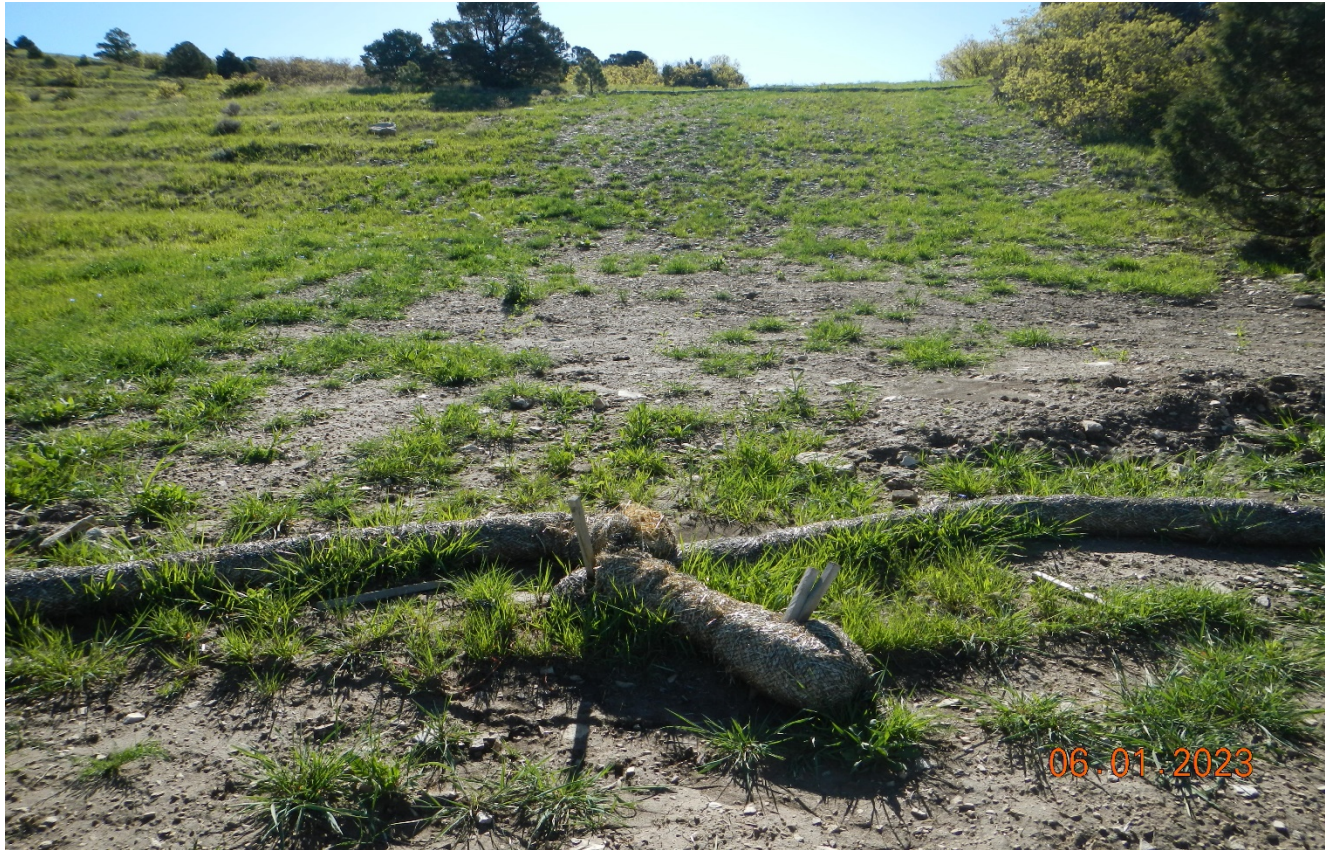
**Photo 2.** Facing east along the flowline. There is a displaced wattle that needs to be repaired or removed. Lat/Long:37.6997,-105.20816.

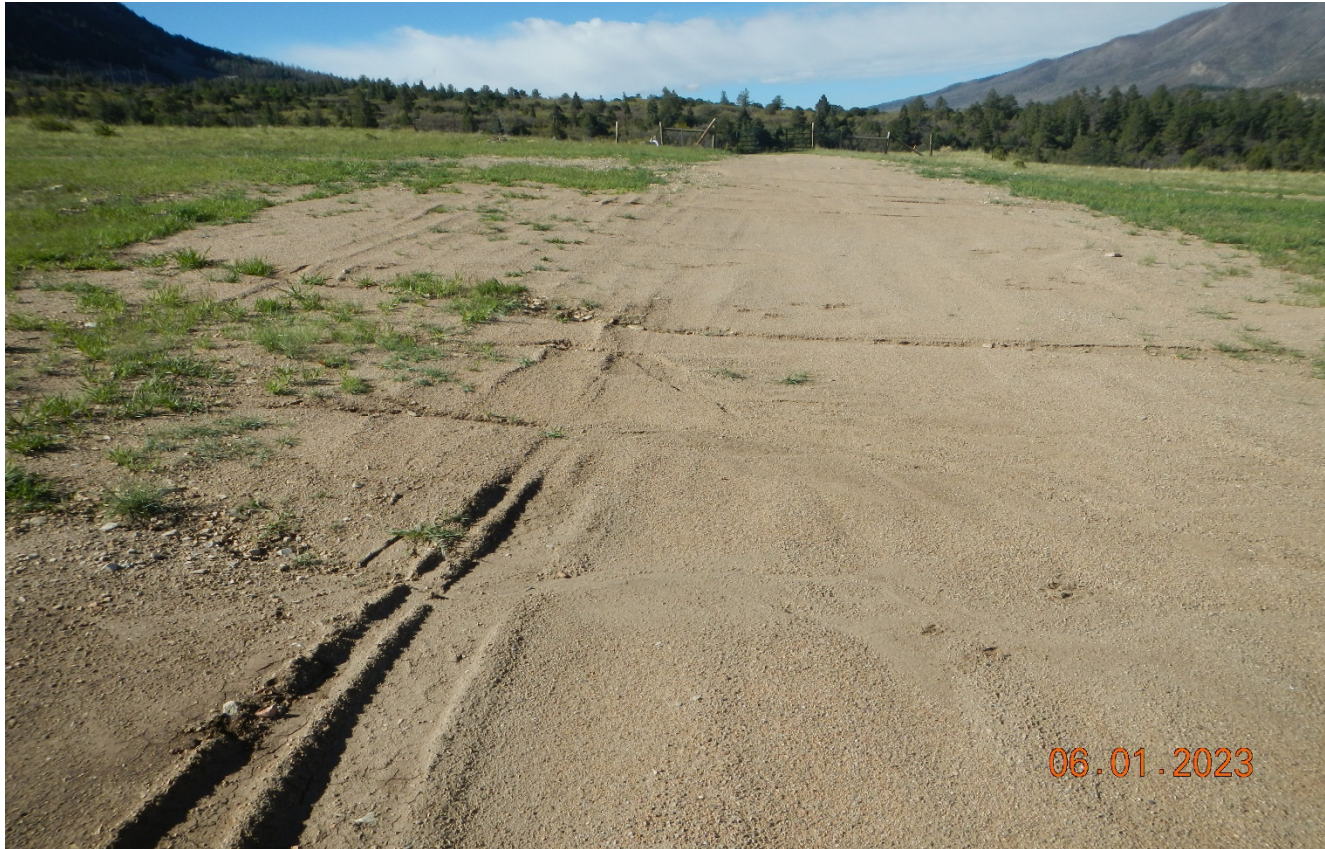
**Photo 3.** Facing south toward the access road. There is a lot of backfill material that remains and is not stabilized.

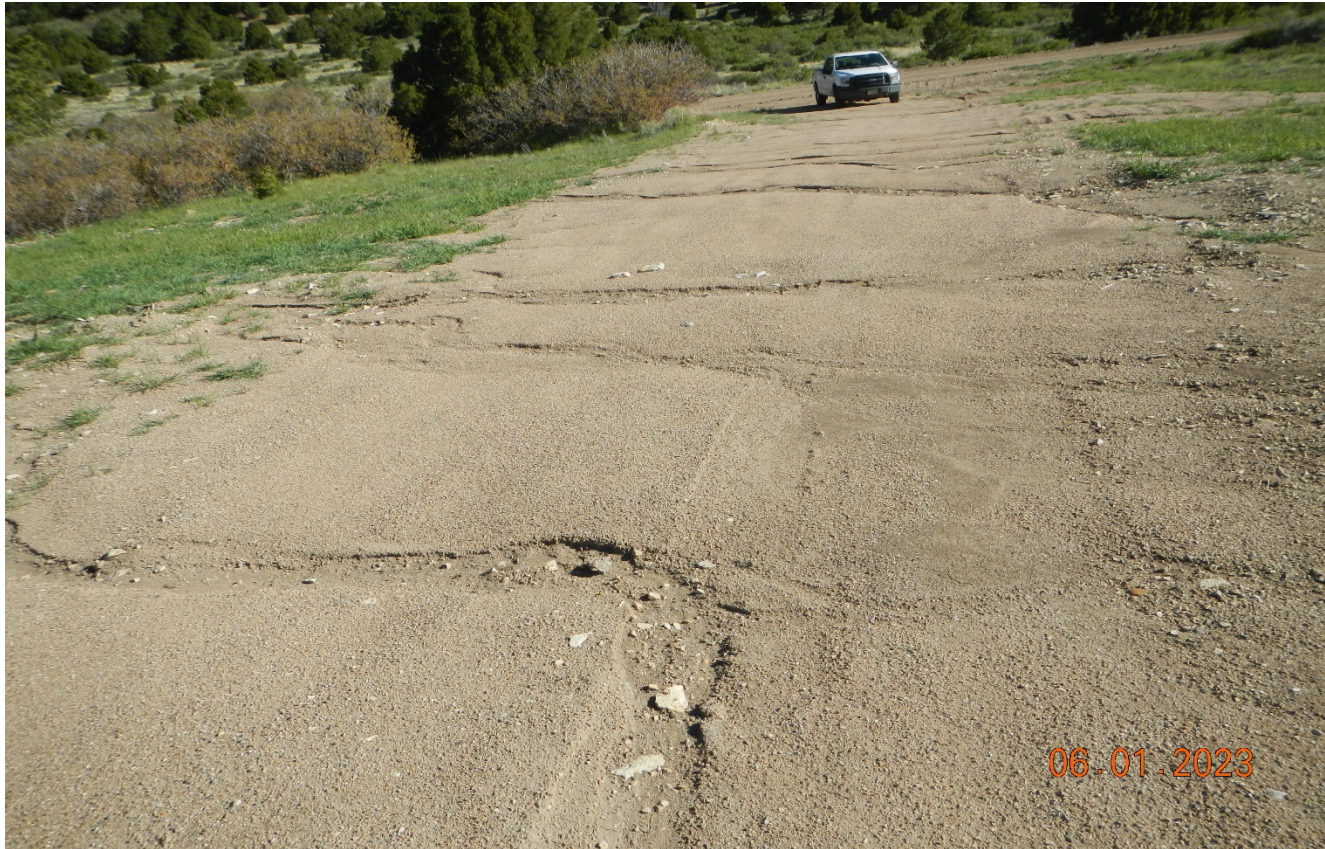
**Photo 4.** Facing back north toward the access road. There is erosion occurring across the road which is transporting sediment material offsite.

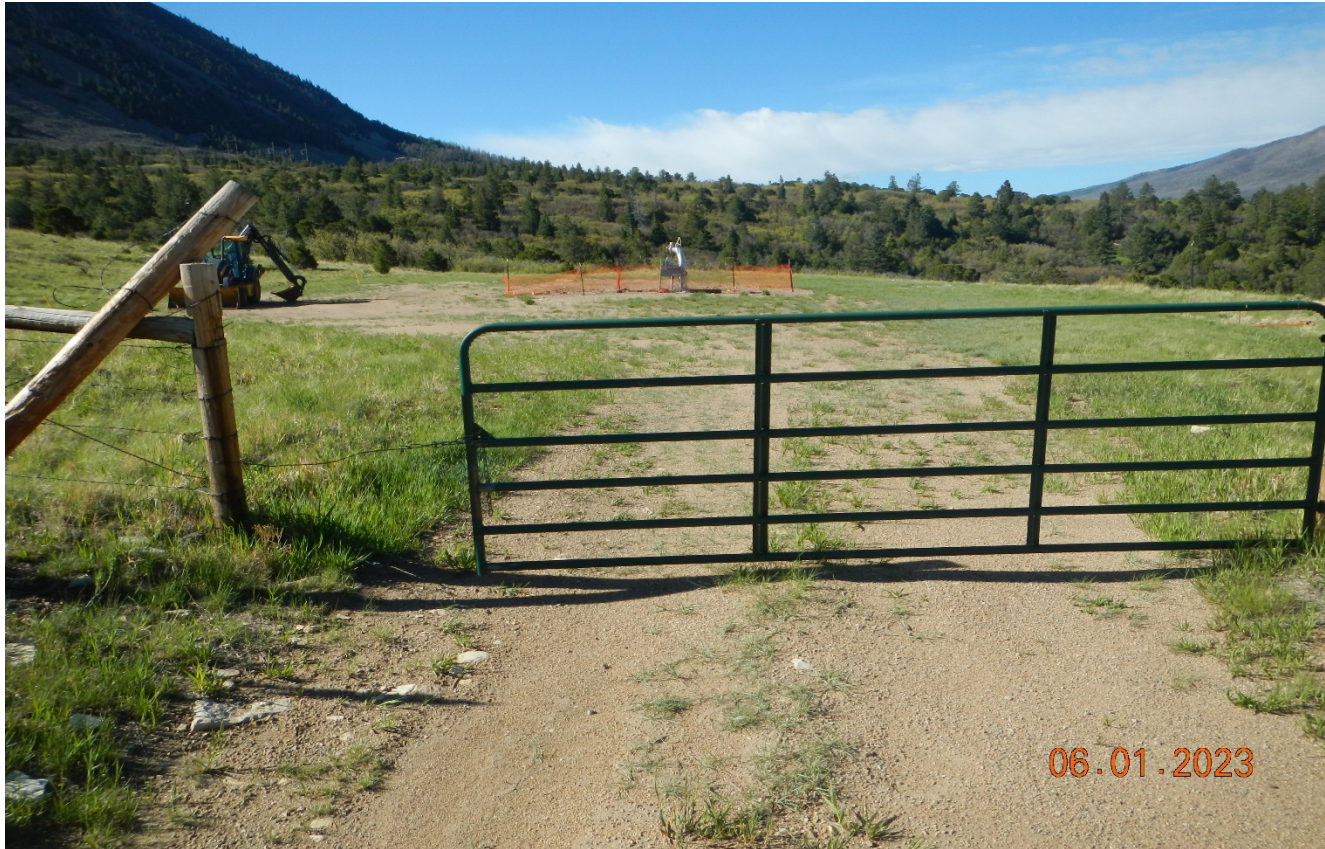
**Photo 5.** Facing south toward the Koscove #1 well site.

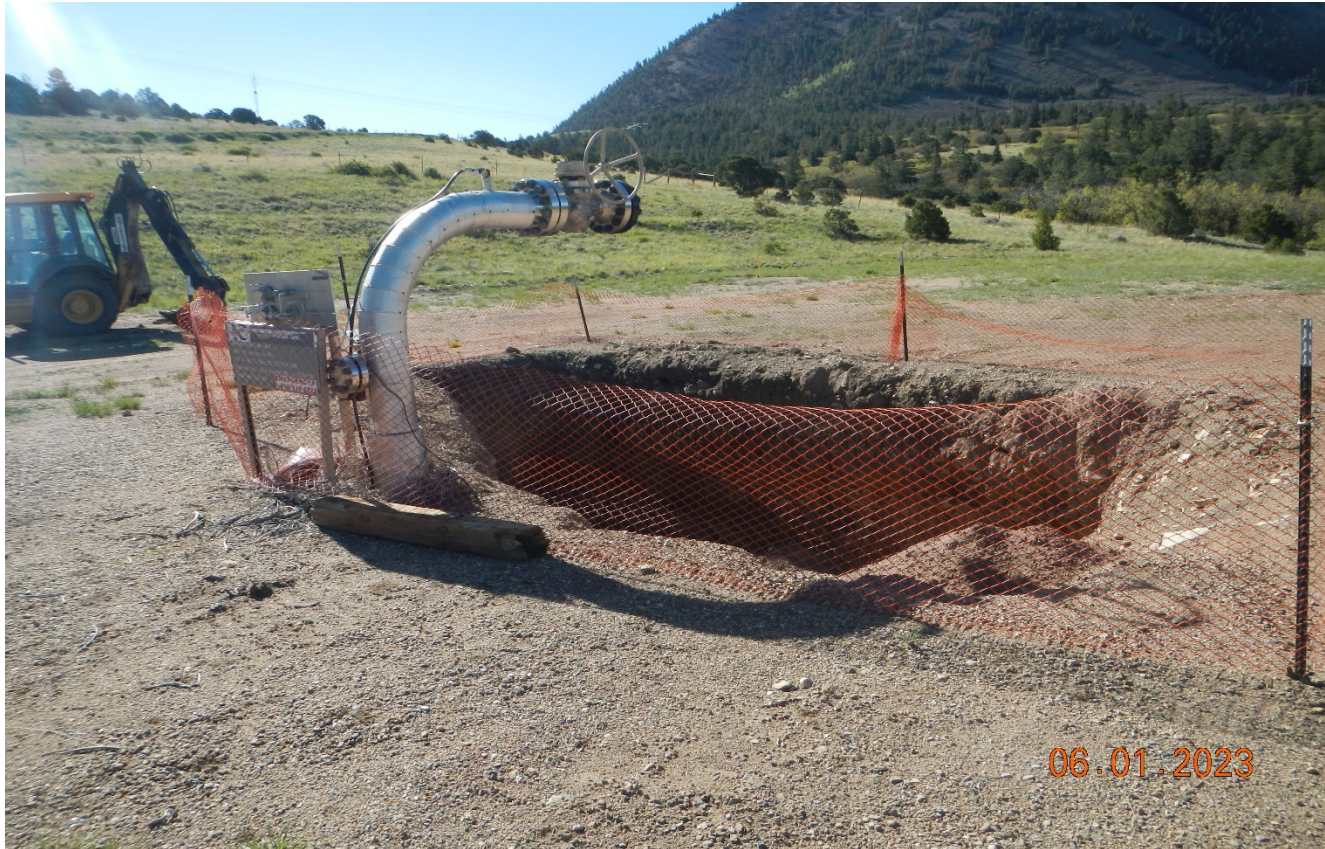
**Photo 6.** Facing toward the wellsite which has been excavated and plugged and abandoned.

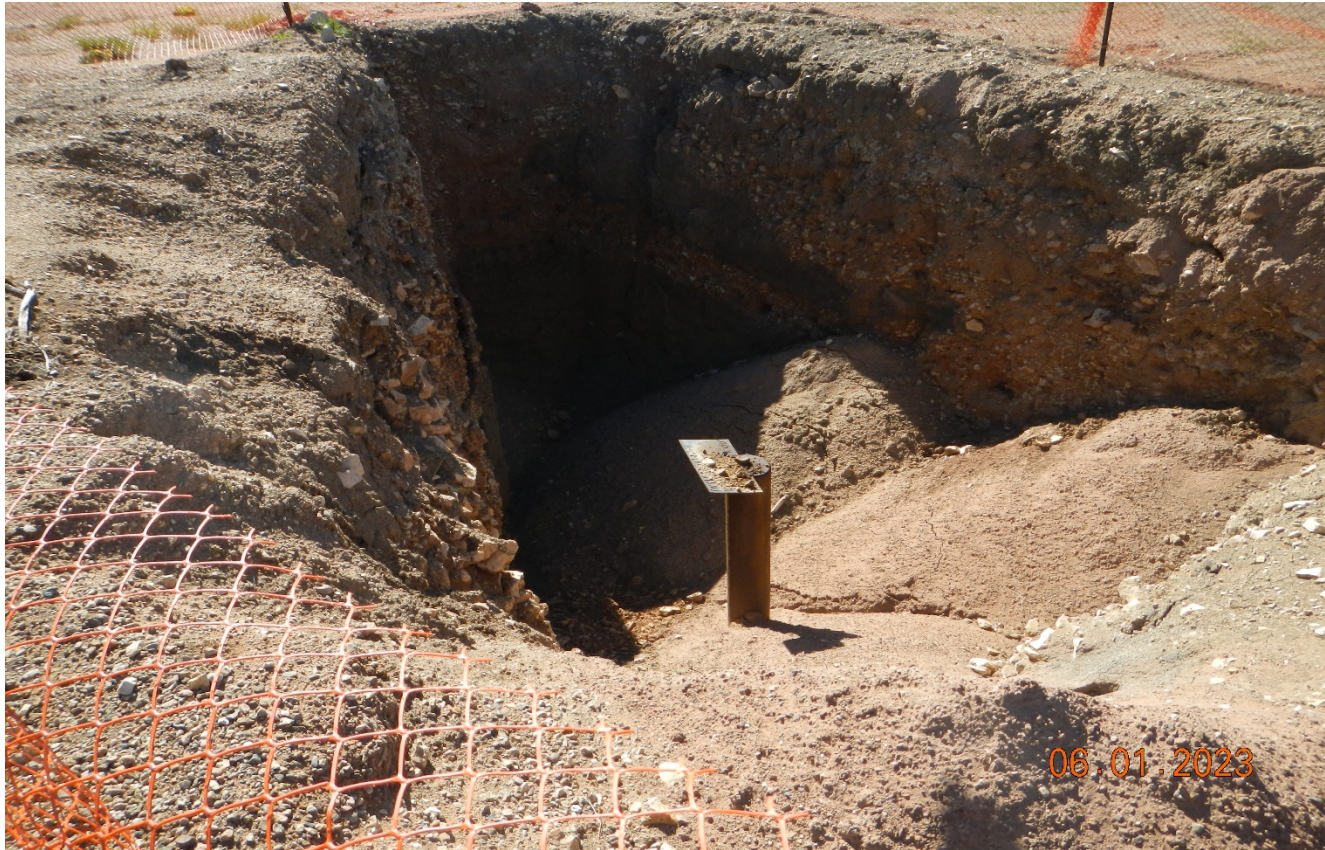
**Photo 7.** The wellhead has been cut and capped. The wellhead should be cut low enough to accommodate recontouring of the location.

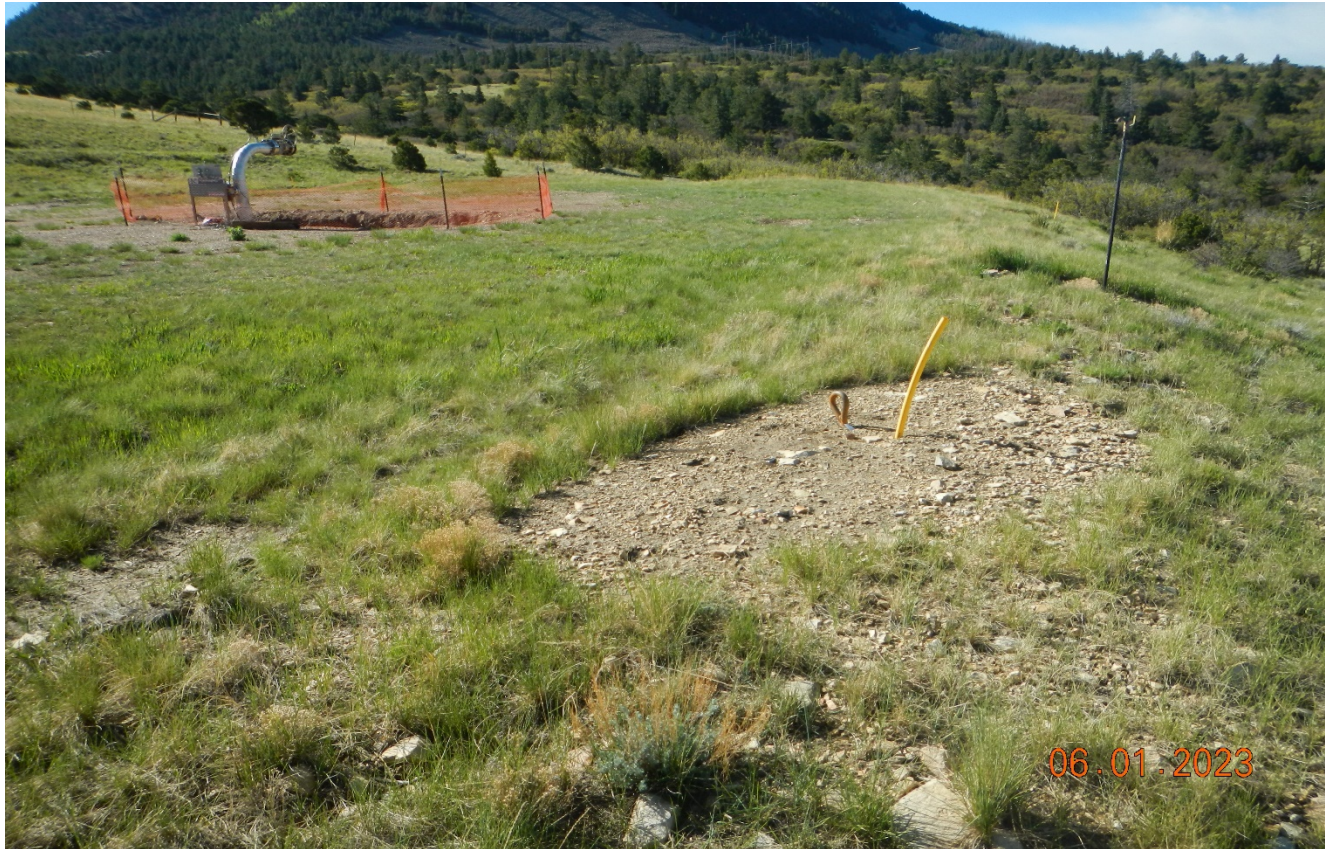
**Photo 8.** Facing southeast toward the location.

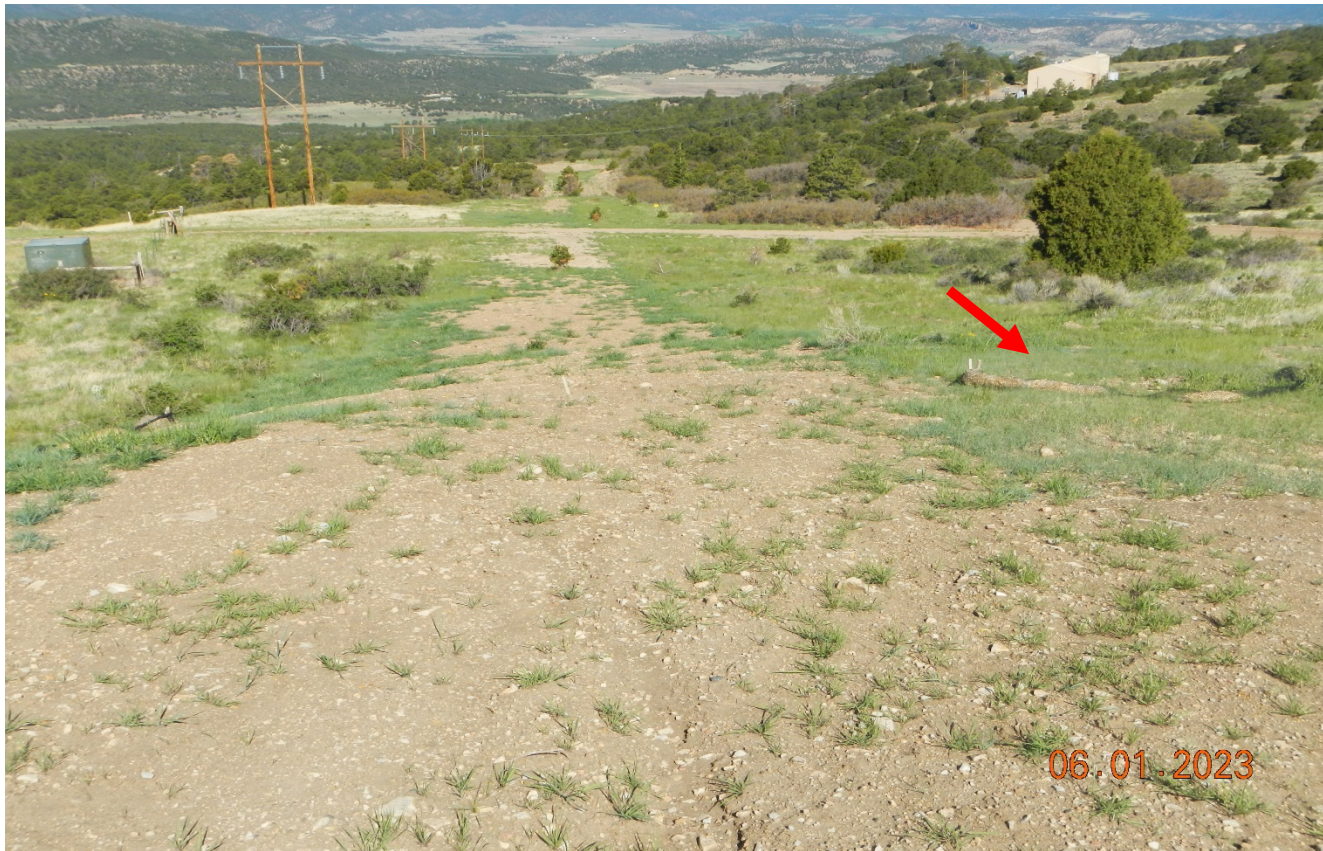
**Photo 9.** Facing west toward the flowline disturbance. Vegetation has not yet reestablished in this area. There is a displaced wattle shown at red arrow.

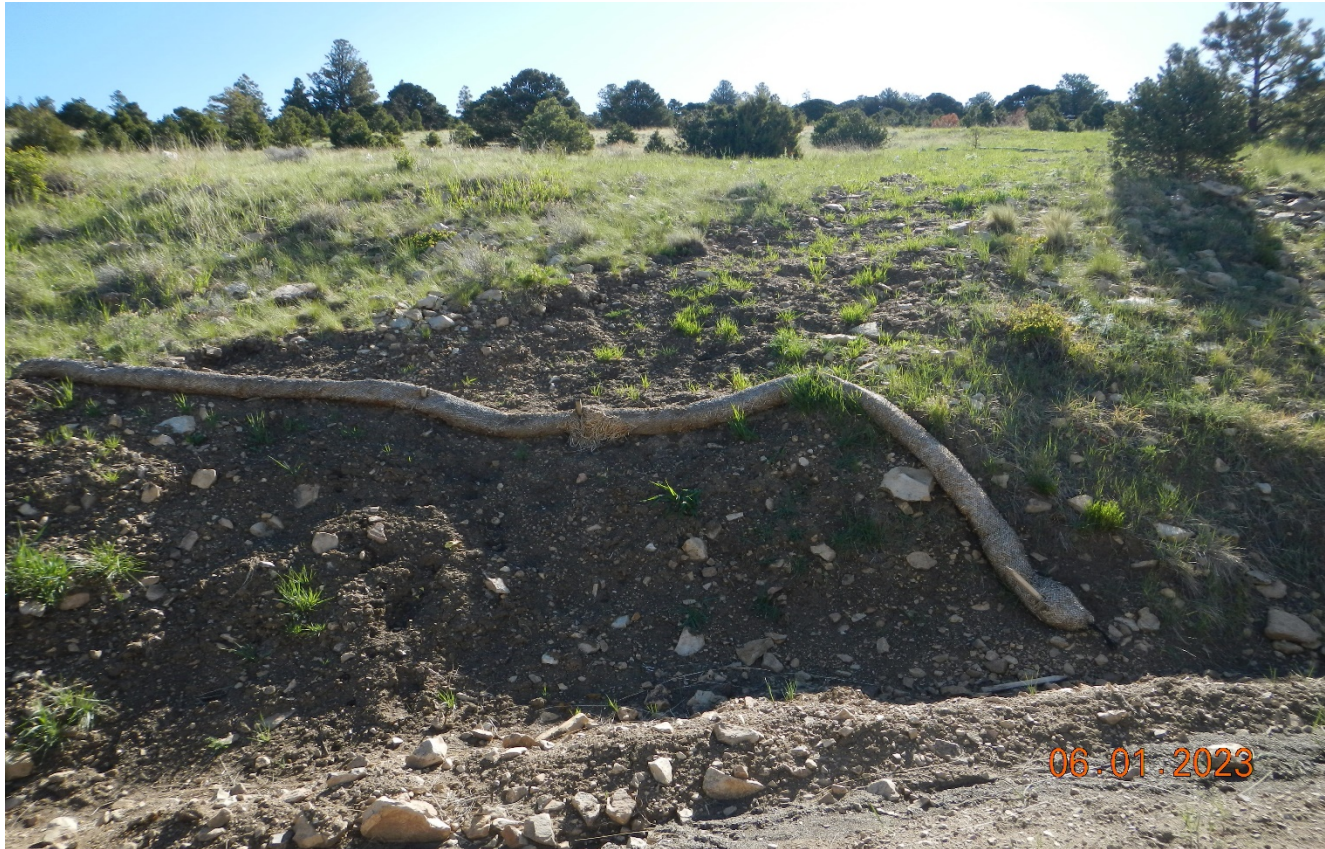
**Photo 10.** Facing opposite from previous phot across the road. There is a displaced wattle that needs maintenance.
