Inspection Photos

API: 055-06012

Operator: OXY USA INC

Inspection Date: 6/1/2023

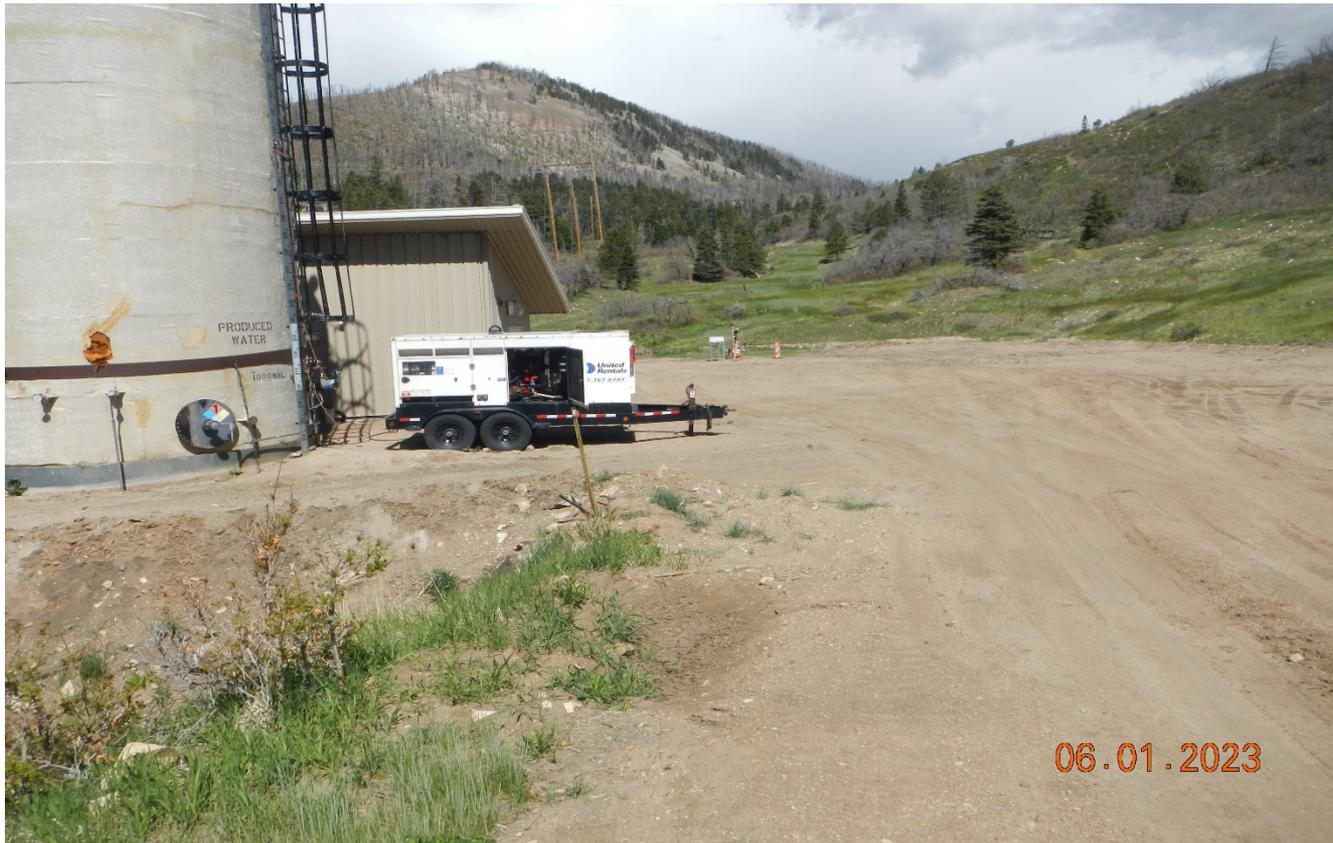
Photo 1. Facing northwest toward the location.

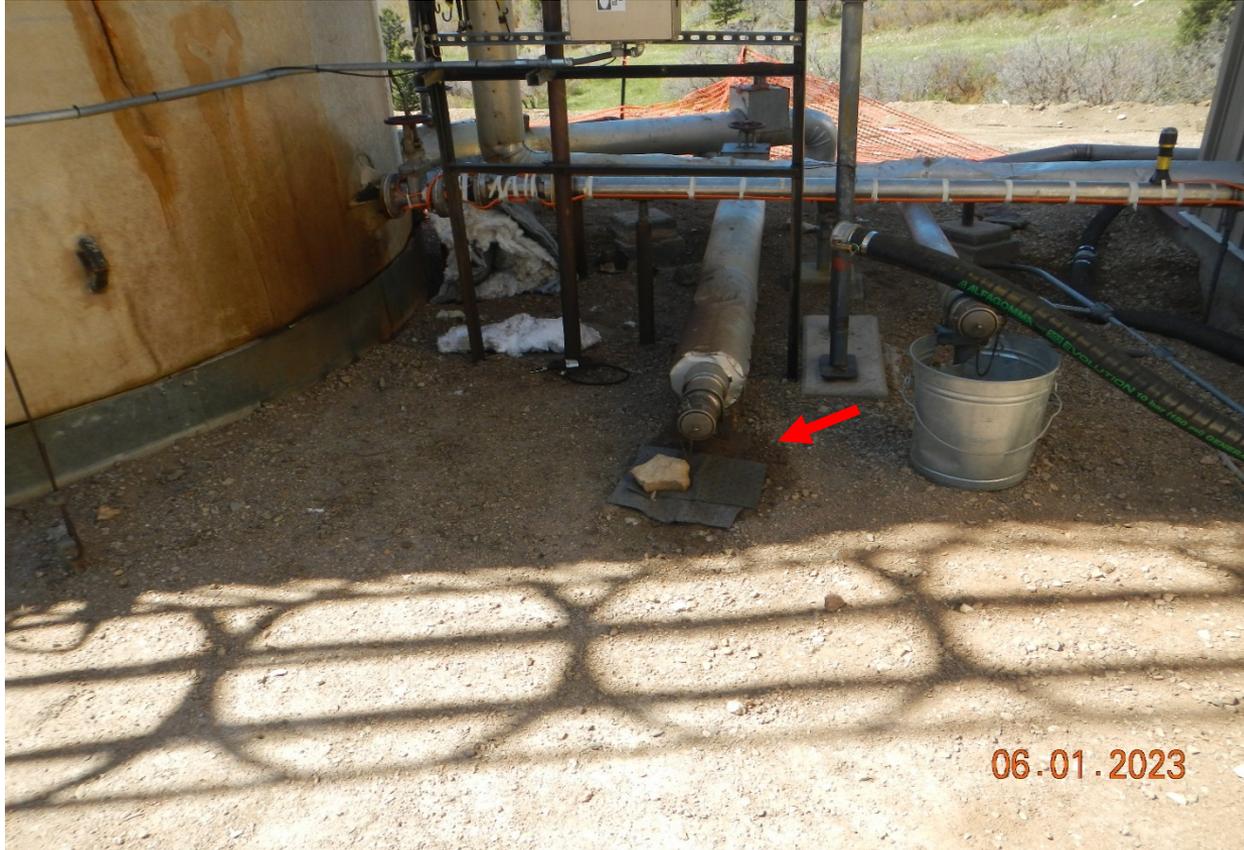
Photo 2. There is still stained soil at the pipe outlet. Previous corrective action was not completed. There is also insulation debris that needs to be removed.

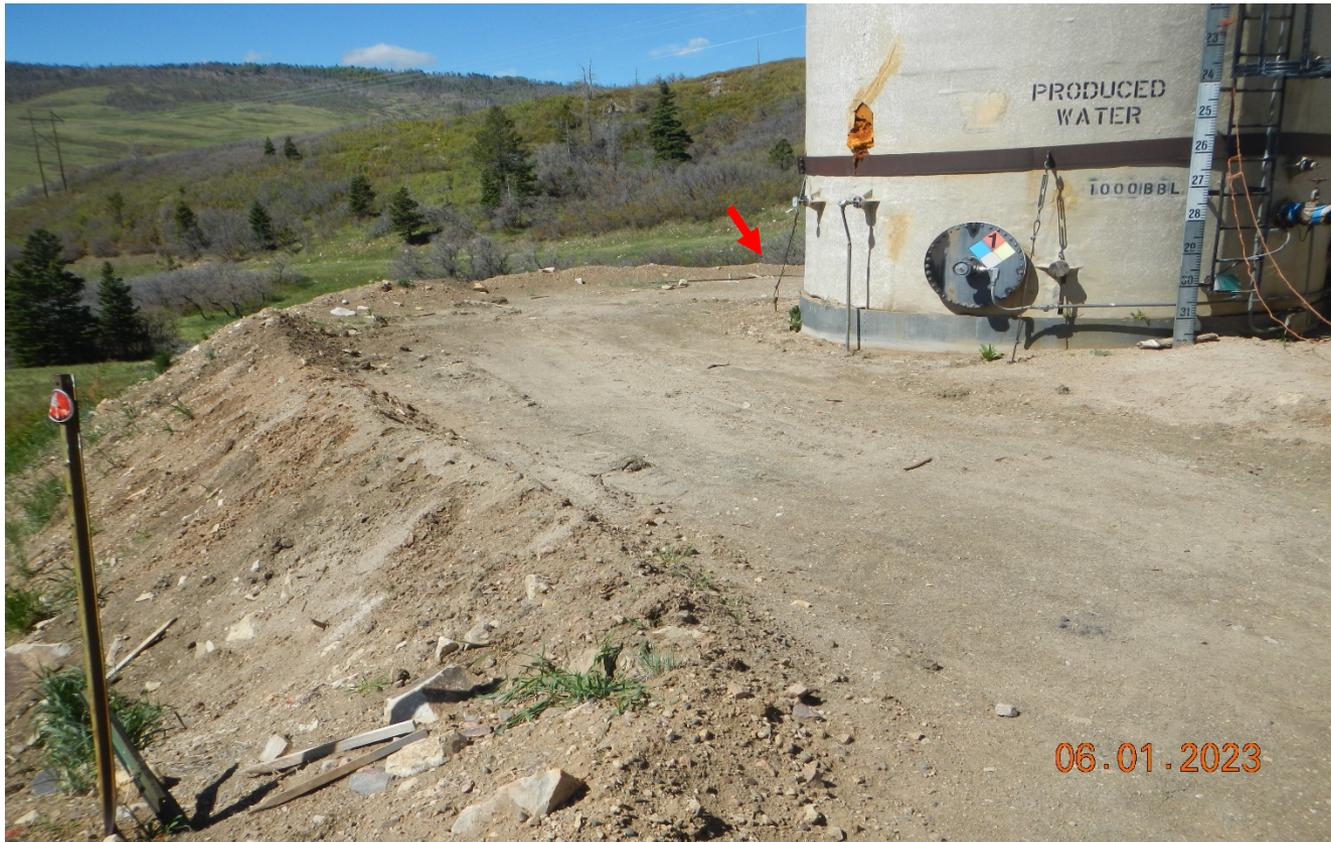
Photo 3. Facing toward the produced water tank. The secondary berm around the tank is insufficient to contain a spill. Red arrow points to small berm which could easily be overtopped by a leak. Previous corrective action was not completed.

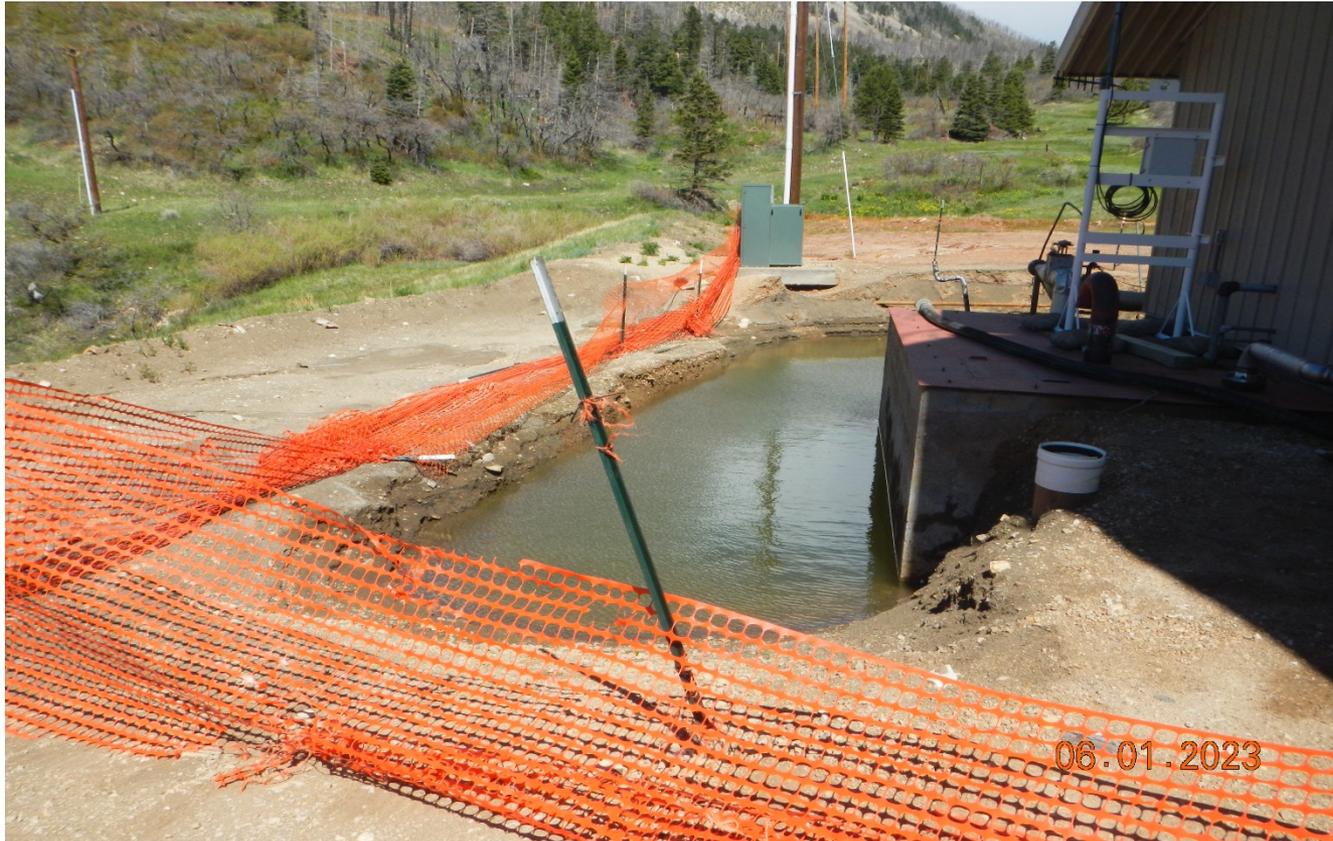
Photo 4. Facing northwest at the location. The remediation area where tank was located remains open and the safety fence is in disrepair. Previous corrective action was not completed.

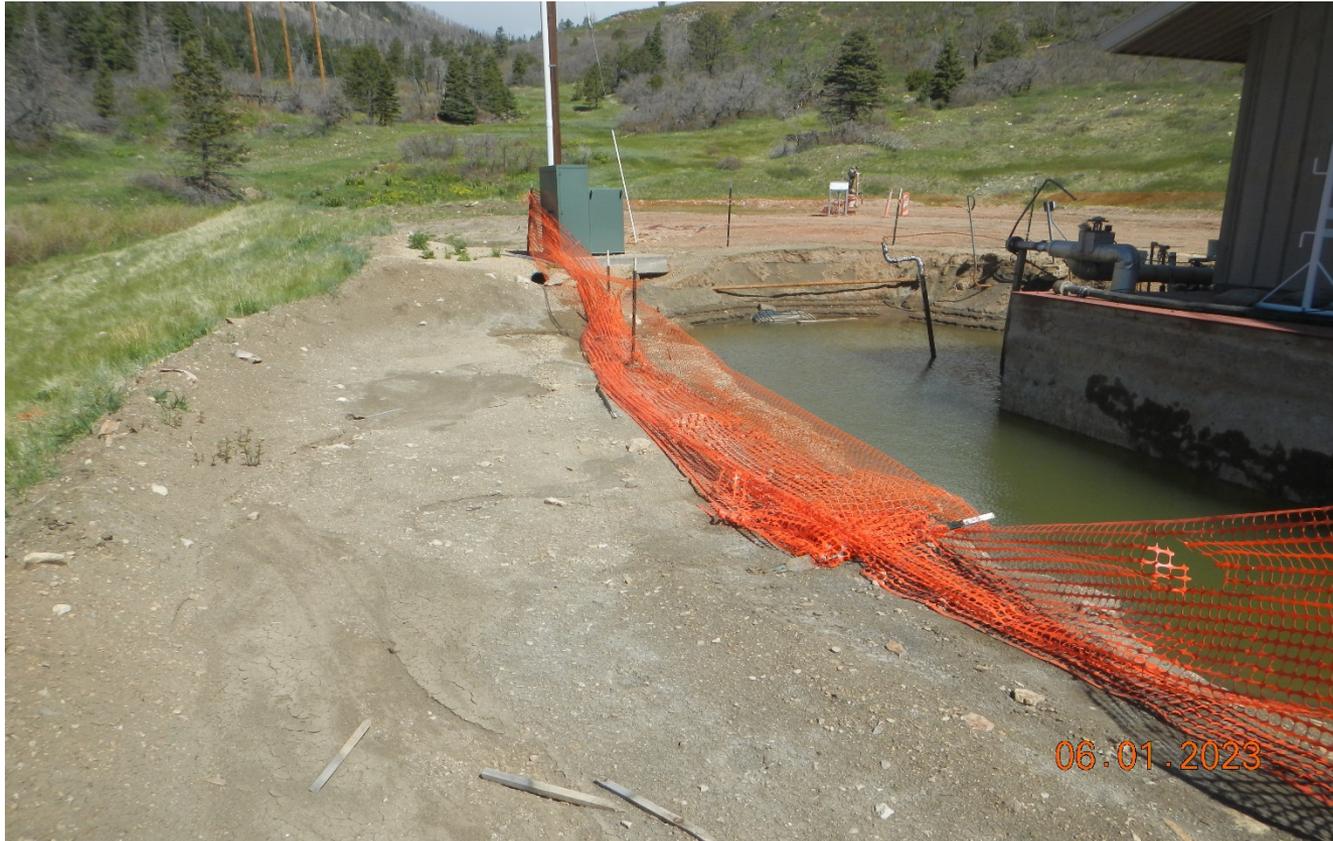
Photo 5. Facing where tank was located which remains an open excavation due to active remediation. Stormwater has filled in the open excavation. Safety fence is in disrepair. Previous corrective action was not completed.

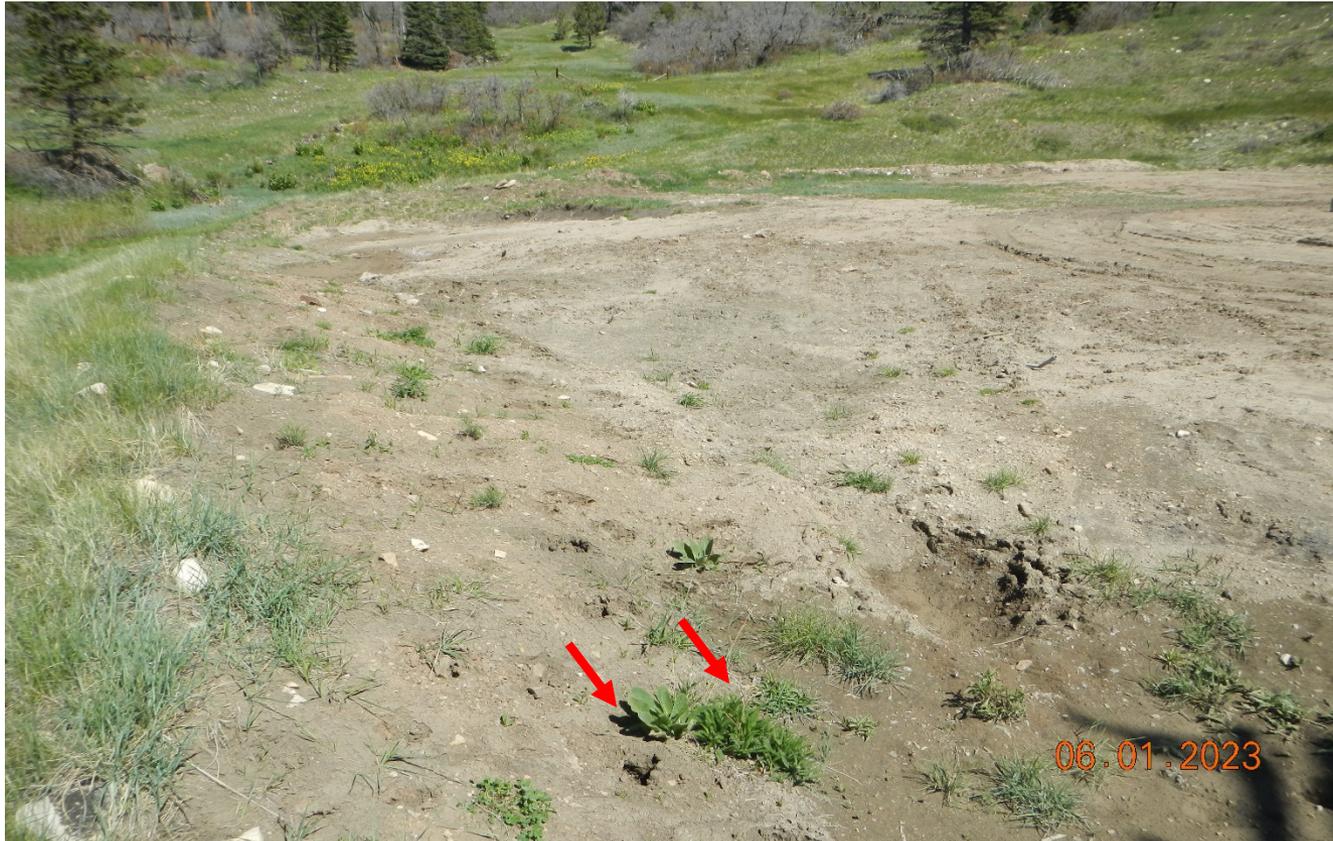
Photo 6. Facing northwest toward the excavated area which has been backfilled. There are noxious weeds shown at red arrow and the disturbed soils need to be recontoured and reclaimed.

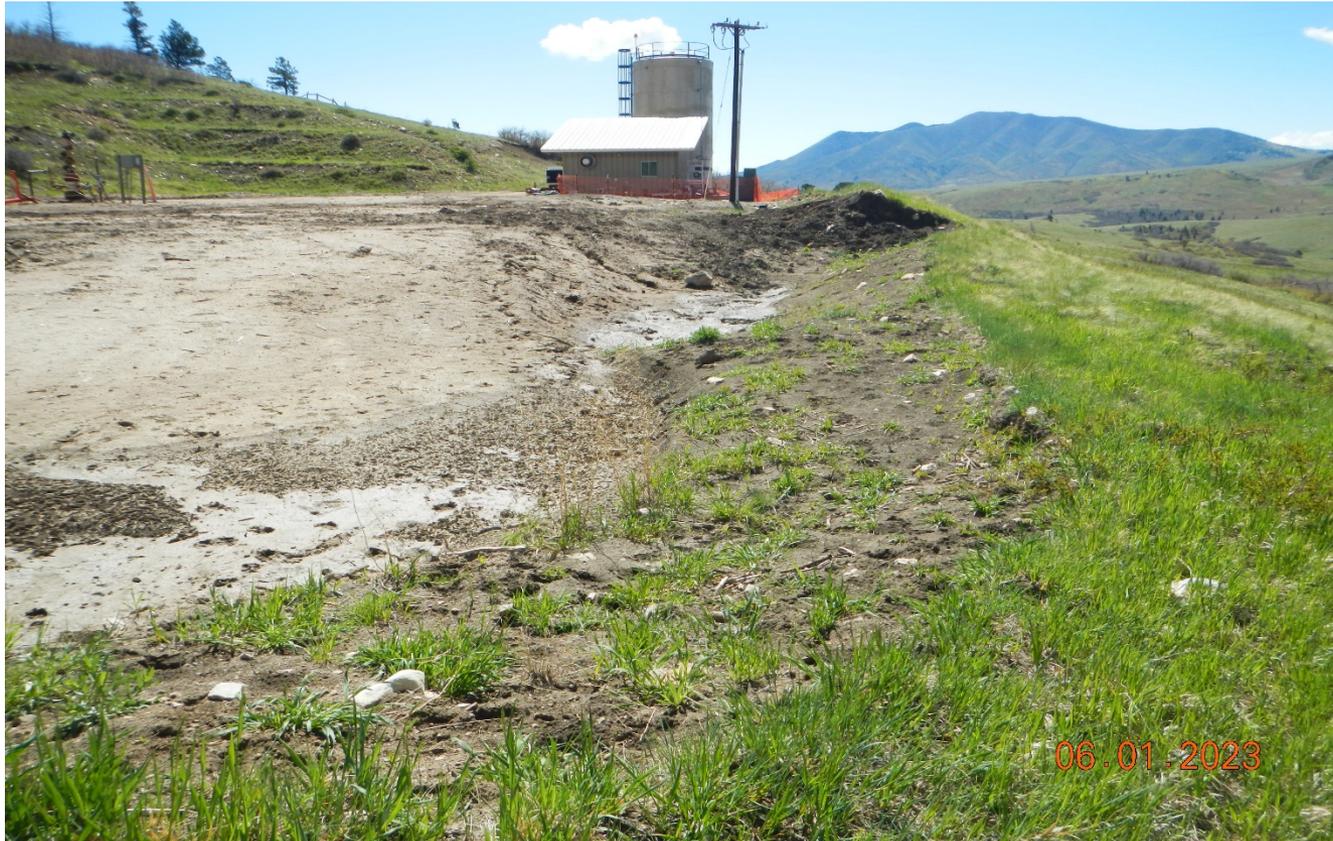
Photo 7. Facing southeast at the down gradient portion of the location. The degraded perimeter wattles were removed however, no new BMP's were installed and there is a creek approximately 10ft' from the edge of the location.

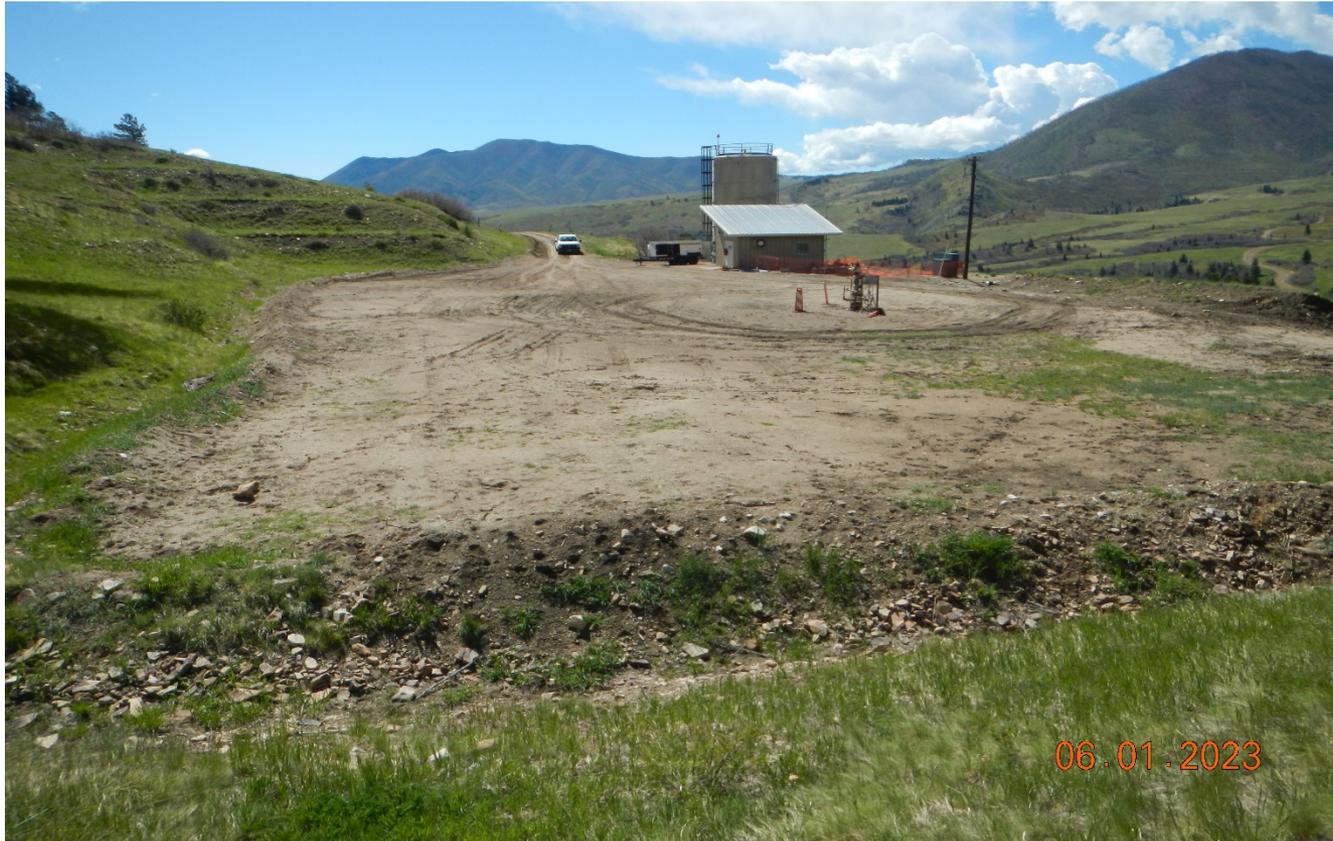
Photo 8. Facing southwest at the location. All disturbed unused areas of the location need to be reclaimed.

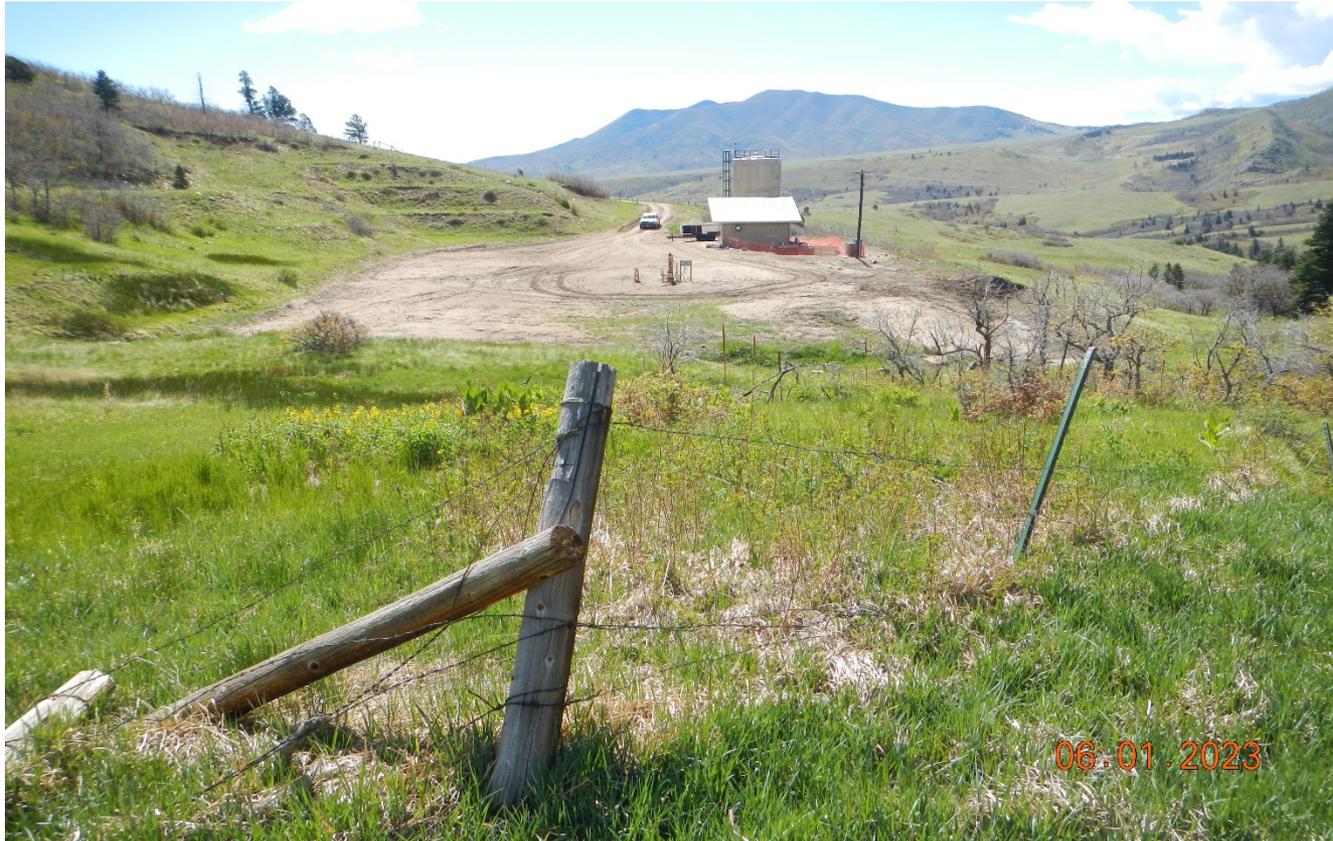
Photo 9. Facing southeast further away from the location. There is a degraded perimeter fence that needs to be maintained.

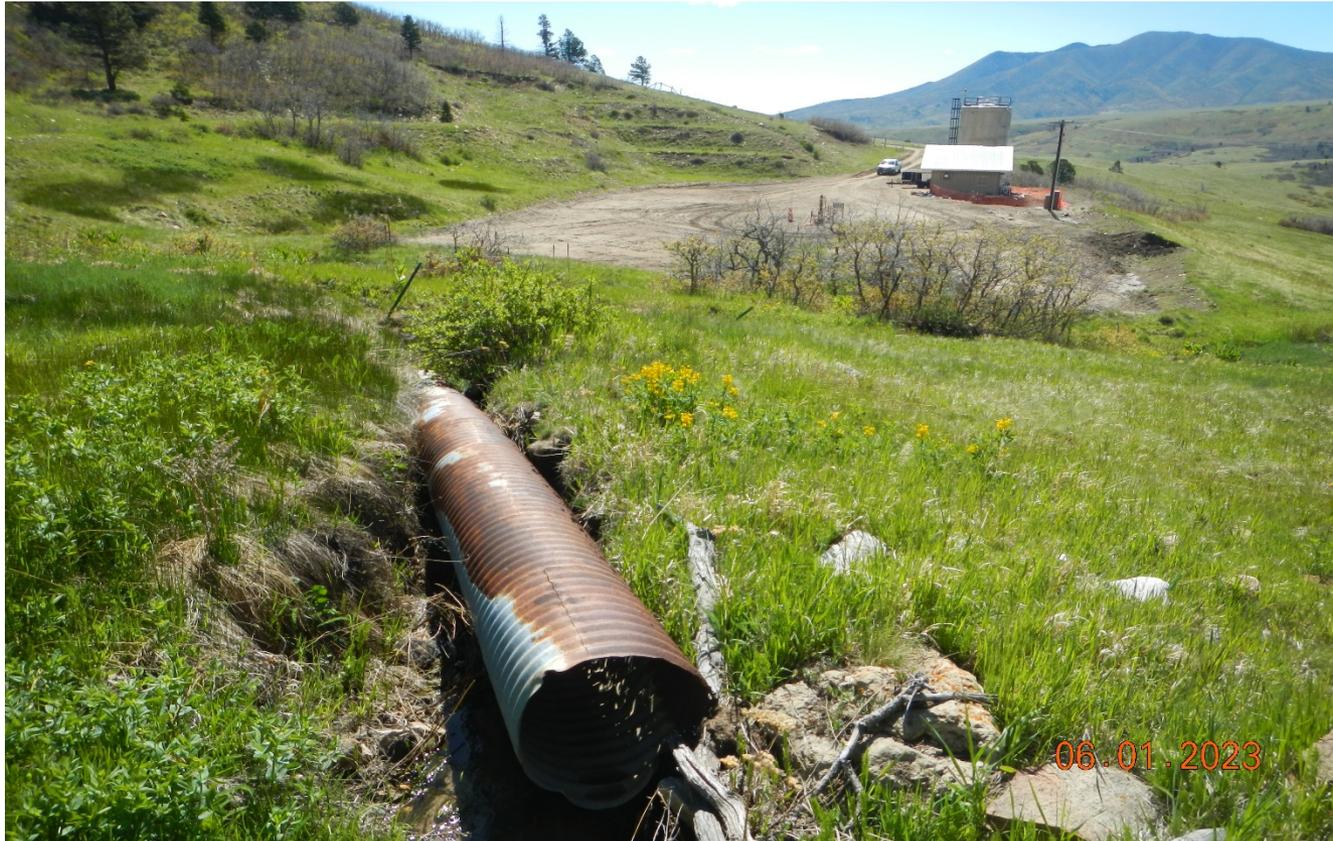
Photo 10. Standing approximately 125' northwest of the location along the flowline area is an eroded out culvert where the creek flows. The culvert needs repaired or removed.

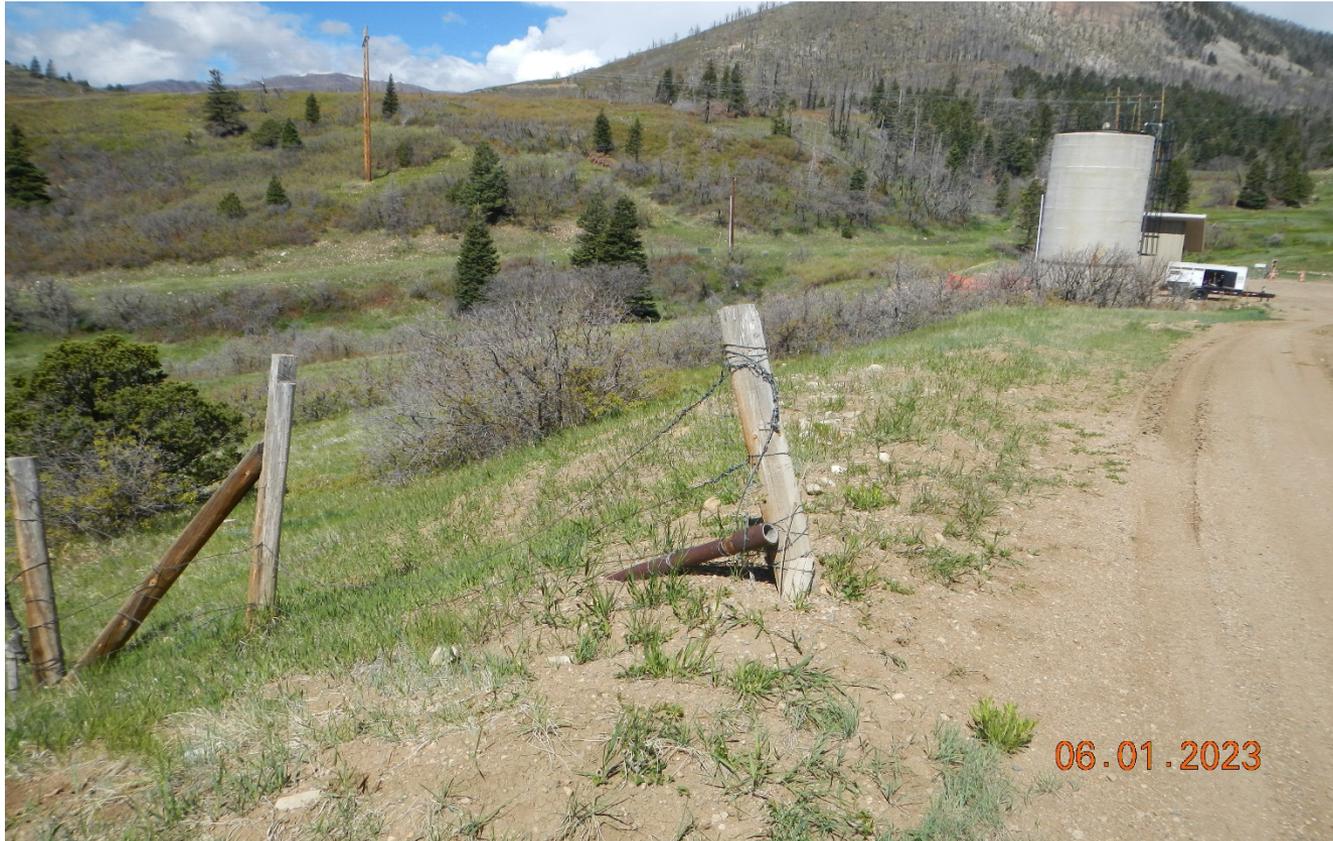
Photo 11. Standing at the east side of the location. The perimeter fence around the location is not maintained and would be beneficial to prevent livestock entry.

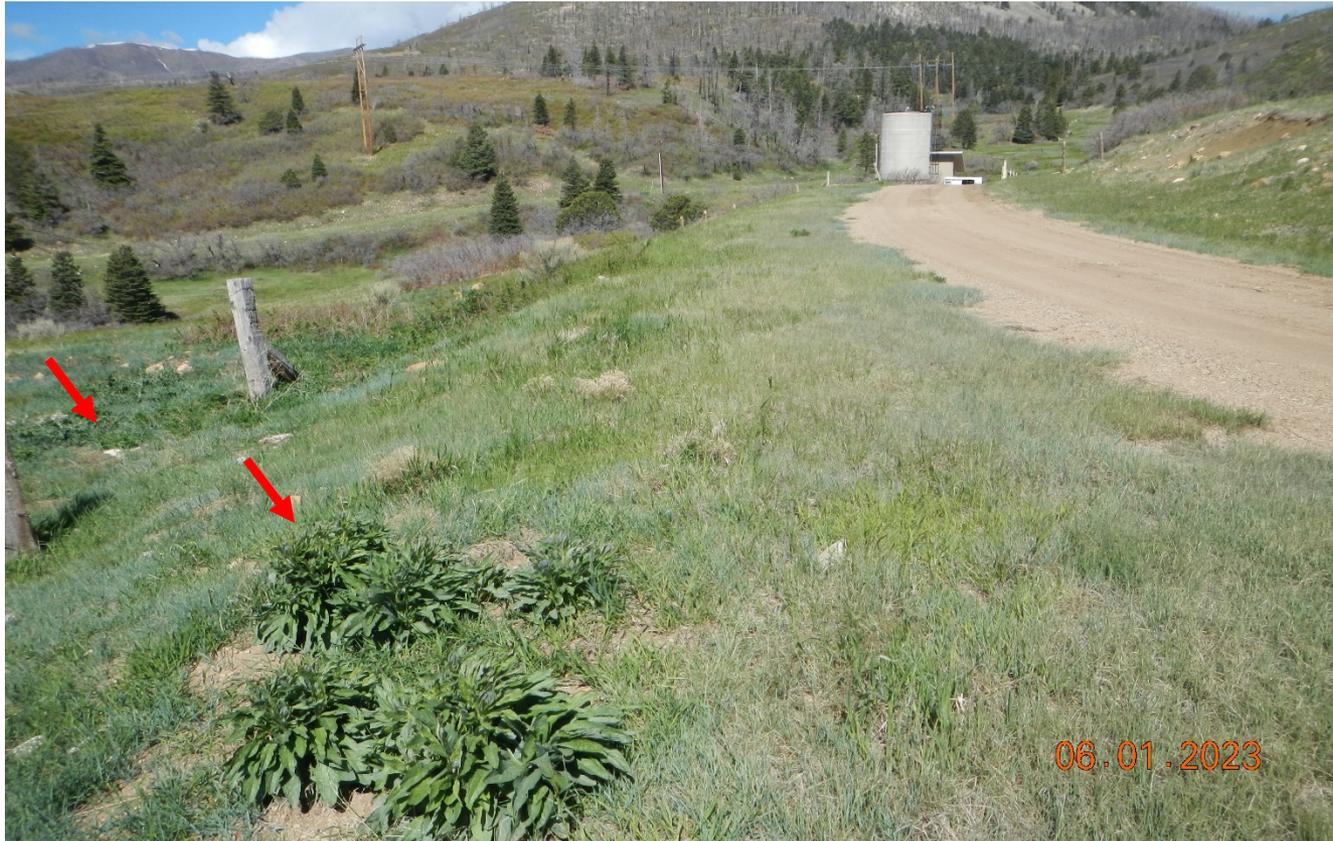
Photo 12. There are noxious weeds along the access road that will soon be seeding out and need to be controlled. Red arrows point to Houndstongue and Canada thistle.

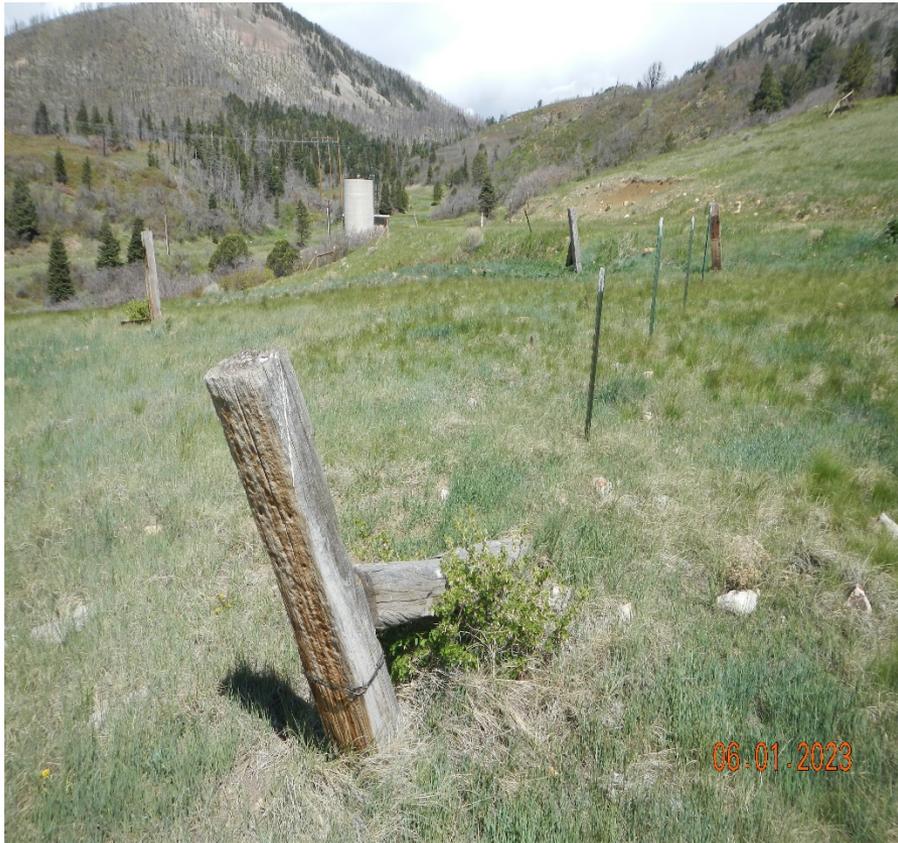
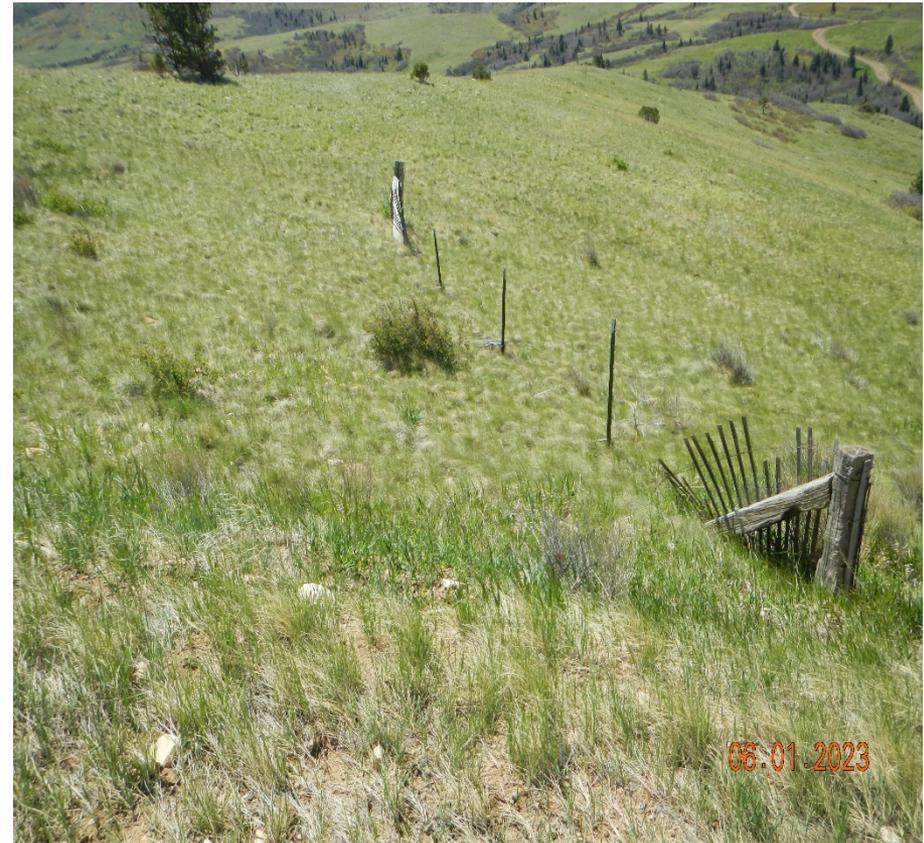
Photo 13. Observed along the access road were several dilapidated snow fences which need to be removed or repaired.
