Storm Water Management and Erosion control
Location Name: CAERUS PICEANCE LLC D8E Pad
Location ID: 334839

**Location Overview: Location is approximately 529 yards from
West Mamm Creek
Section/Township/Range: 8 7S92W**

COLORADO
Oil & Gas Conservation
Commission
Department of Natural Resources

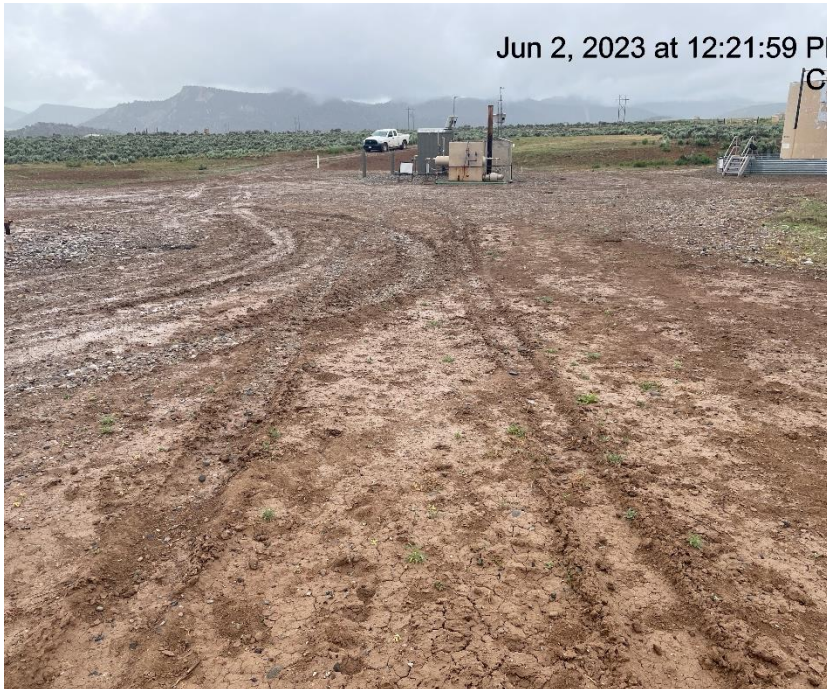
**Photo # 9271 Lack of stabilization/compaction
/insufficient BMP's on location**

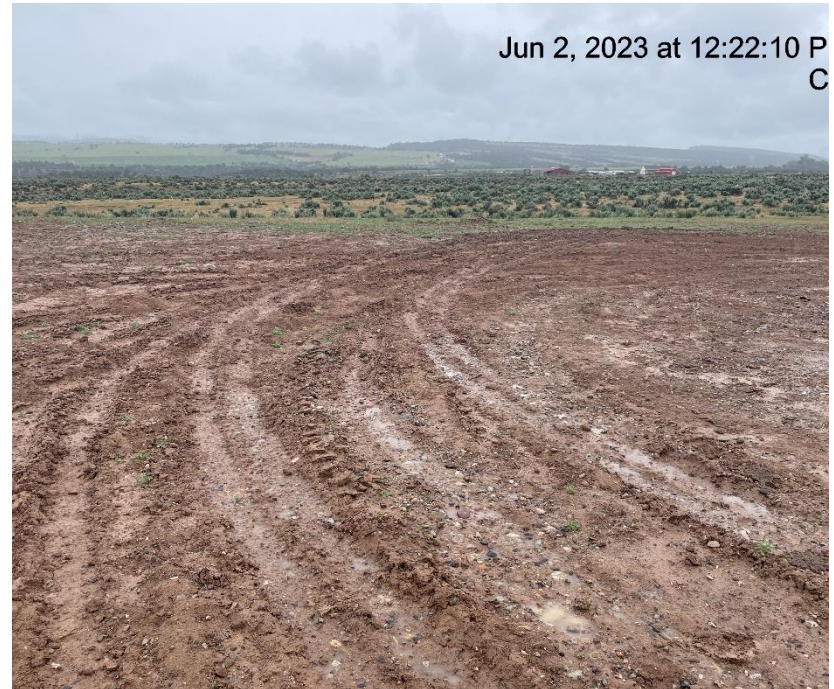
**Photo # 9272 Lack of stabilization/compaction
/insufficient BMP's on location**

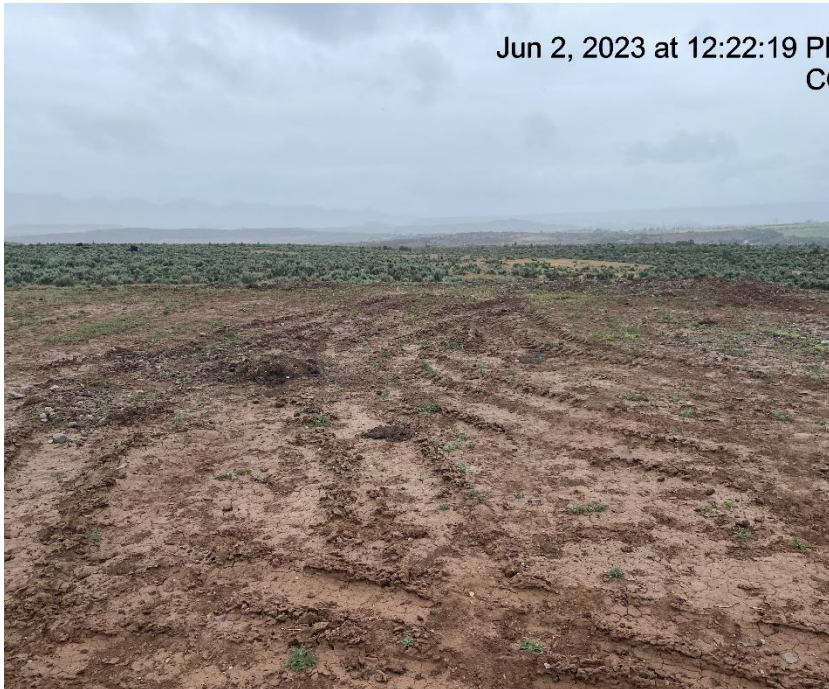
**Photo # 9273 Lack of stabilization/compaction
/insufficient BMP's on location**

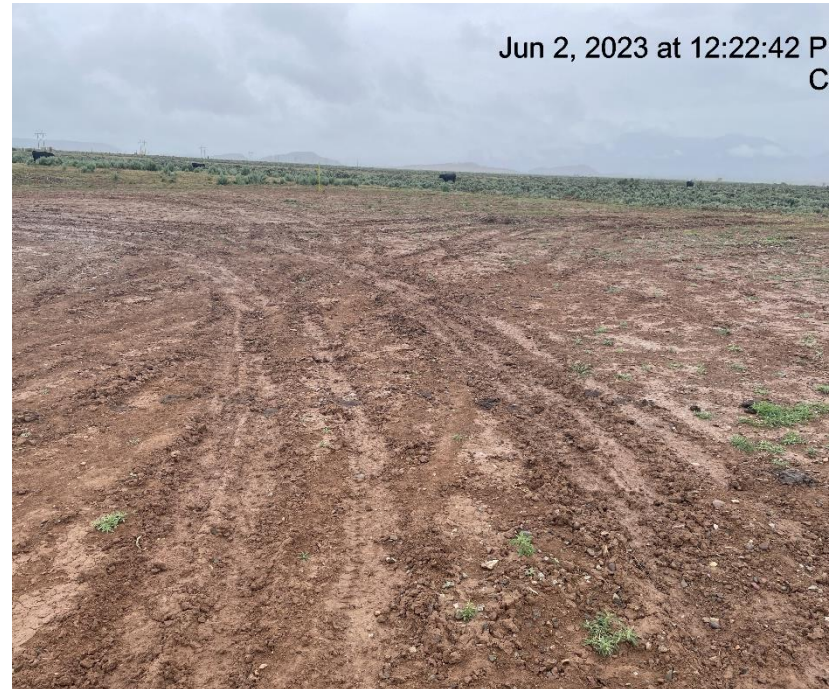
**Photo # 9274 Lack of stabilization/compaction
/insufficient BMP's on location**

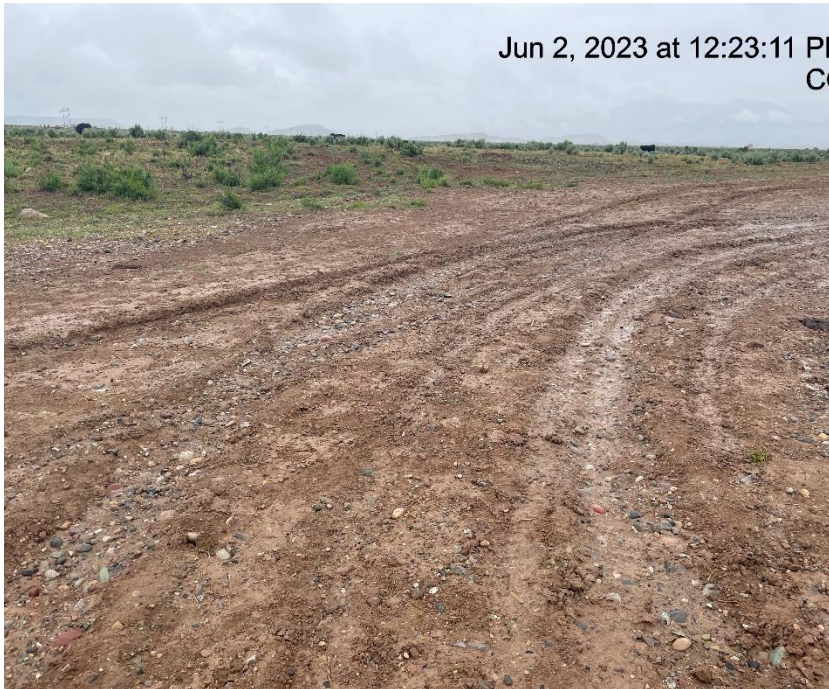
**Photo # 9275 Lack of stabilization/compaction
/insufficient BMP's on location**

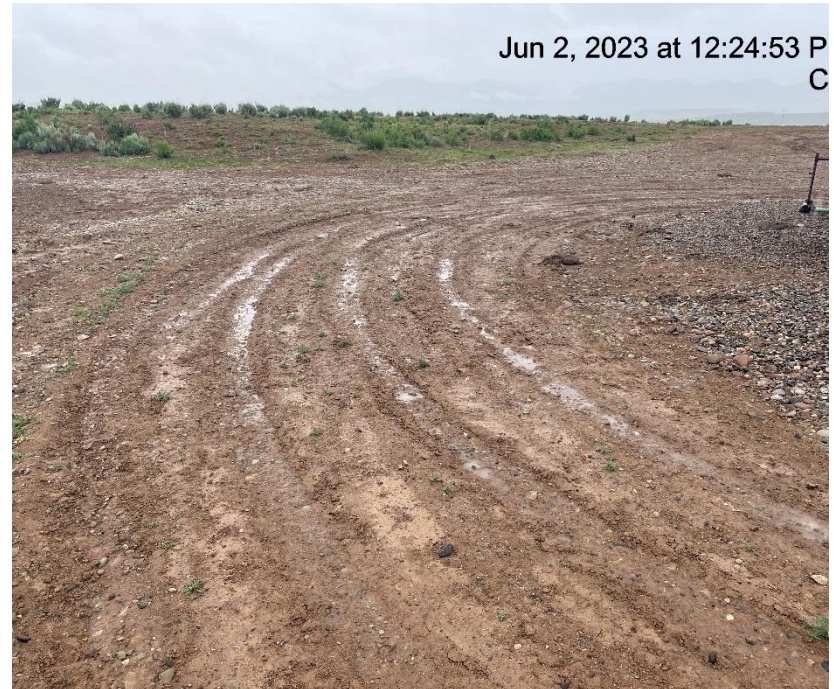
**Photo # 9277 Lack of stabilization/compaction
/insufficient BMP's on location**

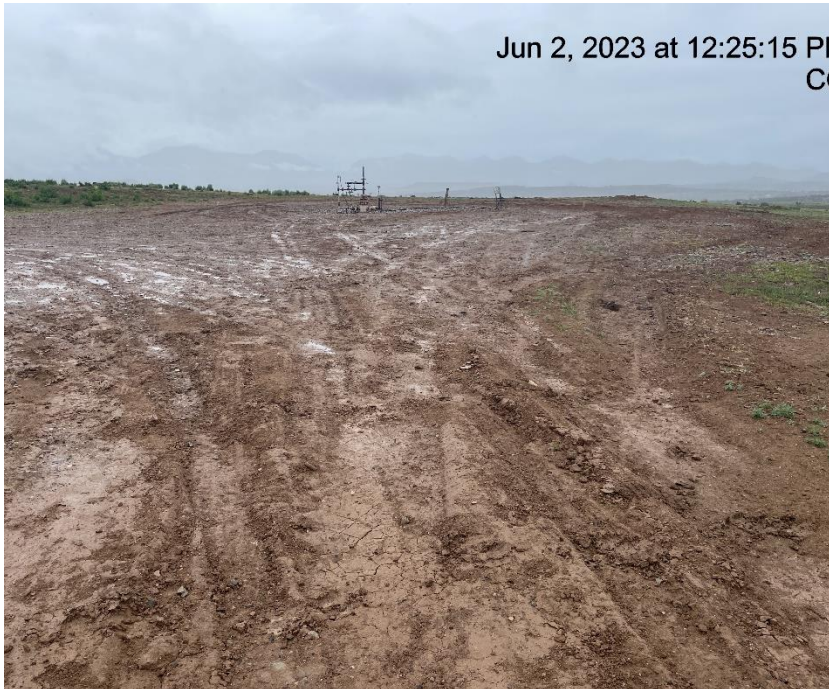
**Photo # 9278 Lack of stabilization/compaction
/insufficient BMP's on location**

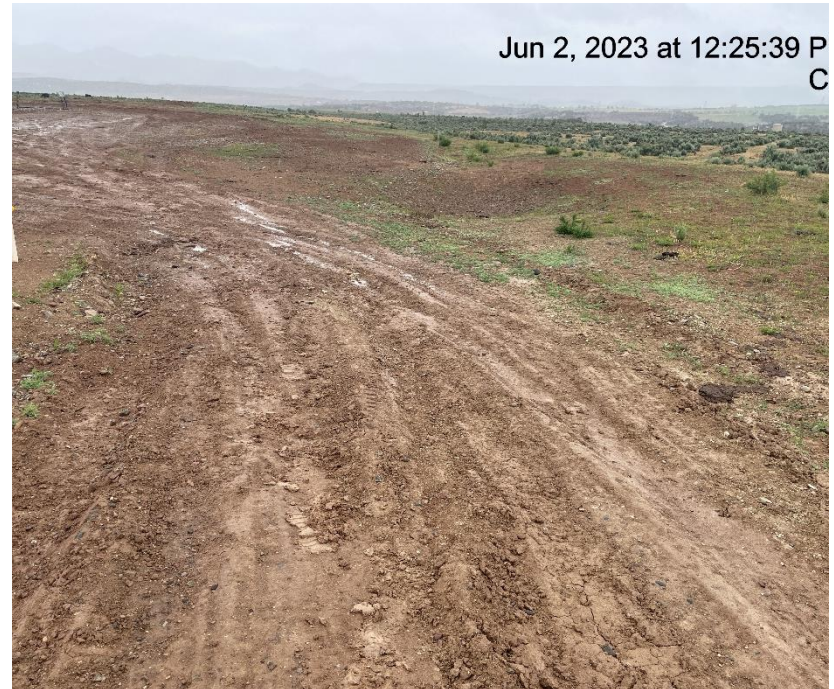
**Photo # 9279 Lack of stabilization/compaction
/insufficient BMP's on location & lease road**

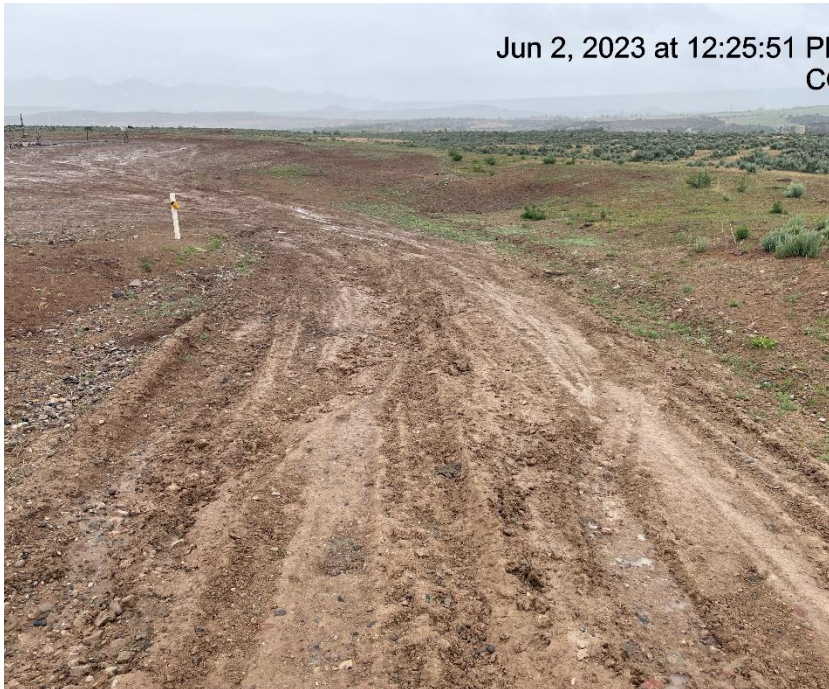
**Photo # 9280 Lack of stabilization/compaction
/insufficient BMP's on lease road**

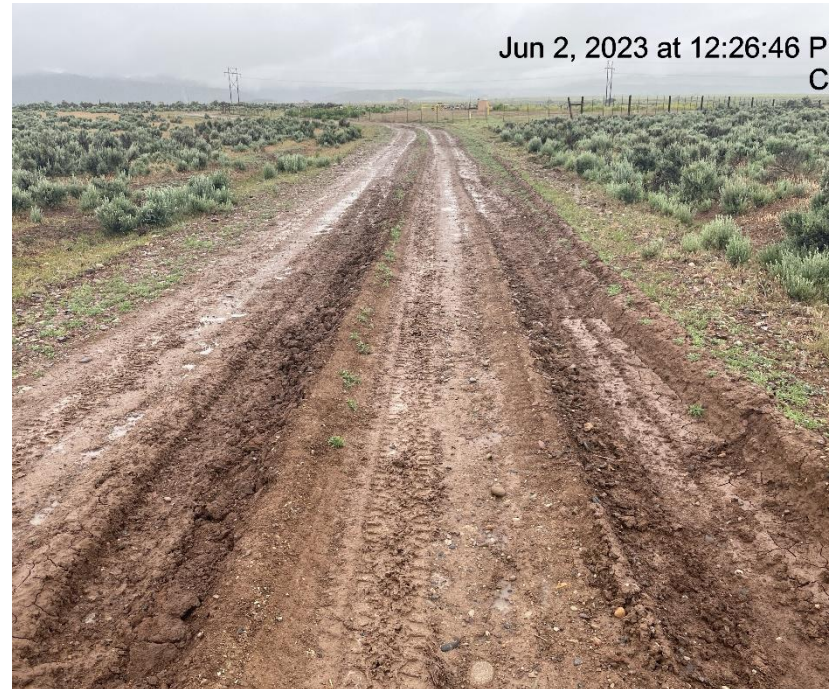
**Photo # 9281 Lack of stabilization/compaction
/insufficient BMP's on lease road**

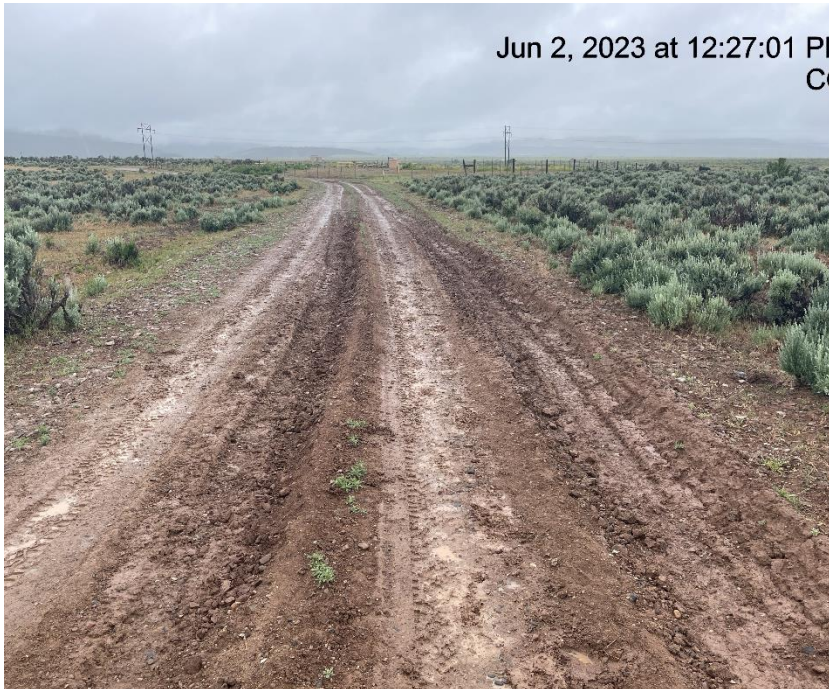
**Photo # 9282 Lack of stabilization/compaction
/insufficient BMP's on lease road**

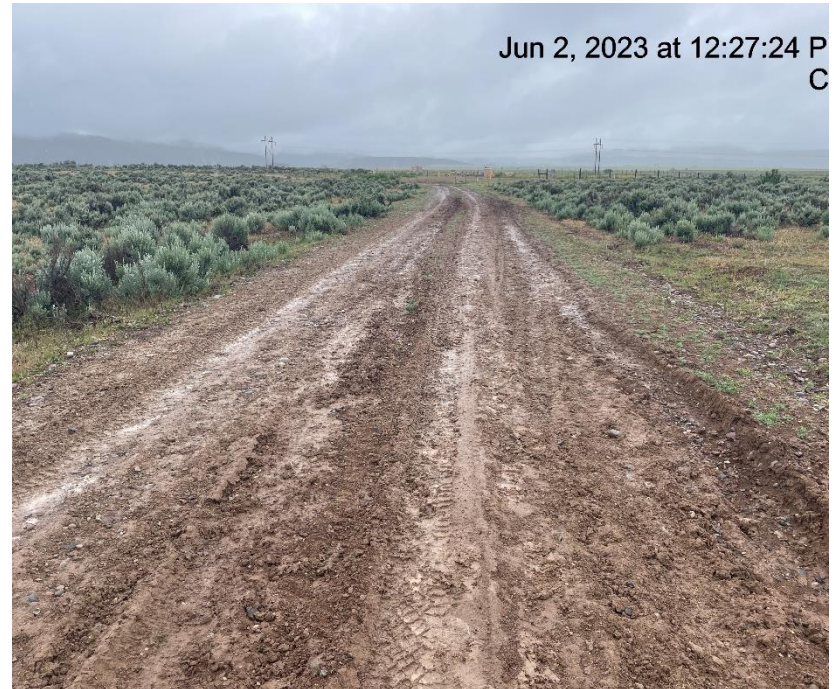
**Photo # 9283 Lack of stabilization/compaction
/insufficient BMP's on lease road**

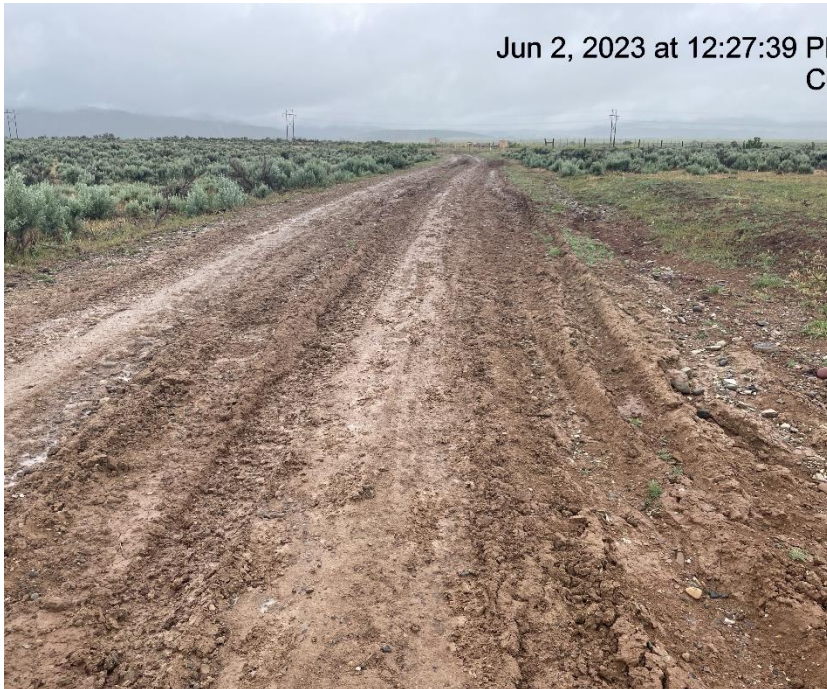
**Photo # 9284 Lack of stabilization/compaction
/insufficient BMP's on lease road**

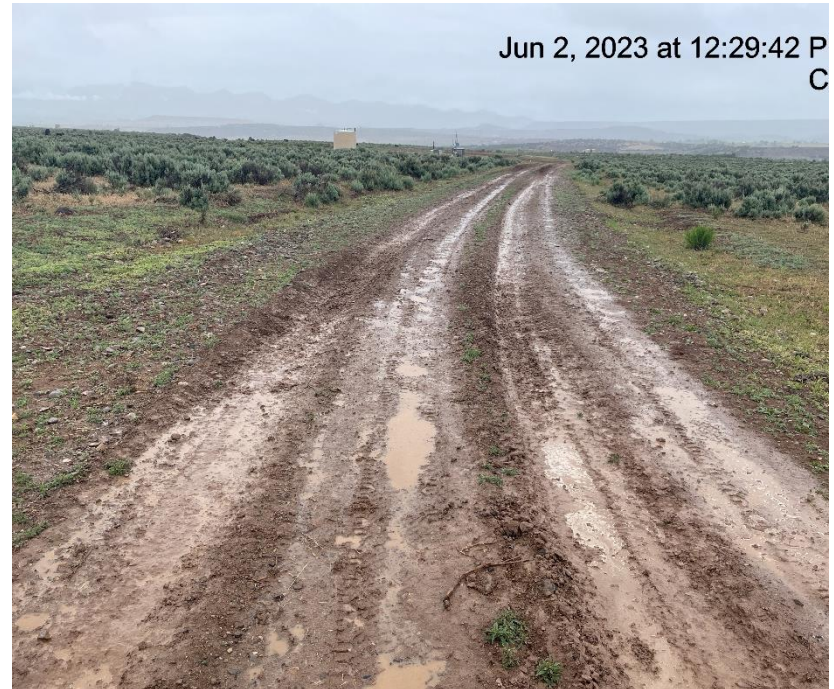
**Photo # 9286 Lack of stabilization/compaction
/insufficient BMP's on lease road**

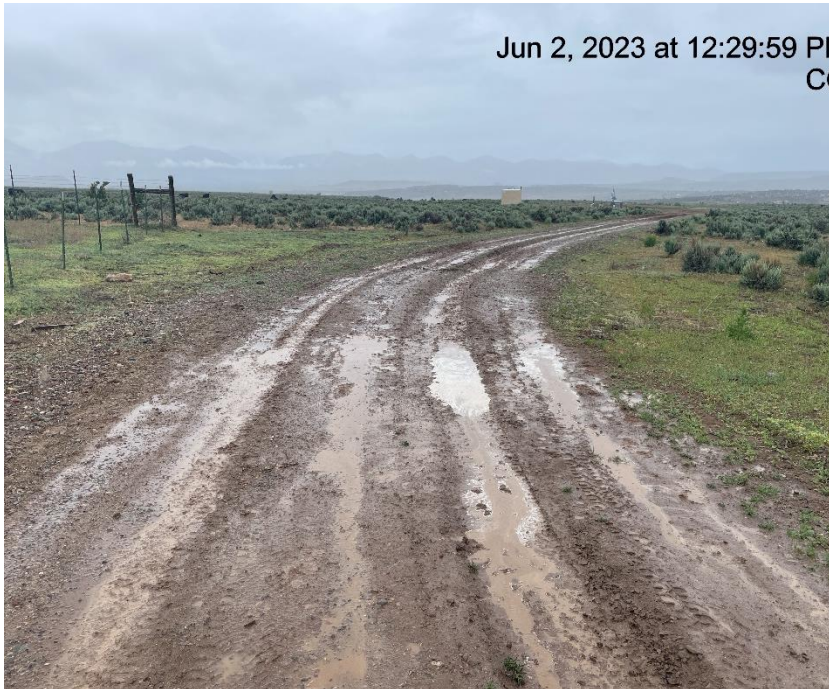
**Photo # 9287 Lack of stabilization/compaction
/insufficient BMP's on lease road**
