Inspection Photos

API: 055-06105

Operator: OXY USA INC

Inspection Date: 6/1/2023

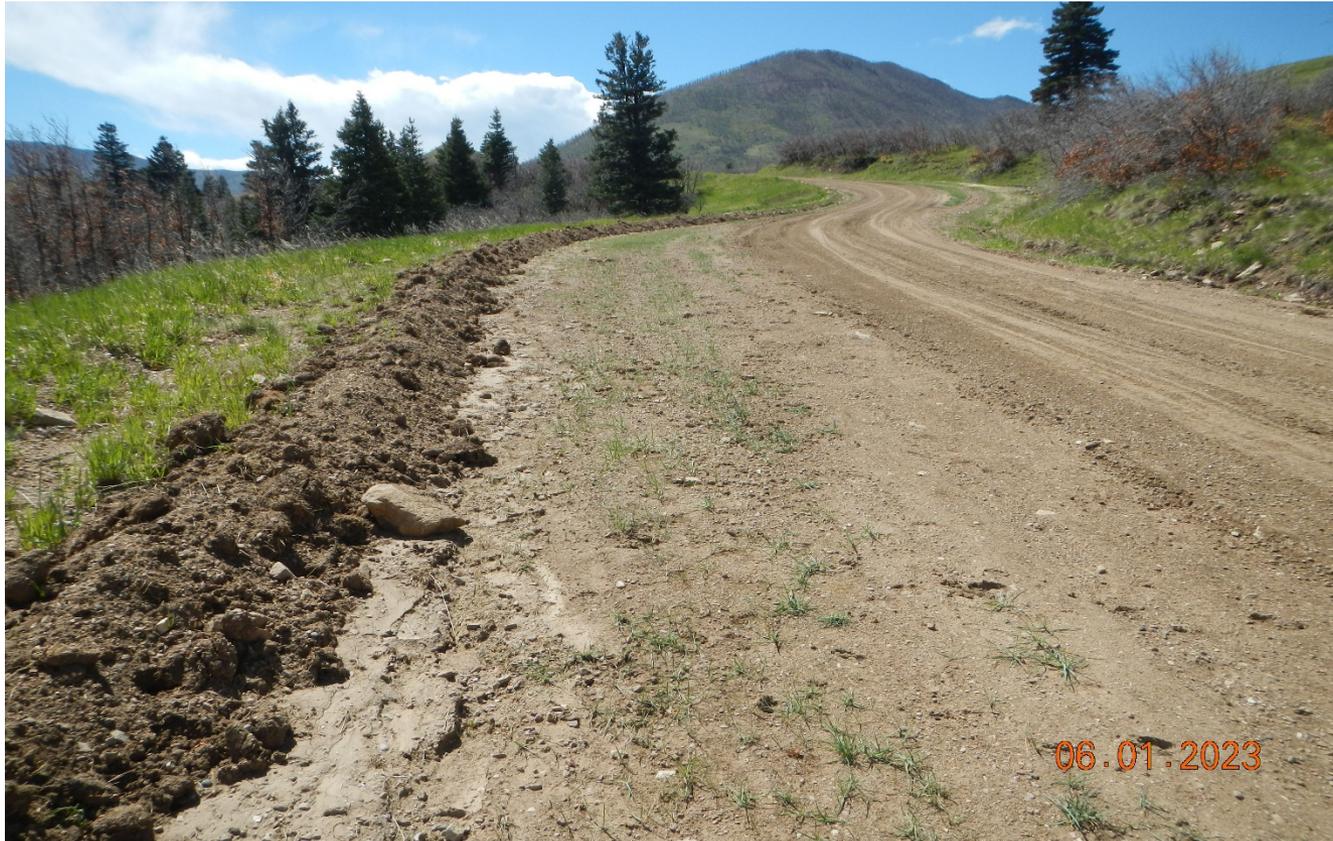
Photo 1. Facing southeast ascending the hill toward the location. Grading has pushed out material into a berm which is creating more of a disturbance and not allowing stormwater to be diverted off the road. There is a long stretch of the road where stormwater will be directed down the road which will cause erosion.

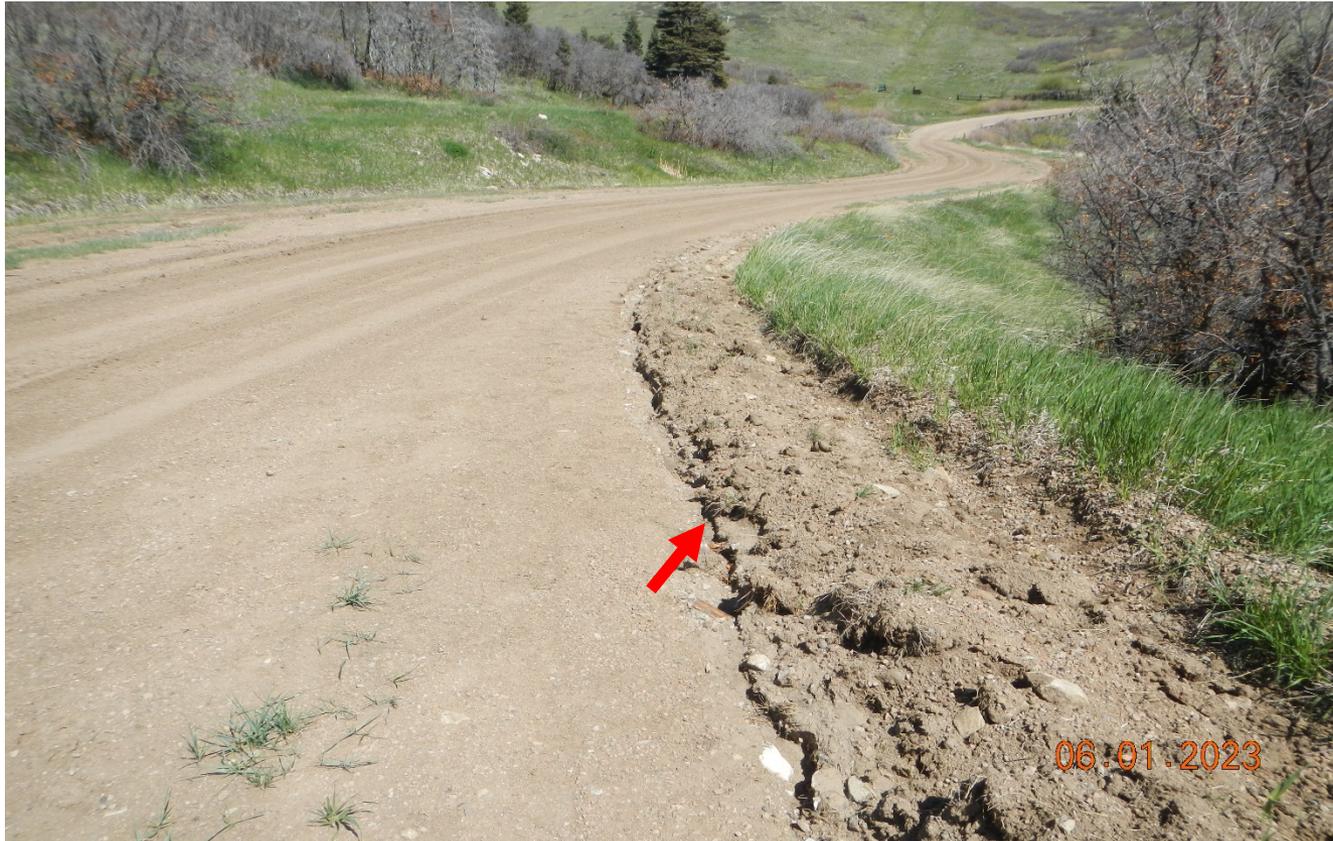
Photo 2. Facing southeast ascending the hill toward the location. Stormwater is not diverted off the road and the an erosion channel is beginning to develop.

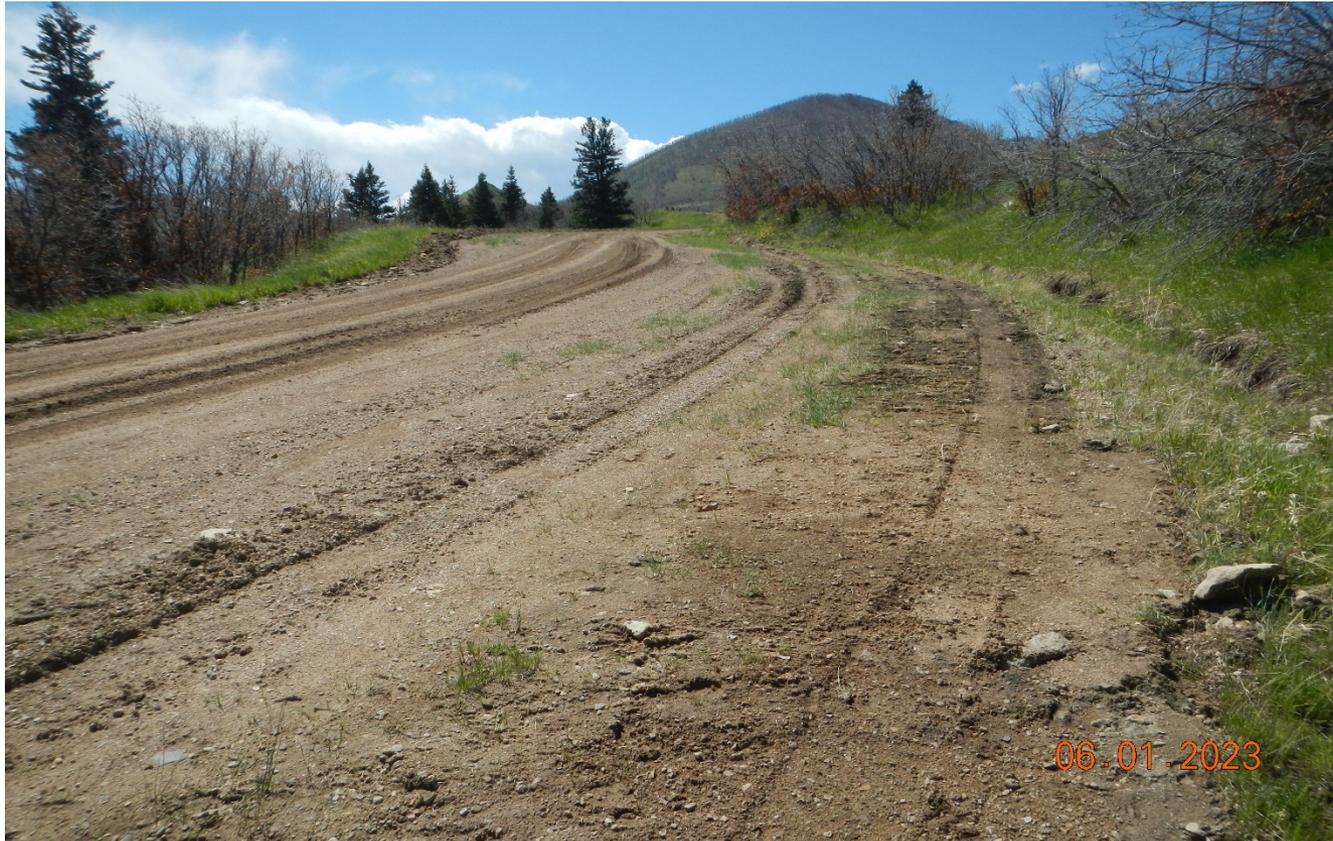
Photo 3. Facing southeast ascending the hill toward the location. The road has been widened along this area which will create more stormwater impact. Disturbance area of the road needs to be minimized.

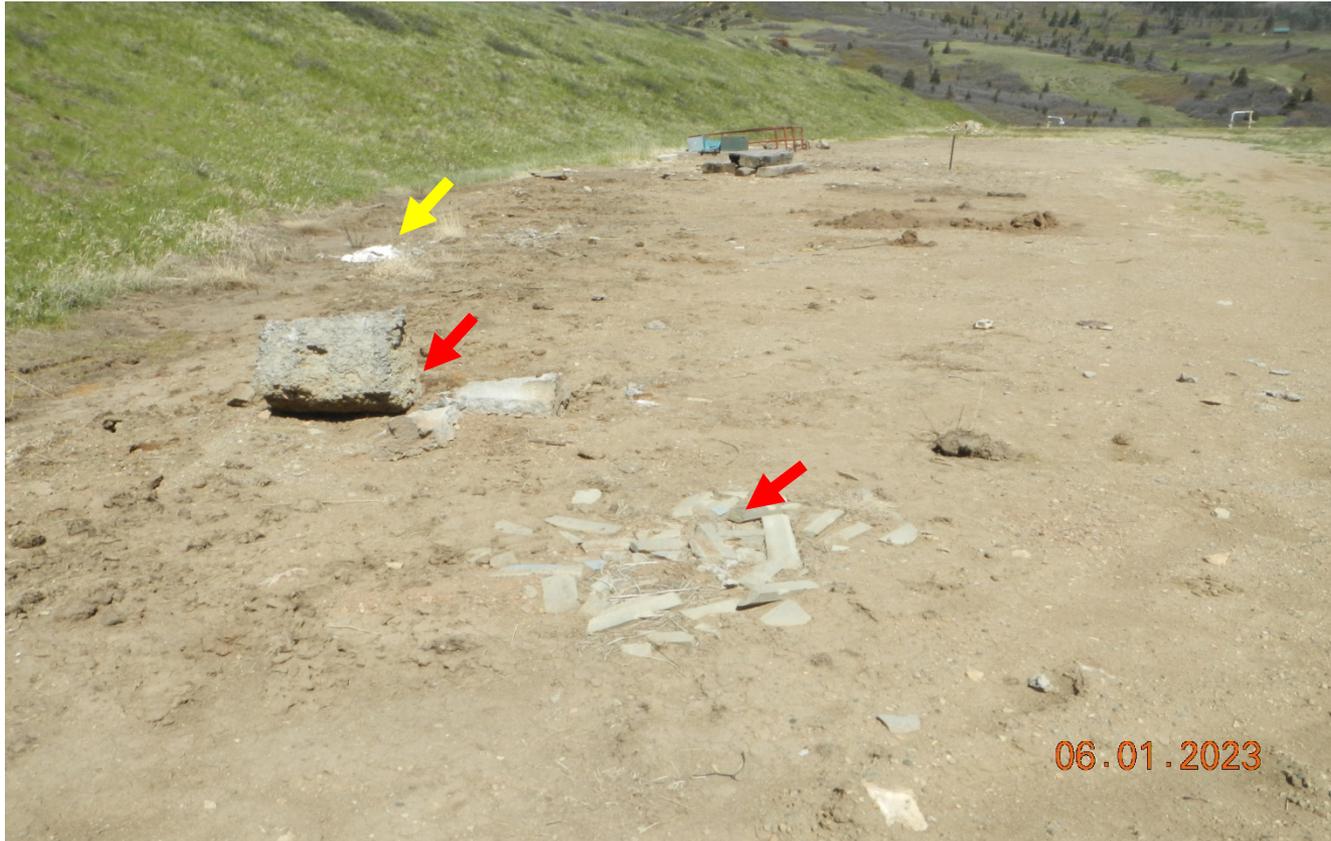
Photo 4. Facing northwest at the location. Most of the unused equipment and debris were removed however there is still cement debris and other unused equipment that remains. Previous corrective action is not complete.

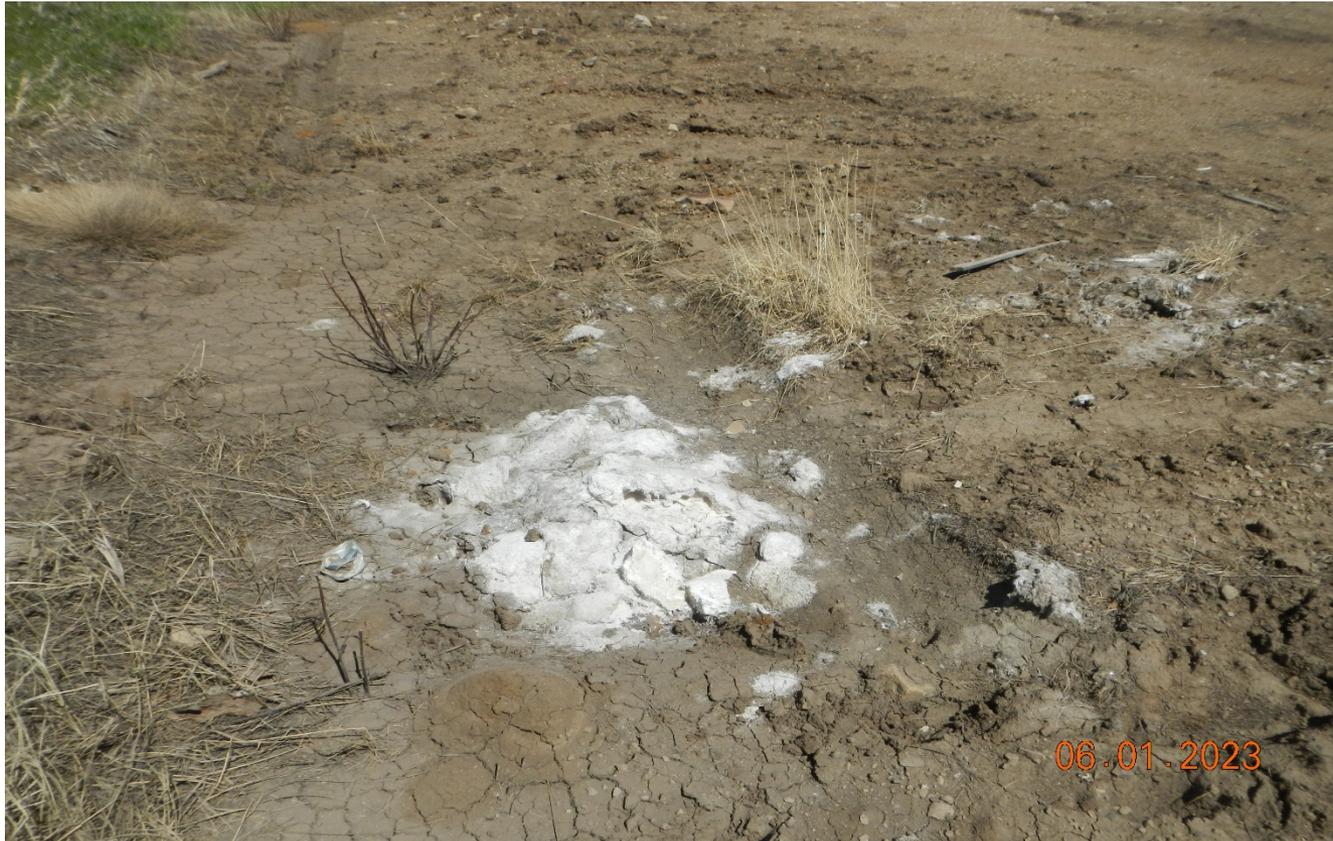
Photo 5. There is a white powder substance spill on the ground that needs to be cleaned up. Yellow arrow in previous photo shows the location.

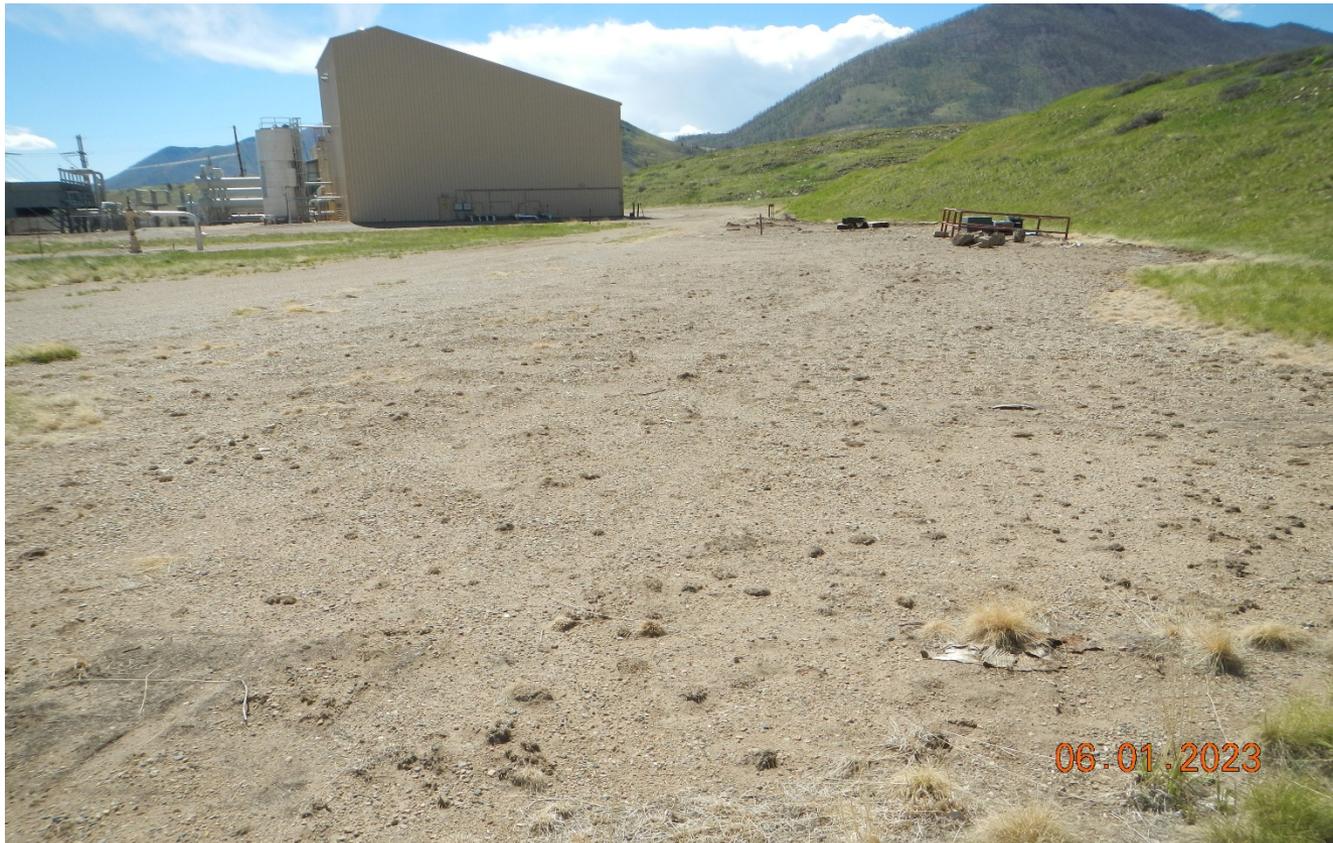
Photo 6. Facing back southeast at the location. The bare soil will need to be reseeded and reclaimed.

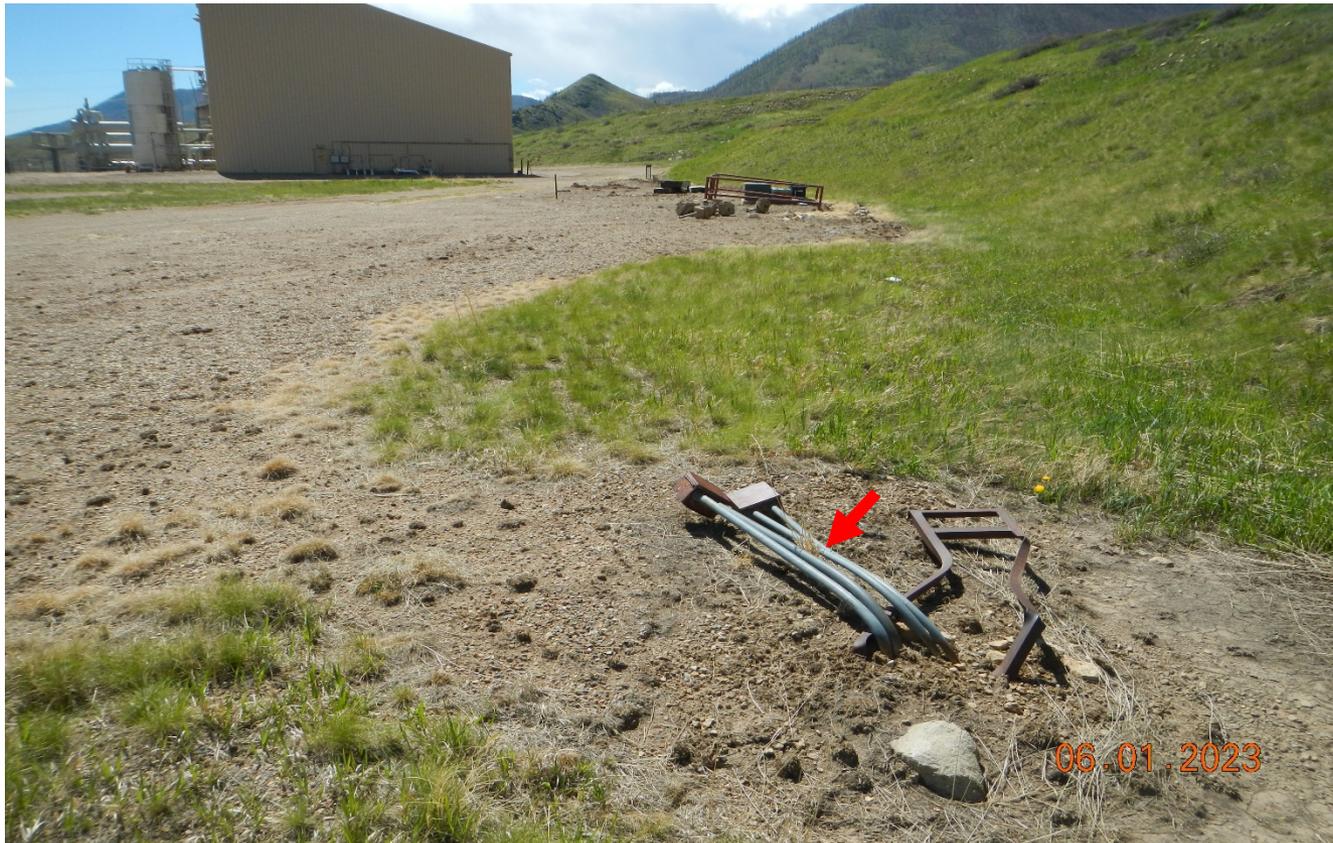
Photo 7. Facing back southeast at the location. There is a bent electric utility at this site that needs to be removed.
