Inspection Photos

API: 055-06067

Operator: OXY USA INC

Inspection Date: 6/1/2023

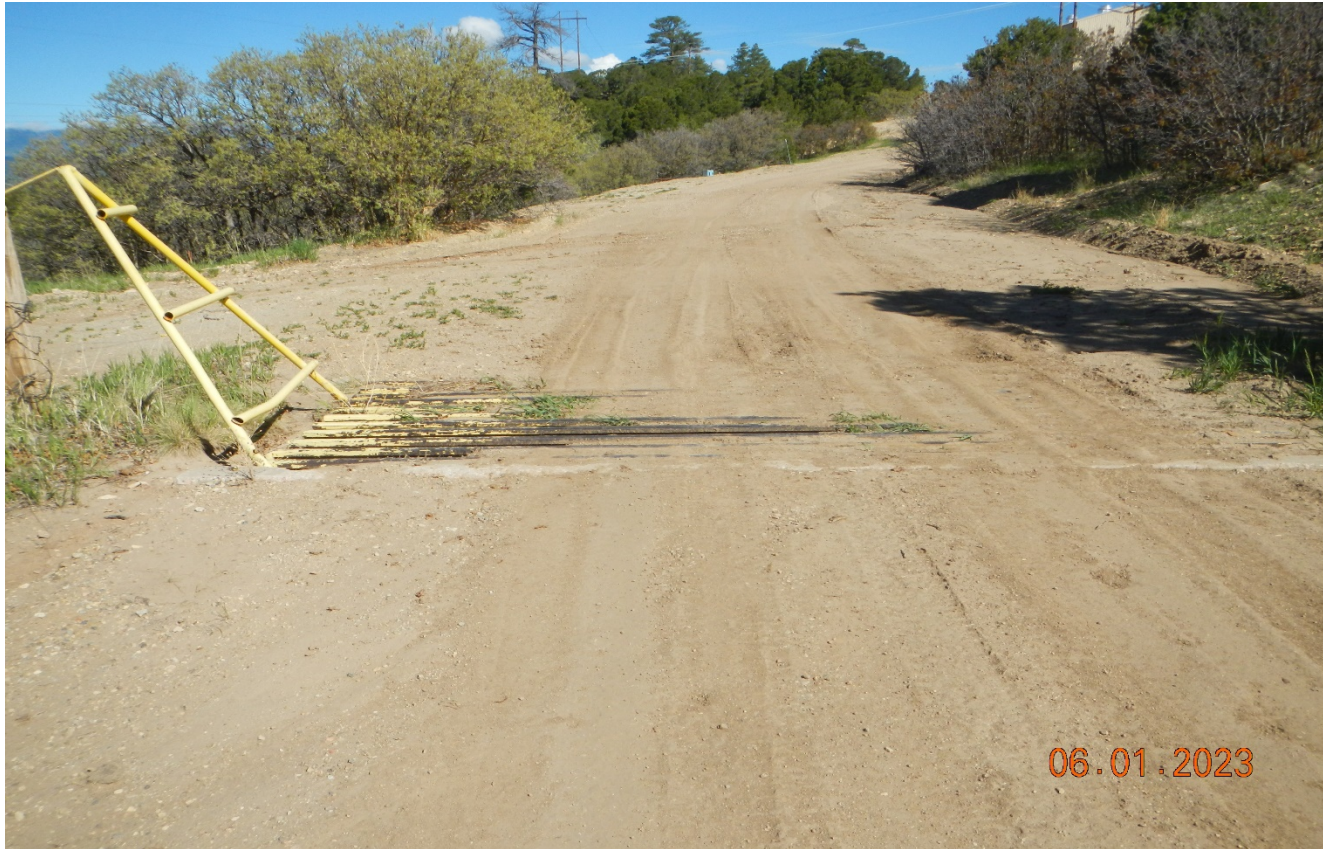
Photo 1. Facing northwest along the access road. This cattle guard has filled in with sediment and is obstructing stormwater flow along the right side of the road.

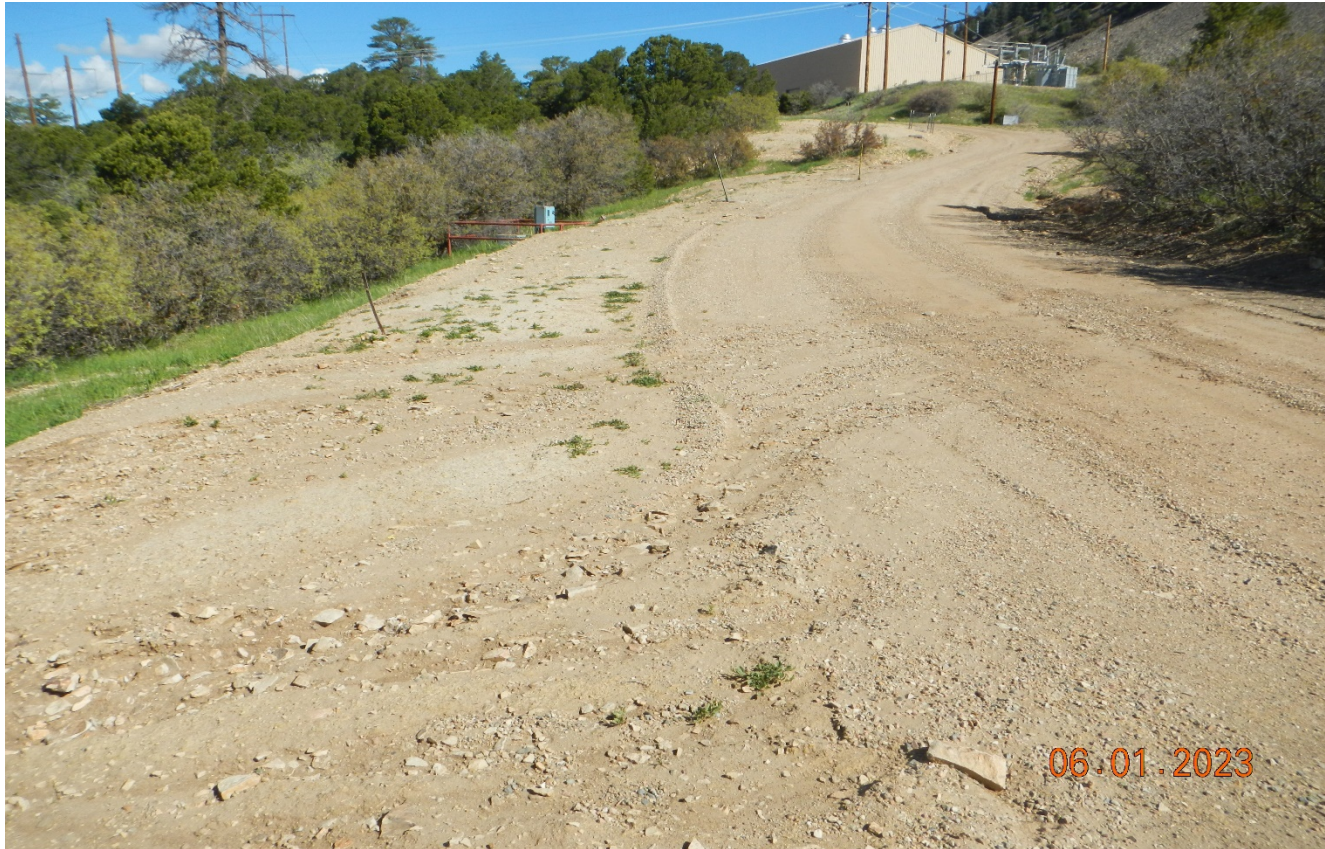
Photo 2. Stormwater is not being properly diverted and is causing erosion across the road transporting sediment offsite shown in the next photo.

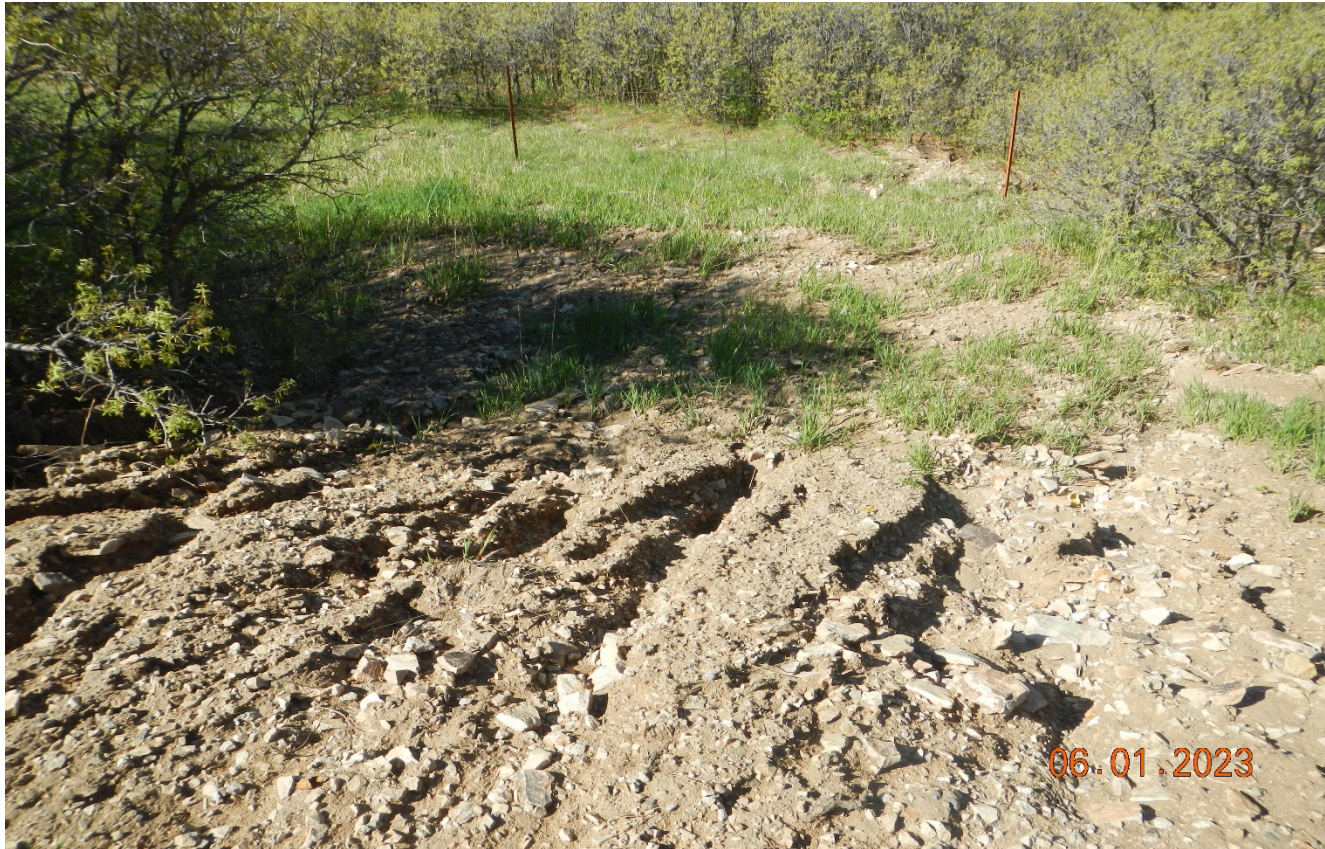
Photo 3. There is erosion of the road side occurring in this same area of previous photo.

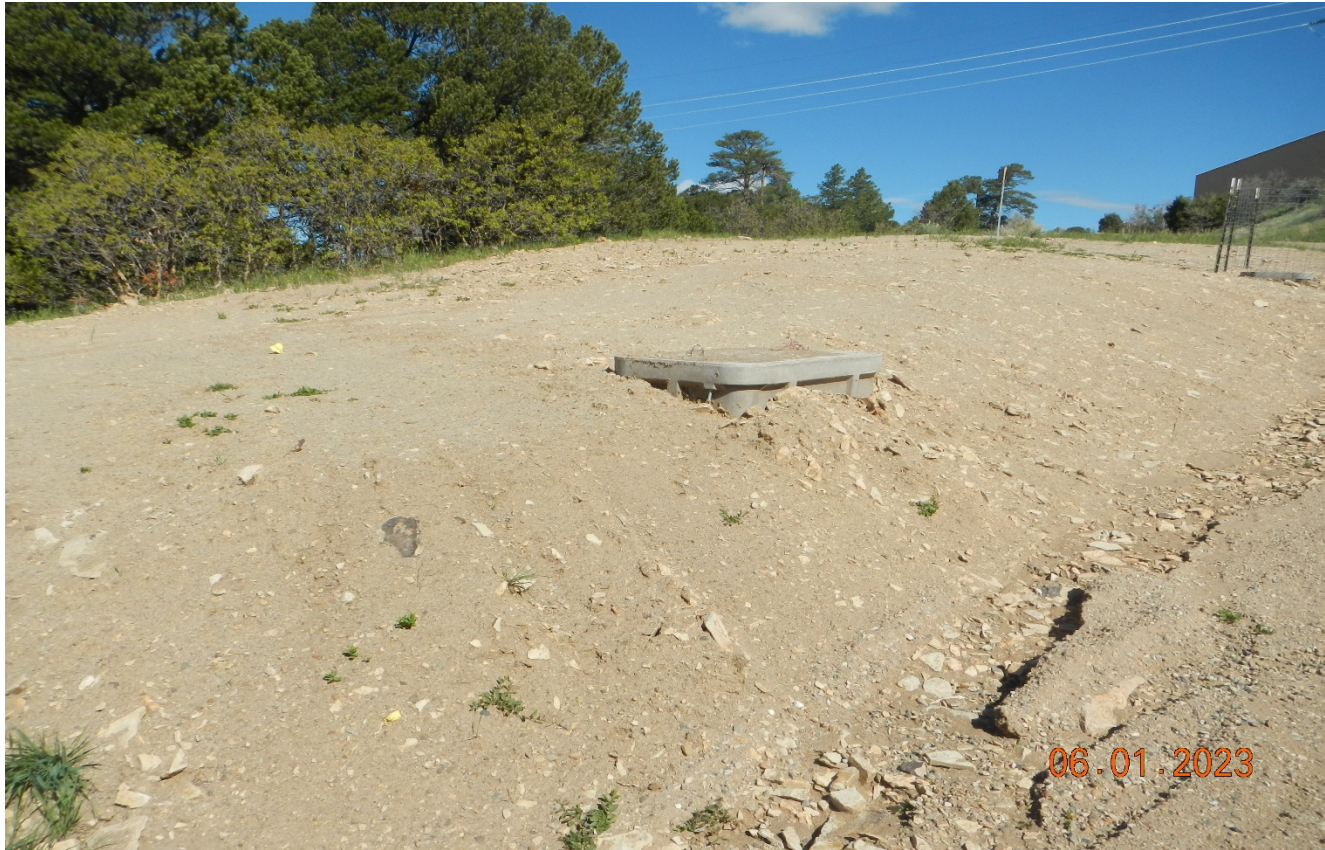
Photo 4. The flowline disturbance area was reseeded last year but vegetation does not appear to be establishing.

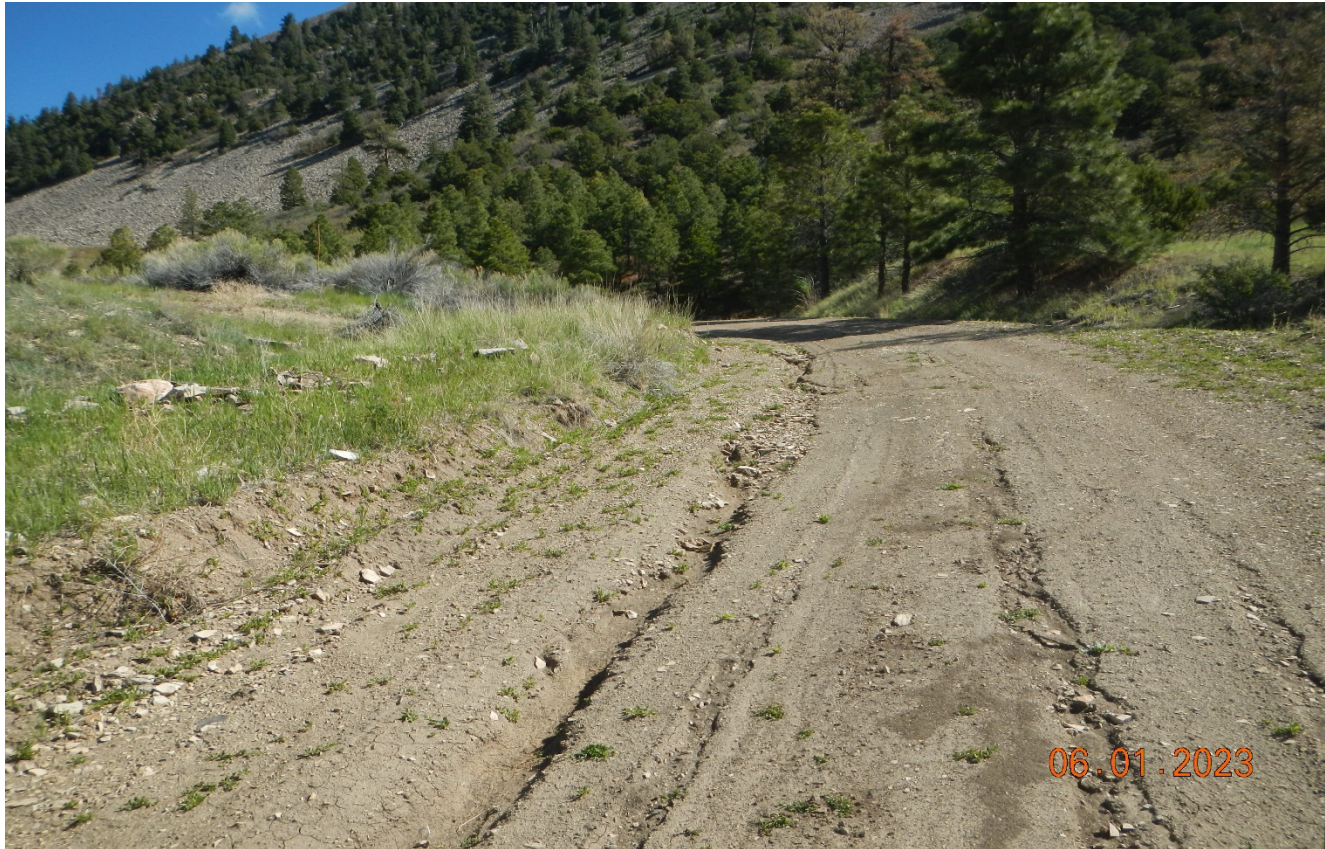
Photo 5. There is erosion occurring on the access road to the location.

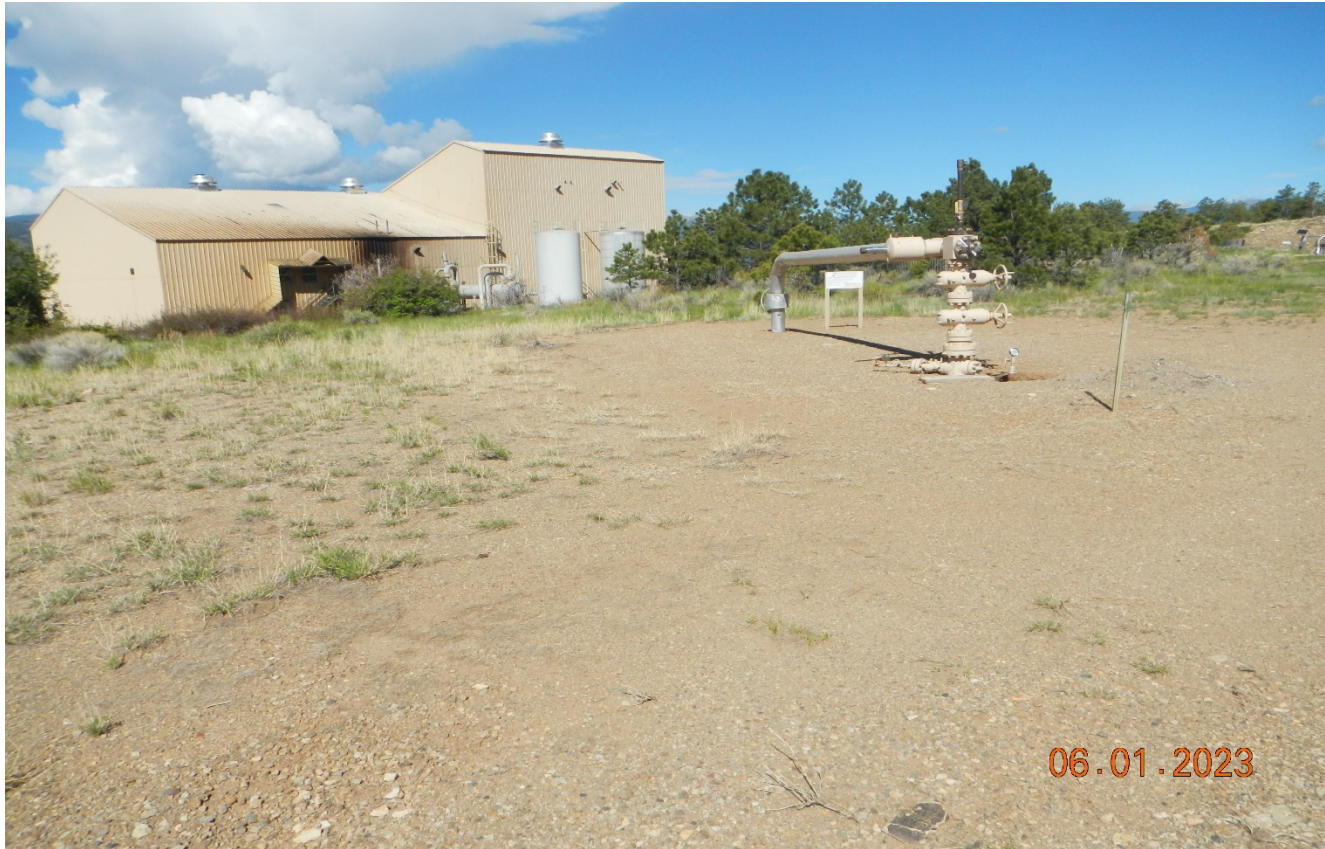
Photo 6. Facing northwest toward the location.
