# Inspection Photos

API: 055-06102

Operator: OXY USA INC

Inspection Date: 6/1/2023

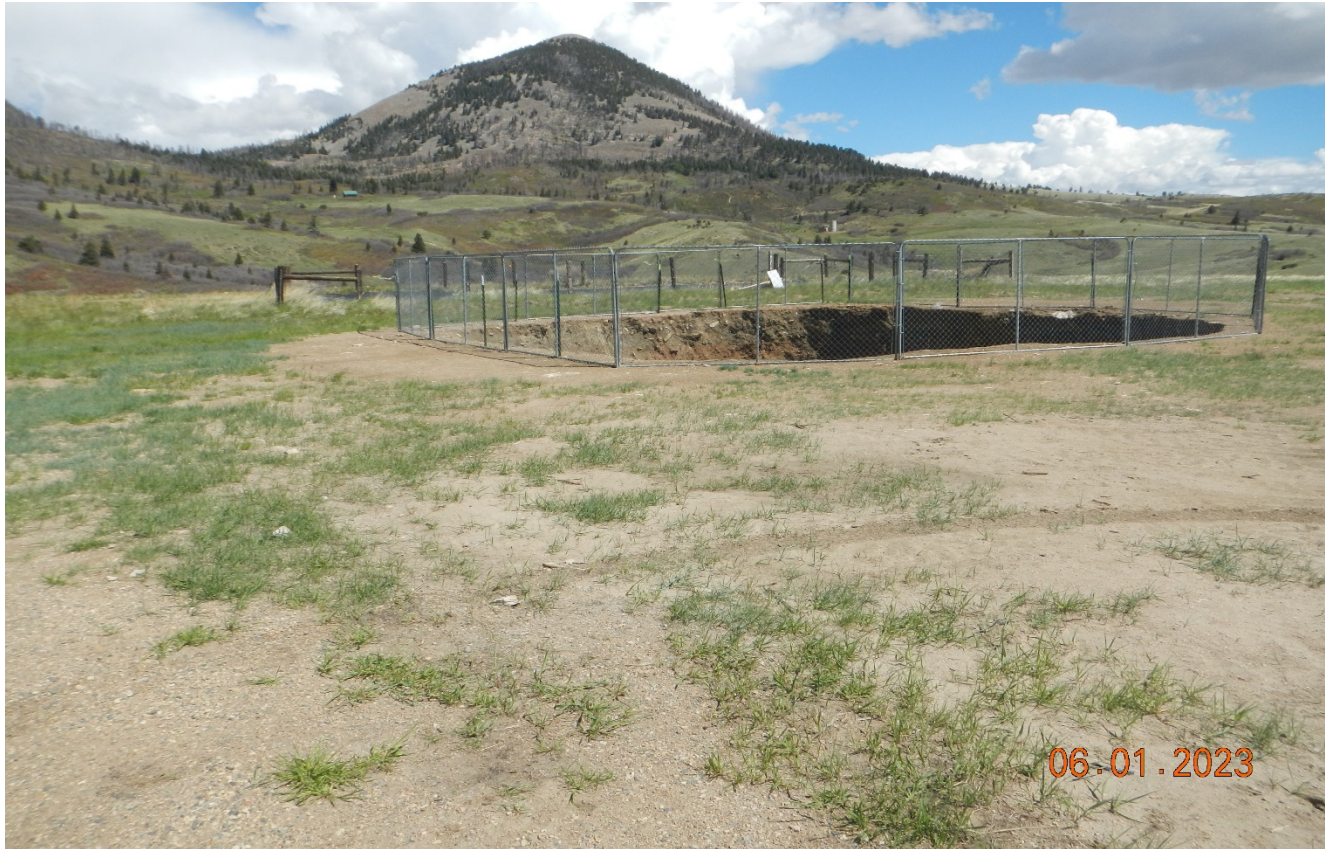
**Photo 1.** Facing northeast toward the wellsite. There is a large excavation around the wellhead has been fenced off to prevent entry.

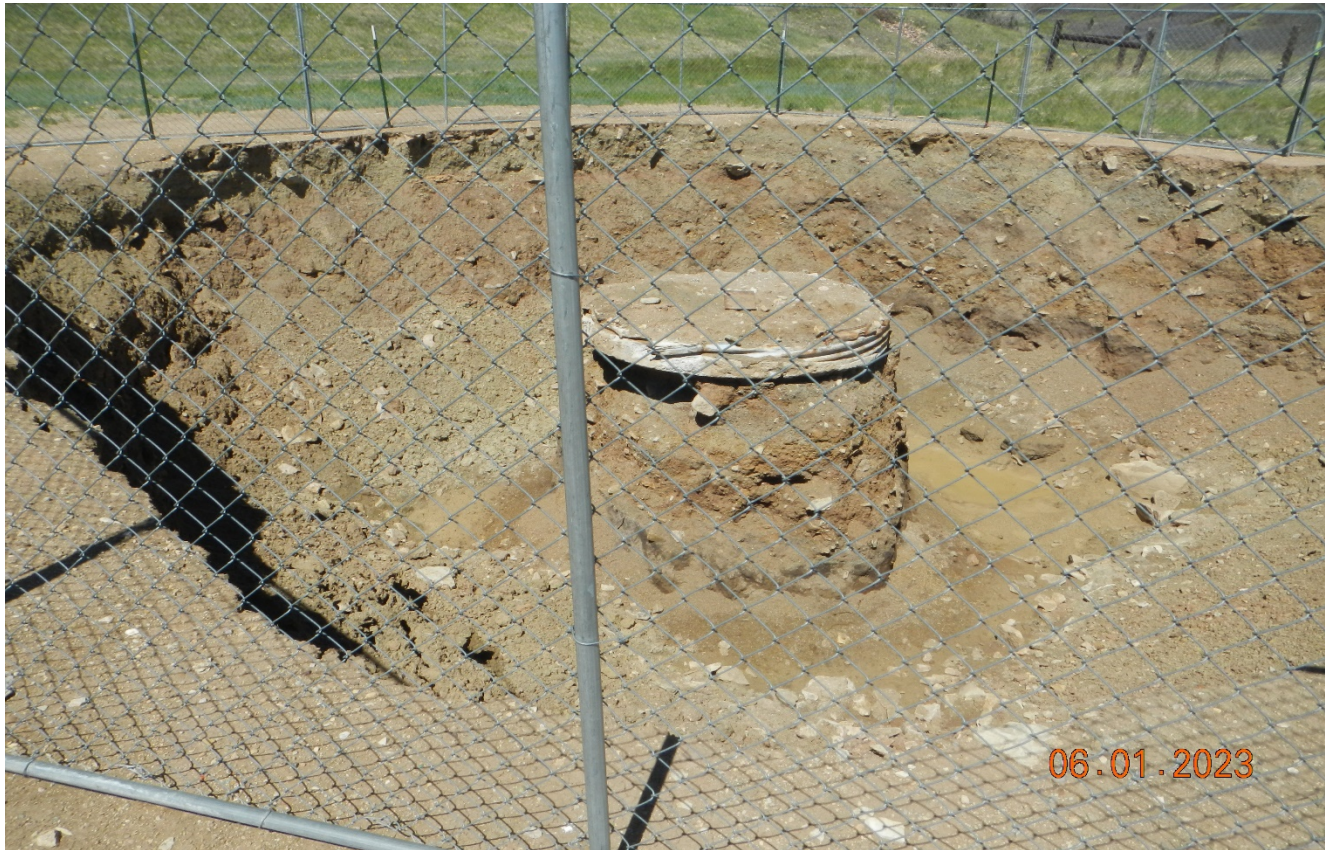
**Photo 2.** There is a large excavation around the wellhead approx. 15ft deep by 15'w. The wellhead will need to be cut an capped far enough below grade to allow proper recontouring.

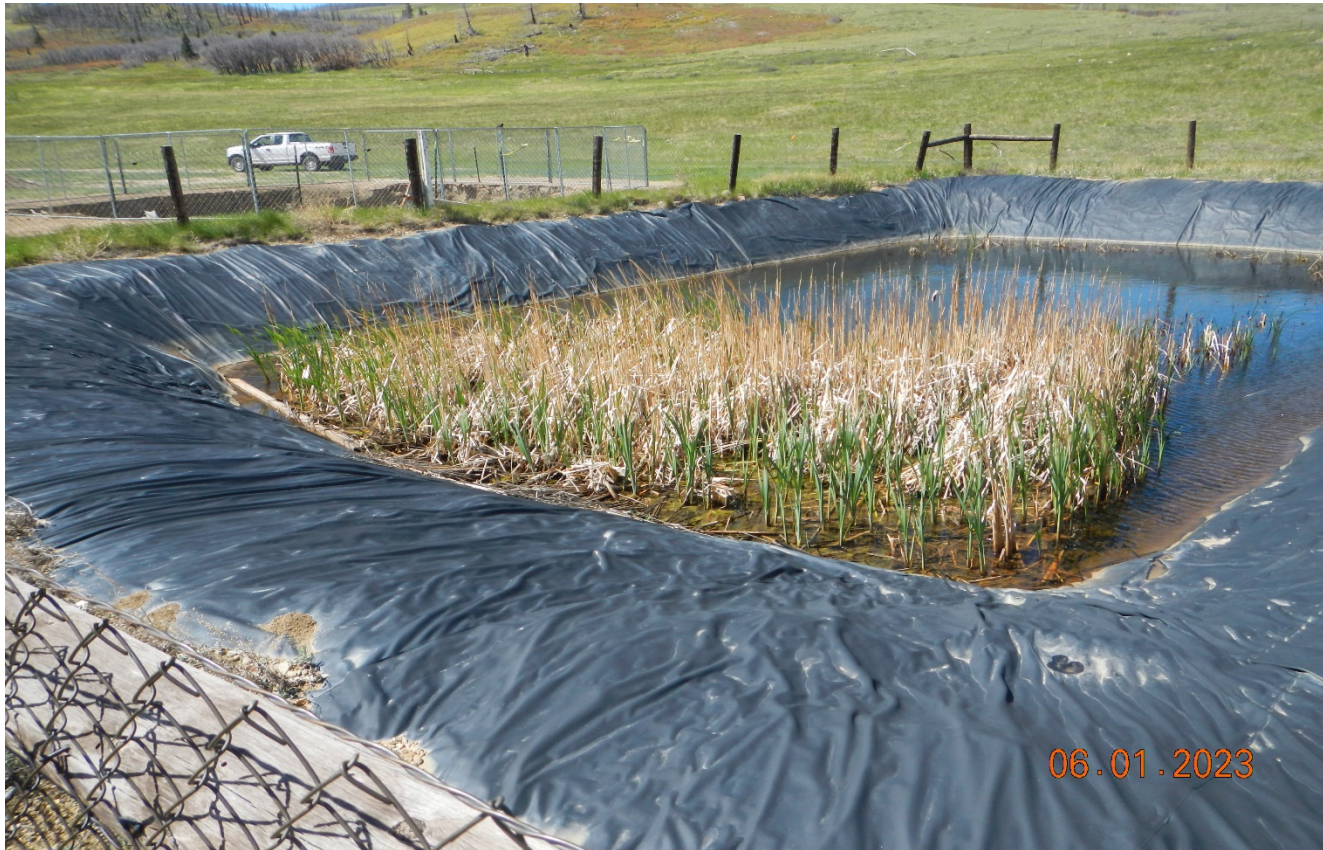
**Photo 3.** There is a lined pit adjacent to the well which does not appear to have any use and needs to be closed per 1004 Rules.

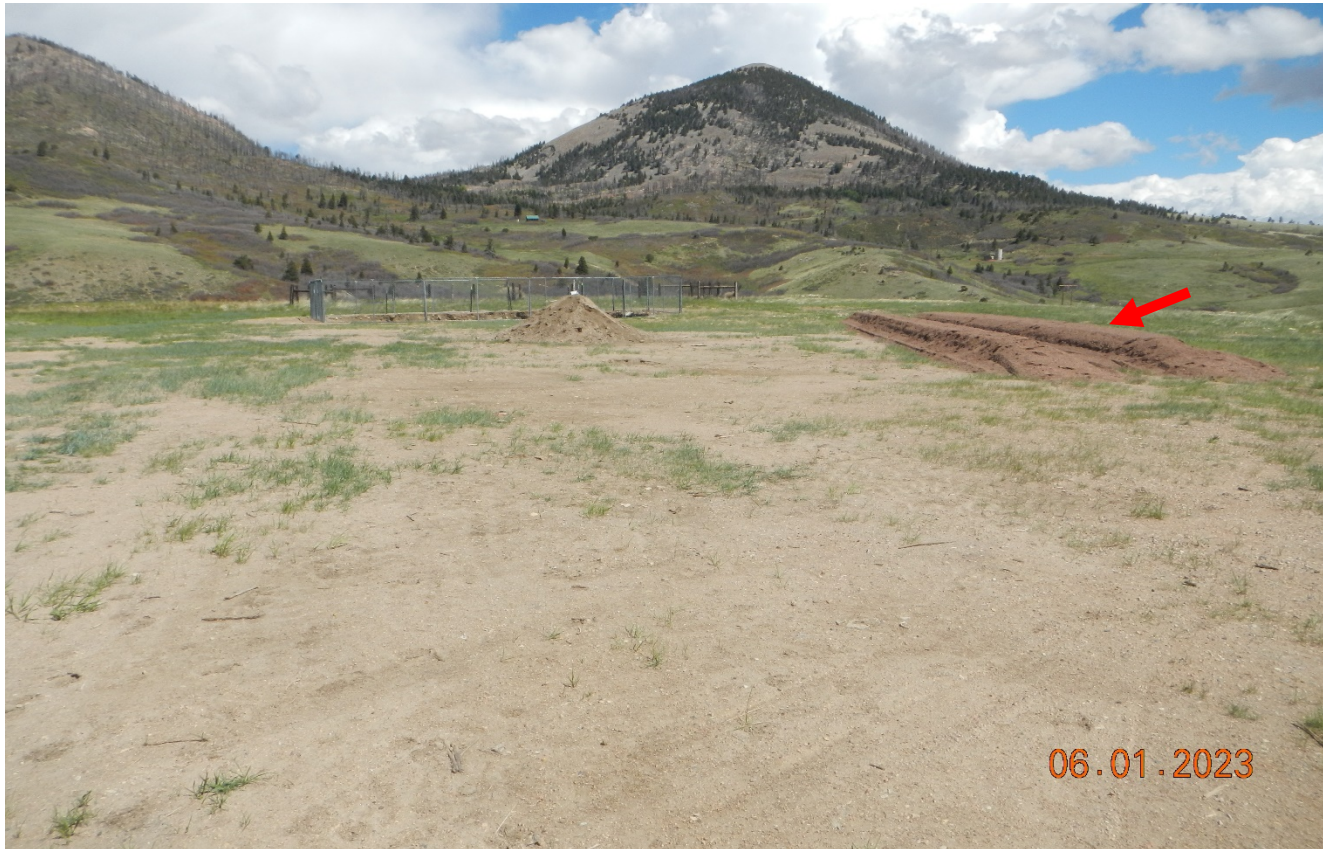
**Photo 4.** Facing north at the location. It appears impacted soils were removed and road base material has been hauled in shown at red arrow.

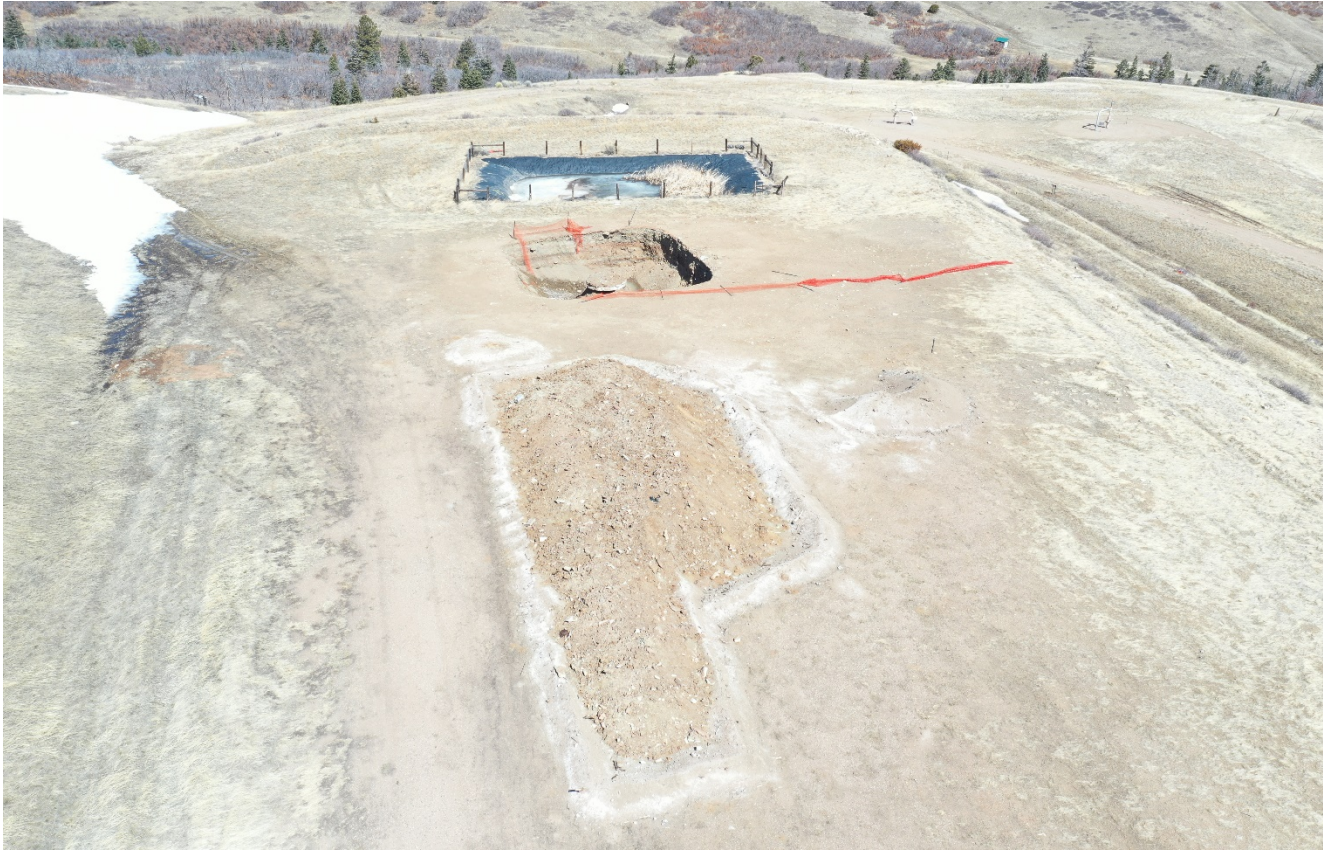
**Photo 5.** Taken during previous inspection on 4/10/2023. Drone aerial photo facing northwest toward the wellsite.
