Inspection Photos

API: 055-06041

Operator: OXY USA INC

Inspection Date: 6/1/2023

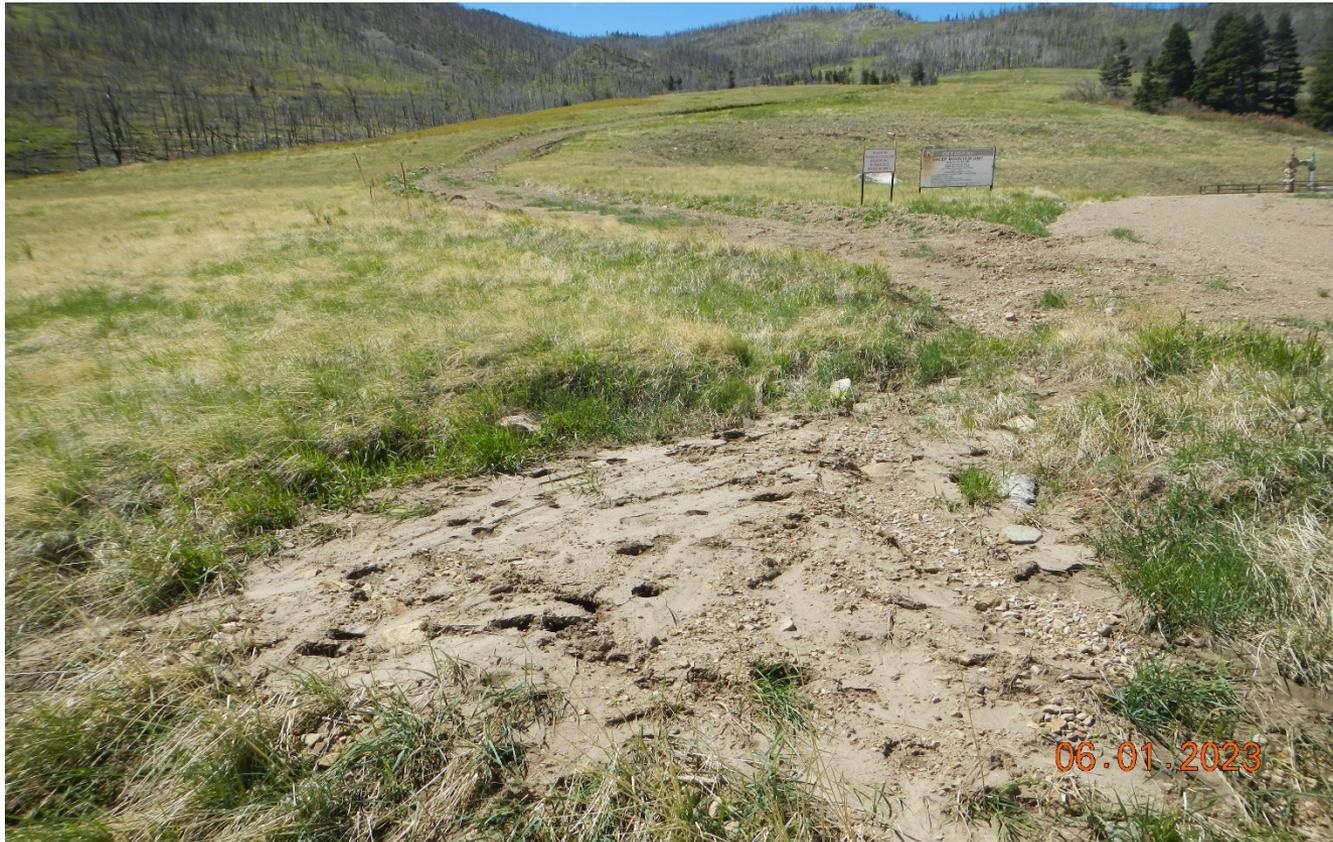
Photo 1. Facing southwest along the access road near the SMU #1-12-B . There is sediment from the road depositing in this area off the road causing additional disturbance. BMP's such as a sediment trap should be installed in this area.

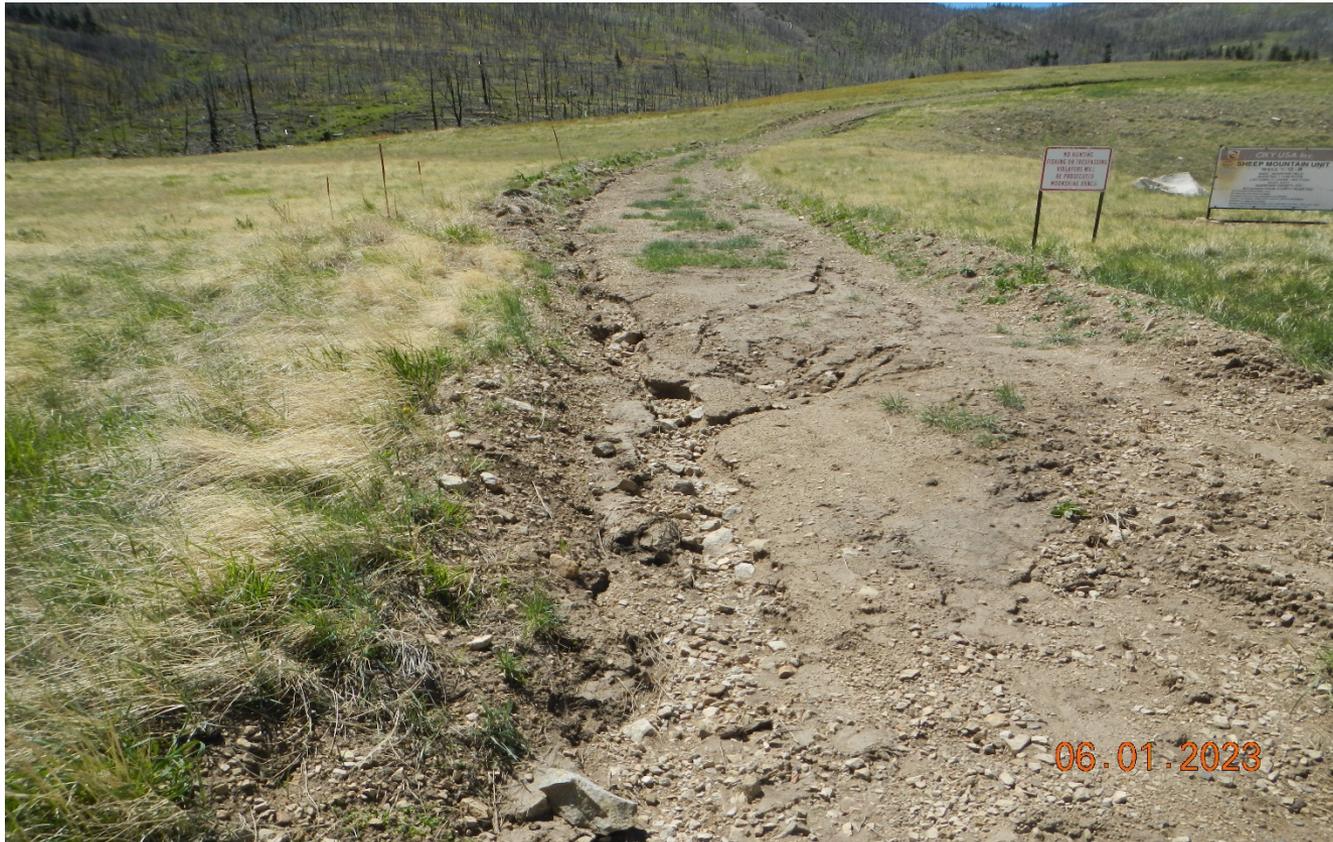
Photo 2. Facing southwest along the access road near the SMU #1-12-B . The is erosion occurring along the access road and no BMP's were installed since previous inspection.

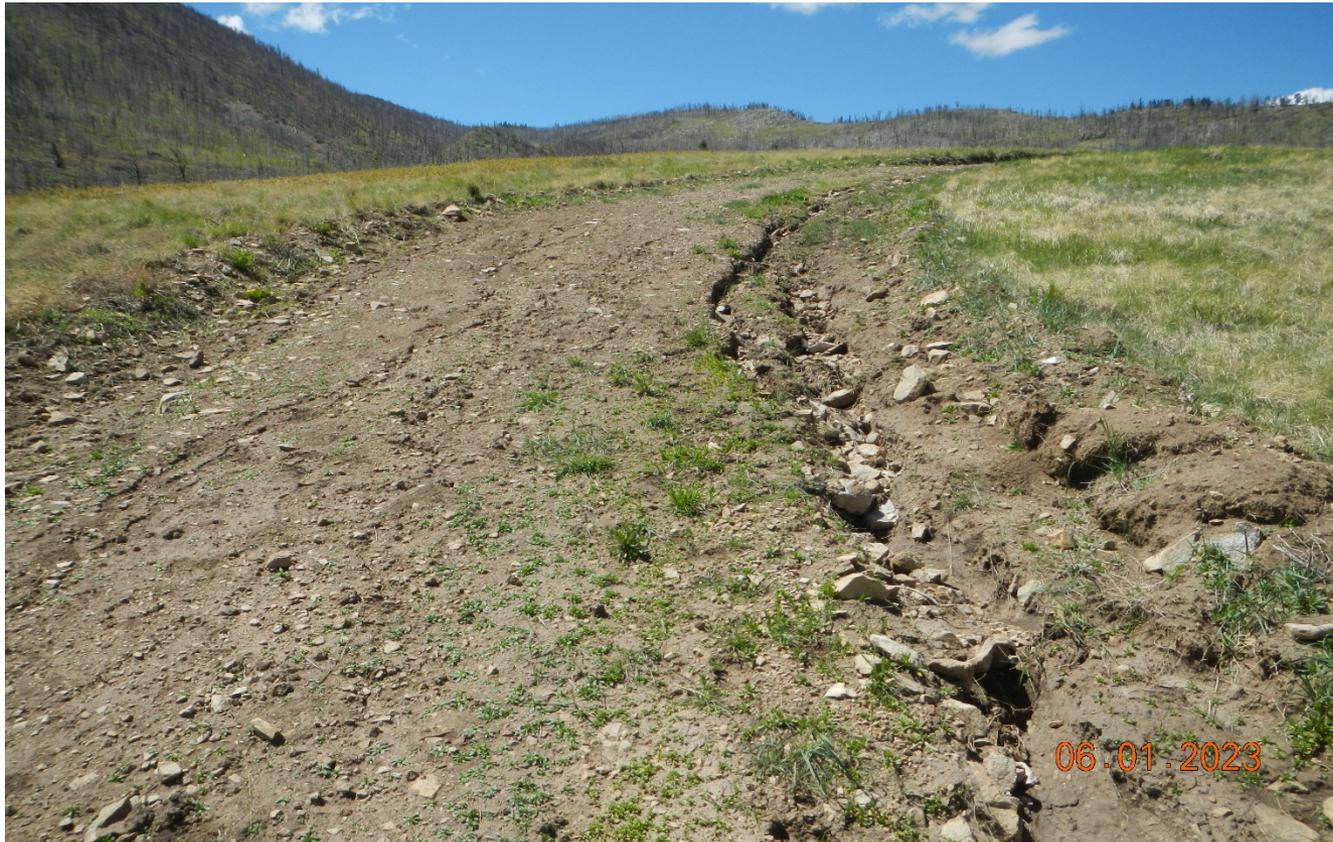
Photo 3. Facing southwest further along the access road. There is erosion occurring along the access road and no BMP's were installed since previous inspection.

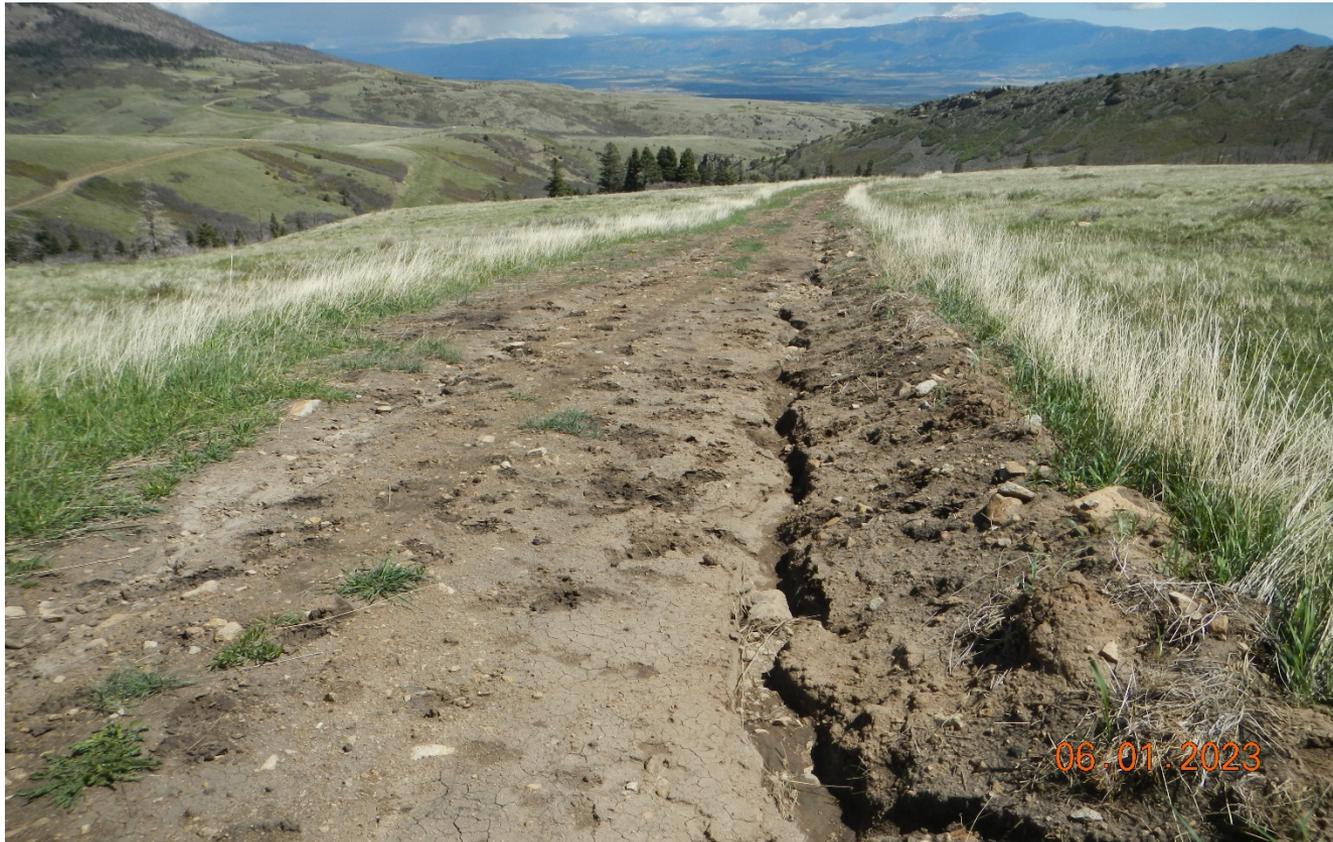
Photo 4. Facing back to the northeast. The road is directing stormwater all the way down the road causing erosion. No BMP's have been installed to direct stormwater off the road and reduce stormwater concentration along the road. Previous corrective action has not been completed.

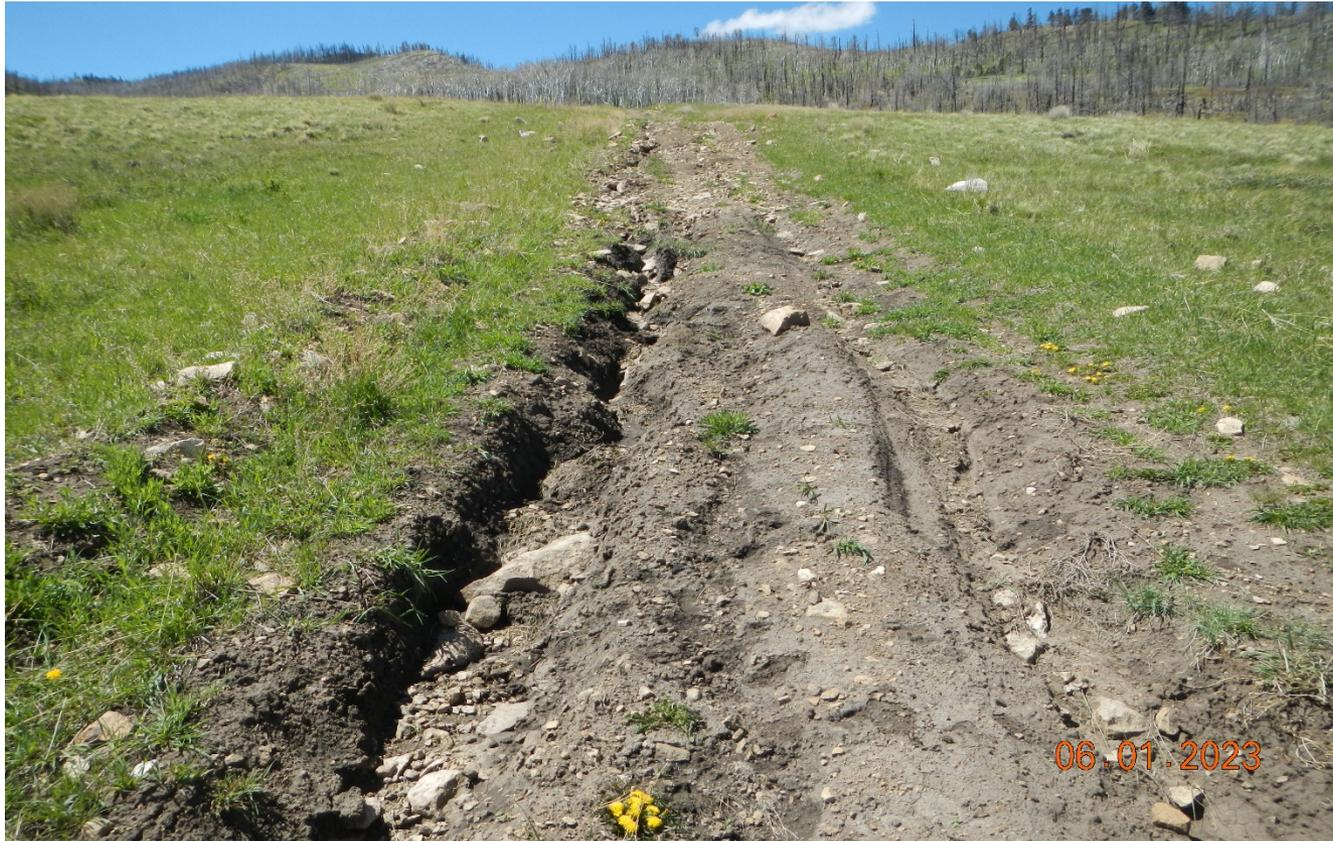
Photo 5. Facing southwest further along the access road. There are areas of erosion occurring which need to be repaired and stabilized. Previous corrective action has not been completed.

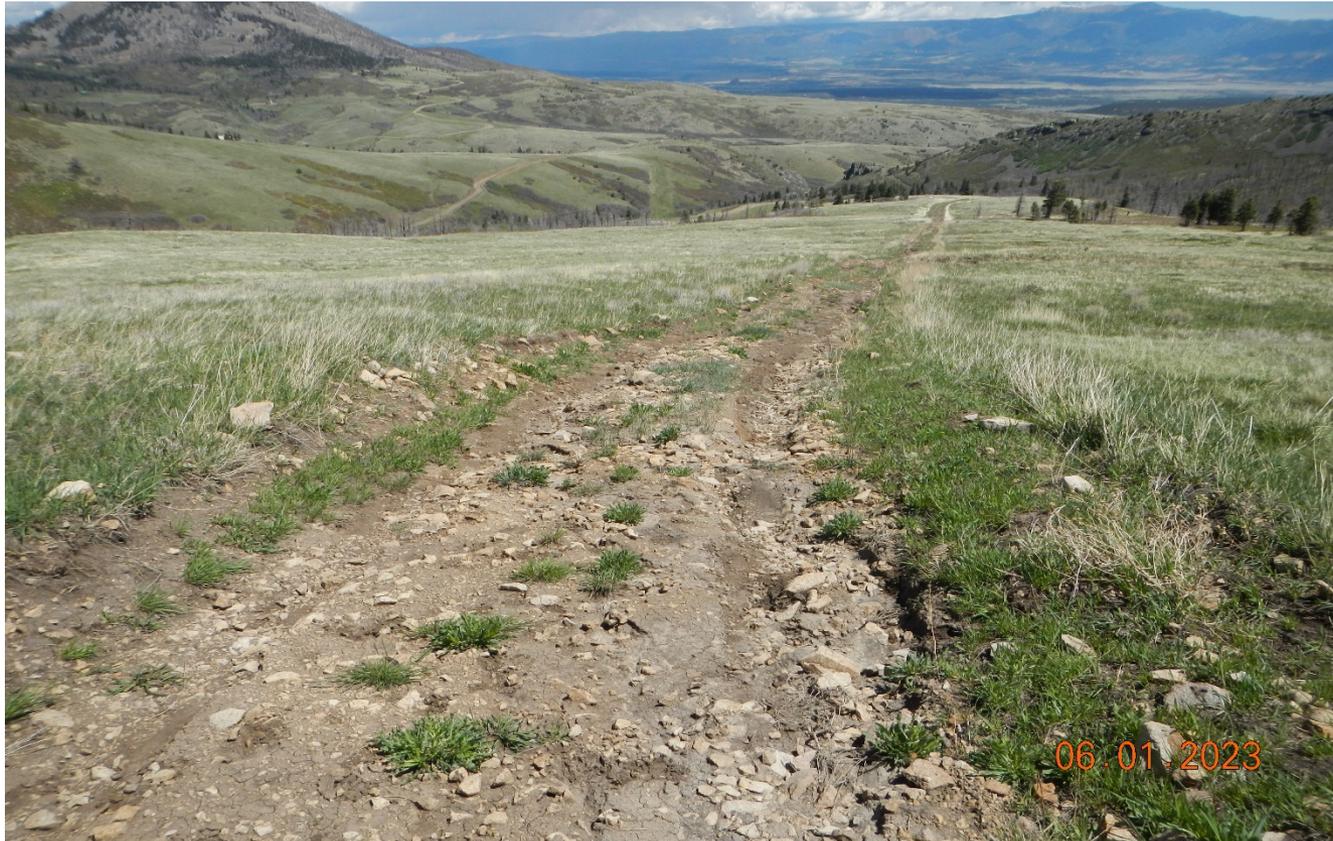
Photo 6. Facing back northeast along the access road. Stormwater is directed all the way down the length of the road with no BMP's to divert and control stormwater. Previous corrective action has not been completed.

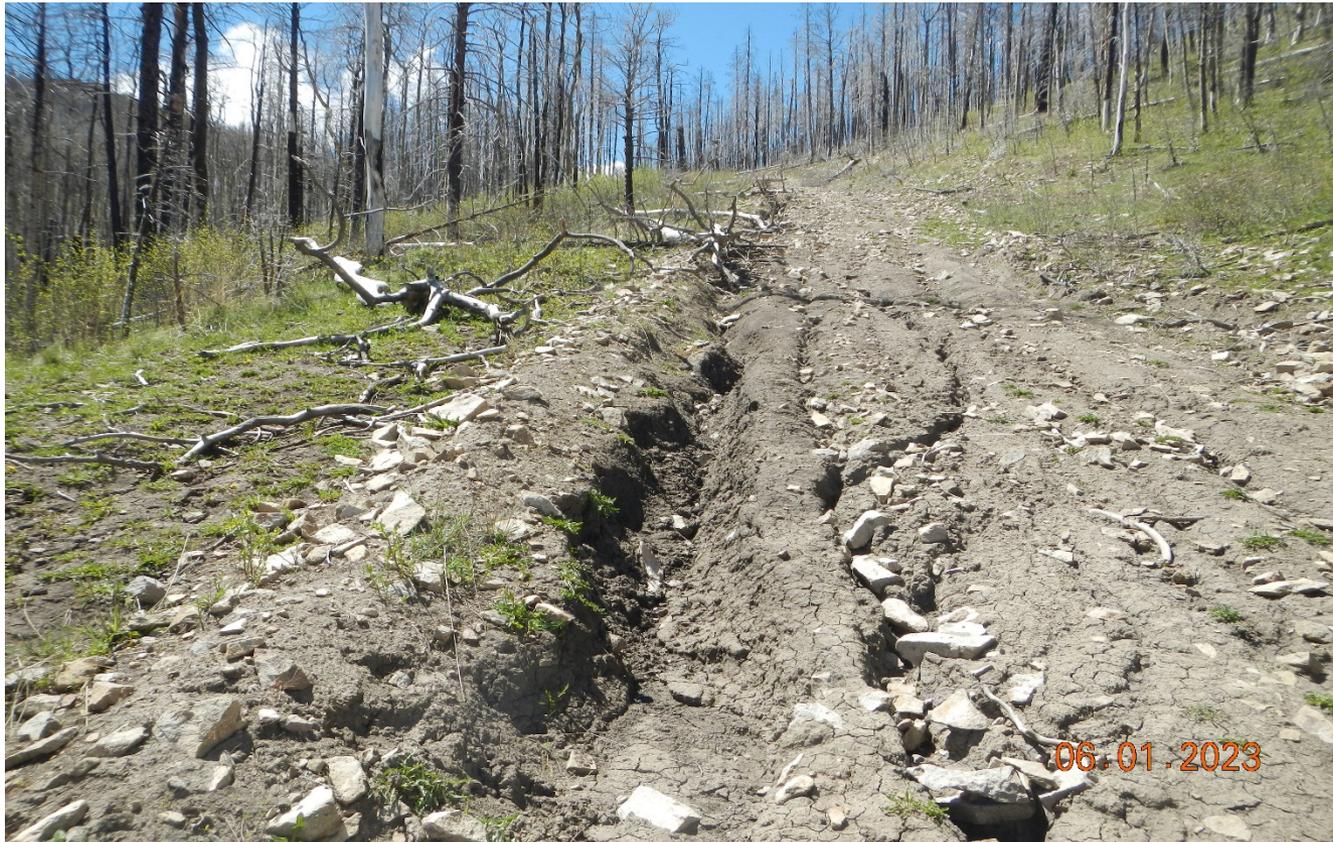
Photo 7. Facing southwest further along the access road. There are areas of erosion occurring which need to be repaired and stabilized. Previous corrective action has not been completed.

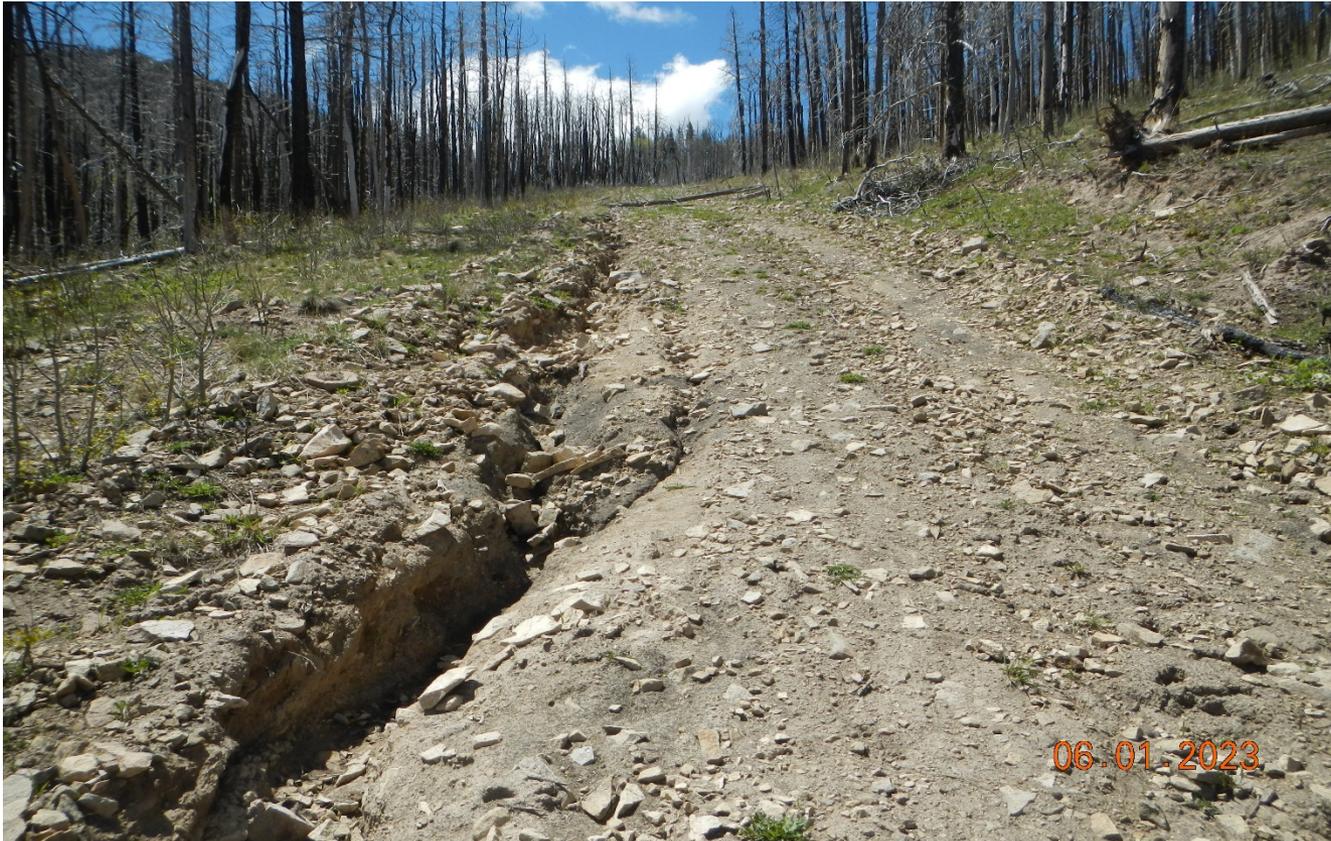
Photo 8. Facing southwest further along the access road. There are areas of erosion occurring which need to be repaired and stabilized. Previous corrective action has not been completed.
