Inspection Photos

May 30, 2023

Location Name: FEDERAL/WMC 24-17

Inspection Document #: 702801565

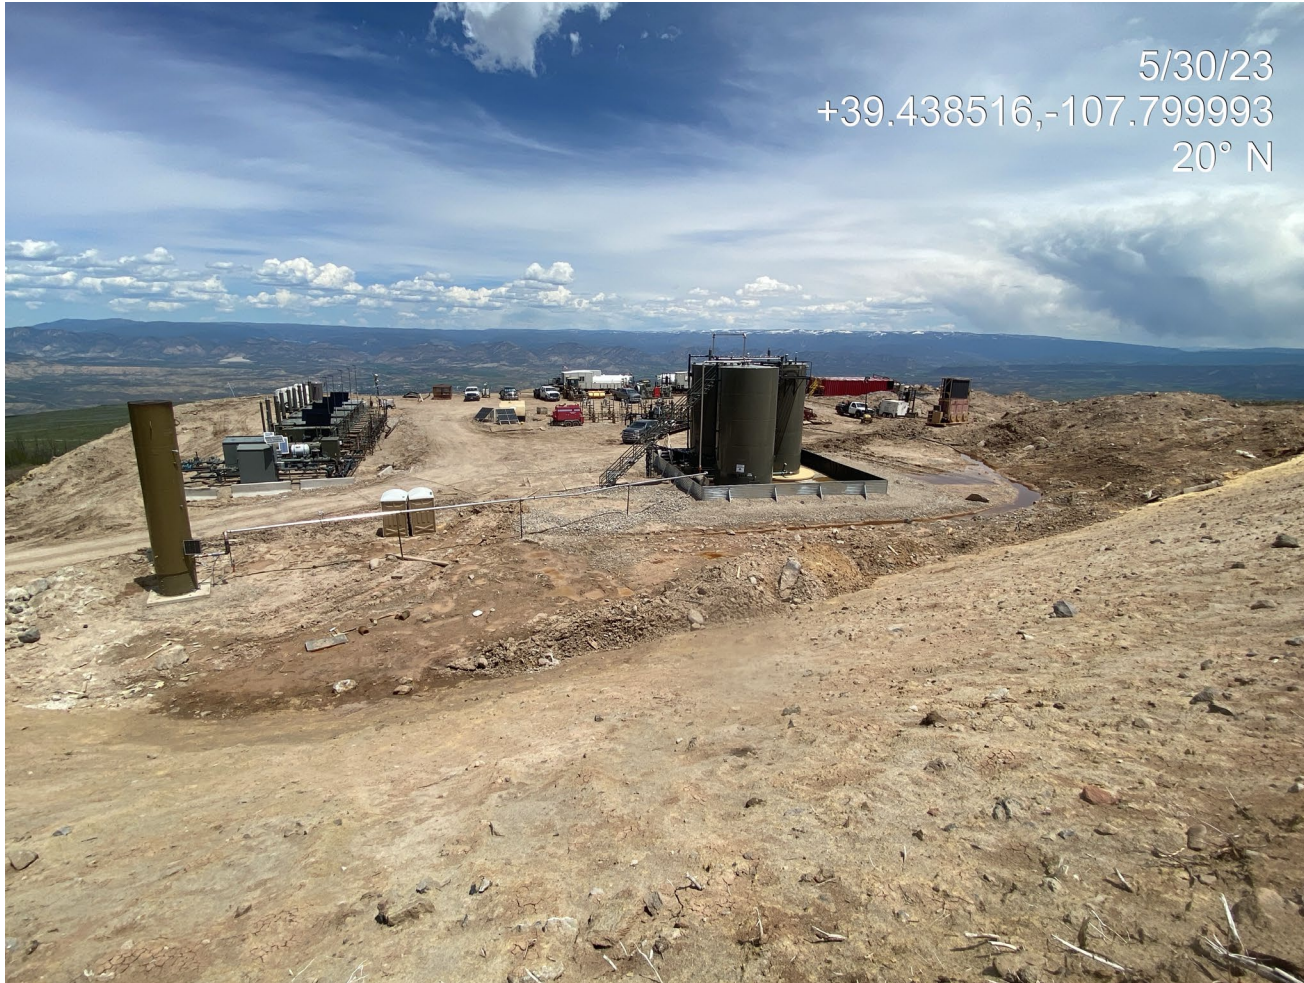
Photo 1. Photo taken from the south shows an overview of the location.

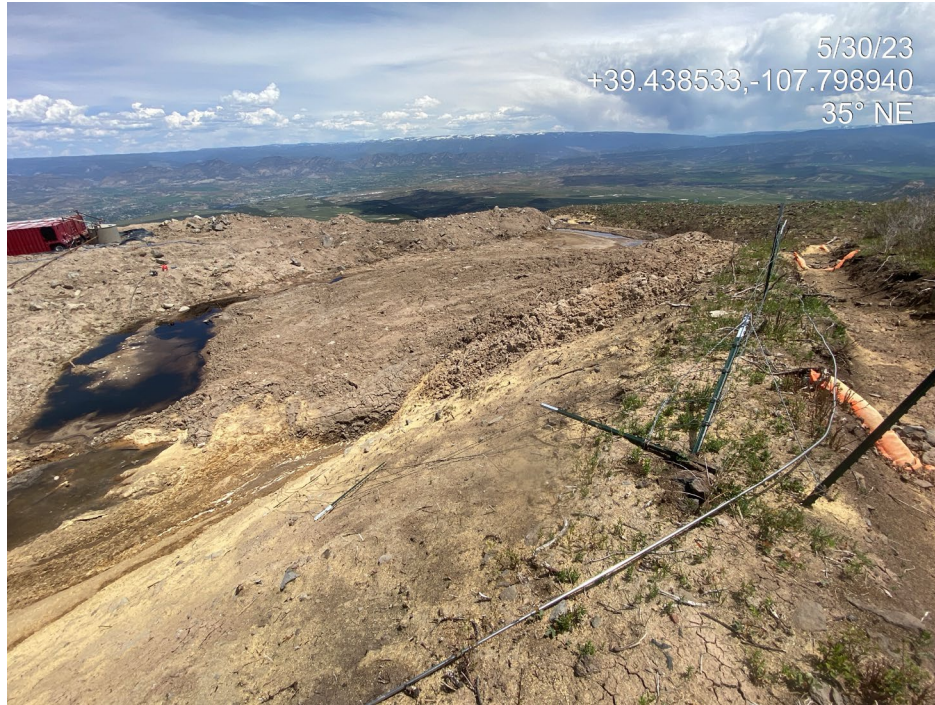
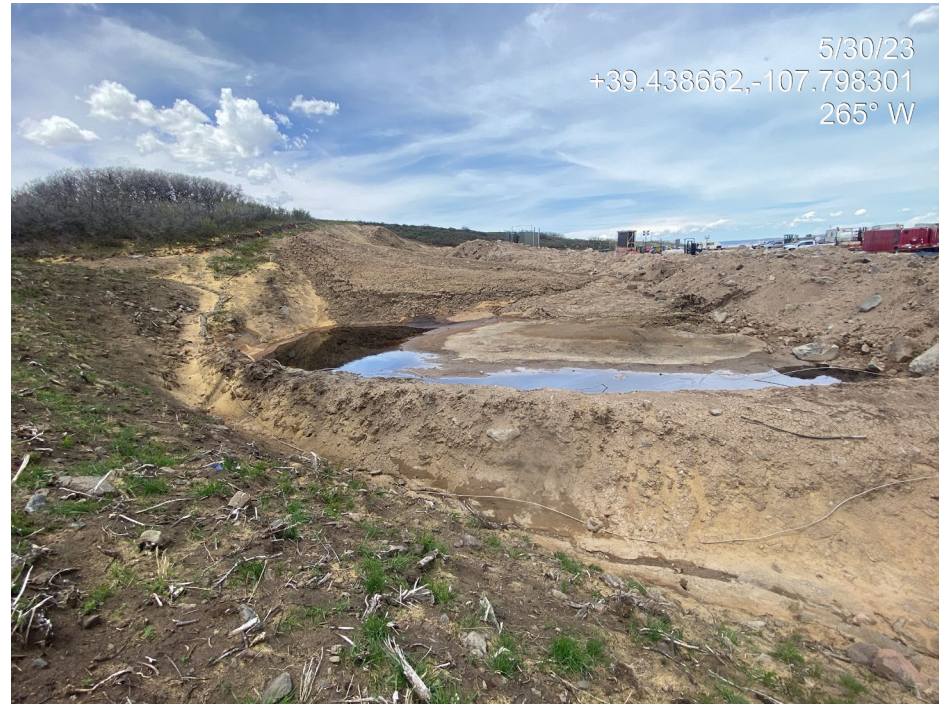
Photo 2. Photos taken from the south show an overview of the western (left) and eastern (right) portions of the cuttings trench. Trench perimeter fencing is in disrepair and non-functioning.

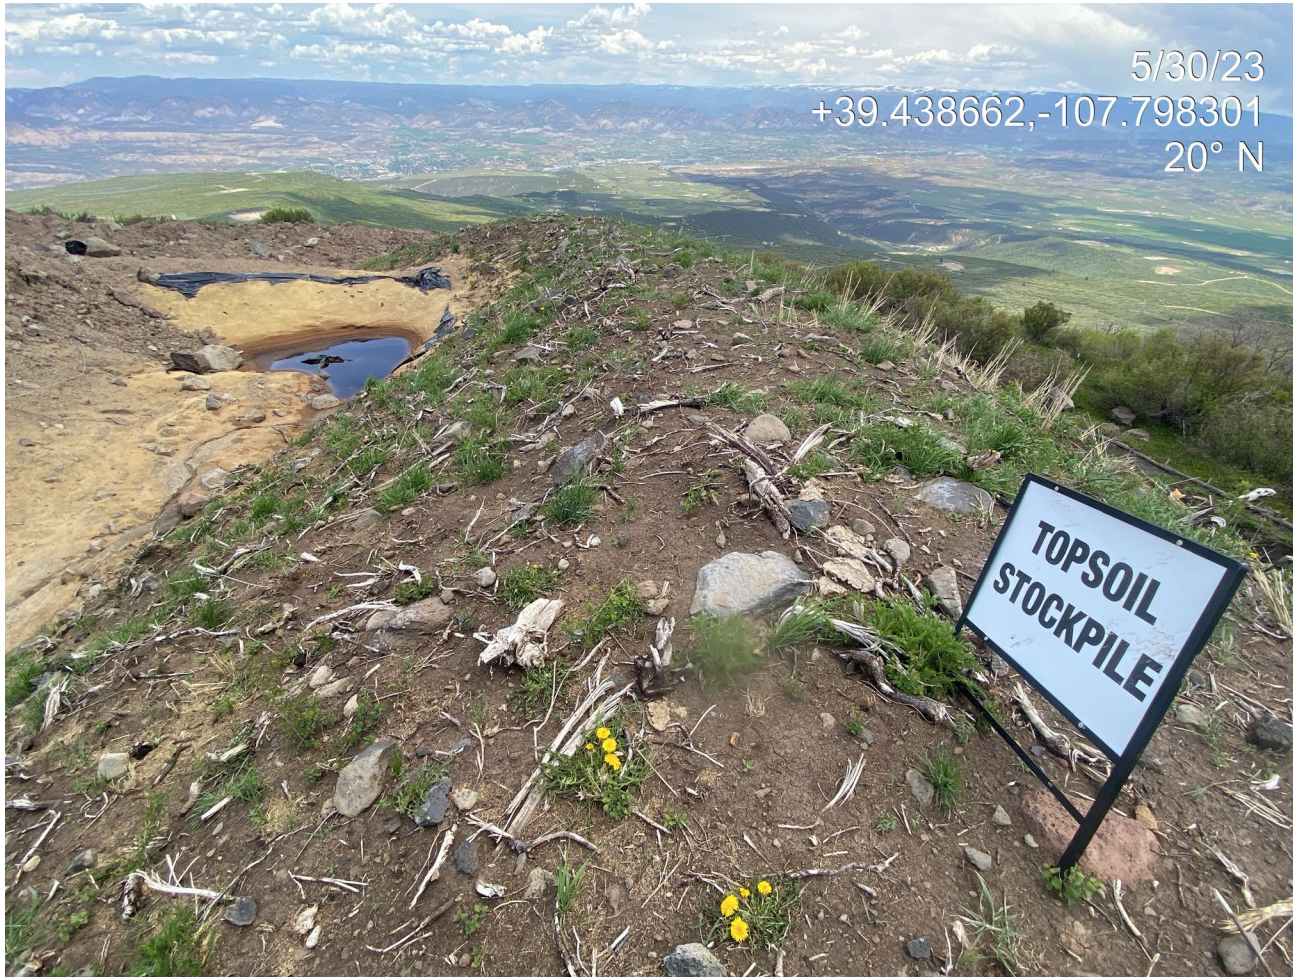
Photo 3. Photo shows the topsoil stockpile at the east of the location as well as a portion of the cuttings trench.

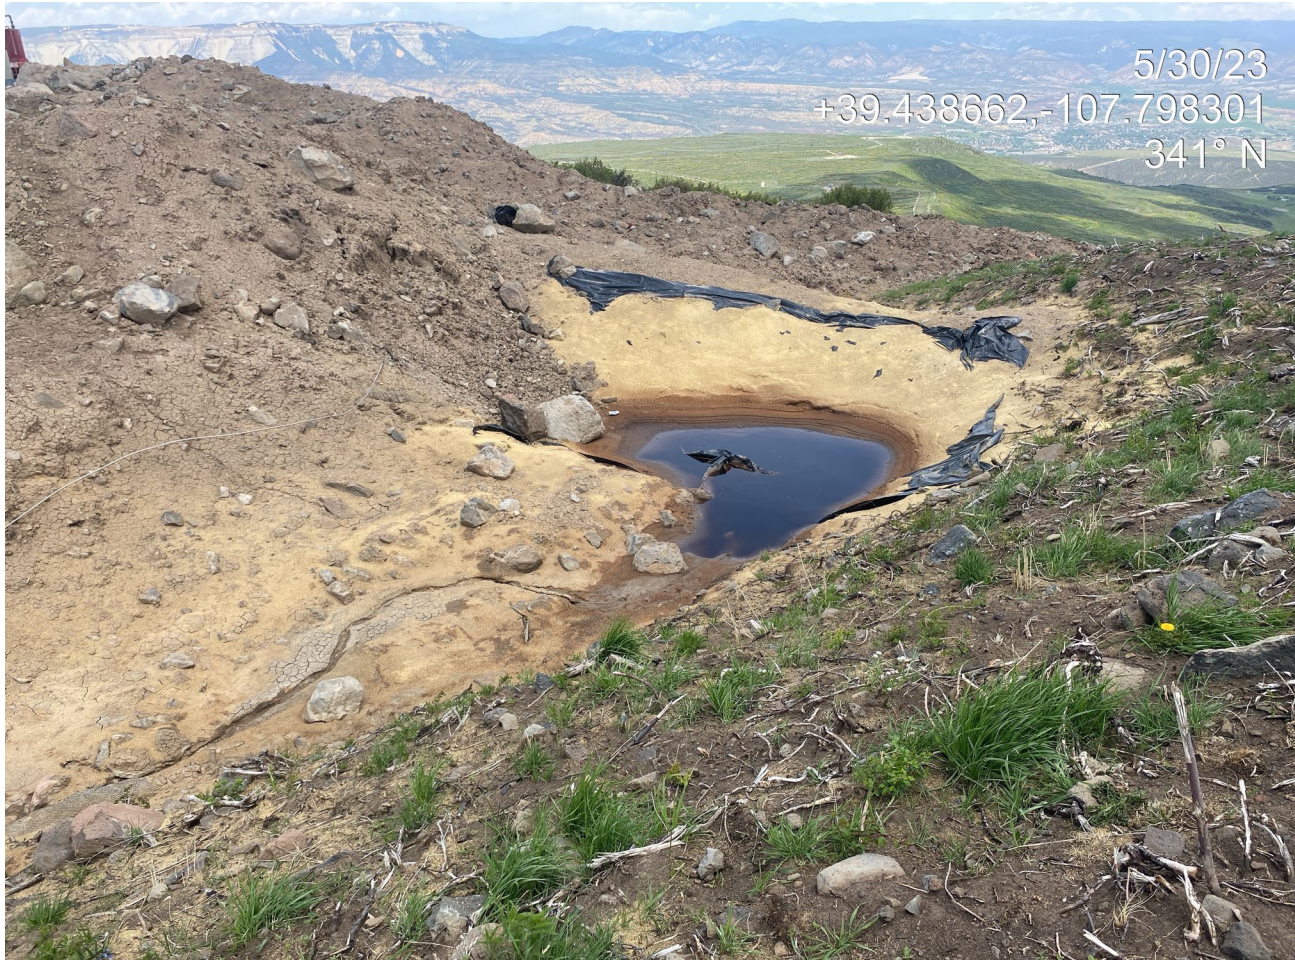
Photo 4. Photo taken from the southeast shows the topsoil stockpile (right) is not properly segregated from subsoils and possible cutting trench materials. The liner pictured is in disrepair. A straw wattle at the base of the topsoil stockpile is not present in areas adjacent to the cuttings trench.

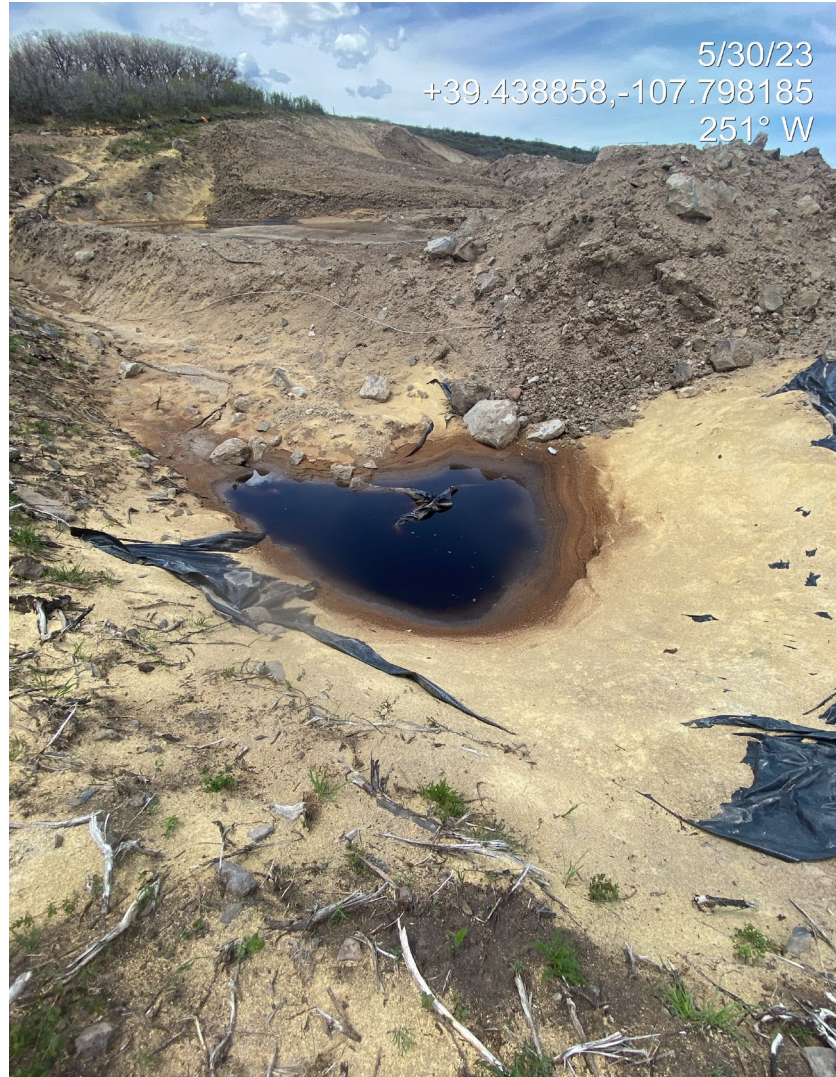
Photo 5. Photo taken from the southeast shows the topsoil stockpile (left) is not properly segregated from subsoils and possible cuttings trench materials. The liner is in disrepair. A straw wattle at the base of the topsoil stockpile is not present in areas adjacent to the cuttings trench.

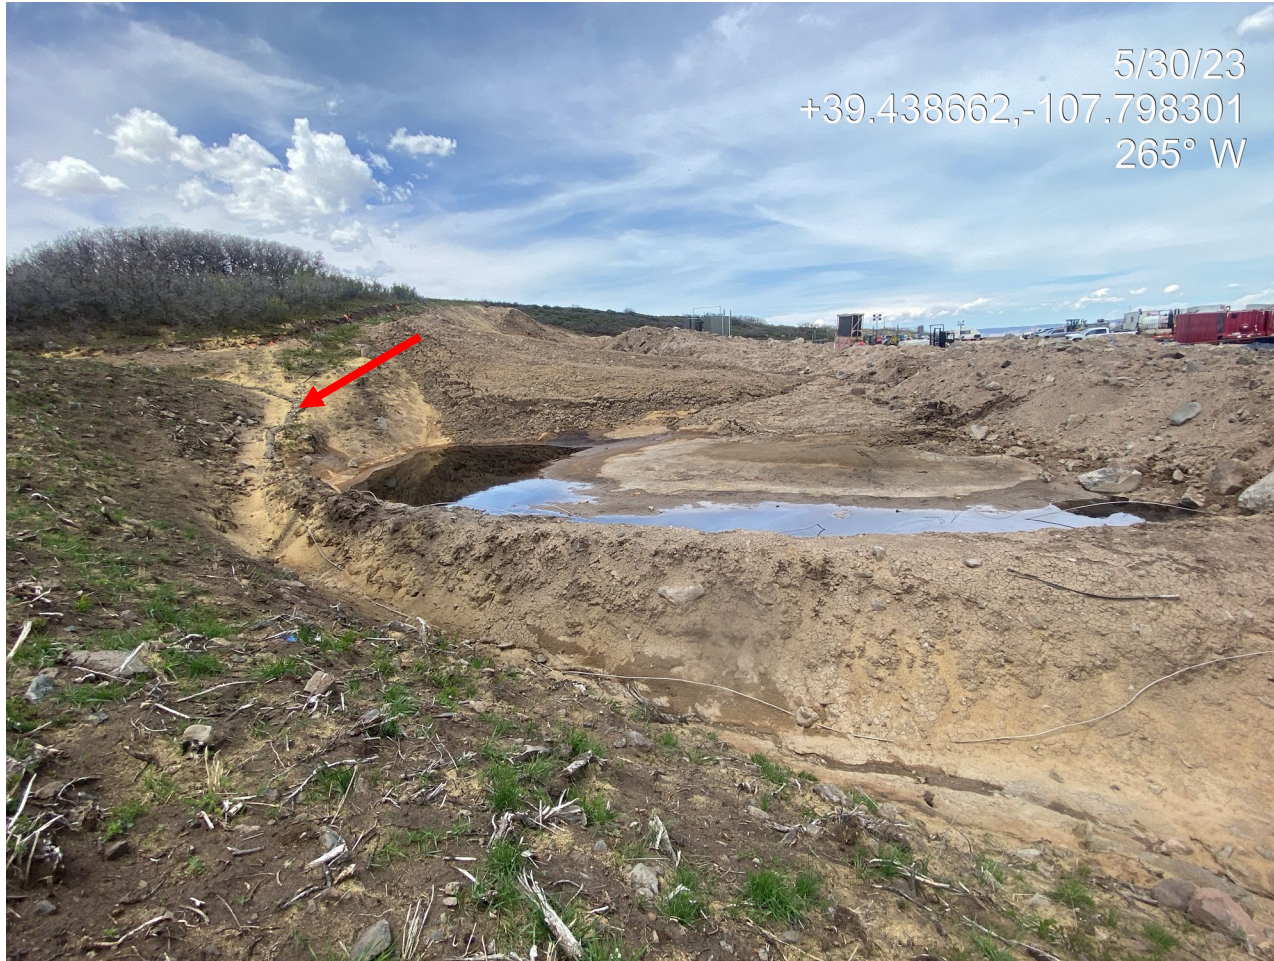
Photo 6. Photo taken from the southeast shows the topsoil stockpile (left) is not properly segregated from subsoils and possible cutting trench materials. A straw wattle (arrow) at the base of the topsoil stockpile is not present in areas adjacent to the cuttings trench.

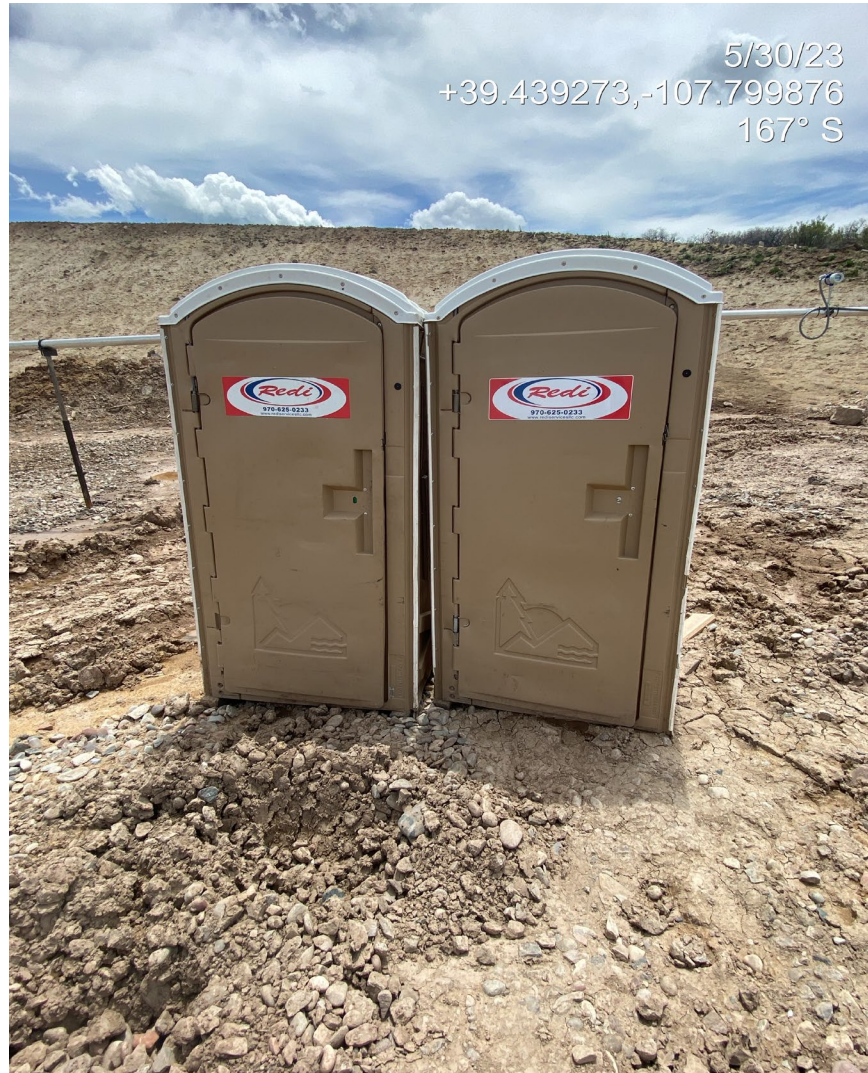
Photo 7. Photo taken from the Location entrance shows portable toilets have not been secured to prevent a spill.

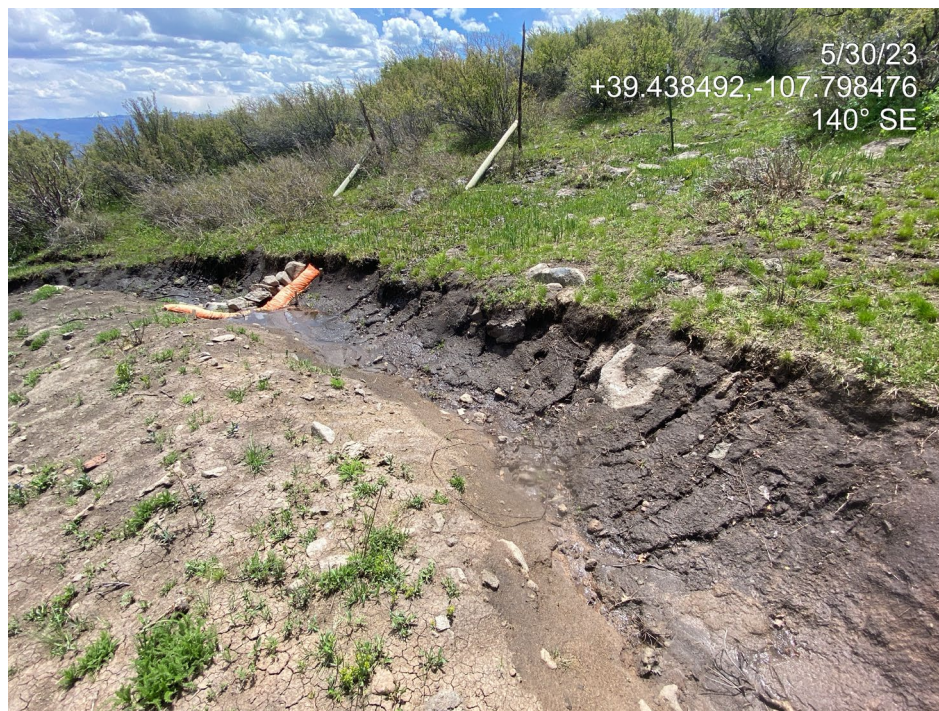
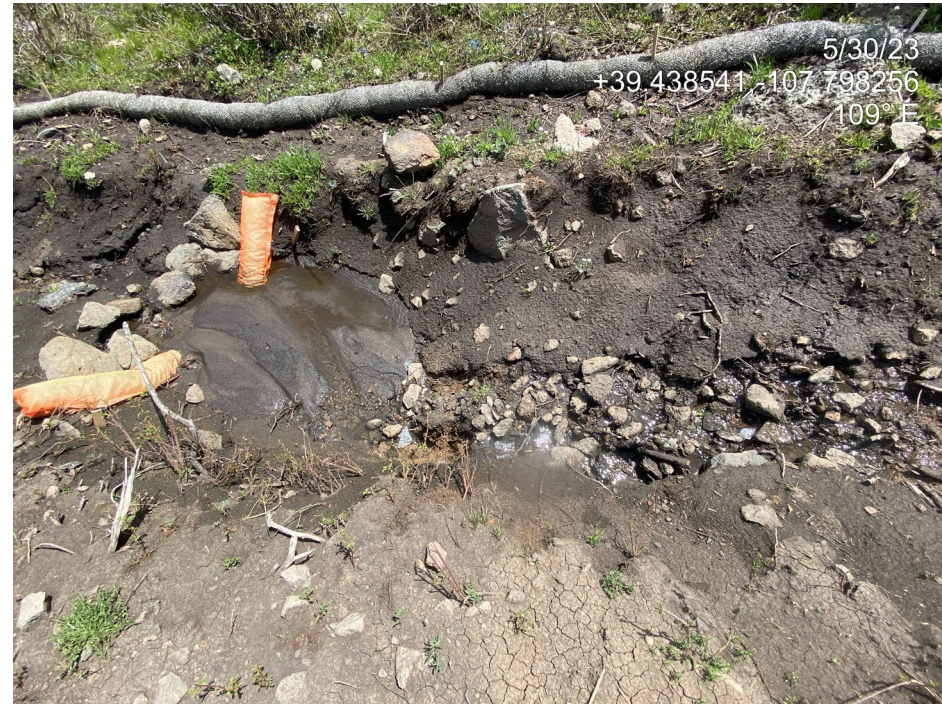
Photo 8. Photos show scouring and rill erosion in the eastern perimeter stormwater ditch resulting in degradation to the BMP and increased sediment loads. Sediment has filled in the check dam.

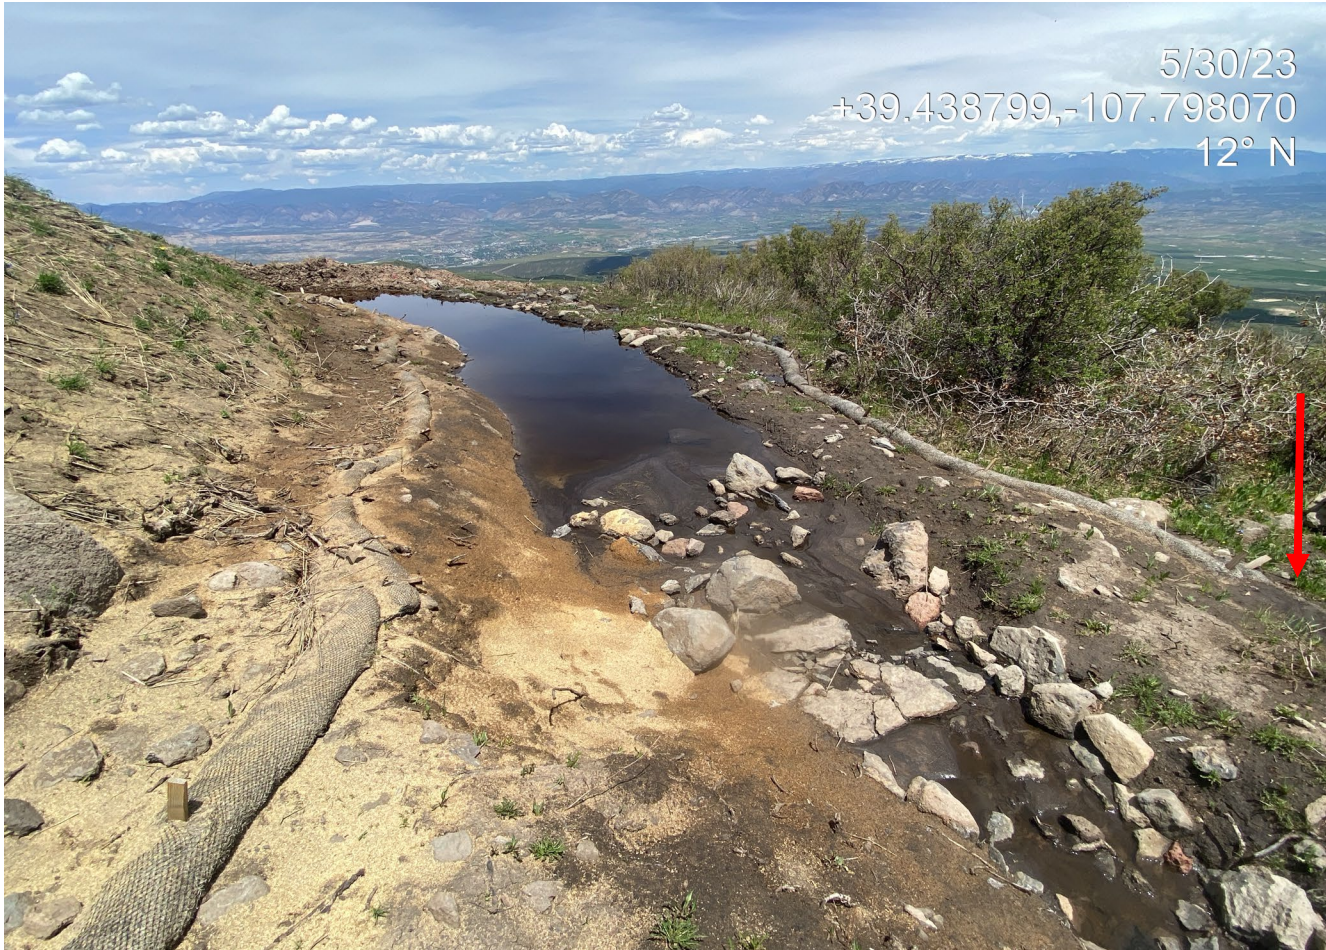
Photo 9. Photo shows a sediment trap at the northeast. The inlet is degraded via scouring, movement/loss of rip-rap and sediment deposition. Sediment laden stormwater is exiting the ditch and inlet before reaching the trap and overtopping a wattle.

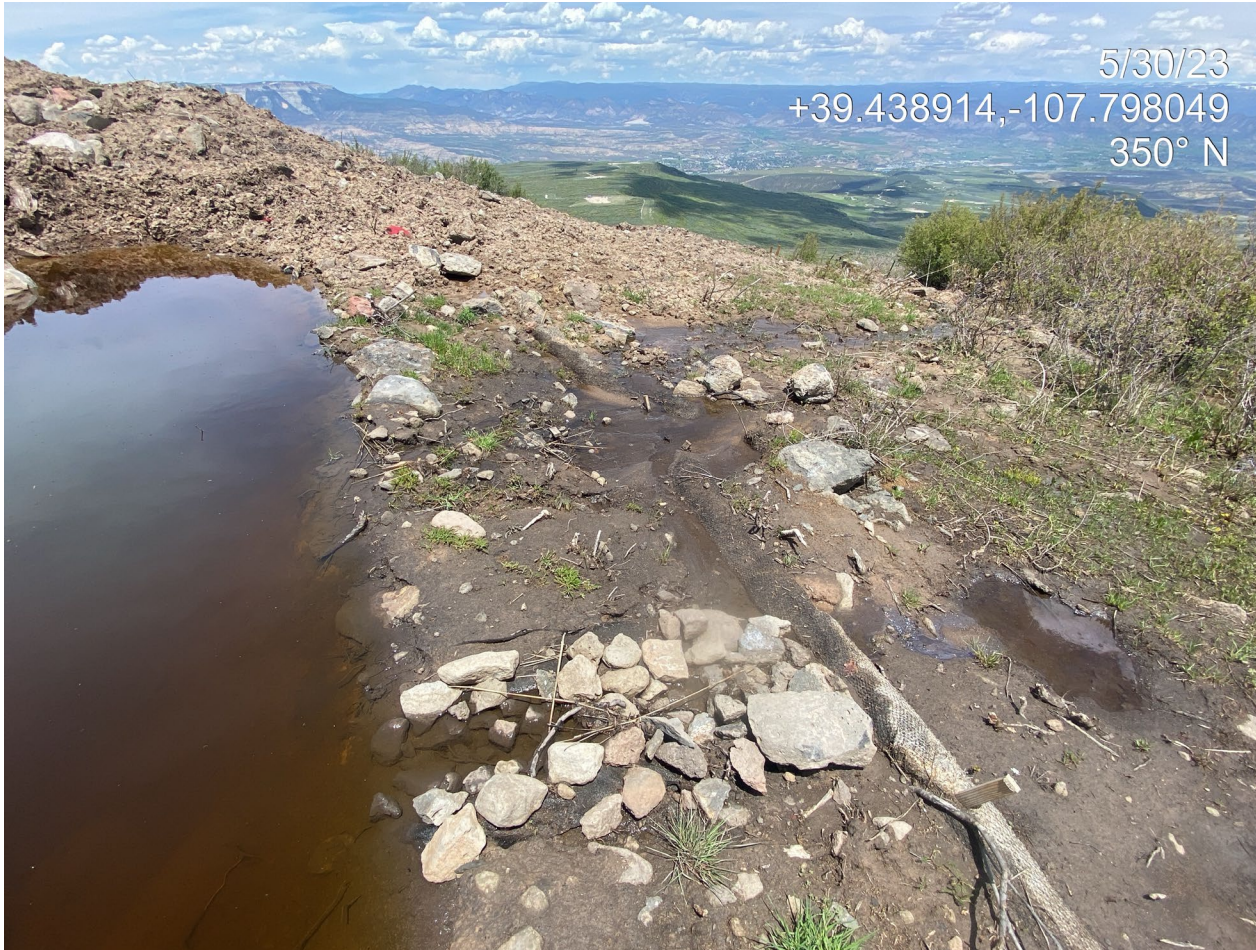
Photo 10. Photo shows a sediment trap at the northeast. The outlet is degraded and eroded and appears to have lost rip-rap. Sediment laden stormwater is exiting the trap in multiple places without a properly engineered outlet.

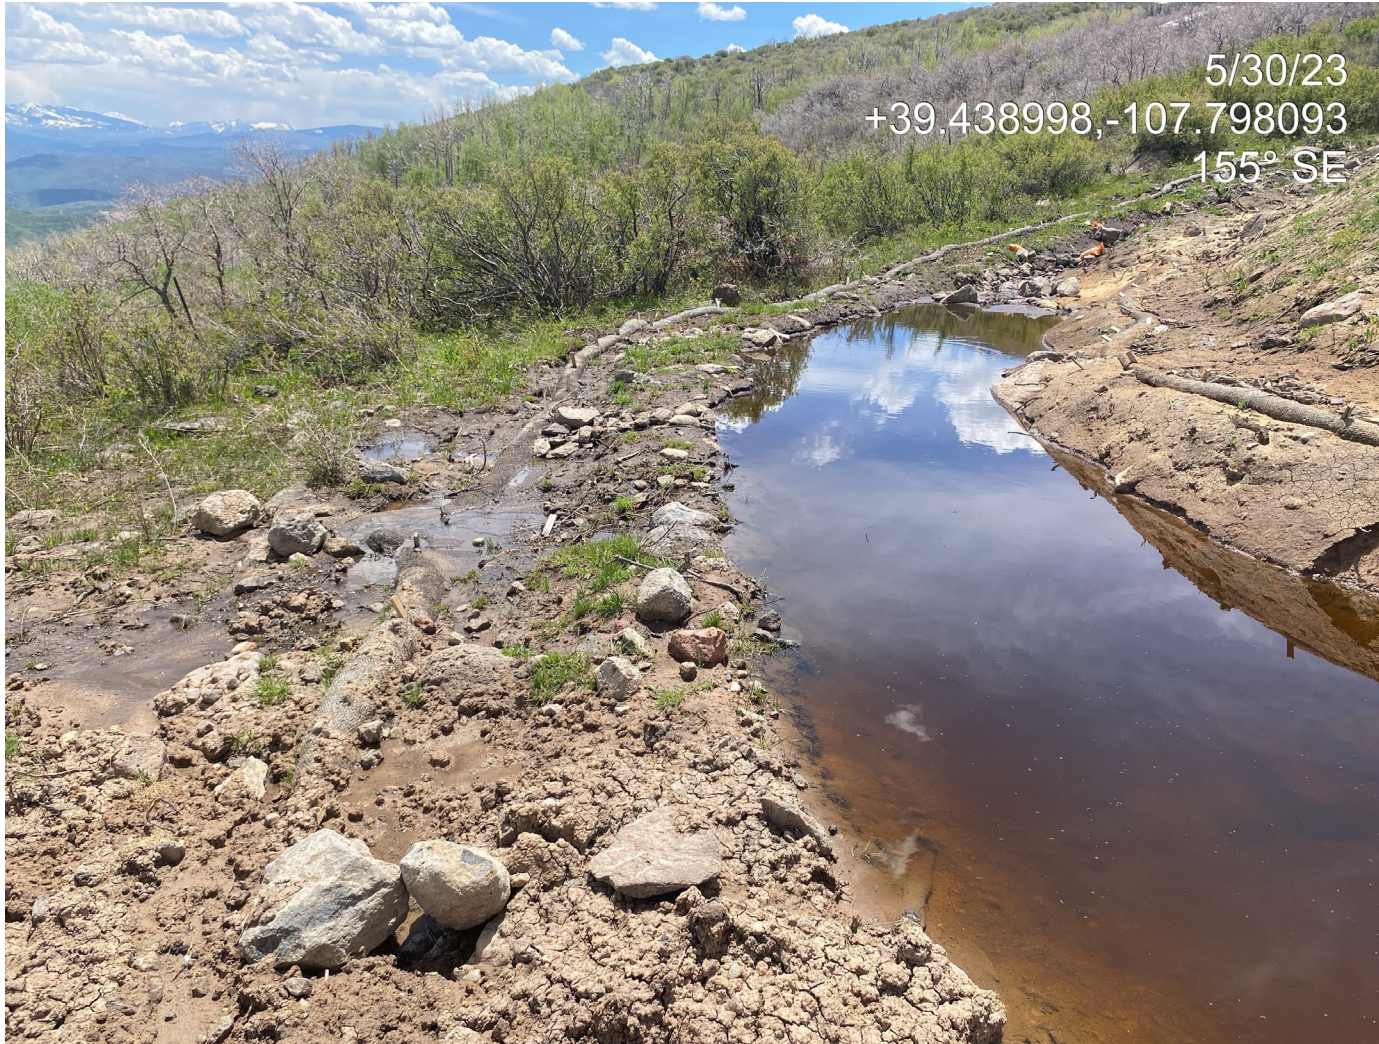
Photo 11. Refer to Photo 10 comment.

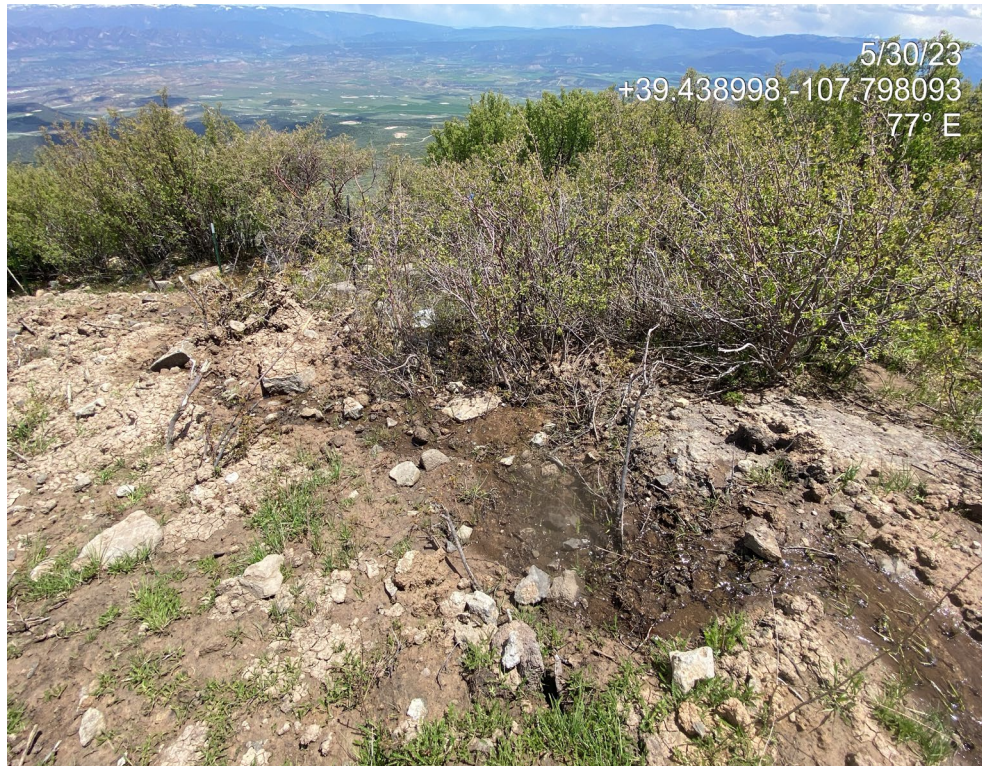
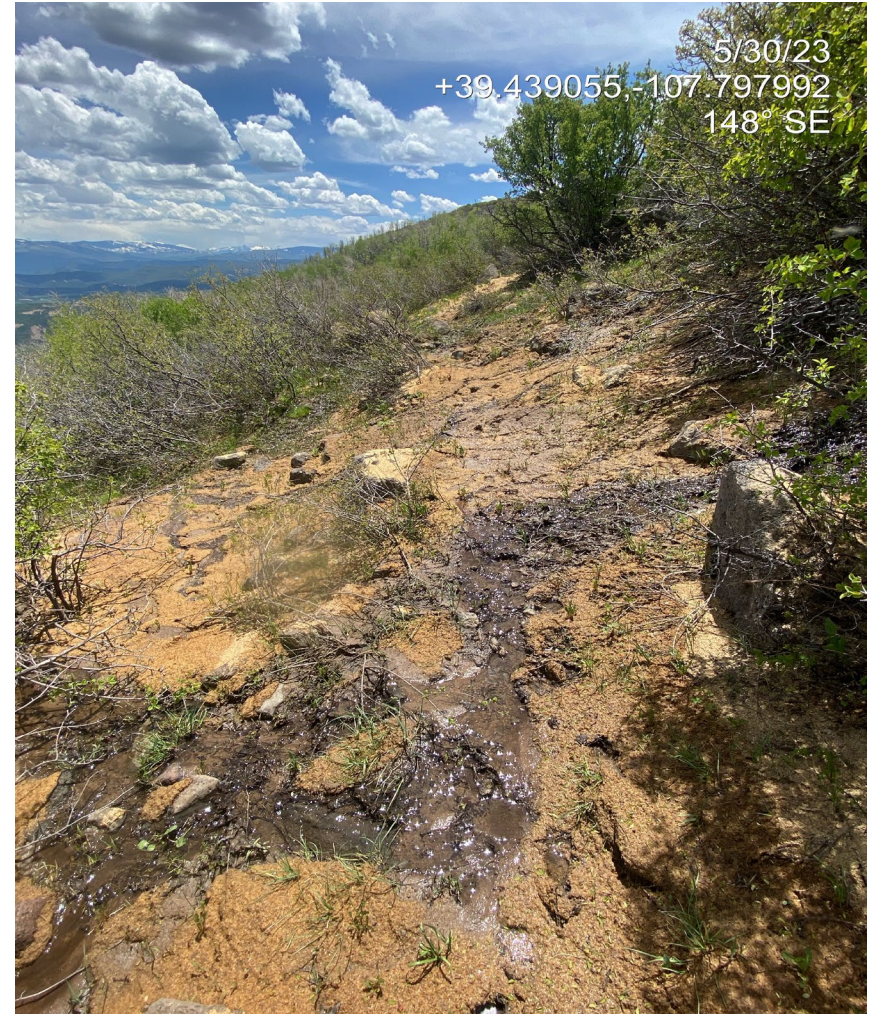
Photo 12. Photos show sediment and sawdust deposition downslope of the sediment trap at the northeast of the location.

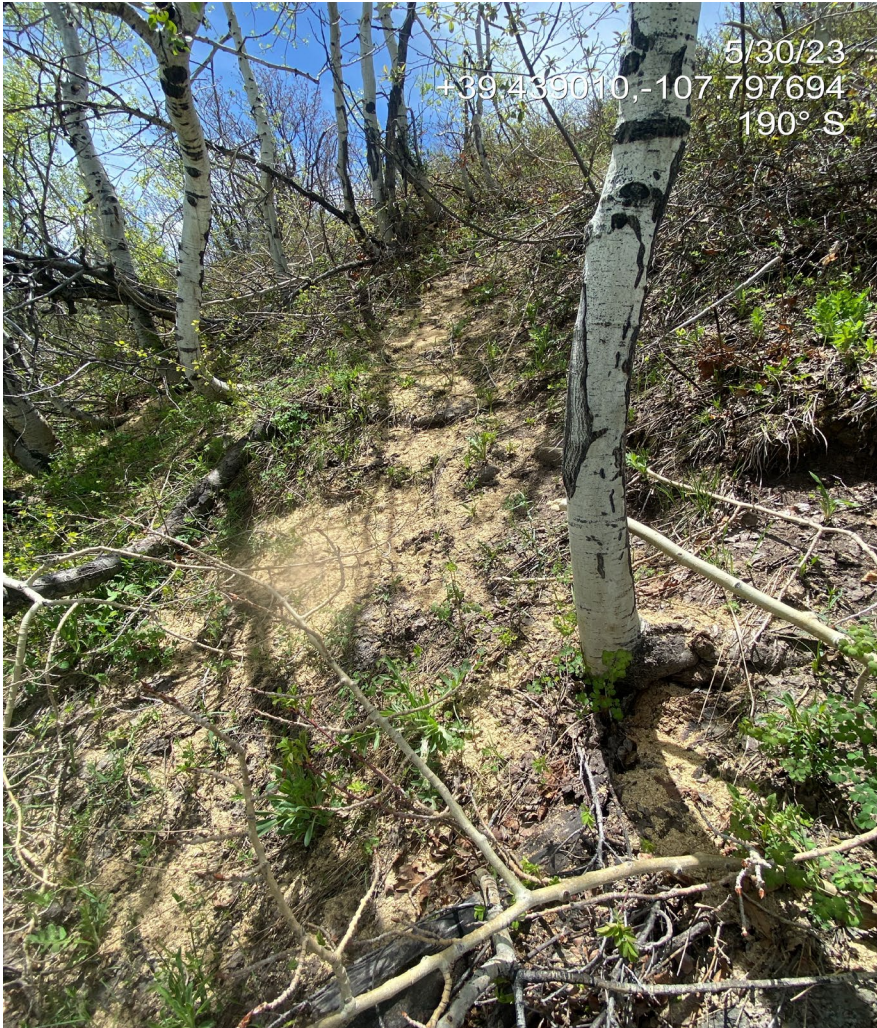
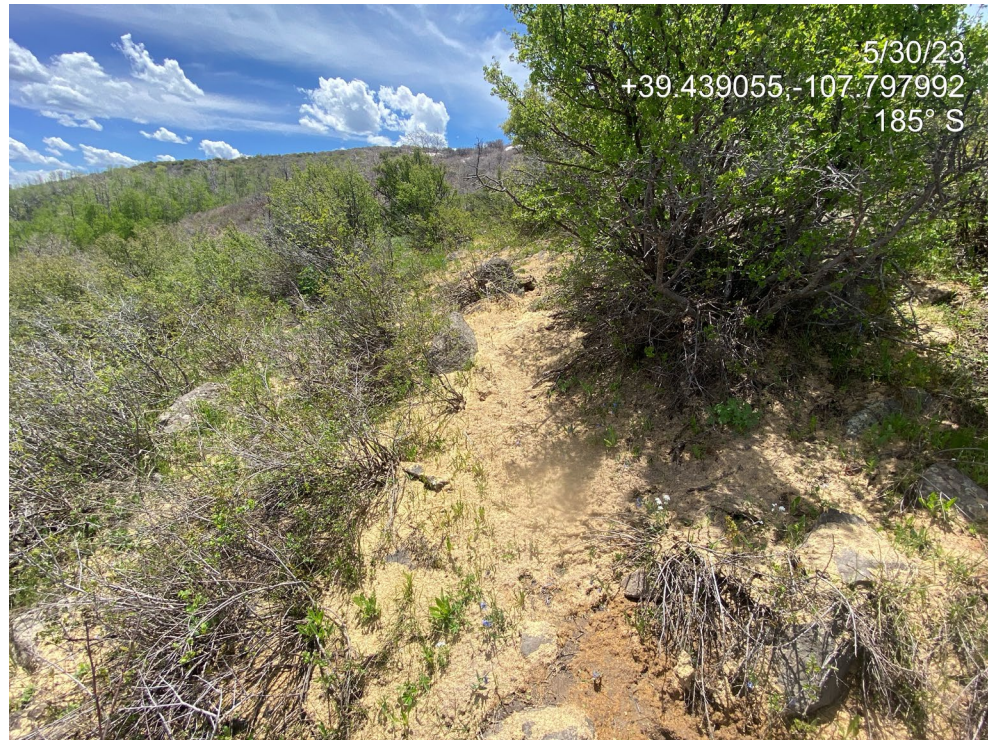
Photo 13. Photos show sawdust from the cuttings trench covering vegetation and causing offsite degradation.

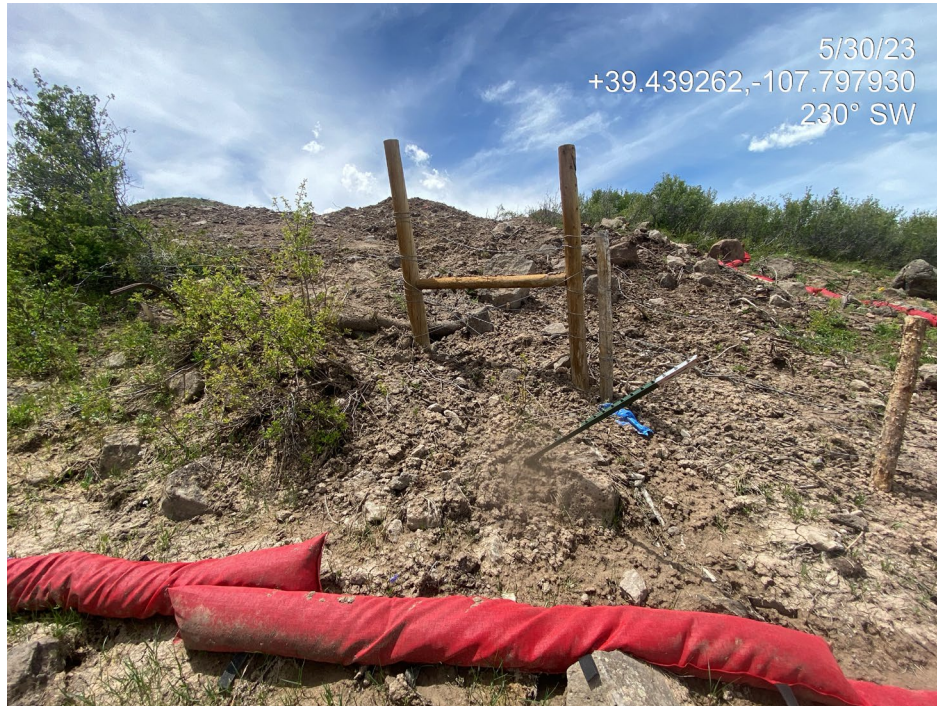
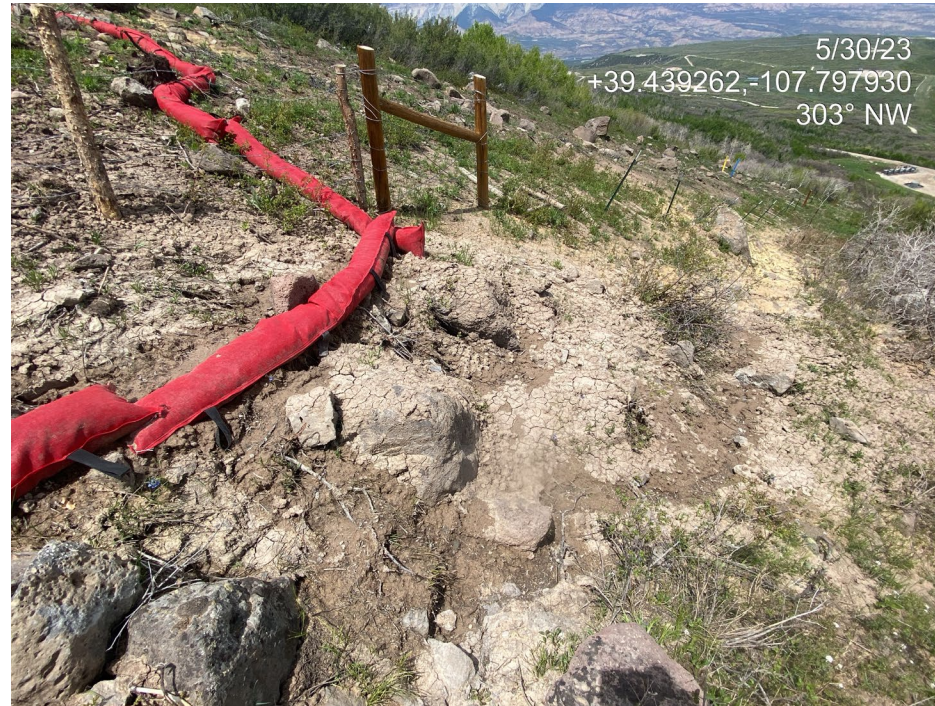
Photo 14. Photos show lack of stabilization BMPs on soils at the east of the location. Sediment is accumulating downslope, offsite.

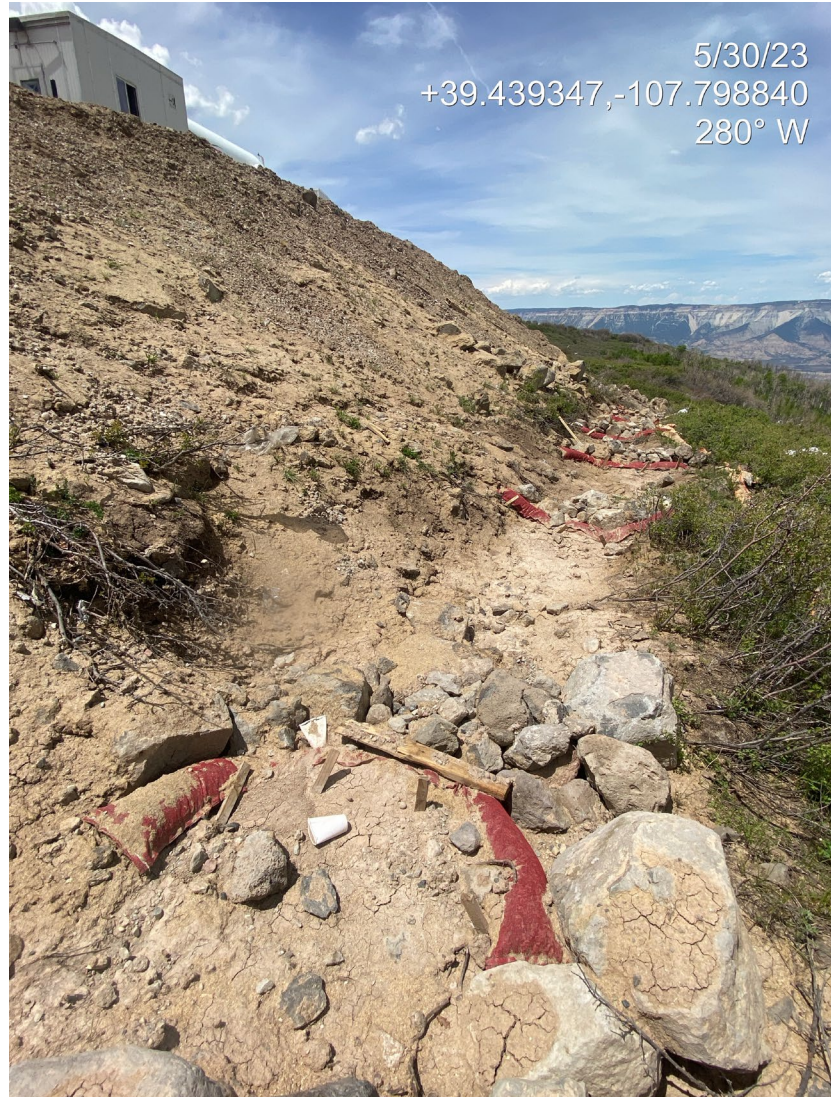
Photo 15. Photo shows sediment deposition downslope of the northern perimeter stormwater ditch. Stormwater is exiting the ditch in multiple places. The ditch is filled with sediment. Note also trash.

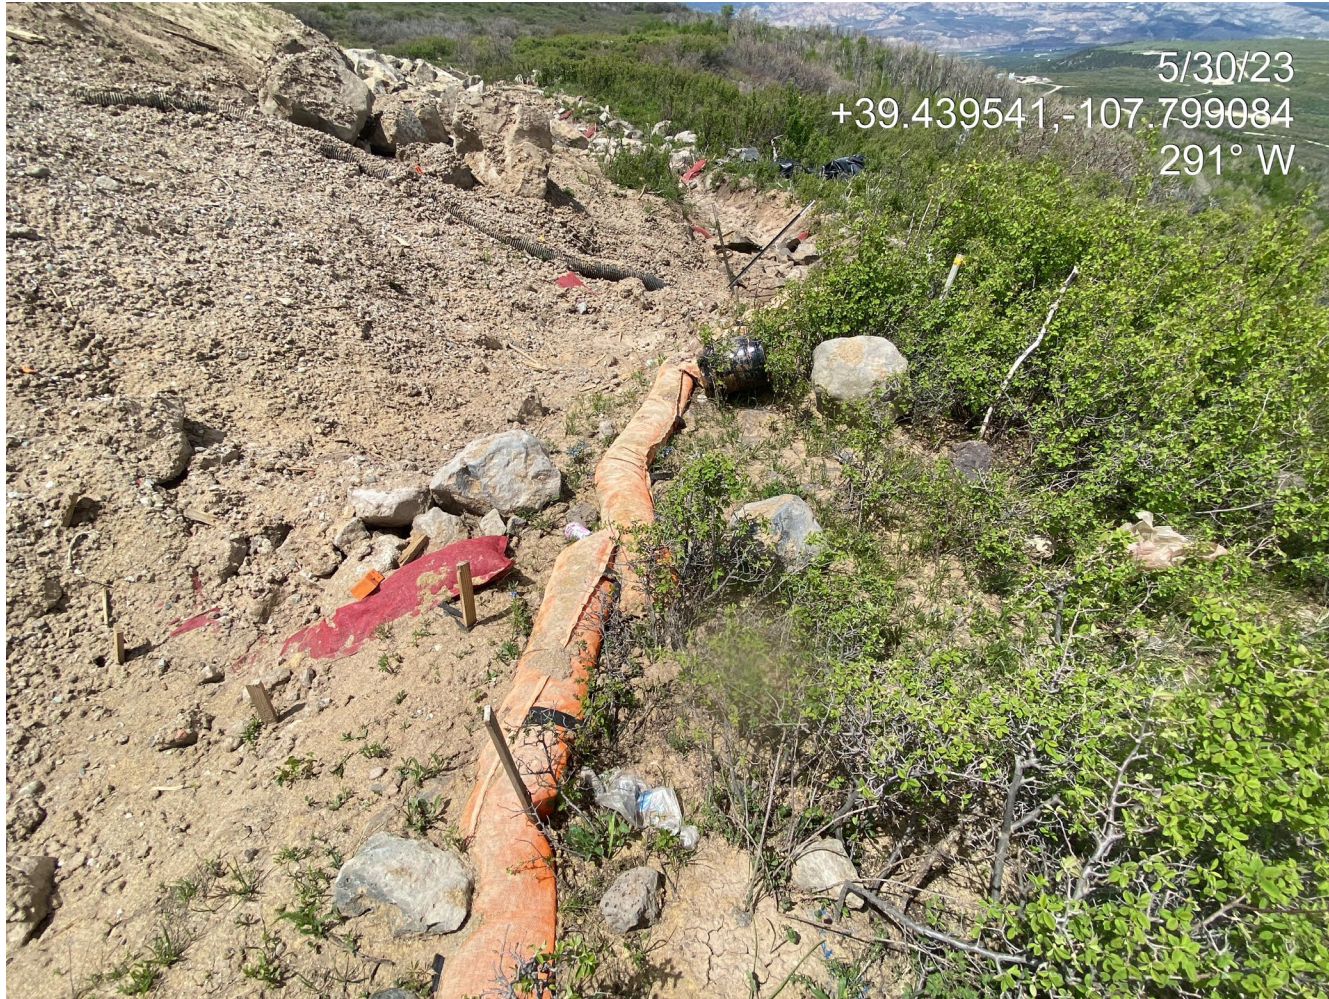
Photo 16. Photo shows the perimeter stormwater ditch to the northwest is filled with eroded fill material and no longer functioning as a ditch to properly transport water. Note also trash.

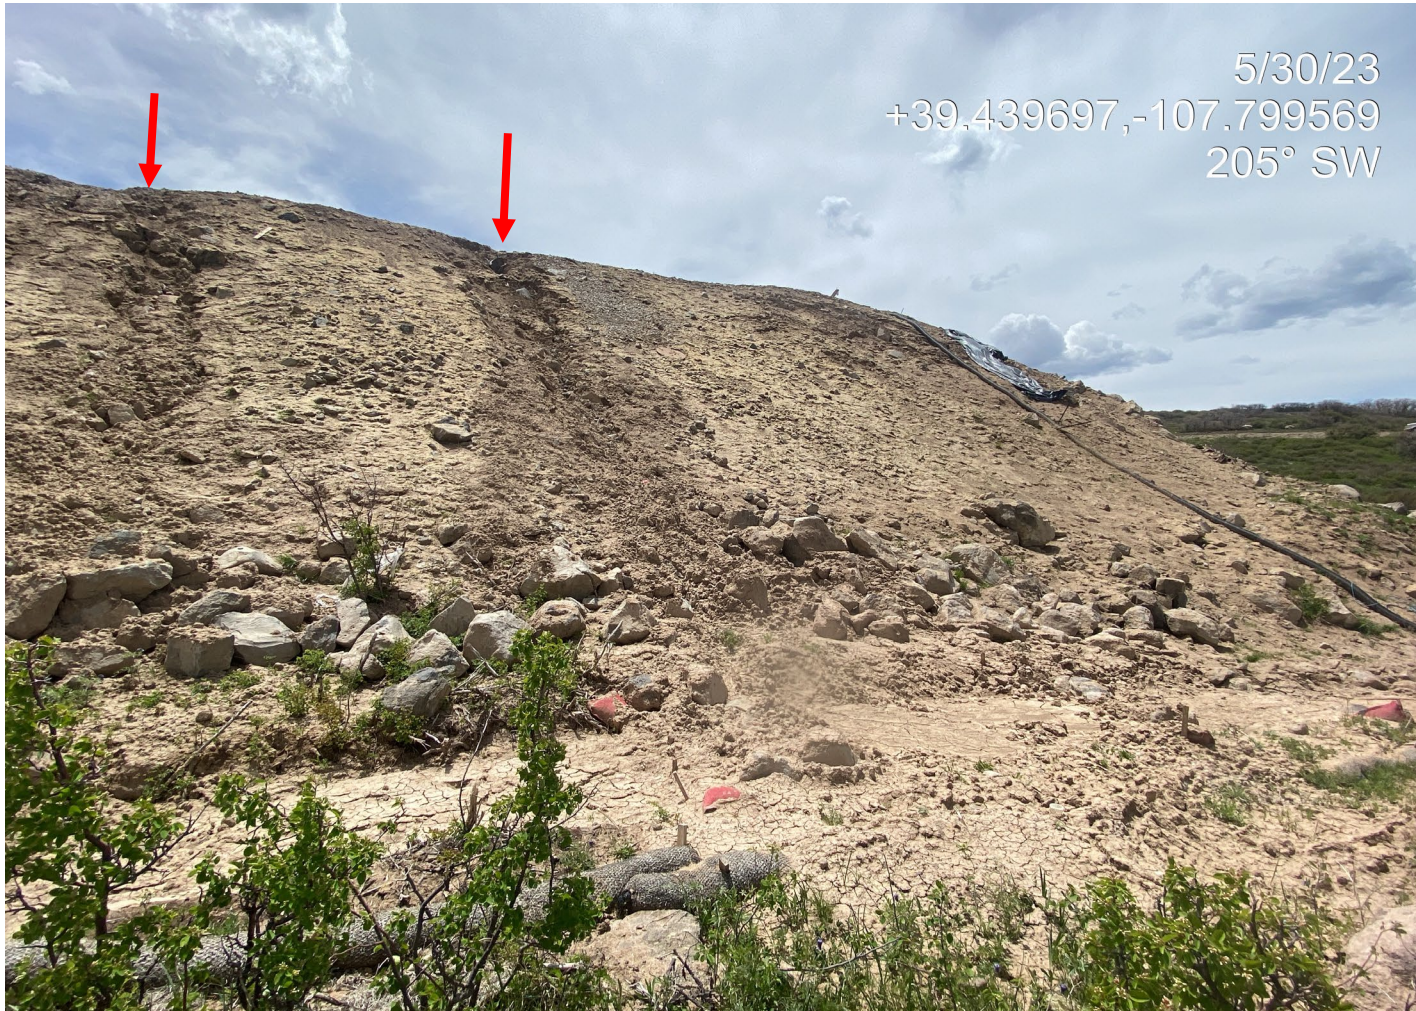
Photo 17. Photo shows the fill slope is unstabilized. Sediment from gully erosion has filled in and overtopped perimeter stormwater BMPs and is being transported offsite.
