Inspection Photos

May 30, 2023

Location Name: FEDERAL/WMC 24-17

Inspection Document #: 702801565

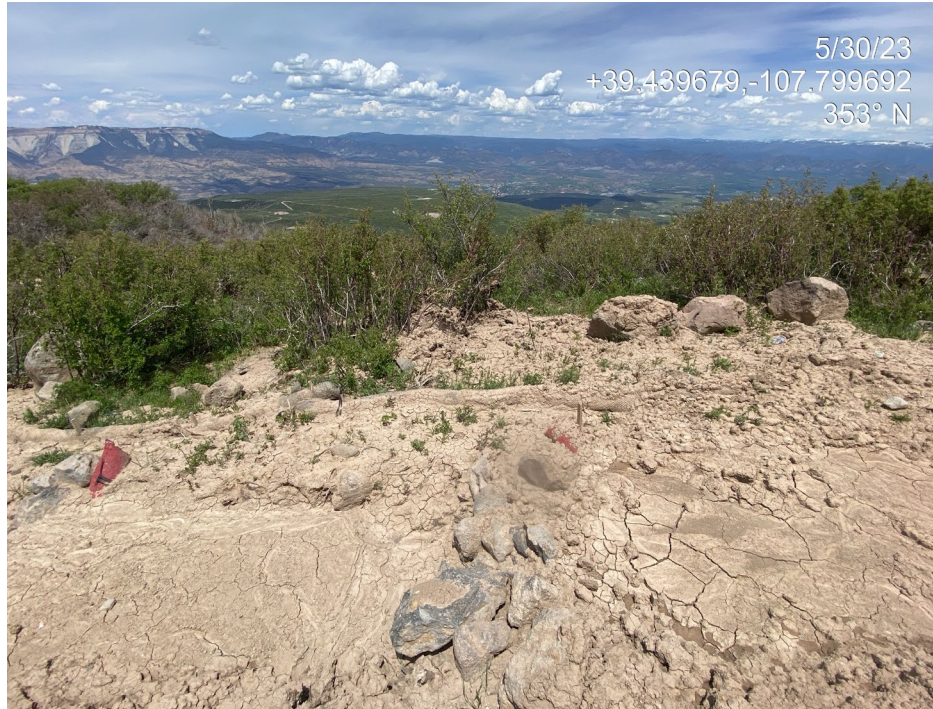
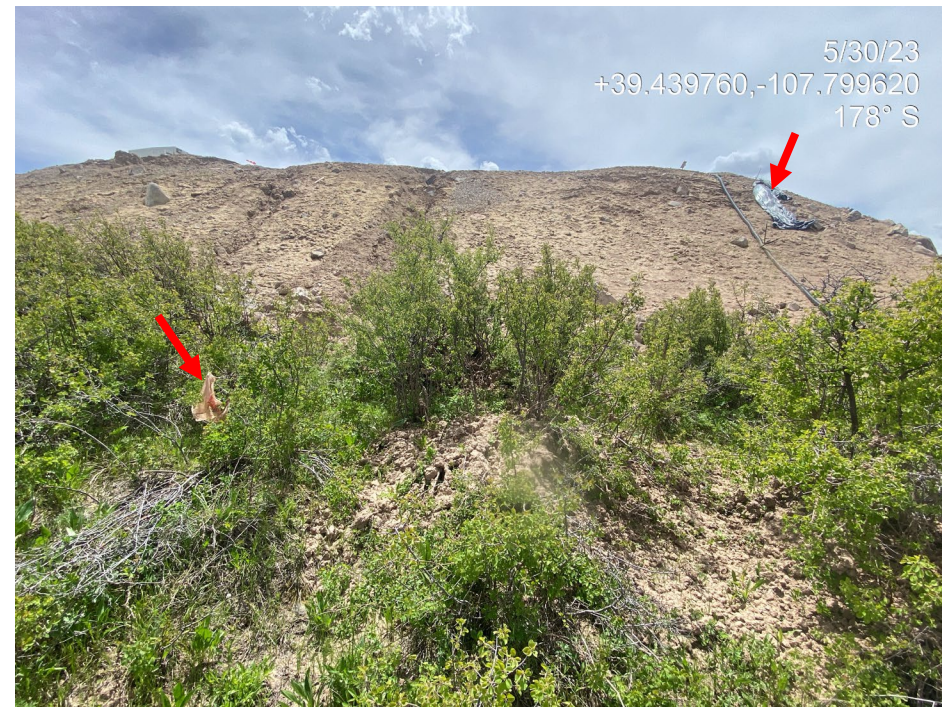
Photo 18. Photos show offsite sediment transport below the fill slope gullies pictured on the previous slide. Note also trash/debris (arrows).

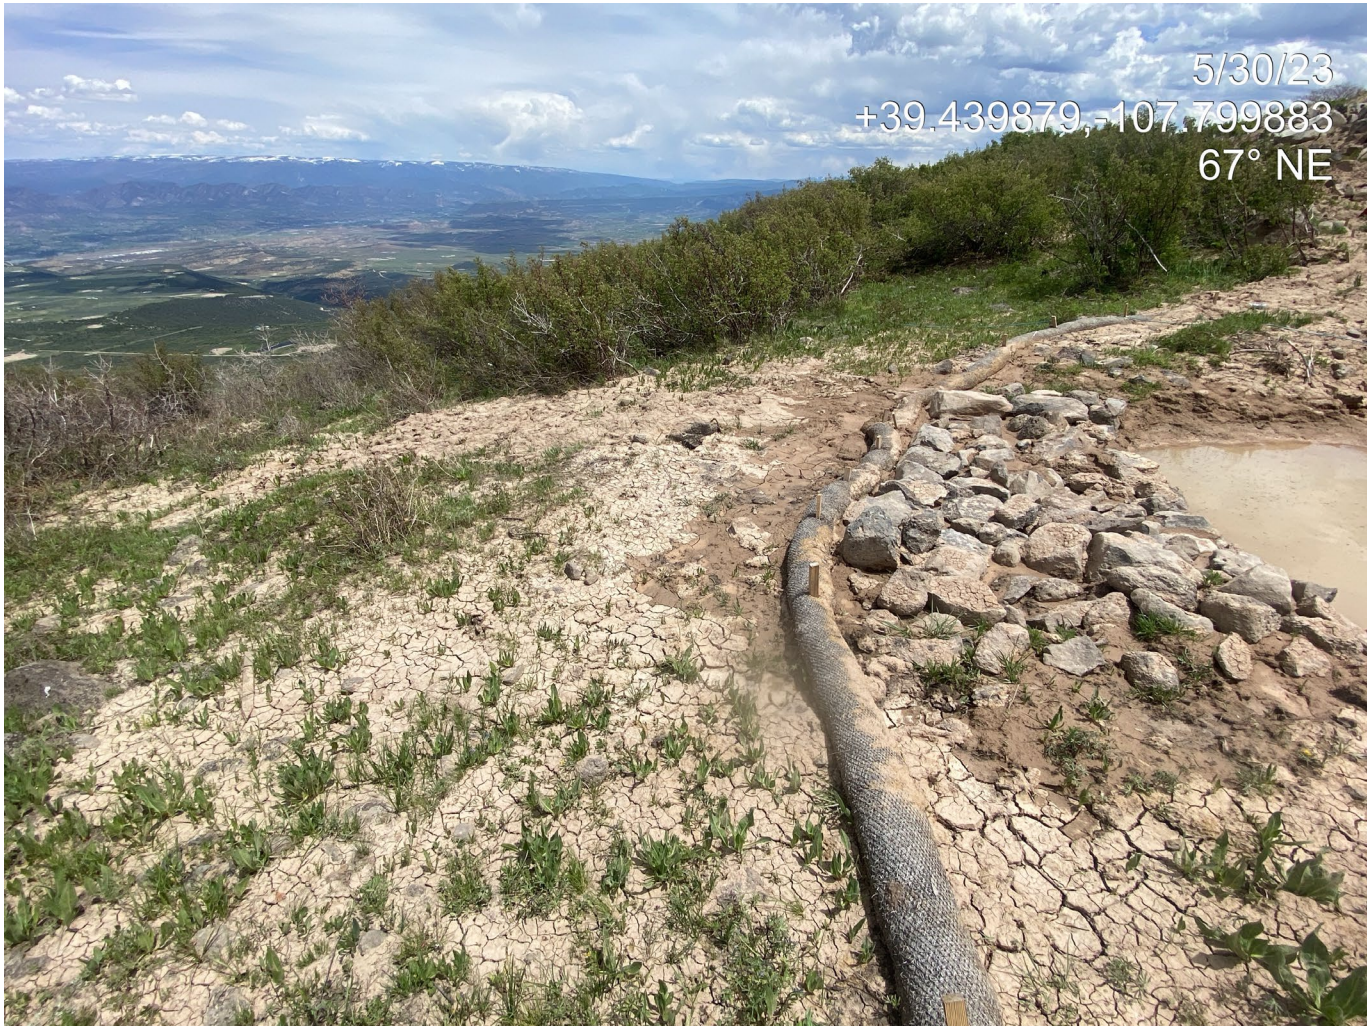
Photo 19. Photo shows sediment laden stormwater bypassing a sediment trap outlet resulting in offsite degradation and sediment transport.

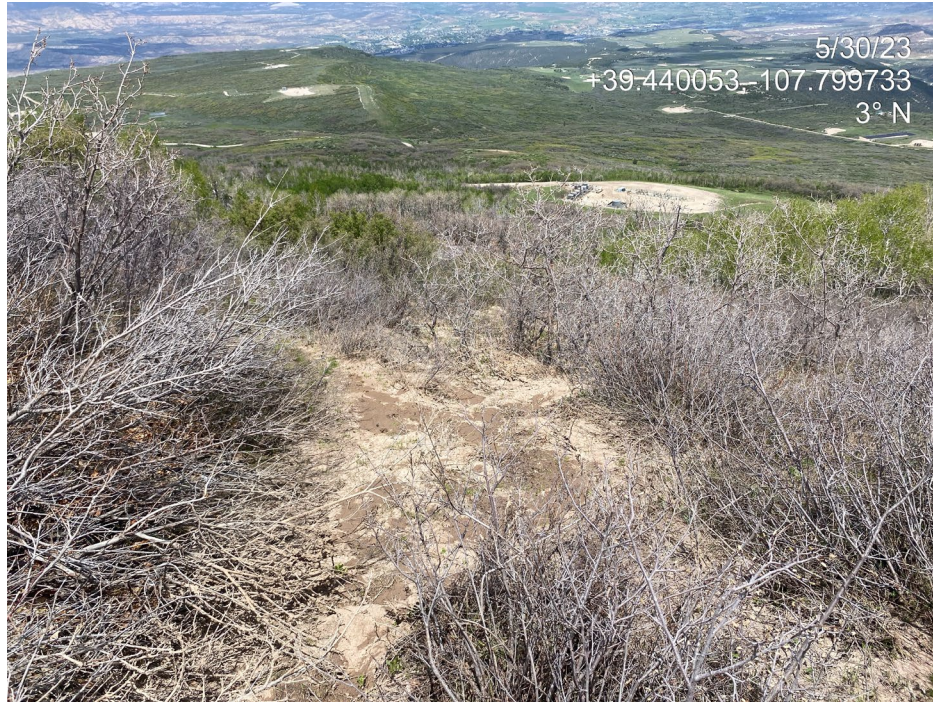
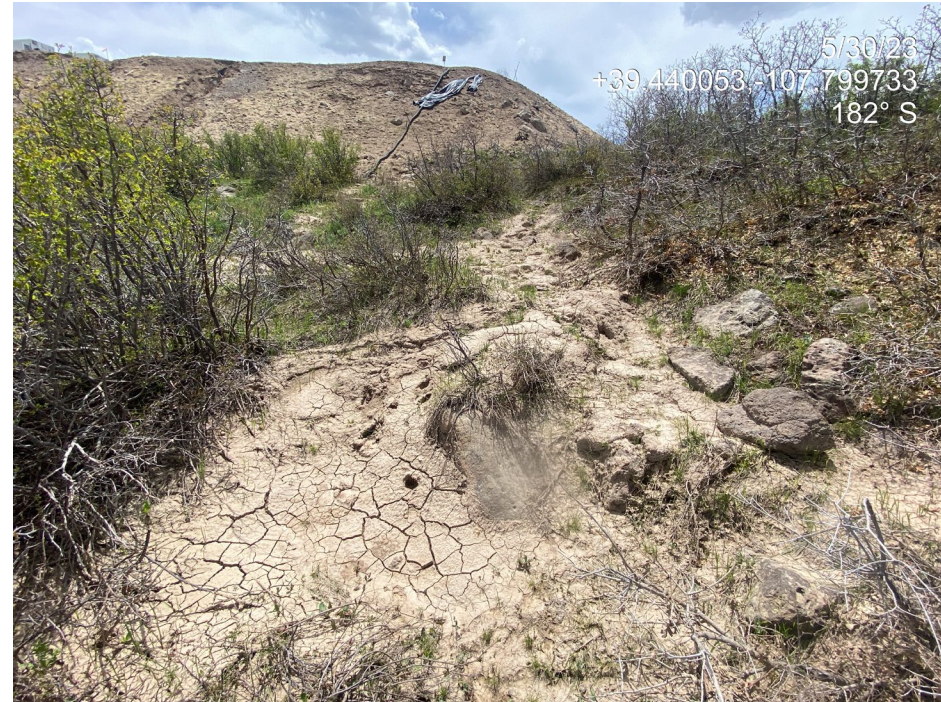
Photo 20. Photos show offsite sediment transport below the sediment trap pictured on the previous slide.

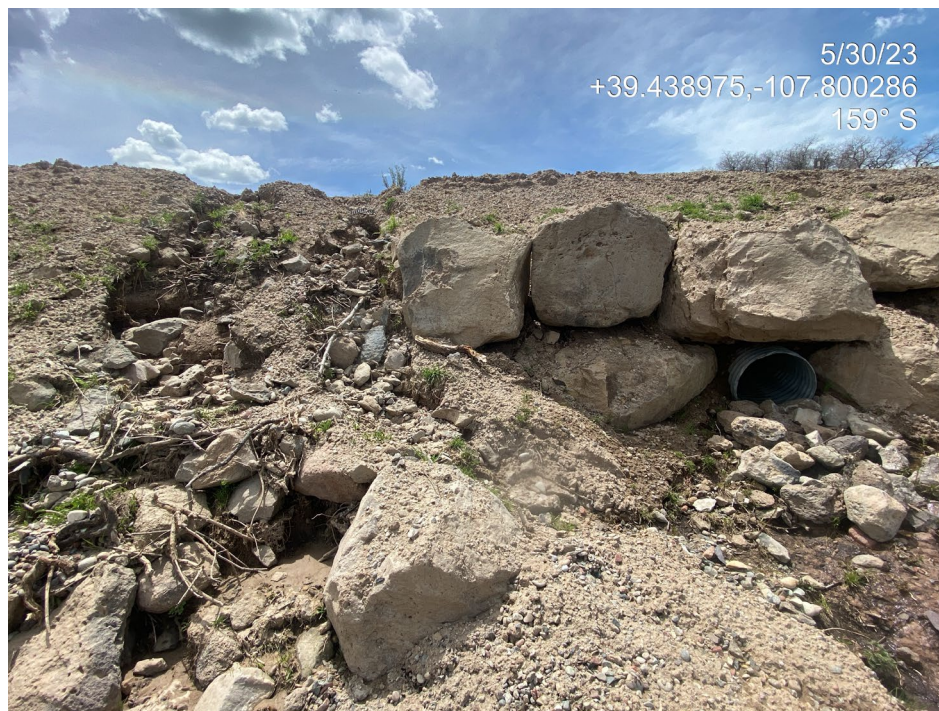
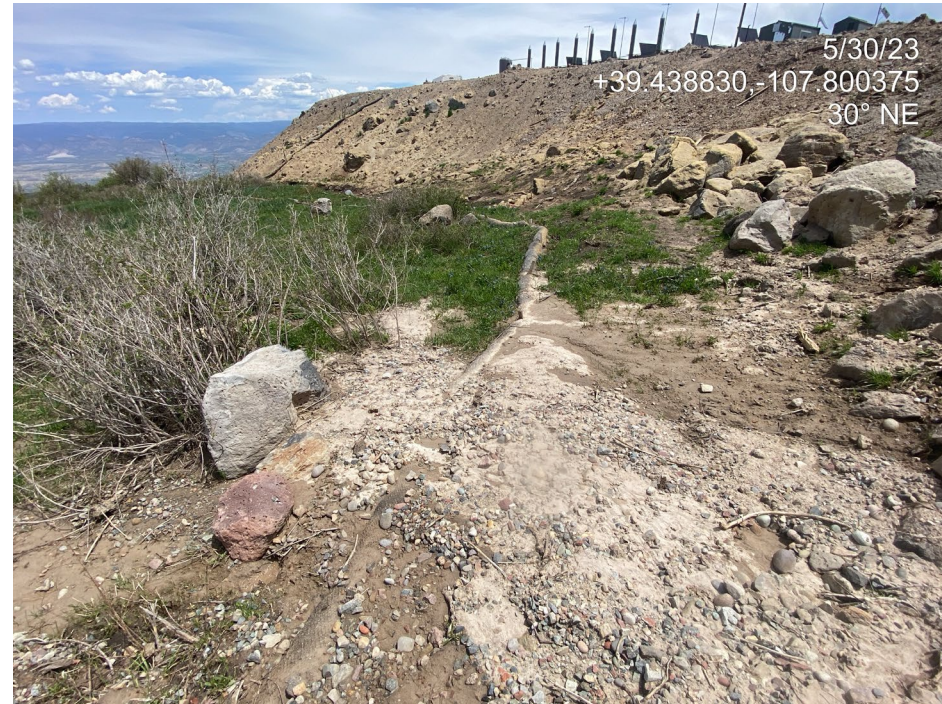
Photo 21. Photos taken from the access road to the west of the location. Stormwater is bypassing a culvert and eroding the road fill (left) and overtopping wattles, and transporting and depositing sediment in undisturbed areas offsite (right).

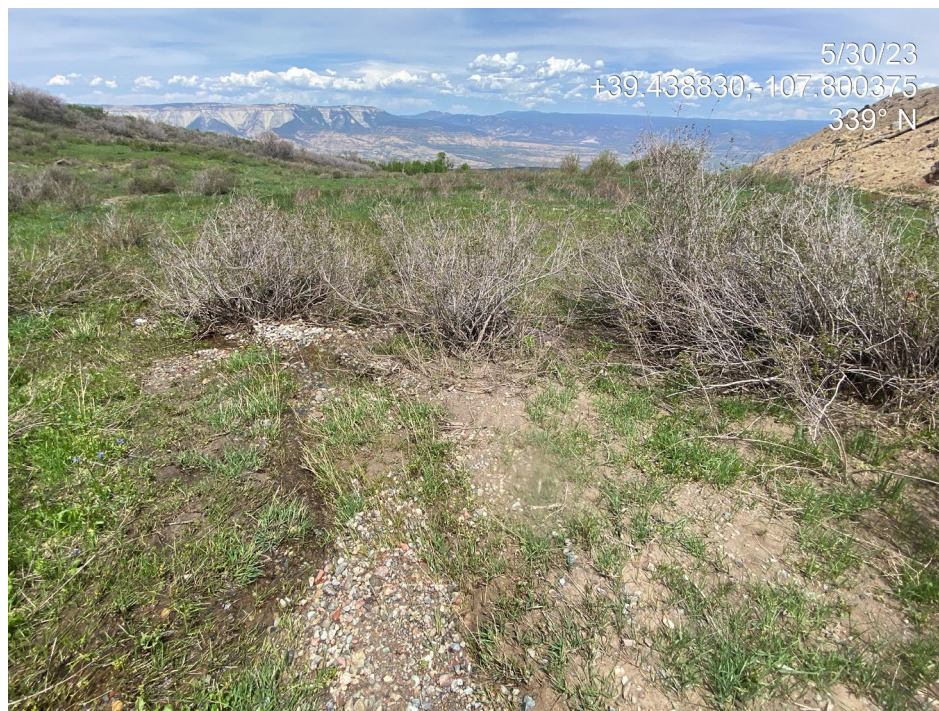
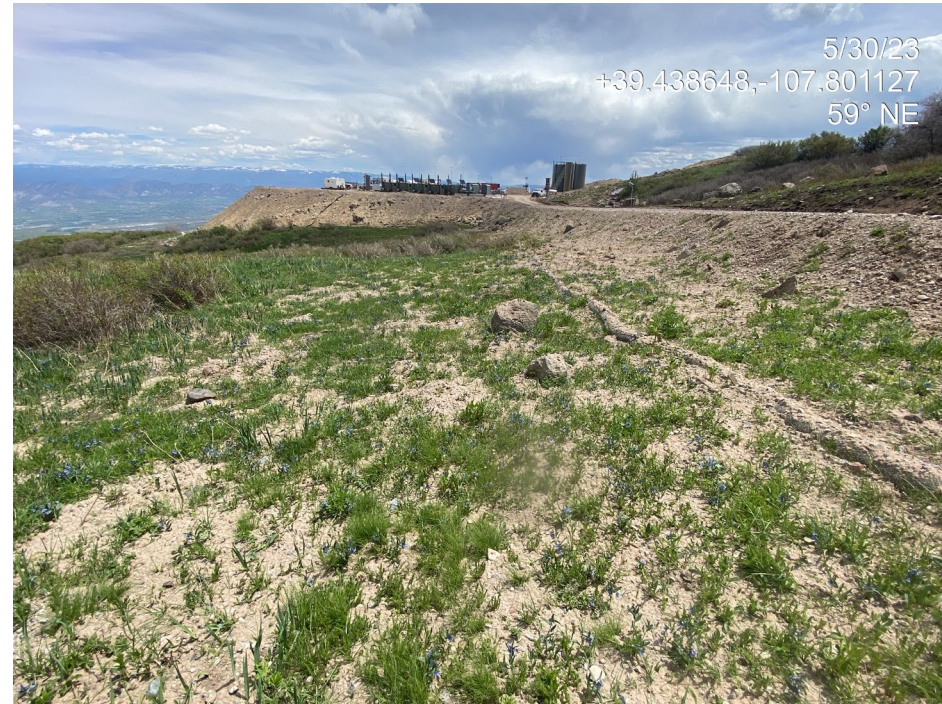
Photo 22. Photos show offsite deposition of sediment and road base gravel downslope of the access road. Wattles have been overtopped (right).

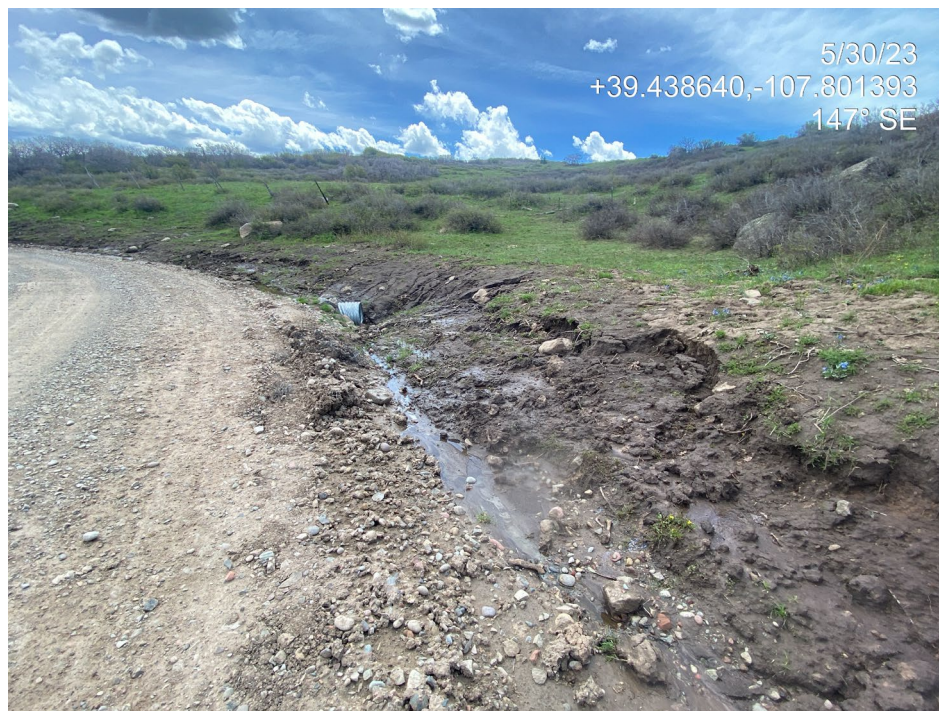
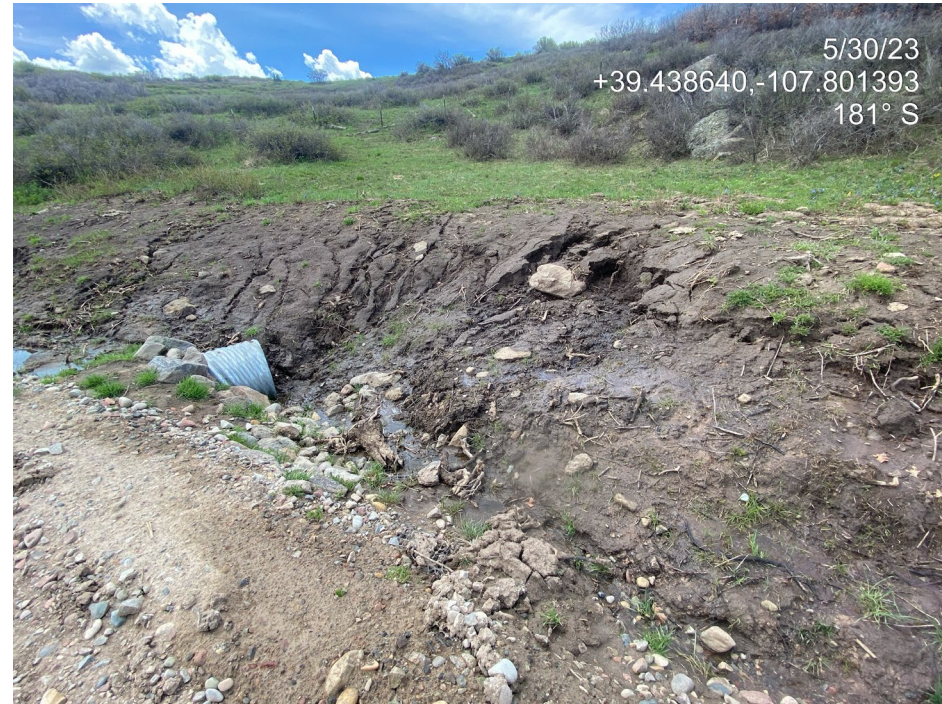
Photo 23. Photos show sloughing, slumping and rill erosion occurring on the access road cut.

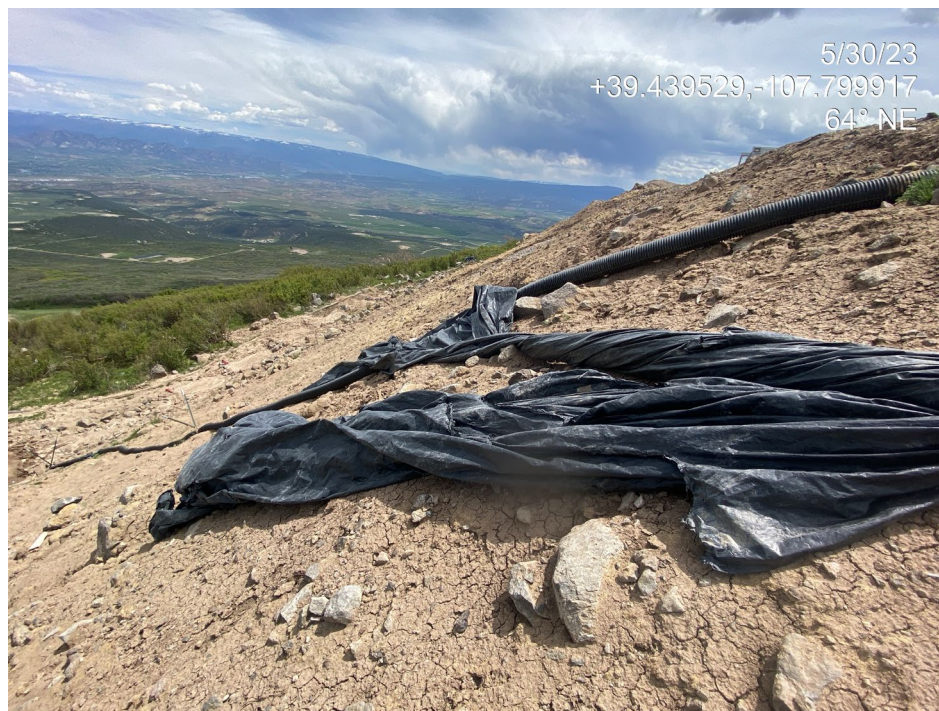
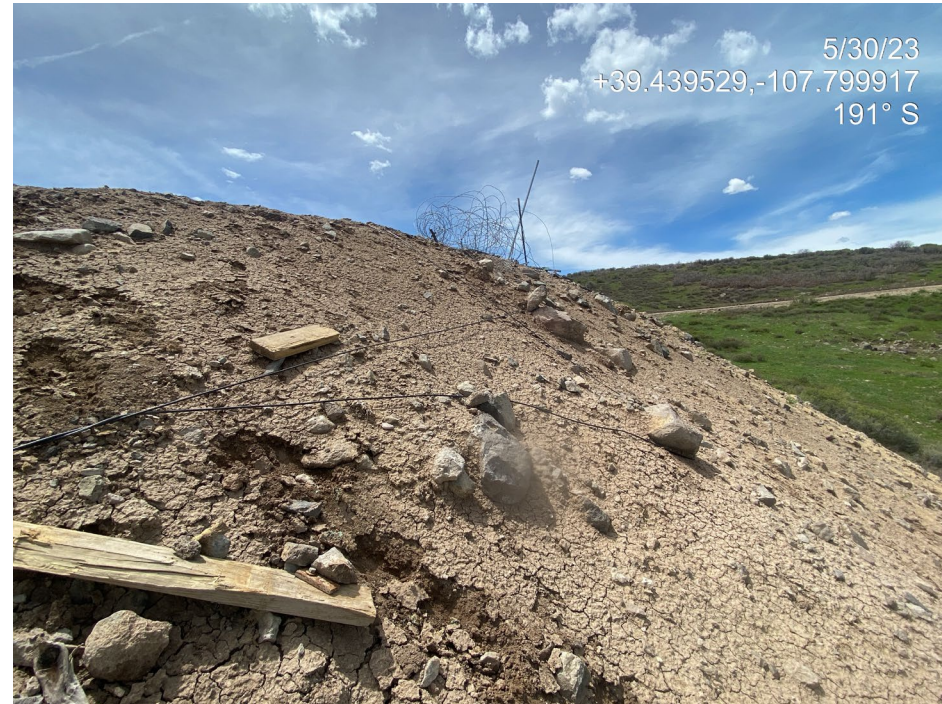
Photo 24. Photos taken from the fill slope to the northwest show examples of trash and debris

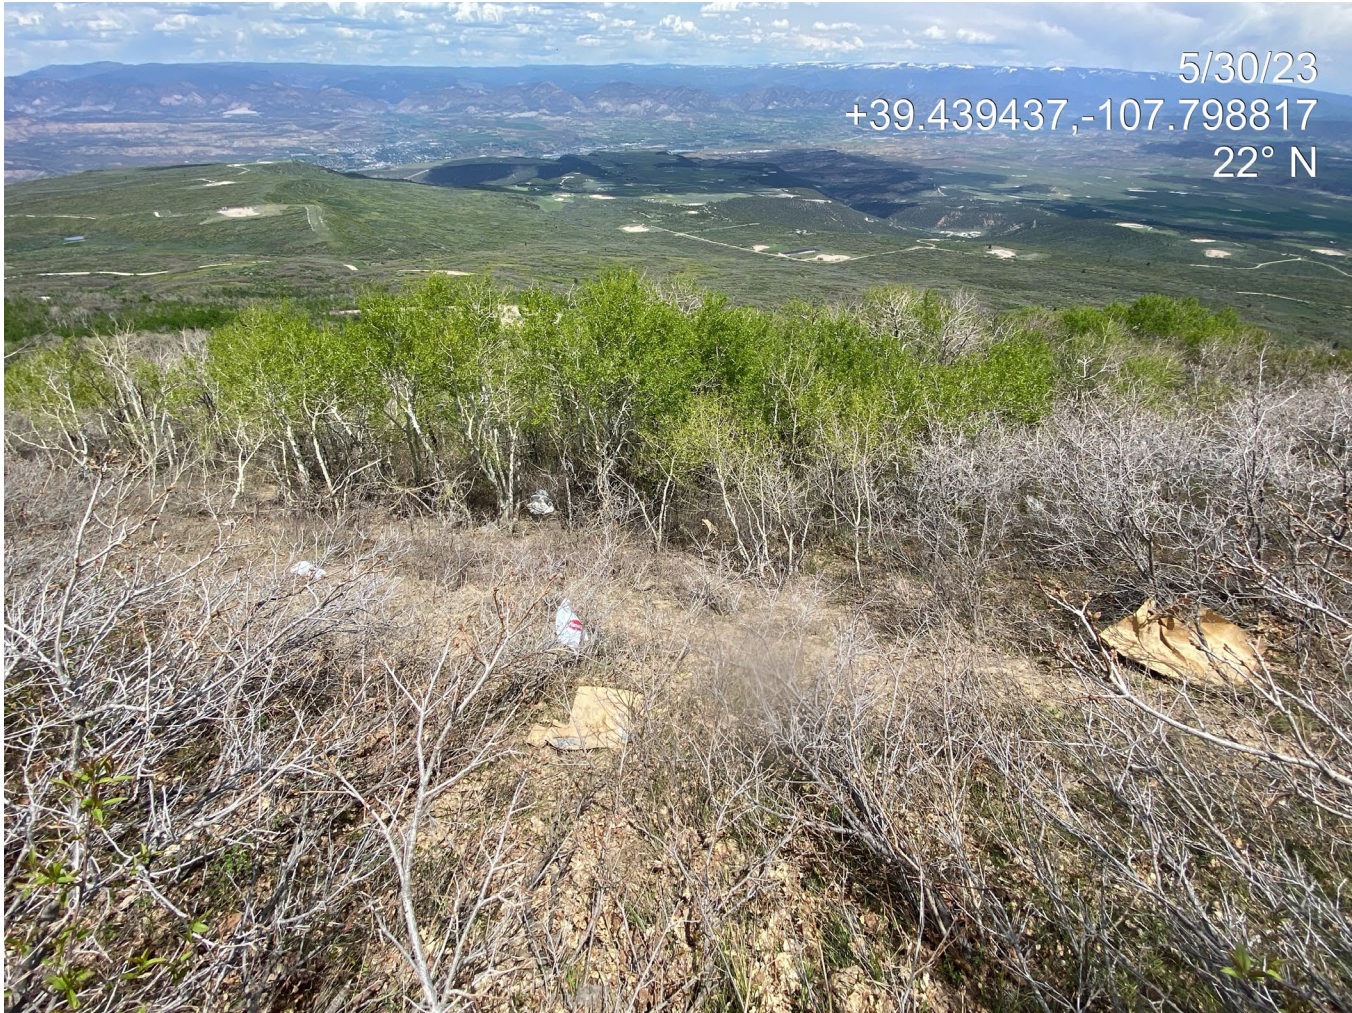
Photo 25. Photos shows examples of trash throughout the reference areas to the north.

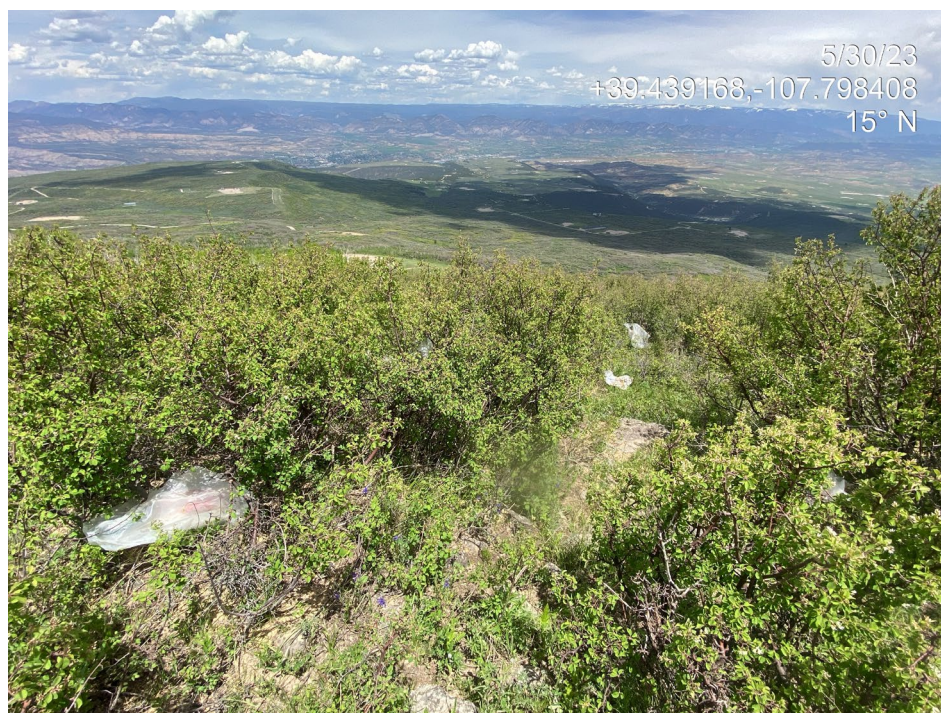
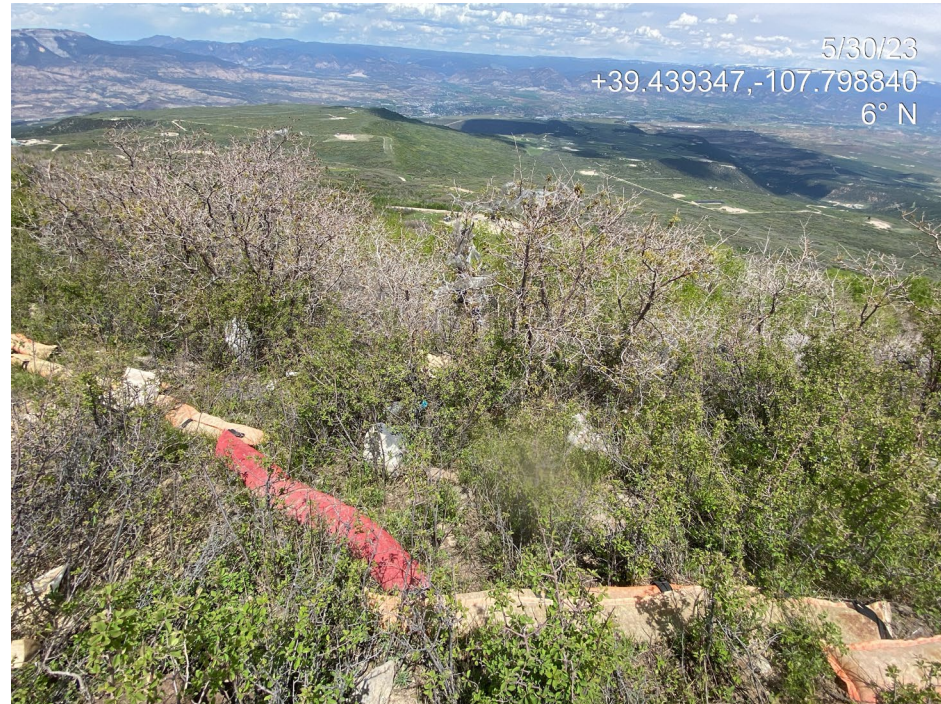
Photo 26. Photos shows examples of trash throughout the reference areas to the north.

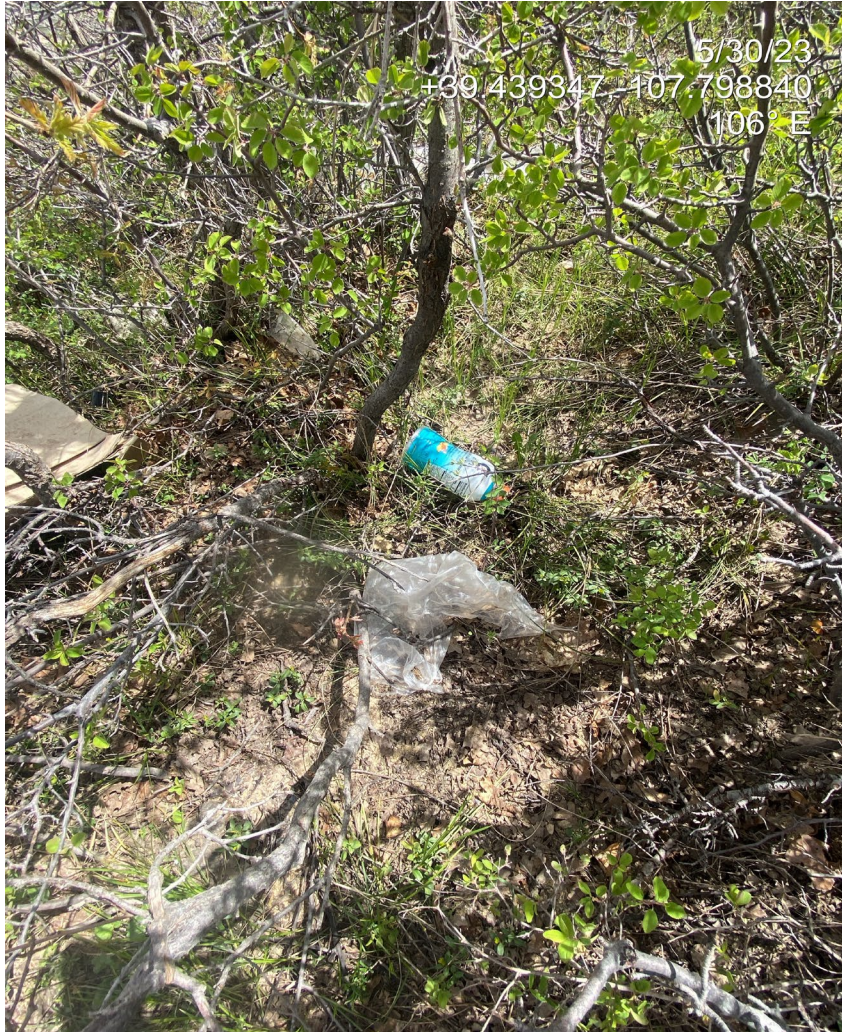
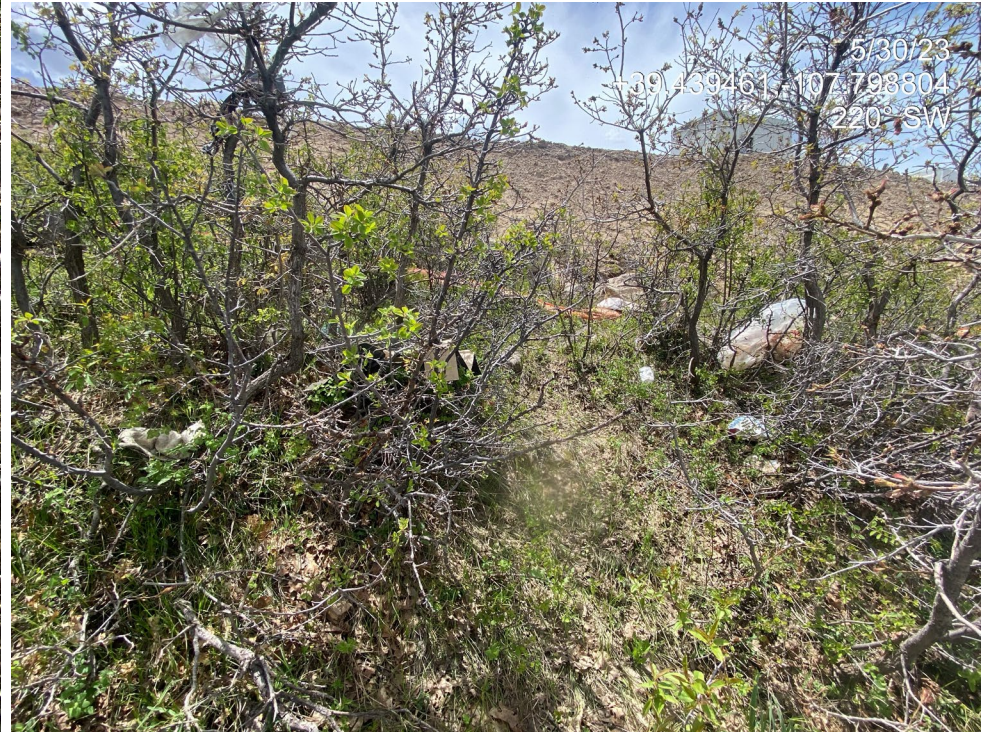
Photo 27. Photos shows examples of trash throughout the reference areas to the north.
