Inspection Photos  
Location Name: CHAMPLIN 459 AMOCO 2  
Location ID: 319997

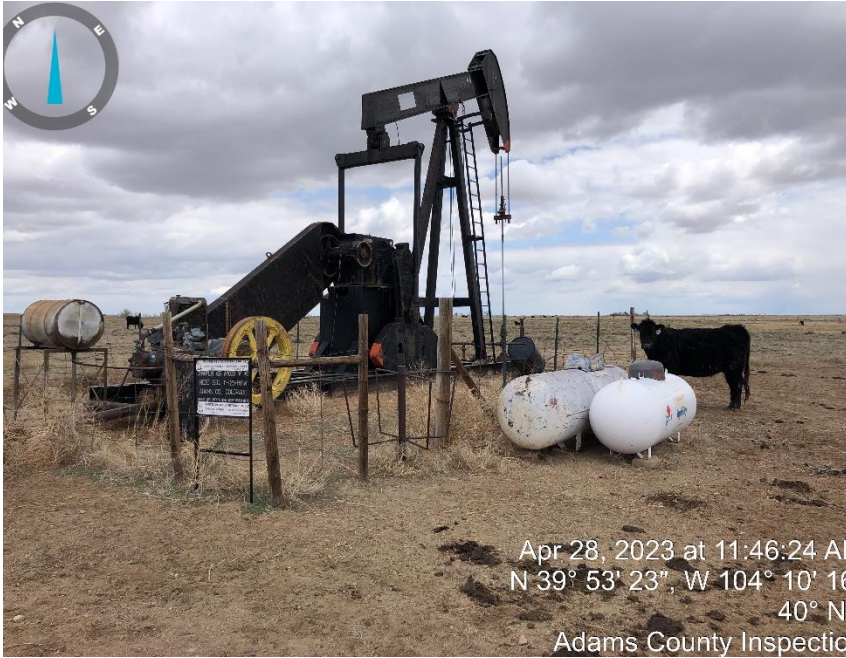
Photo# 1 Pump jack.

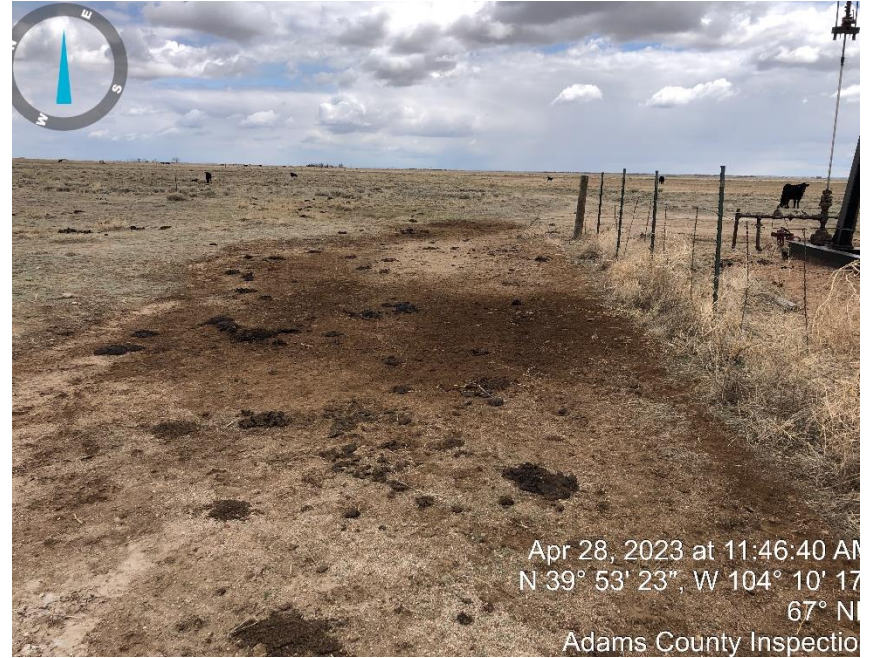
Photo# 2 Stained soil.

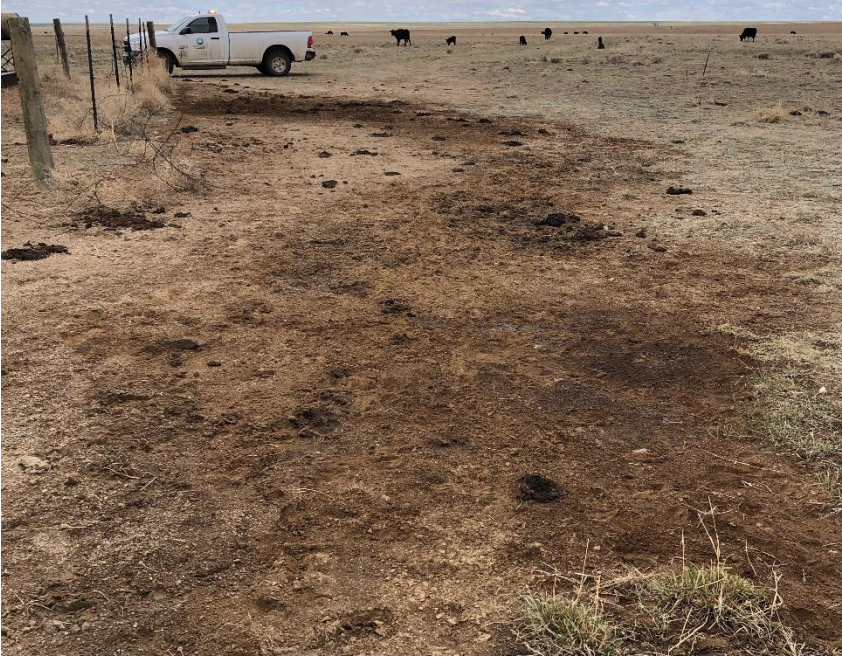
**Photo# 3 Stained soil.**

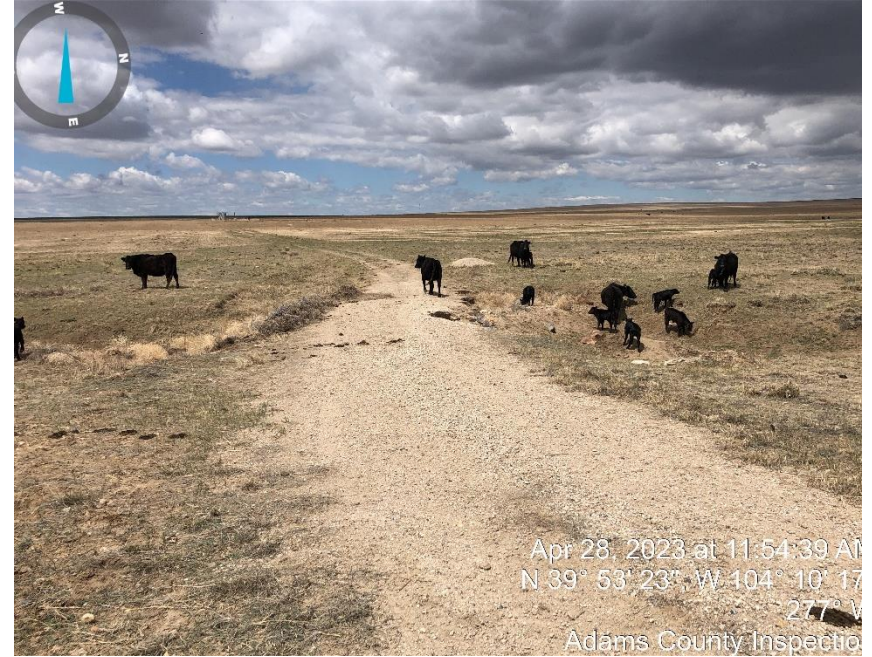
**Photo# 4 Damaged road.**
