**Antler Energy LLC
Ross-Government-USA 43-7
Location #312970**

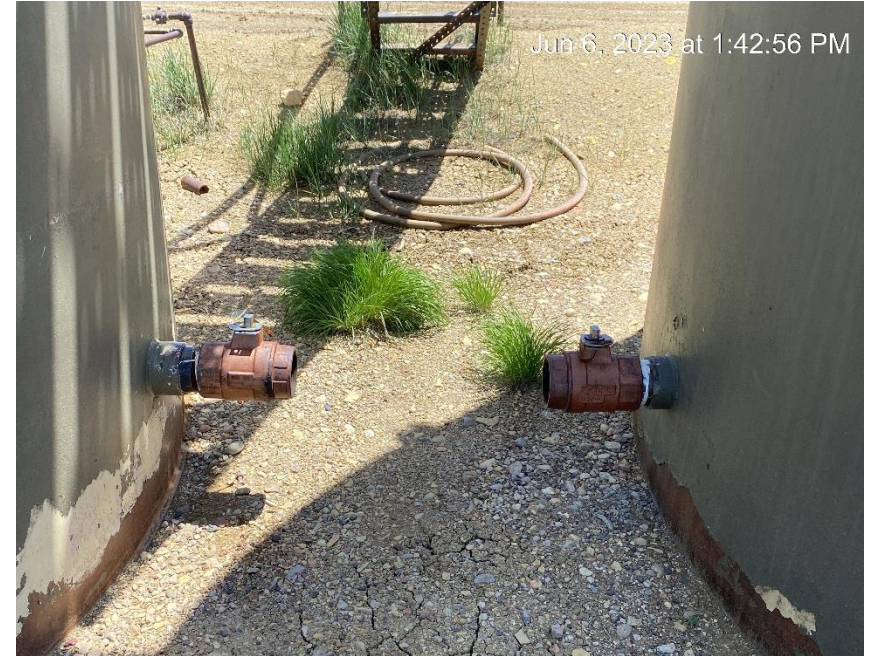
Open end tank valves. Debris

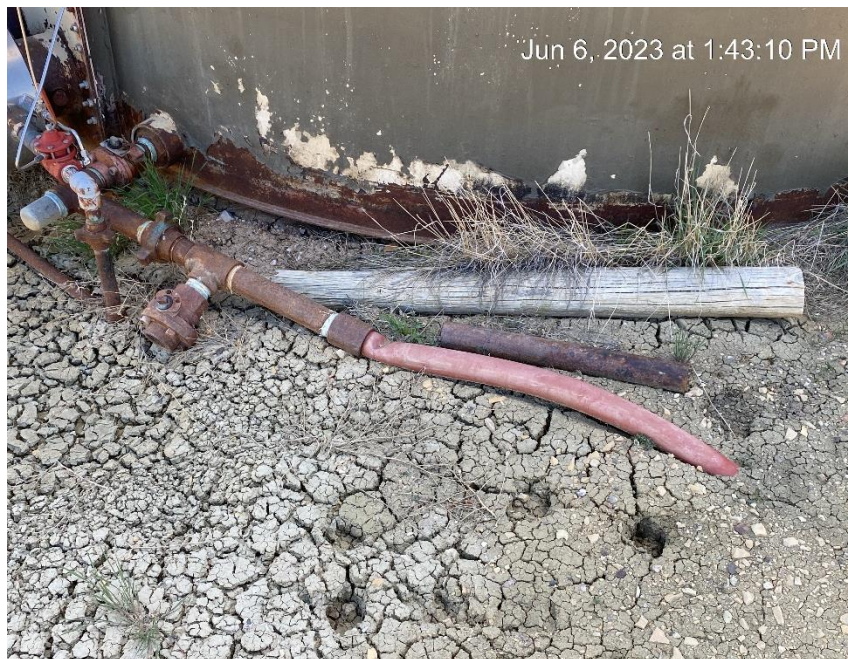
Open end tank valve. Debris

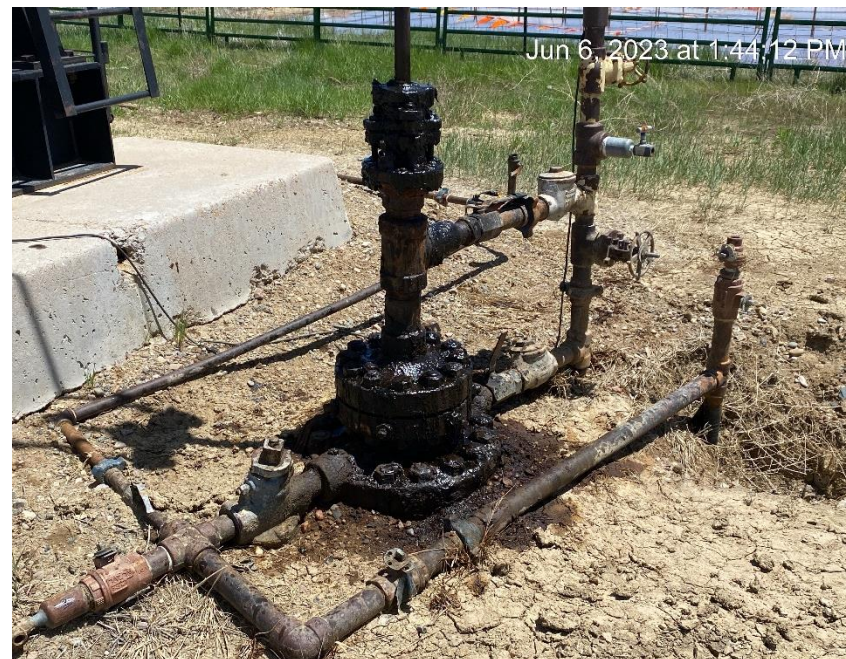
Leaking equipment. Stained equipment and soils

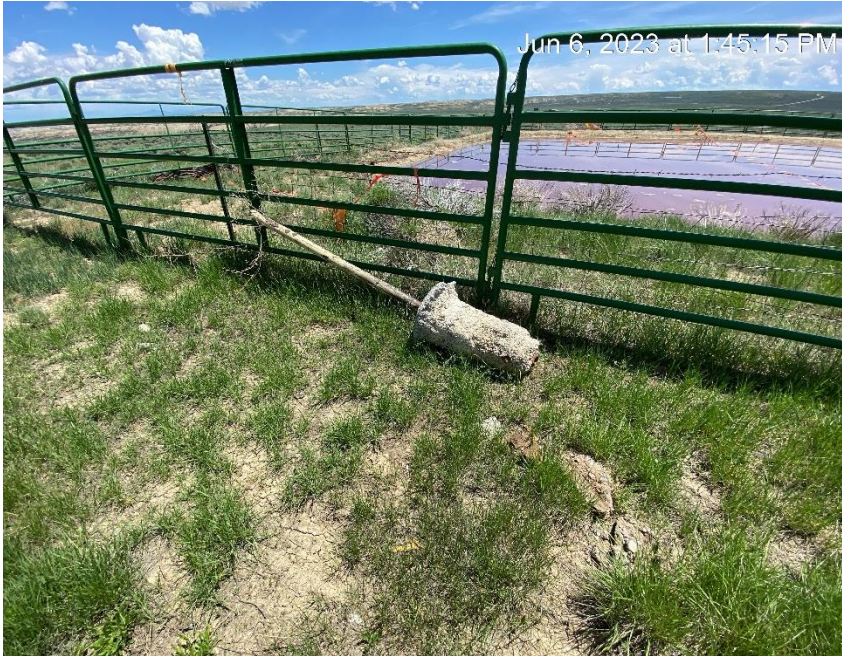
Debris

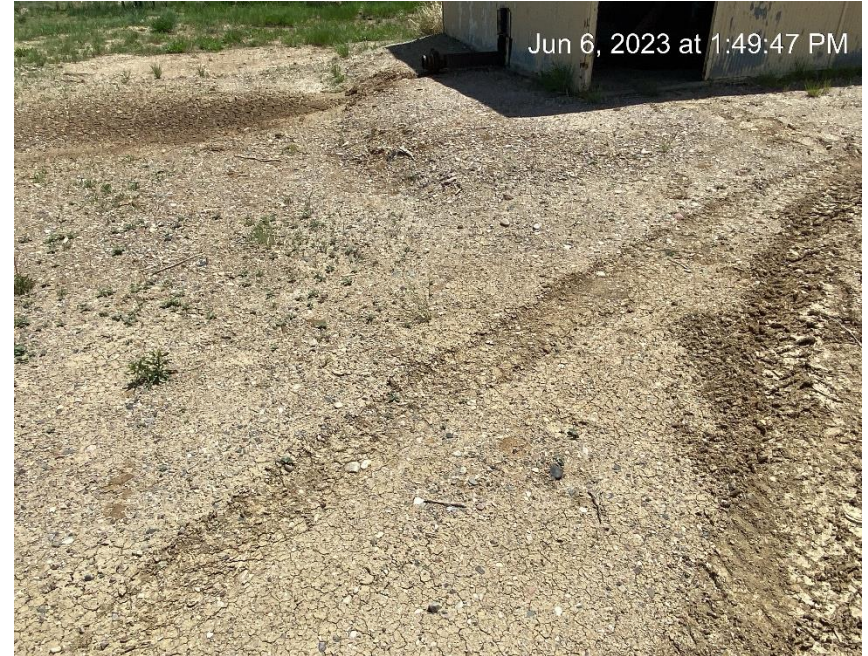
Stained soil

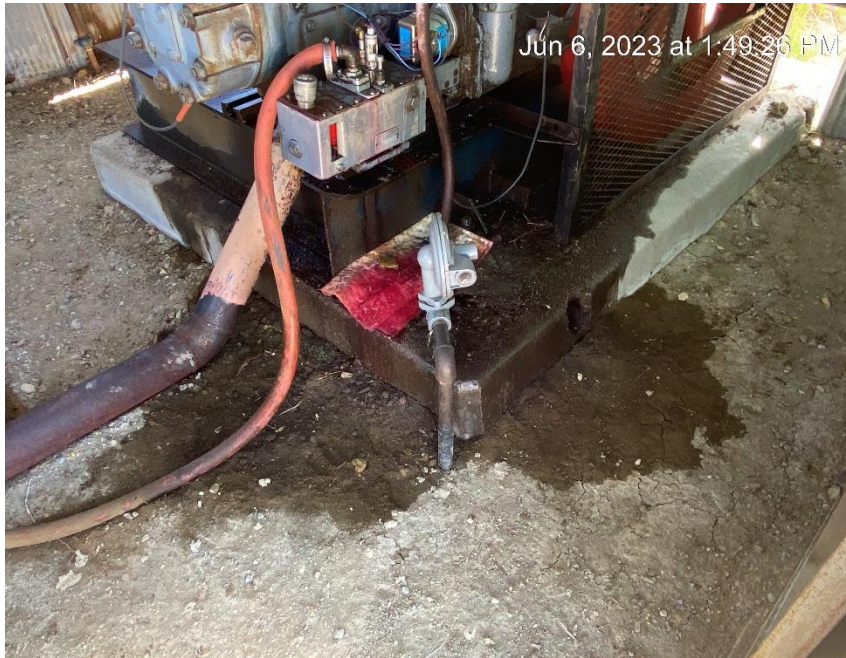
Oil leak. Stained equipment and soil

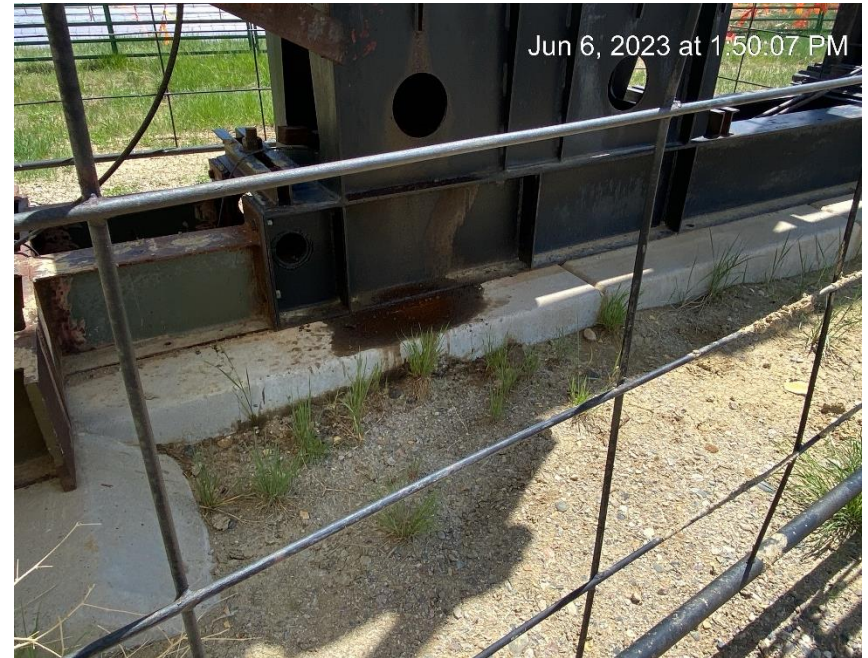
Oil leak. Stained equipment and soil

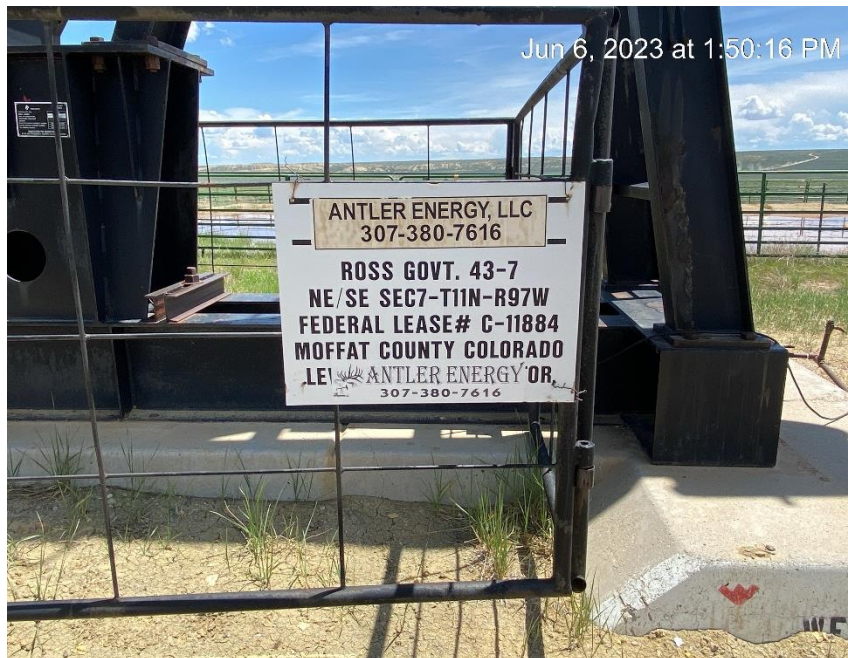
Sign at wellhead missing required information

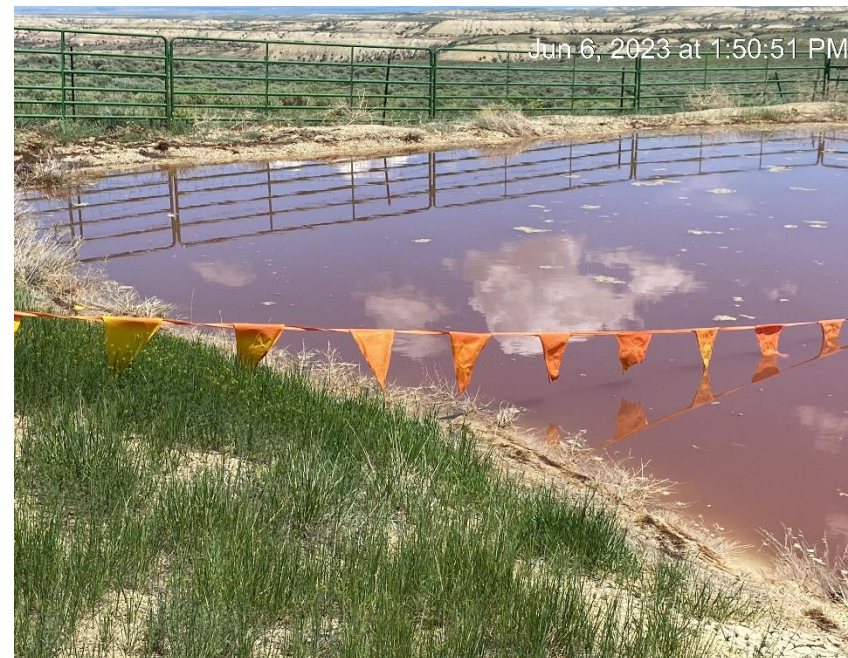
Lacking freeboard capacity

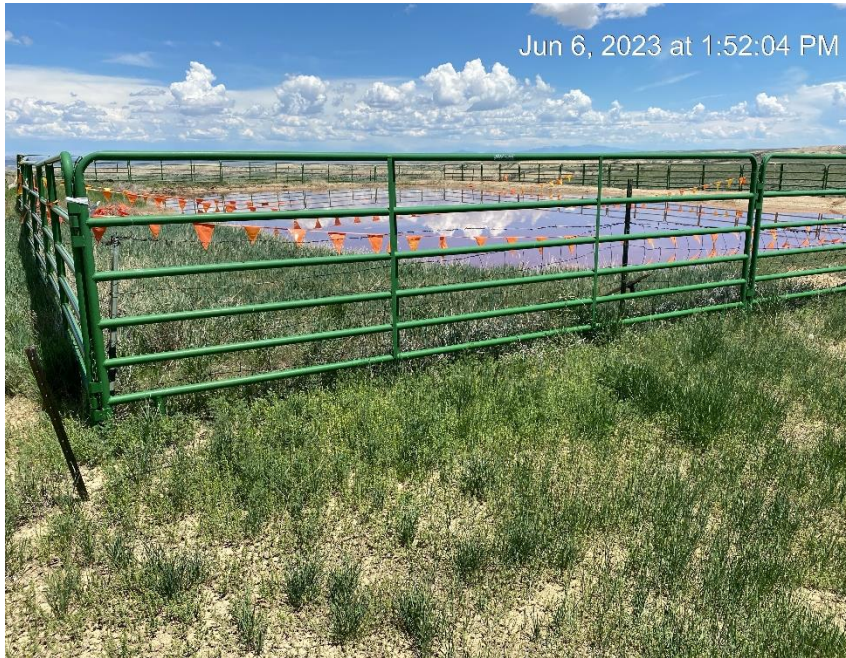
No Pit ID registration

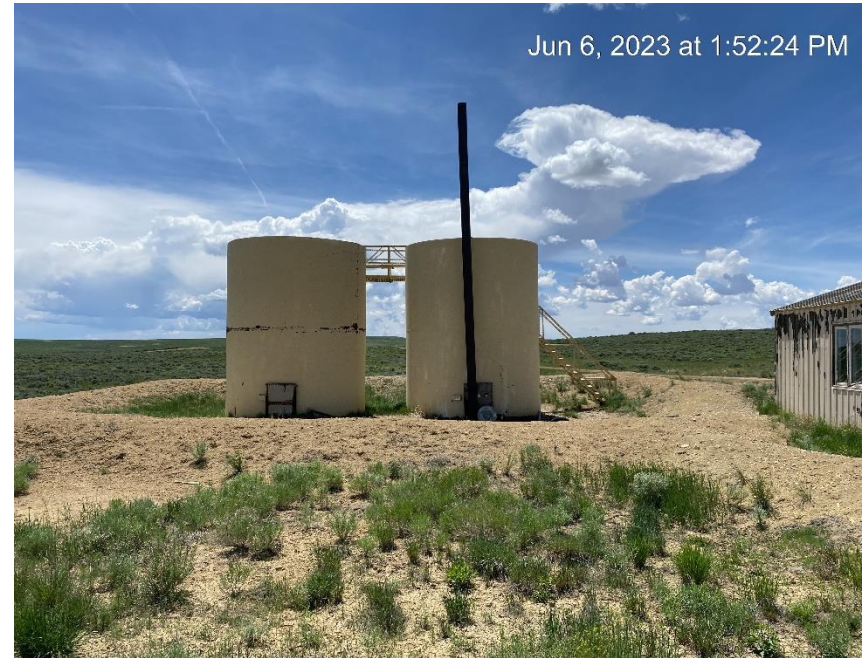
Unused equipment

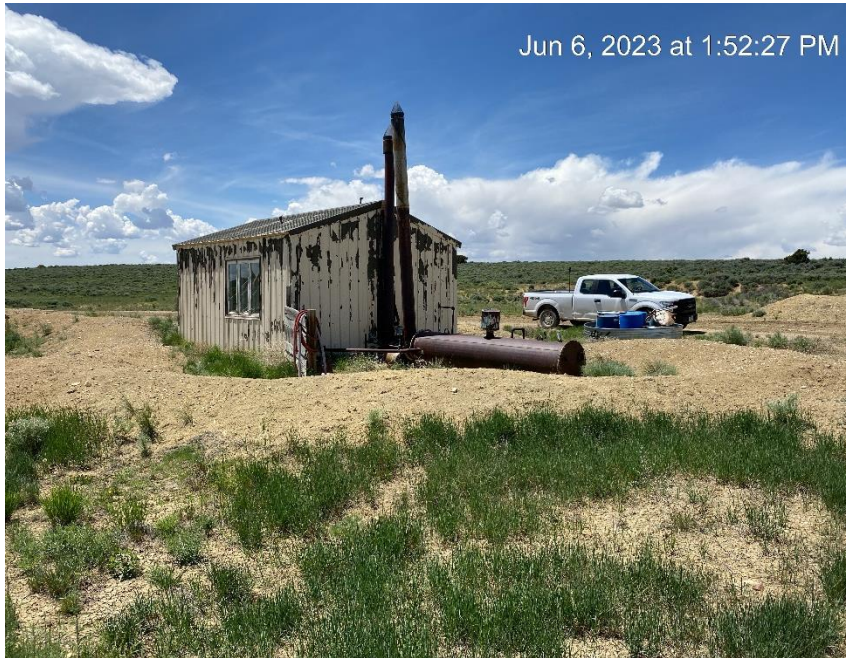
Unused equipment

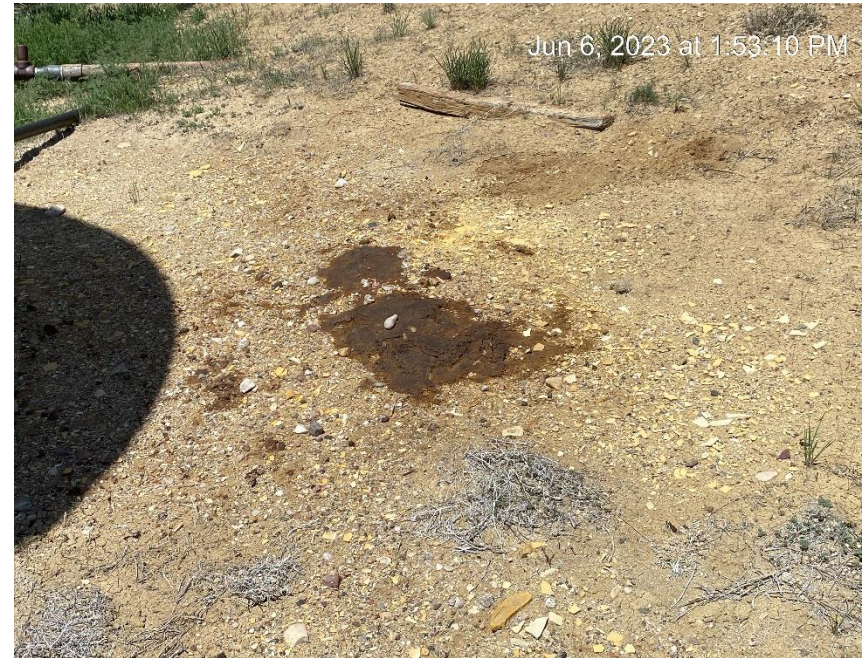
Stained soil

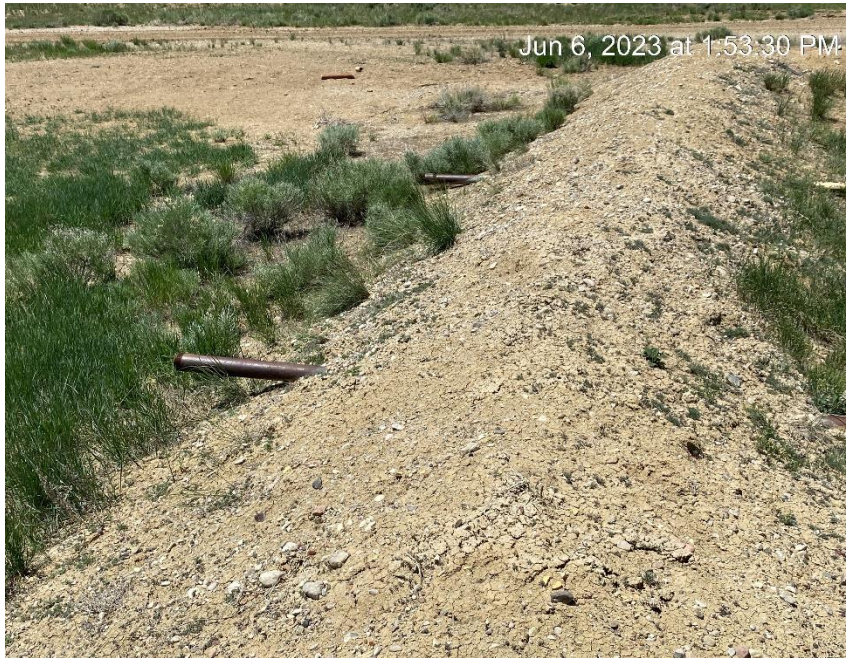
Open end loadlines

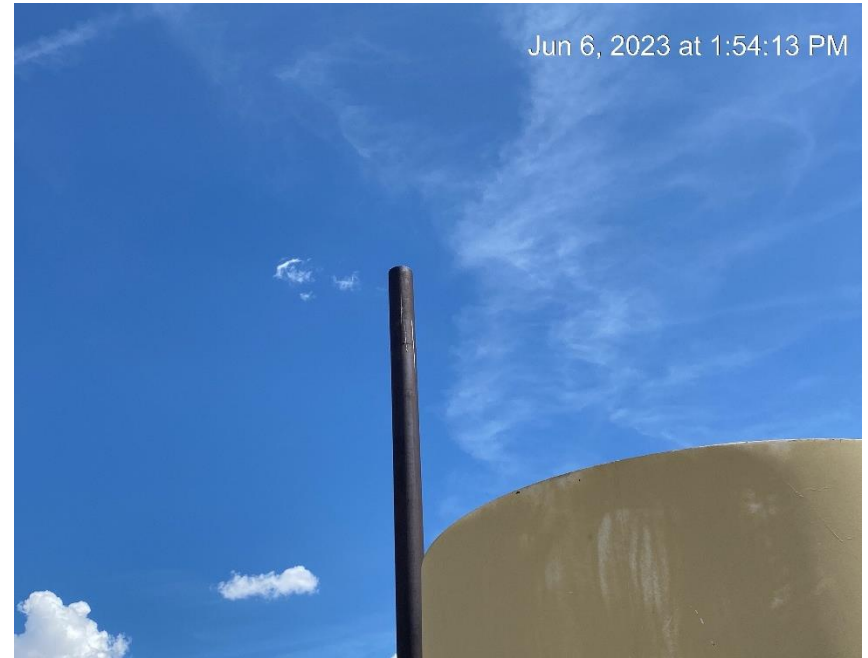
No bird protection

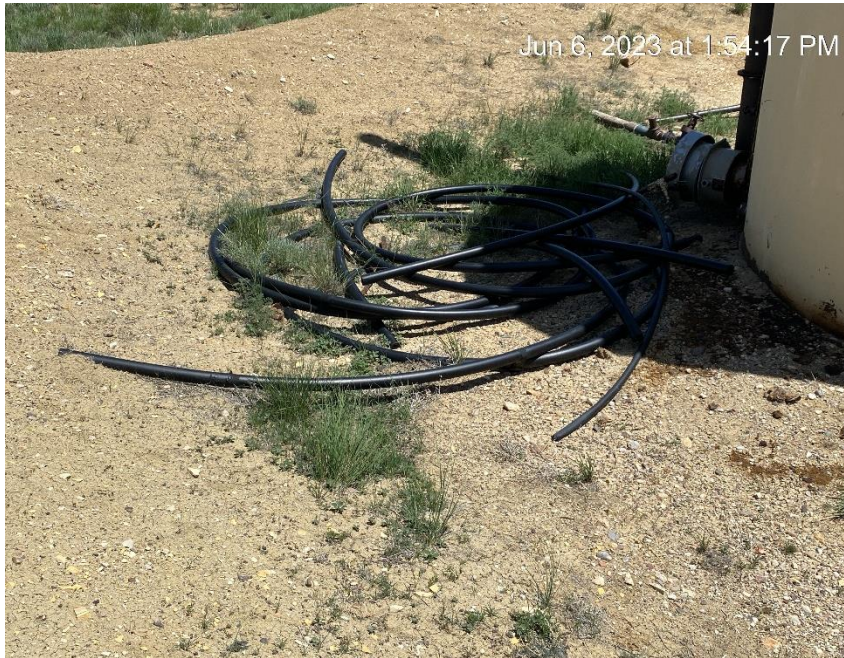
Debris

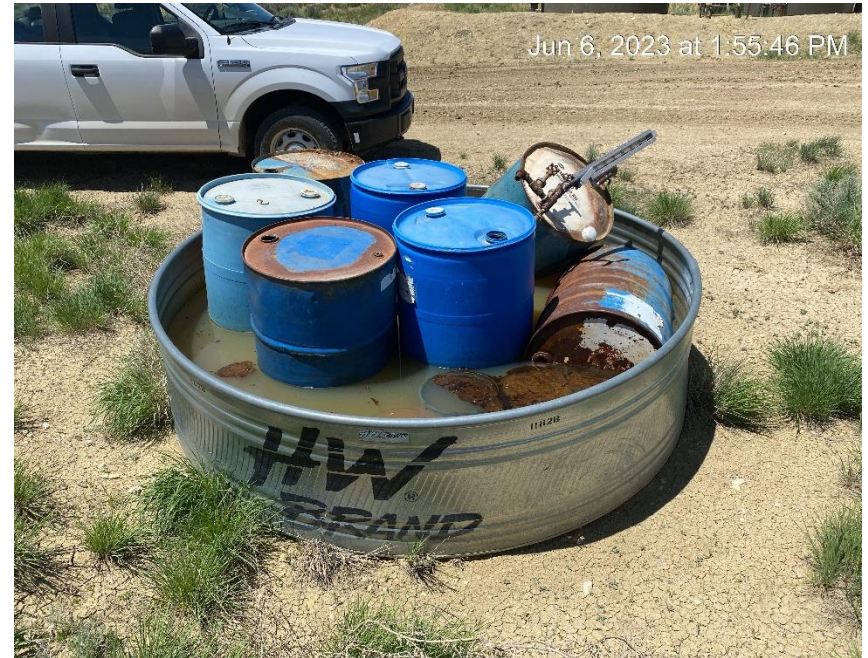
Unidentified chemical drums. Open to wildlife

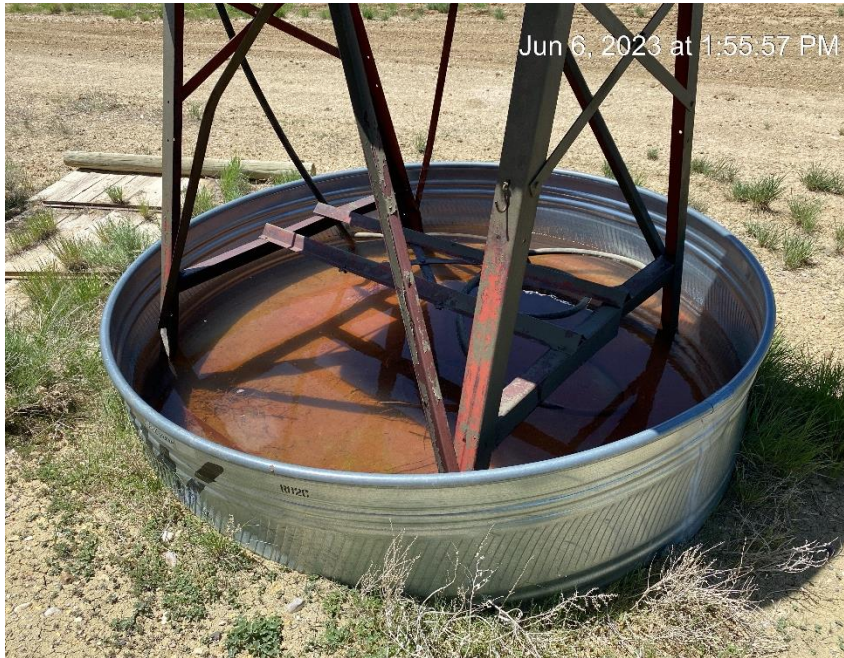
Open to wildlife

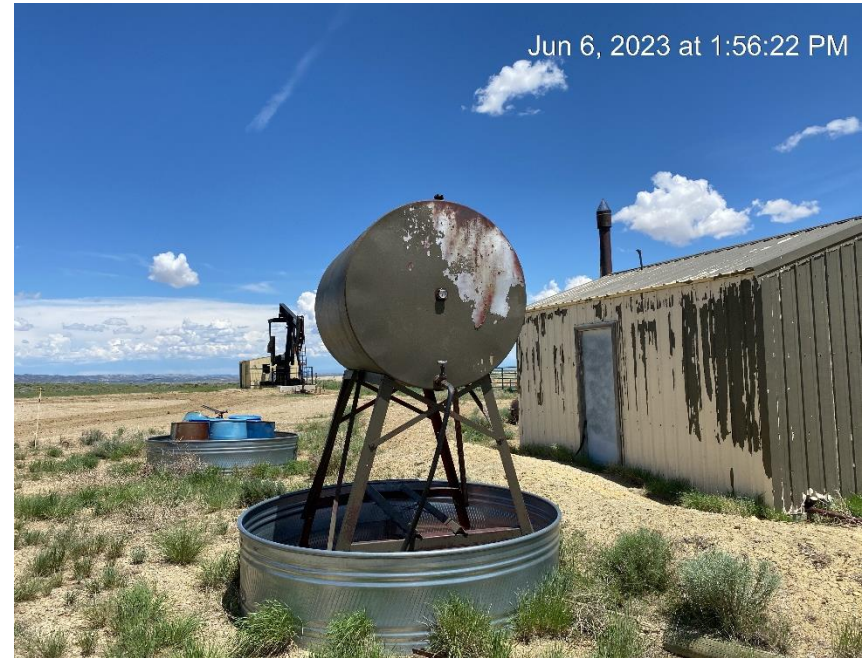
Unidentified tank missing required labels

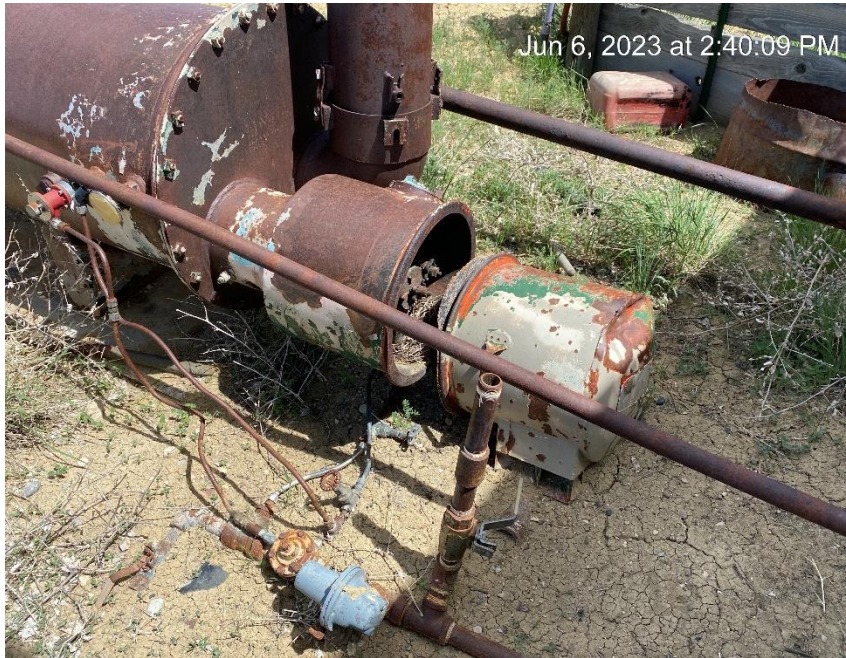
Unused equipment open to wildlife

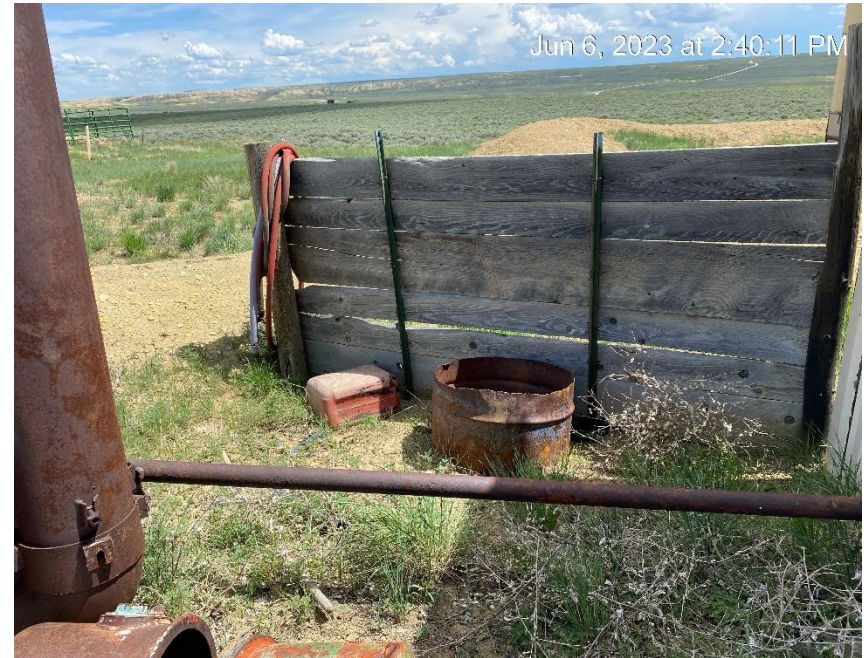
Debris

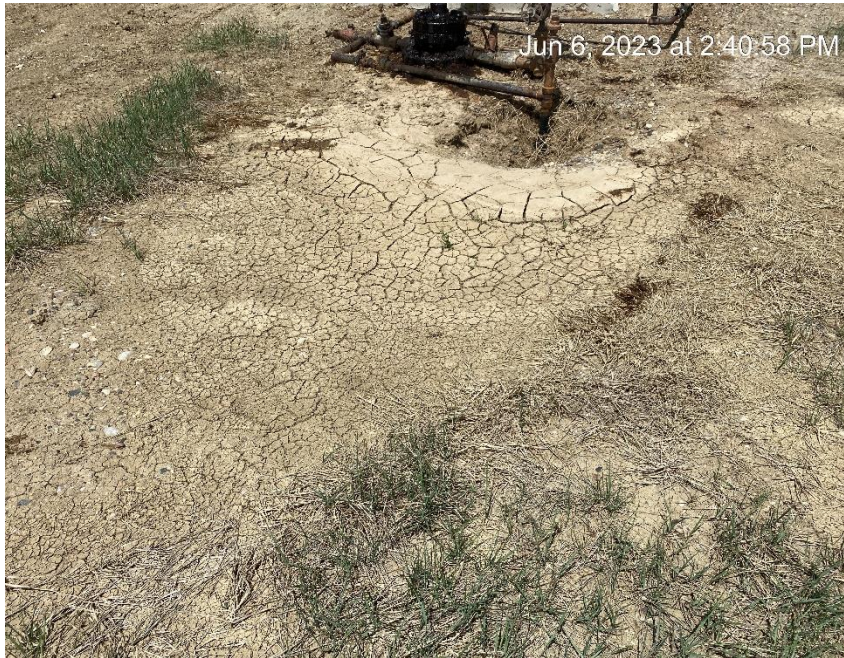
Flowline leak? Spill reported?

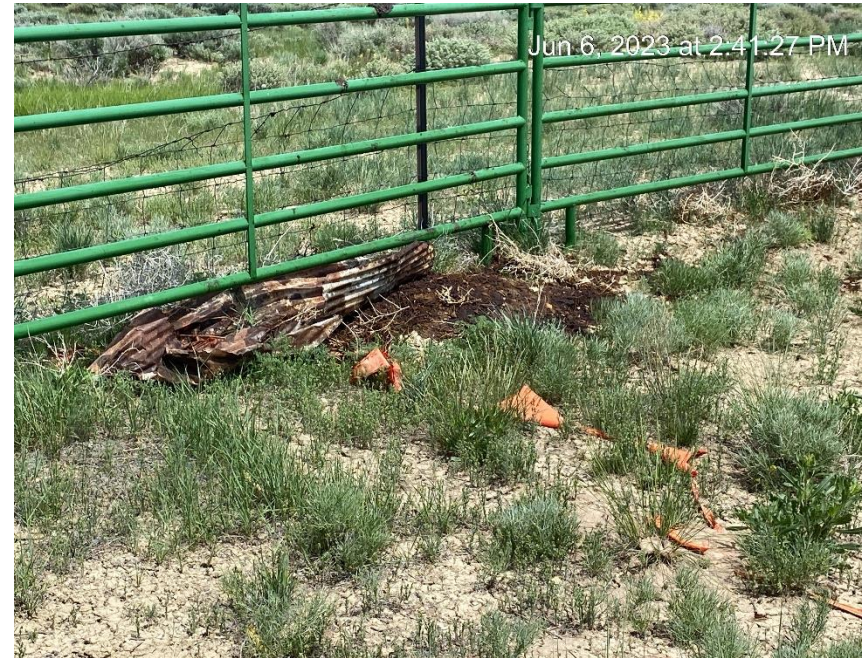
Debris and oil residue

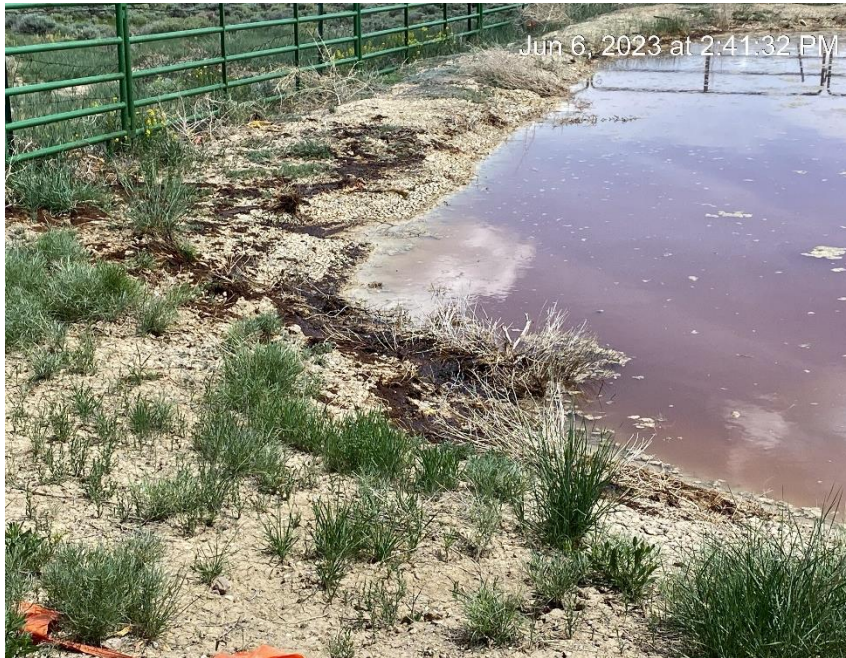
Oil residue along pit

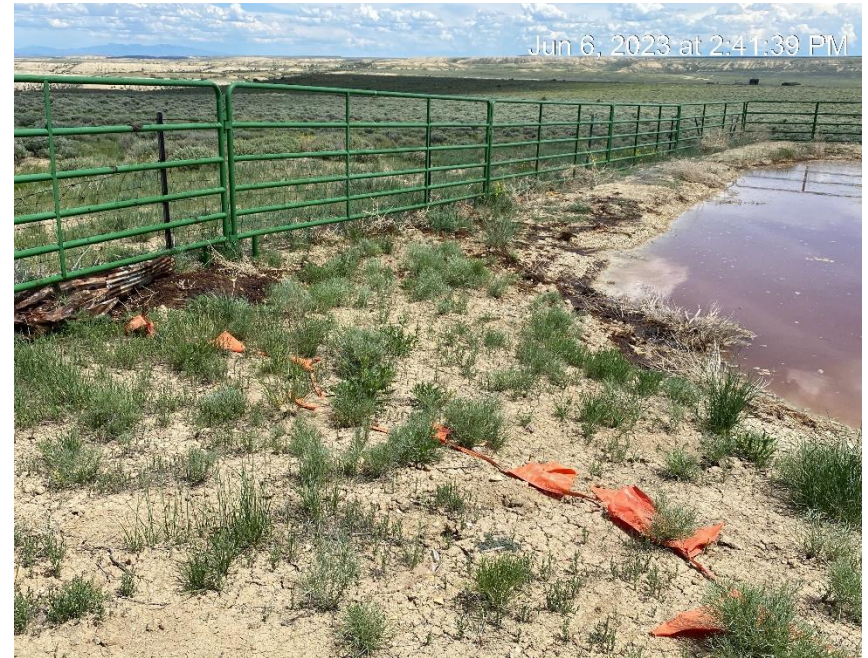
Oil residue and debris
