Inspection Photos

API: 055-06195

Operator: EVERGREEN NATURAL RESOURCES

Inspection Date: 6/6/2023

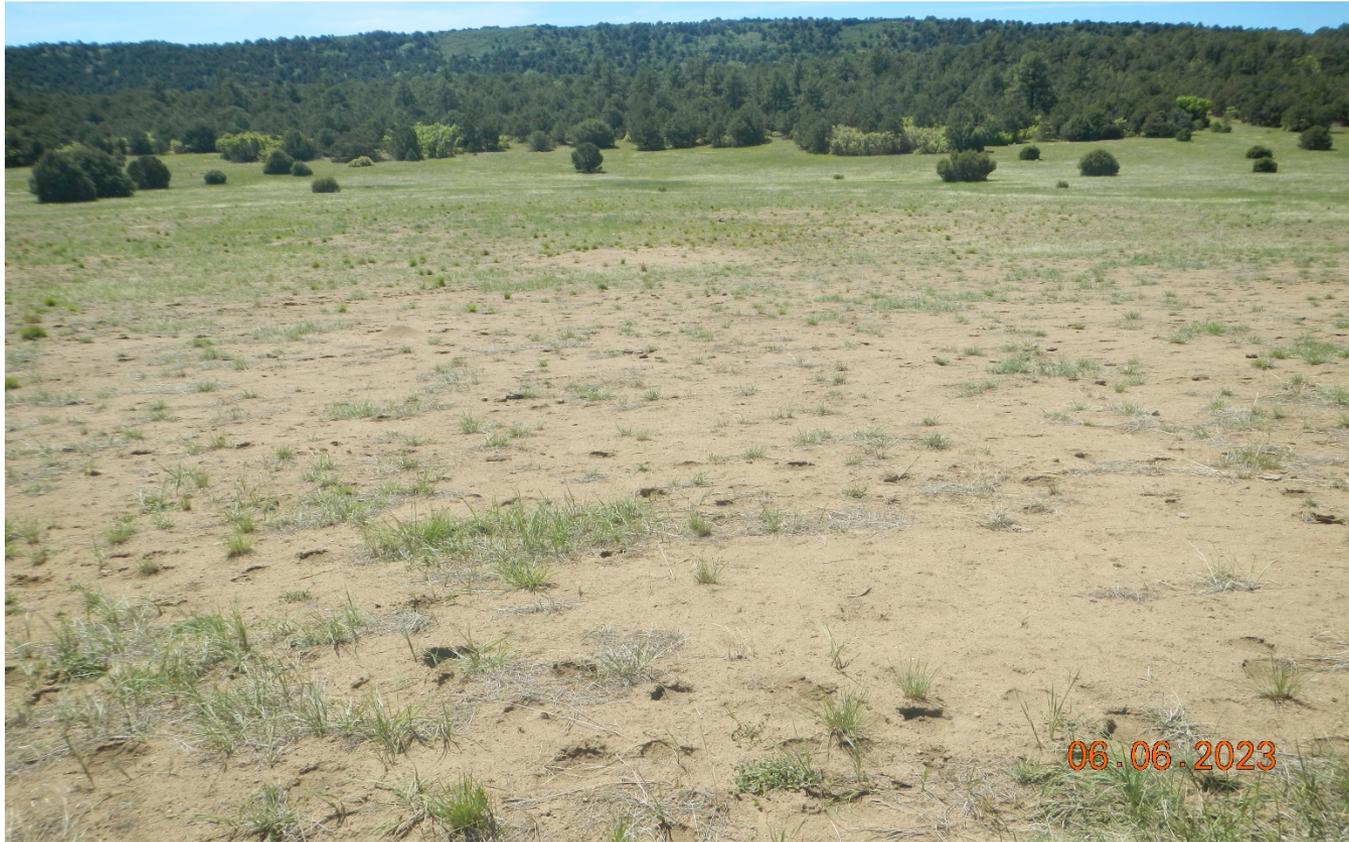
Photo 1. Facing south toward the location. There is sparse perennial vegetation at the location but also a reduction in noxious weeds was observed.

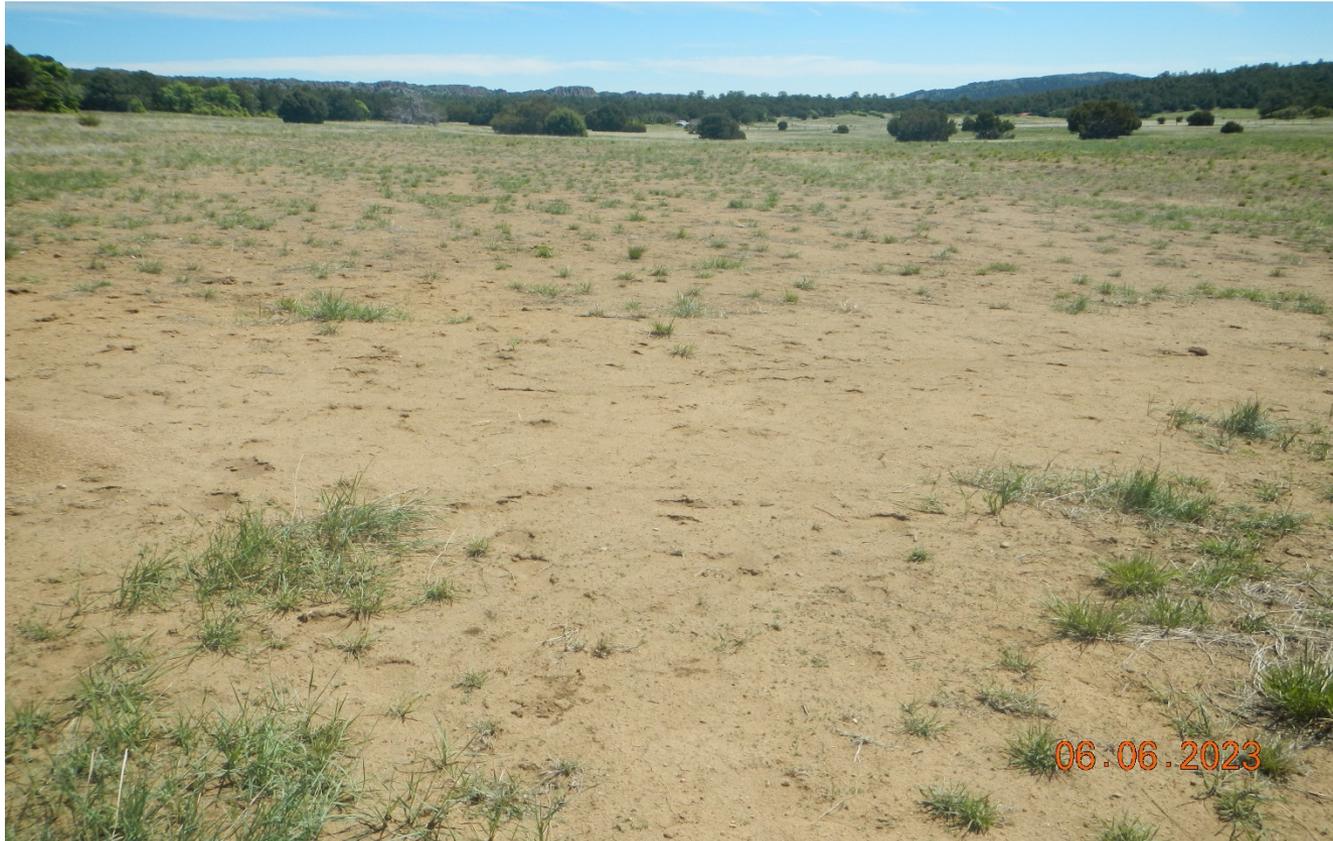
Photo 2. Facing east toward the location. There is sparse perennial vegetation at the location but also a reduction in noxious weeds was observed.

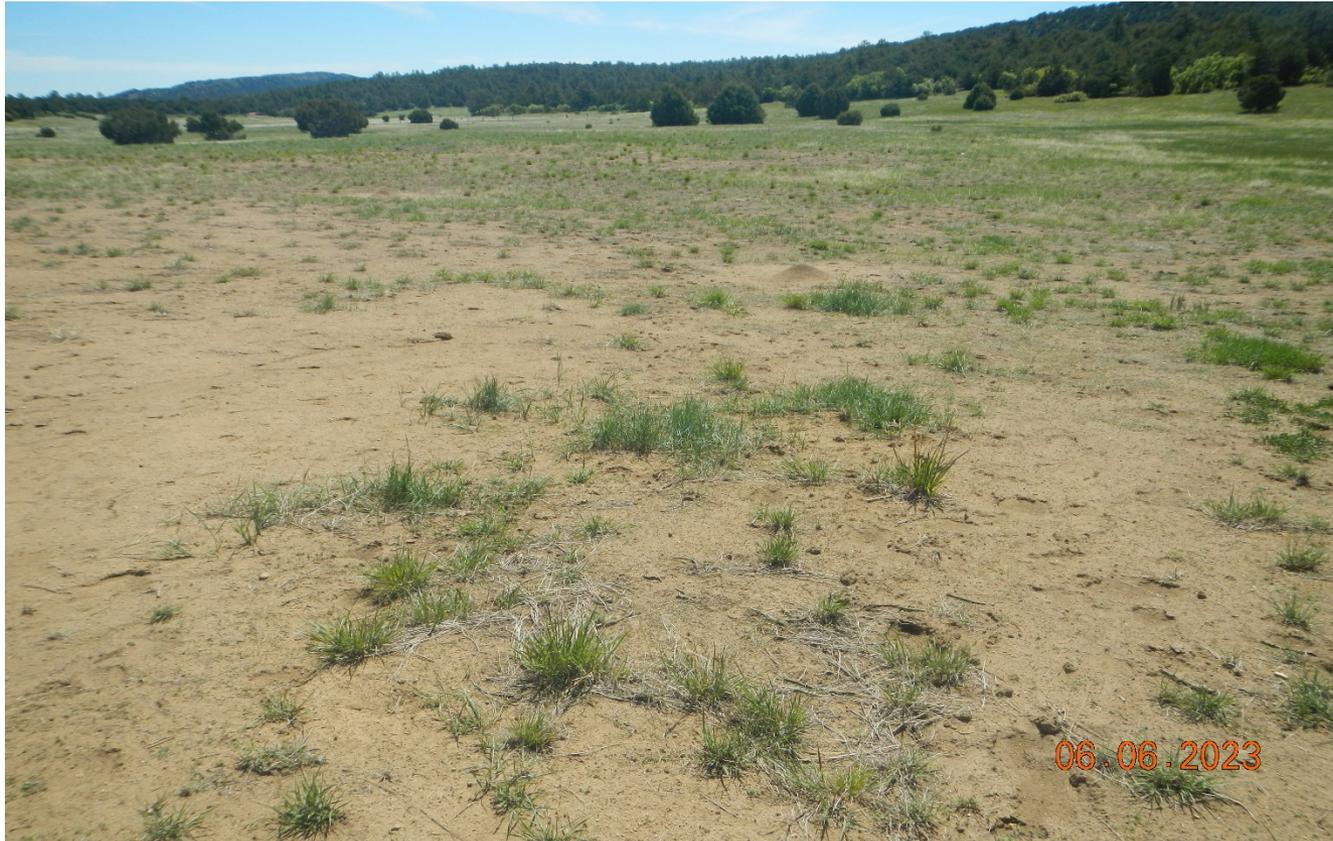
Photo 3. Facing southeast toward the location. There is sparse perennial vegetation at the location but also a reduction in noxious weeds was observed.

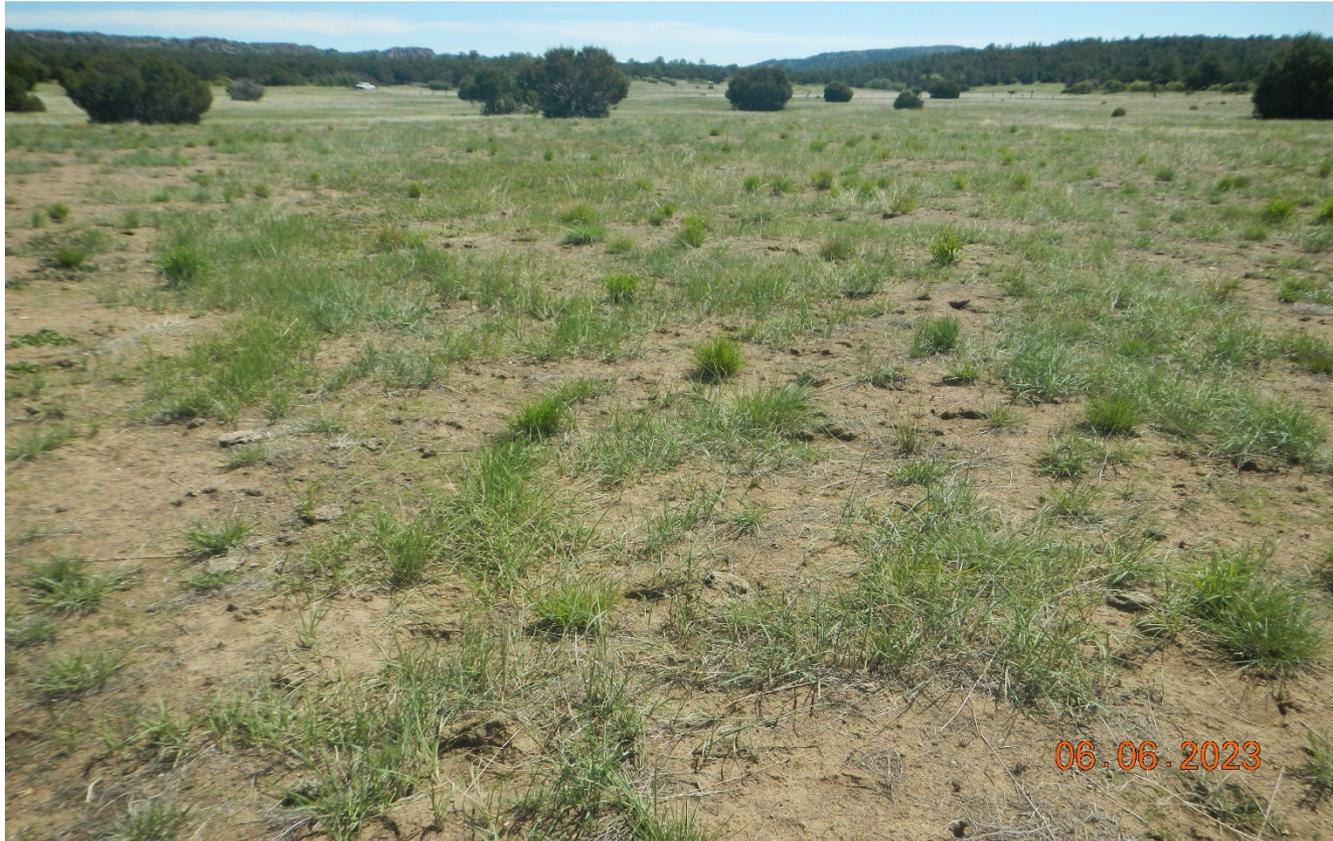
Photo 3. Facing toward the southside of the location. There is more vegetation establishment at the side of the location but is still not 80% of reference area.

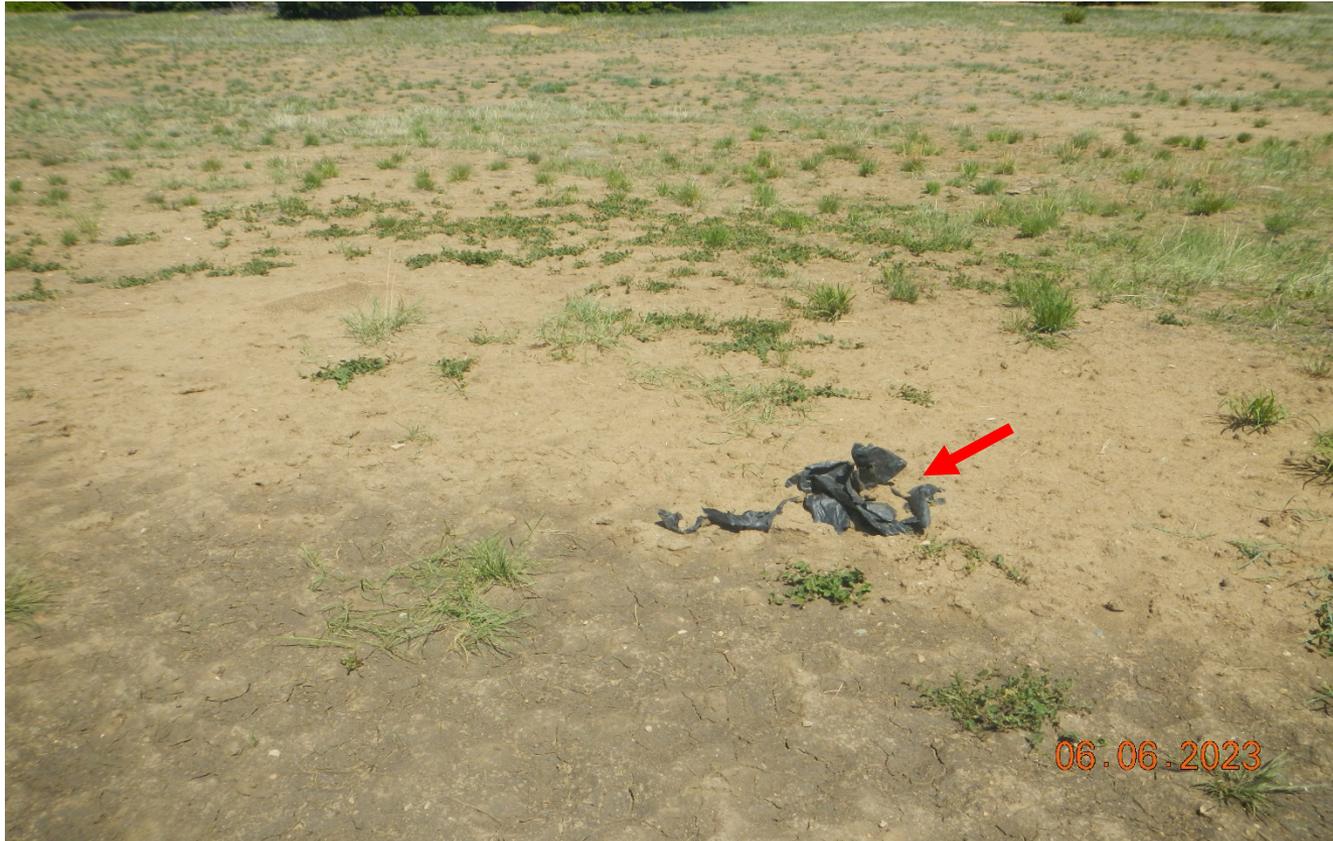
Photo 5. Center of the location facing north. There is some plastic debris that needs to be removed.

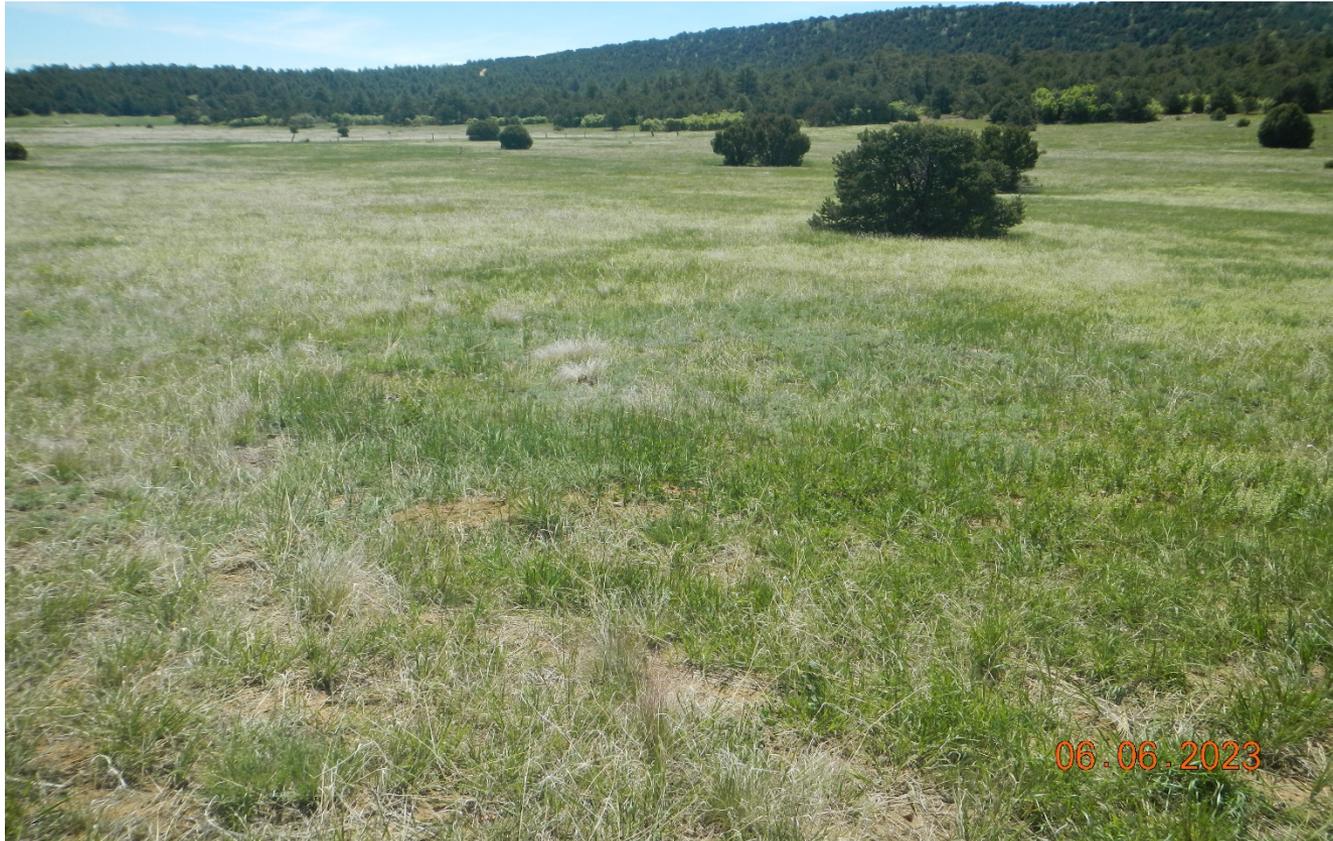
Photo 6. Facing southeast at the surrounding undisturbed vegetation which consists of Western wheat, Needle and thread grass, Sand drop seed, among other native species.
