Inspection Photos

API: 055-06278

Operator: EVERGREEN NATURAL RESOURCES

Inspection Date: 6/6/2023

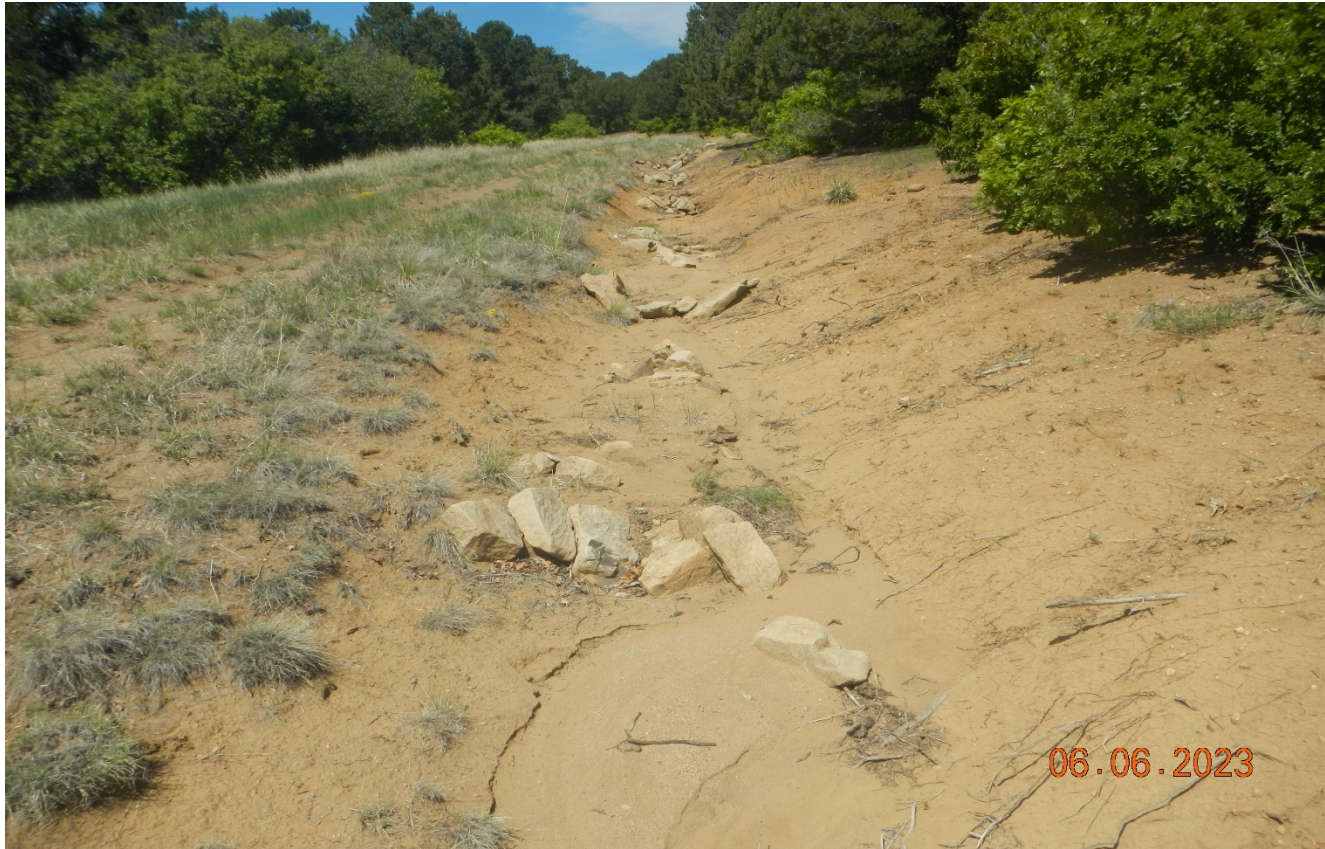
Photo 1. Facing southwest along the former access road. The road was not recontoured and reclaimed. There is erosion occurring along the road and the rock check dams are displaced. Previous corrective action was not performed.

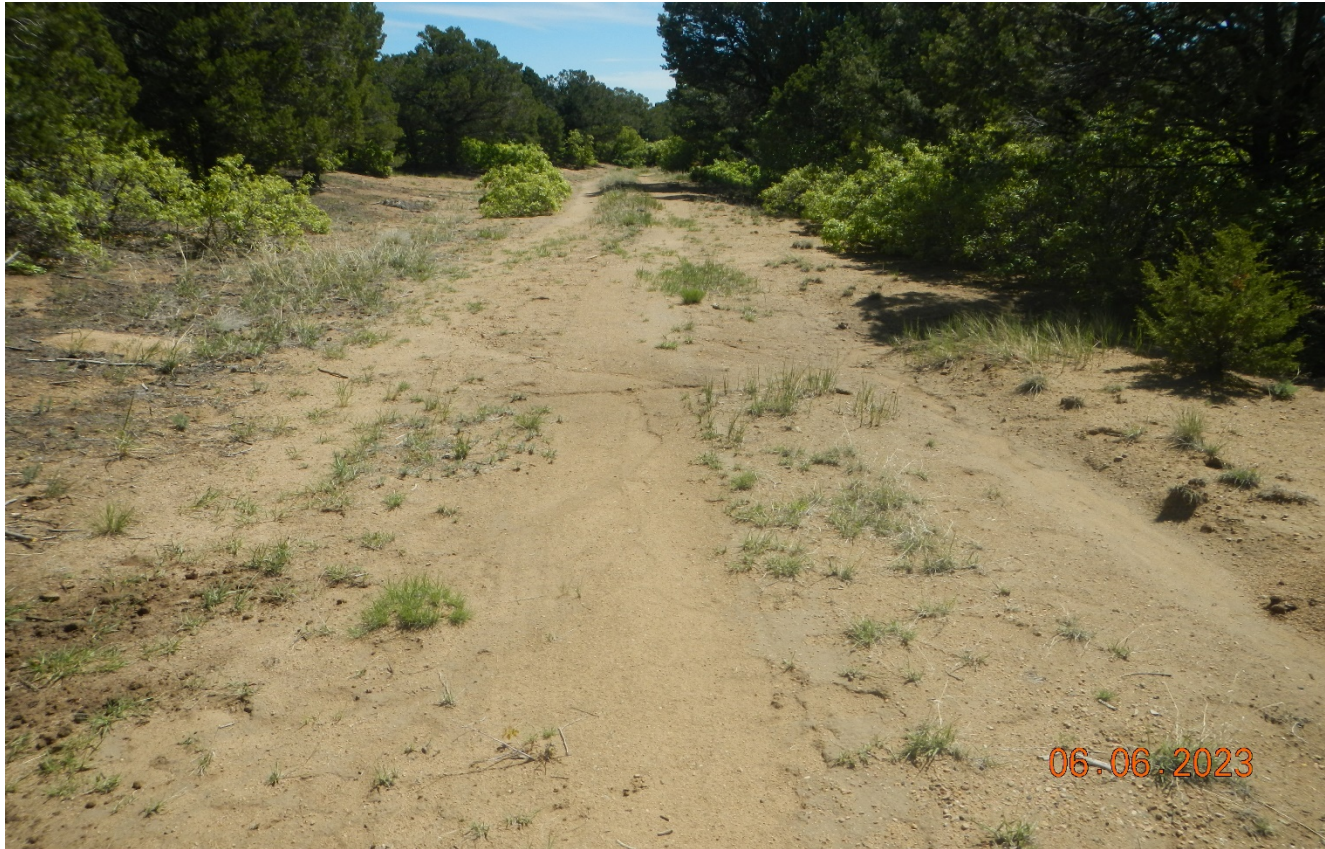
Photo 2. Facing northeast along the former access road which was not reclaimed. There are signs of erosion along the road.

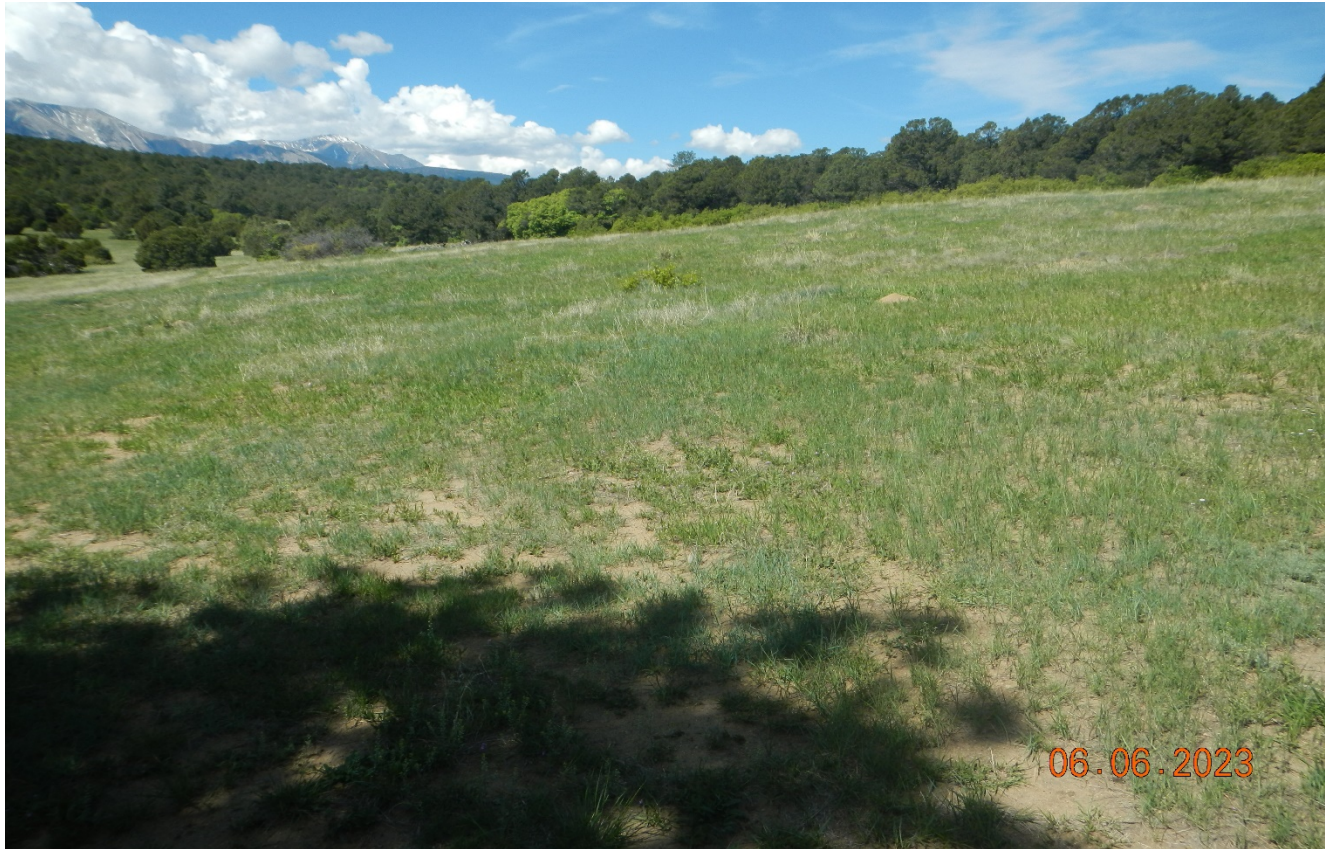
Photo 3. Facing southwest toward the location which was recontoured and reclaimed. There is desirable vegetation established throughout most of the location.

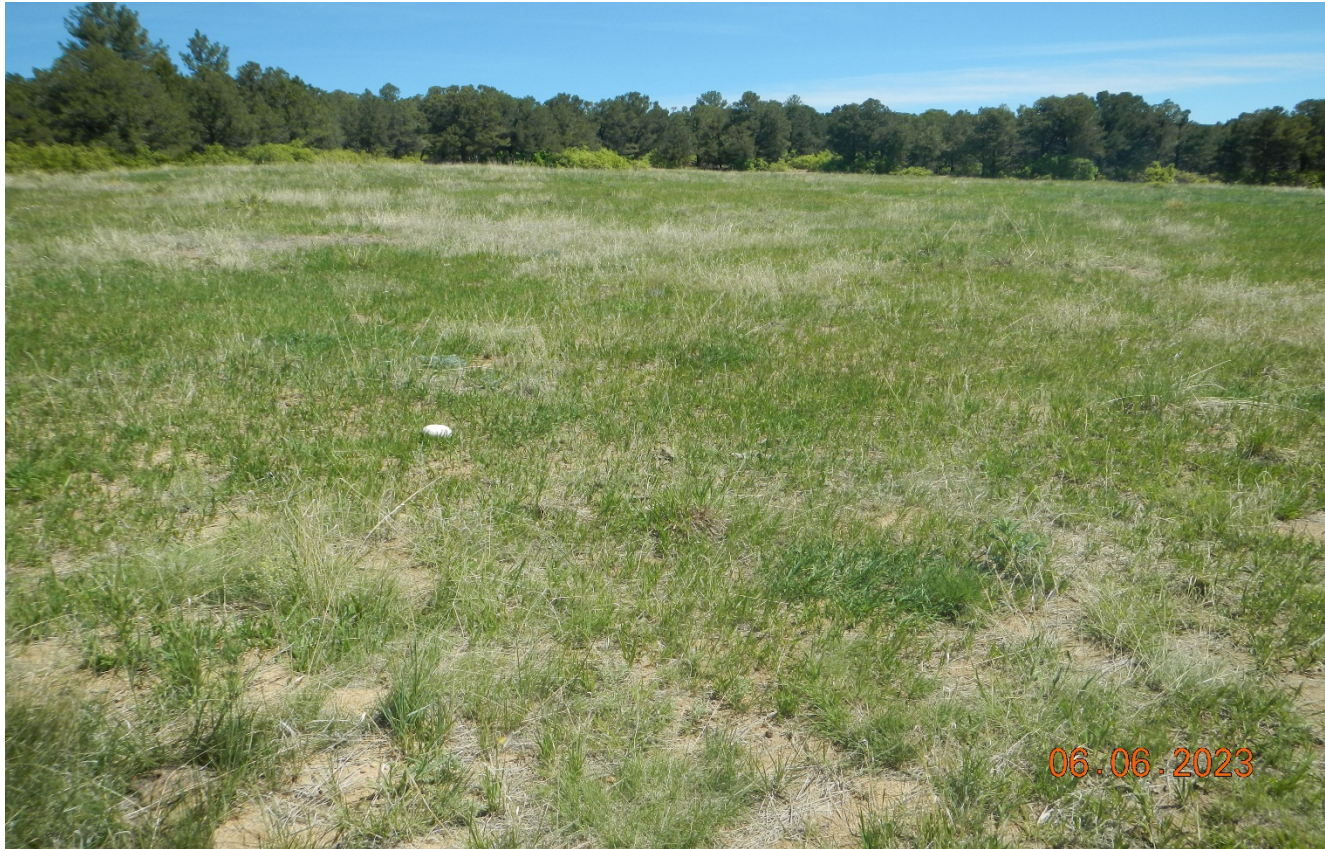
Photo 4. Facing northeast toward the location which was recontoured and reclaimed. There is desirable vegetation established throughout most of the location.
