Interim Reclamation and Stormwater Inspection

June 6, 2023

Operator: KERR MCGEE OIL & GAS ONSHORE LP - #47120

Location ID: 336152

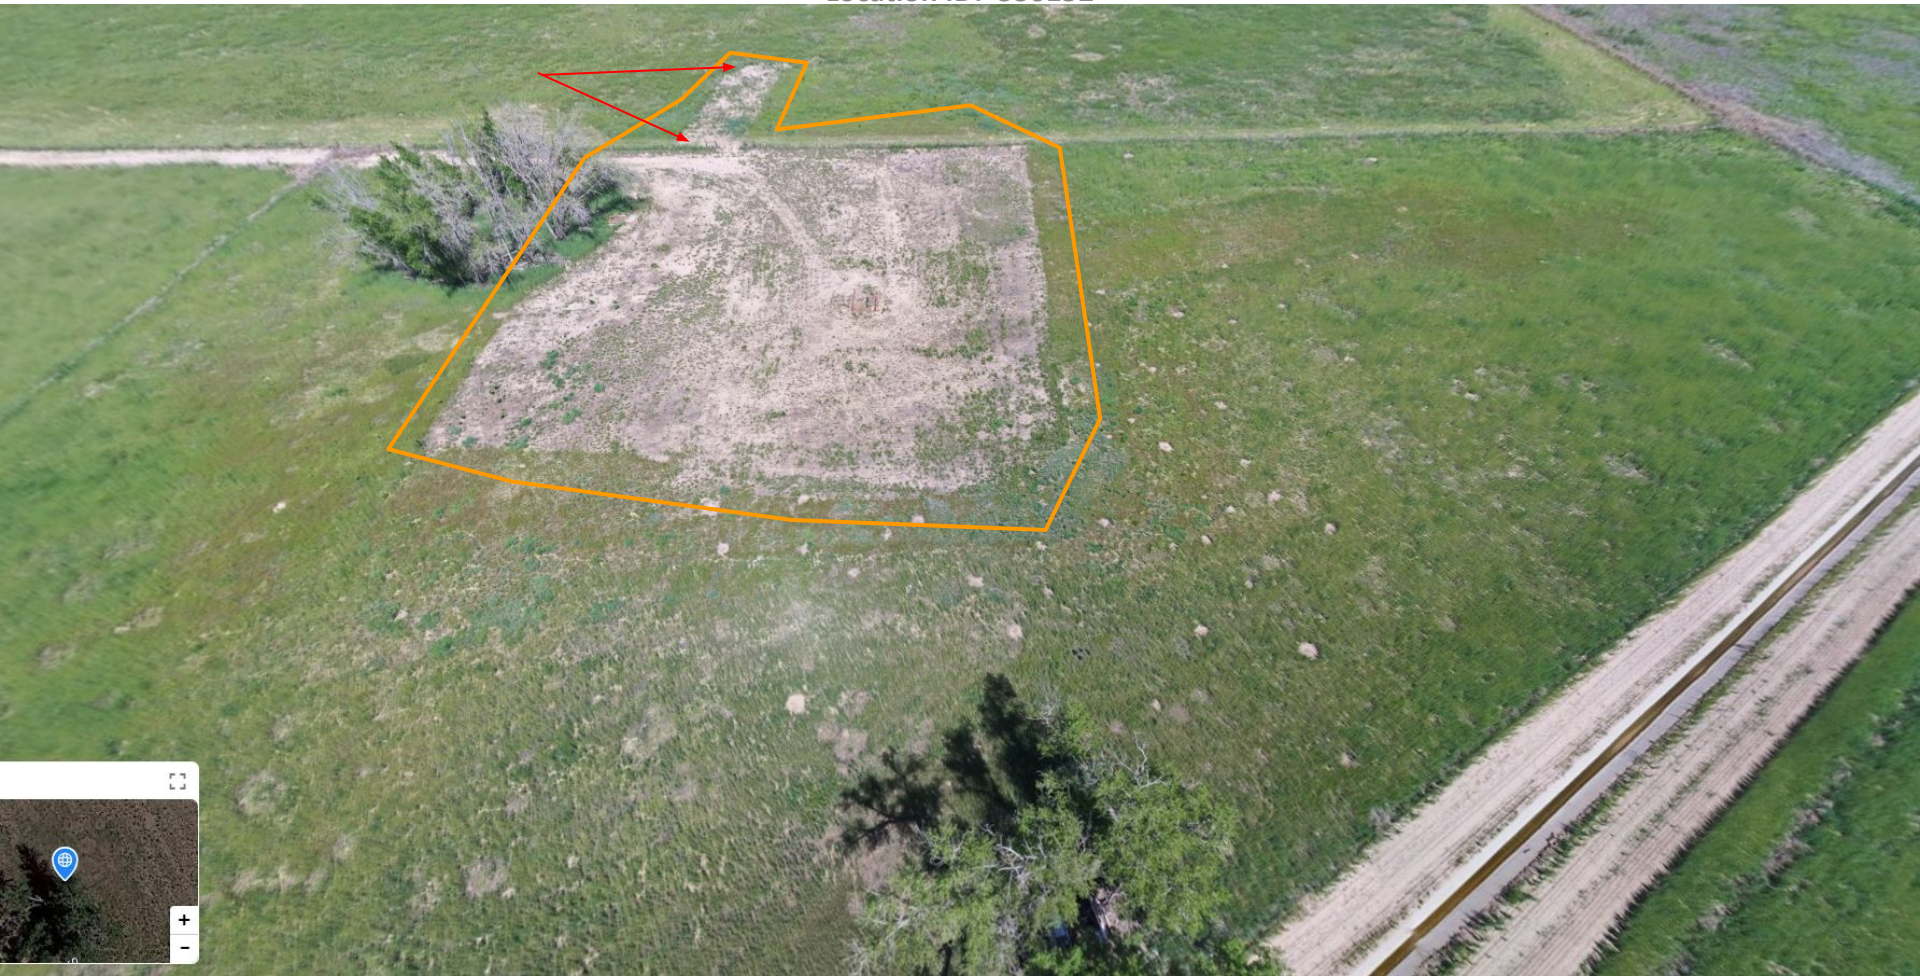
Photo 1. Drone aerial imagery illustrates the interim reclamation area for the HSR-Vadney location, a portion of the associated access road, and the Lorraine Adams property (red arrows). Photo illustrates weed management is being performed around the wellhead and Lorraine property (orange polygon), but the remainder of the interim area consists mostly of Common rye and Cheatgrass was observed in patches but more persistent south of the wellhead (reddish vegetative color). Smooth brome has established along portions of the northern interim area but has diminished around the wellhead and south of the wellhead where Cheatgrass was observed.

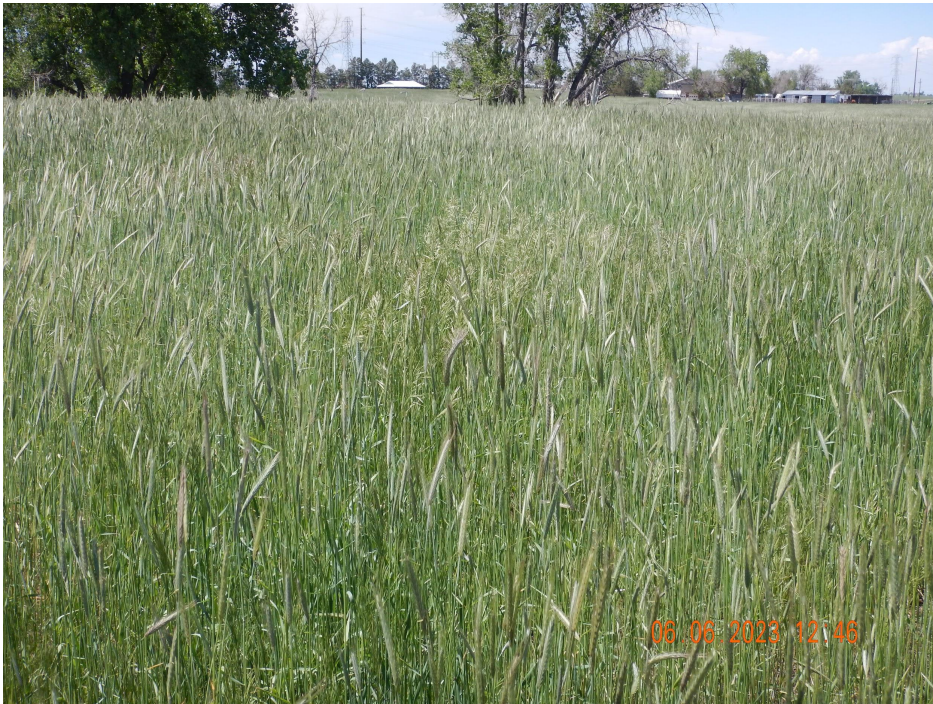
Photo 3. Photo taken from the northeastern area, facing West. Photo illustrates the current vegetation which is predominantly undesirable annual vegetation, Common rye.

Smooth brome was observed in small patches along the north-central and northwestern interim areas.

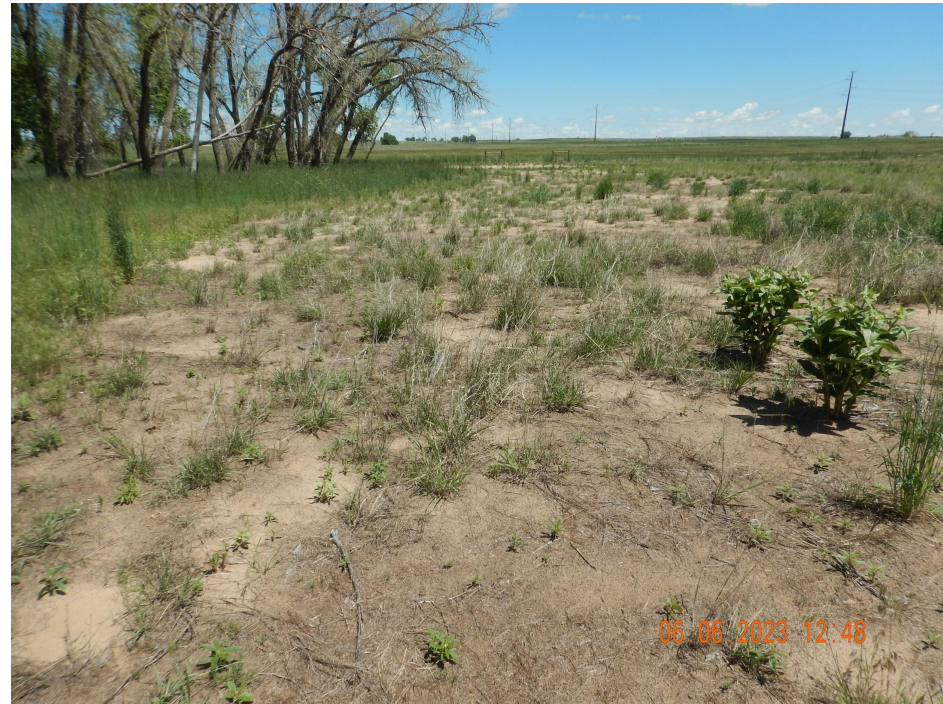
Photo 4. Photo taken north of the wellhead, facing East. Photo illustrates the area that was described in Photo 1 as being actively managed for weeds.

Note- there has been a decrease in Smooth brome within this actively managed area.

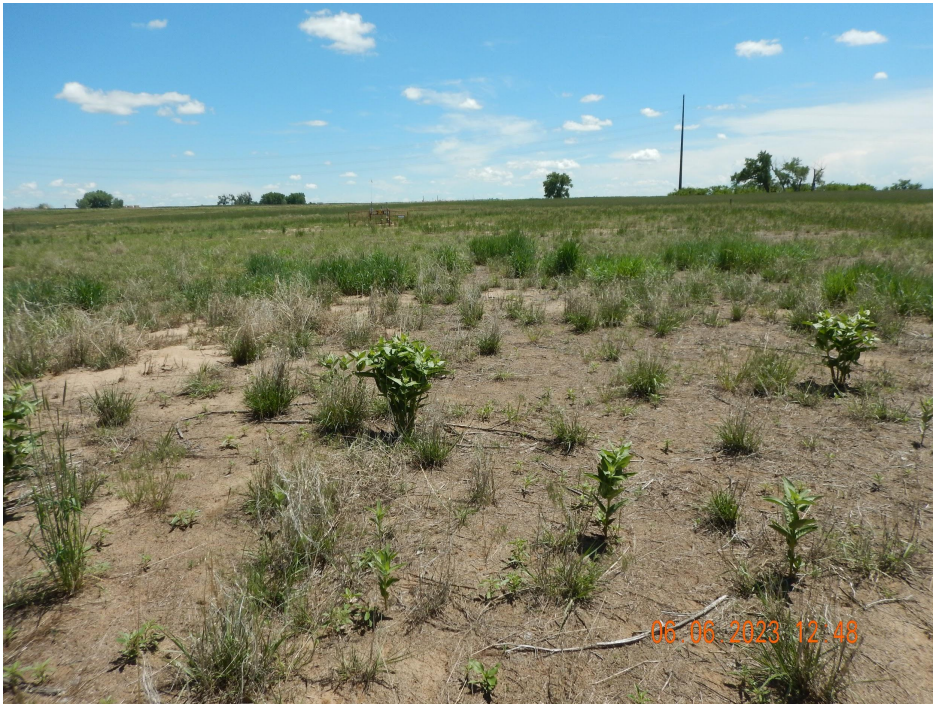
Photo 5. Photo taken north of the wellhead, facing South. See comments under Photo 4.

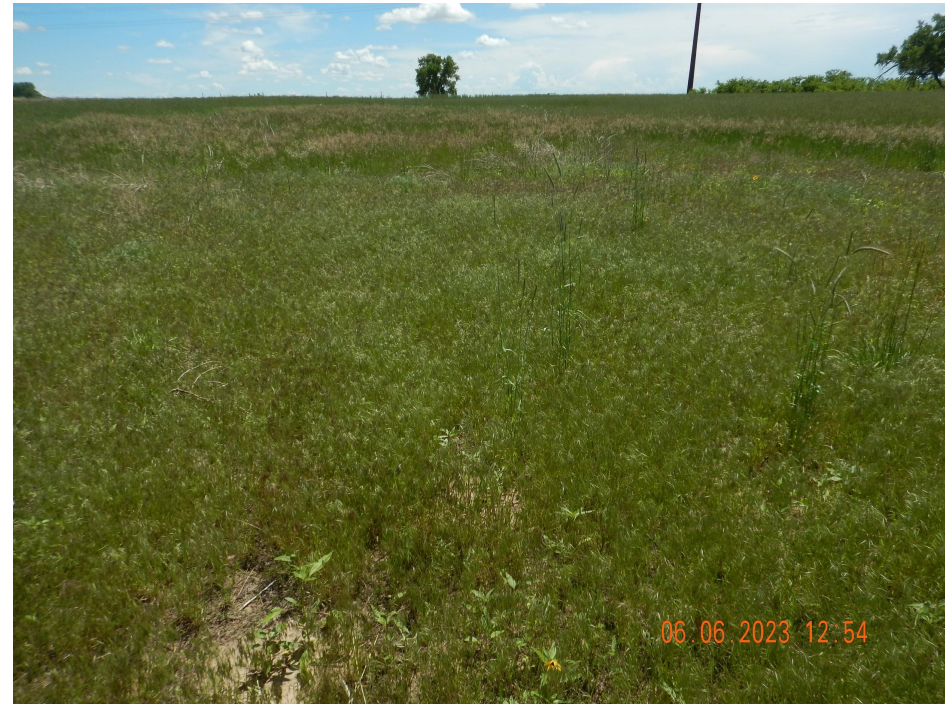
Photo 6. Photo taken south of the wellhead, facing South. Photo illustrates an area of cheatgrass establishment. It appears this area has decreased in Smooth brome presence.

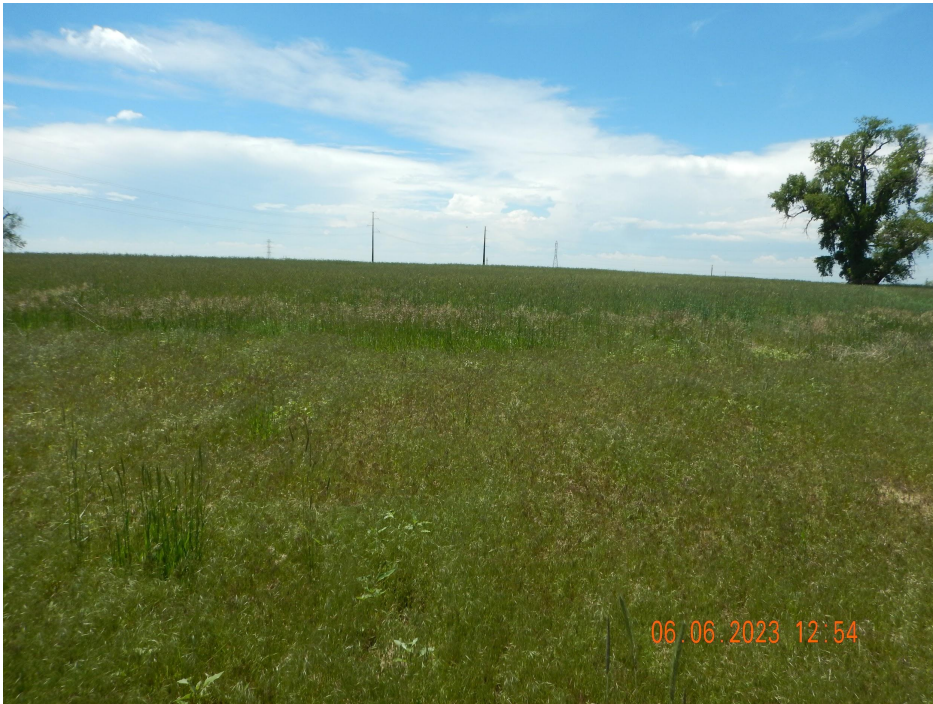
Photo 7. Photo taken south of the wellhead, facing West. See comments under Photo 6.

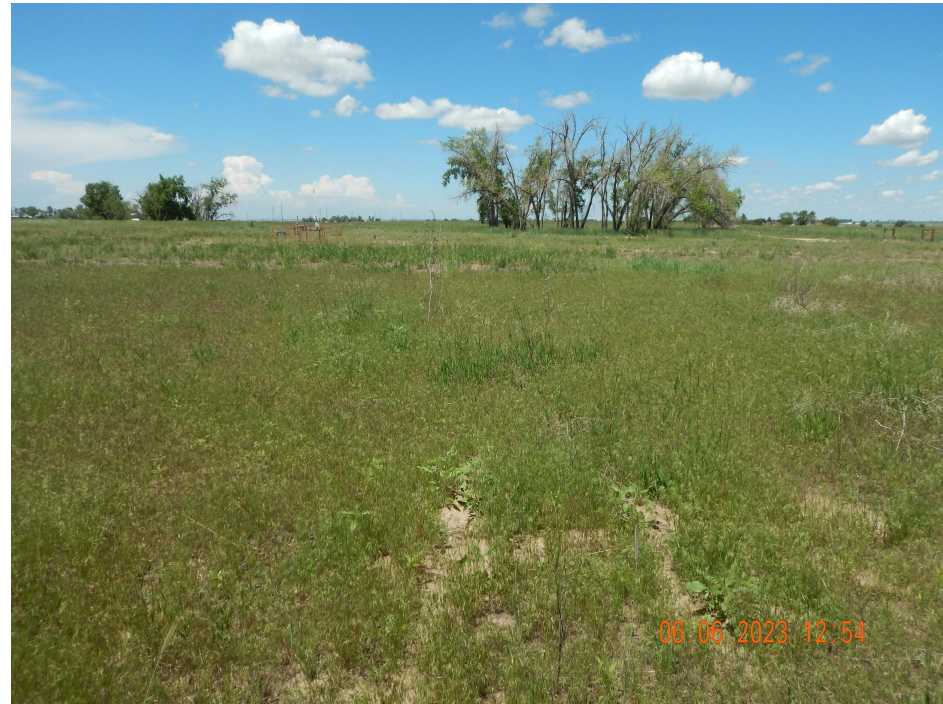
Photo 8. Photo taken south of the wellhead, facing North. See comments under Photo 6.

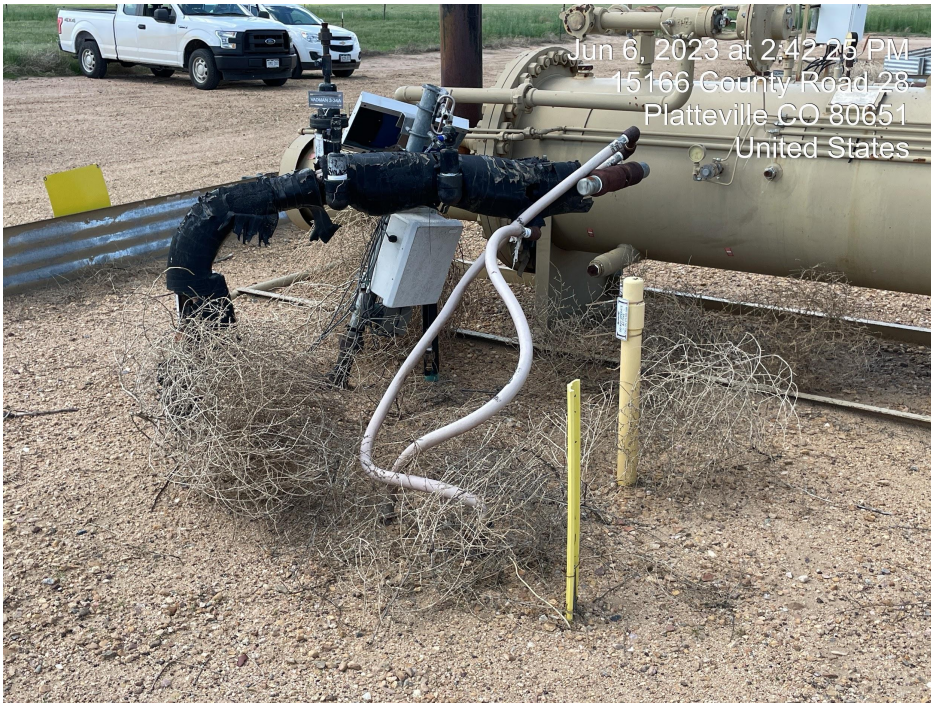
Photo 9. Photo taken from the associated offsite tank battery. Photo illustrates weed debris around equipment that appears to have blown in from the surrounding area.

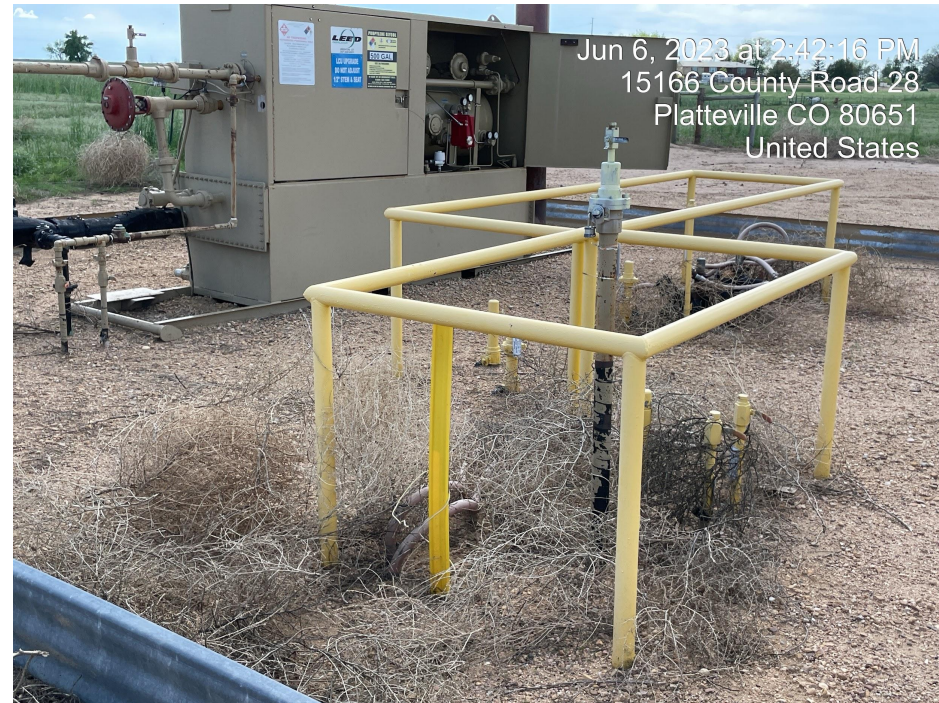
Photo 10. Photo taken from the associated offsite tank battery. See comments under Photo 9.

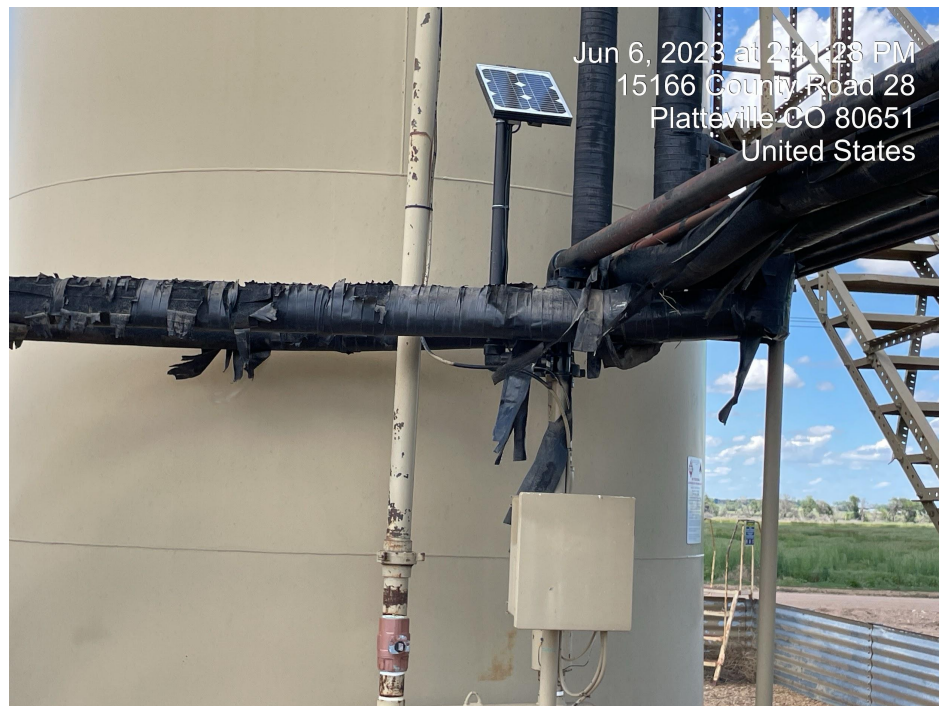
Photo 11. Photo taken from the associated offsite tank battery. Photo illustrates tape that is degrading. Tape and foam coming off piping, which is contributing to trash around the location.

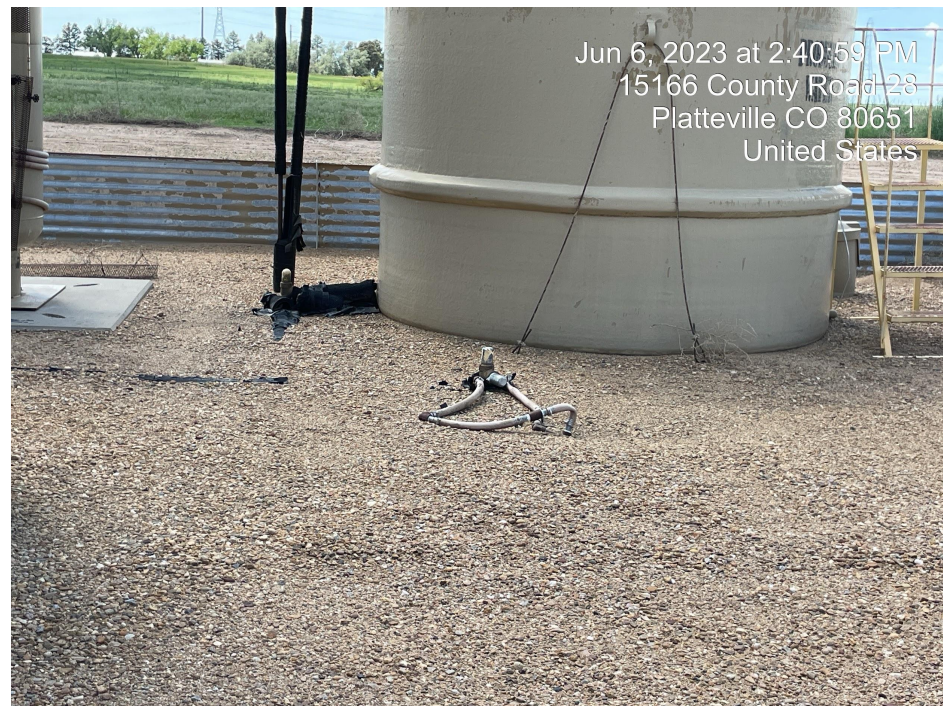
Photo 12. Photo taken from the associated offsite tank battery. Photo illustrate unused equipment being stored within secondary containment.
