# Inspection Photos

API: 055-06196

Operator: EVERGREEN NATURAL RESOURCES

Inspection Date: 6/6/2023

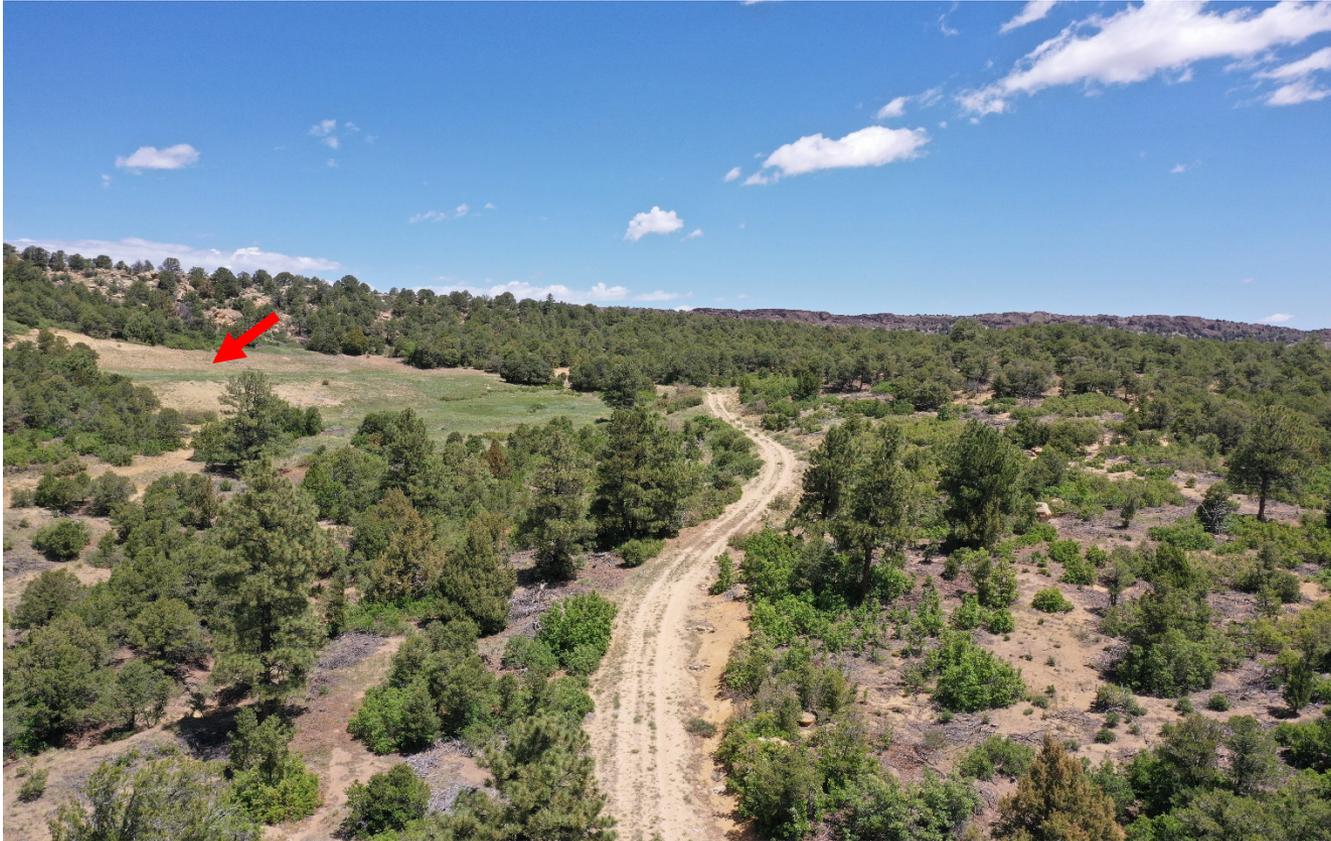
**Photo 1.** 2022 Drone aerial photo facing north along the former access road. The road was not recontoured and reclaimed but continues on past the location. Location shown at red arrow.

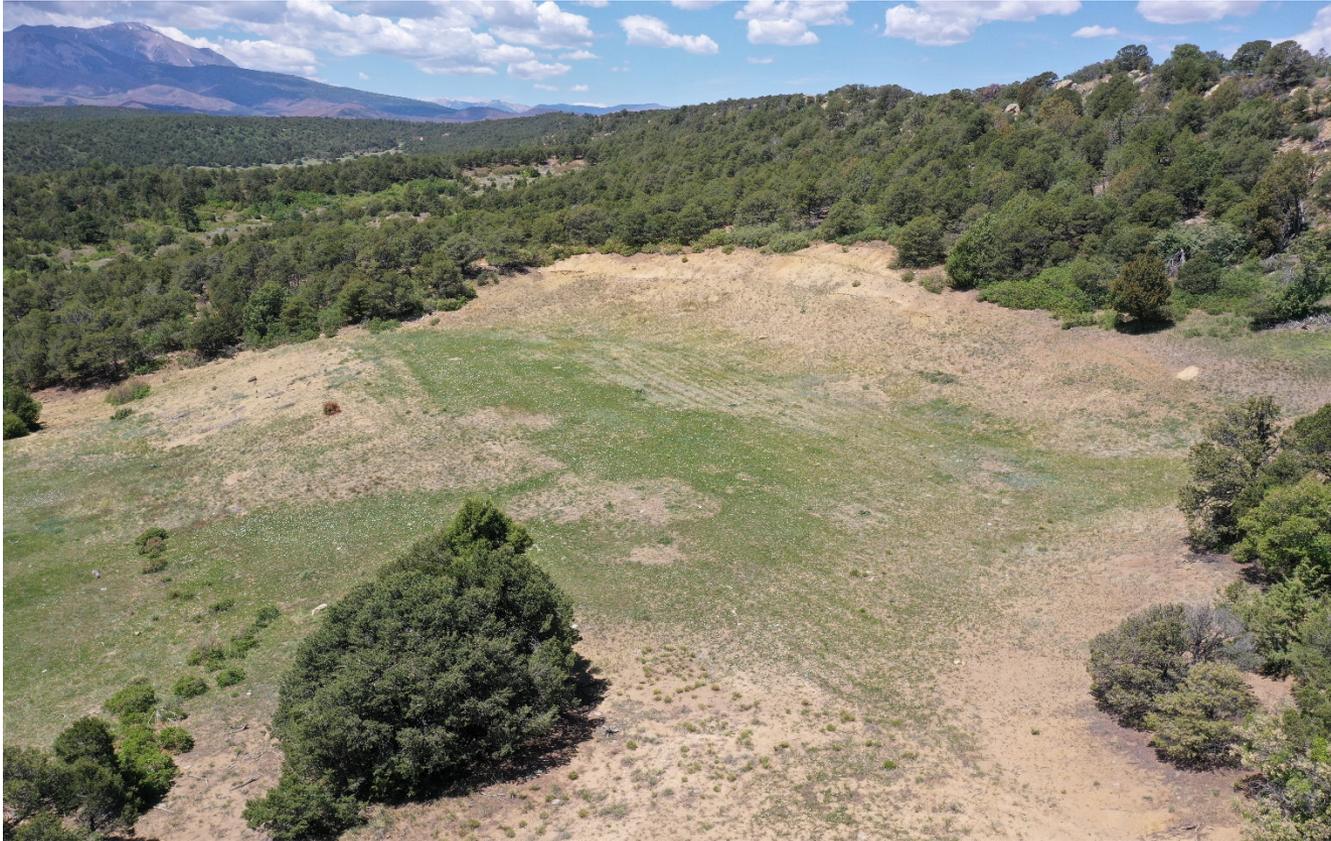
**Photo 2.** 2022 drone aerial photo. Facing southwest toward the location which was not recontoured and reclaimed. Previous corrective action was not performed.

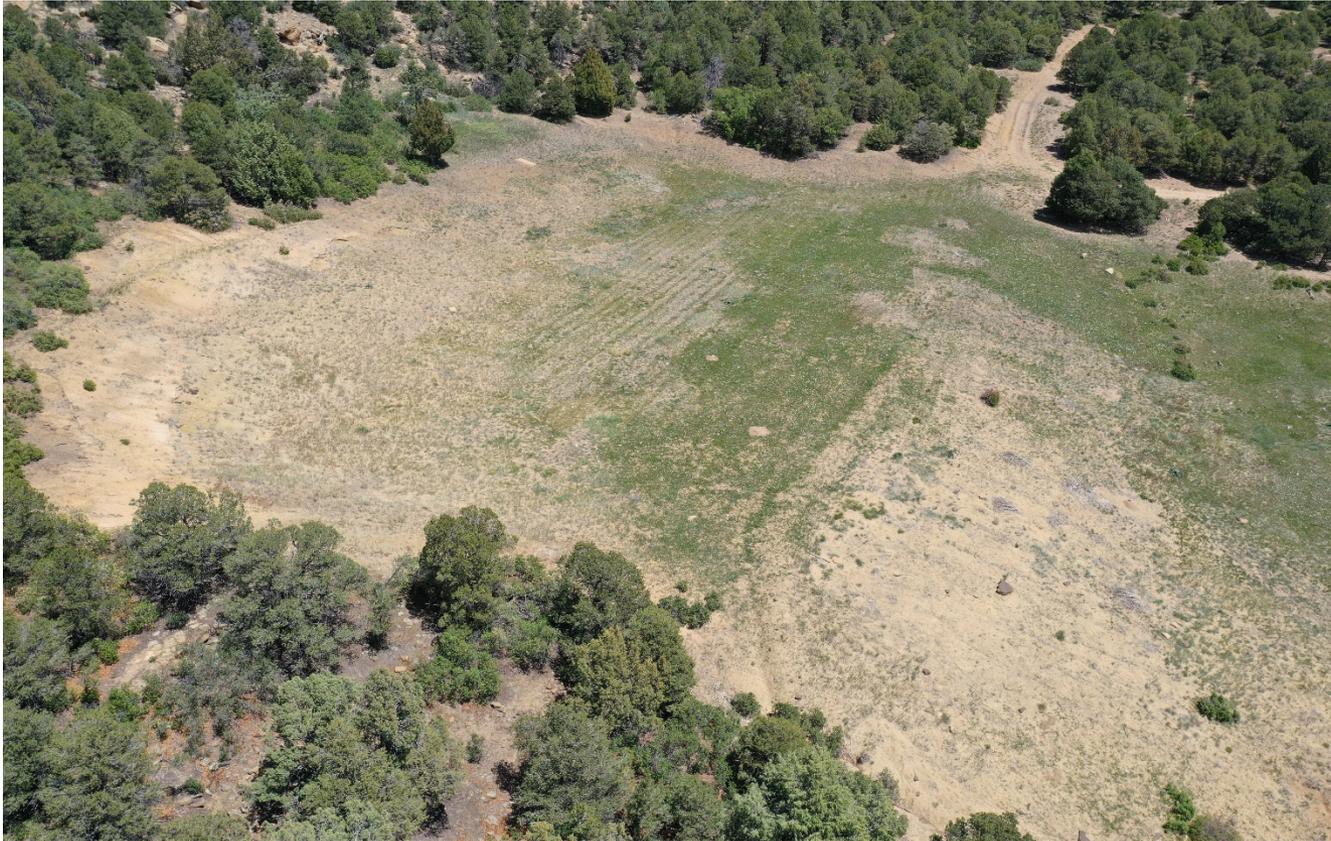
**Photo 3.** 2022 drone aerial photo Facing northeast toward the location. The location is not recontoured and reclaimed. Previous corrective action was not performed.

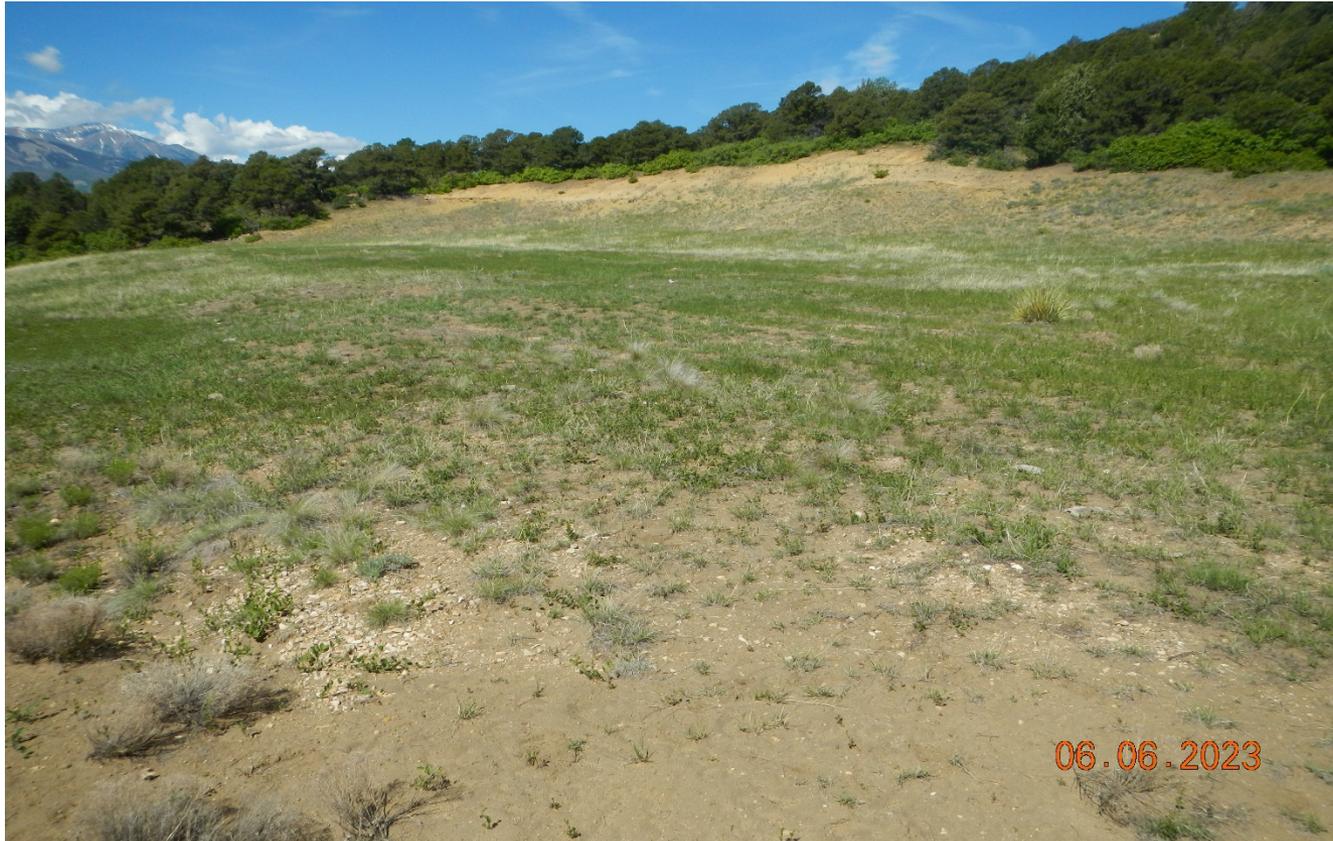
**Photo 4.** Facing northwest toward the location. The location is not recontoured and reclaimed. Previous corrective action was not performed.

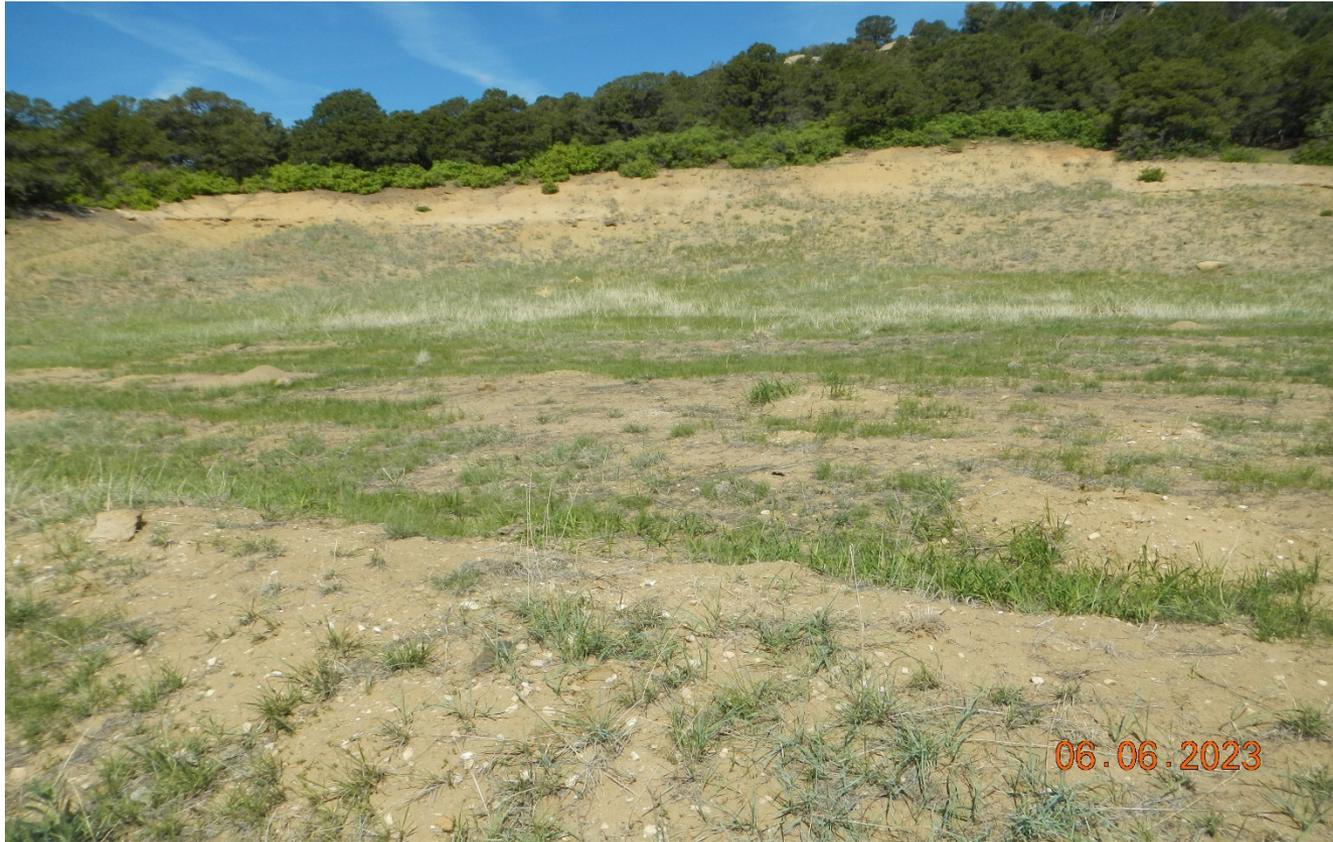
**Photo 5.** Facing northwest toward the cut slope of the location.

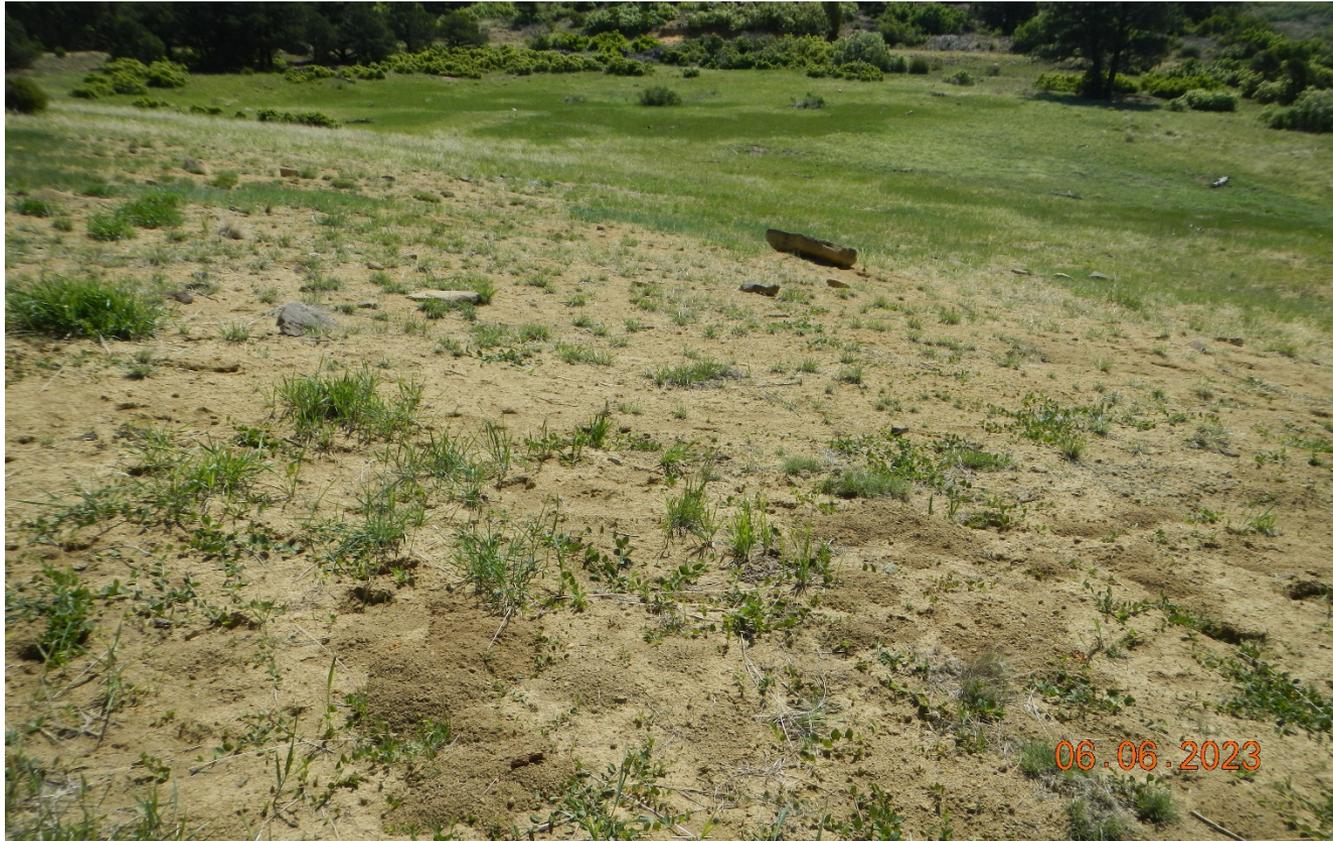
**Photo 6.** Facing east toward the fill slope of the location. There are noxious weeds along the fill slope such as field bind weed.

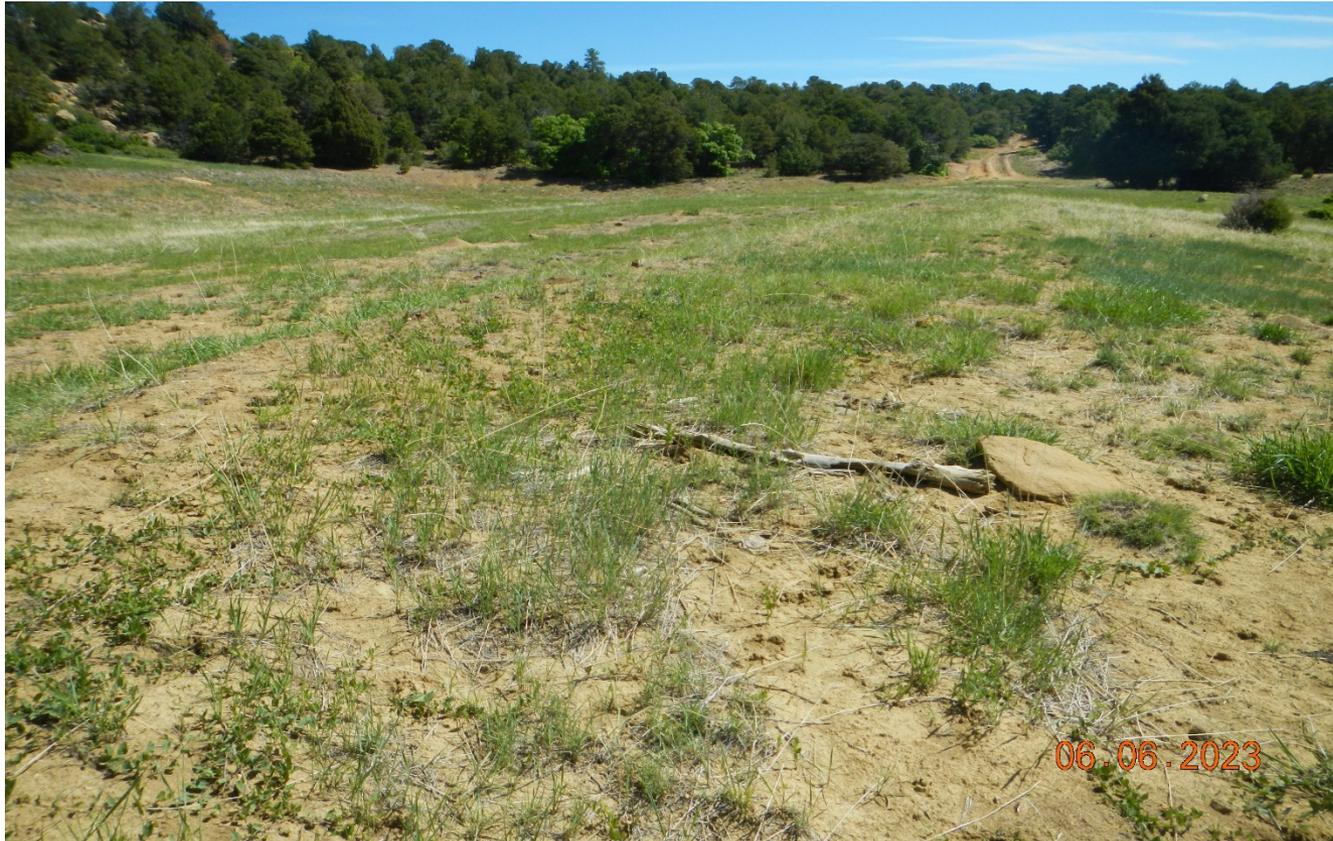
**Photo 7.** Facing northeast at the location.
